CSS *GEORGIA*
ARCHEOLOGICAL DATA RECOVERY AND MITIGATION
FOR THE SAVANNAH HARBOR EXPANSION PROJECT (SHEP),
CHATHAM COUNTY, GEORGIA AND JASPER COUNTY, SOUTH CAROLINA

**FINAL DRAFT REPORT
OCTOBER 2019**

Stephen R. James, Jr. and Gordon P. Watts

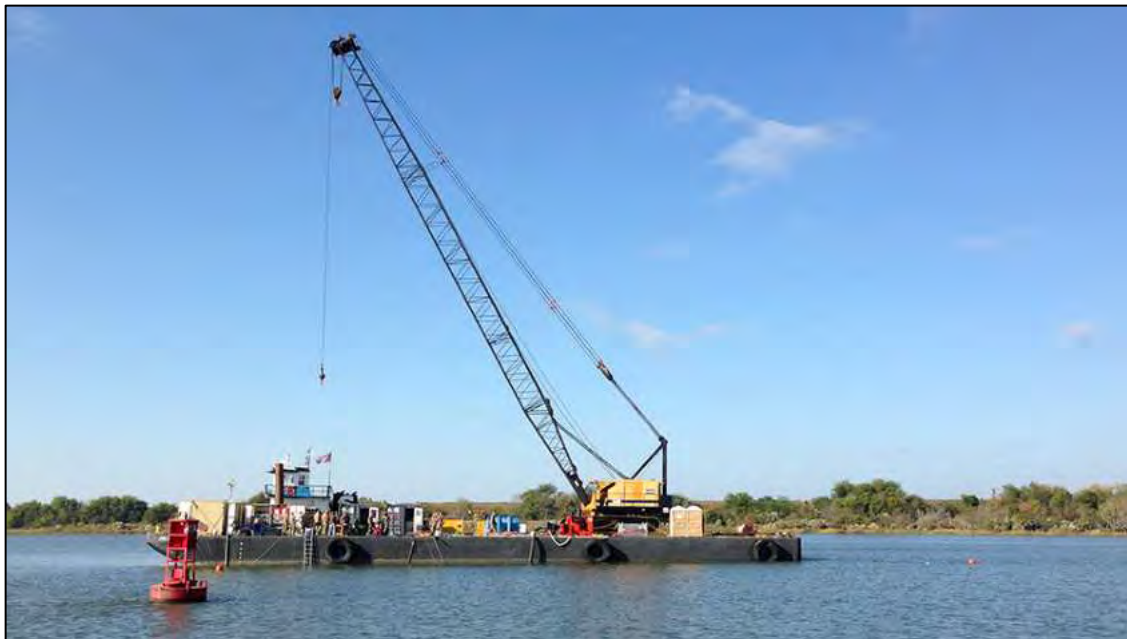
Figure 3-14. Barge on site with lift crane. Note the small orange West (left) and East (right) Casemate mooring balls that were employed to align the barge on the northern side of the site. Crane body is directly opposite the recovery section.

Objectives 5 and 6 were performed with SUPSALV/MDSU-2 from November 8 through 16 aboard Donjon Marine’s rented 150-foot “spud” barge with crane. Illustrated in Figures 3-14, and 3-15, the barge was anchored on the northern side of the site employing the visible East and West Casemate mooring balls to position the barge in the correct location and alignment so as to first ensure anchoring would not affect wreck components, and secondly to afford optimum access to site components by MDSU-2 divers and recovery by crane. The mooring balls had been placed on-site by Panamerican archaeologists only for the duration of the project, and the barge anchoring location, besides not affecting the site, was well outside of the navigation channel.

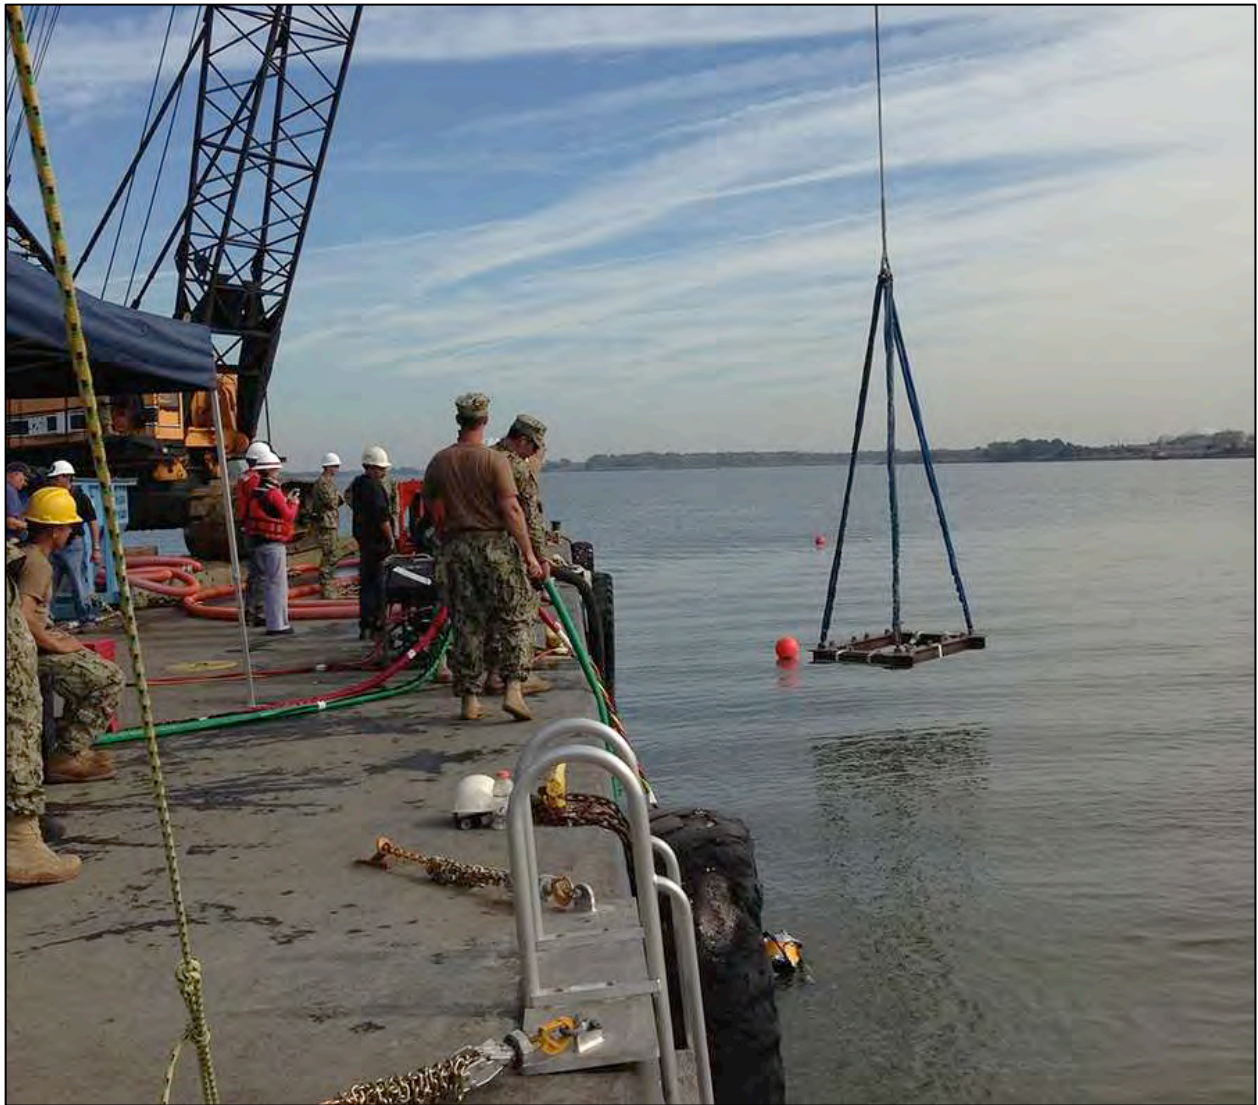
Figure 3-16. Iron I-beam cradle being lowered down to the recovery section.

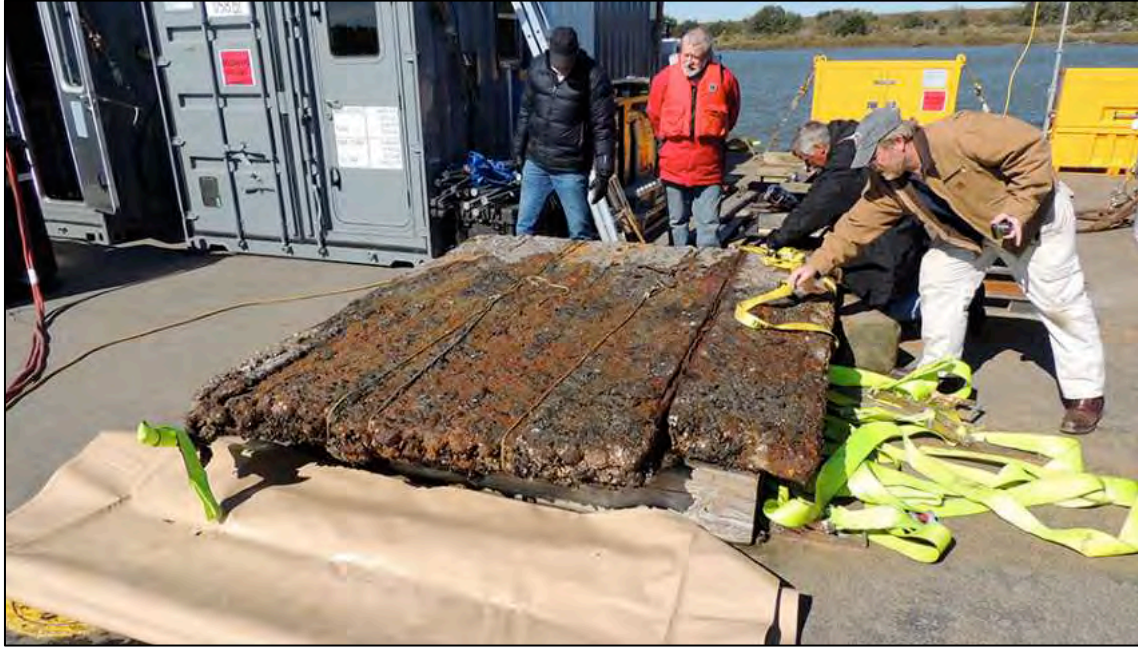
Figure 3-17. Recovery Section with the cradle removed (note ratchet straps). Small section of rail has broken away as evidenced by linear cracked seam.

The lift cradle, constructed of iron I-beams, was then lowered onto the recovery section and attached to the either end of the section again with large ratchet straps (Figure 3-16). As seen in Figure 3-17, the recovery section was successfully lifted by this method. However, a small

section of rail did calve off the main section. This small section was shorter than the other rails, and had not been ratcheted together as the main section was. Also, as illustrated in Figure 3-18, the wood backing, for the most part, was in a highly deteriorated condition with little integrity and mostly detached from the iron rails.

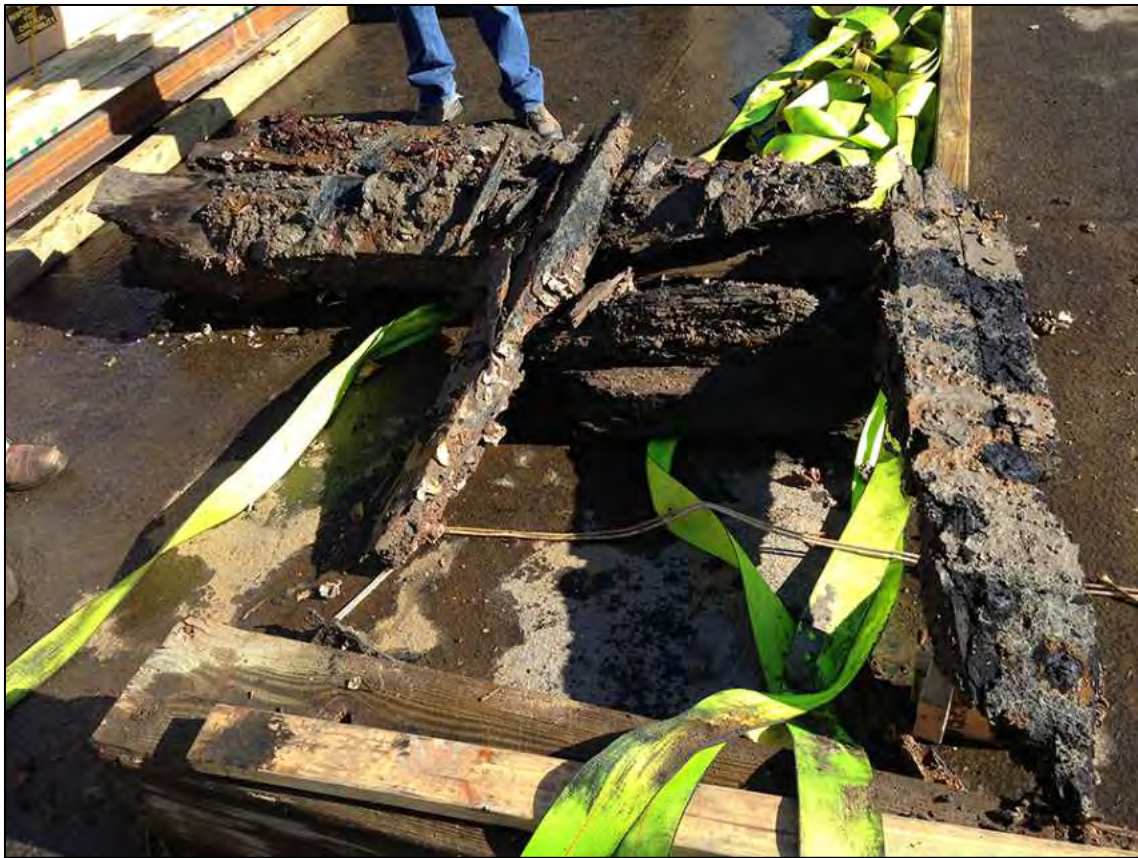
Figure 3-18. Wood backing that detached from the Recovery Section. The wood for the most part was in a highly deteriorated condition with little integrity that fell away from the iron rails when unsupported.

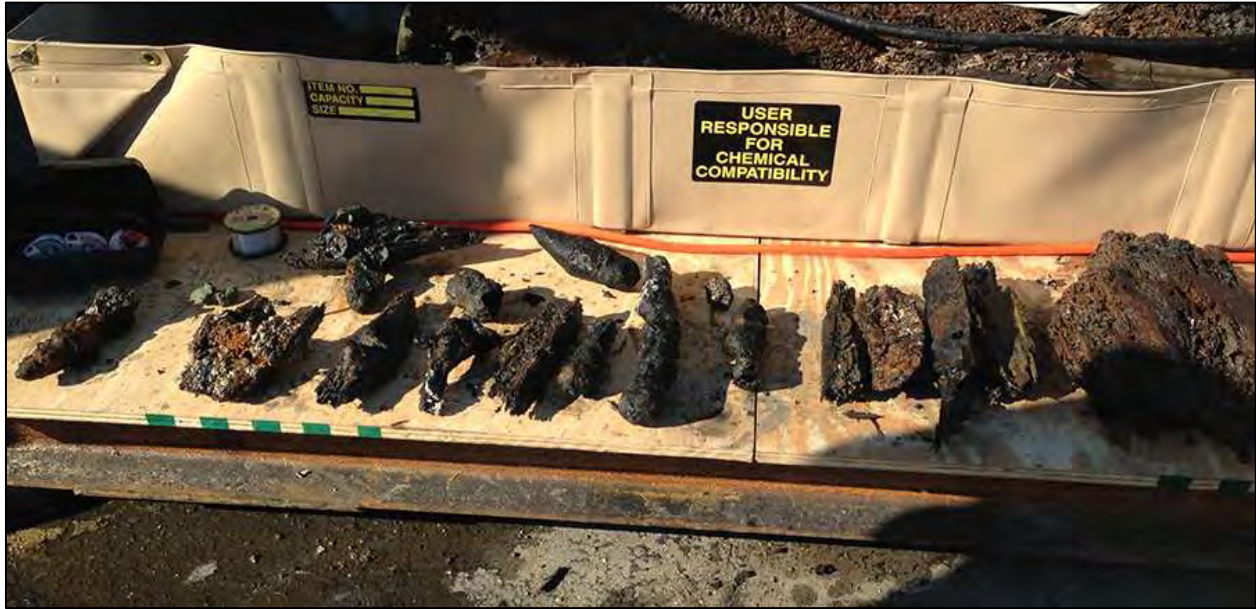
Figure 3-19. Artifact recovery from excavation beneath Recovery Section. The majority, if not all, of the recovered artifacts were small fragments of non-significant concrete and wood.

After recovery, excavation of the sediments down to clay was conducted underneath where the recovery section had originally lain. Preceded by hand collection of all visible wood fragments and artifacts into a basket, excavation was conducted by MDSU-2 divers with a 6-inch venturi dredge powered by a large diesel water pump; however, as illustrated in Figure 3-19, very little was recovered other than small fragments of non-significant concretion and wood fragments. Several fastener fragments were also recovered.

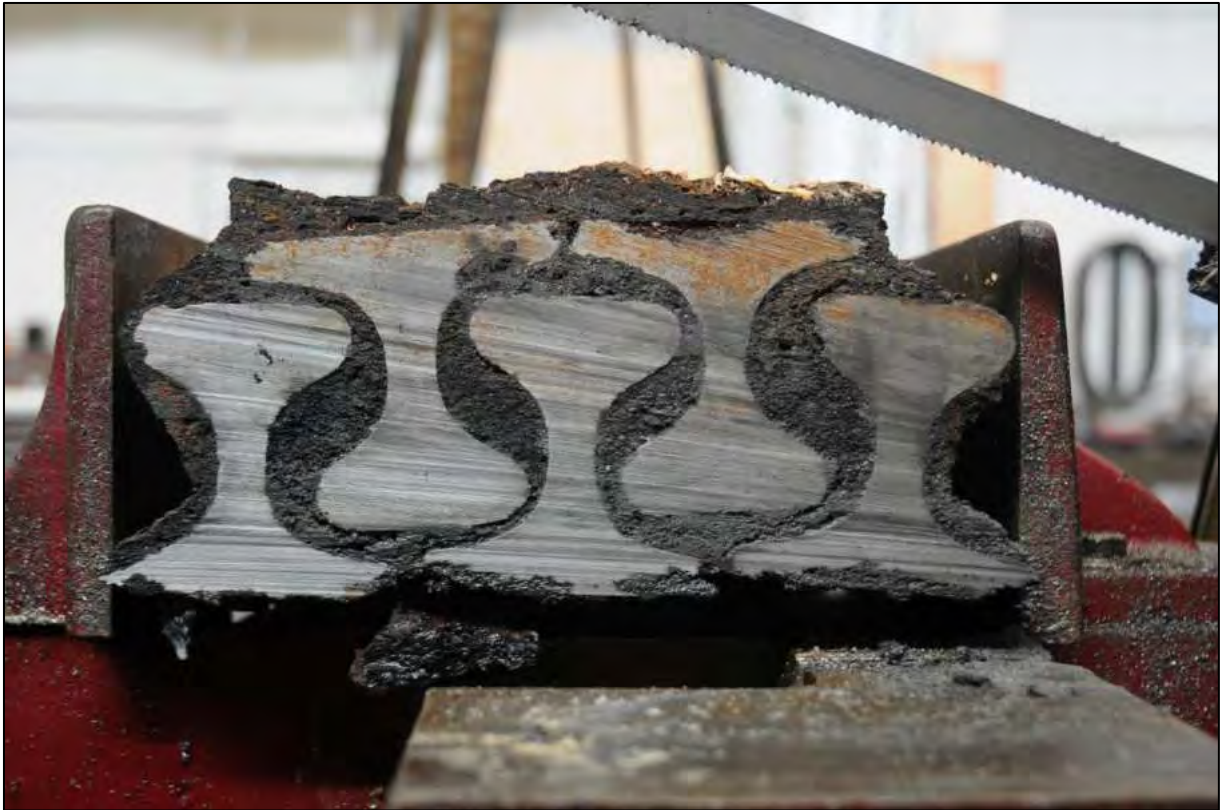
Figure 3-20. Initial profile cut of the small section of rail required for subsequent testing. This cut took six hours. Note that the rails look to be in excellent condition, with only minimal metal loss due to corrosion.

Designed to help acquire data that was employed by SUPSALV engineers for the lifting of casemate sections during the current recovery phase (i.e., lift frame strength and design requirements, amount [weight and length] able to be lifted, purchase points, etc.), destructive testing was undertaken on the smaller of the two casemate sections in November 2014 (Figure 3-20). Focused primarily on the rails and to lesser degree on the fasteners, the following tests were conducted.

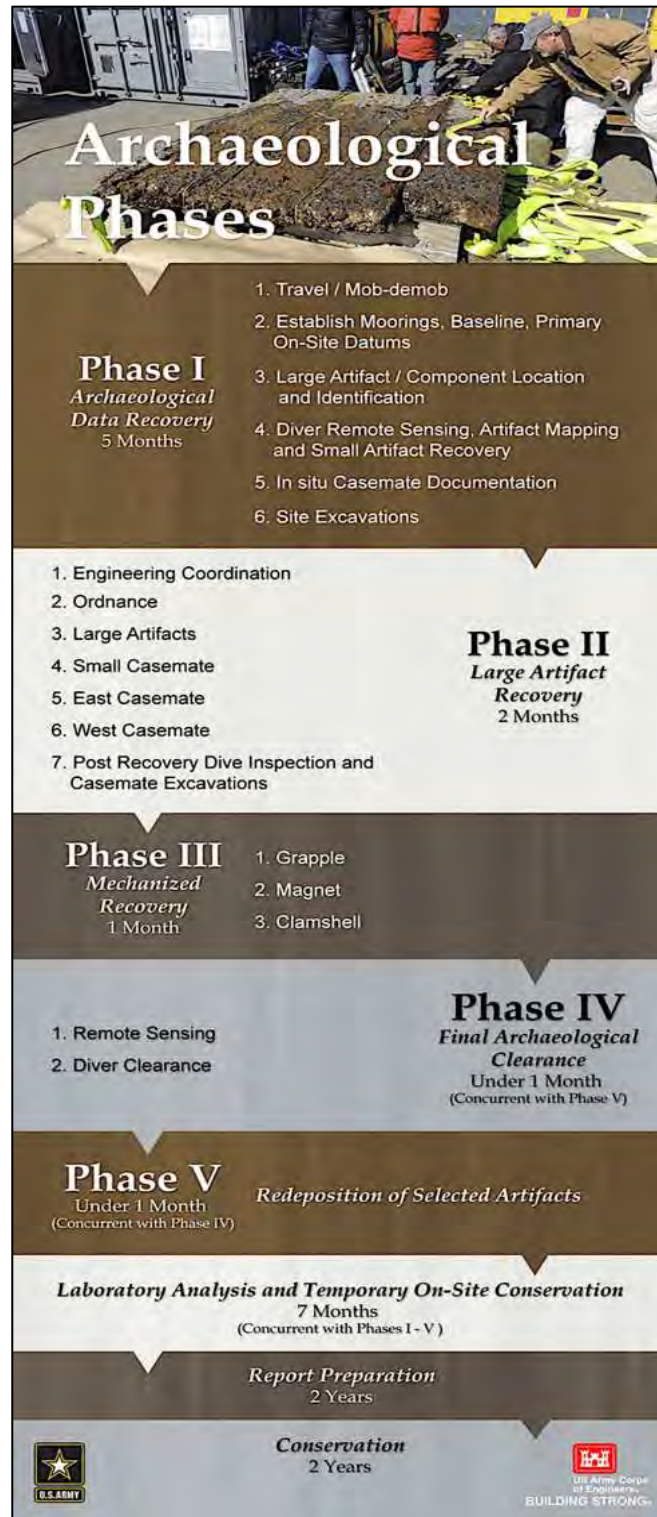
Figure 4-01. Archaeological phases (courtesy of the USACE, Savannah District).

As proposed, on-site operations in 2015 were broken down into five main phases (Figure 4-01). Phase I, the Archaeological Phase, was to be continued archaeological investigation designed to locate, map, and tag artifacts and site components; clear the entire site of observable small artifacts; and locate ordnance associated with the wreck. Phase II was the heavy lift recovery of site components, beginning with recovery of ordnance and followed by recovery of disarticulated vessel structure and machinery. Once the site was cleared of those elements, the three surviving sections of casemate were to be recovered, although as stated, recovery of the East and West Casemate sections were unsuccessful in 2015, subsequently being recovered in 2017. Phase III involved the mechanized clearance of remaining materials employing both a crane-operated grapple magnet and a clamshell (originally proposed, an electromagnet was employed on the USS *Westfield* recovery operations would not be utilized). Phase IV entailed an archaeological

clearance of the sight through remote sensing and diver survey. Phase V, the final phase, involved redeposition of selected artifacts and vessel components. Recovery efforts in 2017 would complete the Phases including East and West Casemates recovery (Phase II), burial of the casemate sections the final aspect of Phase V.

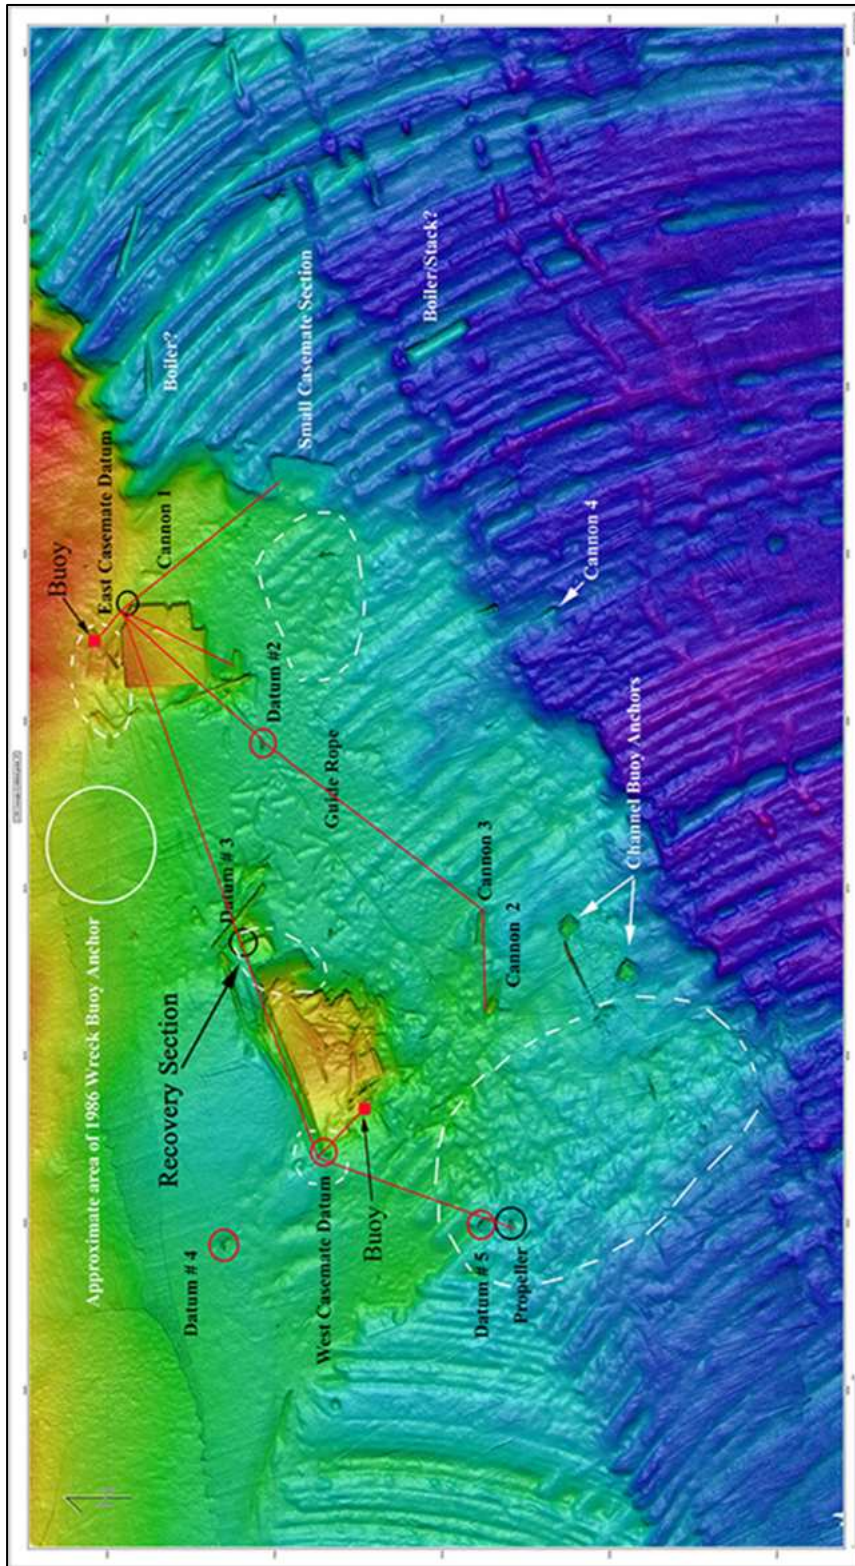
Figure 4-02. 2013 Georeferenced Multibeam Site Map. Shown are Casemates, Cannon, Propeller, Boilers (?), Mooring Buoy locations, Datum, and Transit Lines. White hatched areas were thought to be debris scatters.

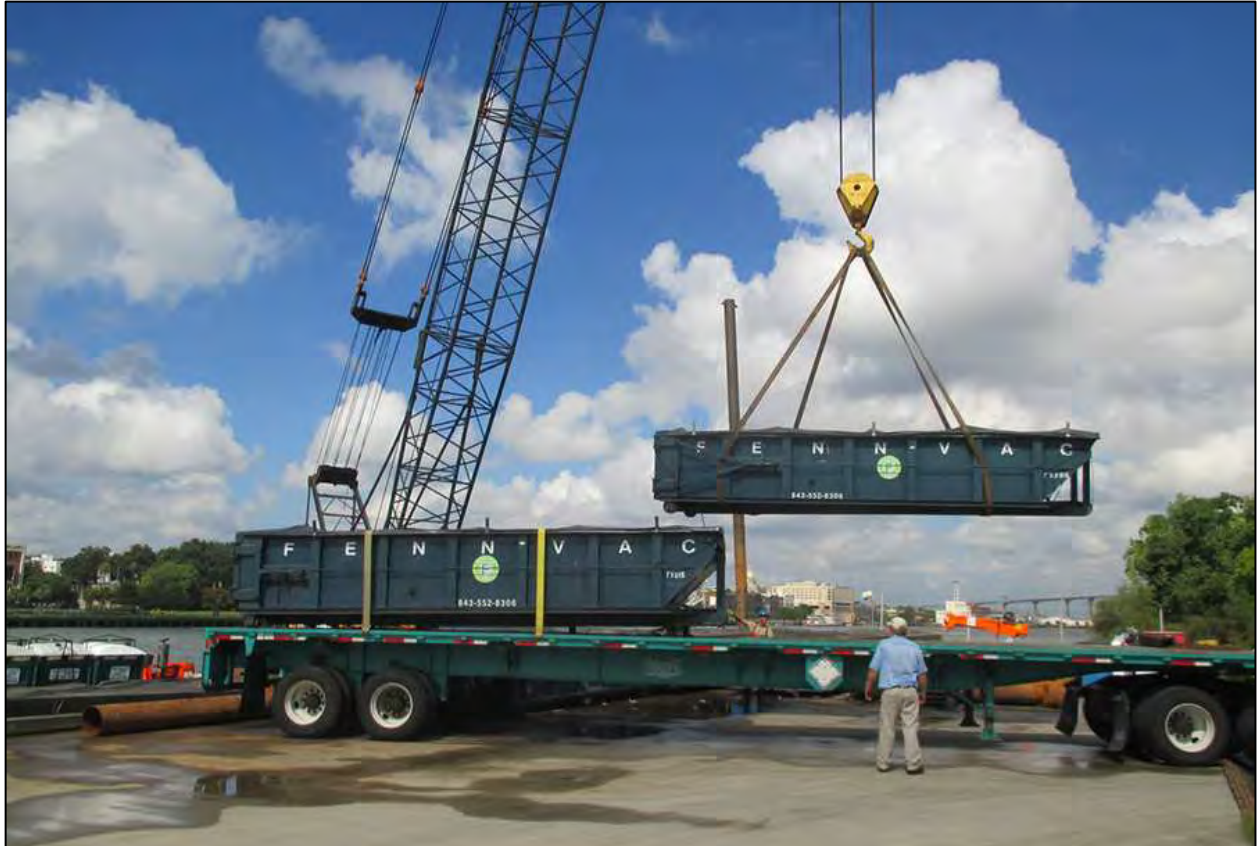
Figure 4-10. Roll-off containers full of artifacts being offloaded from the materials barge onto a flatbed truck at the USACE Depot dock for transport to CRL. The majority of the artifacts would be shipped in roll-off containers, including cannon.

and shipped in roll-off containers, as well. The casemate section(s) also will be in this category, as we have not yet decided how much is going to be conserved. These sections could very easily make up their own load, in a separate truck and shipped in roll-off containers for the smaller sections (Figure 4-10).

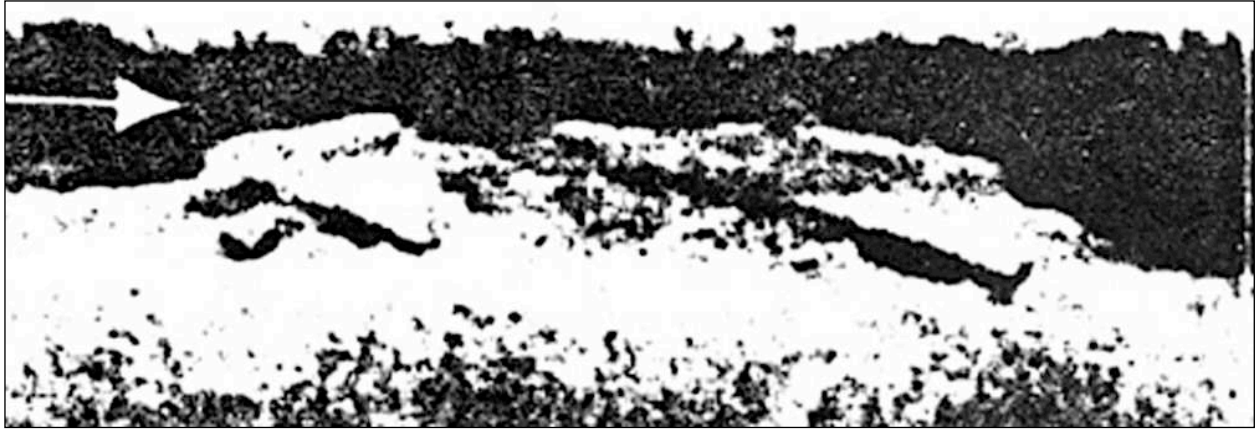
Figure 5-10. Excerpt from the 1979 acoustic sidescan image showing casemate sections with little if any surrounding sediment (as presented in Garrison et al. 1980:Figure 39).

Figure 5-08, a 2003 Reson Bathymetric oblique image of the site taken just before diving investigations, illustrates the West Casemate similarly pedestaled on a uniform surrounding bottom. Like the 2002 image, depths can be seen to increase as one moves down slope from the East Casemate towards the West Casemate and into the channel proper. This is graphically illustrated in Figure 5-09 below, a close up image of the East Casemate. Furthermore, when both the 2002 and 2003 images are contrasted with the 1979 sidescan image below, the wreck sections do not appear to be buried, suggesting little if any sediment was present at the site at this early, pre-Tide Gate Closure date (Figure 5-10).

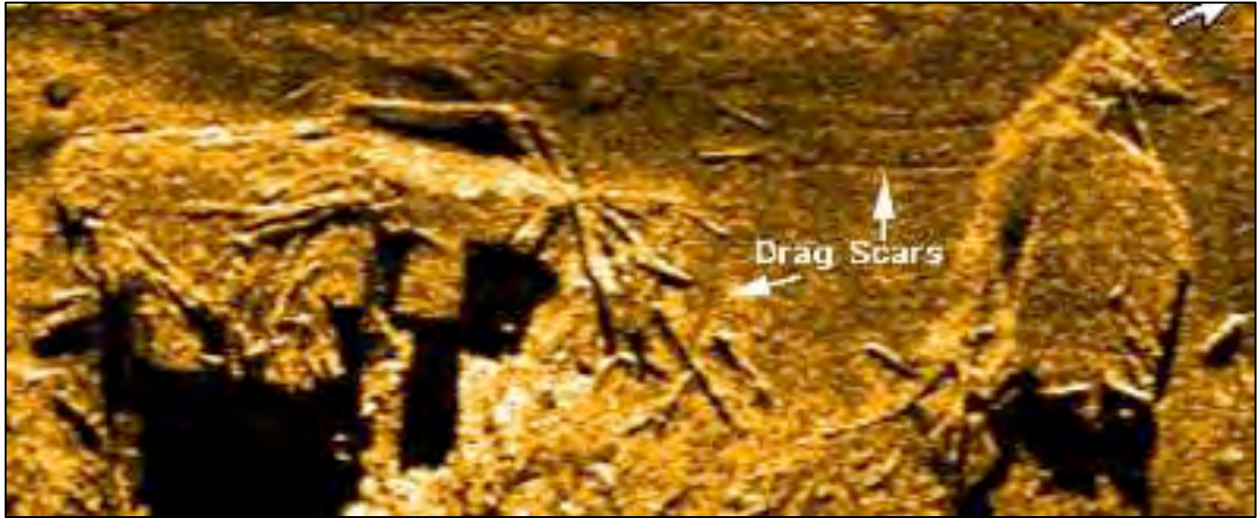
Figure 5-15. 2003 acoustic image of the West (left) and East (right) Casemate sections. Note the two linear drag scars at the top left of the East Casemate projecting toward the West Casemate, and a second fainter set running toward the channel to the right of the West Casemate. Also note 6-pownder cannon to the right of the East Casemate's midsection.

A comparative analysis of sidescan images from the 1986 study and the 2003 study, a period of 17 years, shows virtually the same site composition and reveals, in some instances, severe degradation to the resource. Taking into account technological advances and directional movement in the survey vessel or tow fish, both the 1986 image (Figure 5-14) and the 2003 image (Figure 5-15) depict the West and East Casemate sections with only slight differences. Figures 5-16 to 5-19 are close-ups from both the 1986 and 2003 images showing comparative differences or changes to each casemate section highlighted in red. The changes in the 2003 images are all thought to be a direct result of the 1982 incident.

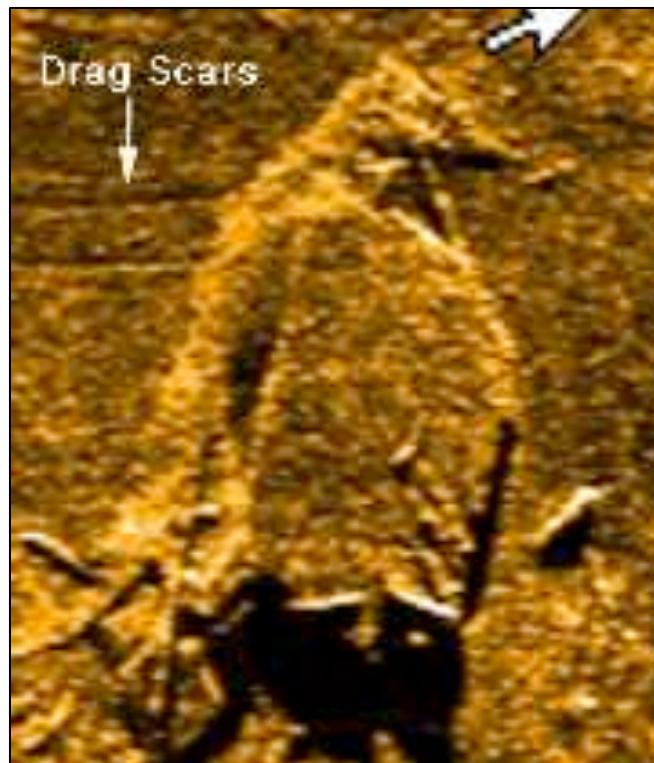
Figure 5-17. 2003 acoustic image of the East Casemate section. When compared to Figure 5-16 above, the damaged areas on both ends and the linear drag scars are clearly evident.

The 1986 image of the East Casemate shows its northern tip to be complete (Figure 5-16), and the 45-degree as-built angle depicted on this image is evidence that this section originally formed one end of a side of the vessel's casemate (port or starboard?). However, a comparison of the 2003 close-up shows that the section's northern tip, once complete, has been severely impacted with the tip now laying separated a slight distance from the section (Figure 5-17). A result of the fouled anchor, the drag scars are clearly visible and they indicate that the anchor was drug either from the east across and through this section transiting toward the West Casemate and then down toward the channel, or from the reverse direction.

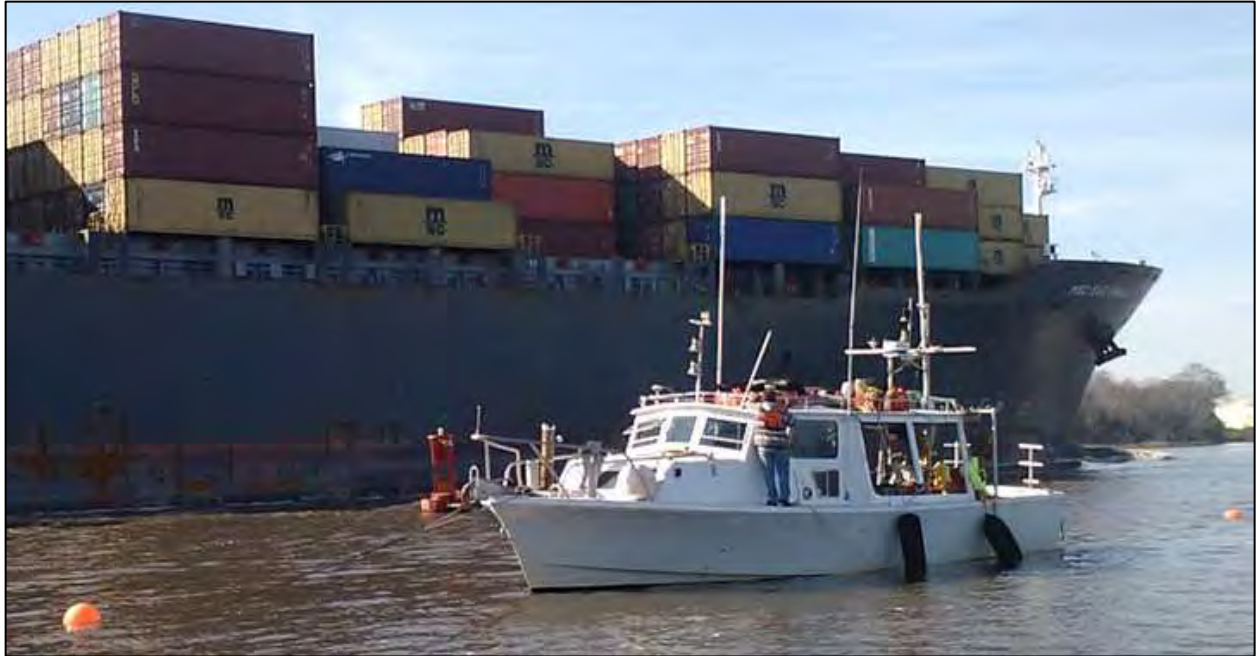
Figure 6-01. Offshore Retriever moored at both bow and stern waiting for tide to turn to begin diving operations. USBL system pole is being fastened vertically aft of black bumper. Looking toward the CSS Georgian shore, red channel/wreck marker is just opposite the bow.

Following Objective 1, which was the mobilization of crew and equipment, Objective 2 was conducted from January 10 to June 6, 2015. Operating from the 40-foot *Offshore Retriever* (Figure 6-01), the first task was mooring placement for ease of daily boat positioning and diver access to the site. Two moorings were placed on-site by the archaeological divers, one on the West Casemate and one on the East Casemate, both comprised of large “Norwegian” balls (i.e., floats with tag lines) with the floats tied to the casemates with lengths of 1-inch polypro chained to the casemate. Short lines were then run from these locations to the baseline at the West and East Casemate datums for diver access and immediate orientation. This system allowed the boat to be rapidly positioned each day between the moorings with its bow and stern tied to the tag lines, either bow upstream or downstream, thus allowing all areas of the site to be easily accessed by the divers.

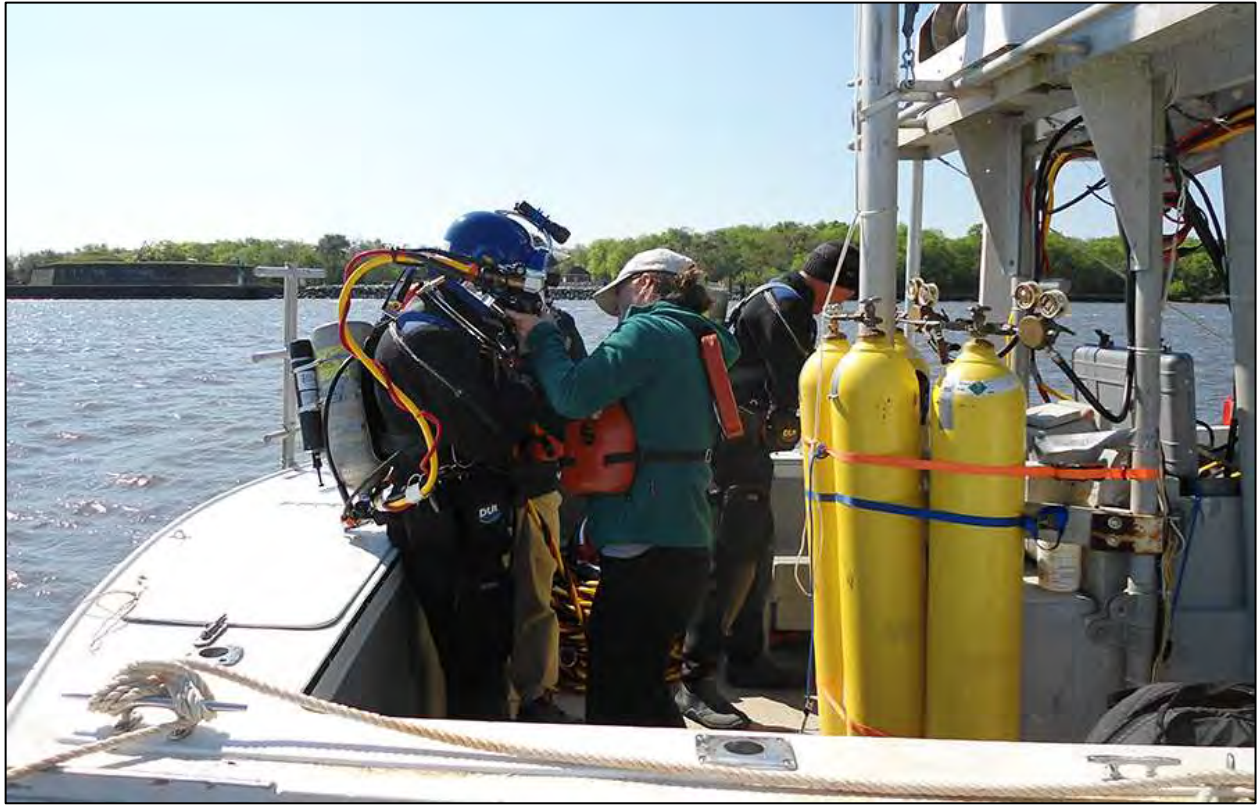
Figure 6-02. Archaeologist preparing to enter the water with Surface-Supplied Air diving equipment. Note black USBL system transponder attached to the bailout SCUBA tank. Fort Jackson in background left.

Surface-Supplied Air (SSA) was chosen as the most efficient and safe method of conducting investigations within the Project Area. Divers employed a Kirby-Morgan KMB-27 or Superlite-17 dive helmet connected to a SSA source, radio communications cable, safety tether, and pneumo hose (Figure 6-02). On the surface, various individuals and pieces of equipment ensured safe diving operations. A dive tender was required to aid the diver in donning and doffing equipment and to tend the diver while submerged and moving about the sea floor. The radio communications operator kept in constant contact with the diver and relayed messages between the diver and the surface support team. A suited, standby diver was required on-site in the event of an emergency situation that would require aid to the primary diver. Finally, a dive supervisor was present on-site at all times to coordinate the activity of the diver and surface support team to achieve the project goals.

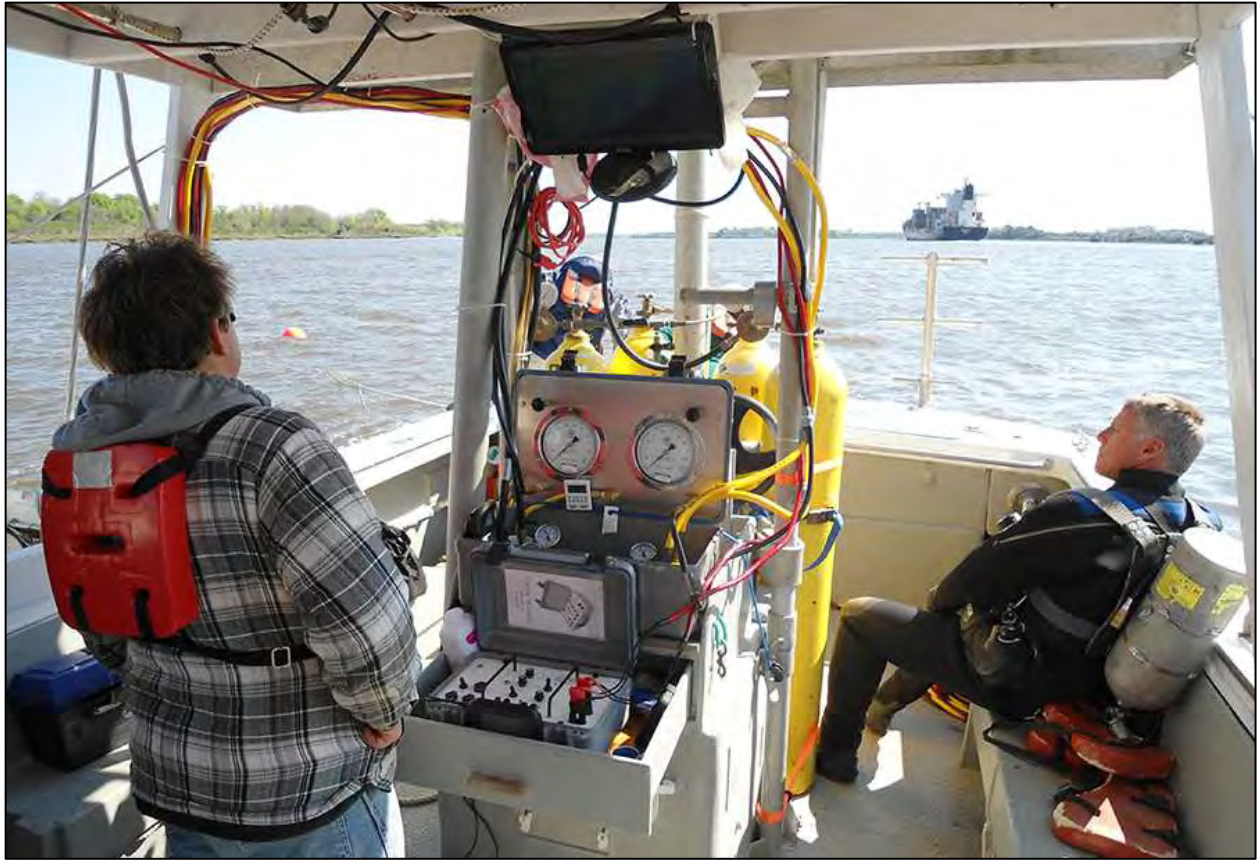
Figure 6-03. Dive station looking aft towards dive tender. Stern mooring ball in the left background. Note redundant yellow air cylinders, dive radio in drawer in front of air manifold, and computer monitor for tracking USBL-equipped diver above. Suited standby diver at right.

Air for SSA diving was provided by a cascade system of two 240-cubic-foot compressed air cylinders, opened to supply air one at a time. Pressure gauges and check valves were included in the air supply system. Illustrated in Figure 6-03, two levels of redundant backup air supply were used, including a second on-deck 240-cubic-foot compressed air cylinder, and a 50-cubic-foot aluminum SCUBA cylinder worn by the diver and connected to the dive helmet. The dive supervisor acted as timekeeper, monitoring the depth, time, and air supply system during each dive to ensure that air pressure was correctly maintained and adequate reserve air was always available, as well as make notes of diver descriptions of environmental data and target or feature data. A certificate of air quality was obtained from the air supplier and submitted to the USACE–Savannah District Diving Coordinator for approval prior to commencement of diving activities. And prior to commencement of each day’s diving operations, a Pre-Dive Safety Meeting was held with all members of the dive team and vessel crew. All safety and diving procedures were discussed in detail. Diving commenced upon completion of the meeting.

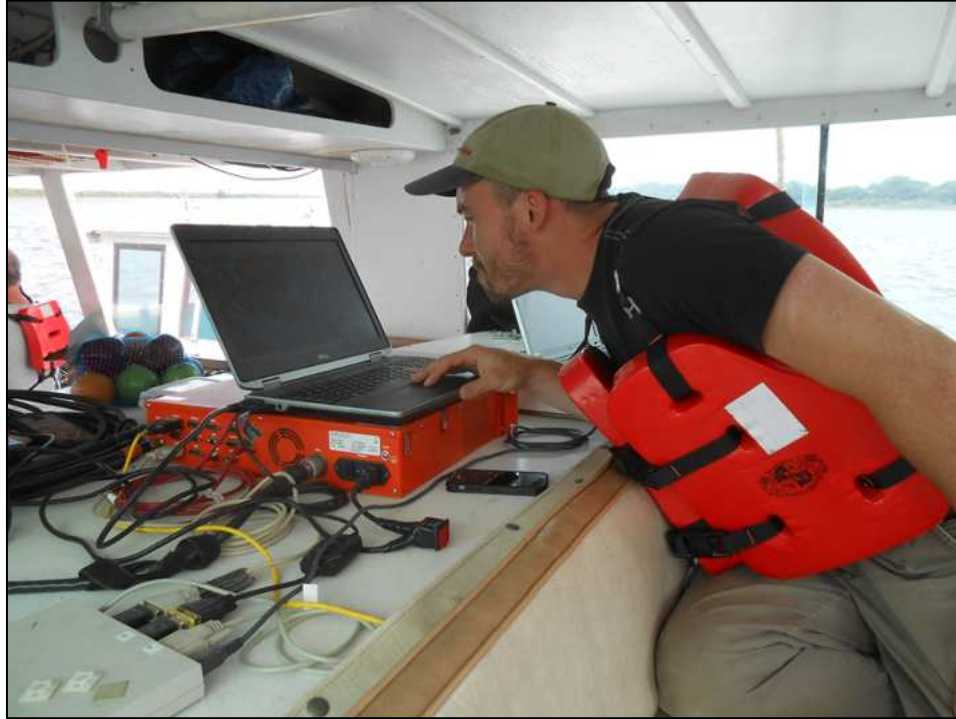
Figure 6-04. Navigation computer operator ensured input of USBL system data, and output onto the 2013 Multibeam Site Map monitor observed by the topside dive supervisor. Operator was also responsible for recording and labeling on the site map the locations of all artifacts observed.

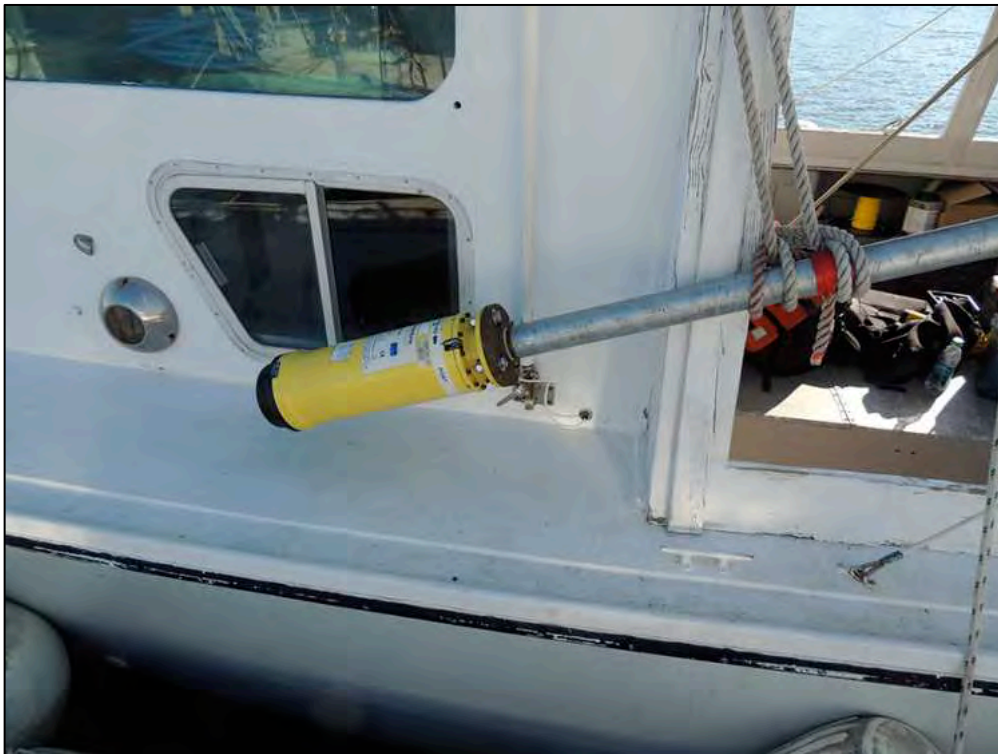
Figure 6-05. Yellow Sonardyne Scout Pro USBL system vessel-mounted receiver lashed amidships during transit to and from the site. Once the vessel was moored up, the receiver would be lowered into the water until vertical (see Figure 6-01).

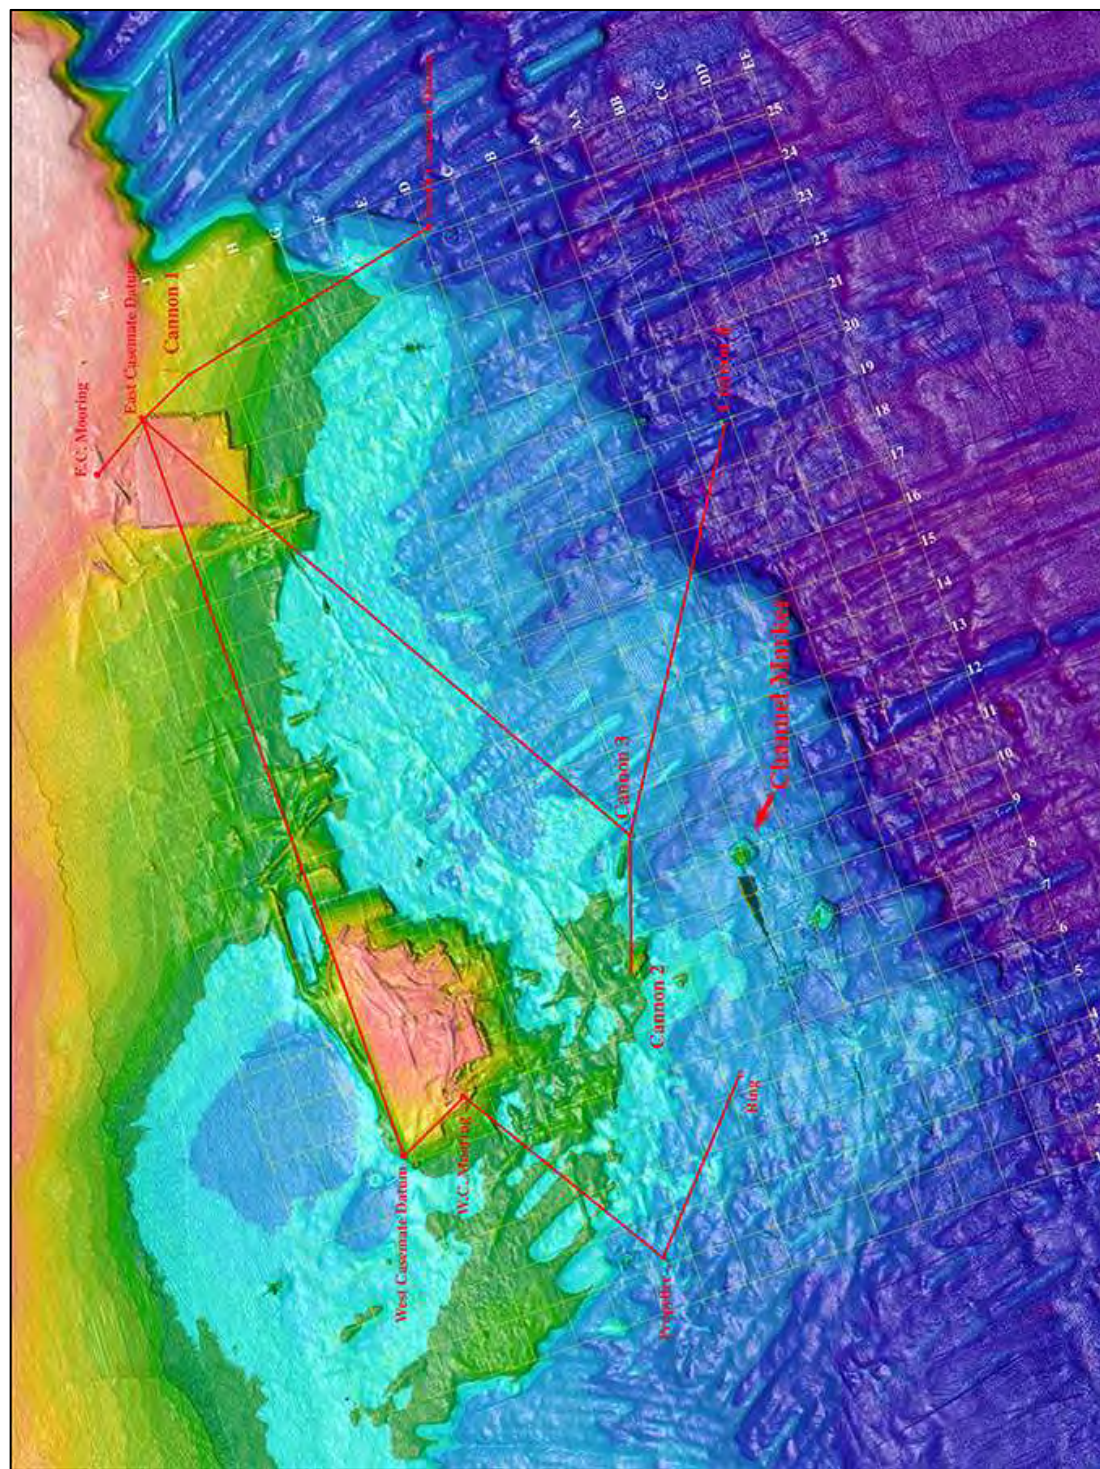
Figure 6-07. Site plan showing mooring buoy locations and transit lines from each to the West and East Casemate datums, respectively; baseline between East and West Casemate datums; and transit lines to Cannon 1, 2, and 3 and the propeller. All placed in 2013, the lines were replaced or tightened, with new transit lines connected to Cannon 4 and a large "ring" in the area of the steam cylinders.

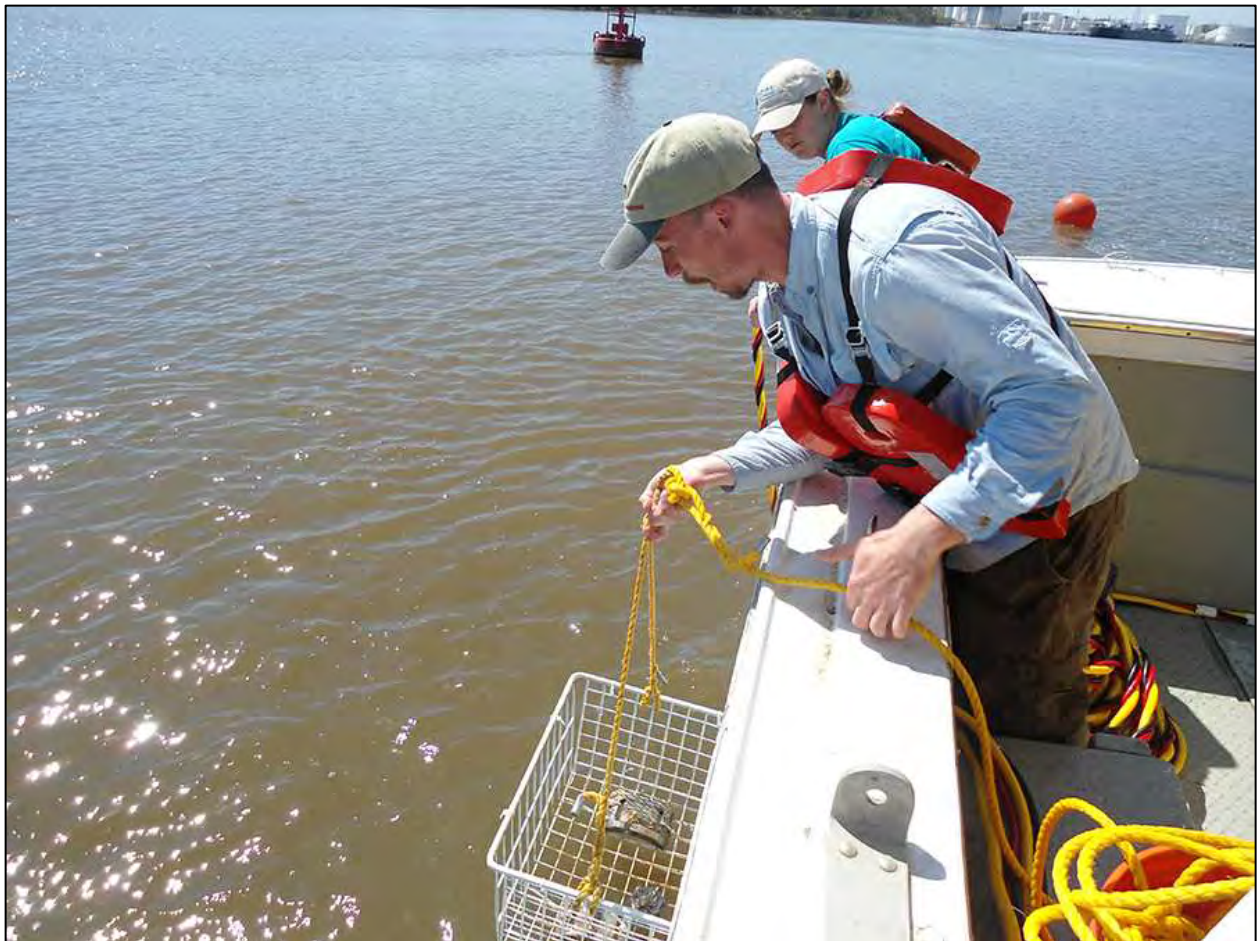
Figure 6-12. Artifact Retrieval Basket being brought to the surface, a very simple yet productive system.

Employing the electronic grid, units were systematically mapped. This entailed the USBL-equipped diver being directed to the center of a unit with a weighted Artifact Retrieval Basket (Figure 6-12). The diver, working from the basket out to a distance of no more than 5 feet, moved in either a clockwise or counterclockwise direction from the basket until encountering an artifact. Again, all in absolute zero visibility, the diver described each artifact's approximate location in reference to the basket, for example, "cannon ball at 2 feet from basket at 12 o'clock." A topside archaeologist recorded the type and location of each artifact described onto a "Unit Form." In this manner the unit was completely mapped. Figures 6-13 and 6-14 present completed artifact recovery unit forms showing the type of data recorded. The Unit 8-D site form shows the basket in the center next to Cannon 2 along with the 8-foot "Condenser" on the opposite side (Figure 6-13), while the Unit 14-A site form shows a dozen UXO, both ball and shell (Figure 6-14).

All artifacts small enough to recover were placed into the Artifact Retrieval Basket and brought to the surface by rope (see Figure 6-12). Bigger artifacts, if present, were mapped in with rough measurements and positioned electronically. Upon completion of mapping and artifact recovery of a unit, the archaeologist would be directed to the center of an adjacent unit to begin the process again. At the end of the dive day, all artifacts were taken to the Field Lab at the USACE Engineer Depot and processed by CRL personnel.
