CSS *GEORGIA*
ARCHEOLOGICAL DATA RECOVERY AND MITIGATION
FOR THE SAVANNAH HARBOR EXPANSION PROJECT (SHEP),
CHATHAM COUNTY, GEORGIA AND JASPER COUNTY, SOUTH CAROLINA

**FINAL DRAFT REPORT
OCTOBER 2019**

Stephen R. James, Jr. and Gordon P. Watts

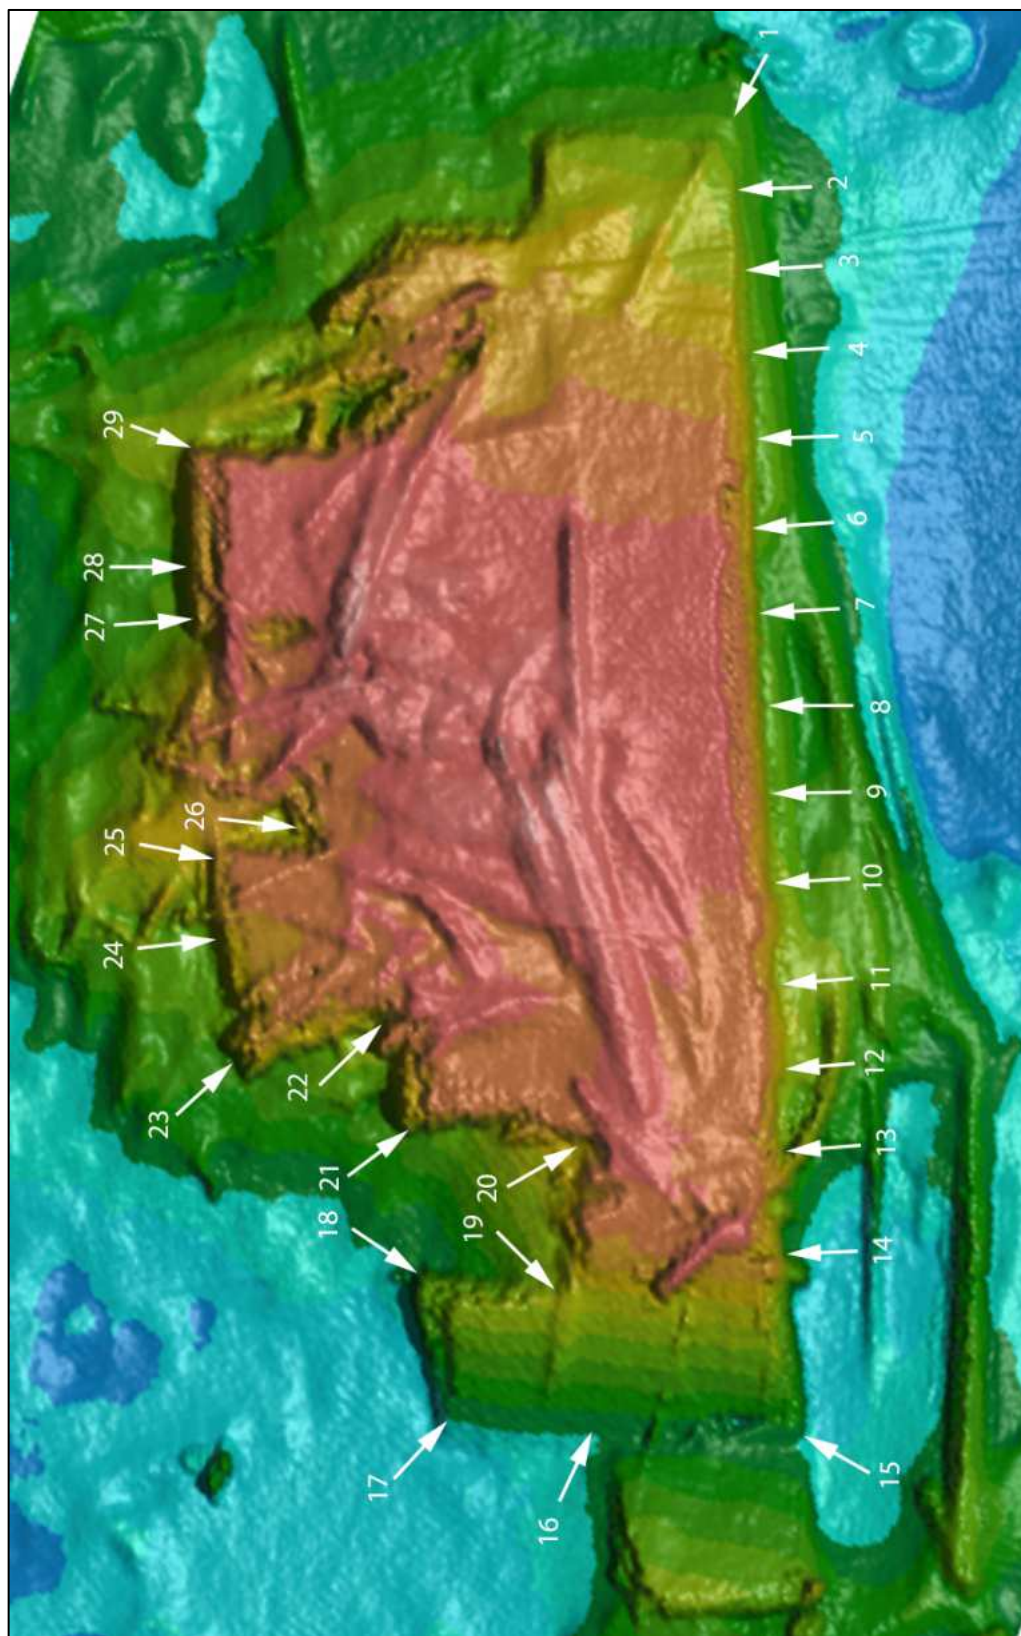
Figure 6-21. West Casemate data point stations. Note the numerous sections of loose rail on top of the casemate. Upriver is to the right.

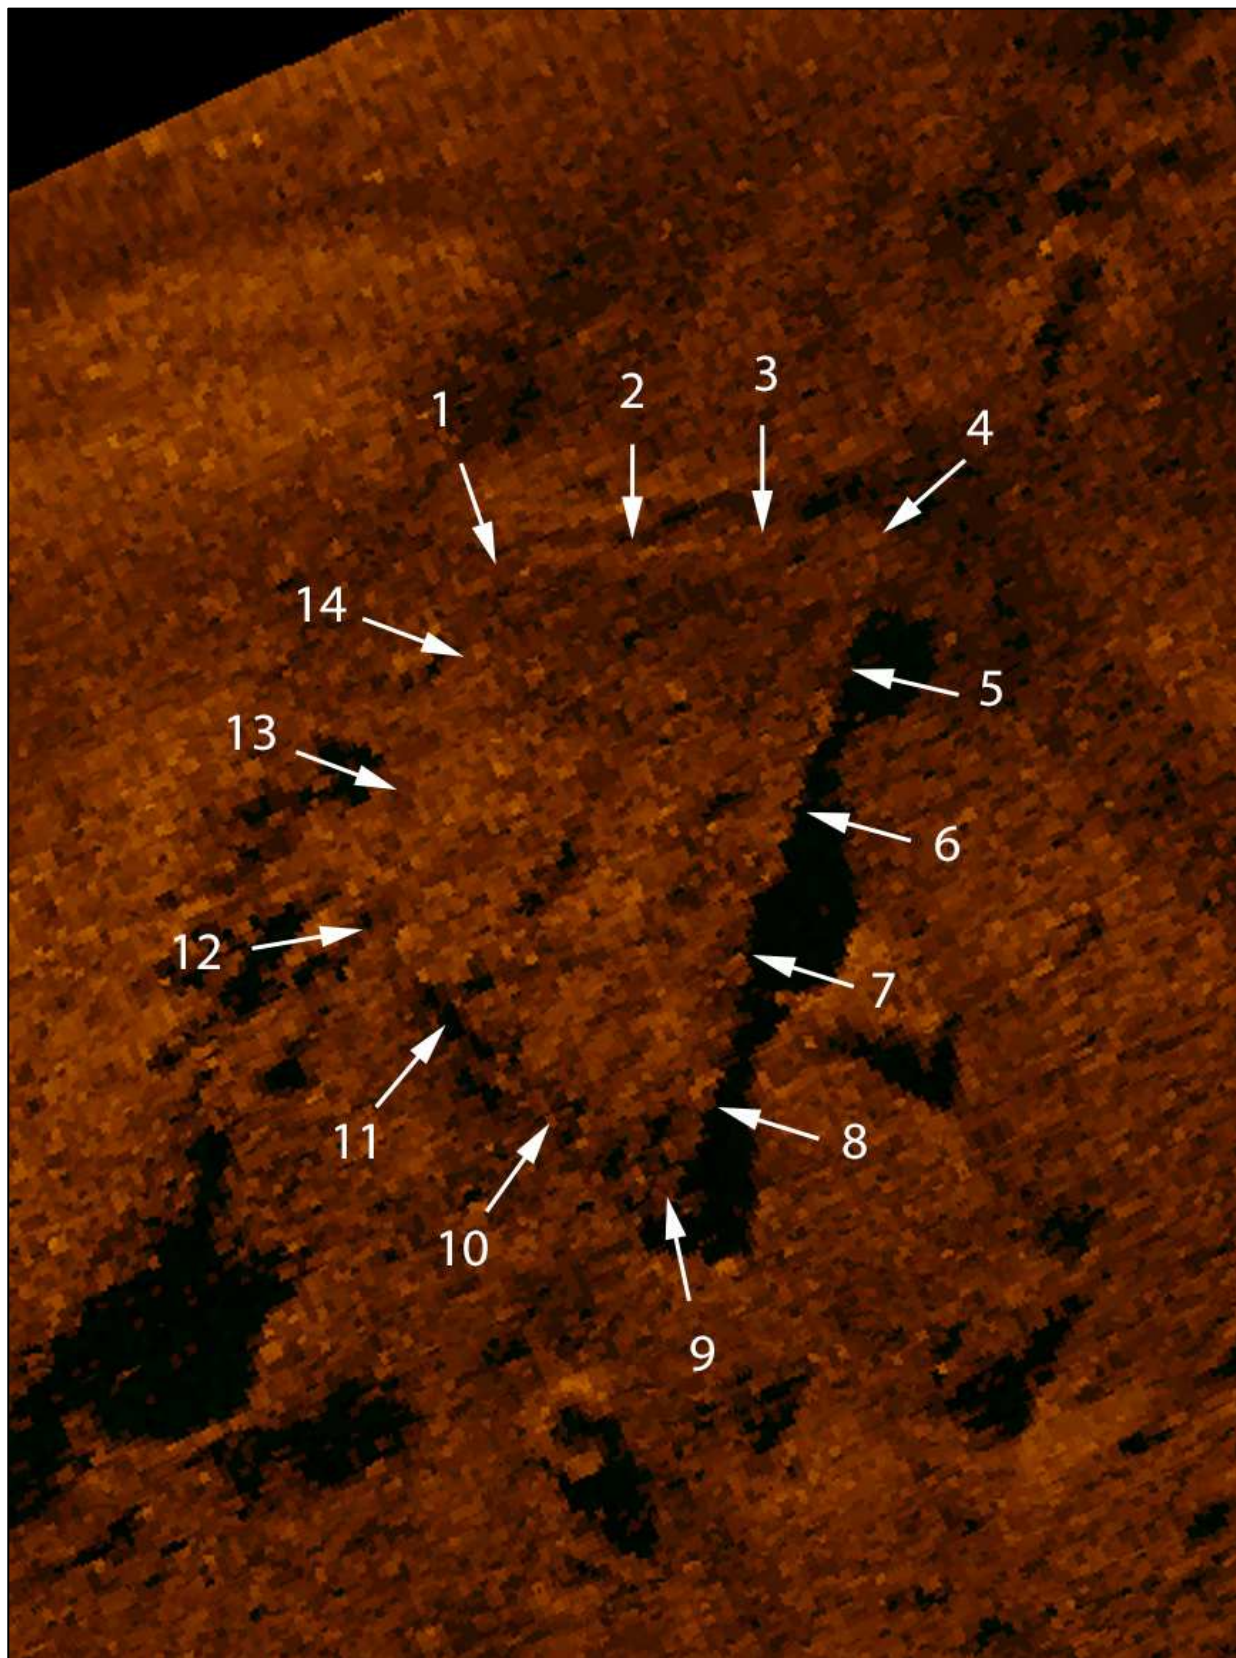
Figure 6-22. South Casemate data point stations. Hawse pipe can be seen under the number 7 station. North is upstream and downriver is to the right.

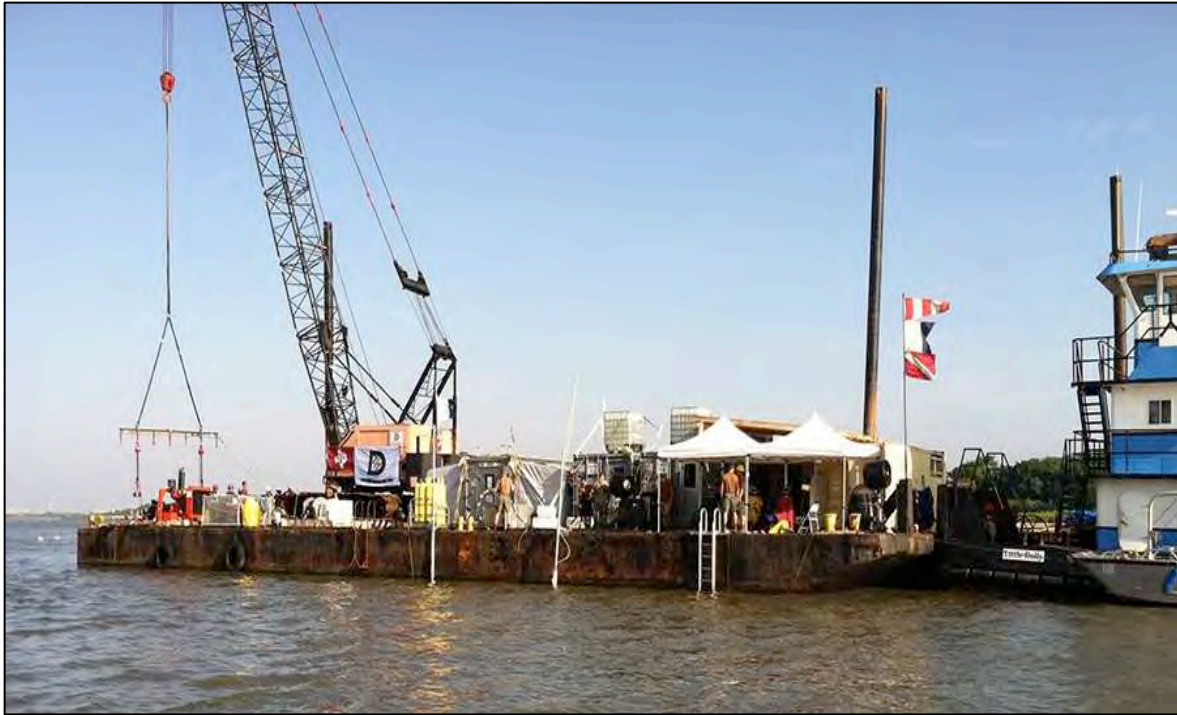
Figure 6-25. The smaller barge with 75-ton crane. The Command Center is immediately to the right of the crane. The Dive Station is far right, marked by a dive ladder and two white tents. CODA system and equipment rooms are in CONEX boxes between the Dive Station and Command Center. The CODA system pole is to the left of the dive ladder, with the USBL transponder pole to its left. The CONEX box at far right next to dive flags holds a recompression chamber.

Illustrated in Figures 6-24 and 6-25, the work platforms for this phase consisted of two spud-barges that were generally positioned side-by-side or end-to-end from one another. The smaller of the two barges held the MDSU-2 dive station and the Command Center. It was 120-x-30 feet and equipped with a 75-ton crane. The second larger barge was 200-x-30 feet, equipped with a 100-ton crane, and employed mainly for artifact storage during this Objective.

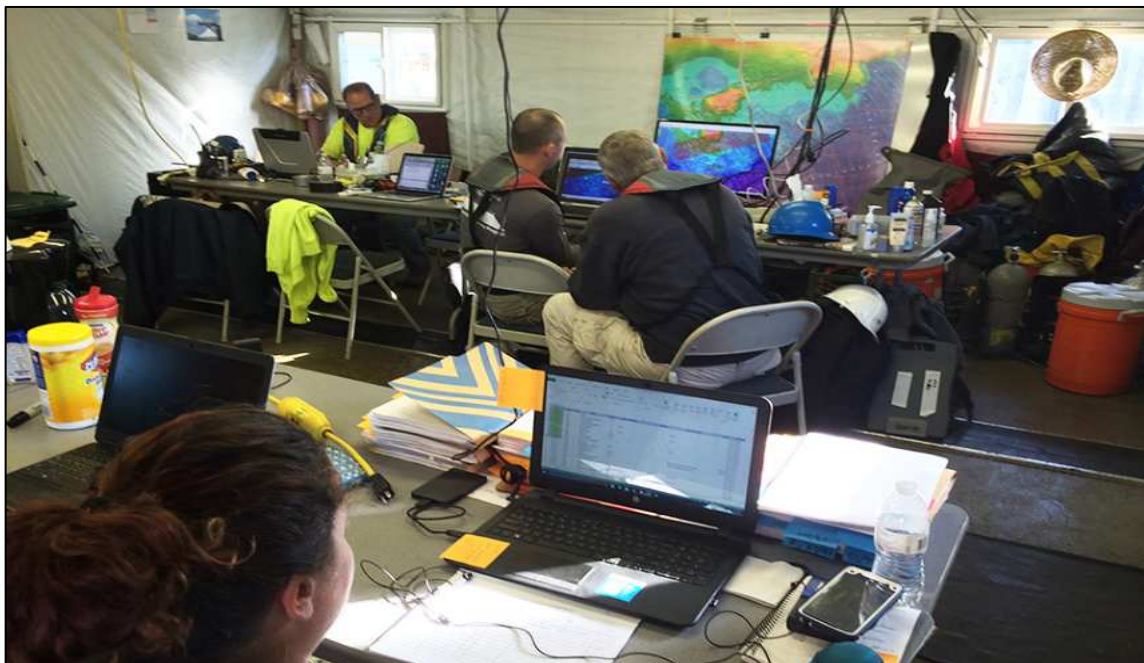
Figure 6-26. The Command Center. Archaeologist William Wilson and Co-Principal Investigator Dr. Gordon Watts are in center at navigation computer for the USBL diver tracking system. In radio communication with the Dive Station, Wilson was responsible for in-putting into GIS any diver-recovered or noted artifact such as DMM or machinery. At the lower left of the image is Erica Gifford, in-putting data from the Mechanized Recovery Phase.

Illustrated in Figure 6-26, besides being the site for briefings, the Command Center was also the onboard computer station for the USBL diver tracking system that proved invaluable to the success of the diving operations. Manning the station, the operator was responsible for ensuring an accurate signal between the barge-mounted USBL system receiver and the diver-mounted transponder, ensuring diver-tracking screen or image availability to the Dive Station, as well as marking or positioning into GIS any diver-recovered or noted artifact such as DMM or machinery. The temperature-controlled Command Center also served as the site for all computer related activities, the site for occasional meals, shelter for all during the numerous afternoon downpours, and the repository and in-coding station for field records during the subsequent Mechanized Recovery Phase.

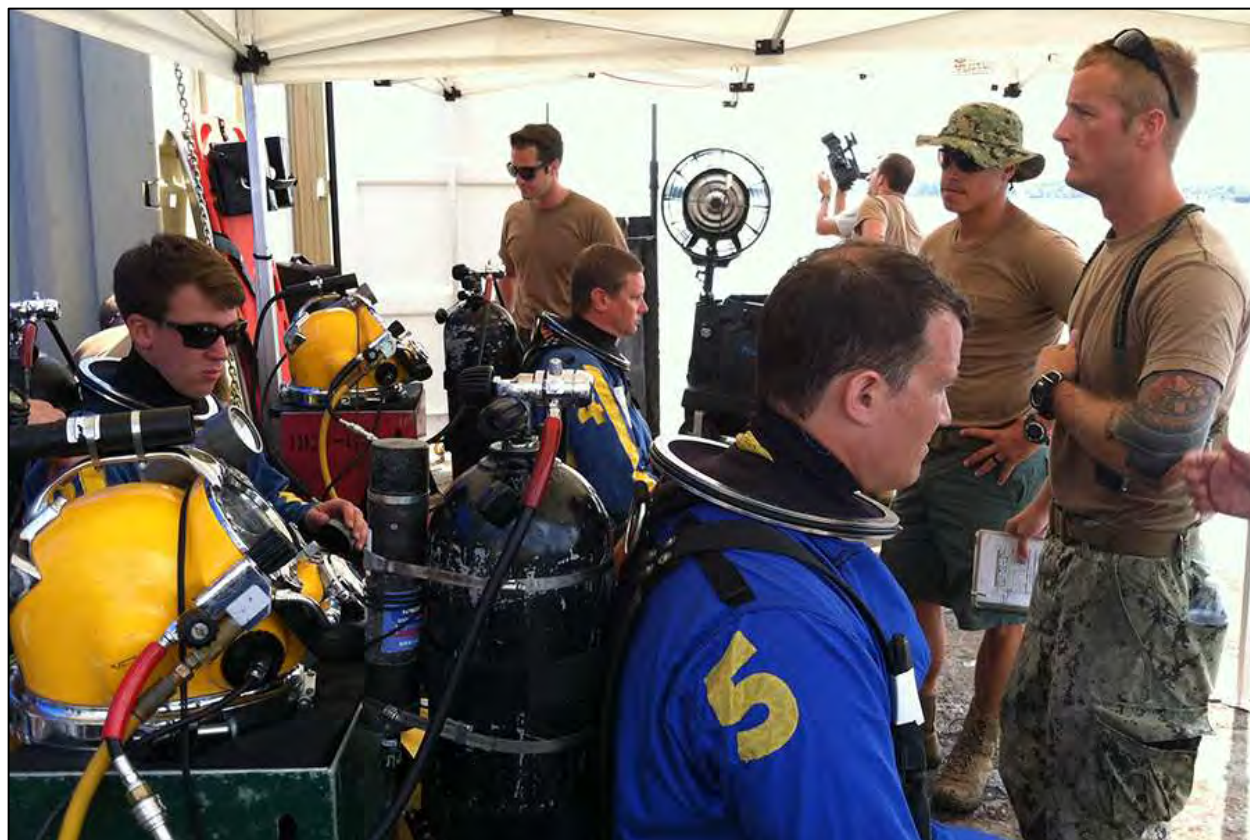
Figure 6-27. The Dive Station. “Green Diver” in foreground is equipped with USBL. “Yellow” Safety Standby Diver is at left. “Red” Diver in background paired with Green Diver for dive.

Comprised of up to 19 divers working in shifts, MDSU-2 divers conducted all dives associated with this objective except for several clearance dives conducted by Panamerican. The divers worked in pairs, with one of the divers equipped with a USBL transponder (Figure 6-27). The dives were conducted during the slack tide windows and lasted from 1 to just under 2 hours, depending on current strength usually with two slack tide cycles dived each day, and occasionally three cycles.

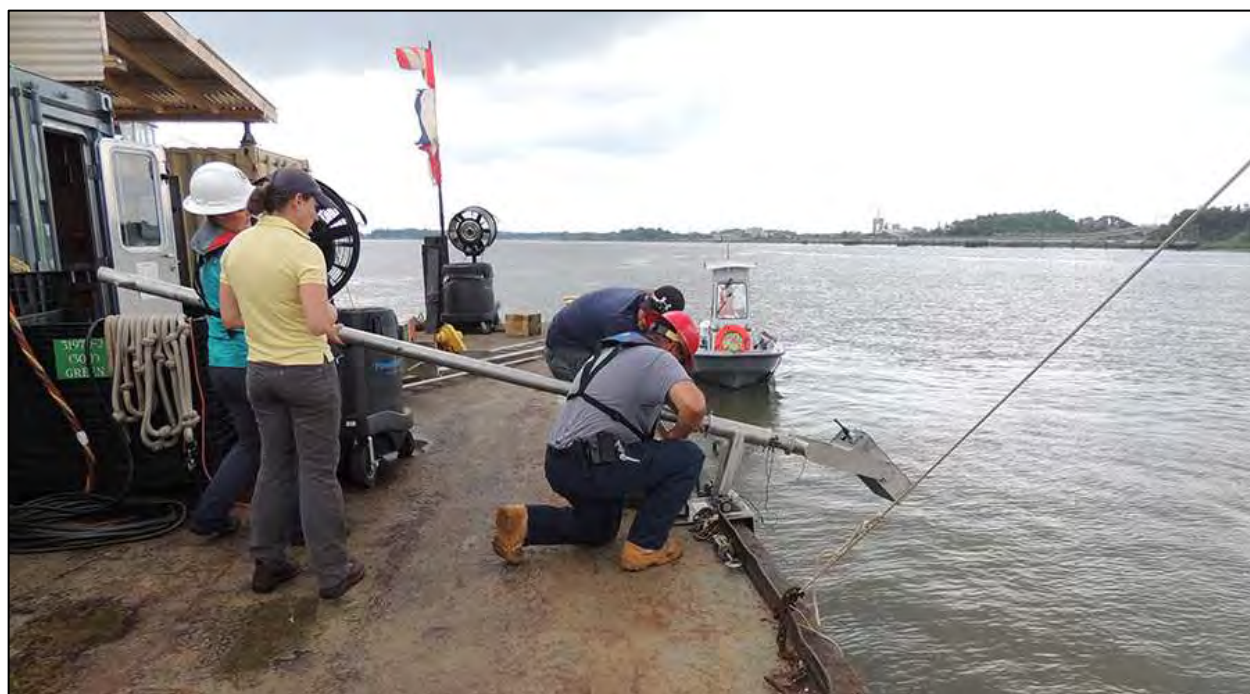
Figure 6-28. CODA sonar head being readied next to the Dive Station. By turning the pole, the sonar head was easily directed to anywhere coverage was required.

As previously stated, underwater visibility during nearly the entire project was generally under 1 foot and more often than not 0 to 6 inches. Offsetting the lack of visibility was the diver equipped USBL system, as well as the Coda Octopus Echoscope (CODA) system, which was a barge-mounted, Real-Time, 3-D directional sonar system (Figures 6-28 and 6-29). While the USBL system was instrumental in diver tracking, as well as tracking equipment (i.e., DMM baskets, mechanized recovery tools), the echoscope was a 3-D image that substantially augmented diver tracking during both DMM and casemate recovery. Both USBL and CODA tracking was conducted at the Communication Station with the MDSU-2 Communications Operator assisted by the on-site Co-Principal Investigator present (Figure 6-30).

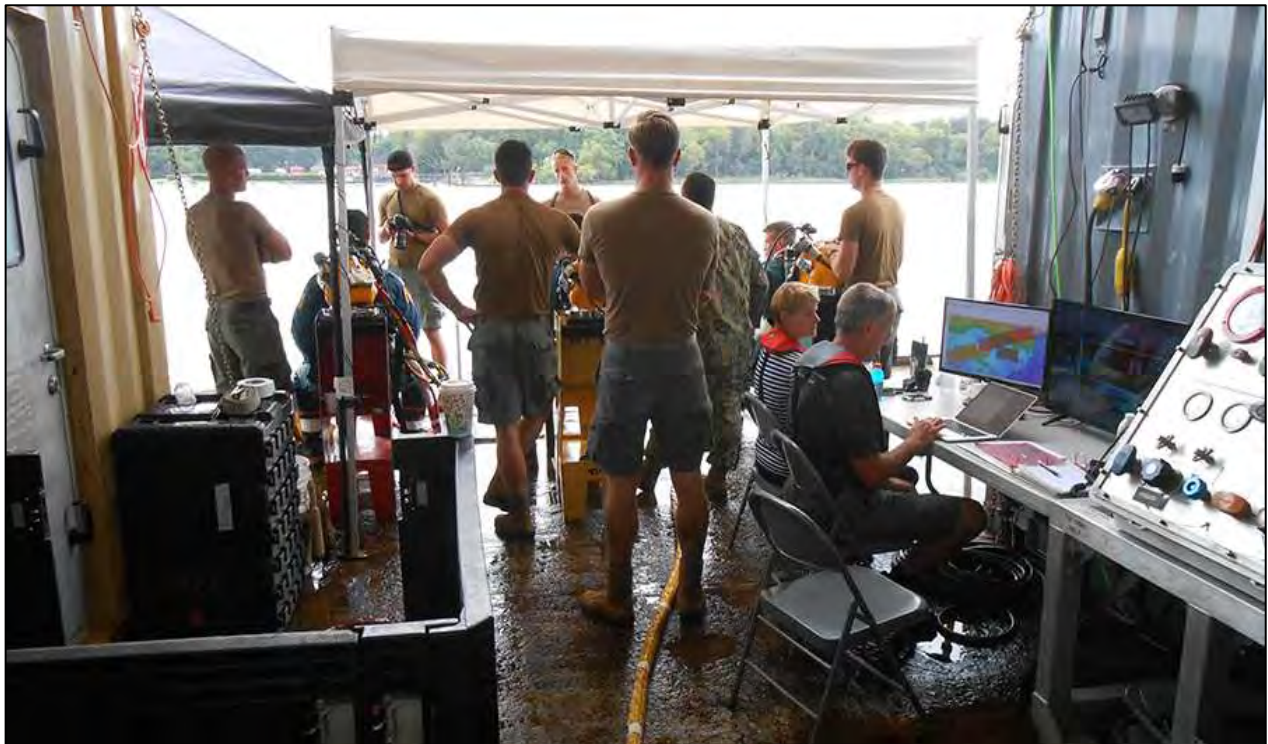
Figure 6-30. The Dive Station with USBL and CODA tracking monitors at the Communication Station (left monitor is for USBL tracking; right monitor is for CODA tracking).

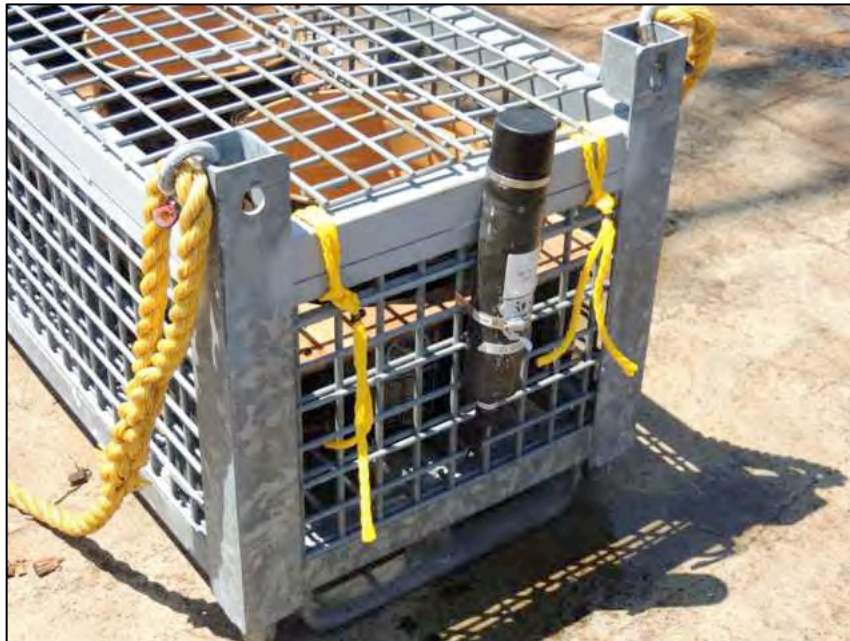
Figure 6-31. Ordnance basket with enclosed DMM buckets as well as the USBL transponder employed for diver location of the basket.

With a U.S. Navy EOD team, headed by Senior Chief Richard Bledsoe, on-site to ensure safety protocols, Objective 2 began with the recovery of DMM beginning near Cannon 2 and 3. DMM were placed into separate tagged buckets, nine buckets per numbered metal basket. The metal basket was lowered onto the bottom near the intended search and recovery location, and the divers were directed to its location with the use of the USBL system. When all nine buckets were filled, the basket was raised, swung to the opposite side of the barge, and placed on the river bottom. There its location was marked by a buoy at the top of its lifting rig. In total, 16 baskets were filled and lifted in this manner (Figures 6-31 to 6-33). These were subsequently recovered and all DMM were taken to the Inerting Site set up on the adjacent Disposal Island just a short distance from the site up Back River.

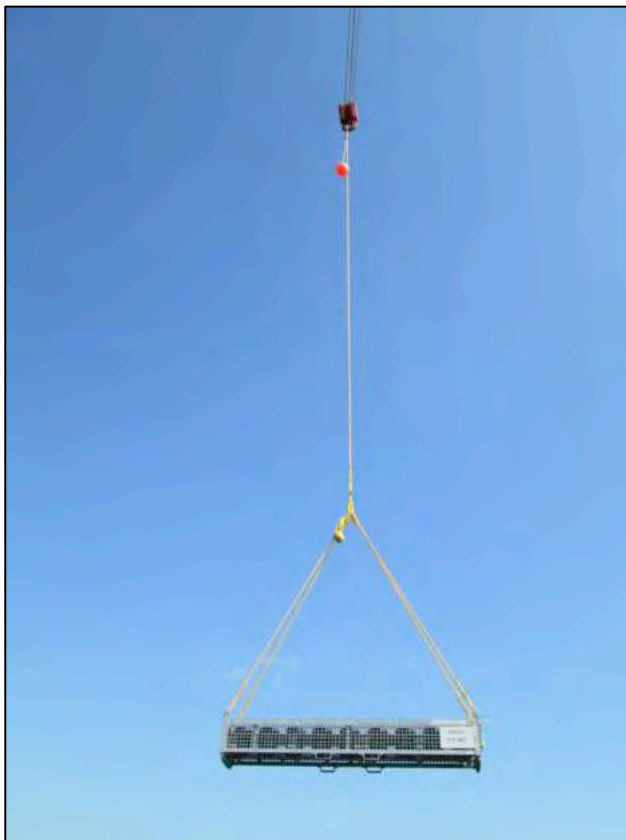
Figure 6-32. DMM-filled basket and lifting rig.

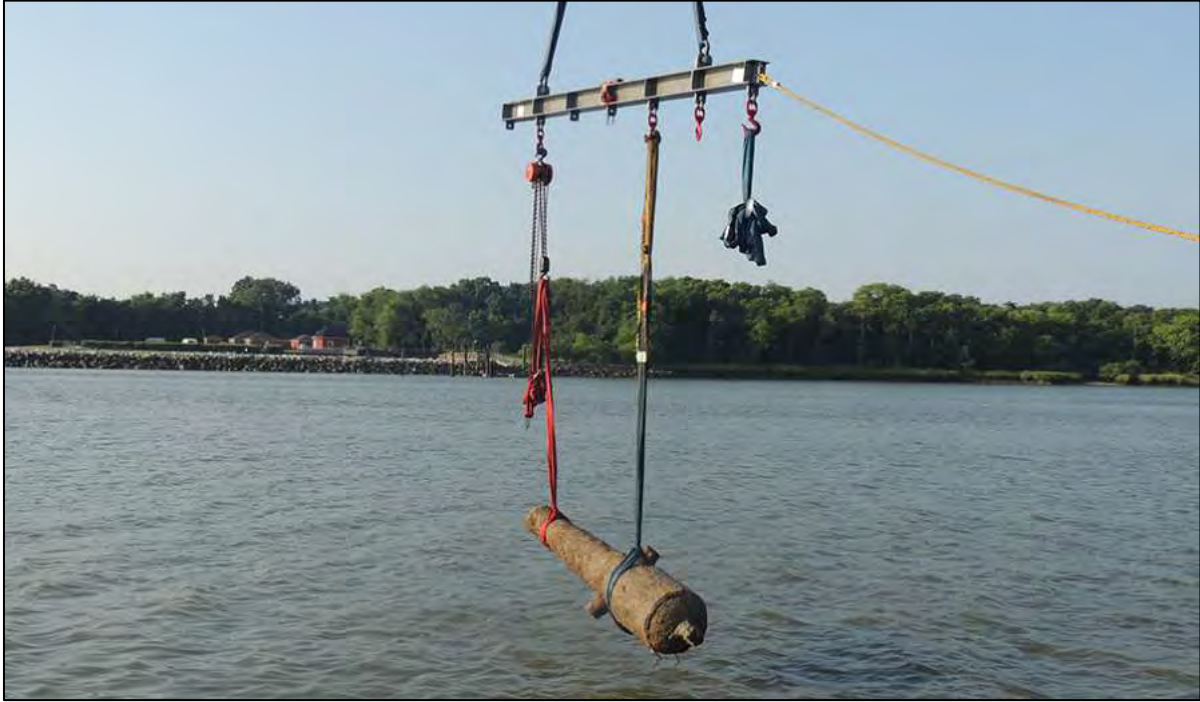
Figure 6-36. Method of rigging cannon for lifting. Cannon 2 is shown being lifted, one “roundsling” placed just aft of the muzzle, the other just aft of the trunnions. Note the USBL transponder on the top center of the beam for positioning over the cannon for easy diver location.

Upon completion of DMM recovery, cannon recovery began with the lifting of the guns from east to west, with Cannon 4 the last to be lifted (Figure 6-35). All cannon were raised with polyester “roundslings” attached to a USBL-equipped and positioned I-beam, some with chainfalls for leveling. The method is shown in Figure 6-36, where one roundslings was placed just aft of the muzzle, the other just aft of the trunnions.

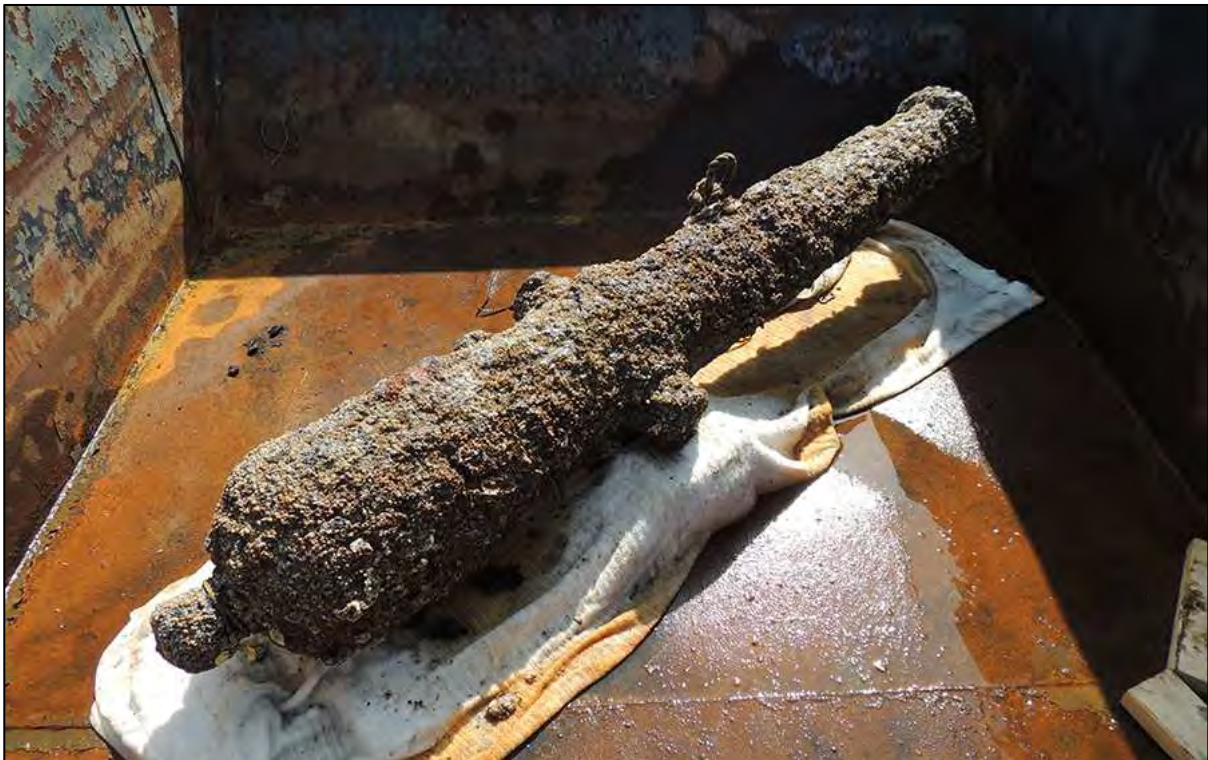
Figure 6-37. Cannon 1, a 6-pounder, is the smallest gun on-site and was located adjacent to and just downriver from the East Casemate.

Illustrated in Figure 6-37, Cannon 1 was the first to be lifted. The smallest gun on the site (a 6-pounder discussed below) and the furthest downriver was located adjacent to and just downriver from the East Casemate. With a total length of 6 feet 5 inches and a bore diameter of 3.5 inches (cleaned of concretion) it is thought to represent the Spar Deck Aft gun that was presented to the CSS *Georgia* by the Ladies of Rome, Georgia. A complete wooden box of round shot for the gun would be found during Mechanized Recovery (discussed below).

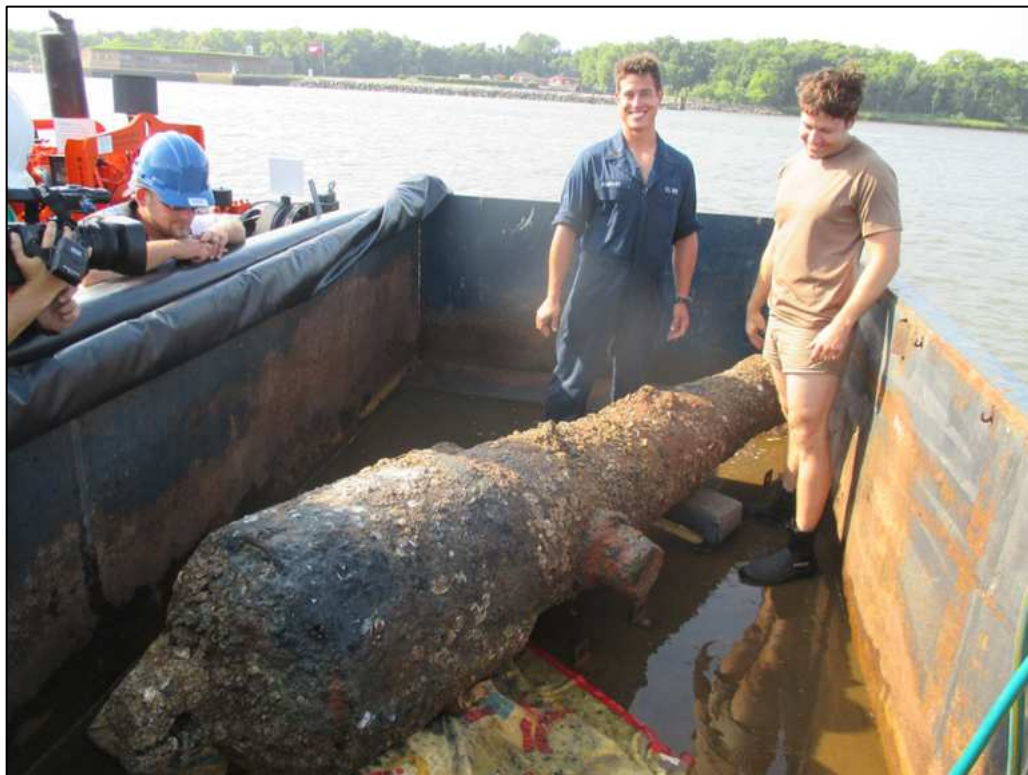
Figure 6-38. Cannon 3, a banded 32-pounder being examined by MDSU-2 divers who helped rig the gun for lifting. Note the 3-inch diameter hole through cascabel.

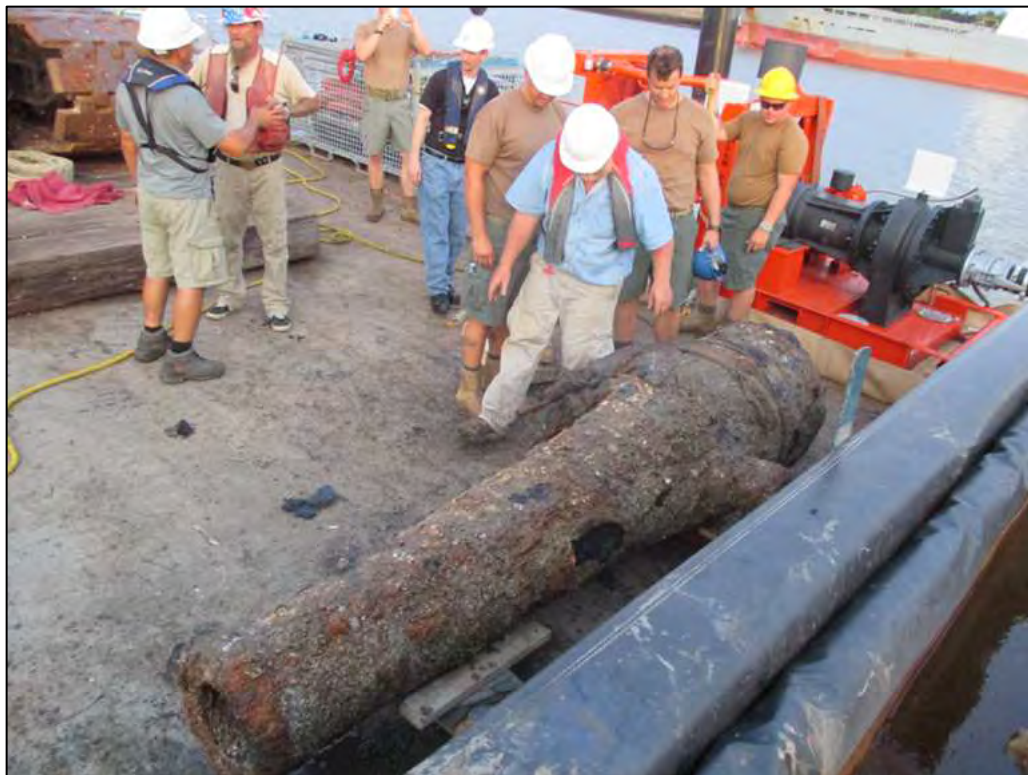
Figure 6-39. Based on its identifying marks, Cannon 2 is the No. 1 Port gun.

Cannon 2 was the next to be raised. Upon the gun breaking the water’s surface, it was surprisingly observed to be a Dahlgren (Figure 6-39). Up to that time it was thought to have been an unbanded, 8.5-inch, shell gun similar to a Seacoast-type. Cannon 2 has a total length of 11 feet 3 inches, maximum diameter of 2 feet, and ring on top of the cascabel. When brought on deck a partially exposed but illegible identifying number was observed on the breach and the Inspector’s identifying partial initial, thought to be “J.B....” was present on the end of a trunnion. Upon cleaning, if it turns out actually to be “J.R.,” depending on the muzzle number (if present) it will represent the No. 1 Port or No. 4 Port gun. This is discussed in detail below.

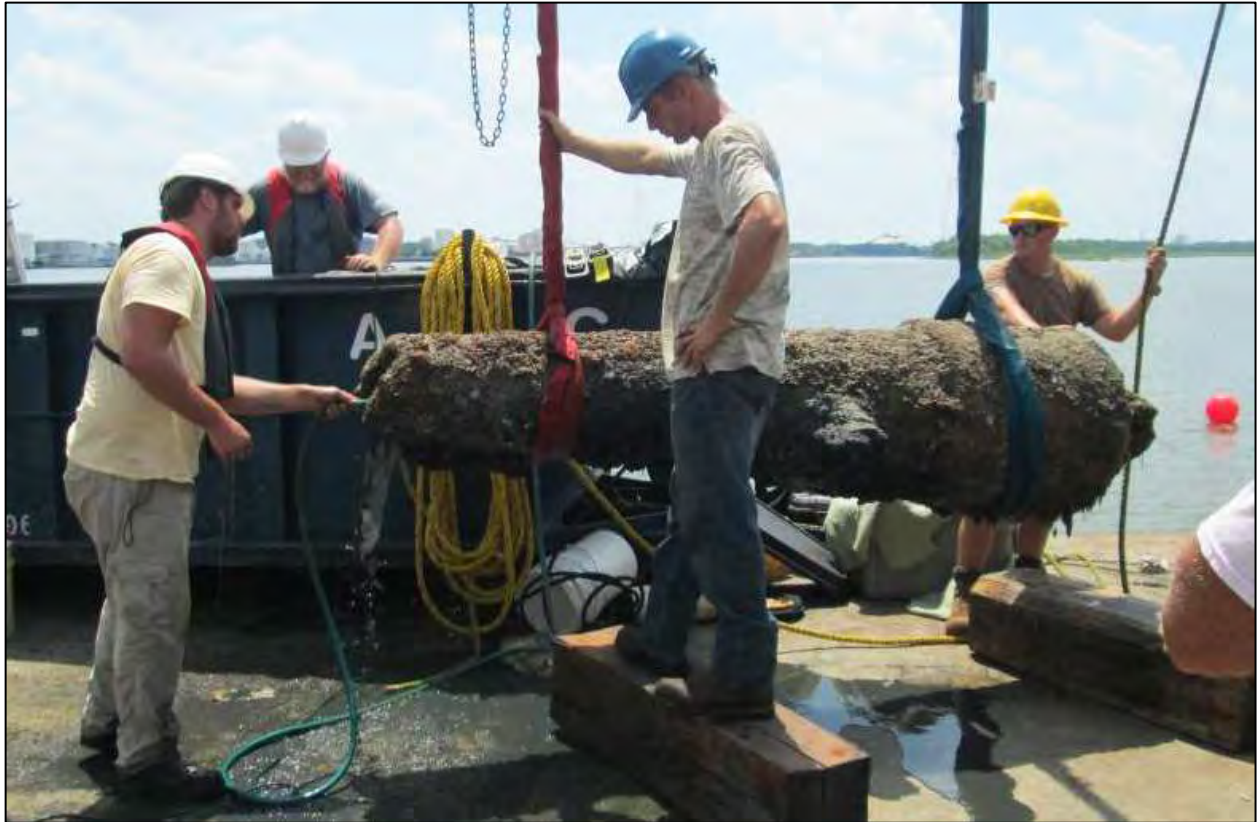
Figure 6-40. Cannon 4, a banded 32-pounder, with its broken muzzle clearly visible. Parker Brooks with CRL is checking the gun for DMM as the single-banded 32-pounder recovered in the 1980s from the site and now on display at Ft. Jackson was spiked and contained an inverted shell. During conservation at CRL it would be found that this cannon was not spiked, but the other 32-pounder (Gun 3), and one of the Dahlgrens (Gun 2) contained inverted shells.

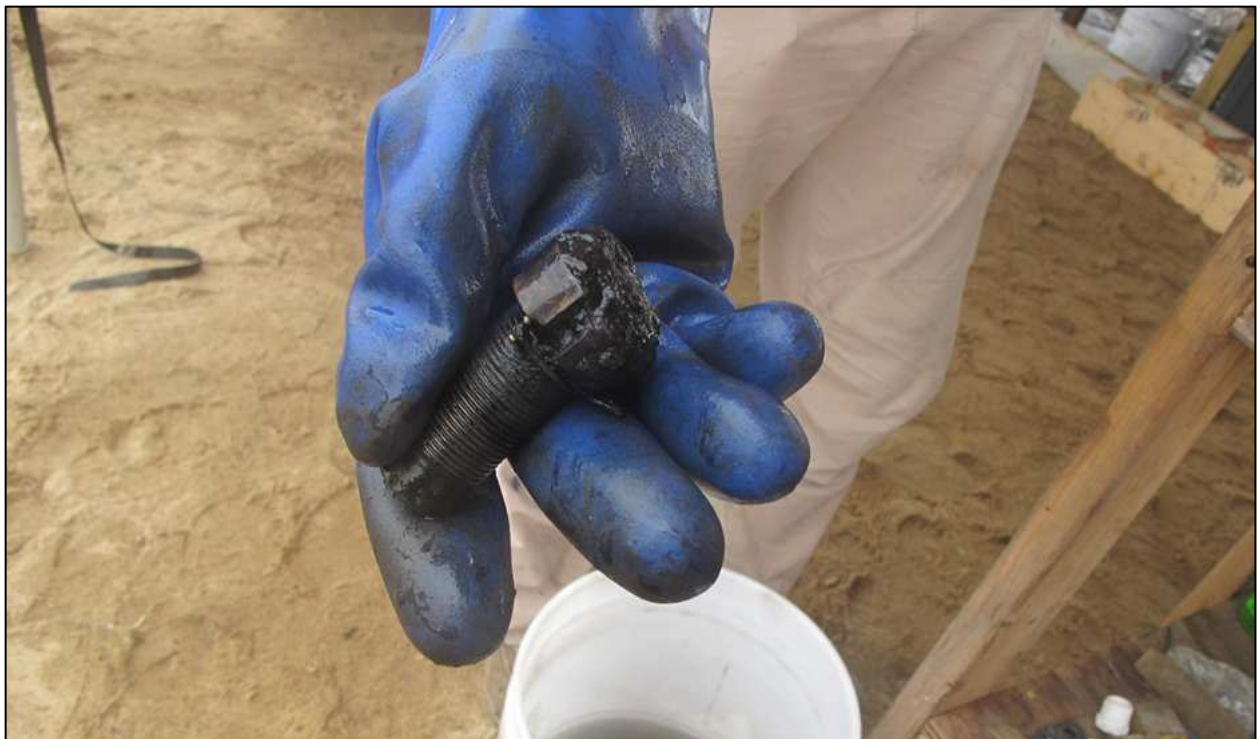
Figure 6-44. Archer fuze that has just been removed from a 6.4-inch Brooke shell (courtesy of the U.S. Army Corps of Engineers–Savannah District).

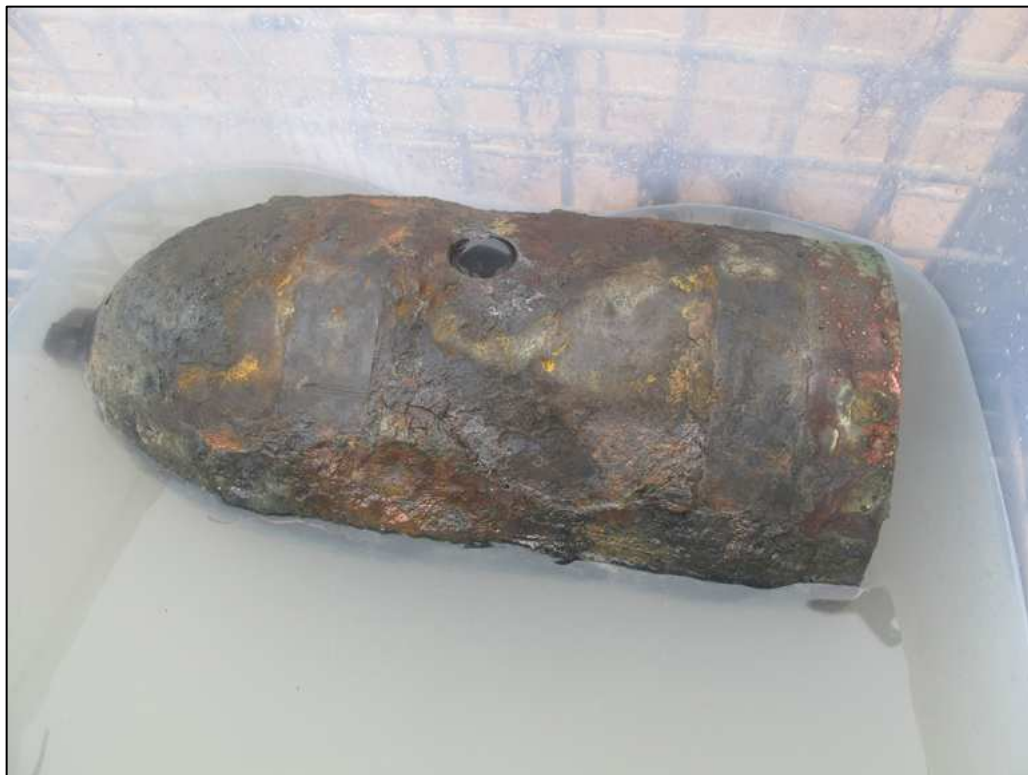
Figure 6-45. Inerted Brooke shell with hole drilled for removal of all contents. Note the fuze has not yet been removed (courtesy of the U.S. Army Corps of Engineers–Savannah District).

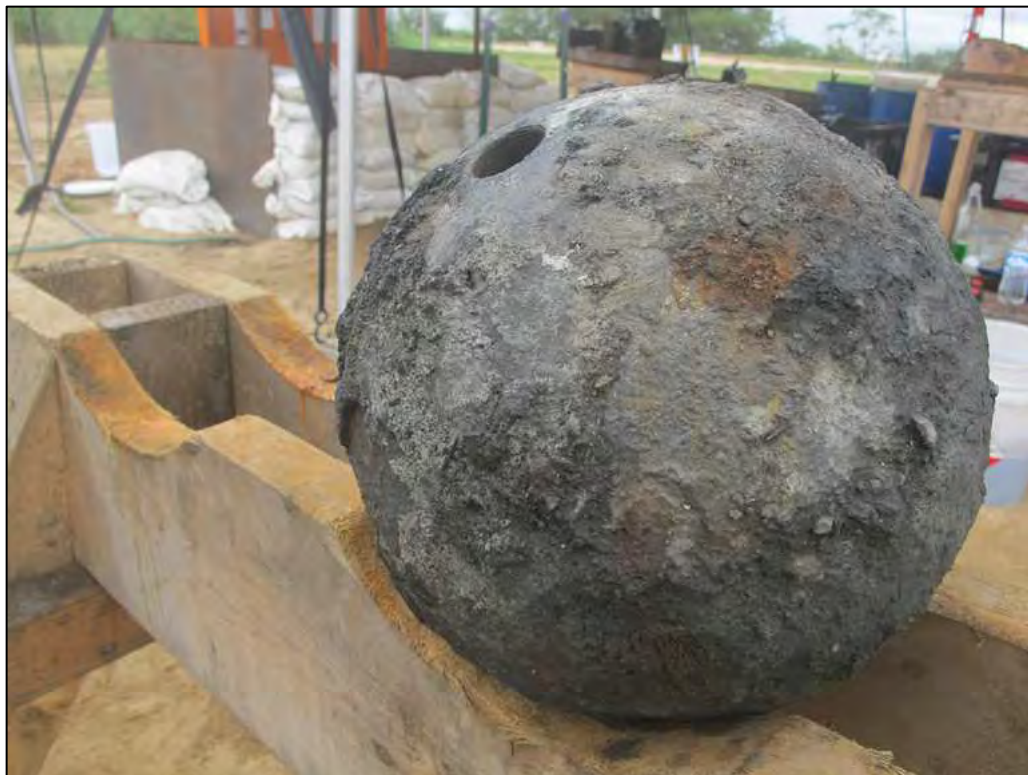
Figure 6-46. Inerted Dahlgren shell with hole drilled for removal of all contents (courtesy of the U.S. Army Corps of Engineers–Savannah District).

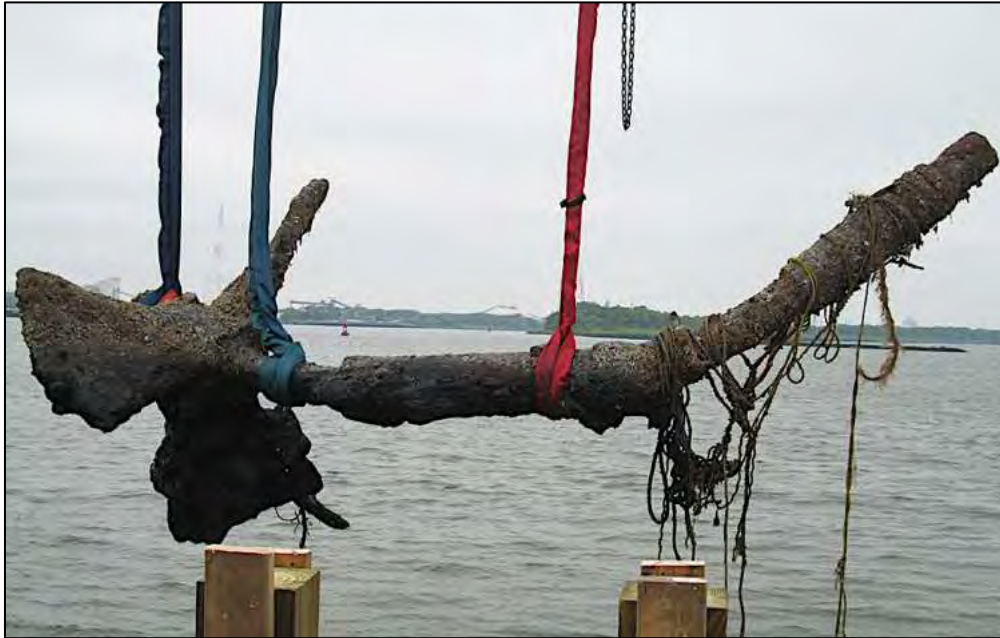
Figure 6-47. Triple-bladed propeller being lifted onto the barge.

Upon completion of cannon recovery, the focus shifted to the recovery of the large artifacts on the site. Located on the upriver edge of the site, the 6-foot diameter propeller was the first artifact lifted (Figures 6-47 to 6-49). The triple-bladed propeller is mounted on a 6-inch diameter shaft approximately 12 feet 6 inches in length. Because two of its three blades were buried, jetting was conducted to uncover the blades prior to lifting. Once lifted onto the barge deck, the shaft was cut free from the 8-foot blade with a saw for ease of transportation and conservation. As illustrated in Figure 6-49, the propeller has a single strut indicating the vessel would have had two propellers, and historical sources indicate that the CSS *Georgia* was powered by “a double engine and twin propellers” (Barnwell 1981:203, 206-208; Melton 2002:19).

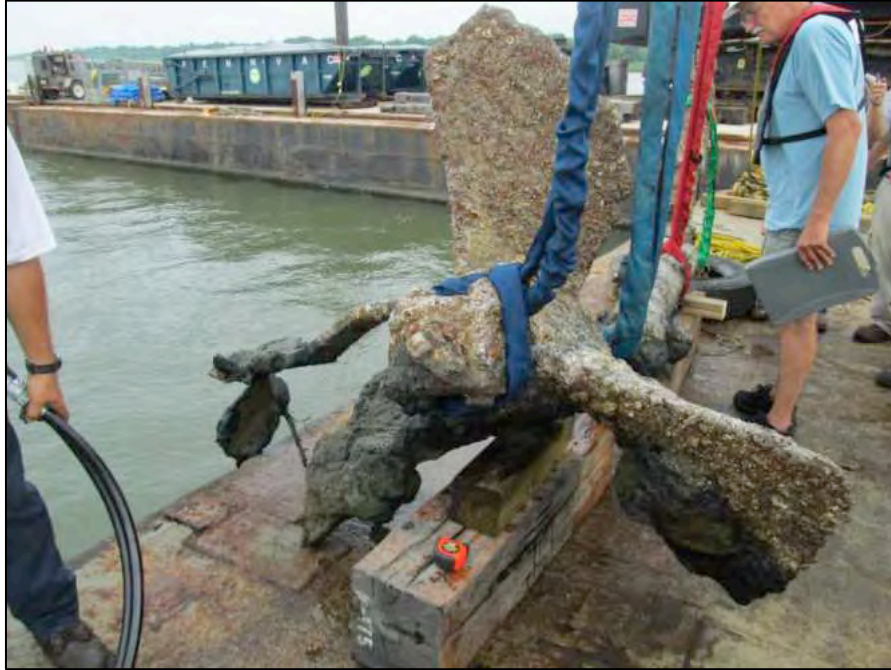
Figure 6-49. Propeller blade with strut at left.

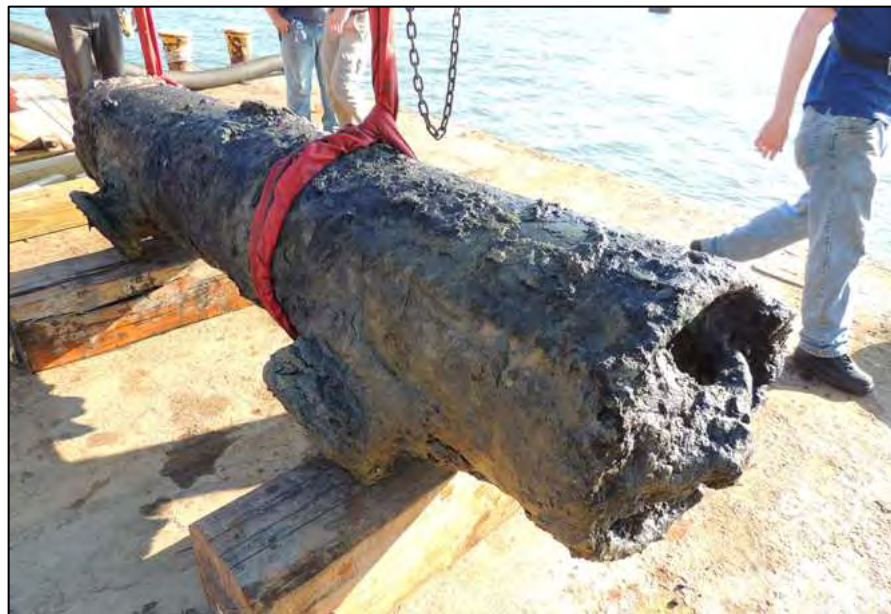
Figure 6-50. First identified as a condenser, it is possible that the riveted cylinder represents a mud drum.

The second artifact recovered, adjacent to Cannon 2, was at first believed to be a condenser. Like the propeller, it had to be jettied free from the bottom prior to lifting. Measuring 9 feet 4 inches in length and 20 inches in diameter, it is possible that the riveted cylinder represents a mud drum (Figure 6-50). Further analysis after conservation will be required to determine its function.¹

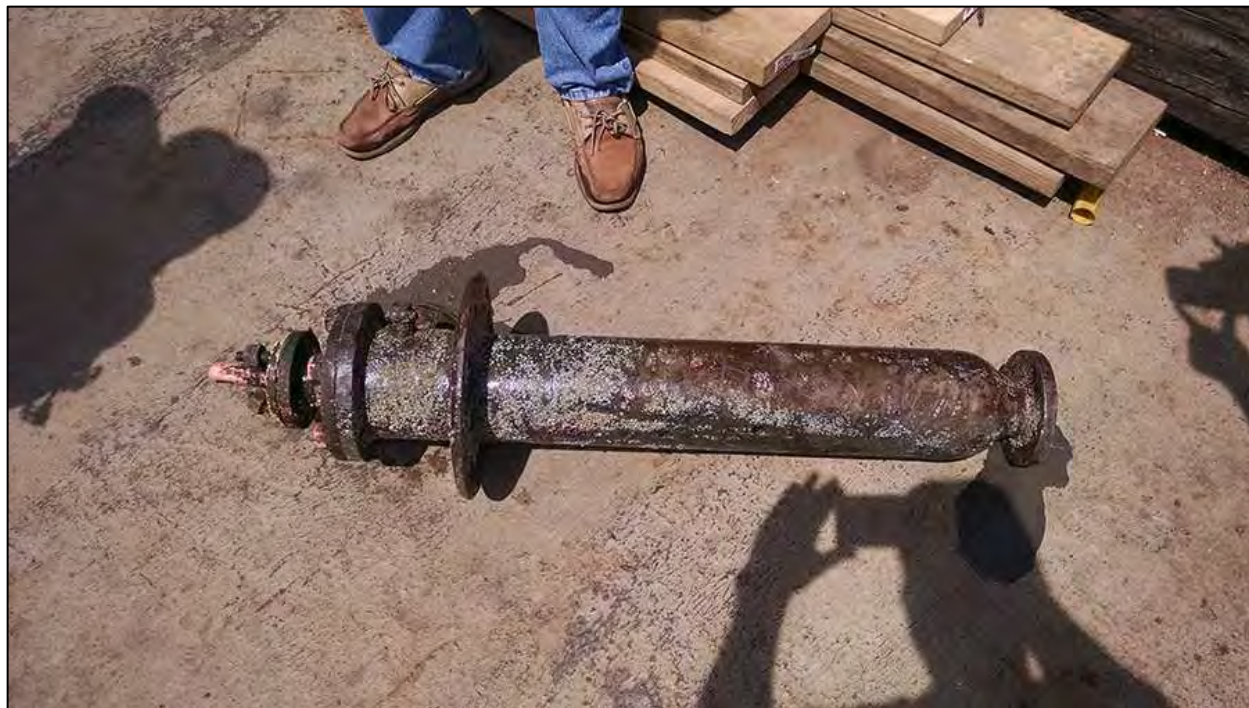
Figure 6-55. Brass steam pump recovered during Large Artifact Recovery.

In addition to these two artifacts numerous cast iron steam fittings and a brass steam pump were recovered during this Objective. Illustrated in Figures 6-53 to 6-56, the location and function on the vessel's steam machinery are discussed below.

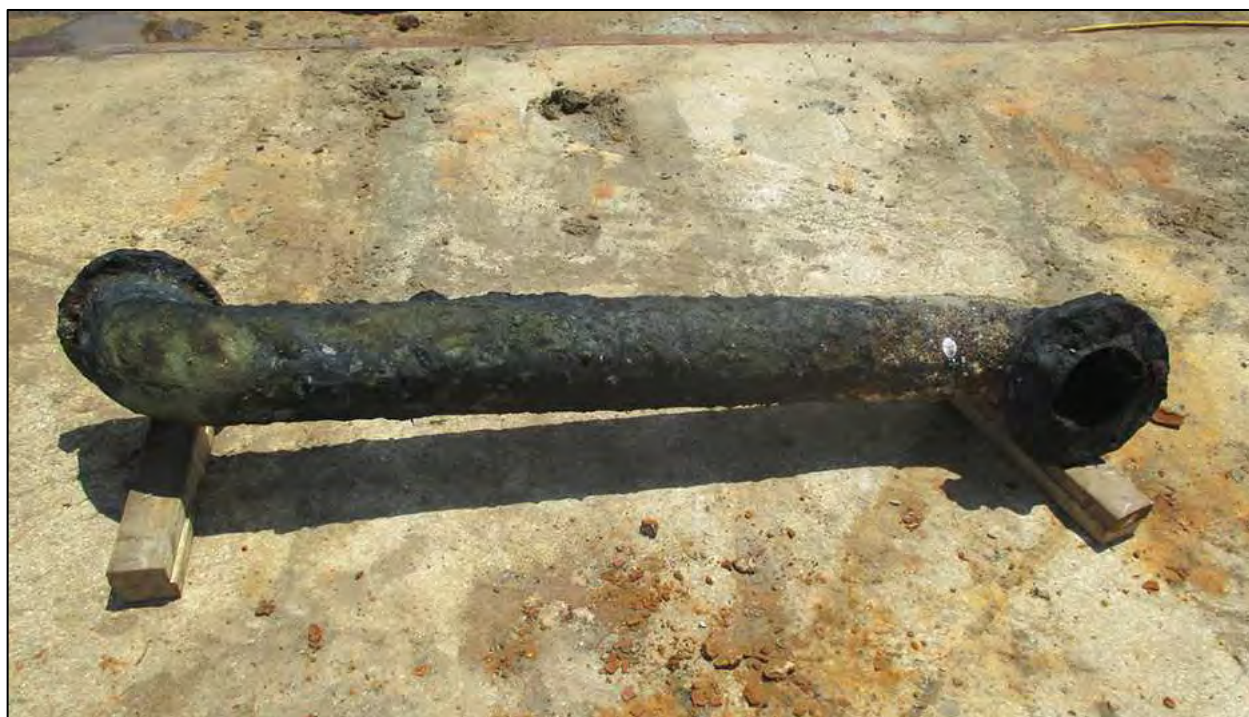
Figure 6-56. Iron steam pipe recovered during Large Artifact Recovery. The ends of the 5-foot pipe are bent 90 degrees in opposite directions and fitted with 12-inch diameter flanges. The flanges are drilled for five bolts and gaskets; several bolts survive.
