CSS *GEORGIA*
ARCHEOLOGICAL DATA RECOVERY AND MITIGATION
FOR THE SAVANNAH HARBOR EXPANSION PROJECT (SHEP),
CHATHAM COUNTY, GEORGIA AND JASPER COUNTY, SOUTH CAROLINA

**FINAL DRAFT REPORT
OCTOBER 2019**

Stephen R. James, Jr. and Gordon P. Watts

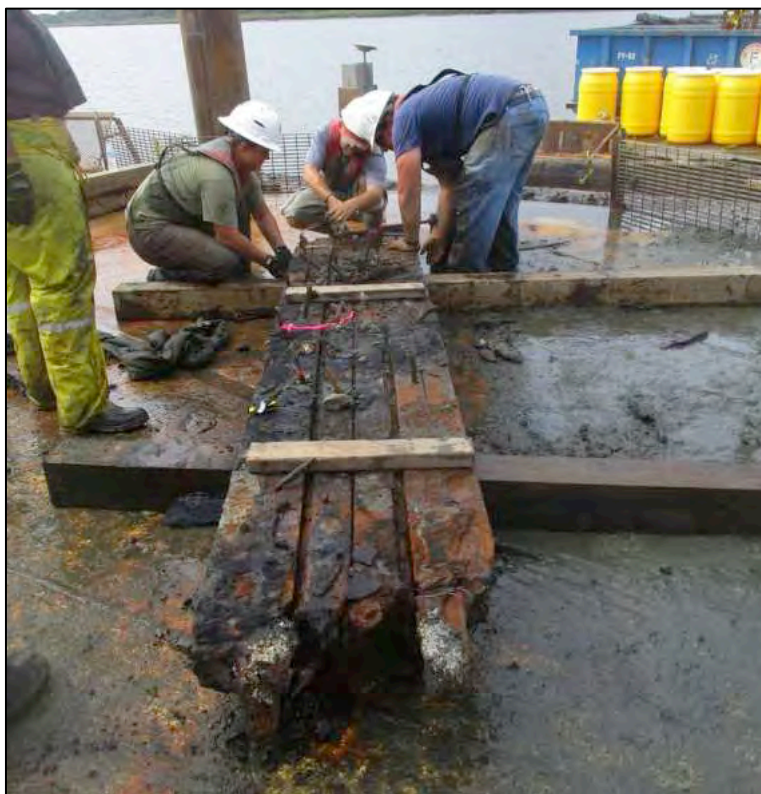
Figure 6-62. Bundling rails on the South Casemate. The angle of the side can be seen on the near end.

In addition to clearing the site of artifacts, the Mechanized Site Recovery Phase, which is discussed in detail below, was employed to recover the South Casemate, as the use of the grapple and clamshell were thought to be the only way to recover this casemate section after the unsuccessful rail separator and MDSU-2 diver recovery attempts (Figures 6-61 to 6-65).

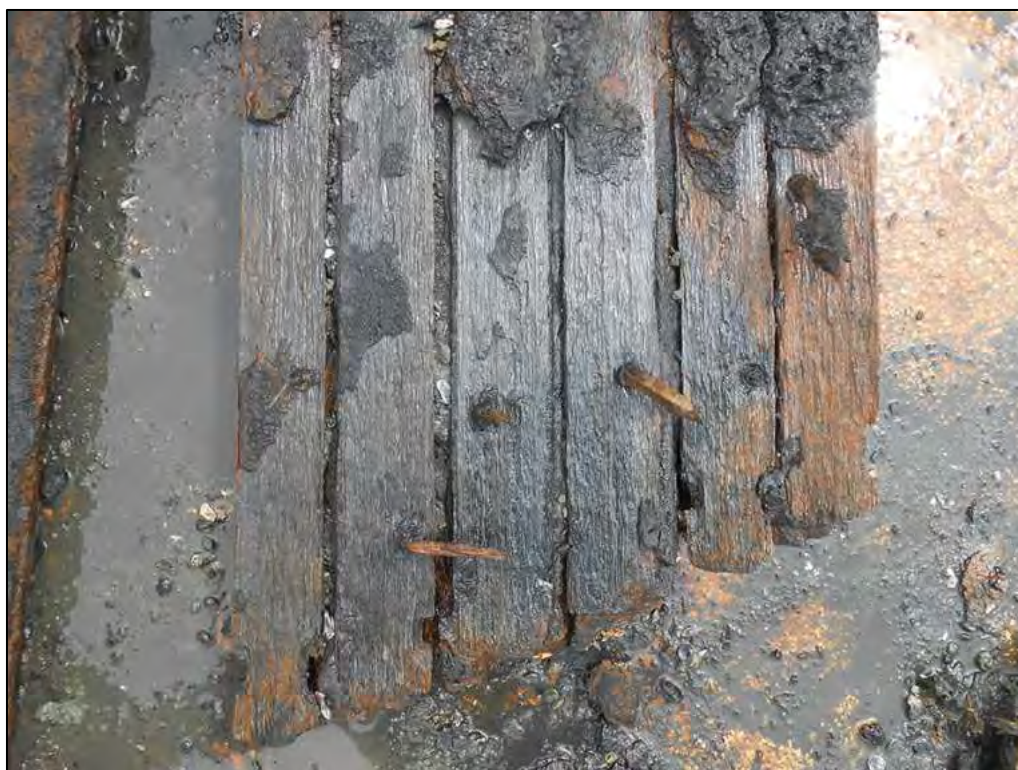
Figure 6-63. Angled side on the South Casemate.

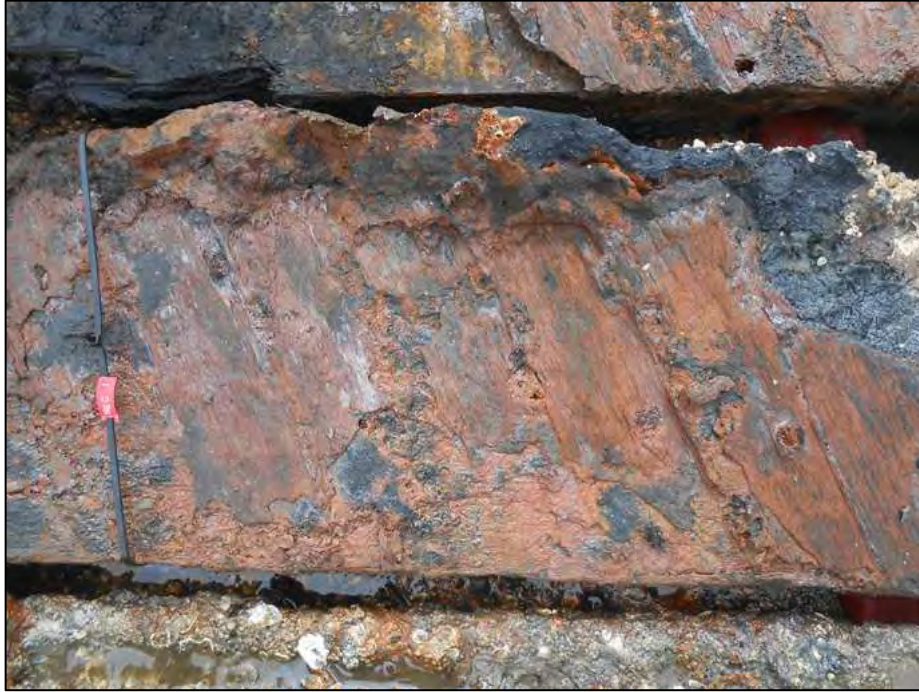
Figure 6-64. One of the two pieces of partially intact wood from SEC-2. The timber, whose straight bottom edge is clearly visible and is only extant because of the iron concretion, shows the rail concretion impression and indicates the rails were at an approximately 30-degree angle when built.

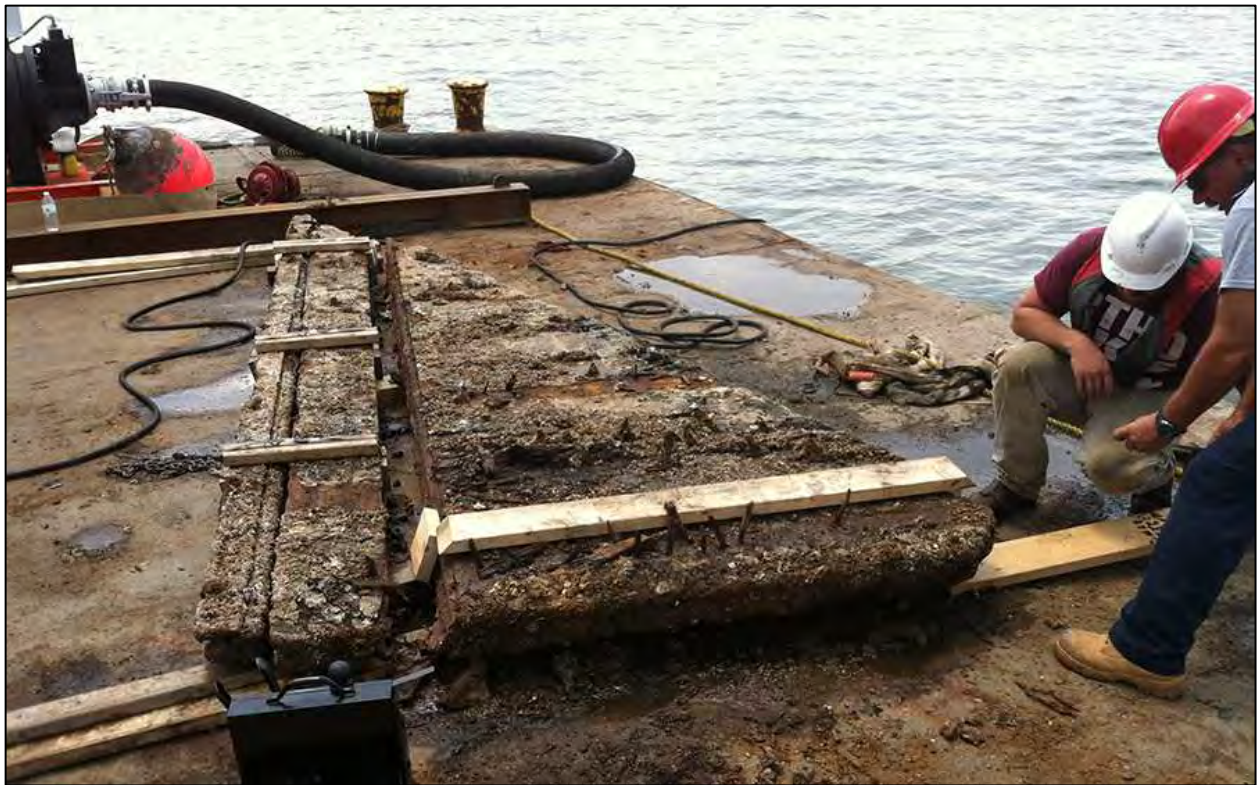
Figure 6-69. Northern, triangularly shaped, first section recovered (No. 1) being readied for shipment. Note the lack of wood backing on the inner face, as evidenced by the spikes that would have attached the wood being visible.

The triangular section on the casemate's northern side was lifted first (Figure 6-69). Intact sections, as well as sections purposely separated into manageable widths, were banded in order to keep them consolidated for transportation (Figure 6-70).

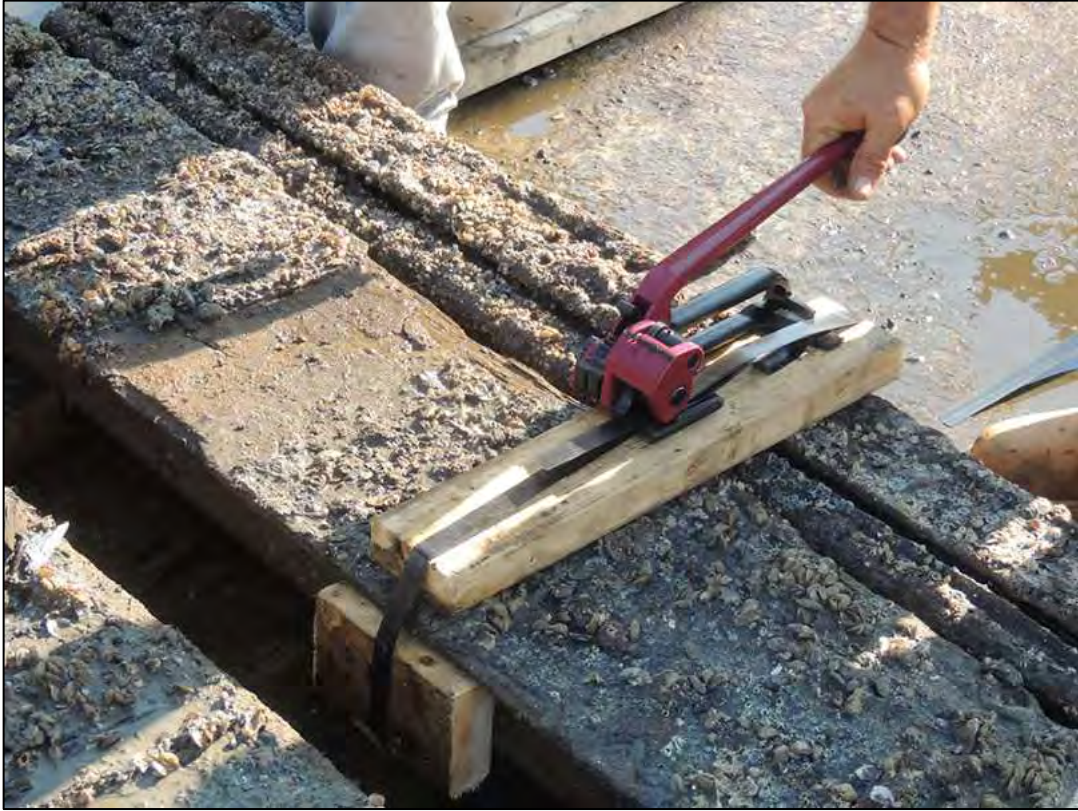
Figure 6-70. Intact sections, as well as sections purposely separated into manageable widths, were banded in order to keep them consolidated for transportation. The sections were separated rail by rail once at CRL, a process required for conservation.

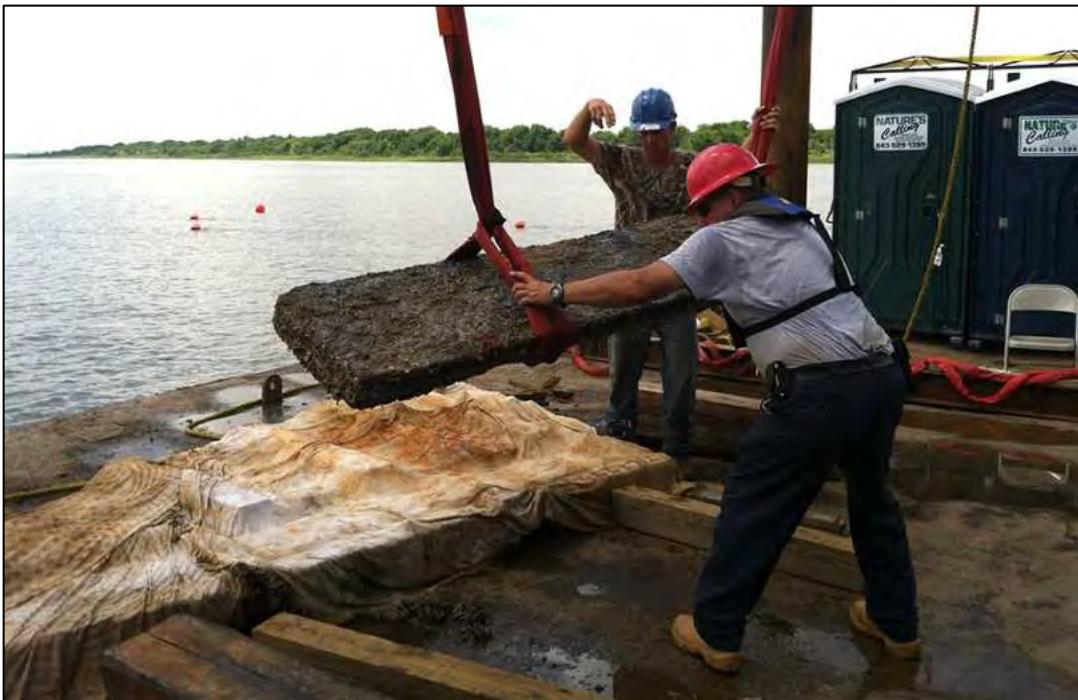
Figure 6-71. The second section raised (No.2); approximately 2-x-8 feet. The original, as-built location for this section is still being assessed.

The triangular section was followed by the small, disarticulated piece (No. 2) on the southern side of the casemate that was approximately 2-x-8 feet in size (Figure 6-71). The third section (No. 3) separated into two pieces when initially raised, the larger 16-x-3-foot piece was raised first. When lifted, it was apparent that the rails were bent on the upper ends (Figure 6-72). Not an as-built feature, this bending is visible in the acoustic image (see Figures 6-67 and 6-68), and is also noted on portions of the West Casemate rails, possibly a result of salvage or a later impact. It is not a recent impact, nor did the rail separator cause it.

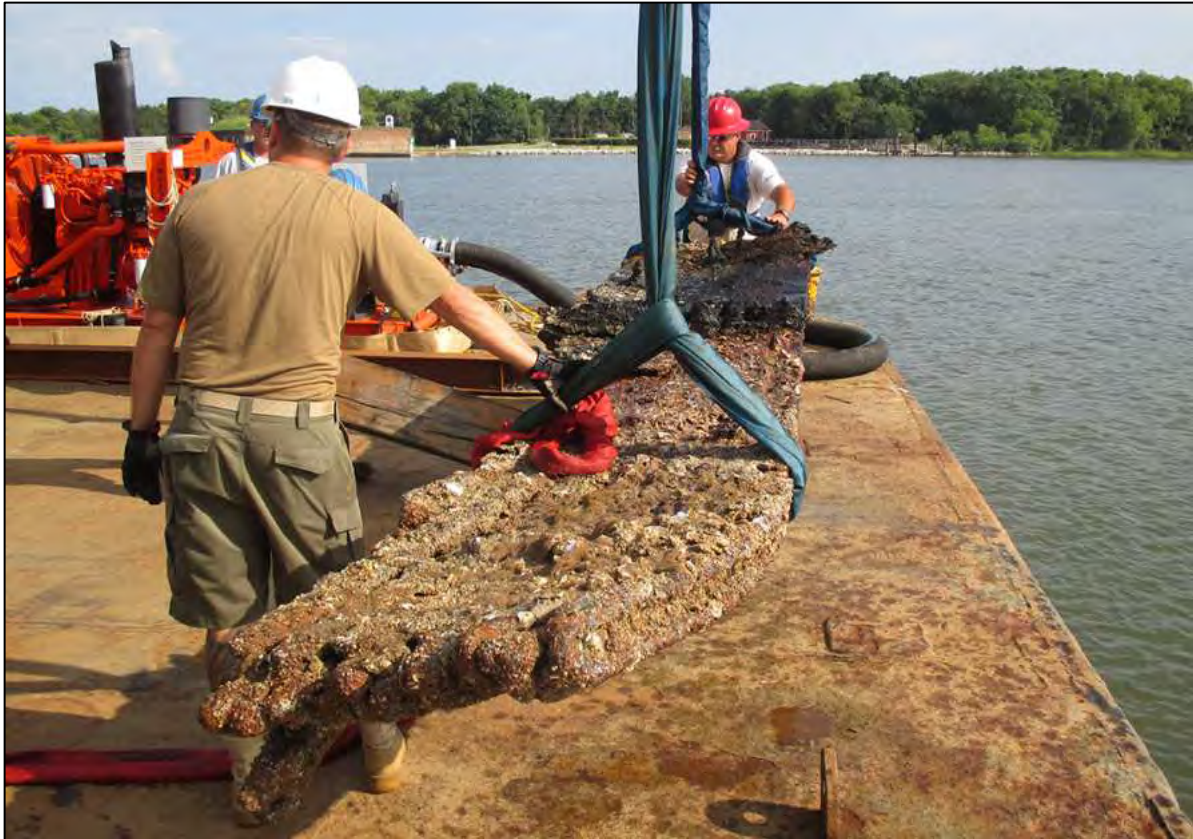
Figure 6-72. The third section raised (No. 3). This piece calved off a smaller rectangular section when lifted. Note that the rails are bent on the upper end. Not an as-built feature, this bending is also noted on portions of the West Casemate rails, possibly a result of salvage or later pre-data recovery impact.

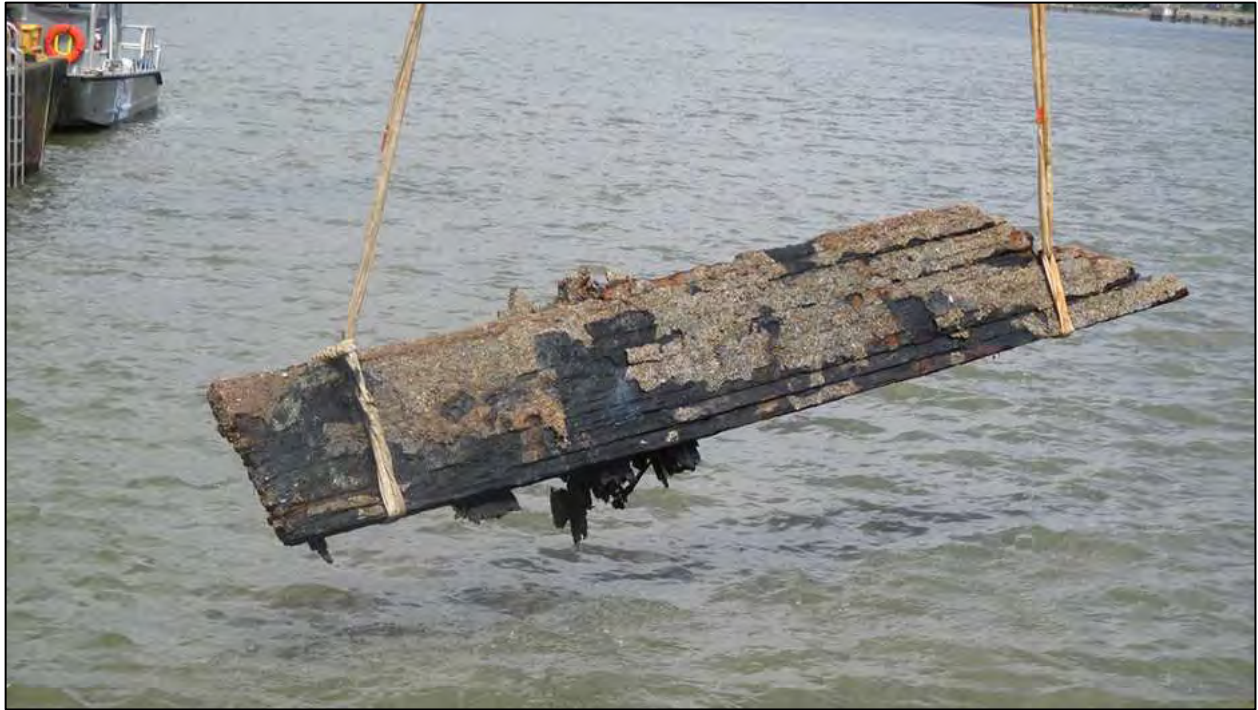
Figure 6-74. Fourth section of East Casemate raised. Separated from the main section with the rail separator, note the descending rail angle. The triangular section (No. 1) originally attached to the upper edge of this section.

The next two sections recovered were sections divided with the use of the rail separator (Figure 6-73). Located on the northern edge of the main section (No. 4), and with its longest rail 24 feet in length, the segment has a descending rail angle on its eastern end. The triangular section (No. 1) originally attached to the upper (northern) edge of this section (Figure 6-74). Located on the southern edge of the main casemate section, the fifth section (No. 5) recovered was also parted with the rail separator. With no wood backing, the 24-foot long rails collapsed in on themselves when being raised (Figure 6-75).

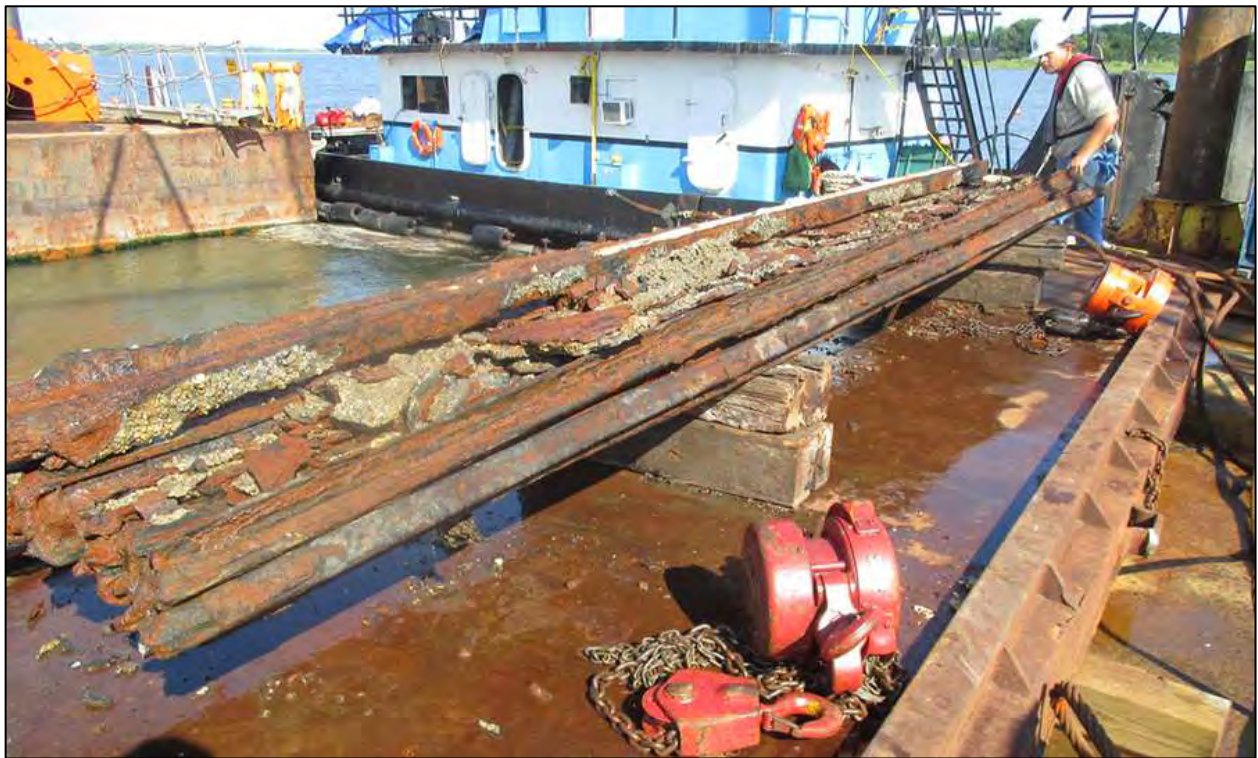
Figure 6-75. The fifth section recovered, located on the southern edge of the main casemate section, was detached with the rail separator. With no wood backing, the 24-foot long rails collapsed in on themselves when being raised.

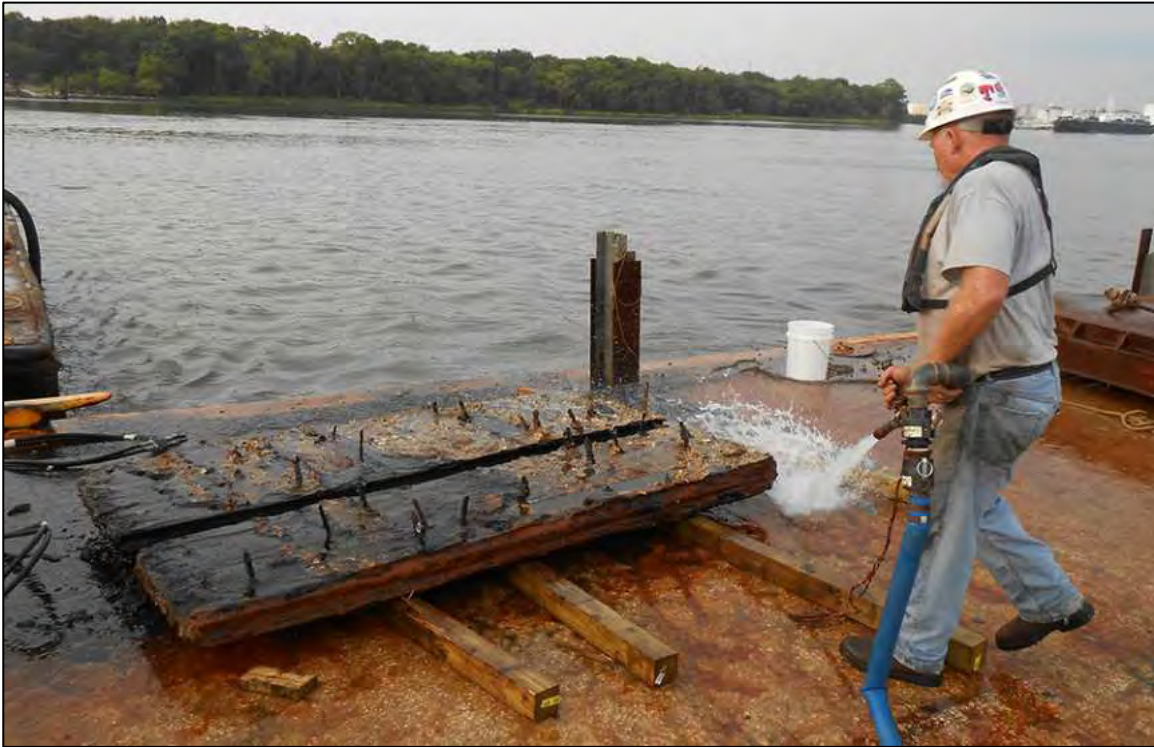
Figure 6-76. The sixth section recovered from the East Casemate. It has been separated into two sections on deck and is being readied for banding and subsequent transportation. The visible spikes are the location of the (now mostly non-extant) original wood backing.

The sixth and last section recovered from the East Casemate was originally attached to the larger bent rail section (No. 3). This small, 6-x-4-foot section was at first thought to have formed the lower portion of a gun port (Figure 6-76). This would not be the case, as is discussed below.

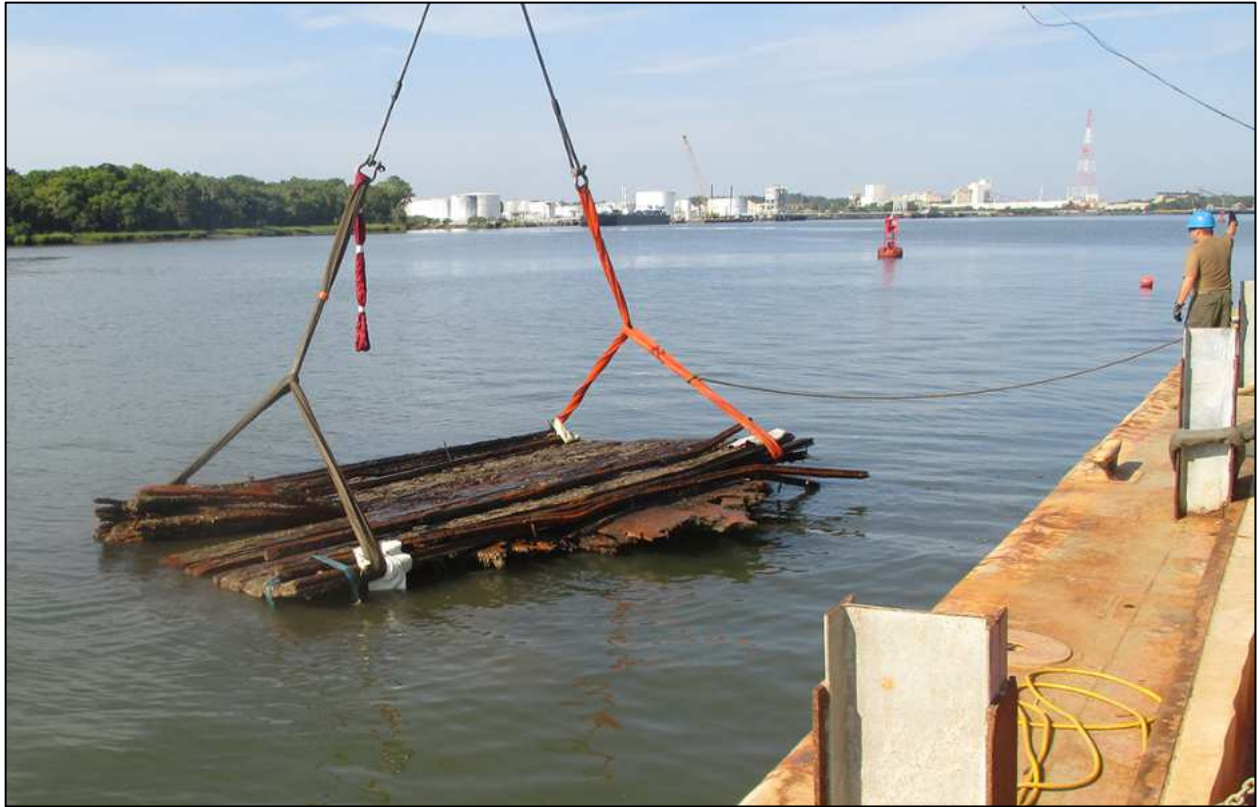
Figure 6-77. The first attempt at raising the large, intact East Casemate section in 2015. Immediately after this photograph was taken, the sling at right slipped off the rail ends and the entire section fell back to the riverbed.

Once the six small sections had been recovered, and further attempts at separation of the main section with the rail separator were unsuccessful, the main section, measuring approximately 24-x-20 feet with a calculated maximum weight of approximately 76,000 pounds, was rigged and readied for recovery. It would later be found to weigh 47,000 pounds (see below). The barge was positioned so as to have as little crane boom as possible for the lift. After MDSU-2 divers ensured that the wire rigging was properly situated, the section was slowly raised. After it broke the surface, it was held stationary to enable engineers to check the rigging and general load for safety. Remaining in this position for just a few moments, several rails collapsed, the rigging came off one of the sides, and the entire section fell back to the riverbed (Figure 6-77).

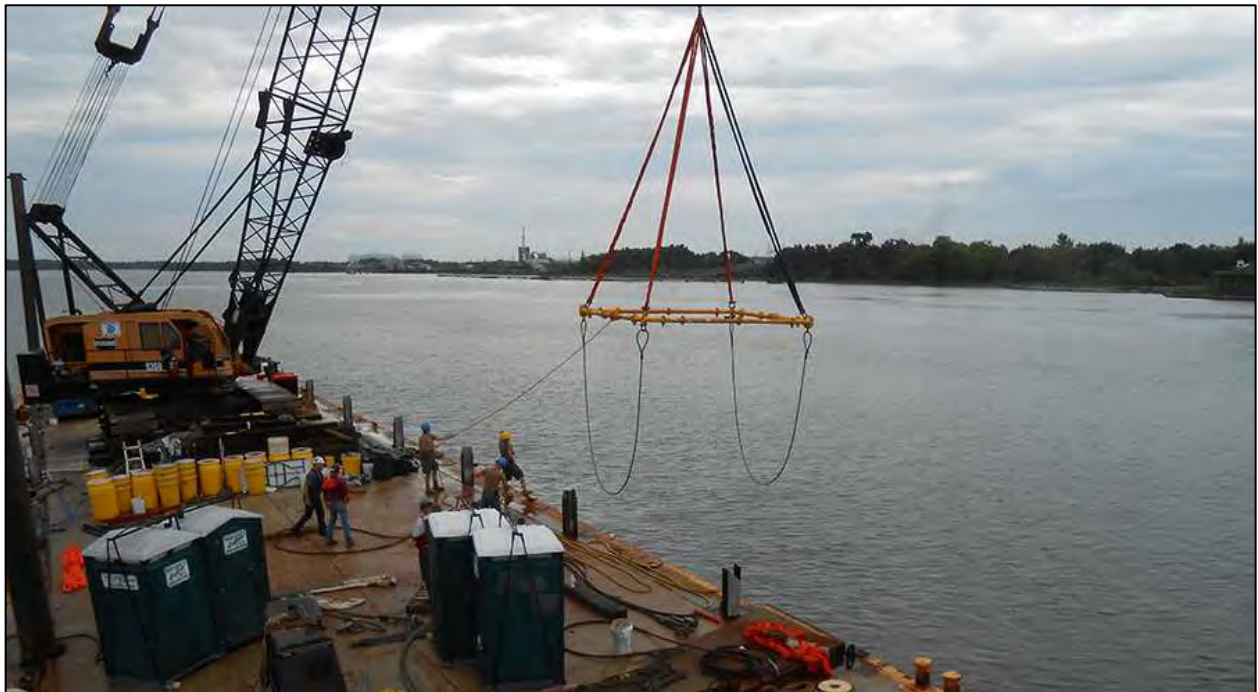
Figure 6-78. Rigging frame constructed that would hopefully allow for a successful second attempt at recovery of the casemate. This would not be the case.

With the advent of this unsuccessful attempt, focus shifted to the recovery of the small test sections of West Casemate previously separated. At the same time, discussions were held with all parties on the best method for East Casemate recovery. It was decided and approved by NHHC to build a rigging frame that would allow for a successful recovery of the casemate. The rigging frame was lowered onto the casemate and rigging wires placed under the segment for the lift (Figure 6-78). Similar to the first lift attempt, after it broke the surface, it was held stationary to enable engineers to check the rigging and general load for safety (Figure 6-79). Remaining in this position for several minutes, it was thought to still be too unstable to lift free of the water, as there was no wood backing on the northern half. It was lowered back to the riverbed and de-rigged, with a sonar survey conducted to assess its actual alignment and coordinate location (Figure 6-80). The consensus was that it could not be raised with the current on-site assets; however, its recovery would be accomplished in 2017 (see below).

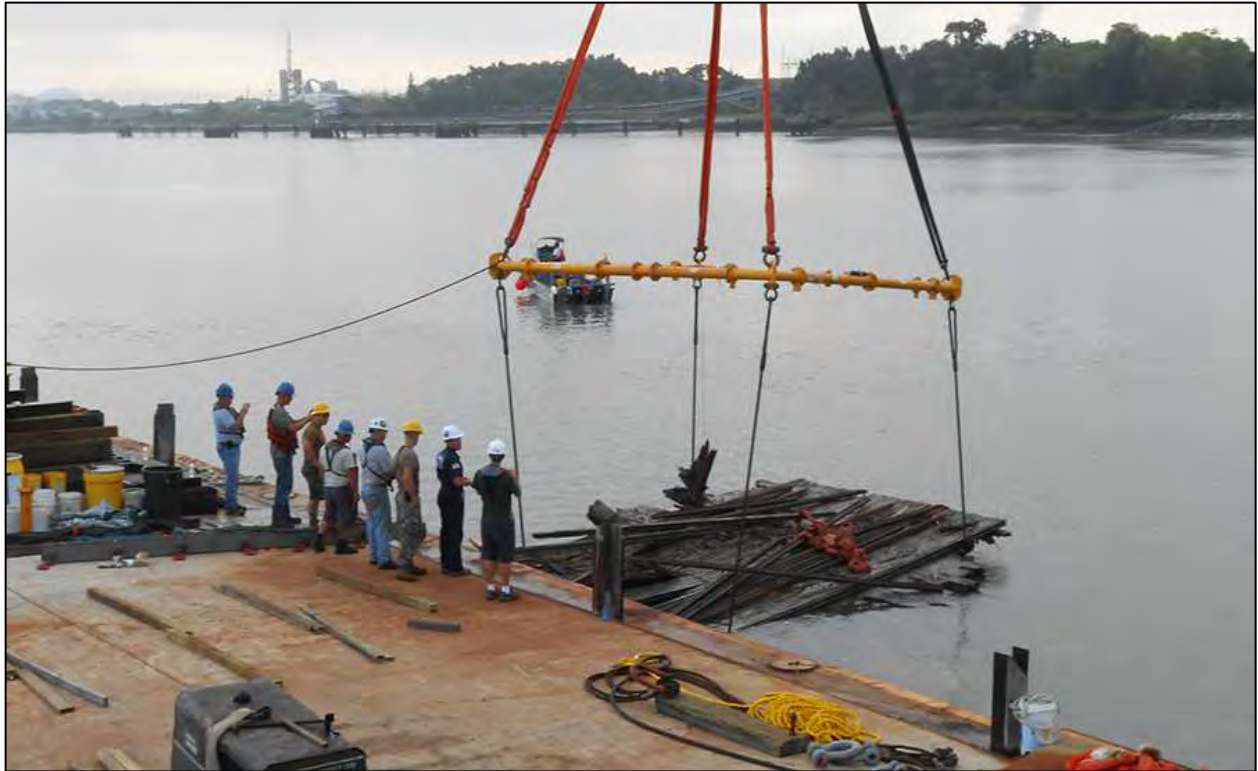
Figure 6-79. Similar to the first lift attempt, after the casemate broke the surface, it was held stationary to enable engineers to check the rigging and general load for safety. Remaining in this position for several minutes, it was thought to still be too unstable to lift free of the water, as there was no wood backing on the northern half. It was lowered back to the riverbed and de-rigged. As discussed below, it would be recovered in 2017 employing a different lifting method.

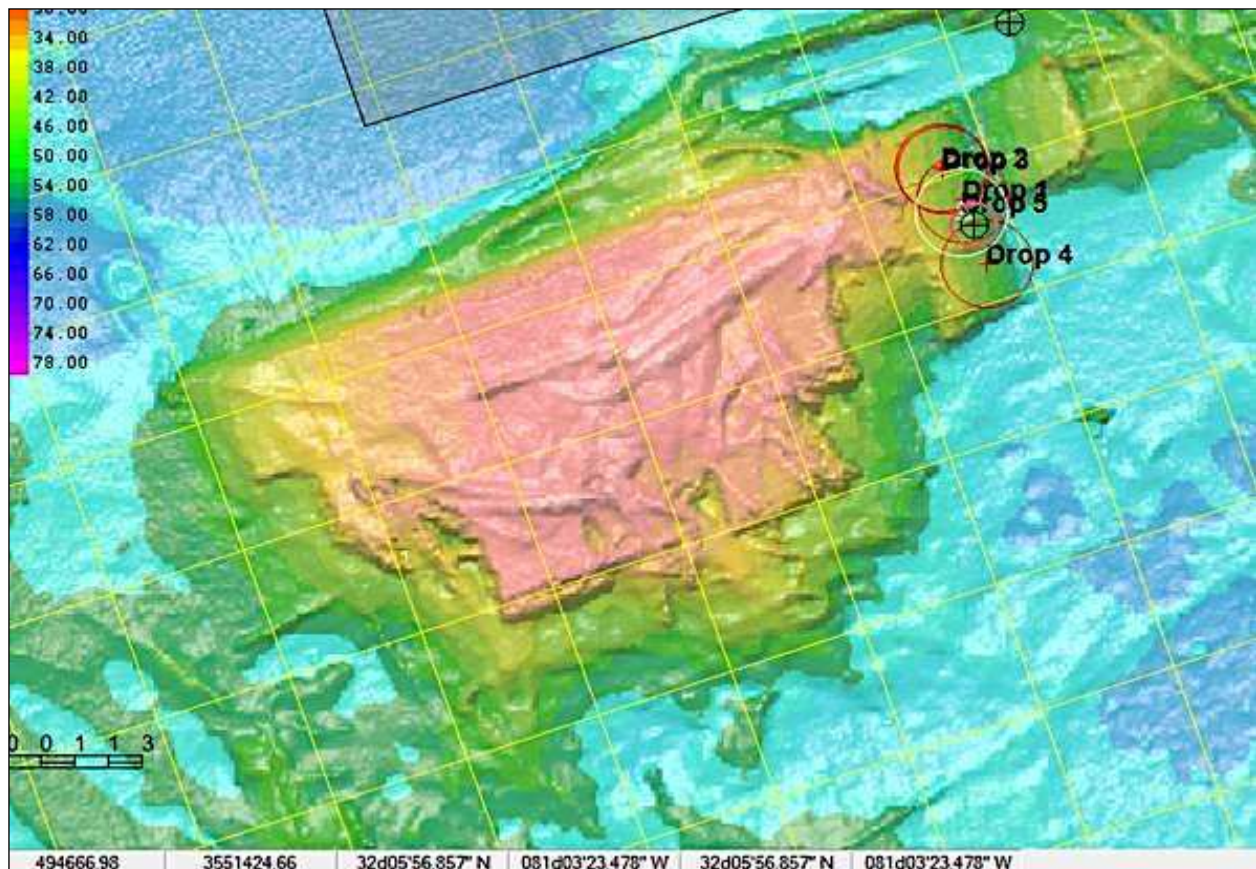
Figure 6-81. Sectioning locations on the West Casemate.

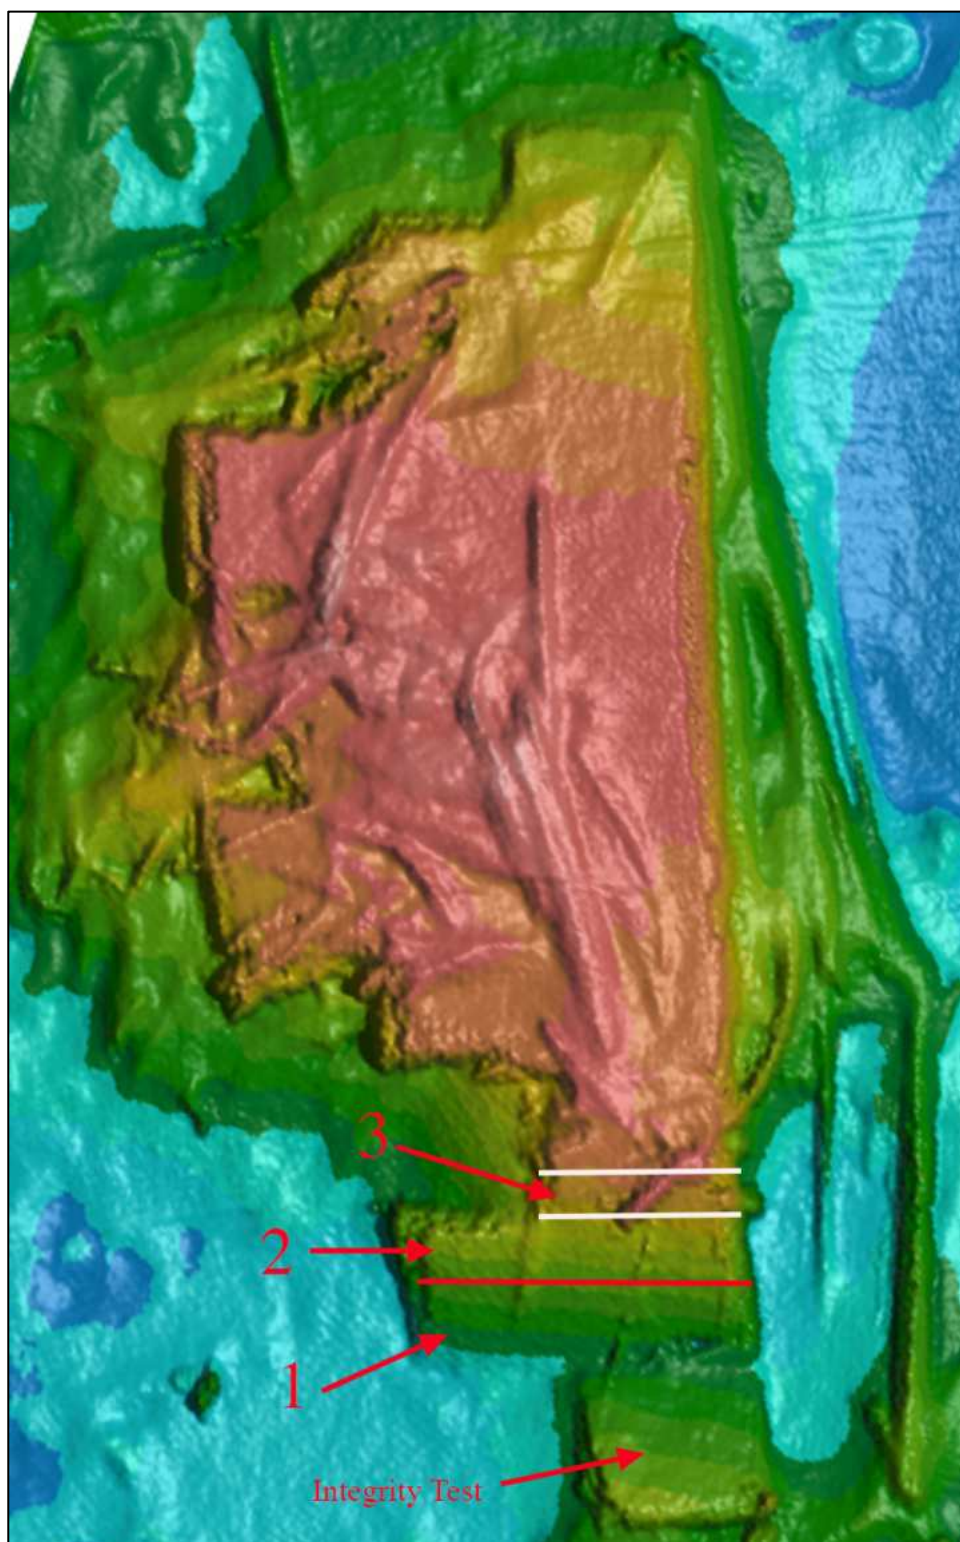
Figure 6-82. Recovered sections from the West Casemate (north is to right). The red line between numbers represents rail separator cuts. White lines are thought to be breaks caused by employing the rail separator, although the bottom break may have been present as the component containing sections Nos. 1 and 2 was slanted downward, as if it had already been broken away. Note bent rail ends at left of the Nos. 1 and 2 sections.

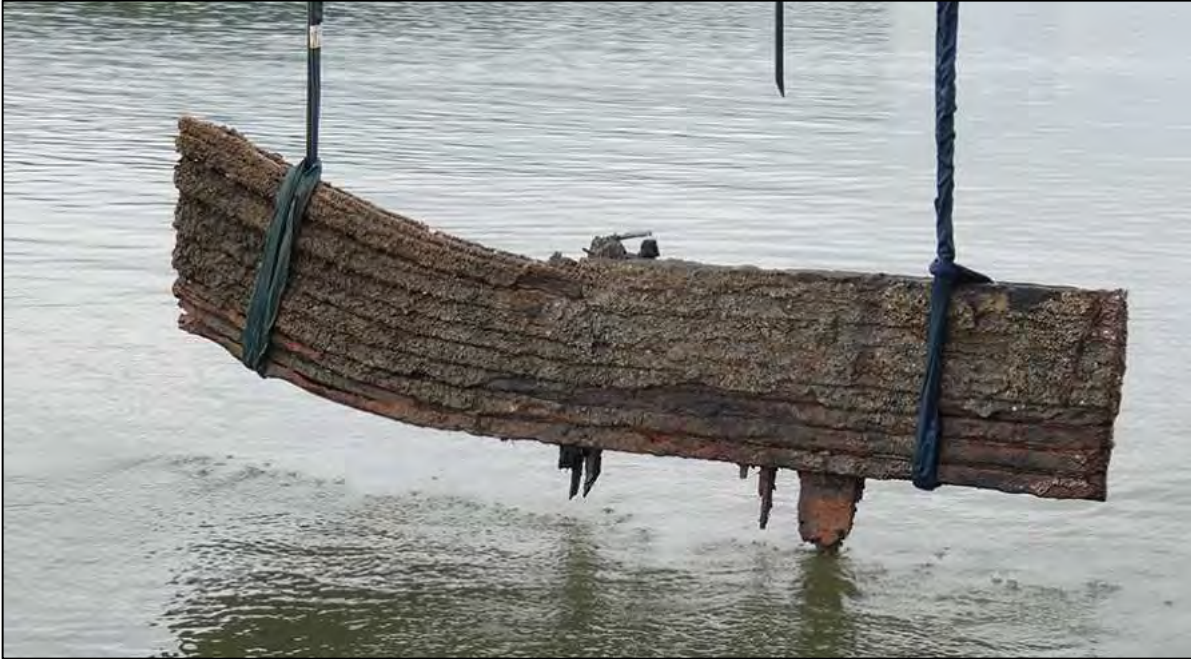
Figure 6-83. Larger (No.1) section recovered from the West Casemate. Note the bent rails at left, a feature clearly seen in Figure 6-77. Not an as-built feature, this bending was also noted on portions of the East Casemate rails, possibly a result of salvage or later pre-data recovery impact.

The first section raised was the lower portion of the 16-foot long section (Figure 6-83). Approximately 4 feet wide, the upper ends of the rails are bent. Not an as-built feature, this bending was also noted on portions of the East Casemate rails, possibly a result of salvage or later pre-data recovery impact. The No. 2 portion was then raised. Also with bent rail ends, this section was approximately 2 feet wide (Figure 6-84). The section was then followed by the recovery of the small, 8-x-2-foot, No. 3 section (Figure 6-85). At first thought to be the bottom of a gunport because of its squared-off top, it would be found that there were a line of fasteners at 8 feet resulting in many pieces having clean breaks at the this 8 foot mark.

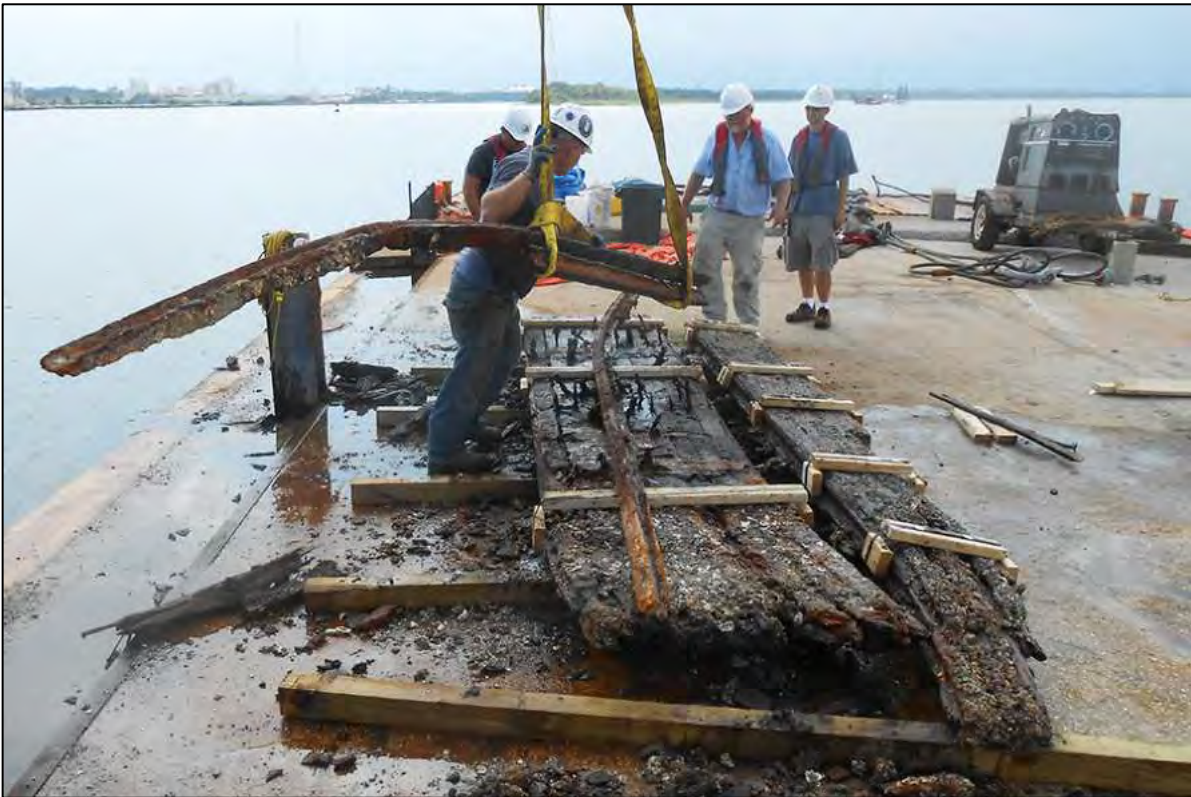
Figure 6-84. Smaller (No. 2) section adjacent to the right of the No. 1 section recovered from the West Casemate. Similar to No. 1 section, it has bent rail ends. Both have been banded and are ready for placement into a transportation container. Two loose rails from the same area are being lowered.

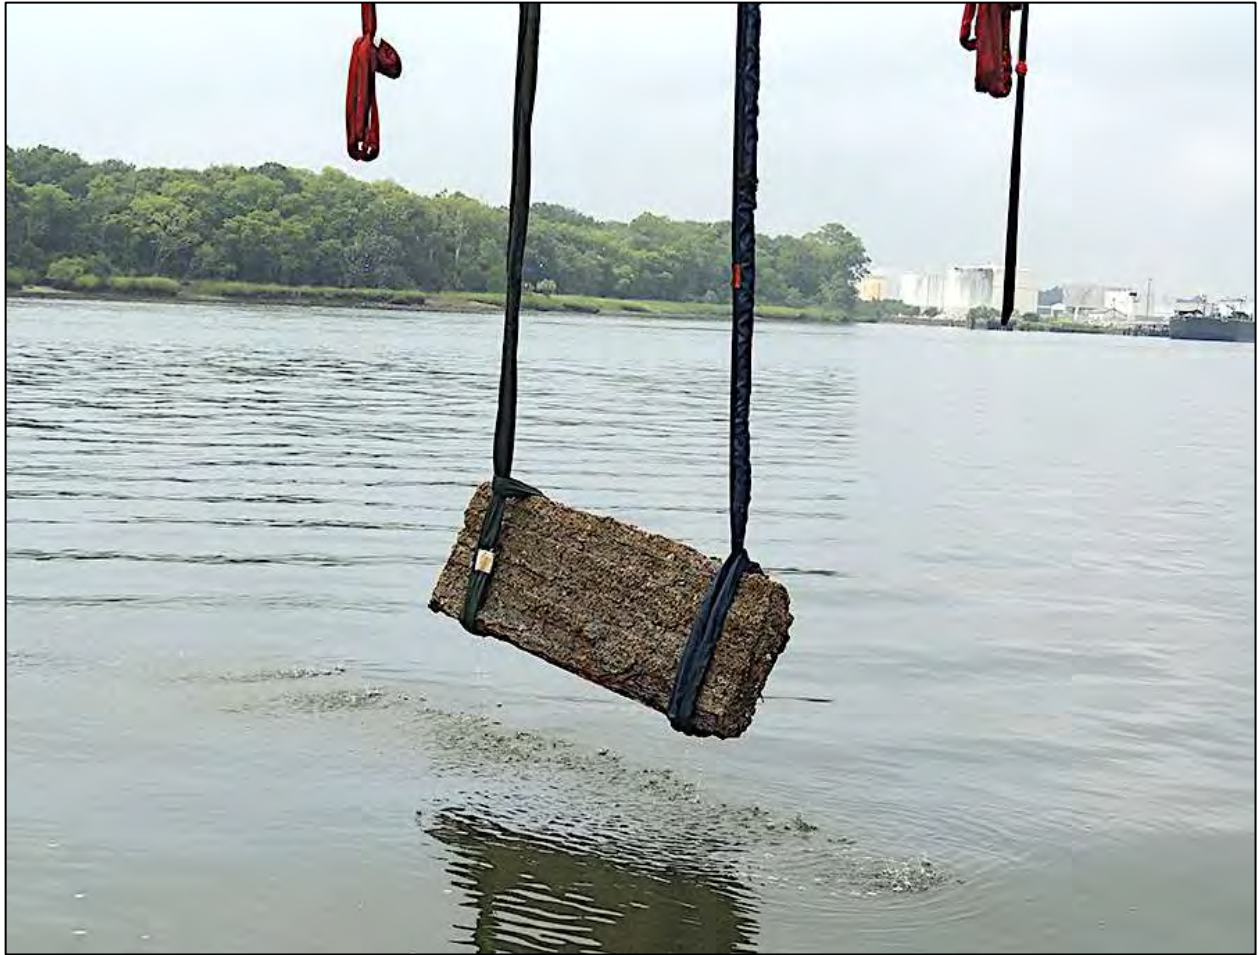
Figure 6-85. Small (No. 3) section recovered from the West Casemate. At first thought to be the bottom of a gunport because of its squared-off top, it would be found that there was a line of fasteners at 8 feet, resulting in many pieces having similar clean breaks at the this 8-foot mark.

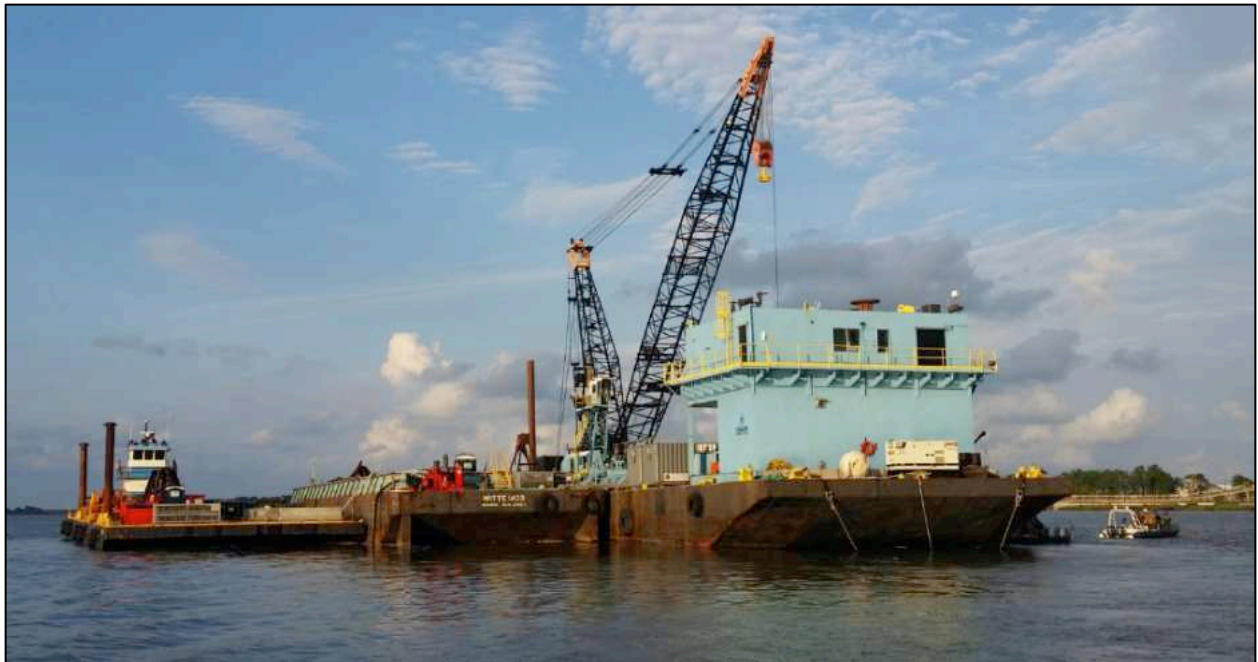
Figure 6-86. The work platforms for the 2017 Operation recovery effort consisted of the Farrell 256 Crane and Dive Barge (right), the Witte 1403 Hopper Barge for casemate storage (center), and a smaller material spud barge for mechanized recovery and screening (right).

The work platforms for the 2017 Operation recovery effort consisted of the Farrell 256 Crane and Dive Barge, the Witte 1403 Barge for casemate storage, and a smaller material barge for mechanized recovery and screening (Figure 6-86). The 200 x 56-foot Farrell barge was equipped with a two-story deckhouse on one end and a crane on the opposite end with a 120-foot boom and a lift capacity of 143 short tons. Anchored in place with a mooring winch system that allowed it to move around the site without lifting spuds or anchors, the Farrell housed on its deck the Dive Station and Communication Station. Accompanying the Farrell was the Witte barge, a 165-x-43-foot hopper-type barge that was used to hold the casemate sections. A third small material spud barge was also on-site for mechanized recovery.

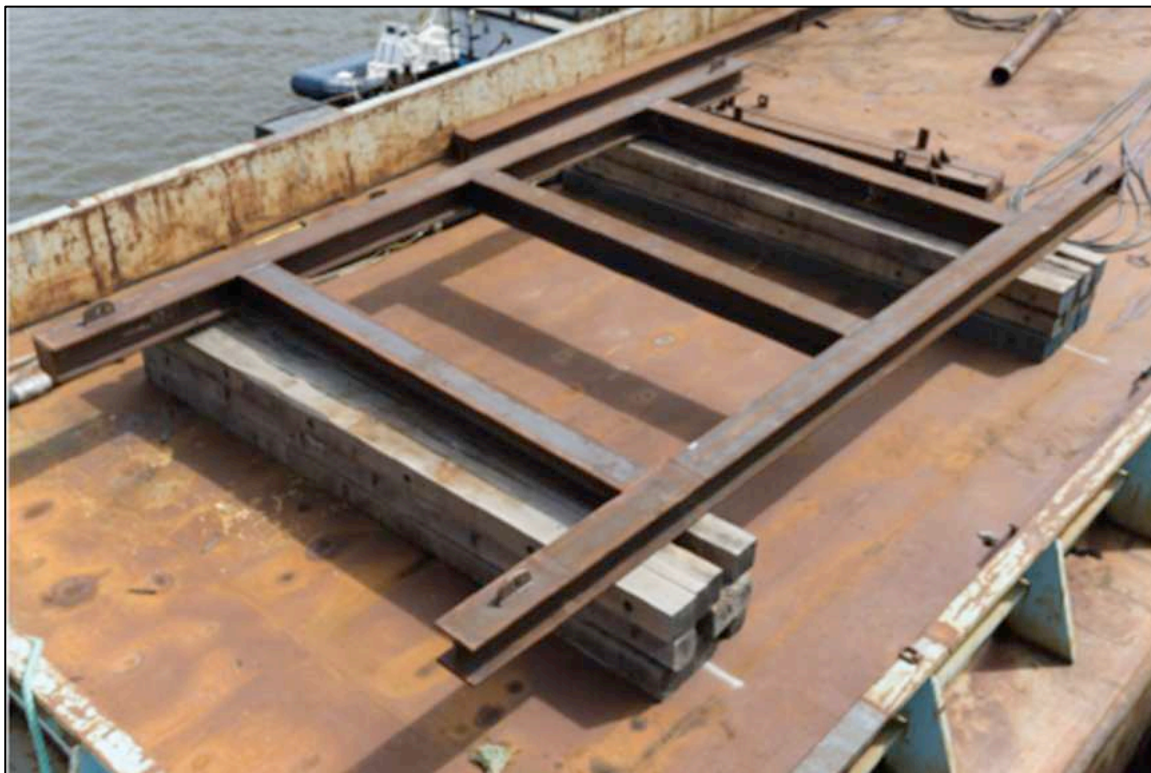
Figure 6-87. Iron I-beam frame for lifting casemate sections.

Accomplished from June 19 to July 2, 2017, the method proposed for casemate recovery was similar to that of the 2015 Operation recovery effort, but with one major difference—the employment of a large lifting frame for the artifact to rest on prior to lifting it from the river (Figure 6-87). The recovery sequence was to lay the large I-beam lifting frame on the bottom adjacent to the casemate, raise the casemate with wire slings, and place it on the frame, then lift the frame with the casemate and place it on the Witte barge. In order to allow the placement of slings underneath the sections airlifting of sediments around certain sides of each casemate would be required. This was accomplished with an airlift made of a 1-foot diameter 30-foot long iron pipe that was lowered into place by crane and then positioned by diver prior to beginning airlifting (Figure 6-88).

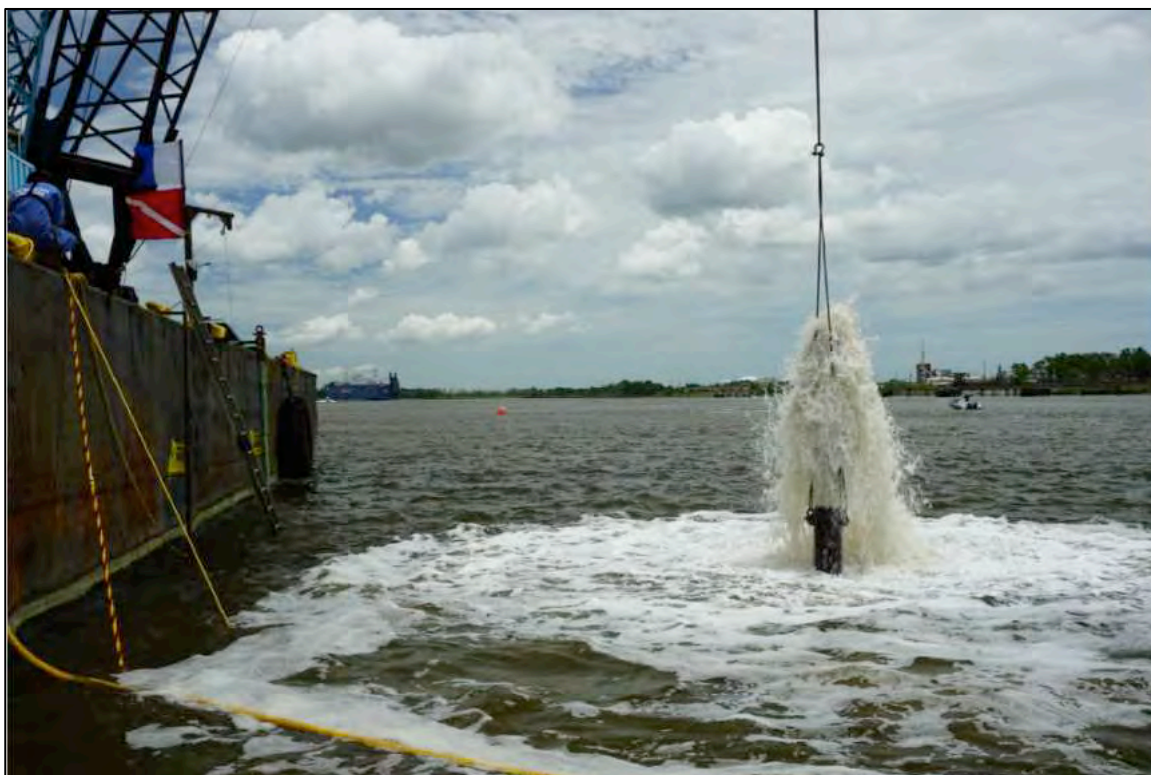
Figure 6-88. Airlift made of a 1-foot diameter 30-foot long iron pipe that was lowered into place by crane and then positioned by diver prior to beginning airlifting on both the East and West Casemates.
