CSS *GEORGIA*
ARCHEOLOGICAL DATA RECOVERY AND MITIGATION
FOR THE SAVANNAH HARBOR EXPANSION PROJECT (SHEP),
CHATHAM COUNTY, GEORGIA AND JASPER COUNTY, SOUTH CAROLINA

**FINAL DRAFT REPORT
OCTOBER 2019**

Stephen R. James, Jr. and Gordon P. Watts

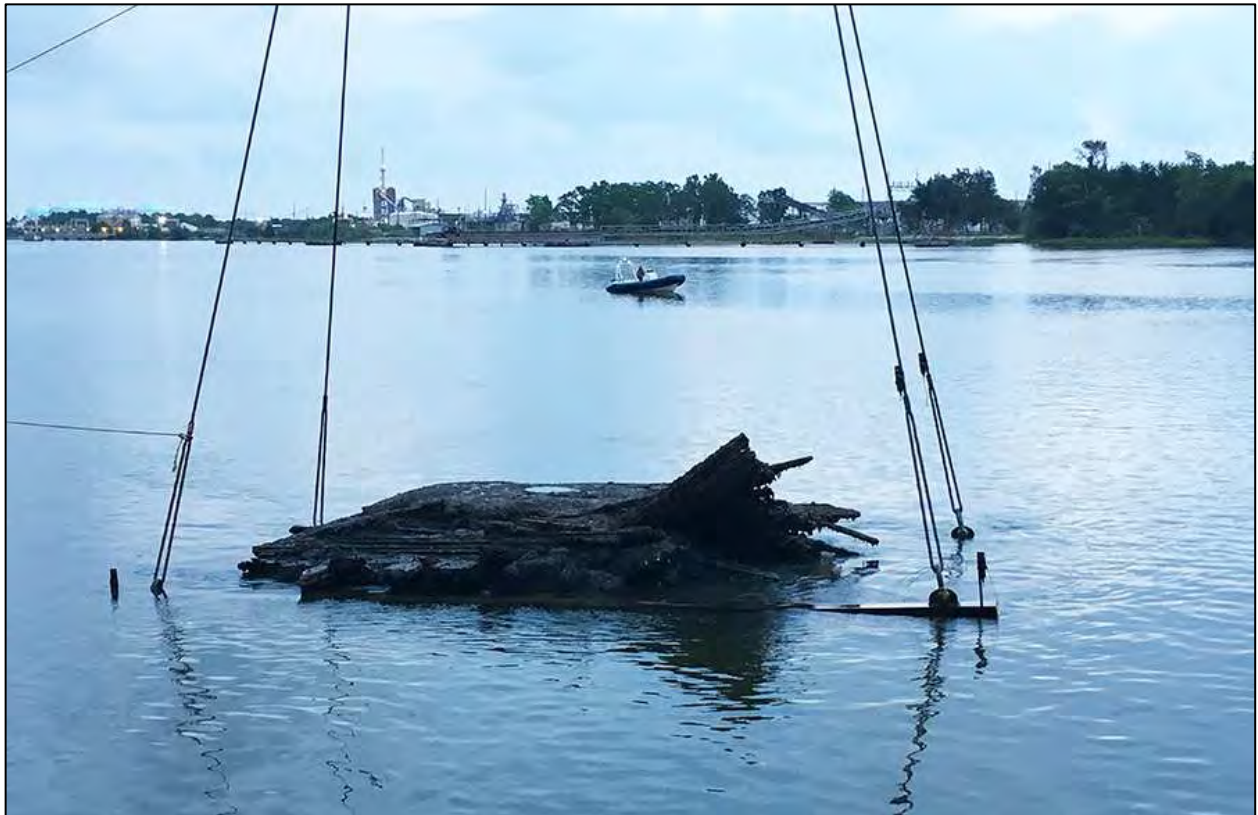
Figure 6-89. East Casemate breaking the surface during recovery. At this point it was found to weigh 23.5 tons (43.5 tons with the lift frame).

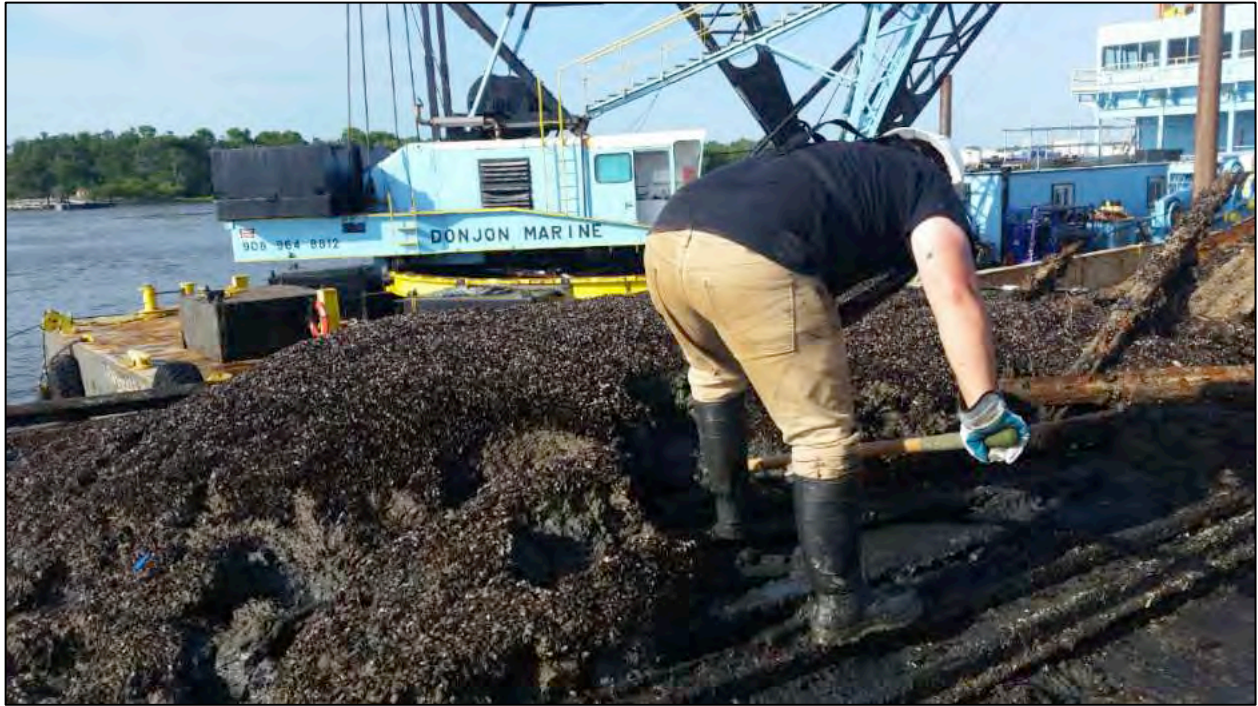
Figure 6-90. Cleaning of the mud and invasive mussels on top of the casemate.

Once on the barge it was found that the casemate was covered by a thick mat of mud and invasive mussels (Figures 6-90 and 8-91). This had to be shoveled off prior to high pressure washing of the casemate for subsequent recordation including drone photography (Figures 6-92 and 6-93). Both casemates would be photographed for 3D modeling, and general photographs and measurements were taken as well (Figure 6-94).

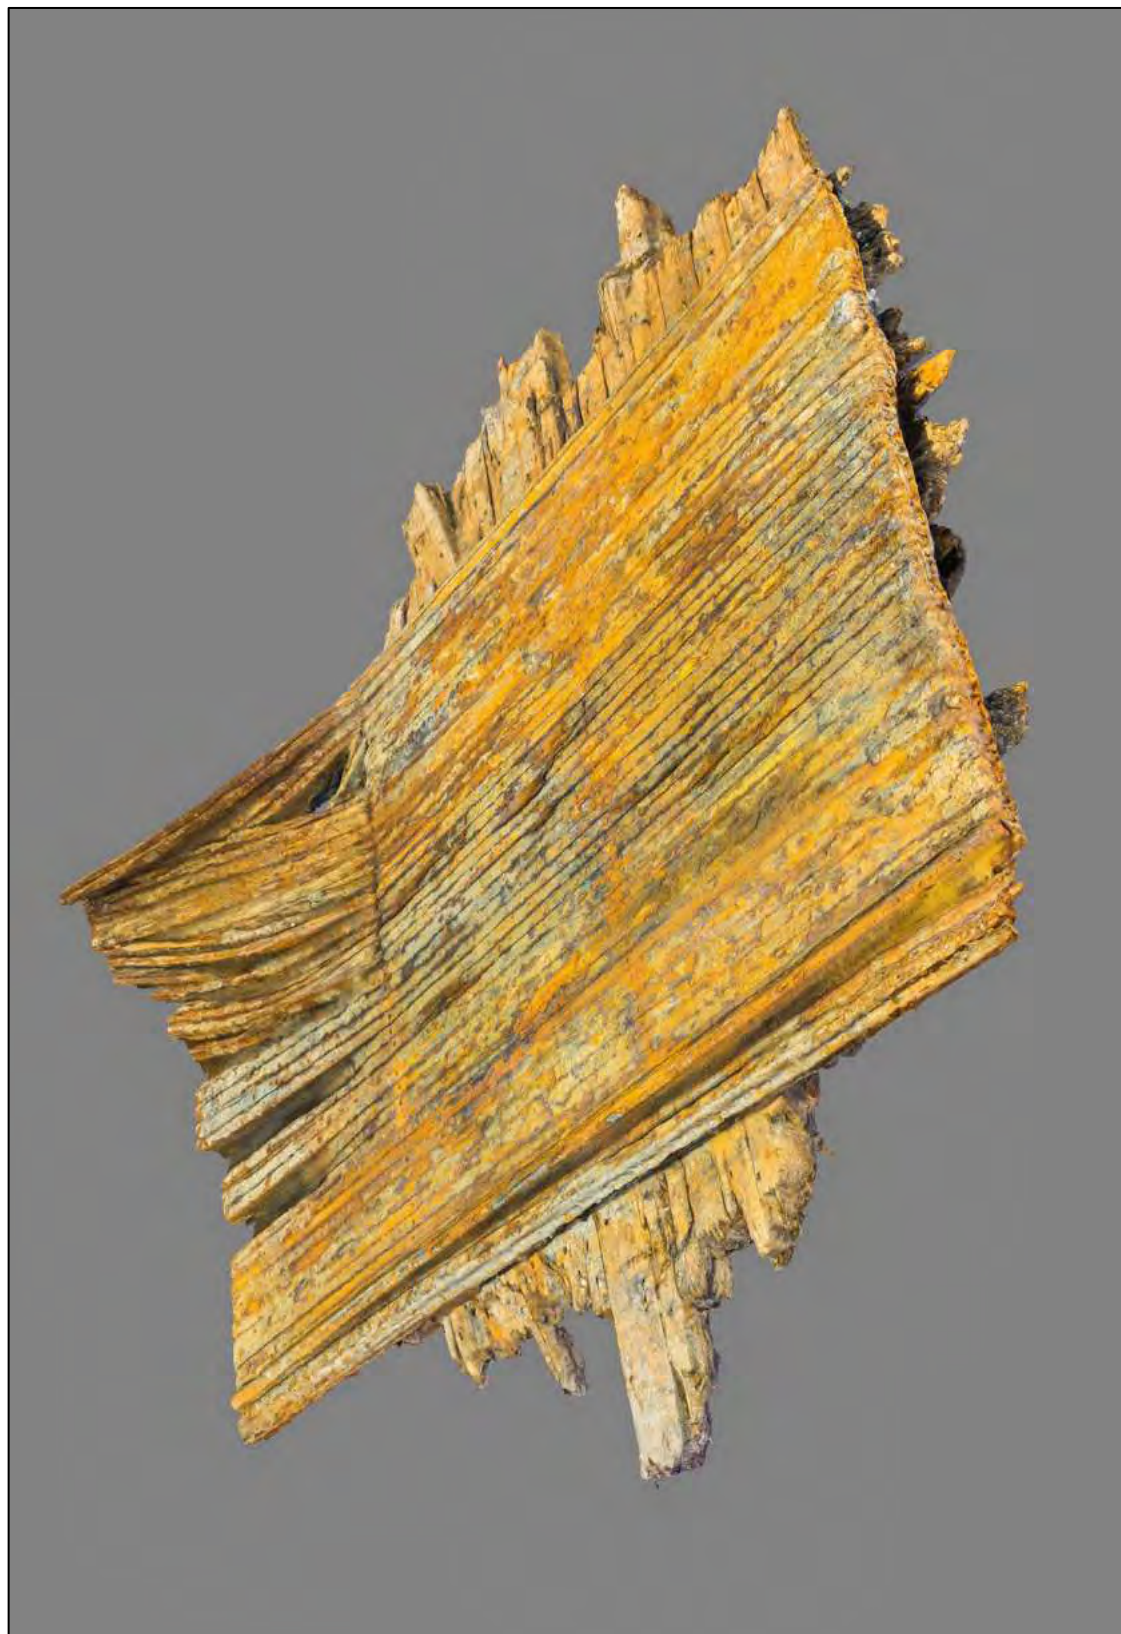
Figure 6-94. 3D isometric of the main section of the East Casemate. Note the bent rails and where they break at the line of fasteners.

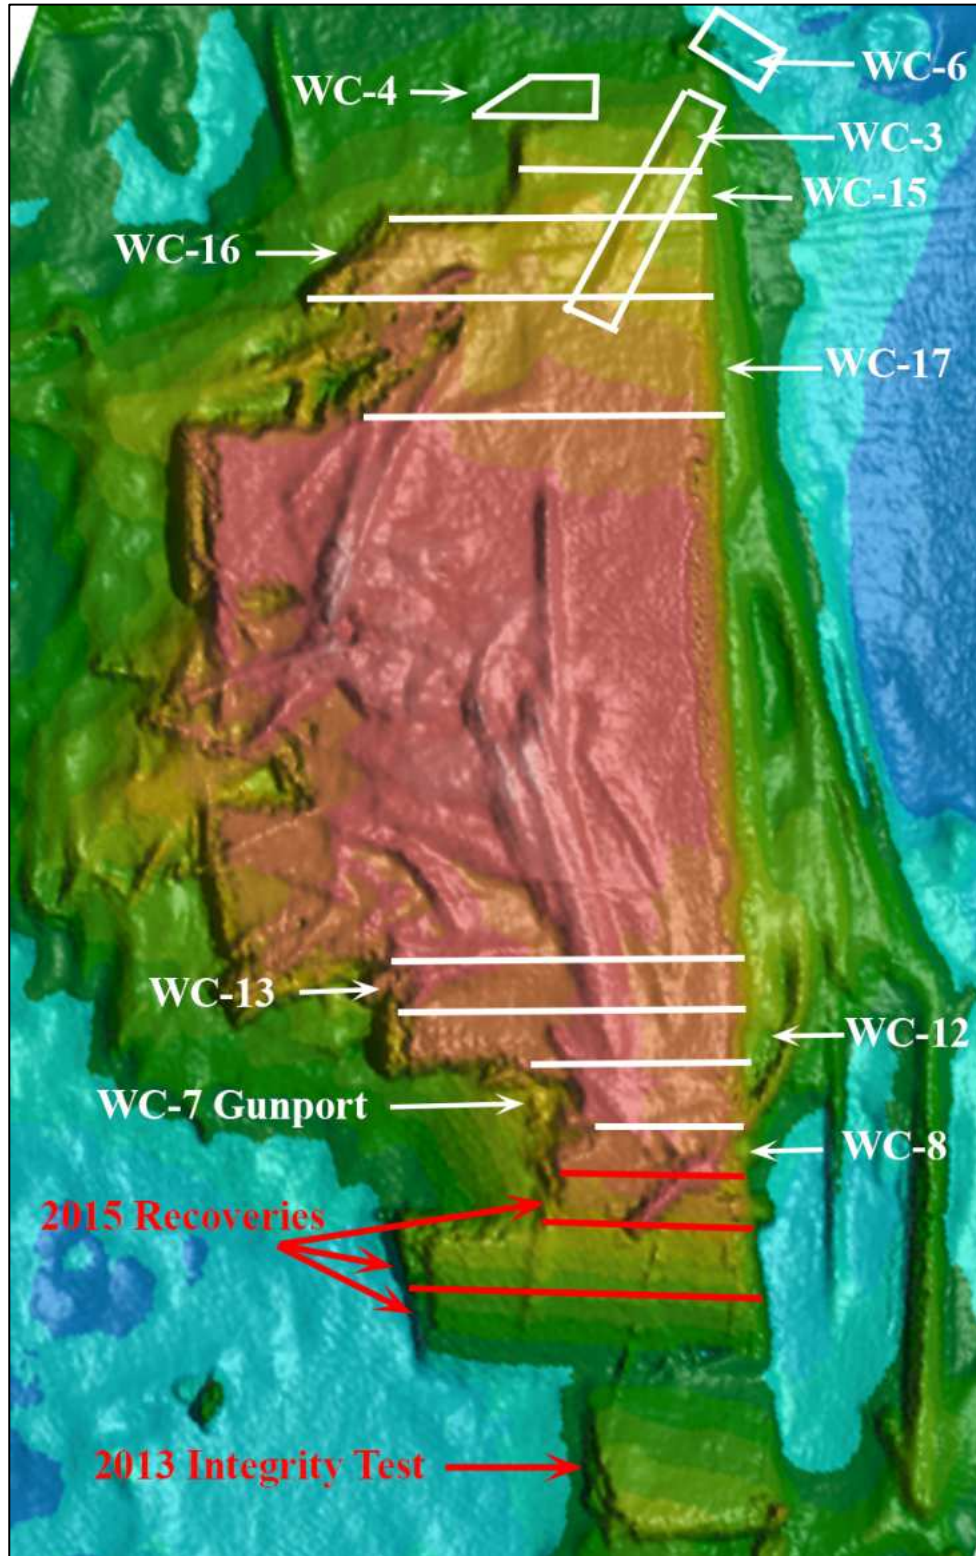
Figure 6-95. Multibeam map of the West Casemate labeled with the majority of 2017 lifts (in white), several of which were very diagnostic. Note the right side of the casemate attached to the hull, the left side the top of the casemate (north is right, upriver is up).

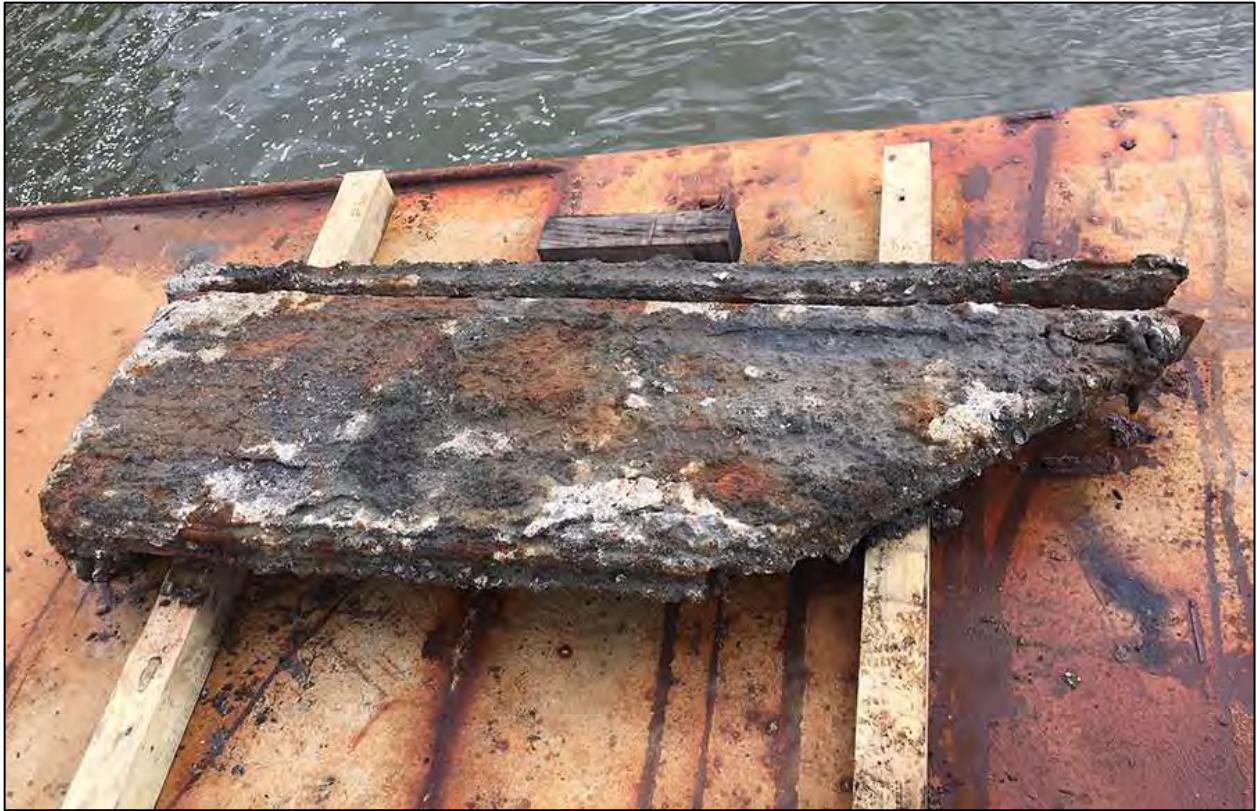
Figure 6-96. West Casemate section WC-4. Its angled top edge represents the end of the angled casemate.

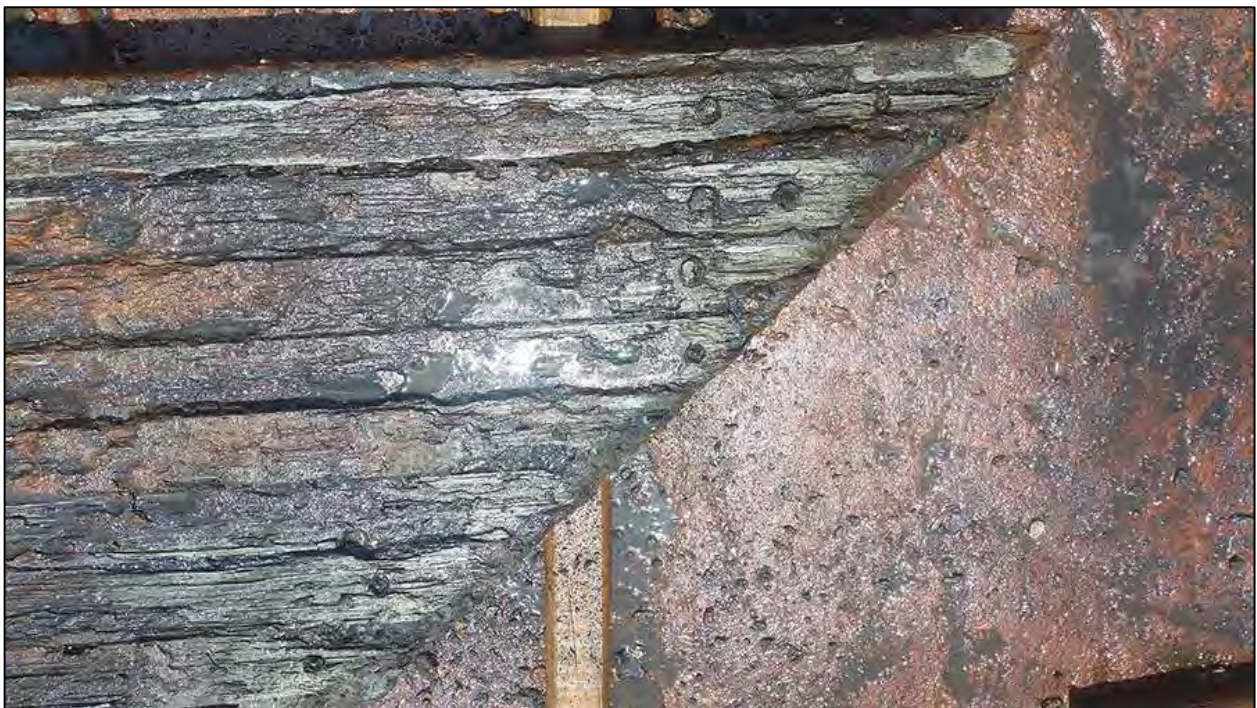
Figure 6-97. West Casemate section WC-4. Its angled top edge after high-pressure cleaning.

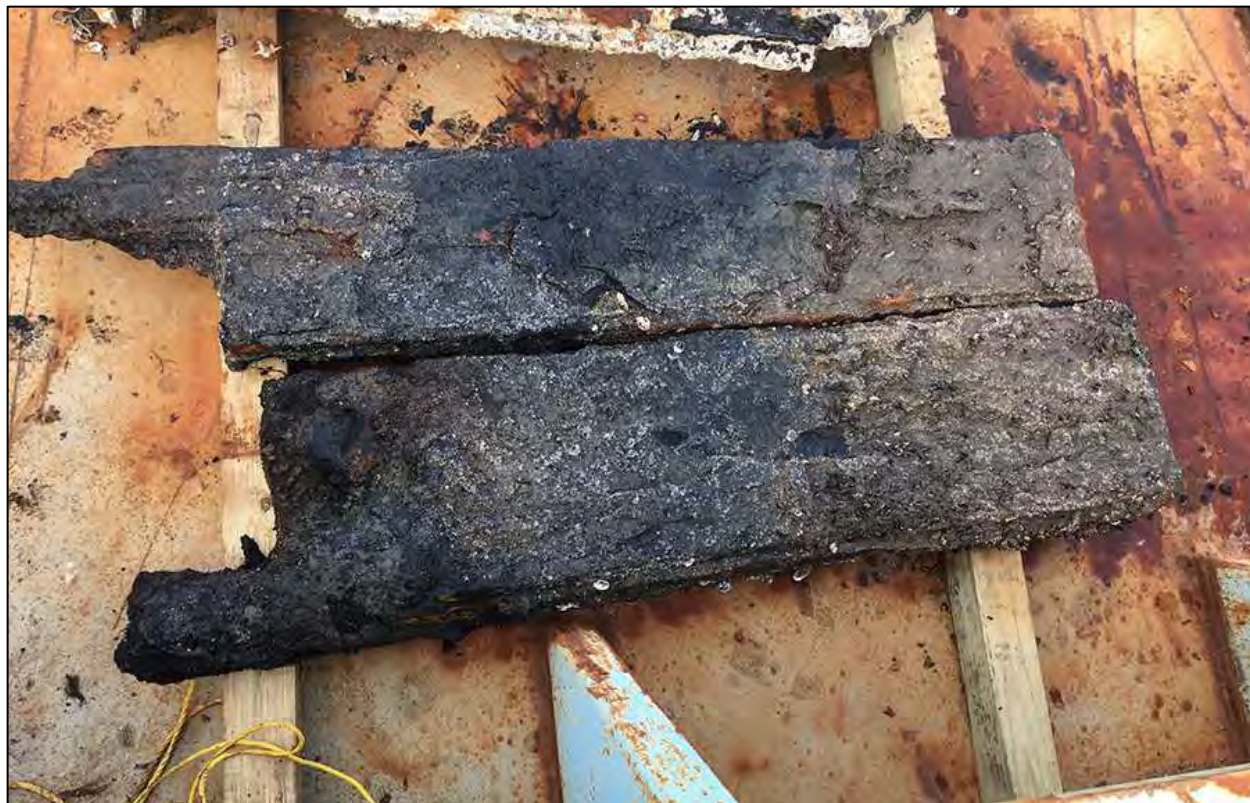
Figure 6-98. Lift WC-7. Originally one 4-foot wide piece, together they form a square, 27-inch wide, as-built cutout thought to represent a gun port. It will be found to be the only gunport on the entire length of the West Casemate.

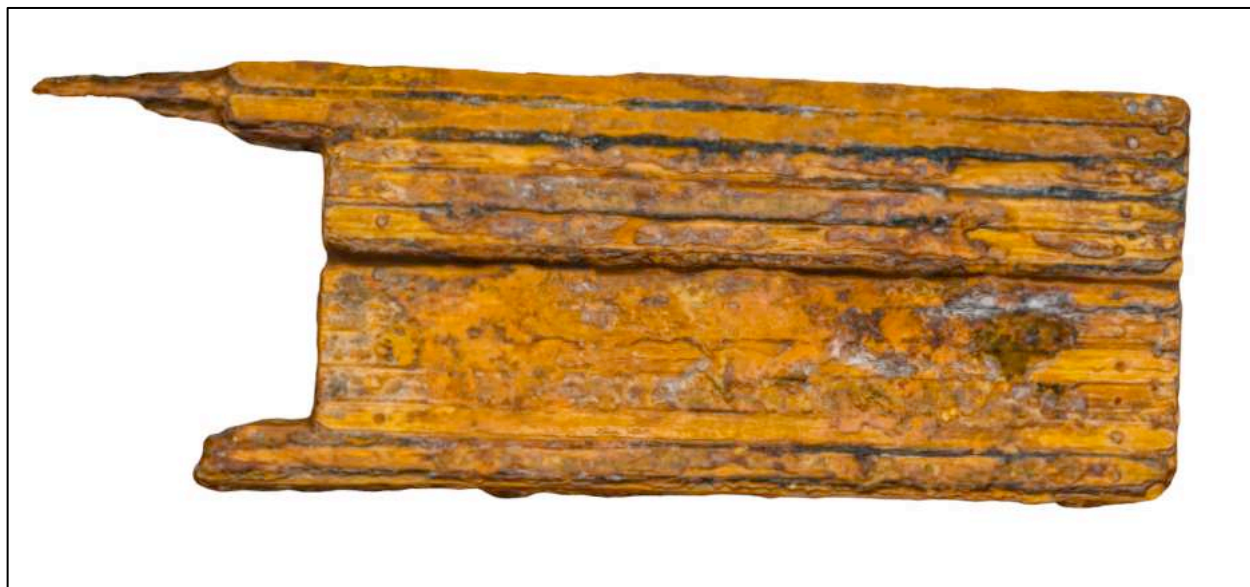
Figure 6-99. 3D-model of lift WC-7 after high-pressure cleaning.

Illustrated in Figures 6-98 and 6-99, the second diagnostic section was WC-7 comprised of two notched sections approximately 7 feet long by 2 feet wide each. Fitting the sections together formed a 4-foot wide, 7-foot long piece with a 27-inch wide square cutout that is thought to represent a gun port. It will be found to be the only gunport on the entire length of the West Casemate, the lack of ports in this area suggesting the casemate opposite the engine and boiler in the stern of the vessel.

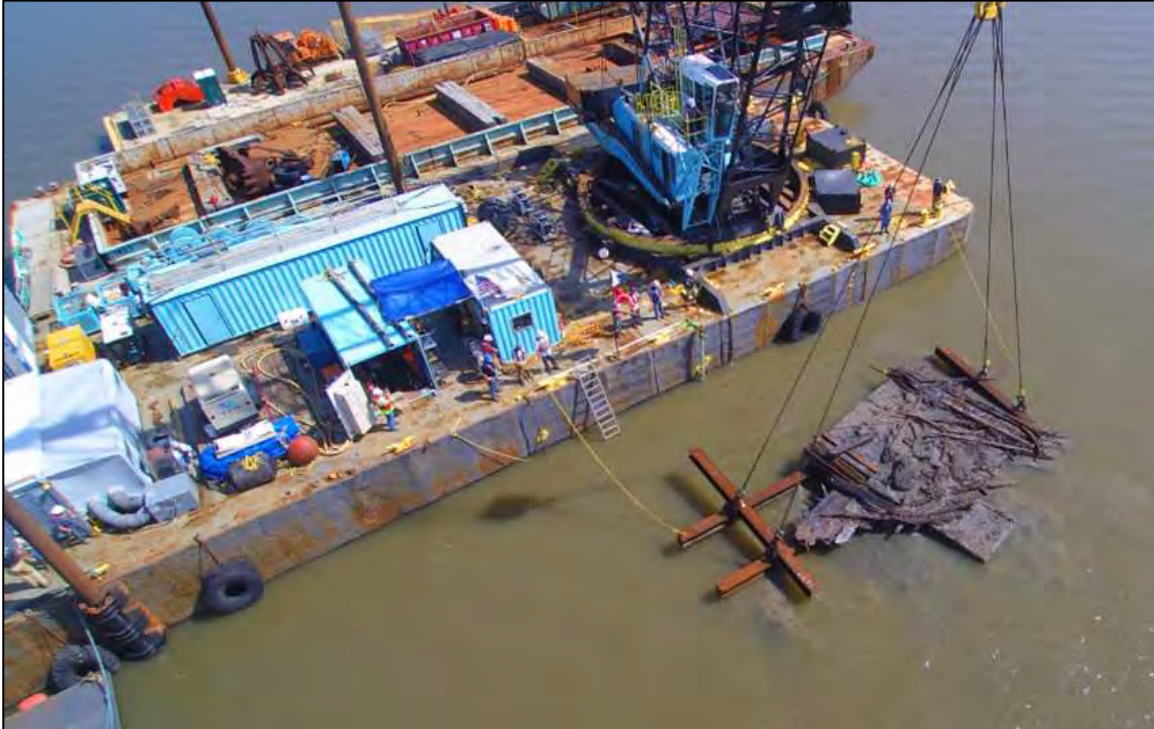
Figure 6-100. Drone shot of West Casemate lift just breaking the surface. At this point it was found to weigh 40 tons without the lift frame. It will be lifted and swung around to the middle Witte barge (middle barge) where it will be placed on wooden bunks next to the East Casemate. Note the dive station CONEX box to the left of the crane, and grey command tent to the far left.

Airlifting and recovery of the small sections and loose rail was followed by wire sling placement under the remaining section, which was 32 feet east/west by 24 feet north/south. Similar to the East Casemate, slings were placed under the northern and southern sides. The crane conducted a trial lift and the West Casemate successfully came off the bottom, after which it was immediately lowered back to the bottom. Employing the same methodology as on the East Casemate, the lifting frame was lowered, the casemate was rigged, placed onto the frame, the frame re-rigged, and the lift begun. The casemate was lifted up to just above the waters surface as seen in the drone shot in Figure 6-100. At this point the lift was visually inspected. Measured by the crane, the West Casemate was found to weigh 40 tons (60 tons with the lift frame), a weight easily within the crane's capacity. The crane then swung the casemate around to the Witte barge where it was placed on wooden bunks at one end of the barge adjacent to the East Casemate where it would be cleaned and recorded (Figures 6-101 and 6-102). Figure 6-103 is a 3D isometric image of the cleaned casemate. Note that from the first reconnoiter dive to recovery and placement on the barge was a period of 11 days.

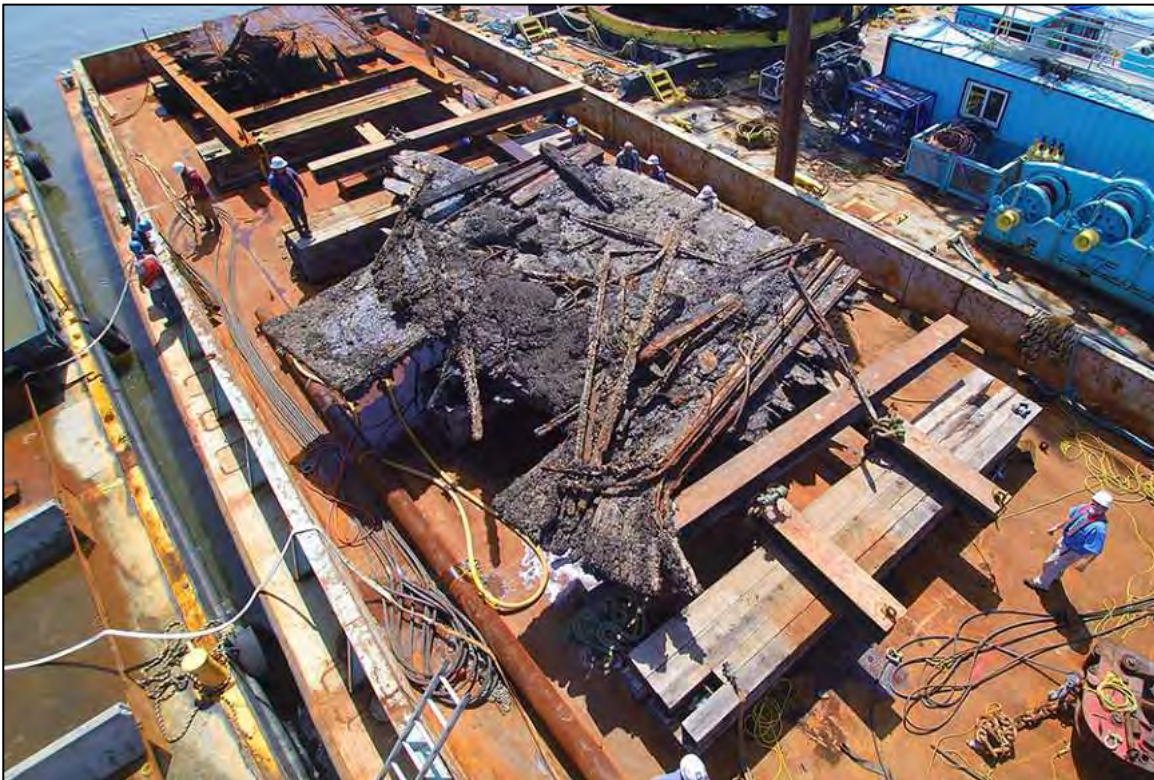
Figure 6-101. Drone shot of West Casemate placed next to the East Casemate on the Witte barge.

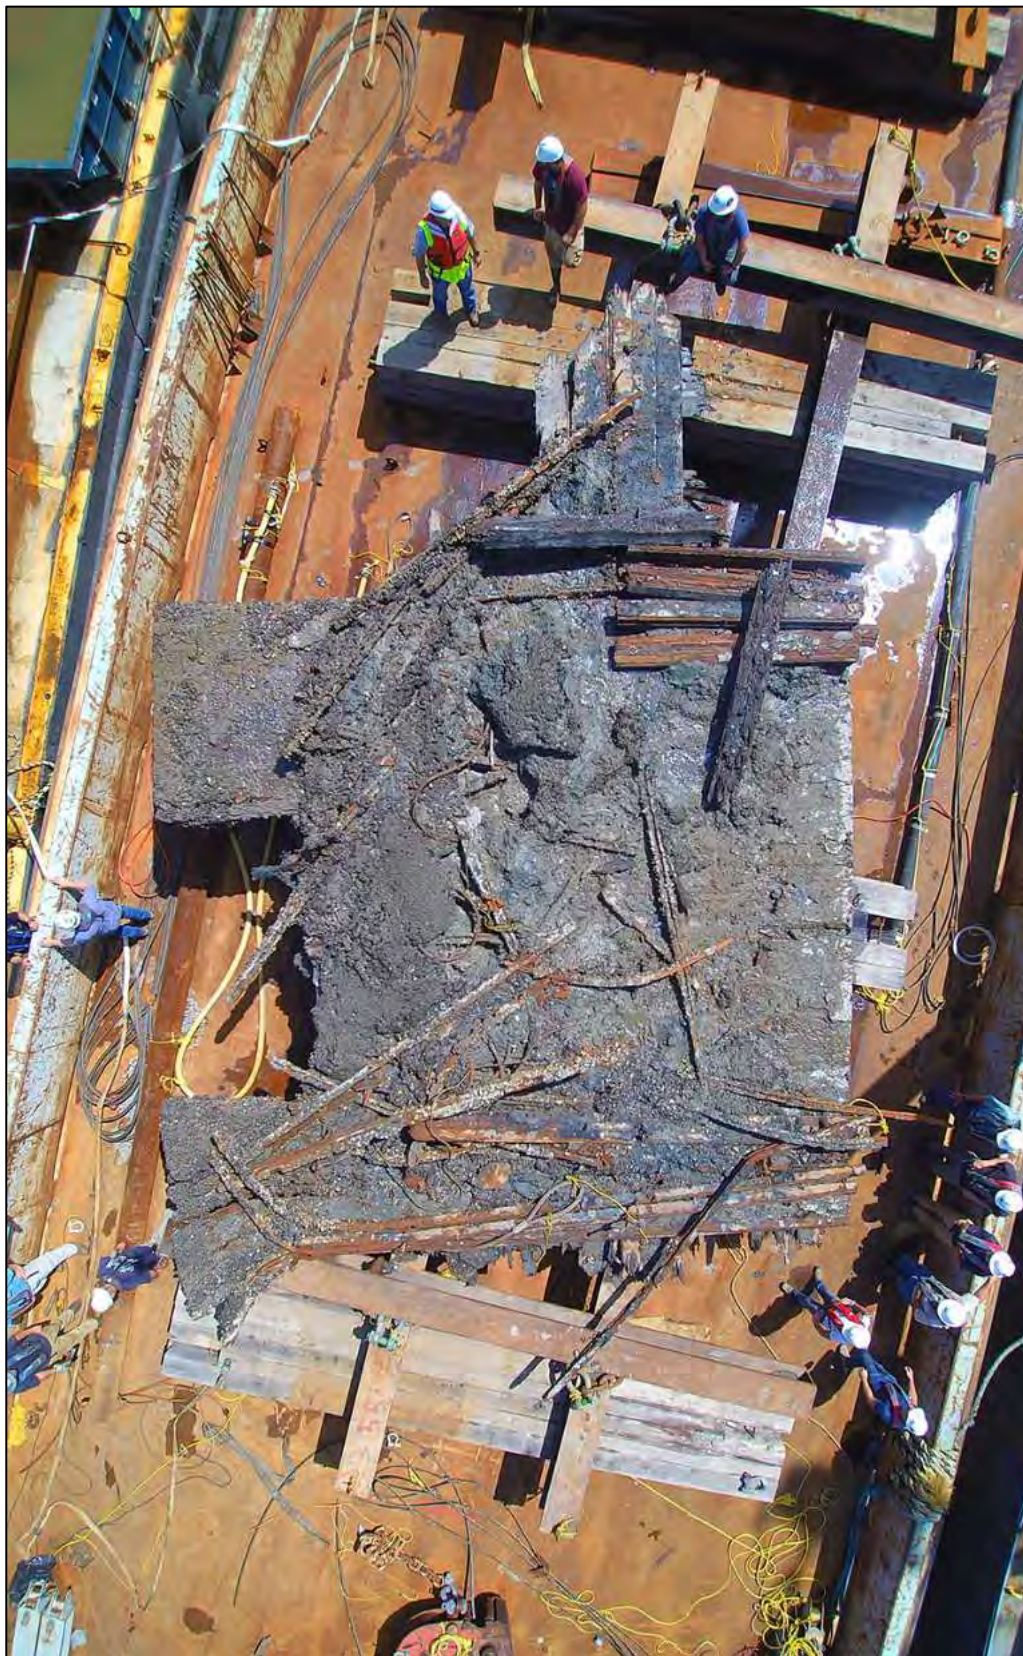
Figure 6-102. Drone shot of West Casemate prior to cleaning. Components of a gun carriage would be found under the mud in the left center atop the casemate.

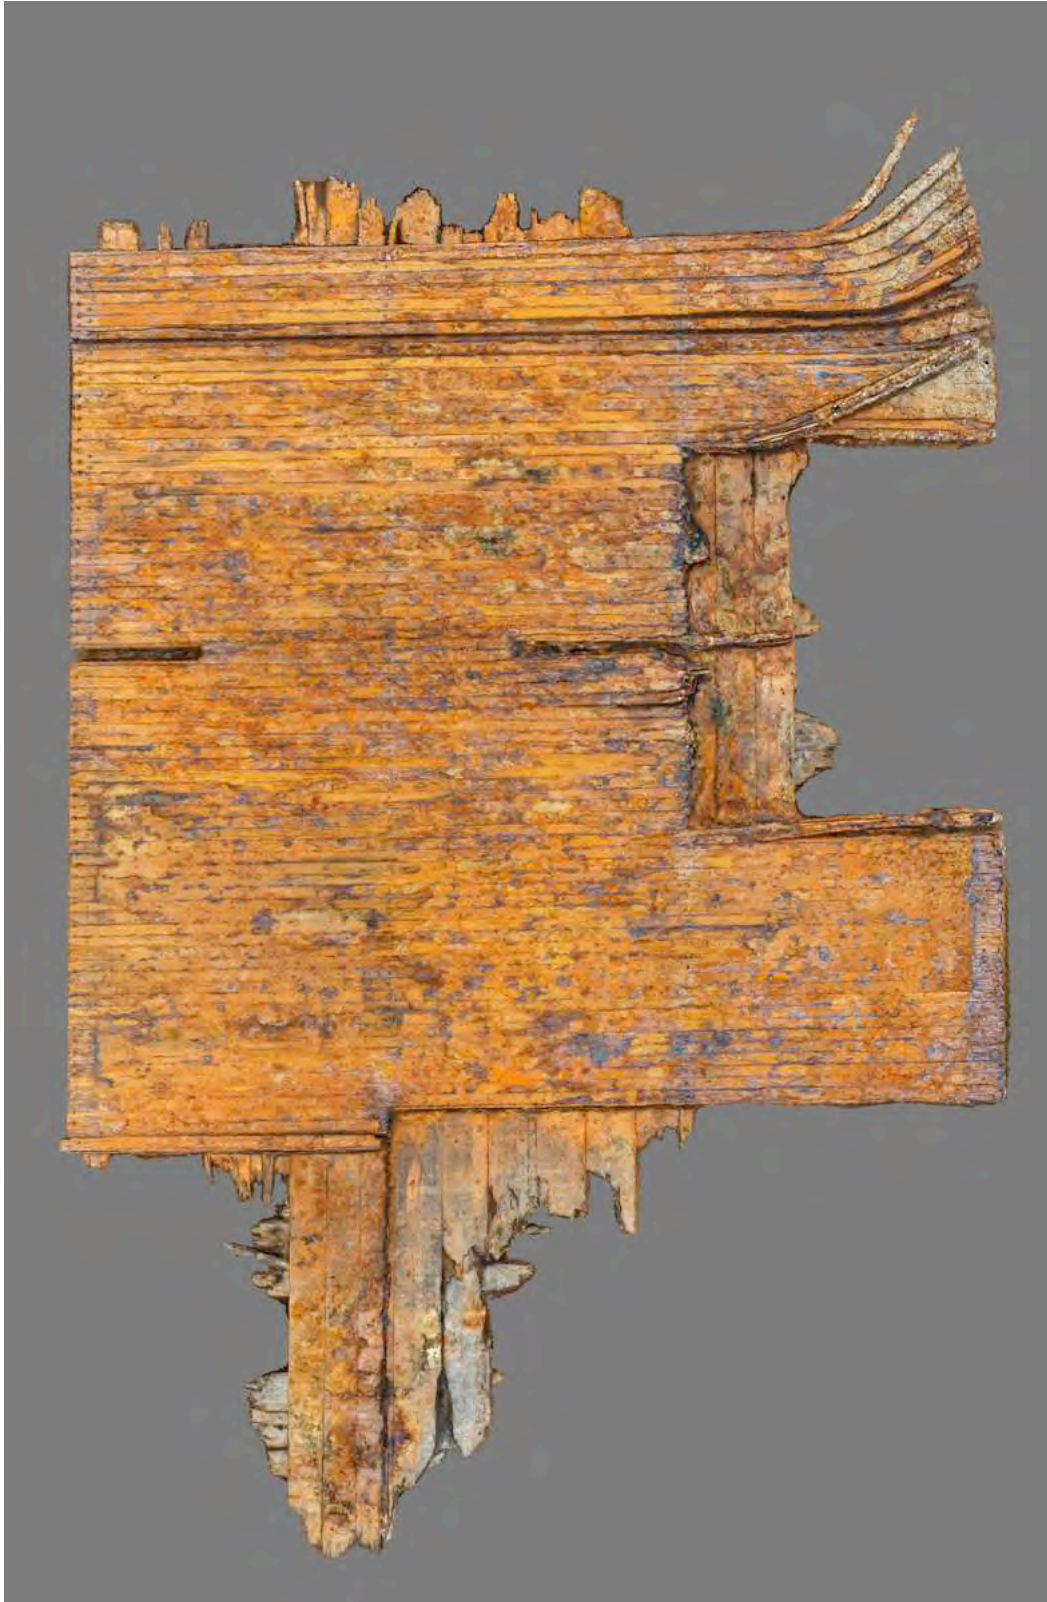
Figure 6-03. 3D isometric of the main section of the West Casemate. Note the bent rails at top and middle section missing the top third of the 24-foot rail lengths. They have all broken away at a line of fasteners.

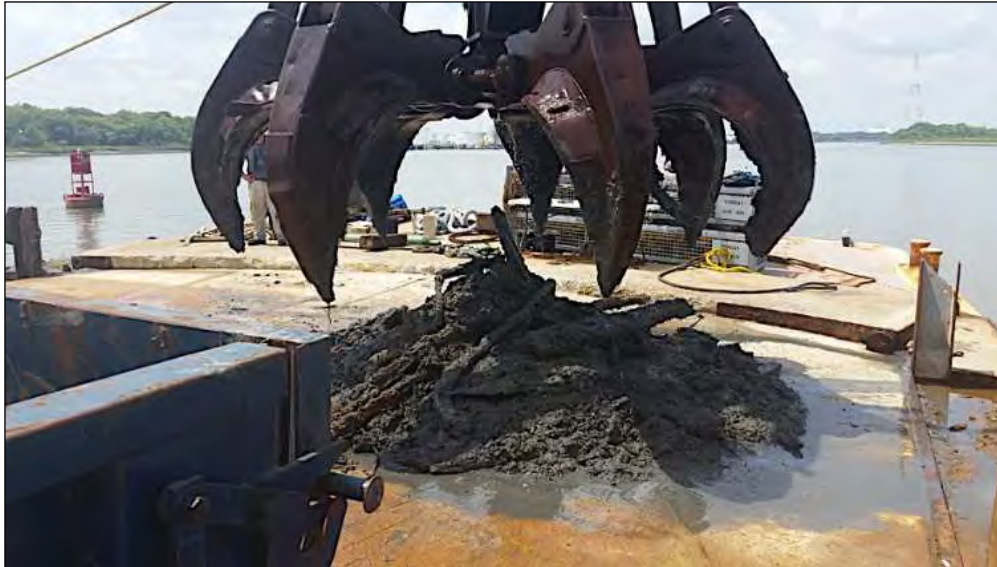
Figure 6-104. 14-ton, seven-finger grapple depositing initial test on deck. The sediment matrix was carefully hosed off the barge to the right and away from wreck site. The first six grapple tests were easily sorted and washed with no loss of material, even with the absence of a screen.

During the latter part of the Large Artifact Recovery Phase and prior to the commencement of the Mechanized Site Recovery Phase, six grapple tests and six clamshell grabs were conducted on the southern side of the West Casemate in order to assess and refine the process and procedures as previously described in the Research Design (see *Chapter IV: Research Design Methodology* and Appendix A). The 14-ton, seven-finger grapple was used for six tests, followed by the clamshell “grabs,” in the same general locations with all 12 recoveries conducted deliberately to refine the process and recordation methods, both in personnel and procedures. The six grapple tests were processed and sorted on deck, while the six clamshell grabs were processed in a prototype screen (Figures 6-104 to 6-107). Over-built, the screen proved to be inefficient for the removal of soil matrix and made separation of artifacts for processing difficult and time-consuming; subsequently, the prototype was not employed. Based on the positive findings from processing the grapple test loads, it was decided to process all mechanized recovery on deck with simple screening bays that allowed for expeditious sediment removal and efficient artifact processing.

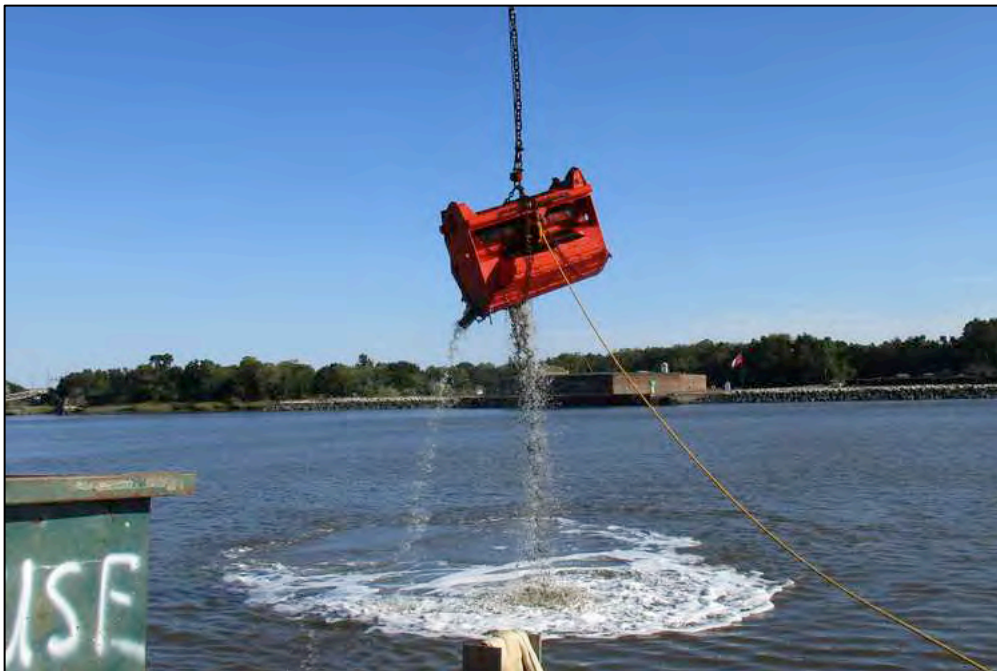
Figure 6-105. Clamshell grab being brought on board. Notice the timber disallowing closure of the mouth, with a resultant loss of sediment.

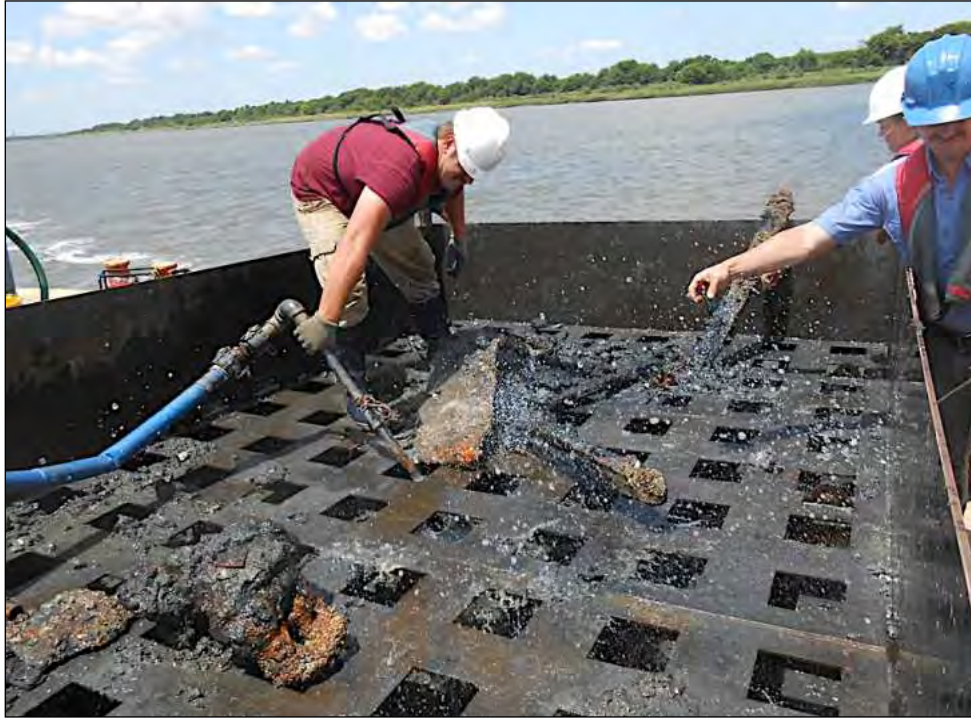
Figure 6-106. Initial processing of a clamshell grab. Over-built, the screen was difficult to access, affected processing efficiency, and raised safety concerns.

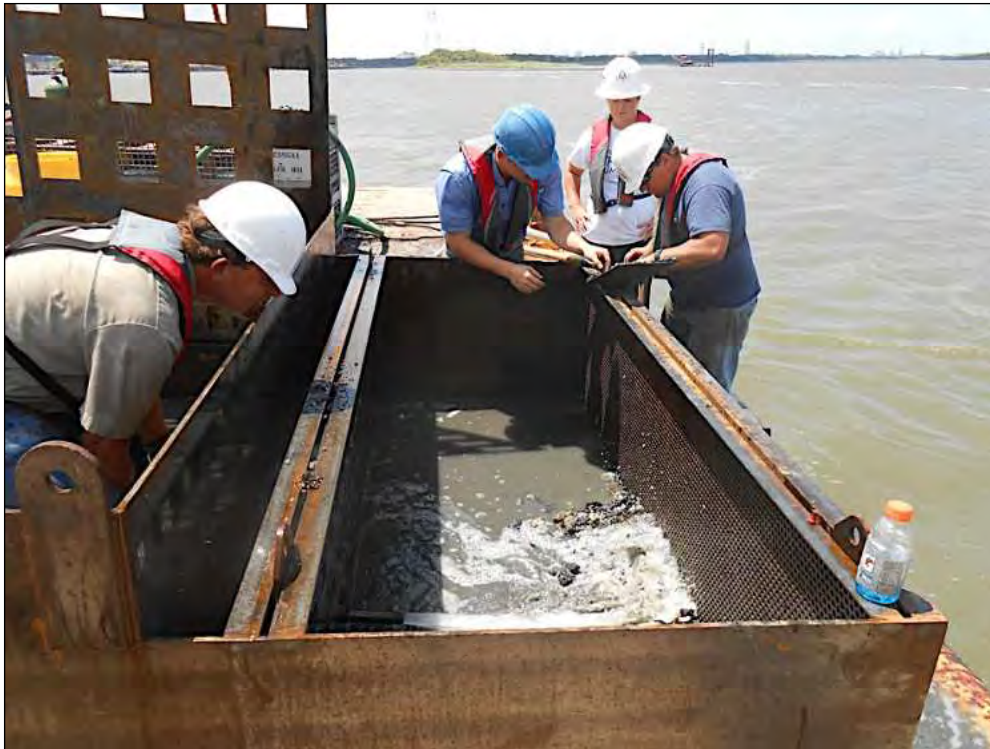
Figure 6-107. With the large 6-x-6-inch top grate raised, personnel had to enter the screen to wash sediment through two horizontal grates. The weight of the grates made them difficult to lift and clean, and the position of the screens was found to be inadequate, with numerous limitations on processing (i.e., removal of sediments, etc.).

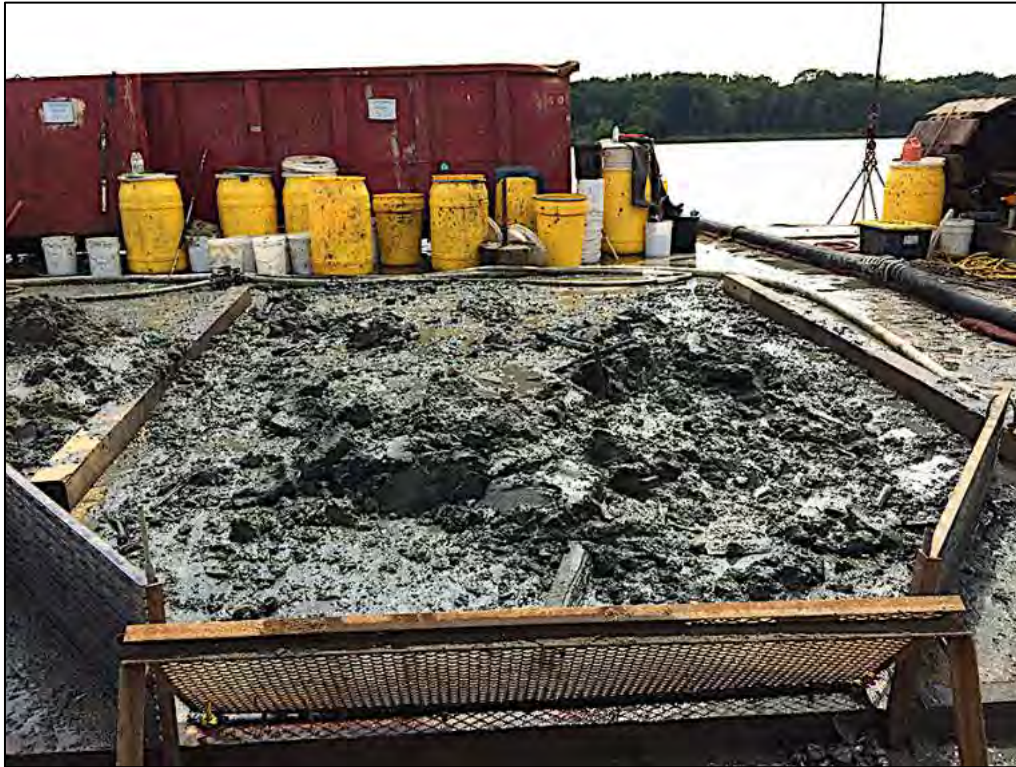
Figure 6-112. Close up of screening bay holding just-deposited clamshell grab S-14. Once deposited into the bay the sediment matrix was then hosed off the edge of the barge through three screens. Note the reburial roll-off containers, as well as the barrels and buckets for artifacts slated for conservation.

Based on findings from conducting and processing the initial 12 excavations, the final 2015 Mechanized Site Recovery Phase barge configuration saw the construction of eight simple, yet efficient screening bays, four on each side of the centrally located crane. The screening bays were located on what would be the northern side of the barge, with reburial roll-off containers lining the opposite side of the barge, along with numerous barrels and buckets for artifact collection (Figure 6-111). As presented in Figure 6-112, located at the edge of the northern side of the barge, the end of each bay had three screens, the two side screens angled into the main screen that could be raised easily after processing to wash over any unwanted shell or soil matrix. Wooden bunks divided screening bays from one another. In 2017, there would only be four screens on one side of the barge.

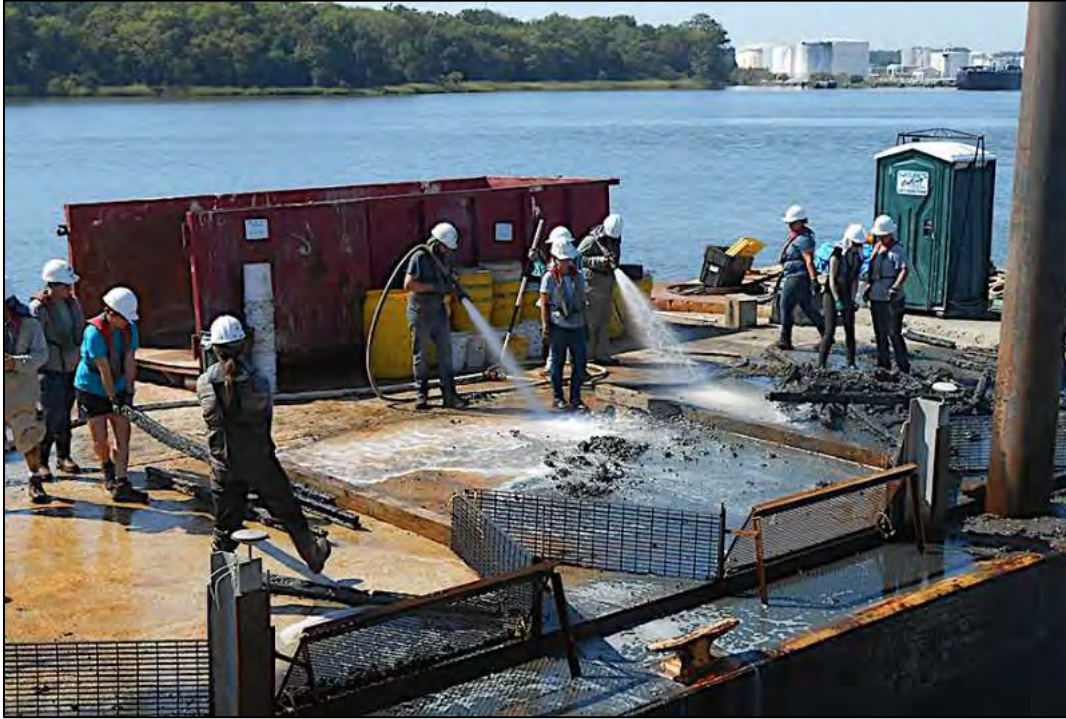
Figure 6-114. Two teams of eight archaeologists processed the filled bays. Fire hoses powered by a high-pressure water pump were employed to wash the sediment matrix overboard while personnel with rakes and shovels identified, collected, and sorted material. Note the personnel at left sorting railroad iron.

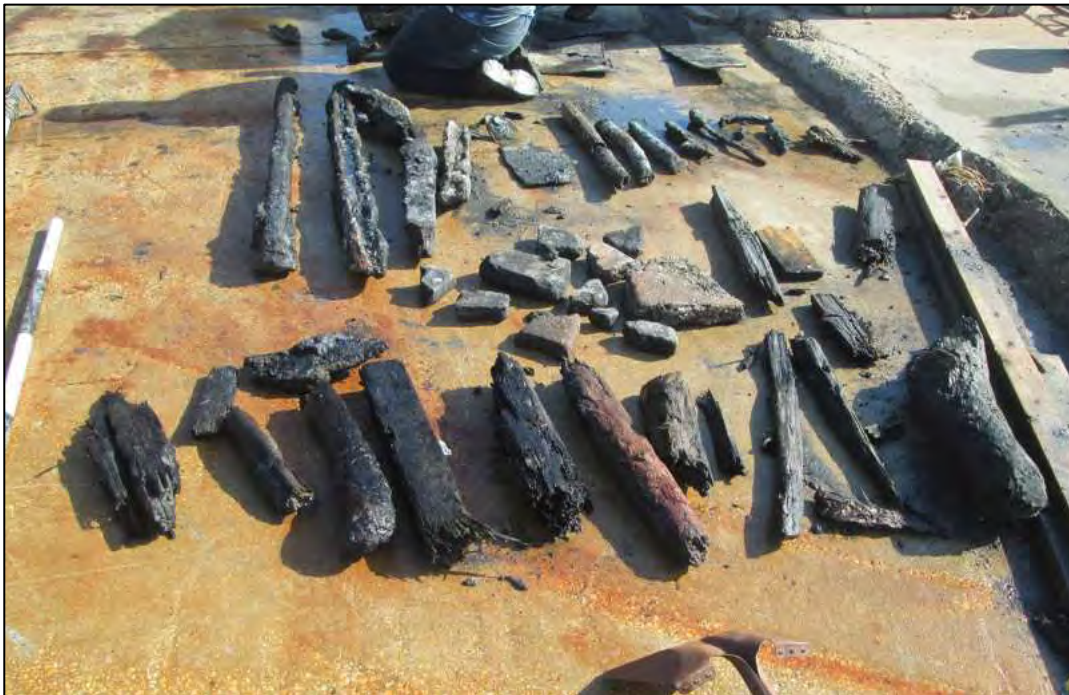
Figure 6-115. After initial removal of the sediment matrix, the artifacts were sorted into artifact groups. The crew chief, facilitated by the main conservator and Co-Principal Investigators, further sorted each artifact group into sets for reburial or conservation. Shown here is material from grapple test G-187 slated for reburial. These artifacts were recorded as to type and number in the artifact catalog.

As outlined in the Final Phase III Permit (Appendix A) and as illustrated in Figure 6-115, after initial removal of the sediment matrix with high-pressure water hoses, rakes, and shovels, the artifacts were sorted into artifact groups and photographed. Then the crew chief, facilitated by the main conservator and Co-Principal Investigators, further sorted each artifact group into sets for reburial or conservation.

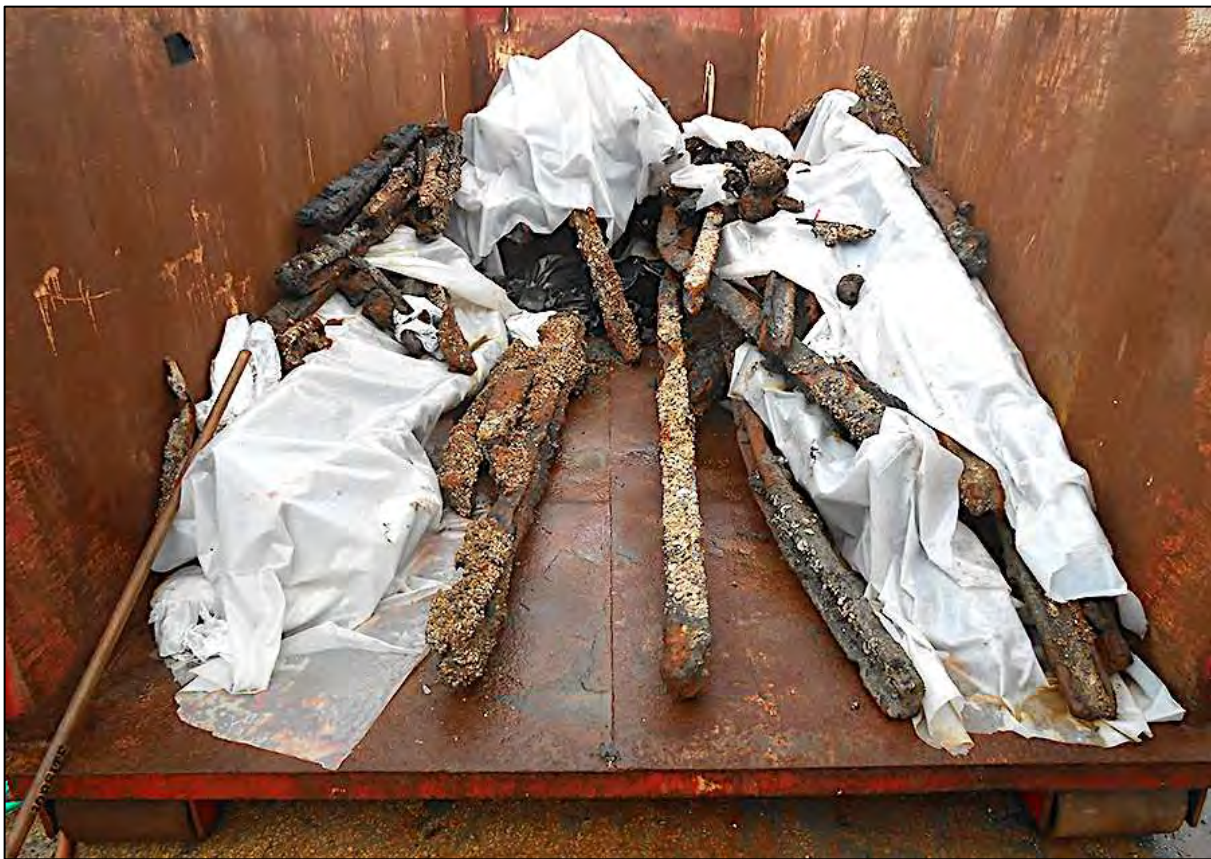
Figure 6-116. Roll-off reburial containers with tagged artifacts and groups segregated by sheets of plastic.

An artifact catalog list was employed to record every recovered artifact regardless of being identified for reburial or conservation. All artifacts and material identified for reburial were tagged with provenience (i.e., G-54, S-145), photographed, and placed into roll-off containers. They were segregated by sheets of plastic, and/or placed in bags (Figure 6-116).
