CSS *GEORGIA*
ARCHEOLOGICAL DATA RECOVERY AND MITIGATION
FOR THE SAVANNAH HARBOR EXPANSION PROJECT (SHEP),
CHATHAM COUNTY, GEORGIA AND JASPER COUNTY, SOUTH CAROLINA

**FINAL DRAFT REPORT
OCTOBER 2019**

Stephen R. James, Jr. and Gordon P. Watts

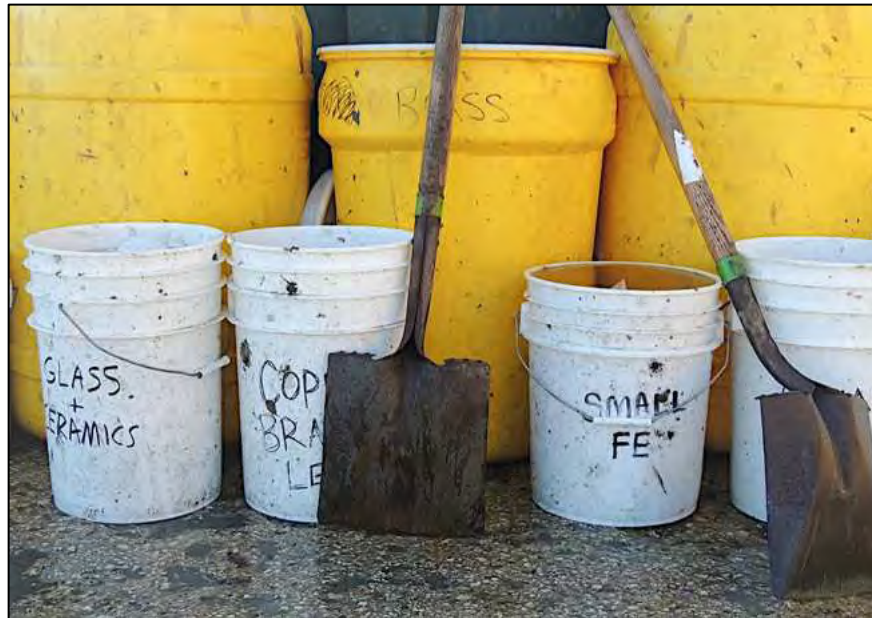
Figure 6-117. Artifacts selected for conservation were placed into drums or buckets by group or class after initial recordation.

All clearly unique, significant, and diagnostic artifacts, all of which were kept for conservation, were counted, recorded on the artifact catalog, photographed, placed in containers (generally large 50 gallon plastic drums), and labeled with the recovery number (Figure 6-117). Similar artifact types (e.g., ceramics, glass, organics) were collected by type (Figure 6-118) and placed in labeled containers (i.e., small buckets; see Figure 6-117). All significant or fragile artifacts (i.e., pistols) were separated, accessioned with a unique number, photographed, recorded, and stored individually.

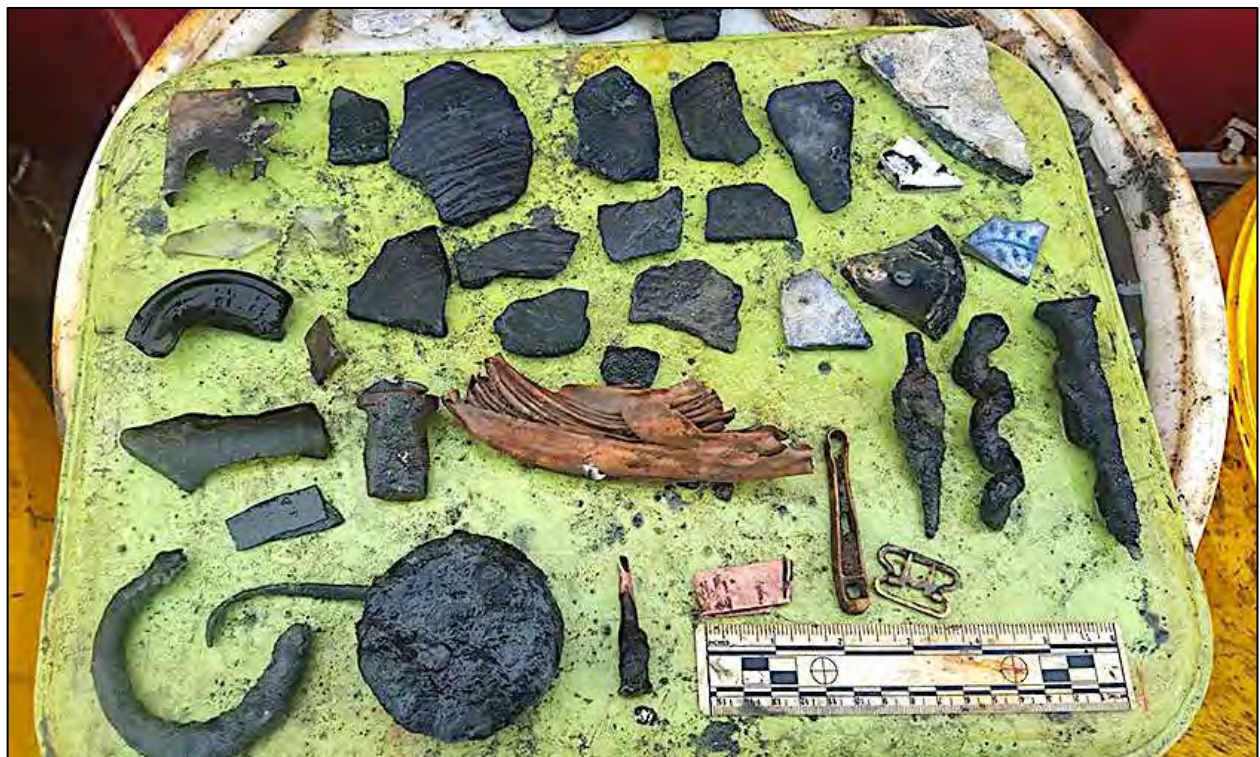
Figure 6-118. Example of small artifacts from an excavation being photographed. They were then separated by group (i.e., prehistoric ceramic, copper, etc.), bagged with provenience, and placed into buckets of similar artifact groups slated for conservation (see Figure 6-94).

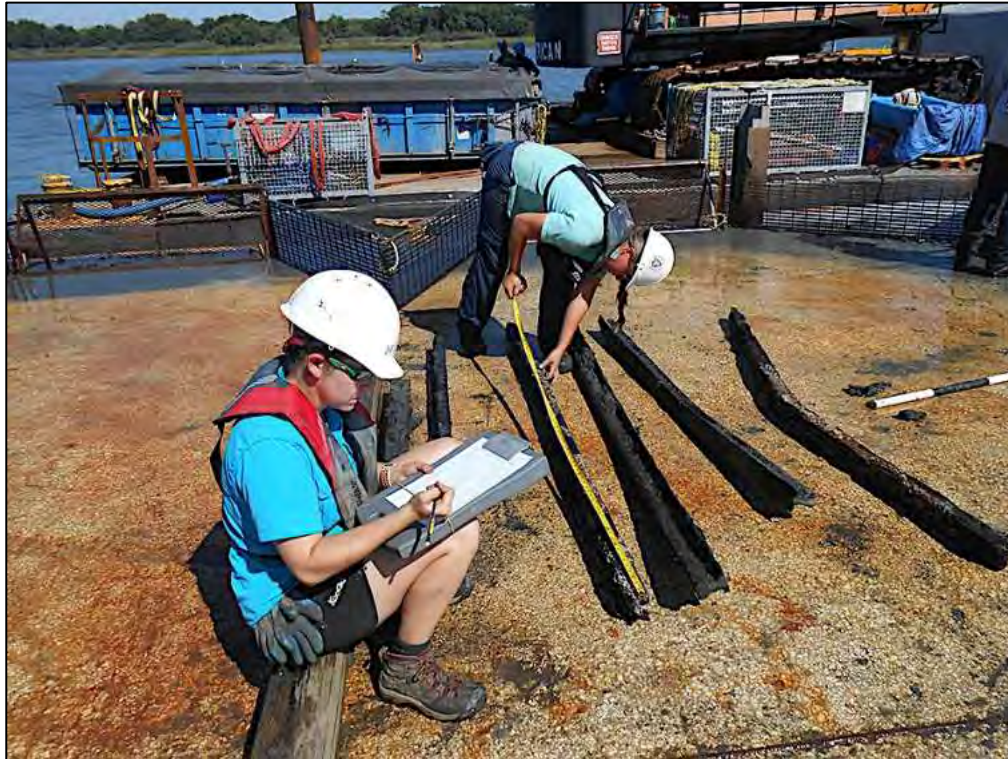
Figure 6-119. Recording rail segments that will be reburied.

from the CSS *Georgia*. Detailed drawings and photographs were recorded for all diagnostic timber scantling using the Wood Recording form. Rails were similarly recorded (see Figure 6-119). The majority were tagged and placed in reburial containers, with some being retained for conservation as representative examples or for some unique feature.

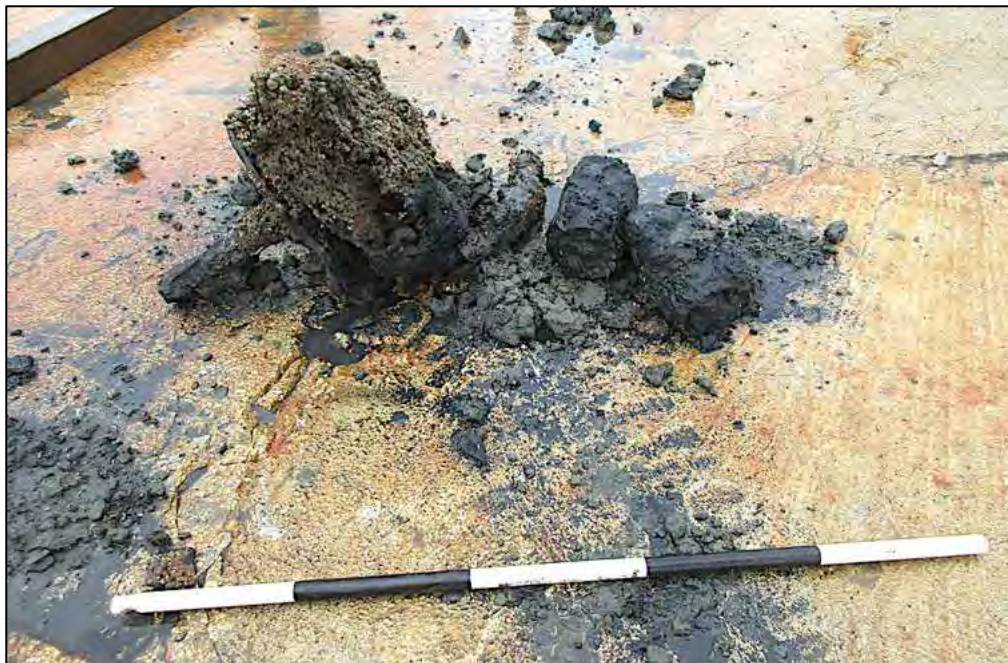
Figure 6-120. Initial photograph of G-401 showing machinery, a Brooke shell, and a Bolt (scale is in feet).

In addition to recordation of timber and rail, any unique machinery was also photographed and sketched prior to it being placed into containers for transportation to CRL. Figure 6-120 illustrates what is believed to be a possible capstan base, a Brooke shell, and a Bolt from grapple test G-401 and Figure 6-121 shows the field drawing and initial postulated appearance/function.

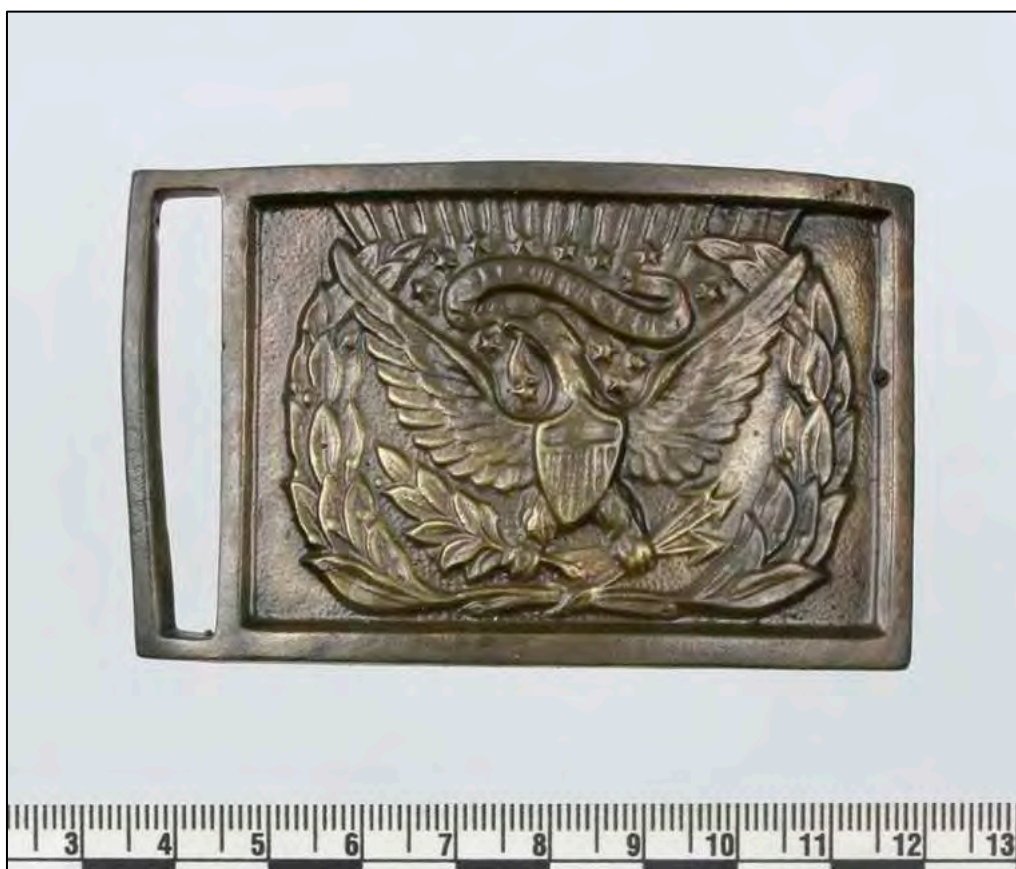
Figure 6-122. Artifact 1878.1: (front) Federal sword belt buckle showing eagle and wreath, design 619 (courtesy of CRL, Texas A&M University).

Artifact 1878.1 is a Federal Eagles waist or sword belt plate (buckle), regulation 1851, issued to officers who carried swords or to those men in the cavalry (Figures 6-122 to 6-125). The buckle is made of cast brass and measures 85-x-56 millimeters (3.25-x-2 inches). On the front side is the design of an eagle with a shield that is holding both spears and olive branches in its talons. The eagle is within a wreath on three sides with a banner over top with the Latin phrase “E PLURBUS UNUM” (*out of many, one*). There are 12 stars surrounding the eagle with symmetrical rays above the banner. On the reverse side is a thin bent metal tongue meant to fasten the belt to a brass clasp or keeper. These were made beginning in the early 1850s in nearly all states and were continuously manufactured until the end of the Civil War. Besides slight design variations, the main composition of the Federal/Union eagle emblem did not change throughout the war years; however, militias did personalize their buckles with specific insignias or regimental numbers (Kerksis 1987: 370-376). Some smaller companies offered personalization and variation to the original design, but Artifact 1878.1 does not show any personalization. There were numerous variations of the design and our example resembles design 619 (O'Donnell and Duncan 2010). Union-issued, it was most likely the property of a Union officer that joined the Confederacy after succession.

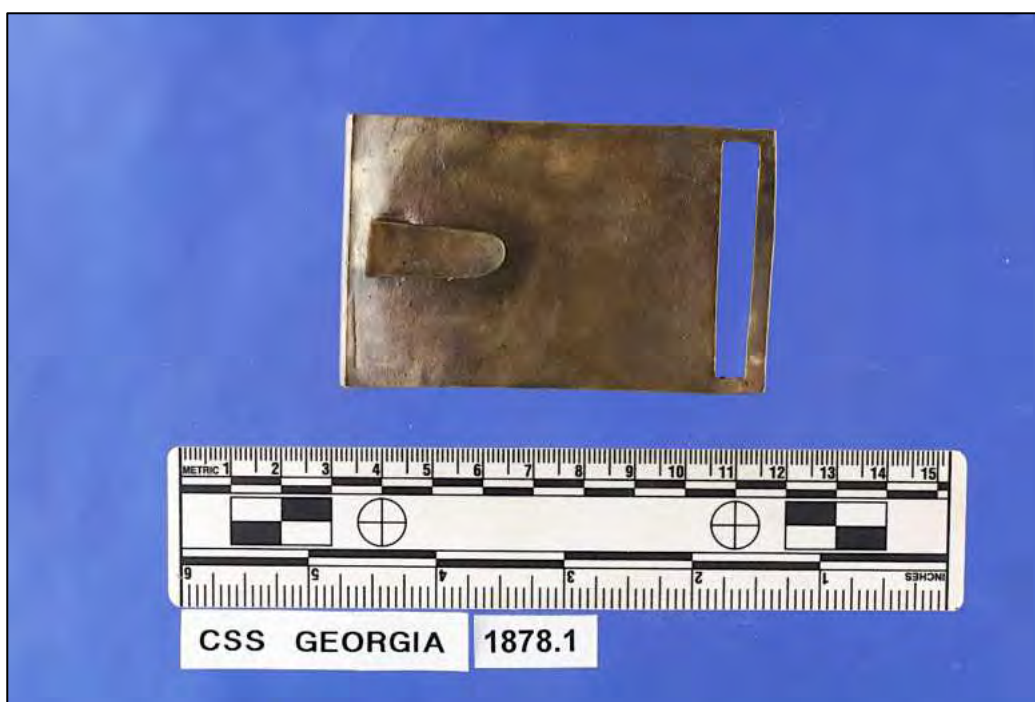
Figure 6-123. Artifact 1878.1: (back) Federal belt buckle showing bent tongue (courtesy of CRL, Texas A&M University).

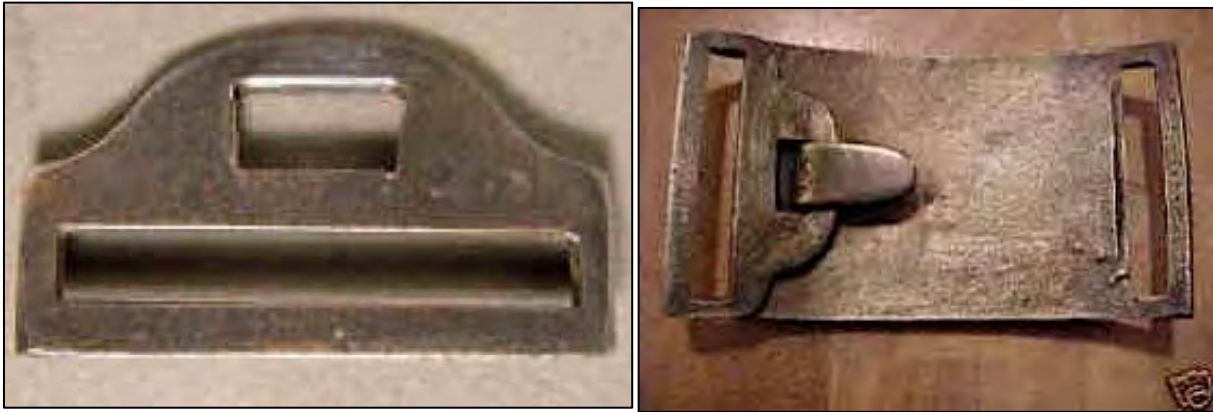
Figure 6-124. Example of the missing clasp (left) and how it would fit together (right; image courtesy of Harry Ridgeway, personal collection).

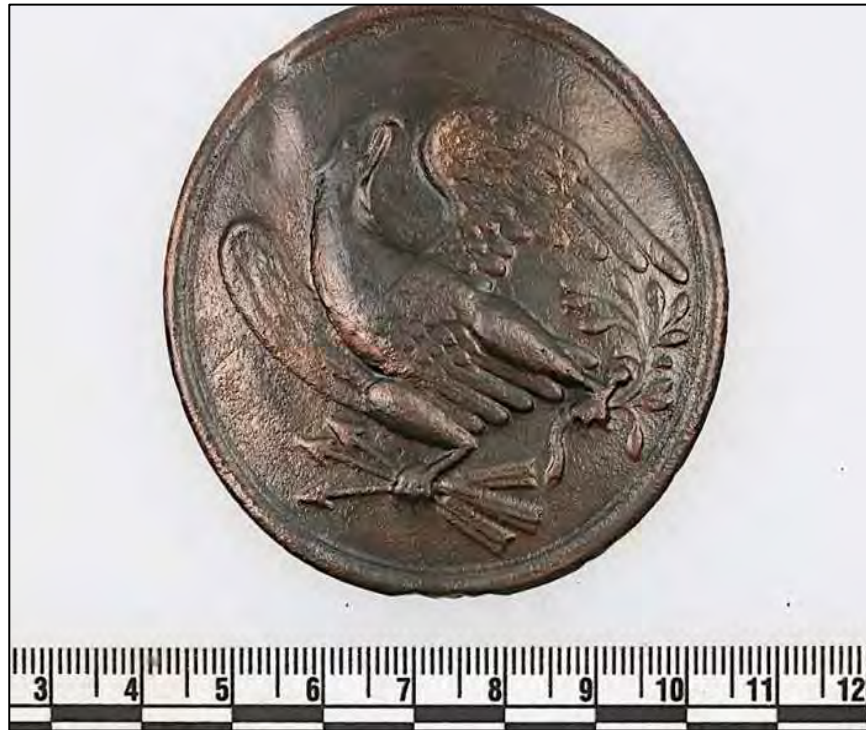
Figure 6-126. Artifact 3284.7: (front) Federal eagle breastplate, regulation 1826 (courtesy of CRL, Texas A&M University).

Artifact 3284.7 is an eagle-embossed breastplate, regulation 1826, issued to Union soldiers (Figures 6-126 to 6-129). This artifact is made of cast brass measuring 66 millimeters (2.59 inches) across. On the front side, there is a depiction of an eagle holding arrows of war and olive branches of peace in its talons. On the reverse side, there are two sets of holes for the hooks that were necessary for attaching the plate to the cross-chest lanyard of a cartridge box.

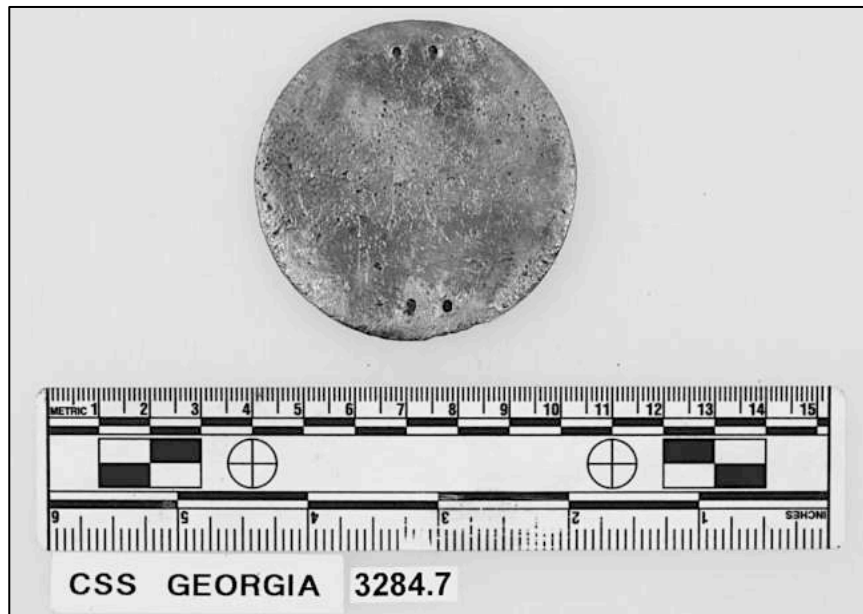
Figure 6-127. Artifact 3284.7: (back) Federal eagle breastplate, regulation 1826 (courtesy of CRL, Texas A&M University). Note the two sets of holes where the original hooks would have been located.

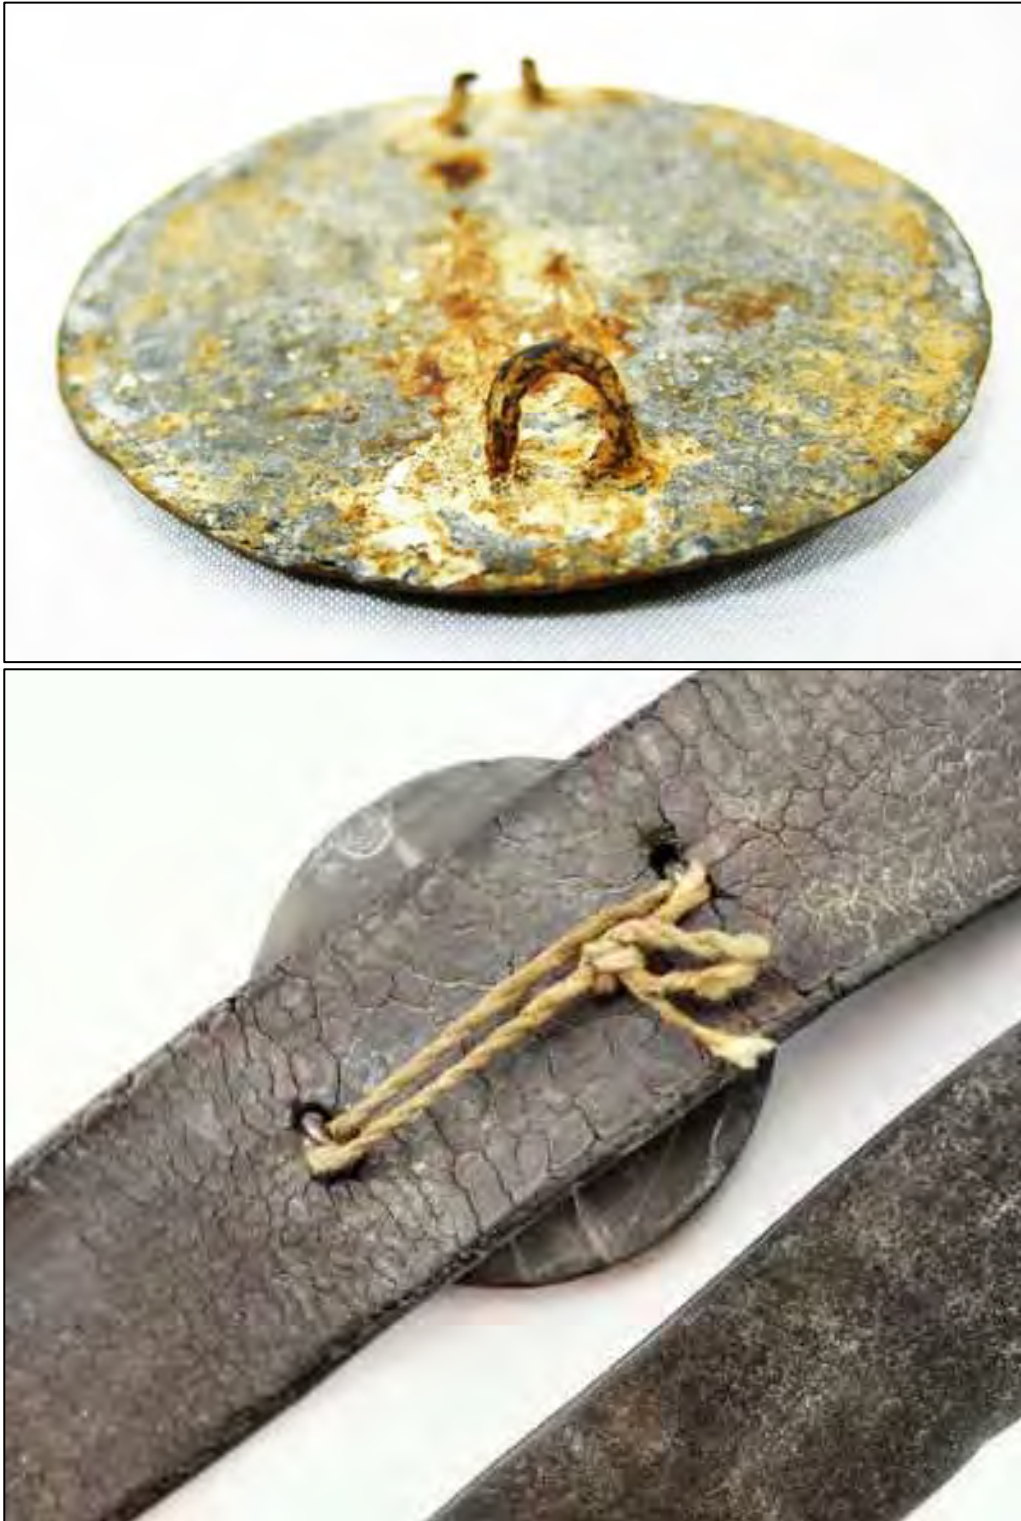
Figure 6-128. Examples of what the hooks on the back of an eagle breastplate would have looked like and how they were attached to the sash belt of the soldier's cartridge box (images courtesy of Union Drummer Boy 2019).

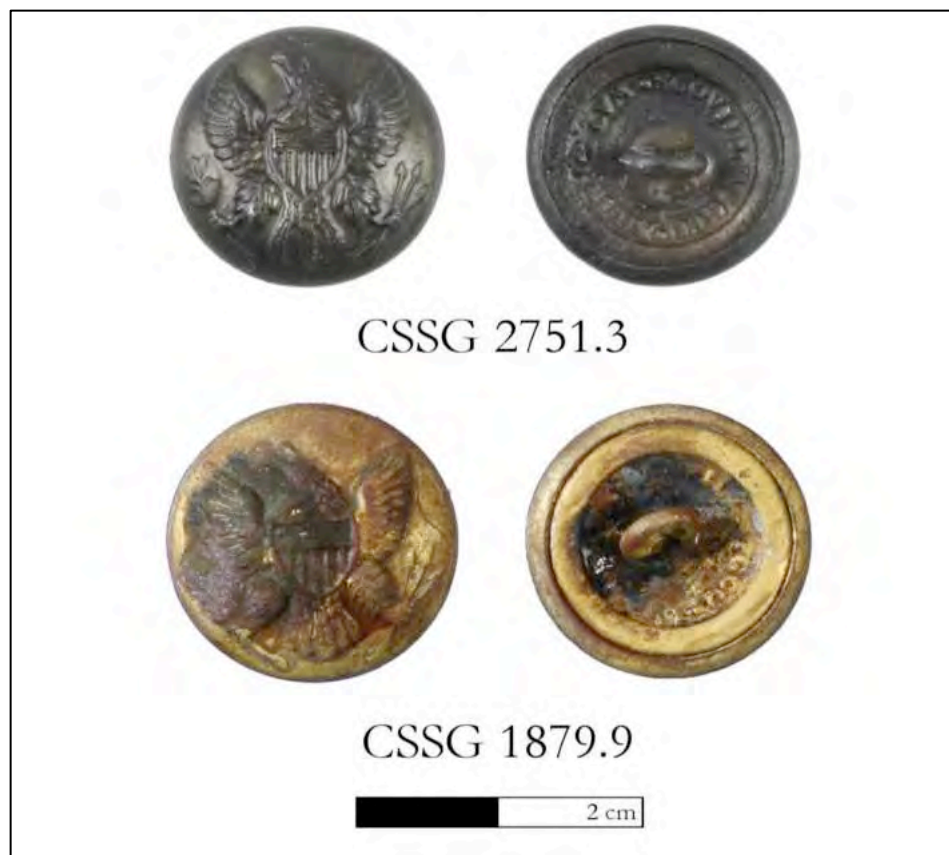
Figure 6-130. Union general service buttons (courtesy of CRL, Texas A&M University).

Two identical copper alloy buttons with an eagle emblem (Figure 6-130) are the only buttons from the site that may represent the Union Army, specifically General Staff. The buttons depict an eagle facing to the right with a striped shield on its chest, grasping an olive branch in the right claw and three arrows in the left. Both are two-piece buttons.

These two buttons are also the only military buttons retrieved from the site with backmarks. The backmarks read “• SCOVILL MFG CO • WATERBURY.” This backmark was produced between 1855 and 1860 (Tice 1997: 32). Buttons bearing a backmark with the Scovill name first appeared in 1811 (Tice 1997: 27). Originally based in Waterbury, Connecticut, the Scovill Manufacturing Company grew to become one of the largest button manufacturers on the east coast (Tice 1997: 39).

Given the design and the backmark, these buttons would be grouped into Tice’s (1997: 141-143) GEN215 series and Albert’s (1976: 40-41) GI 94A series. The front and back of CSSG 1879.9 were tested to determine if the compositions differed (Figures 6-131 and 6-132). The front returned strong results for copper, iron, and zinc. There were also trace amounts of mercury, lead, tin, and strontium. The back had the same elements present, although the iron was much less prominent, coming in fourth strongest. This is most likely due to the large ferrous staining present on the front face, rather than a difference in the alloying processes of the two halves.

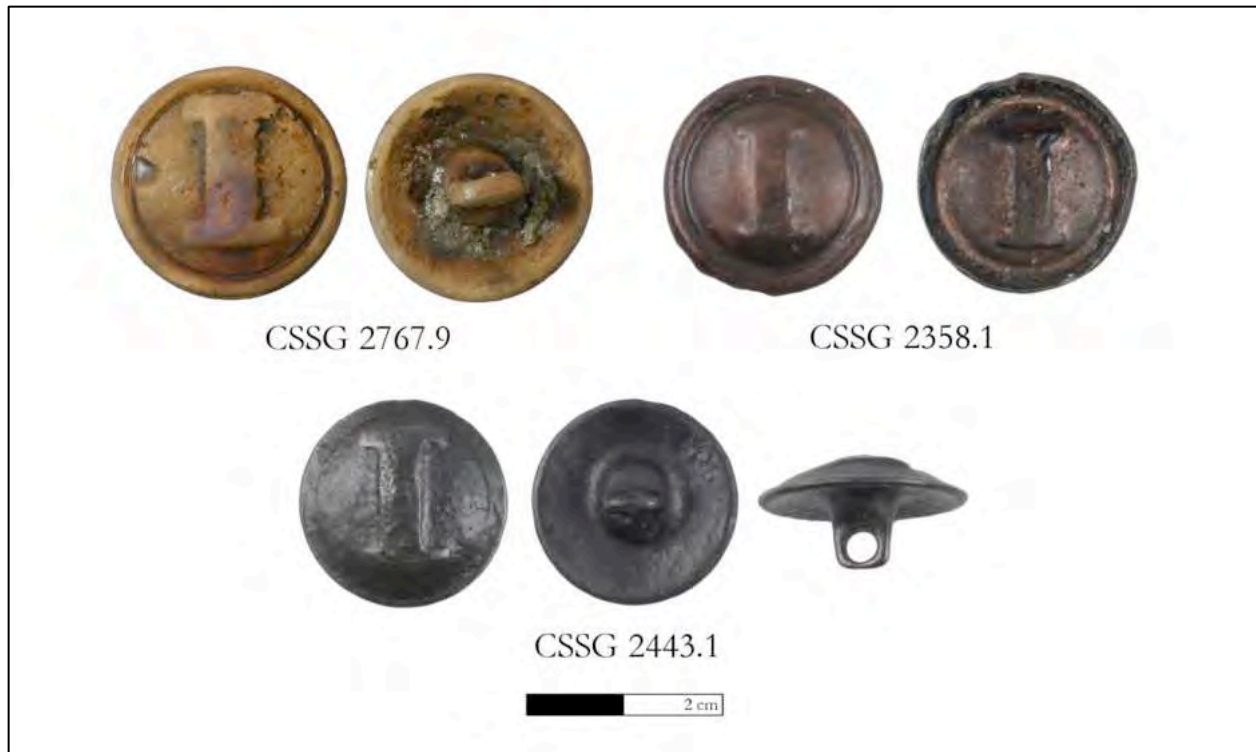
Figure 6-133. Confederate Infantry buttons (courtesy of CRL, Texas A&M University).

Three Confederate Infantry buttons were found on the site (Figure 6-133). CSSG 2443.1 and CSSG 2767.9 are single piece casts with no backmarks. CSSG 2358.1 is the front die for a two- or three-piece button; since the back die is missing, no backmark is present. There may be several reasons the back die is not present, the most likely being that it was made of a material, such as iron, that degrades easily and simply corroded prior to excavation of the site; if separated on purpose, it is possible the front die was used as a mold for new buttons if a soldier needed a replacement in the field (Tice 1997: 2-5). CSSG 2767.9 was tested with the XRF spectrometer, revealing a copper alloy with trace amounts of lead, iron, tin, and antimony; the presence of tin and lack of zinc indicates that it is likely bronze rather than brass.

Because Infantry buttons are so common, without a backmark it is not possible to positively identify the manufacturer or a narrow date range for the three buttons.

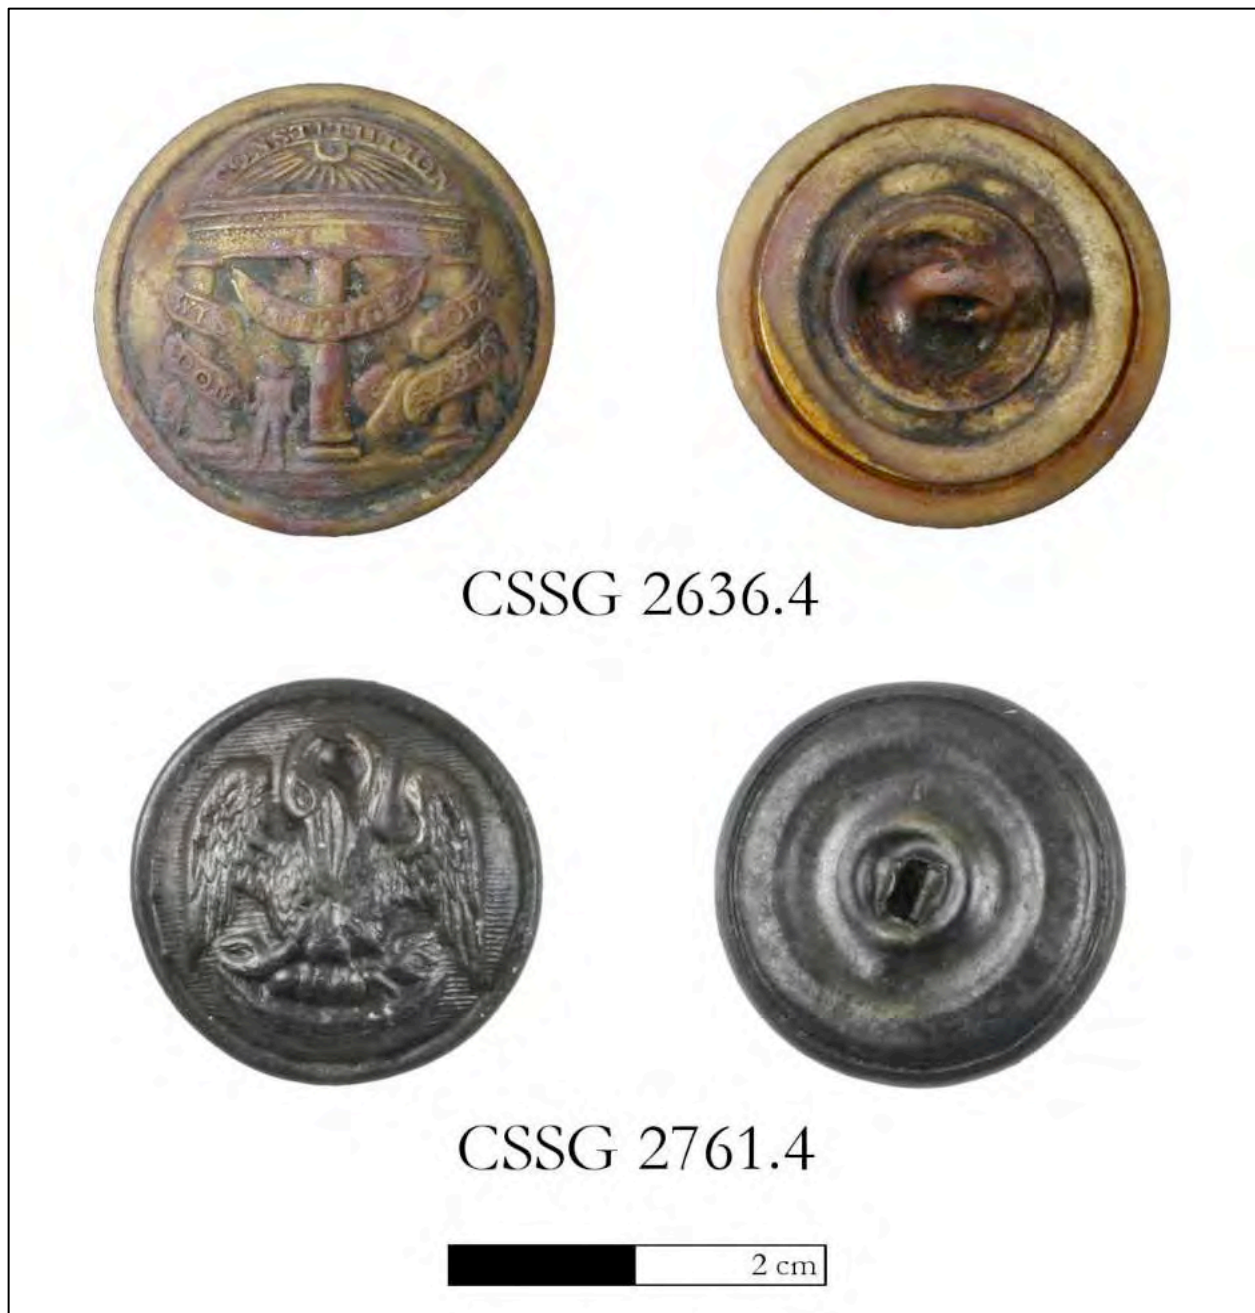
Figure 6-134. Georgia (top) and Louisiana (bottom) buttons bearing state seals (courtesy of CRL, Texas A&M University).

CSSG 2636.4 (Figure 6-134 top) is a two-piece button made of a copper and zinc alloy with trace amounts of mercury, lead, tin, nickel, and iron; and there is no backmark. The closest match found at the time of publication is Albert's (1963: 65, 67) GA 61B.

CSSG 2761.4 (Figure 6-134 bottom) is a two-piece button made of a copper alloy, with no backmark. The background is lined, and the pelican faces to the right, feeding at least four young, which are not well defined. It is most likely part of Tice's (1997: 292, 294) LA249 series, produced by Bellenot in New Orleans at the beginning of the war; it is one of the most common Louisiana militia buttons found on sites—in fact, so many buttons were made that the dies began to show wear, which may be why it is difficult to decipher fine details in this button.

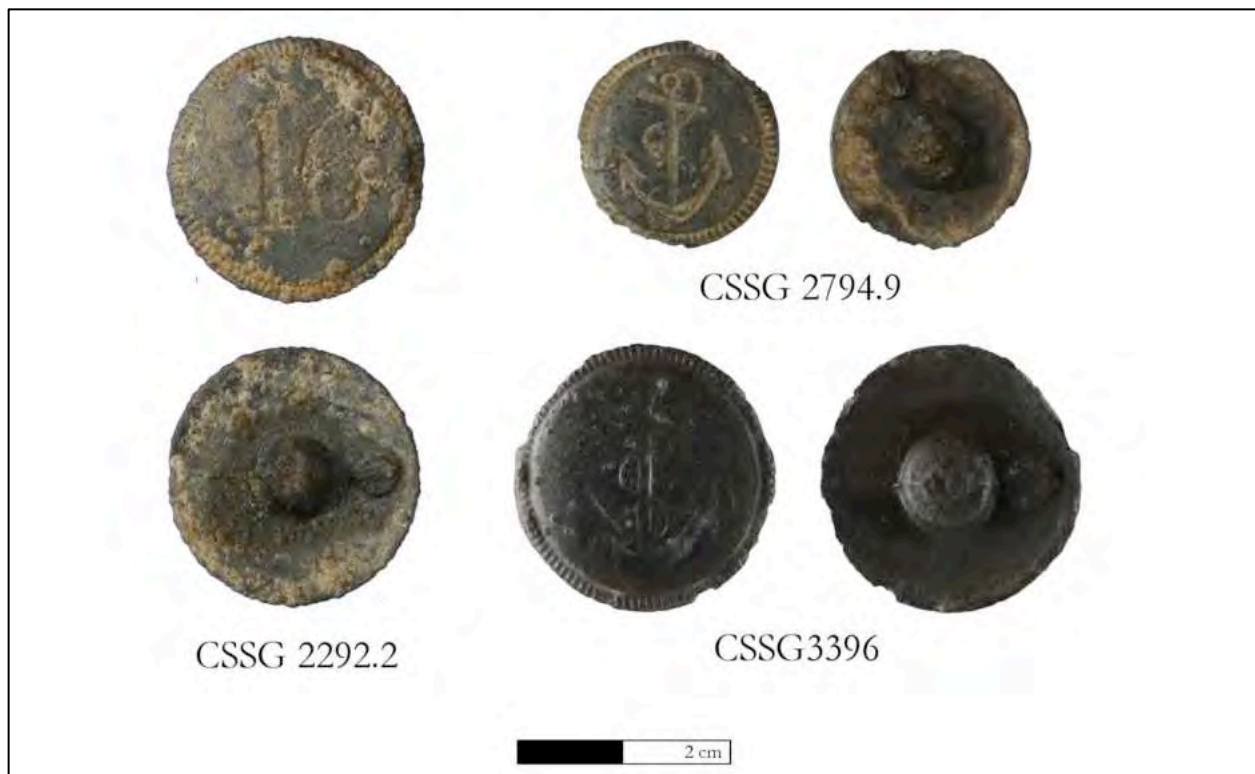
Figure 6-135. Revolutionary War buttons (courtesy of CRL, Texas A&M University).

Three buttons from the site can be traced to the Revolutionary War period (Figure 6-135). CSSG 2292.2 is a cast pewter button with the number “16” inside a rope border. The shank is missing, but a mold seam is visible on the back. This design was used for the British Army's Sixteenth Regiment of Foote. The regiment was stationed in Pensacola, Florida beginning in 1767 and sent out troops to other locations as needed; some troops were stationed in Savannah, Georgia between 1778 and 1782; the regiment returned to England in March 1782 (Troiani and Kochan 2012: 61-62). XRF tests show that CSSG 2292.2 is created from a lead alloy with trace amounts of zinc, tin, iron, copper, mercury, and strontium.

There are two cast pewter buttons featuring a fouled anchor inside a rope border. The shanks are missing, but a mold seam is visible on the back of both buttons. These buttons were most likely used by the British Royal Navy; indeed, nearly identical buttons have been found on the 1758

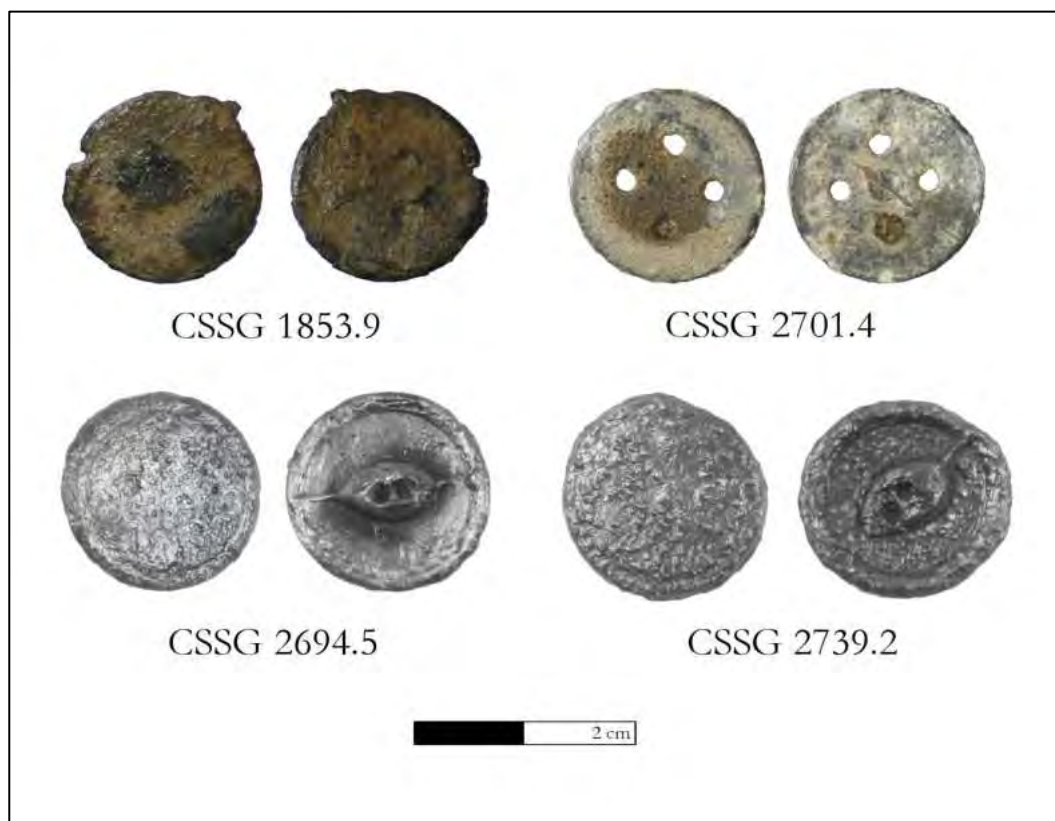
Figure 6-137. Unidentified plain metal buttons (courtesy of CRL, Texas A&M University).

Several buttons recovered from the site have no markings (Figure 6-137). Although it is not possible to determine exactly when the buttons would have been in use, it is possible to provide the earliest manufacturing date possible by the method of manufacture.

Two pewter buttons, CSSG 2739.2 and CSSG 2694.5, are single piece casts with mold seams at the back. There are also visible holes where an iron wire would have attached. According to Olsen (1963:553), buttons like these began to be manufactured around 1760.

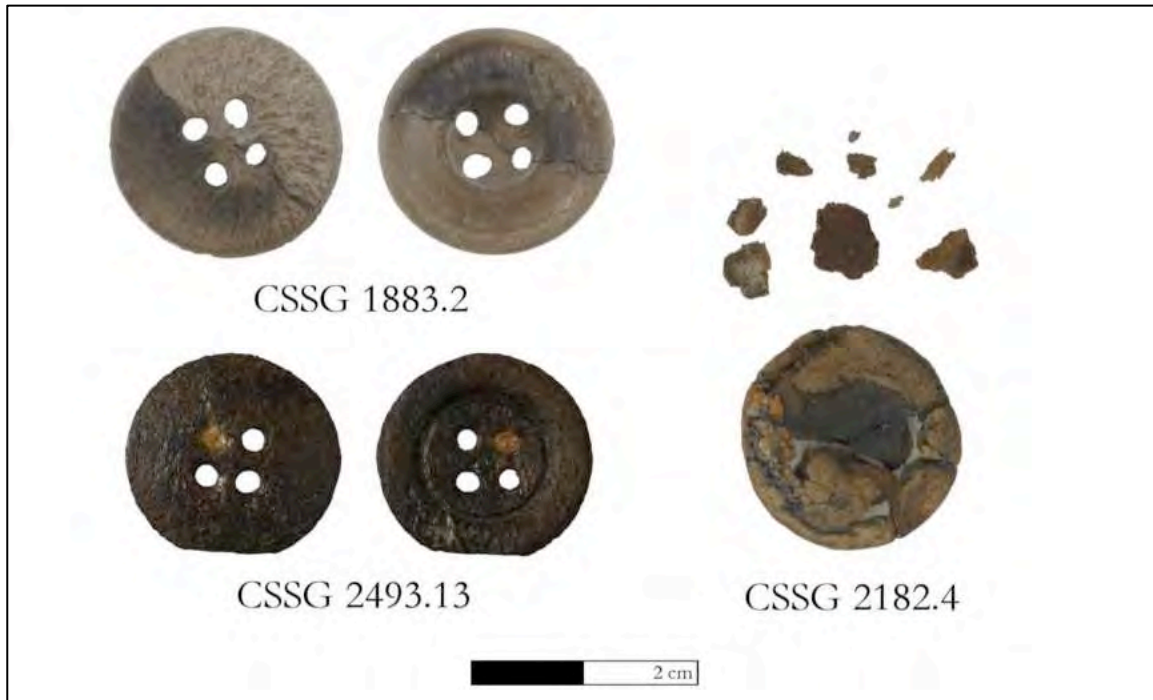
Figure 6-139. Wood and composite buttons (courtesy of CRL, Texas A&M University).

In addition to the unidentified metal buttons, there are two wood or bone buttons, a textile-covered button (Figure 6-139), and three milkglass buttons. Wood and bone were two of the earliest materials to be made into buttons, and could easily be worked in any home, whether used on their own or covered in textile or thread (Marcel 1994:8, 15, White 2005:69-72). Both the wood and glass buttons would have been used for utilitarian purposes, such as fastening underclothes or shirts (Marcel 1994:14-15, White 2005:69-72).

The composite button, CSSG 2182.4, appears to be comprised of a metal disc covered in textile. XRF analysis (Figure 6-140) shows a strong presence of iron and nickel. Iron was probably used to construct the disc; while the amount of nickel present could indicate nickel-plating to the disc.

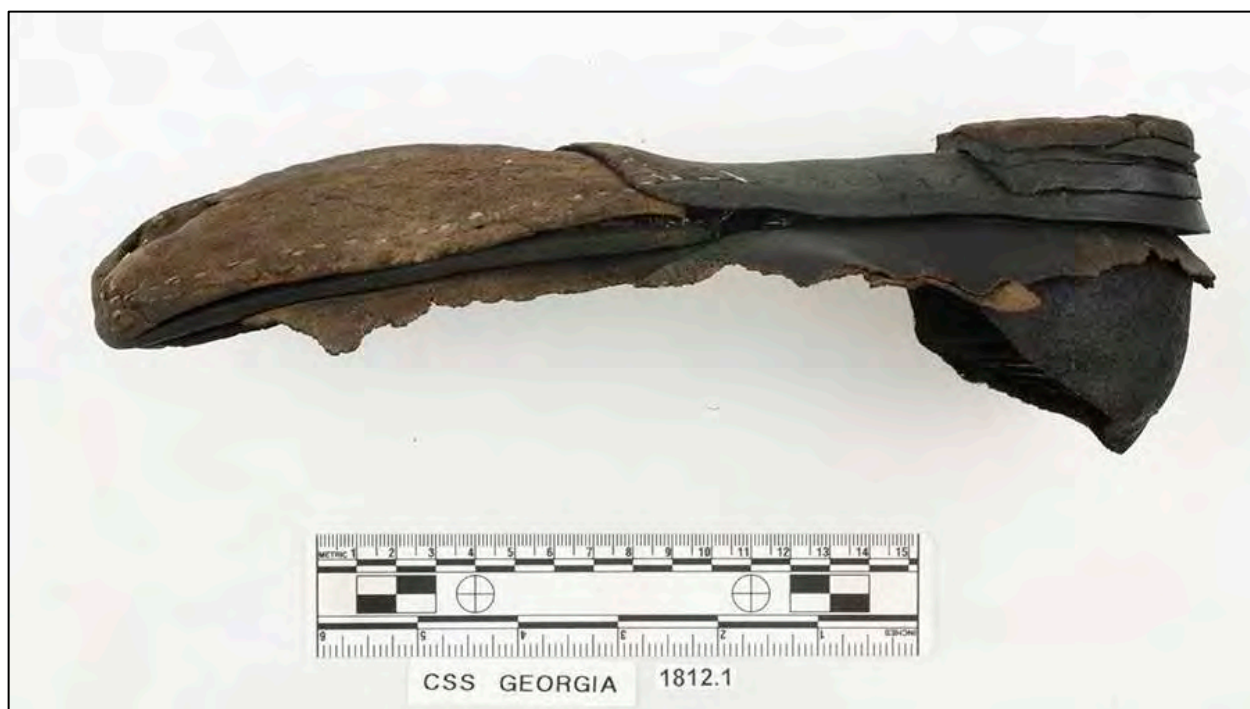
Figure 6-142. Side view of Artifact 1812.1, a mostly intact sole with a little side leather remaining.

Their general site provenience shown in Figure 6-141, 68 boot or shoe fragments, were recovered from the site. Most are small fragmentary pieces of leather with no complete shoe or boot, the soles of several examples being the most intact portion of recovered footwear. In-depth analysis was not conducted on these, as the majority is still in conservation. However, the most complete examples that allow for a visual analysis and illustrate variation in the sole shape and composition are presented in Figures 6-142 to 6-145 below.

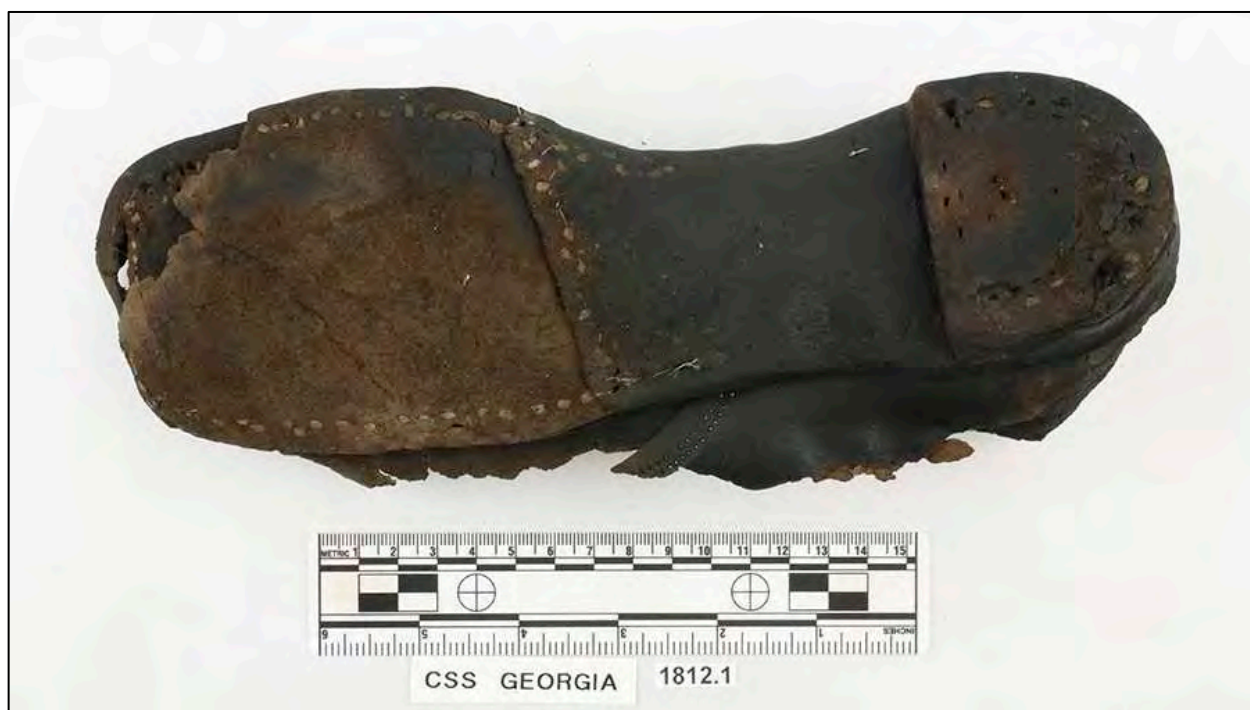
Figure 6-143. Bottom view of Artifact 1812.1, a mostly intact sole with a little side leather remaining. Composition is clearly visible.

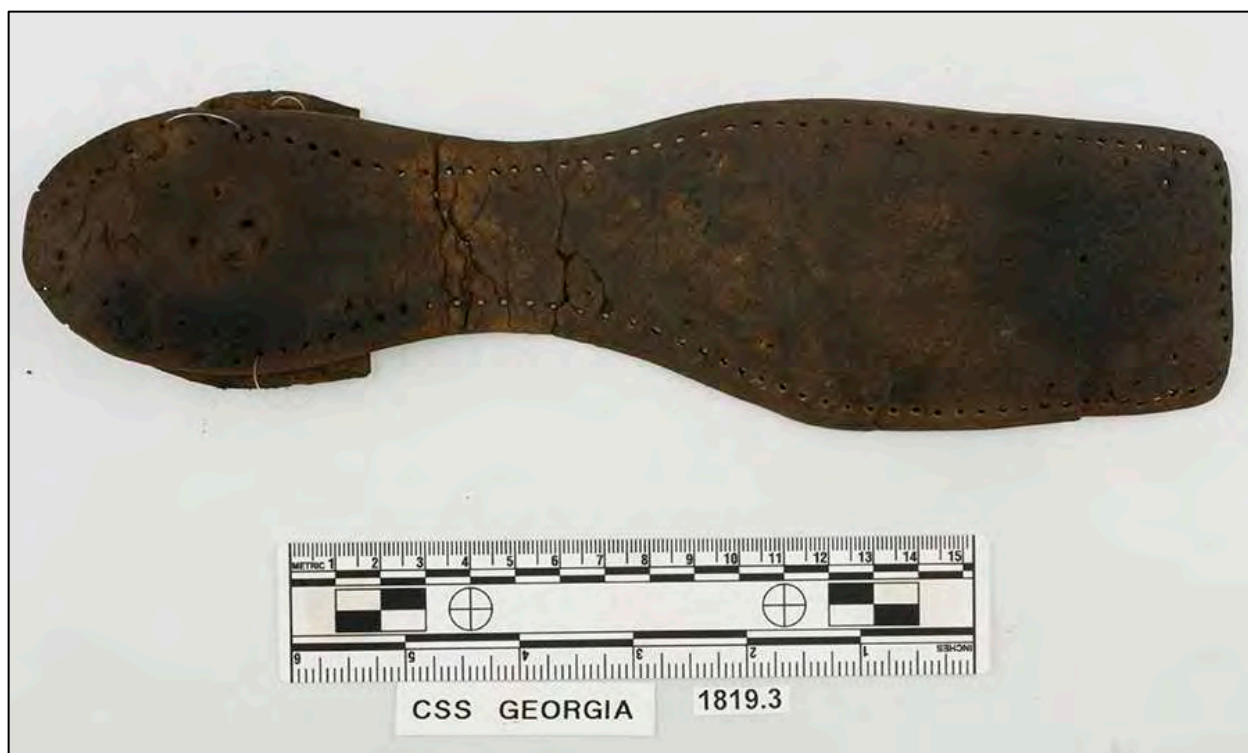
Figure 6-144. Top or interior view of the sole of Artifact 1819.3, the toe of which is very square.

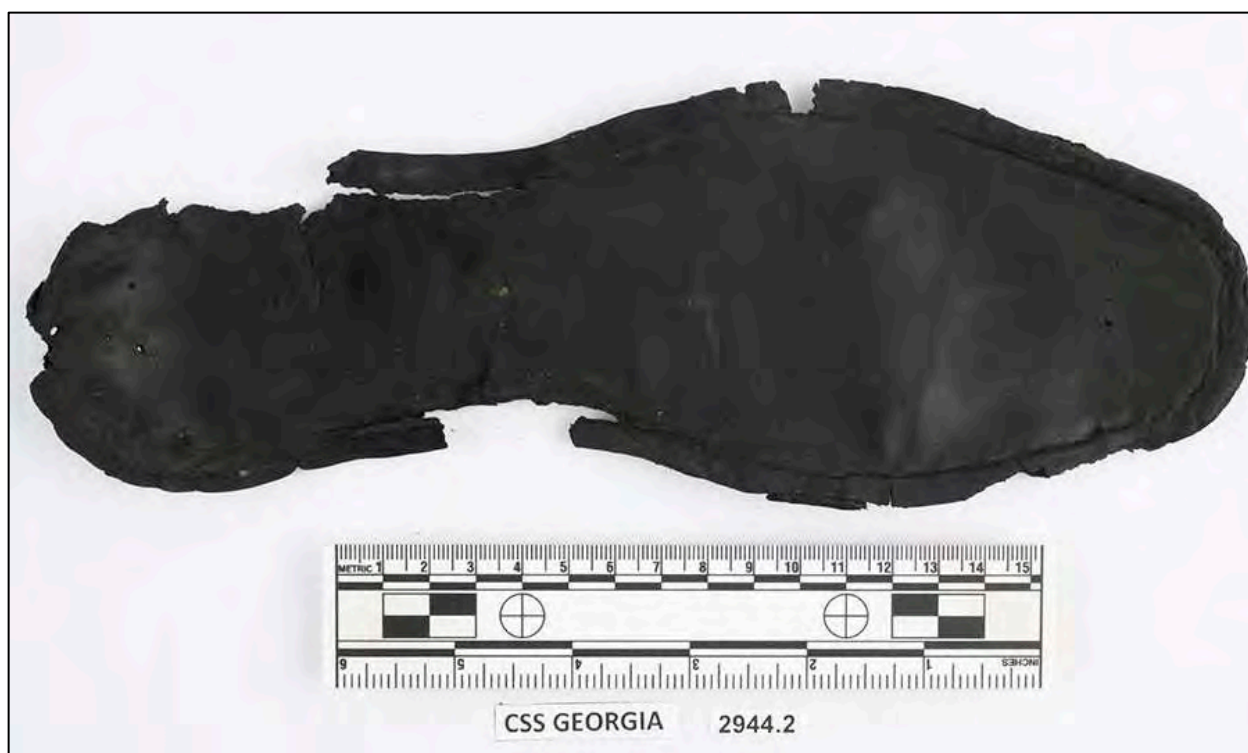
Figure 6-145. Top or interior view of the sole of Artifact 2944.2, the toe of which is rounded.

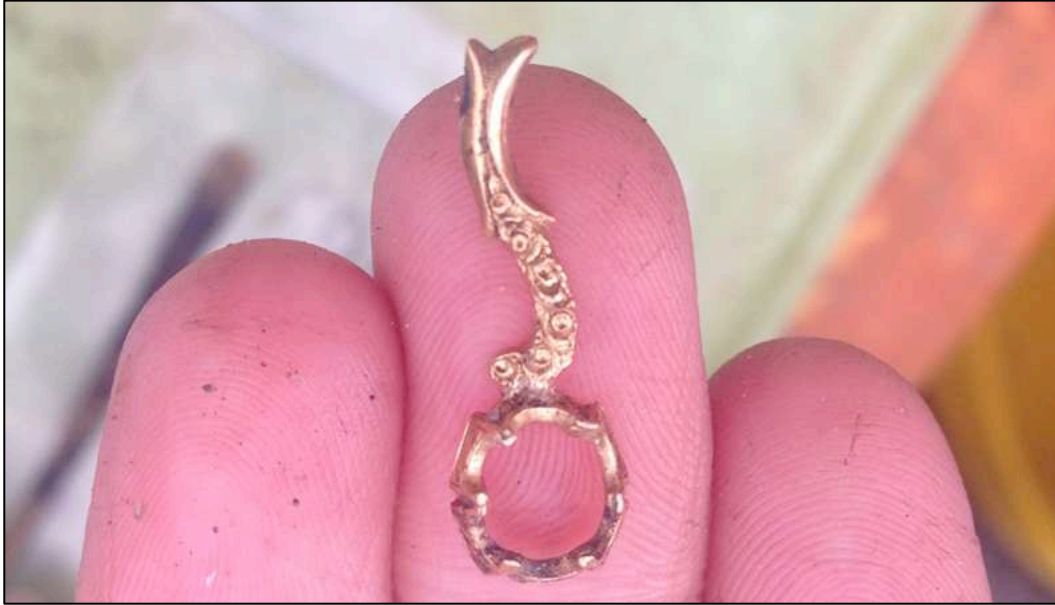
Figure 6-146. Ornate piece of gold jewelry (stone missing), Artifact 2521.04, recovered from Unit 11-D.

Two small pieces of jewelry were recovered from the site. Artifact 2521.4 is a small cast gold piece just under 1 inch in length. As illustrated in Figure 6-146, the piece has a setting for a stone that is now missing. The opposite end has what appears to be solder of some type on the back, possibly indicating a hook location. If this is correct, the piece could possibly represent an earring or small pendant. The second piece classified as jewelry, Artifact 2436.2, is actually an ornate buckle. With a 2.5-inch diameter, the cast bronze circular floral wreath buckle was recovered from Unit 14-B. Presented in Figure 6-147, it has a tang at right center on the back of the buckle used for fastening.

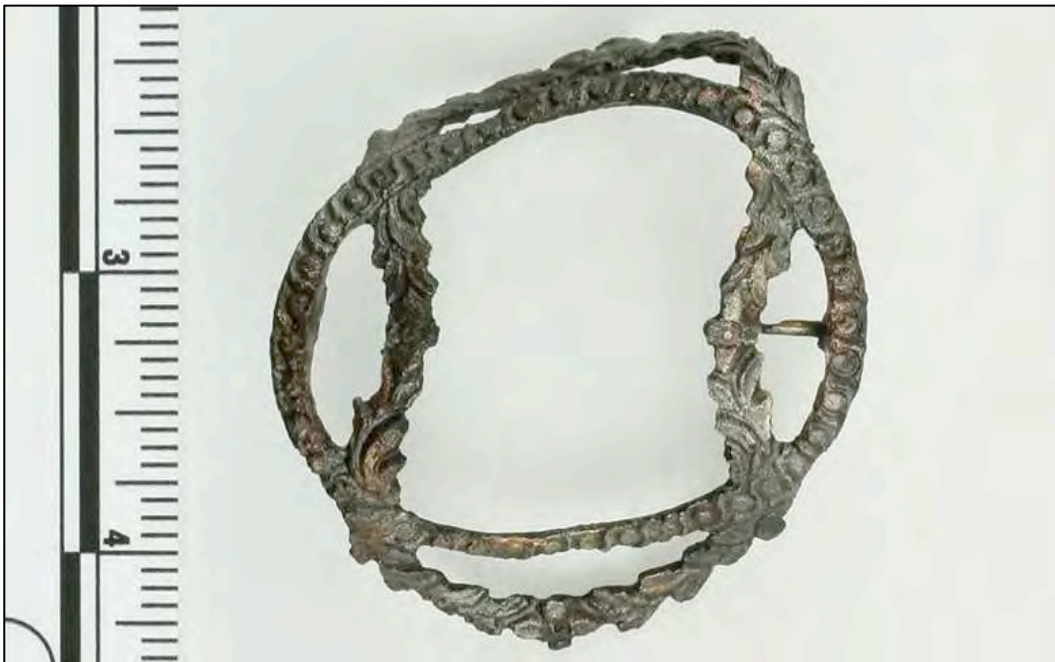
Figure 6-147. Artifact 2436.2, the 2.5 inch diameter, bronze circular floral wreath buckle was recovered from Unit 14-B. Note the tang at right center on the back of the buckle used for fastening.
