CSS *GEORGIA*
ARCHEOLOGICAL DATA RECOVERY AND MITIGATION
FOR THE SAVANNAH HARBOR EXPANSION PROJECT (SHEP),
CHATHAM COUNTY, GEORGIA AND JASPER COUNTY, SOUTH CAROLINA

**FINAL DRAFT REPORT
OCTOBER 2019**

Stephen R. James, Jr. and Gordon P. Watts

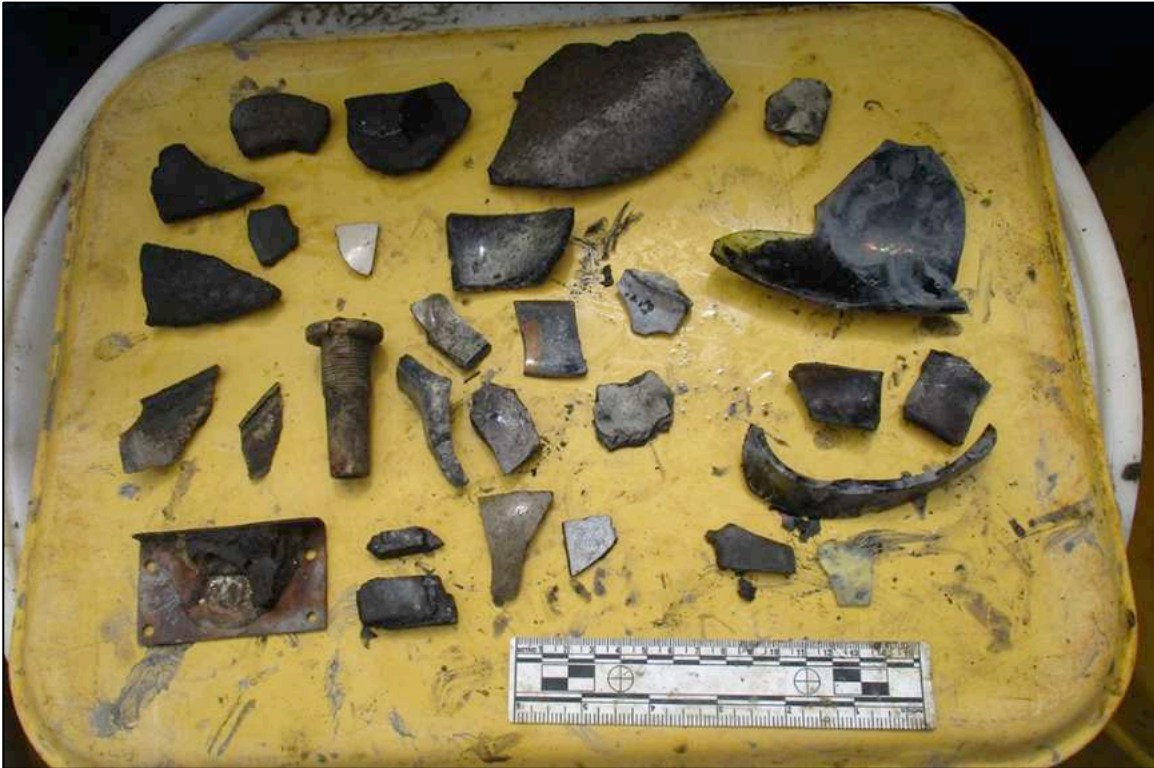
Figure 6-148. Recovery from G-133 that shows an assortment of artifact types including six glass fragments (right), a dozen small ceramic sherds (center), along with, metal, prehistoric ceramics, and a DMM fuze. This assortment is representative of the type and size of glass, as well as ceramics generally recovered.

Another class of artifact is glass. Represented on the site mainly as small fragments, but with several whole bottles present, 1,925 glass artifacts were recovered. Figure 6-148 below, Mechanized Recovery from Unit G-133, shows an assortment of artifact types including six small glass fragments (right side), along with prehistoric and historic ceramics, metal, and a DMM fuze. This recovery is representative of the type and size of glass generally recovered. Illustrated in Figure 6-149 is one of the few whole bottles recovered during Mechanized Recovery. The provenience of glass is presented

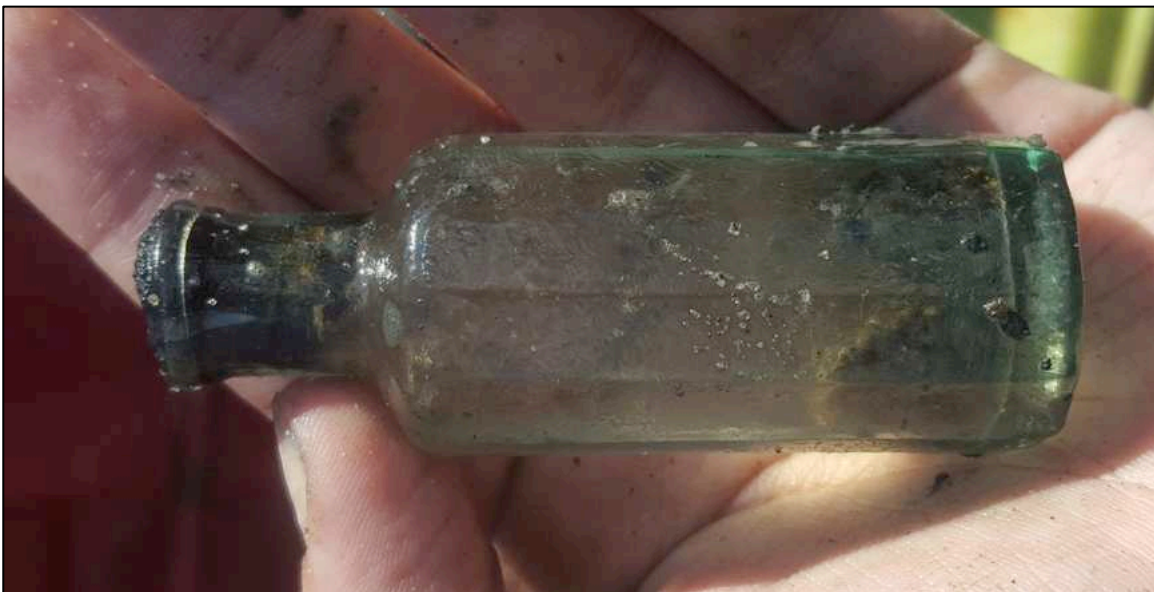
Figure 6-149. One of several whole bottles recovered during Mechanized Recovery.

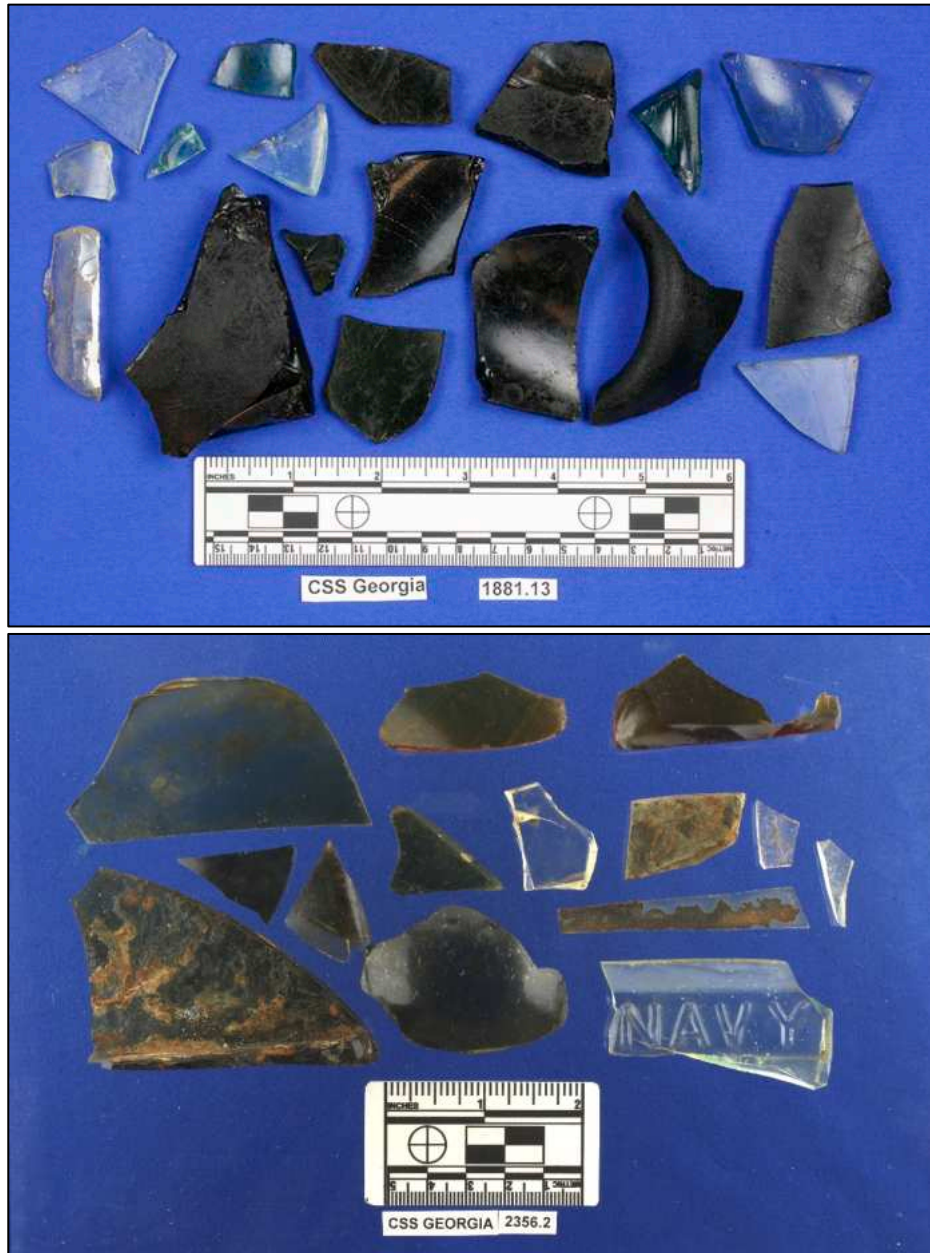
Figure 6-151. Examples of assorted glass colors recovered from the wreck. Note the fragment stamped with “NAVY” in the bottom photo.

With historic glass, the color and thickness of the glass can aid in the determination of a date range. Within the assemblage from the *CSS Georgia*, there are multiple colors and types of glass represented (Table 6-04; Figure 6-151).

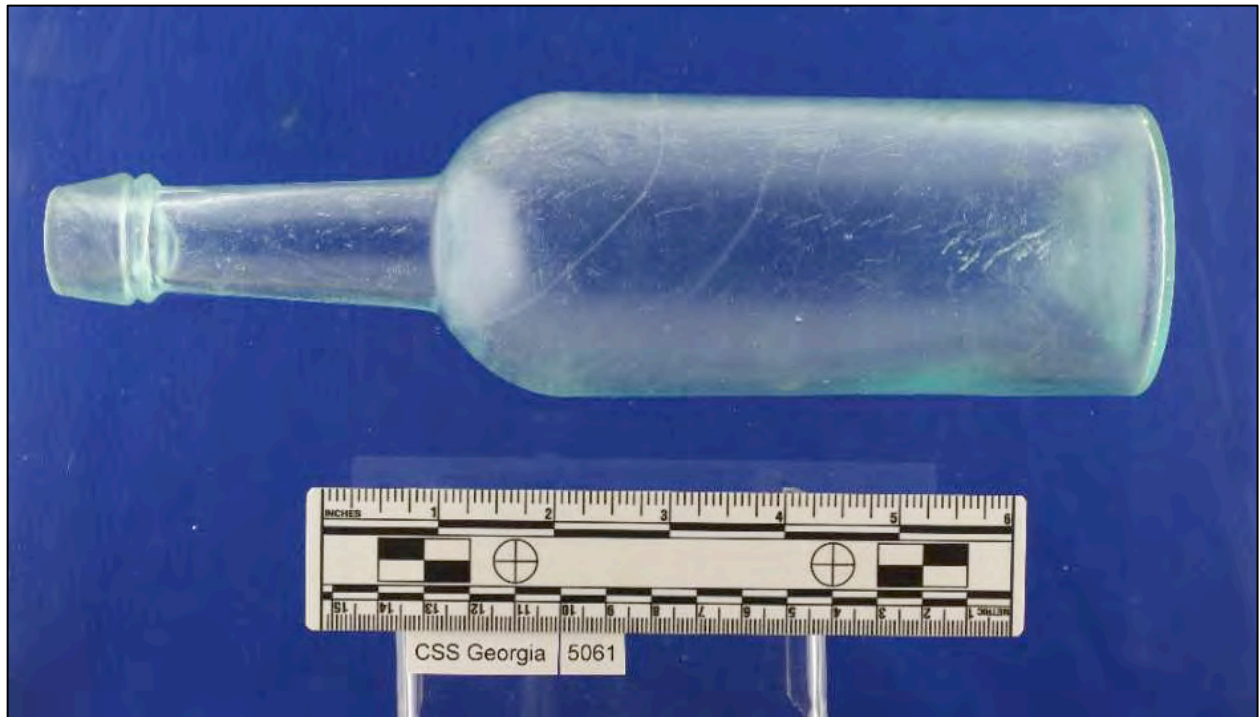
Figure 6-152. Artifact 5061, intact bottle, plain, recovered during Mechanized Recovery of Artifacts.

Due to the dynamic flow of the Savannah River, it is unsurprising that there are only a few examples intact bottles within the *CSS Georgia* assemblage (excluding modern bottles; Figure 6-152). However, there are some sections of bottles that show makers' marks and other identification indicators.

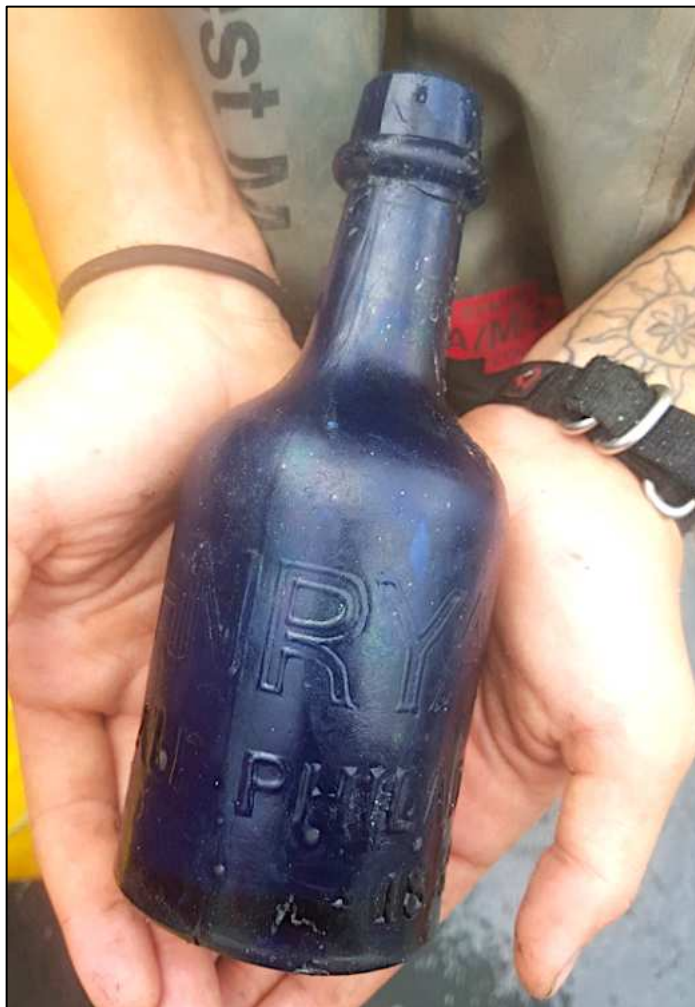
Figure 6-153. Artifact 2070.4, whole bottle embossed with “JOHN RYAN PORTER & ALE PHILADA XX 1859.”

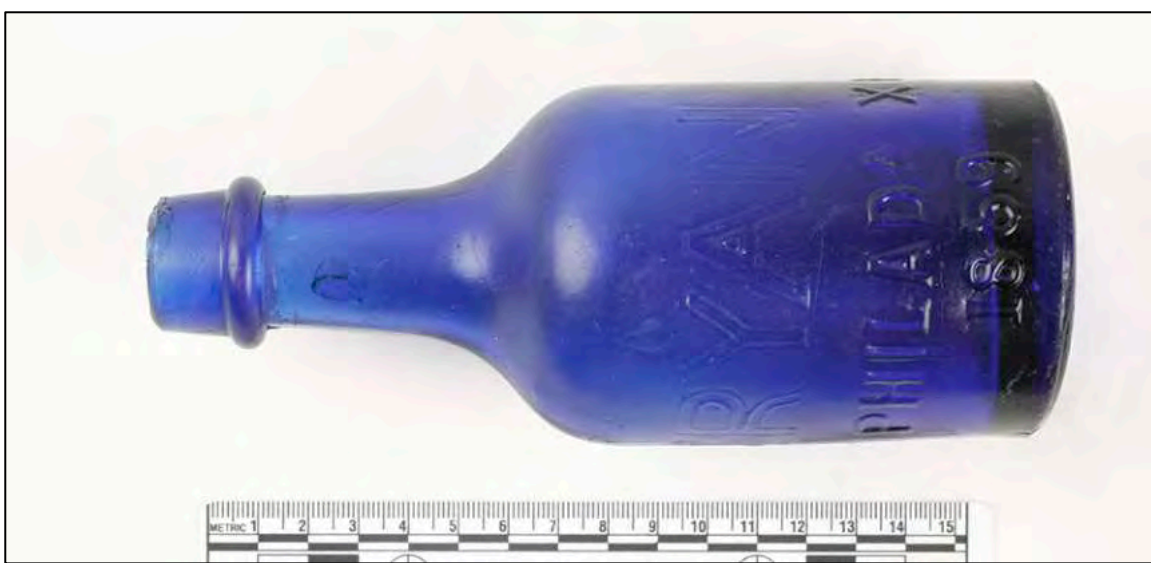
Figure 6-154. Artifact 2070.4, from an angle showing “PHILADA XX 1859.”

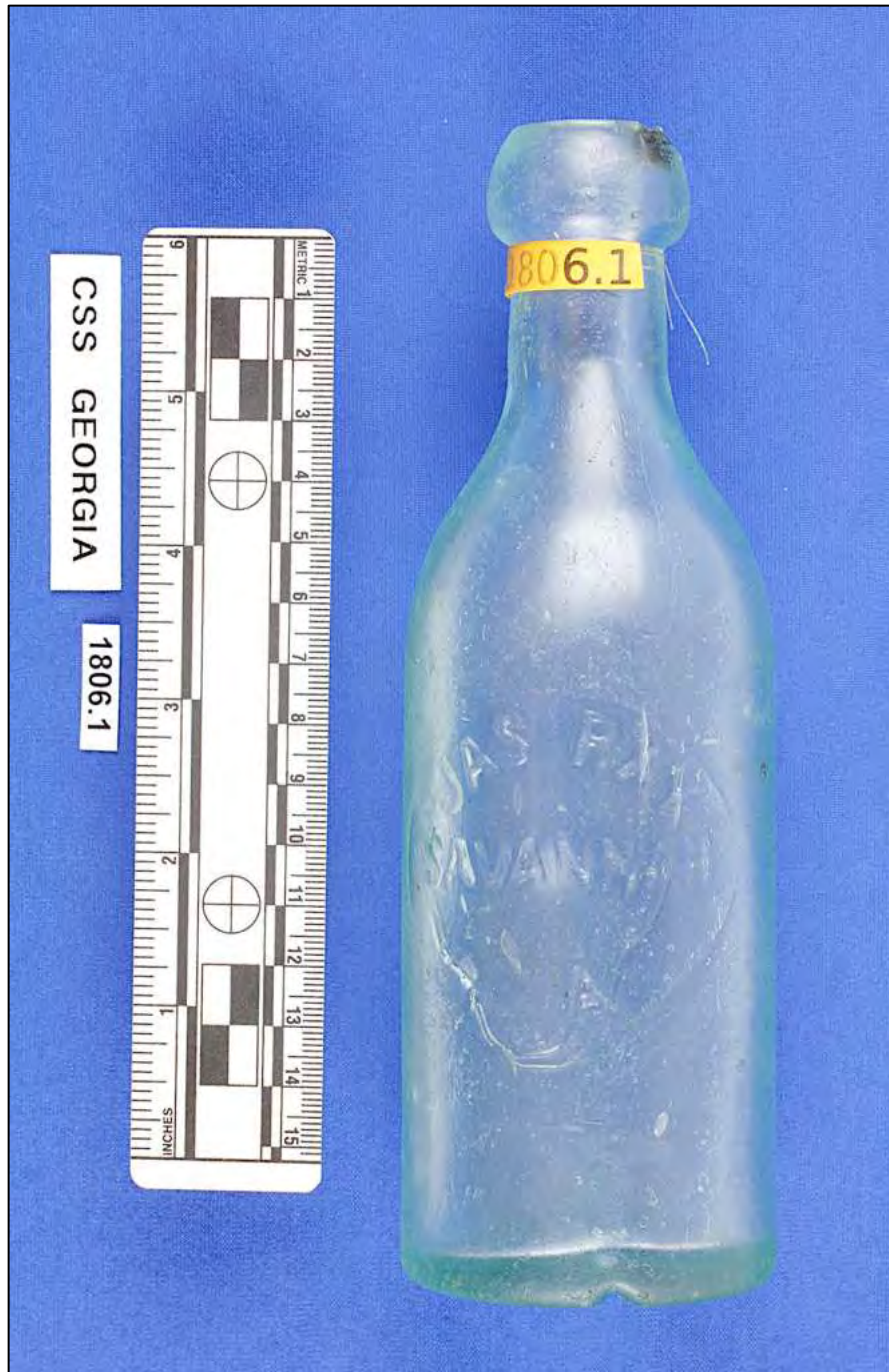
Figure 6-155. Artifact 1806.1, “JAS RAY SAVANNAH GA” mineral soda bottle.

An additional example of a fairly intact artifact with local origin is the Jas Ray mineral soda bottle. Most likely employing a Hutchinson-type stopper (post-1879), this specific bottle also dates to the 1880s with a tooled-blob style top and thick base. The text “JAS RAY SAVANNAH GA” can be seen on the bottle side as well as “C-24” stamped on the base (Figure 6-155). Its post-scuttling manufacture date again underscores the intrusion of glass, as well as other artifacts into the site.

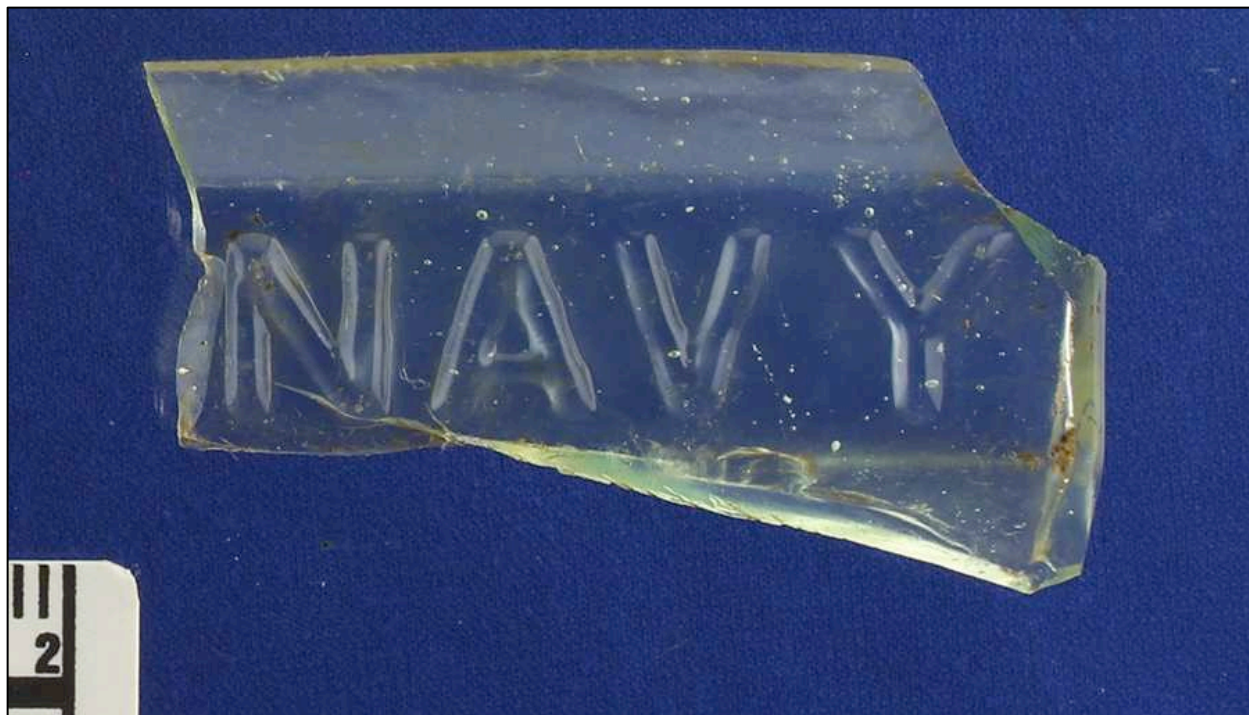
Figure 6-156. Artifact 2356.2, 2.5-x-1.5-inch fragment of a panel from a glass bottle embossed with “NAVY.” Not shown, Artifact 1814.2 is an almost identical fragment retaining only “NAVY” as well.

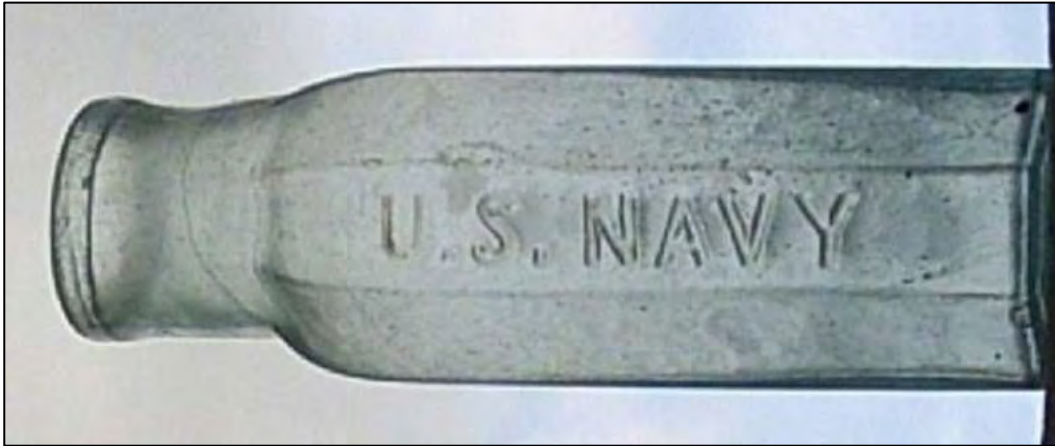
Figure 6-157. Recovered from the CSS *Cairo* and on display at the Vicksburg National Military Park, panel bottled embossed with “US NAVY” on one side panel and either PEPPER or MUSTARD on the other (as presented at Antique-Bottles.net).

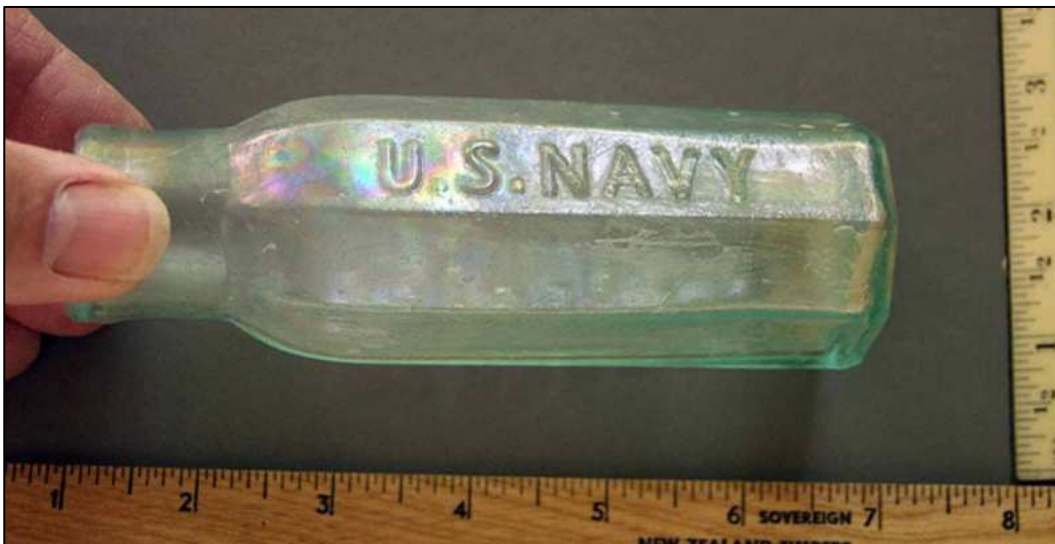
Figure 6-158. Similar bottle originating from the USS *Monongahela* that grounded on St. Croix in 1867 during a hurricane (as presented at Peachridgeglass.com).

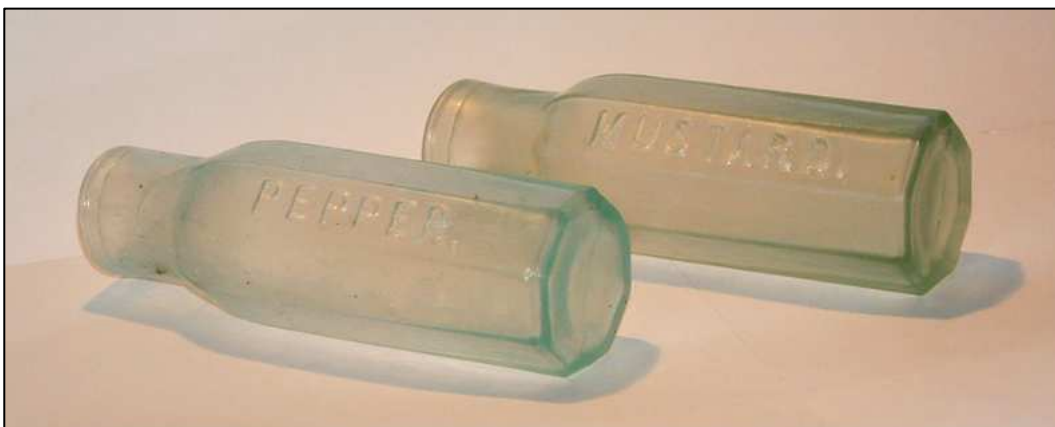
Figure 6-159. Opposite panels showing either “PEPPER” or “MUSTARD” (as presented at Antique-Bottles.net).

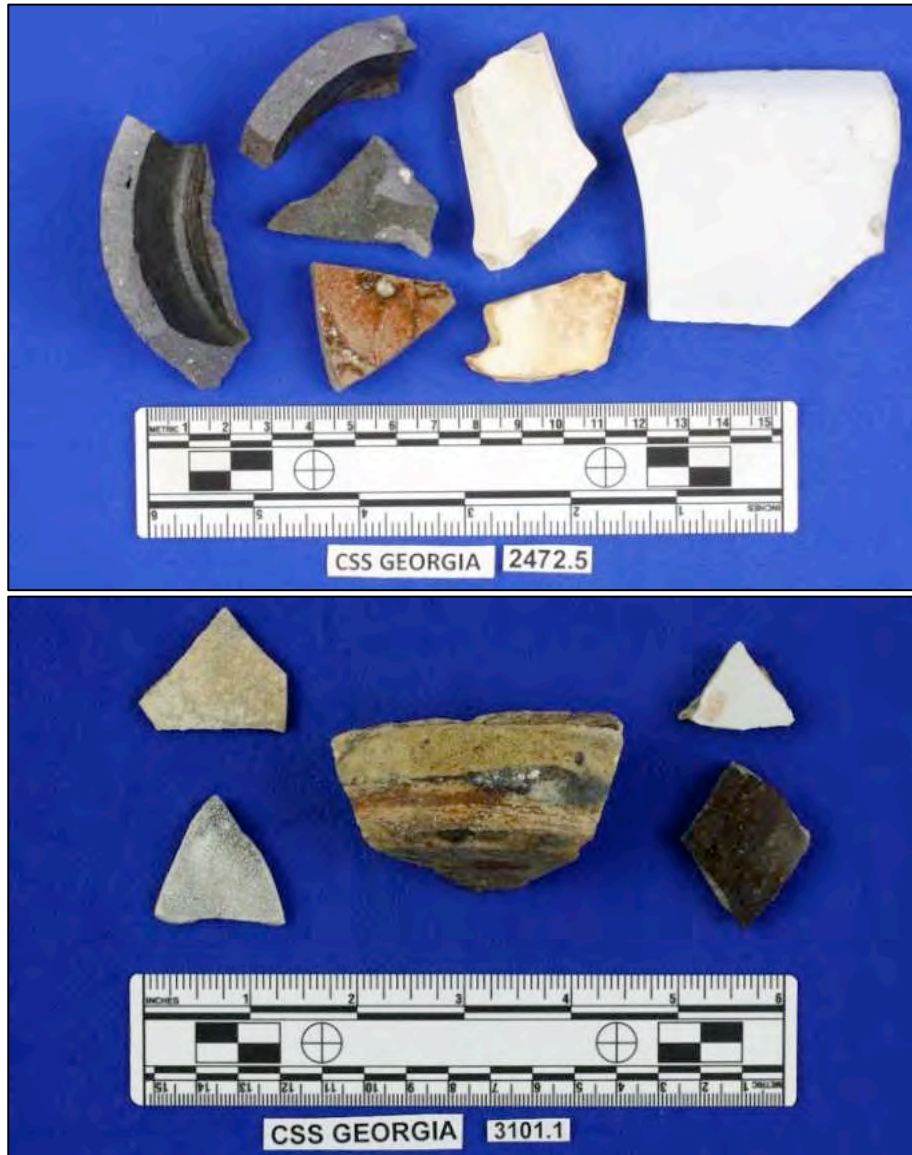
Figure 6-160. Examples of the types and numbers recovered during the Mechanized Site Recovery Phase.

One of the most numerous artifact types found on-site was historic ceramics. Mainly represented by small fragments, 1,299 were recovered and include creamwares, pearlwares, whitewares, stonewares, porcelains, ironstones, etc. (Table 6-05). Illustrated in Figure 6-160 are examples of the variety of historic ceramics on the site. Surprisingly, no whole ceramics was recovered (Figure 6-161). Dating of historic ceramics on our site, outside of a general time period, is problematic. Additionally, the ambiguous dates for some of these pottery types throws this set of artifacts into the same realm as the glass where it can be postulated that much of the assemblage could be intrusion from the nearby City of Savannah, as well as the over 4,000 intrusive prehistoric ceramics that were recovered from the site. We know the time period for the wreck site. The problem is attributing the ceramics to the site because of intrusion issues. Subsequently, the following ceramic analysis, which was written by William Wilson, then becomes a discussion of numbers, types, decorations, and makers' marks.

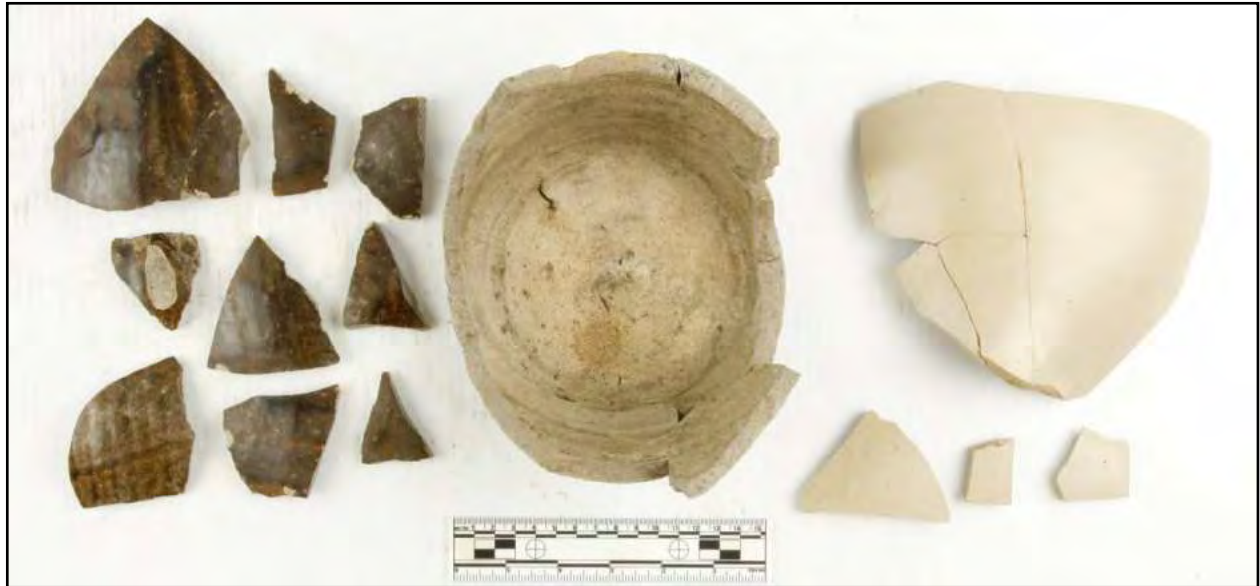
Figure 6-163. Artifact 1812.03, a salt-glazed stoneware base with unglazed interior recovered from Unit 8-F.

The earliest American utilitarian stoneware was generally salt-glazed on the exterior and unglazed in the interior. This was the most commonly used utilitarian stoneware glaze throughout the nineteenth century (Greer 1981:180). Salt-glazed vessels are manufactured using a different process for most other glazes: the vapor method. Common salt (sodium chloride [NaCl]) is thrown or dropped into the hot kiln, where it immediately vaporizes and adheres to the surfaces that are approaching vitrification. Salt-glazed vessels exhibit a characteristic "orange peel" texture and the glaze is most often transparent (Greer 1981:181). Surfaces are often very glossy as well (Figure 6-163).

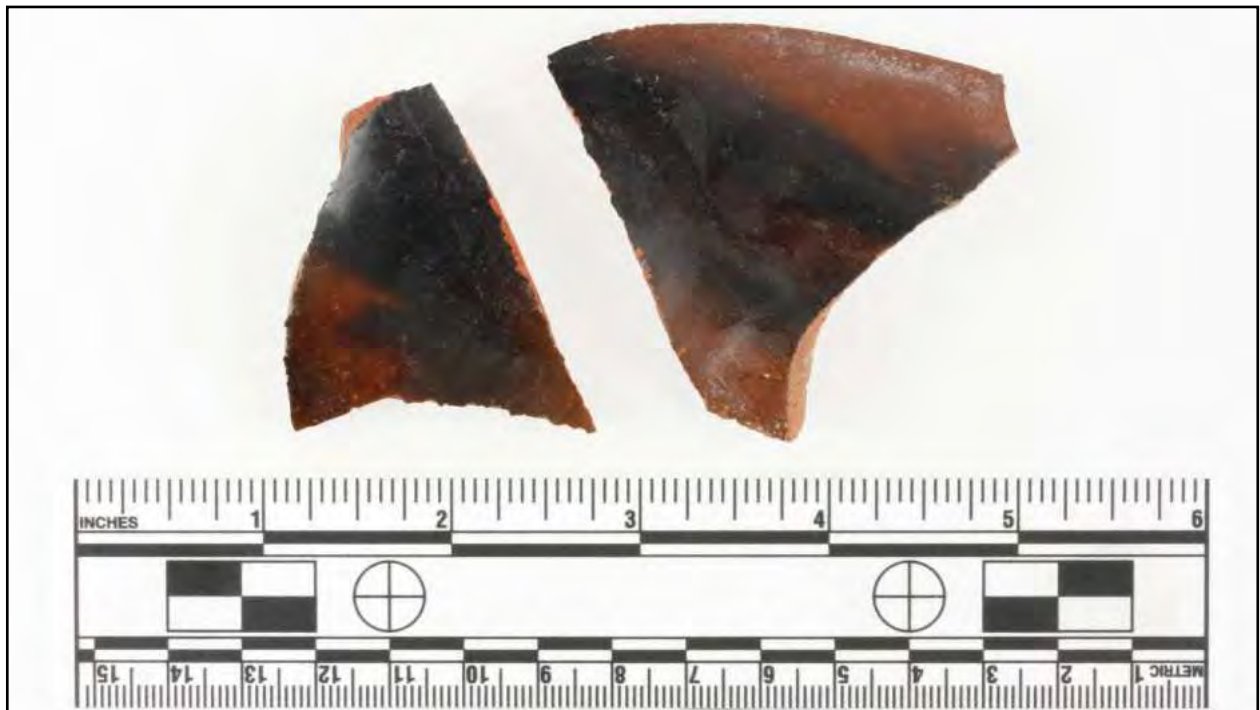
Figure 6-164. Artifact 1863.01, a slip-glazed stoneware recovered from Unit 5-E.

Natural clay or slip glazes (Figure 6-164) began to be employed by American stoneware potters during the nineteenth century (Greer 1981:194). They were created by dipping vessels in a watery solution created by straining clay, and thus suspending clay particles in the liquid. Greer (1981:197-198) remarks that “most slip glazes are generally not purposefully colored; they are natural clays, containing varying amounts of iron...[and] other color influencing oxides” that typically result in glazes that are shades of brown. Slip clay glazes are typically, smooth, untextured, and opaque (Greer 1981:200).

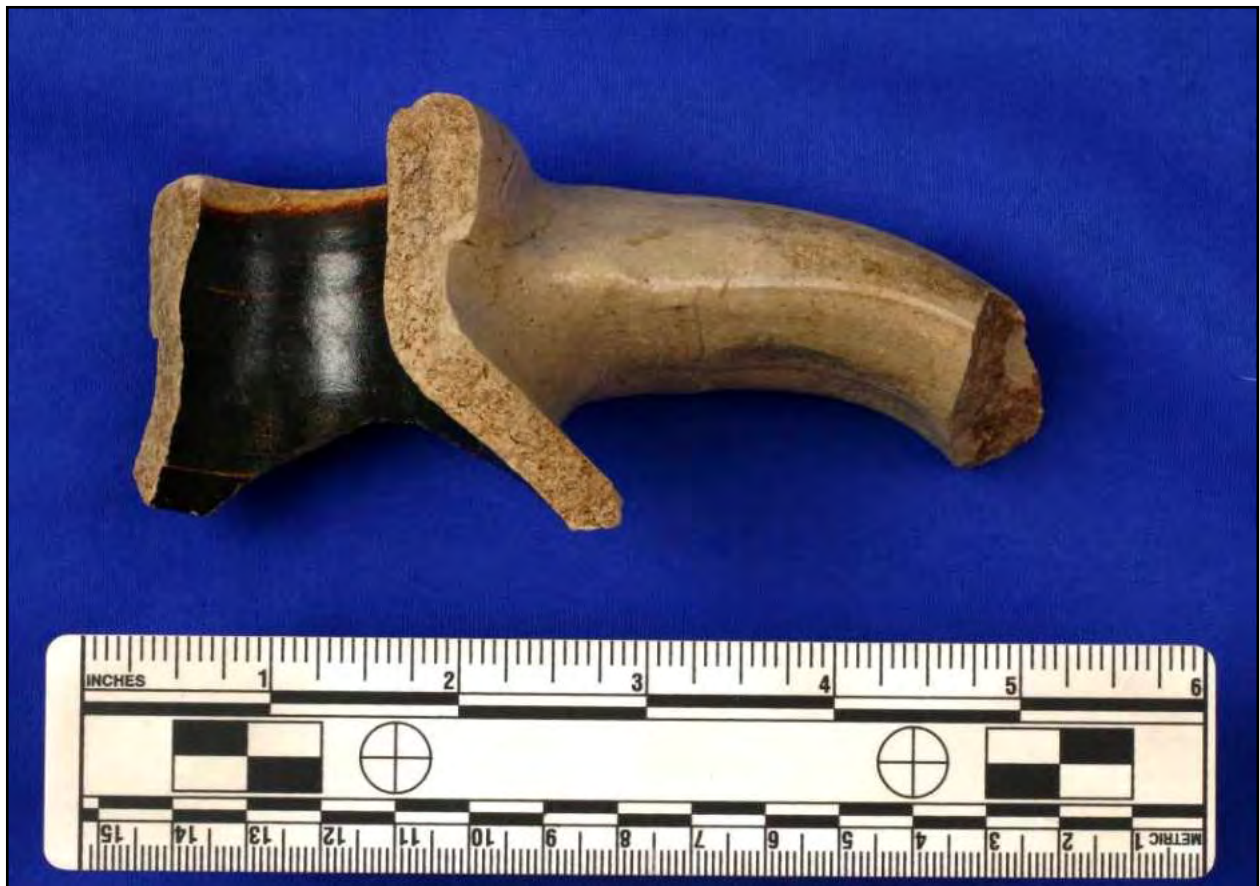
Figure 6-165. Artifact 1876.01, a stoneware jug handle, neck, and rim showing Albany glaze on interior recovered from Unit 8-D.

The most well-known slip glaze is Albany (Figure 6-165), a shiny, dark-dark colored glaze that was developed during the early 1800s by potters using clay from Albany, New York. Similar glazes that are derived from other clay sources are referred to as “Albany-like.” After 1850, most vessels that were salt glazed on the exterior were Albany glazed on the interior to prevent seepage (Greer 1981:197). During the late nineteenth to early twentieth centuries the increasing popularity of lighter colored slips, which were associated with cleanliness, diminished the popularity of dark slip glazes.

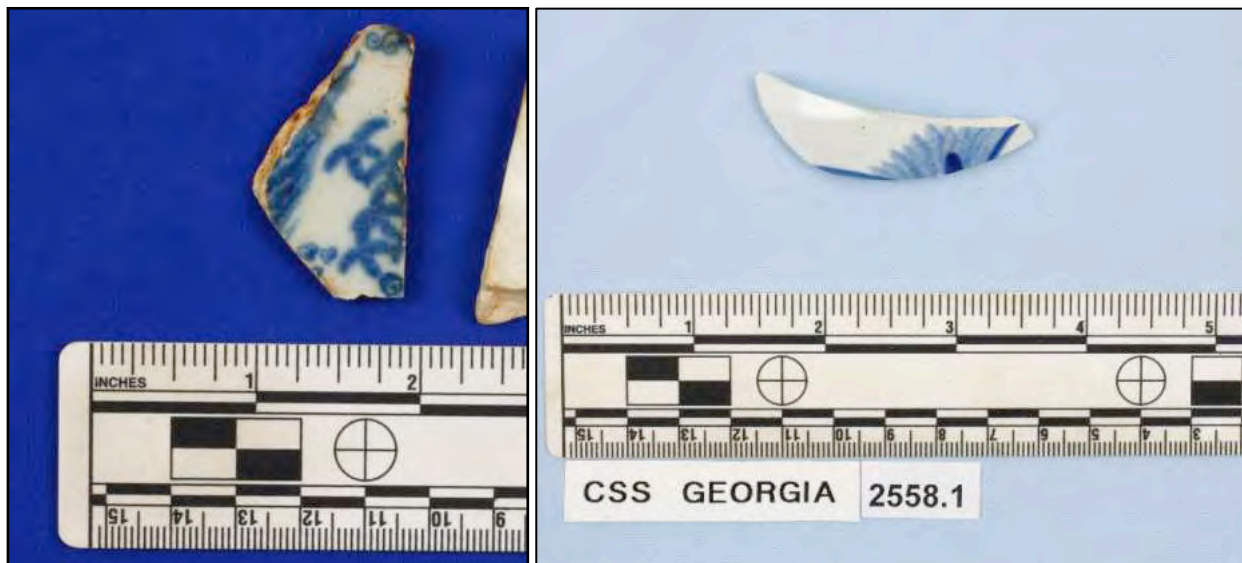
Figure 6-166. Hand-painted motif on pearlware (left) recovered from north of the site grid (Artifact 2709.3). Note the contrast in sharpness compared with the transfer print on the left side of the artifact. On the right (Artifact 2558.01) is a small piece of whiteware with a hand-painted floral motif.

Hand-painted designs were applied (as the name implies) by hand painting minerals into the glaze. This contrasts with later transfer prints in appearance, as the hand-painted designs tended to have visually softer edges. This resulted from pooling of glazing, creating a haze around designs. Figure 6-166 illustrates the contrast between transfer-print and hand-painted motifs, as both are included on the ceramic fragment. Hand-painted blue was also popularly used on shell-edged molding of some refined earthenwares, one of which is shown in Figure 6-167. Of the analyzed historic ceramics, only ten were noted specifically to have hand-painted decorations.

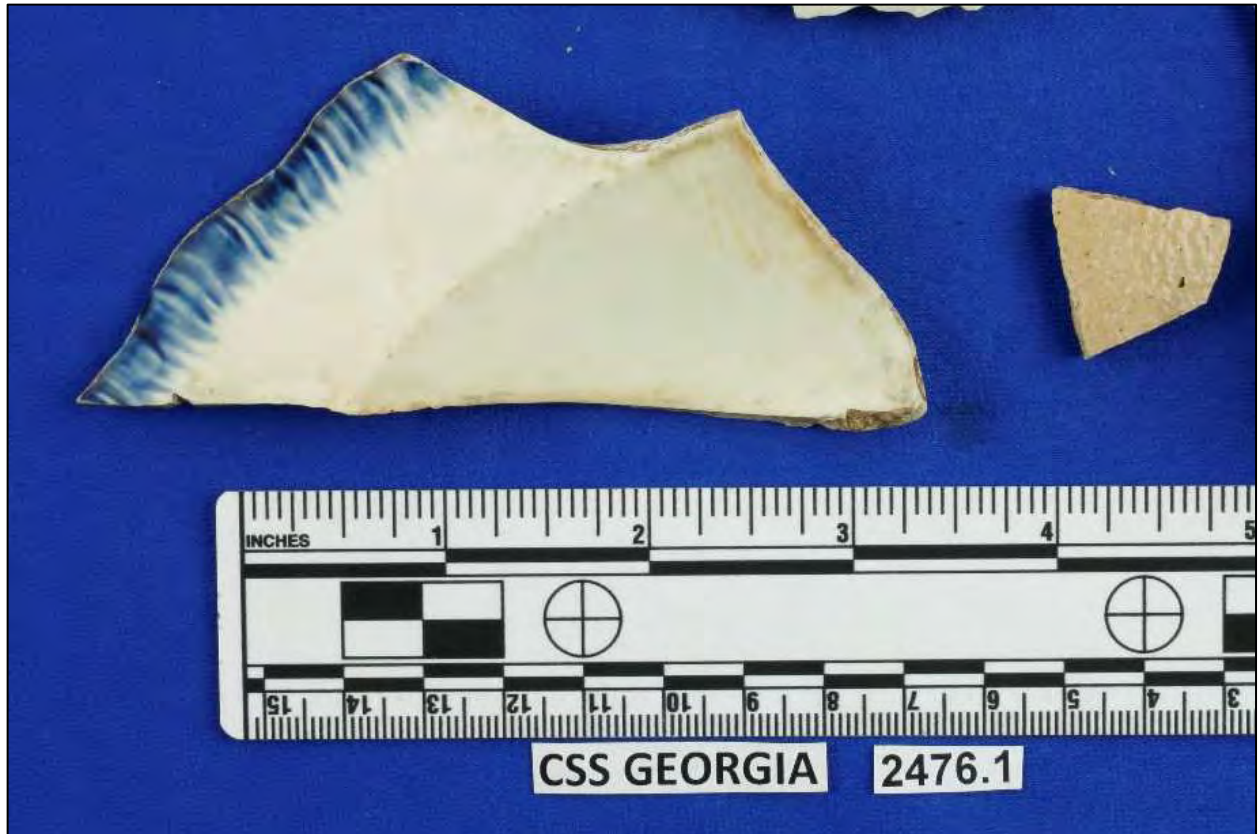
Figure 6-167. Hand-painted blue design on shell-edged whiteware.

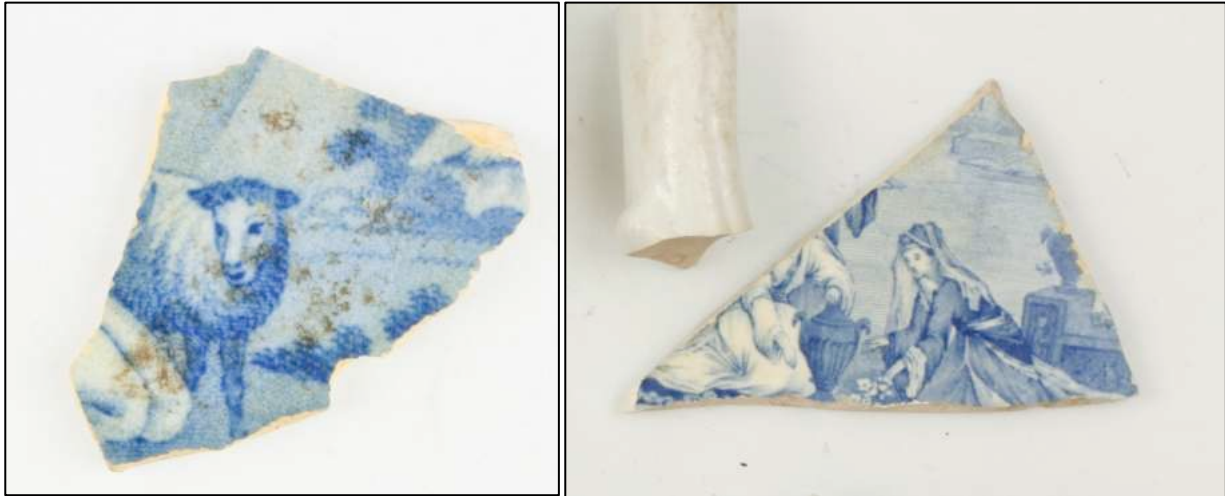
Figure 6-168. Transfer-printed sheep motif on pearlware (left) recovered from Unit 18-M (Artifact 2681.06), and a transfer-printed woman with amphora motif on whiteware (right; Artifact 2381.02).

Transfer-printed wares (n=5; Figure 6-168), exhibit colored designs that are applied to the vessel surface by means of an inked paper onto which the design was transferred from a copper plate engraving (Price 1979:19; Figure 6-169). During the nineteenth century, vast quantities of transfer printed wares were manufactured for the American market at the Staffordshire potteries in England. Transfer-printed designs were the most expensive designs to produce in the nineteenth century (Miller 1991). The first step in the transfer print process is engraving flat copper plates with designs. The engraved plates are then warmed and filled with color, which are metallic oxides mixed with oil (Gross 1996). The designs are then printed on special nonabsorbent tissue paper and dried. The impressions on the tissue paper are cut to fit a given vessel's shape, and the designs are hand rubbed onto bisque ware (unfired ceramic body). Friction causes the color to adhere to the bisque ware in clear outline, and the paper is then removed using water. Because the color is oil based, the water does not affect it. The bisque ware with the transfer designs are then immersed in a fluid glaze and fired in a glaze kiln.

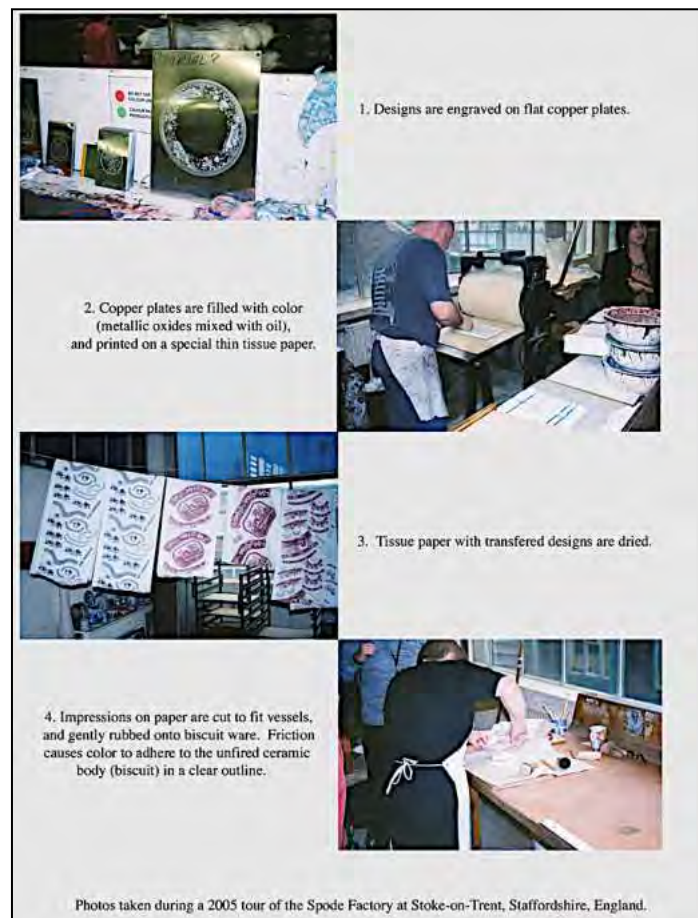
Figure 6-169. Steps in the transfer print process (courtesy of C. Andrew Buchner).

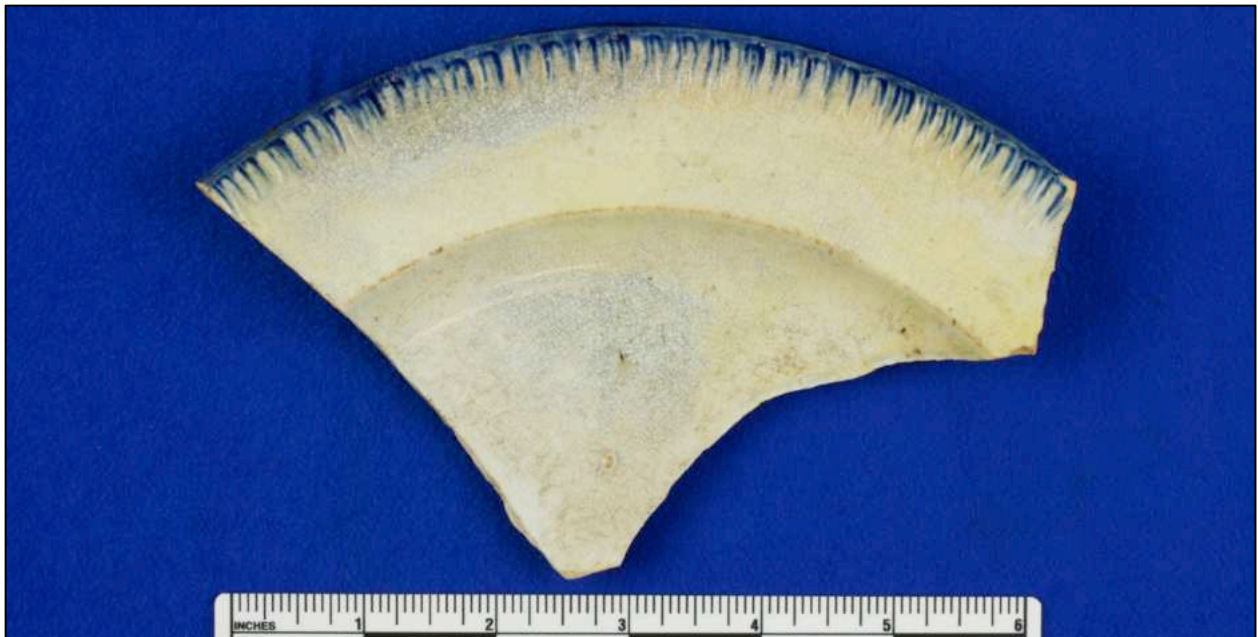
Figure 6-170. Shell-edged pearlware recovered from Unit 5-F (Artifact 1839.07).

Decorations also took the form of molding techniques. Among the common edge molding forms during the nineteenth century found on the site were shell edging (Figure 6-170) and diamond band (Figure 6-171). The most common motifs of edge decorations are shell-edge designs (Noël Hume 1982:131). Blue edging became the dominant color by 1830. Green and red are

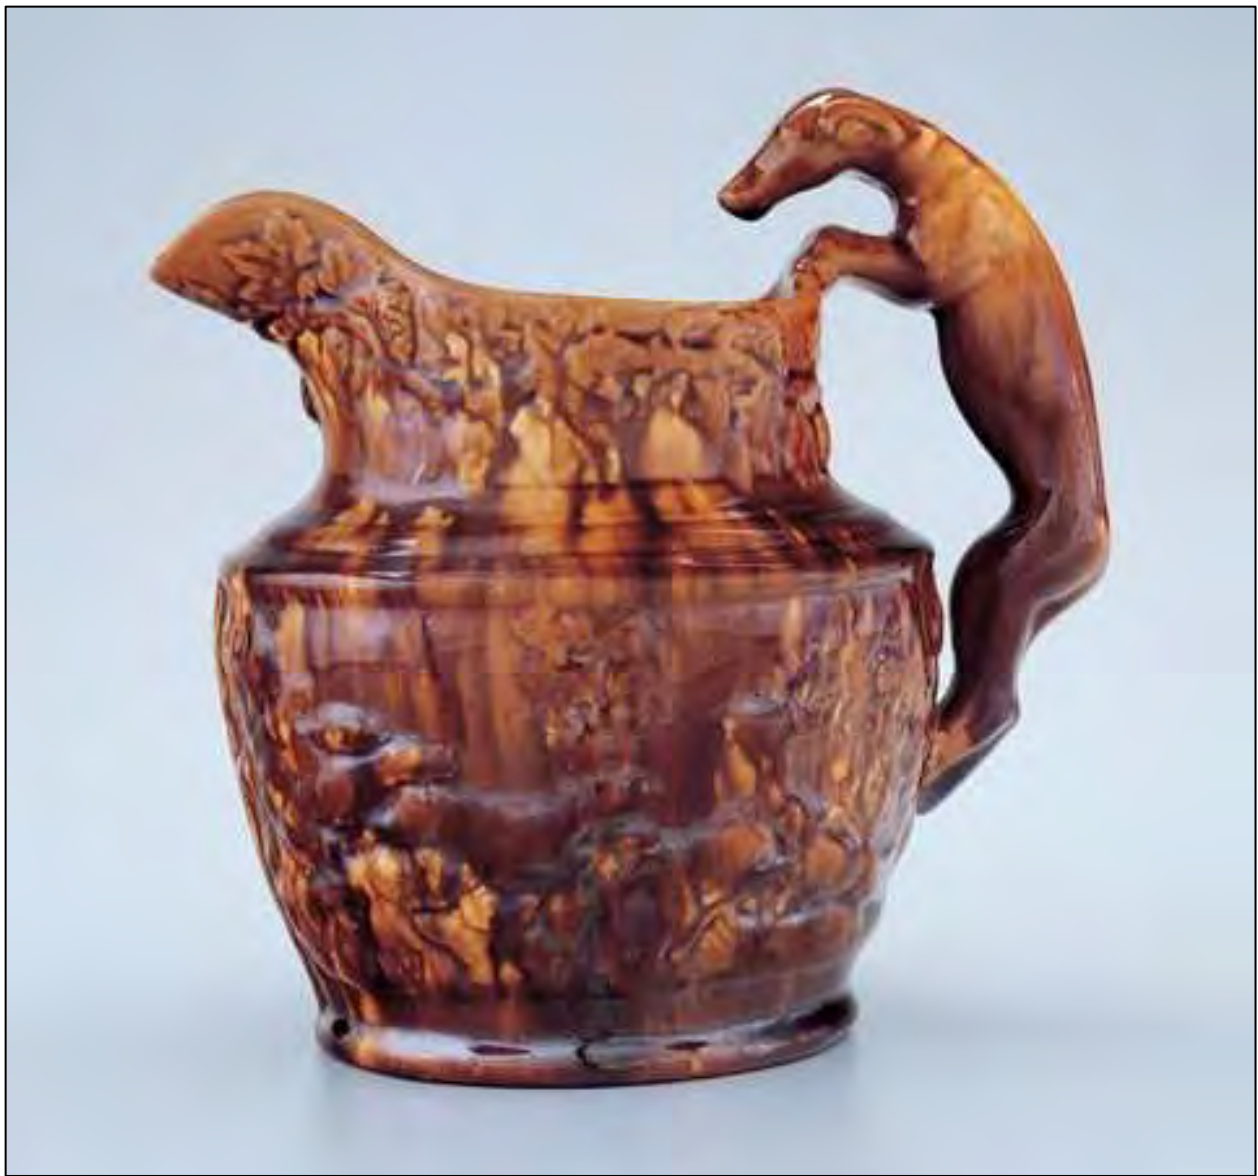
Figure 6-172. Example of a complete Rockingham-style pitcher with hound handle, and stag and boar hunt design (from Goldberg 2003).

One of the most unique finds amongst the ceramic assemblage was several fragments of a Rockingham-style stag and boar hunt-motif pitcher (Figure 6-172). The Rockingham-style of pottery was produced widely and was popular in the 1840s and 1850s. It is identified by a distinctive brown-and-yellow-tinted glaze over both yellowware and stoneware pottery. The stag and boar hunt motif was copied by multiple American pottery companies from their English counterparts and modified for the cultural climate (Goldberg 2003). Illustrated by three different yellowware fragments showing different aspects of the scene on the pitcher (Figures 6-173 to 6-175), it is interesting to note that these separate artifacts were not found in the same vicinity, but were recovered from multiple grabs during Mechanized Recovery of Artifacts. Recovery locations included Units 4-J, 5-L, and 23-L (see Figure 6-162). While Units 4-J and 5-L are only 20 feet apart, Unit 23-L is some 180 feet away. It is possible that there are multiple vessels represented here, but the glaze and thickness appear to be consistent in all of the pieces recovered. That does not necessarily place this artifact on the wreck at the time it was scuttled, but it is an interesting note on the distribution of a single disarticulated artifact.

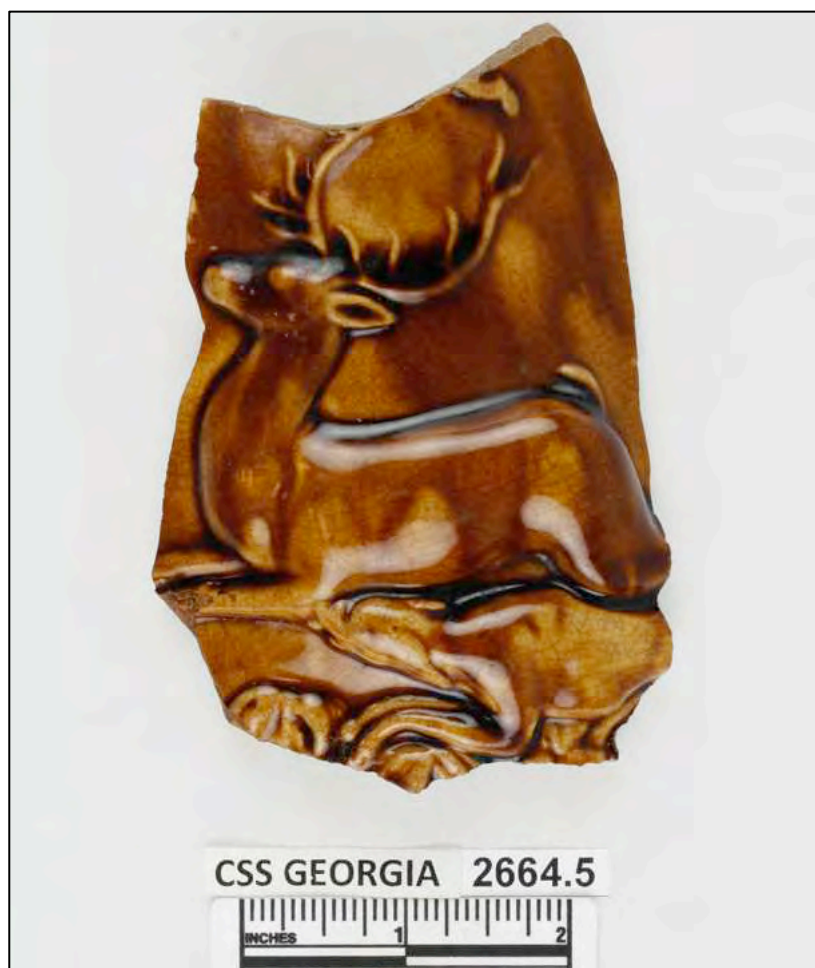
Figure 6-173. Artifact 2664.05 from Unit 23-L a stag motif fragment from a Rockingham style hound and stag motif pitcher.

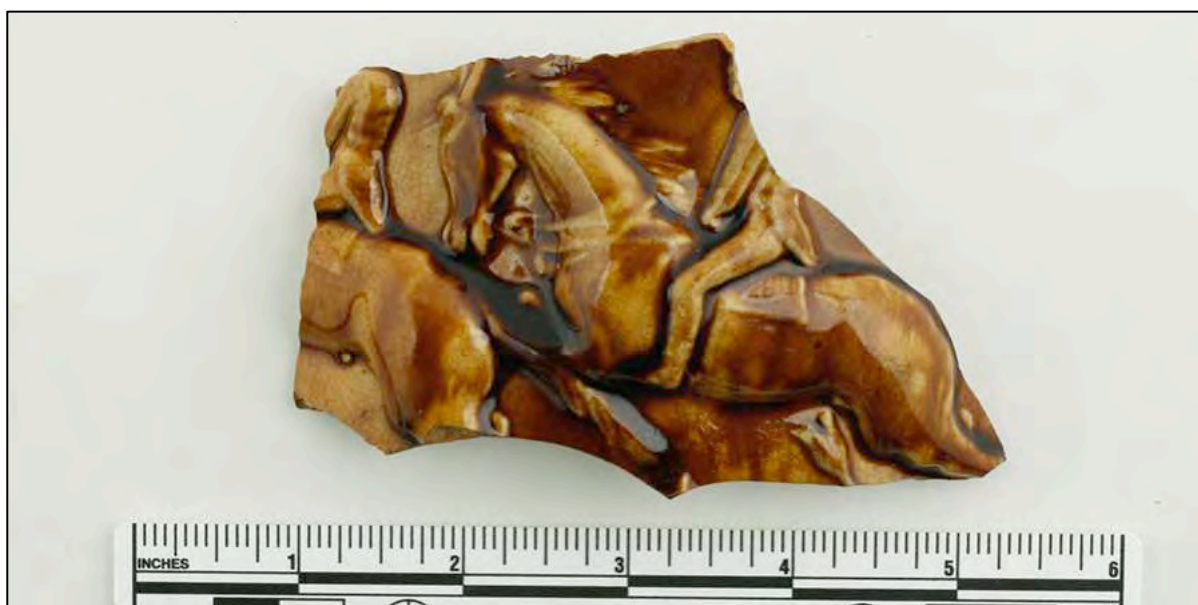
Figure 6-174. Artifact 2855.02 from Unit 4-J a horse and rider fragment from a Rockingham style hound and stag motif pitcher.
