CSS *GEORGIA*
ARCHEOLOGICAL DATA RECOVERY AND MITIGATION
FOR THE SAVANNAH HARBOR EXPANSION PROJECT (SHEP),
CHATHAM COUNTY, GEORGIA AND JASPER COUNTY, SOUTH CAROLINA

**FINAL DRAFT REPORT
OCTOBER 2019**

Stephen R. James, Jr. and Gordon P. Watts

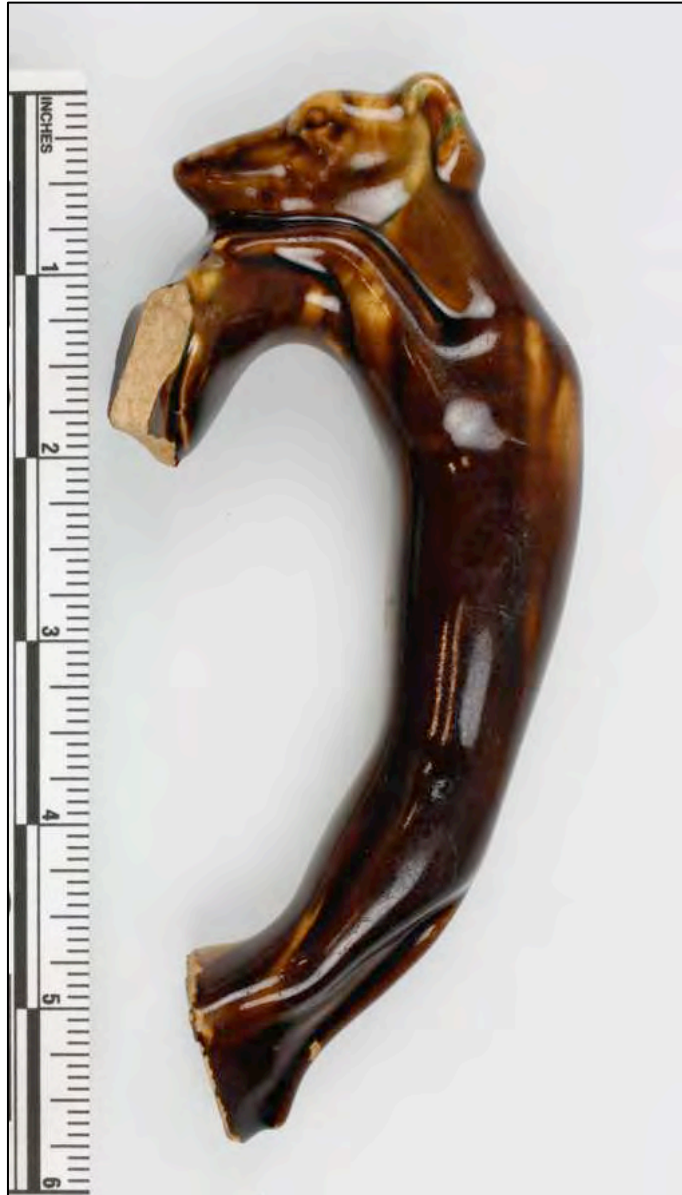
Figure 6-175. Artifact 2777.11 from Unit 5-L a hound handle from a Rockingham style hound and stag motif pitcher.

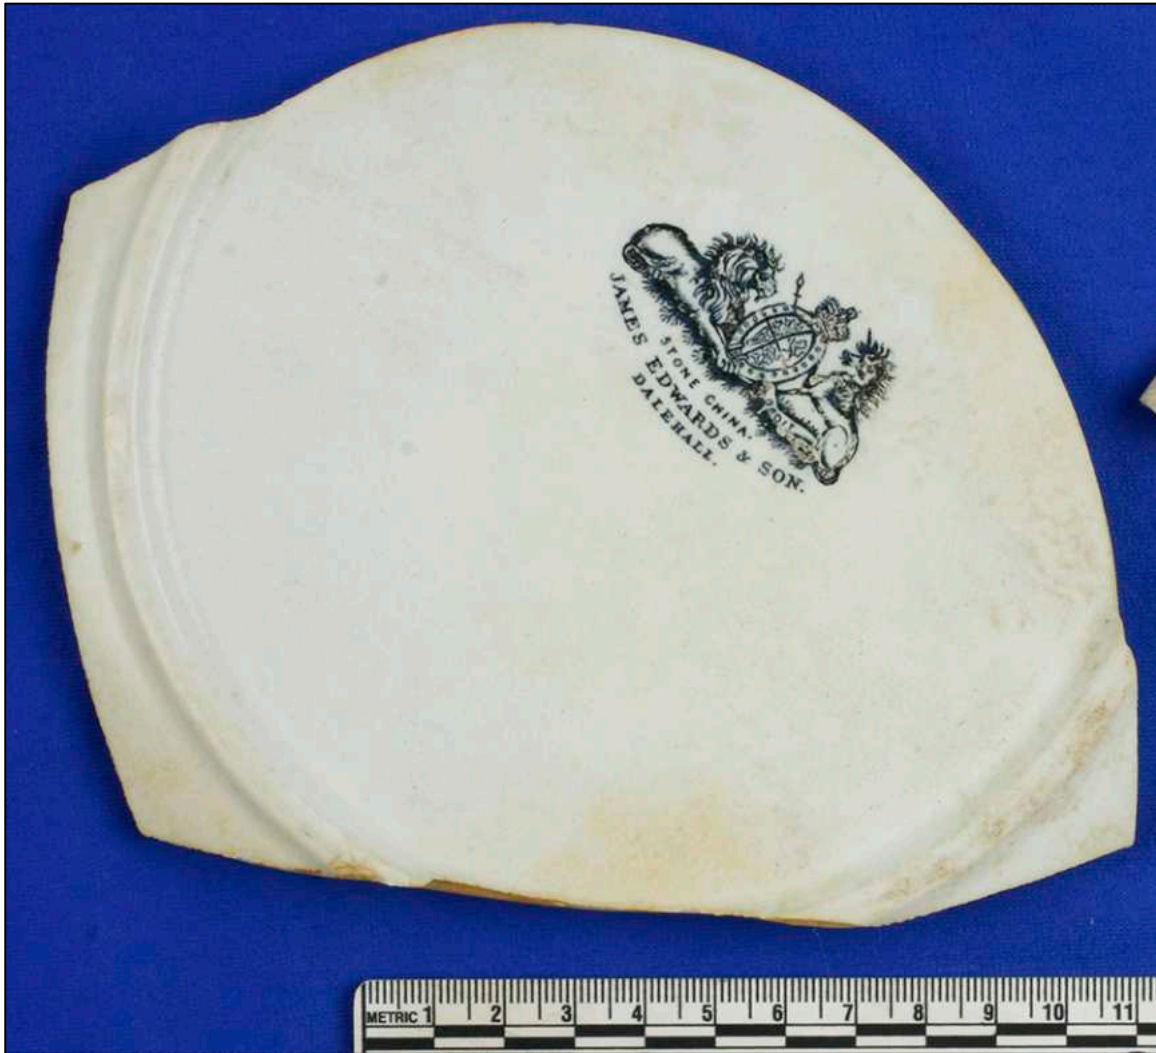
Figure 6-176. Example of a complete James Edwards and Son maker's mark. Artifact 2797.4.

The most common mark found on the ceramic fragments from the *CSS Georgia* was from James Edwards & Son. This father and son partnership was based at the Dale Hall Pottery in England. They operated as a partnership from 1851 to 1861, when James retired. Eventually the business was passed to Knapper and Blackhurst in 1882. Much of their inventory was exported to the U.S. and they specialized in whiteware and ironstone (Birks 2019). This mark (or partial mark) was identified on ten individual items. Figures 6-176 and 6-177 shows examples of the marks from this company that were seen on ceramic fragments from the site.

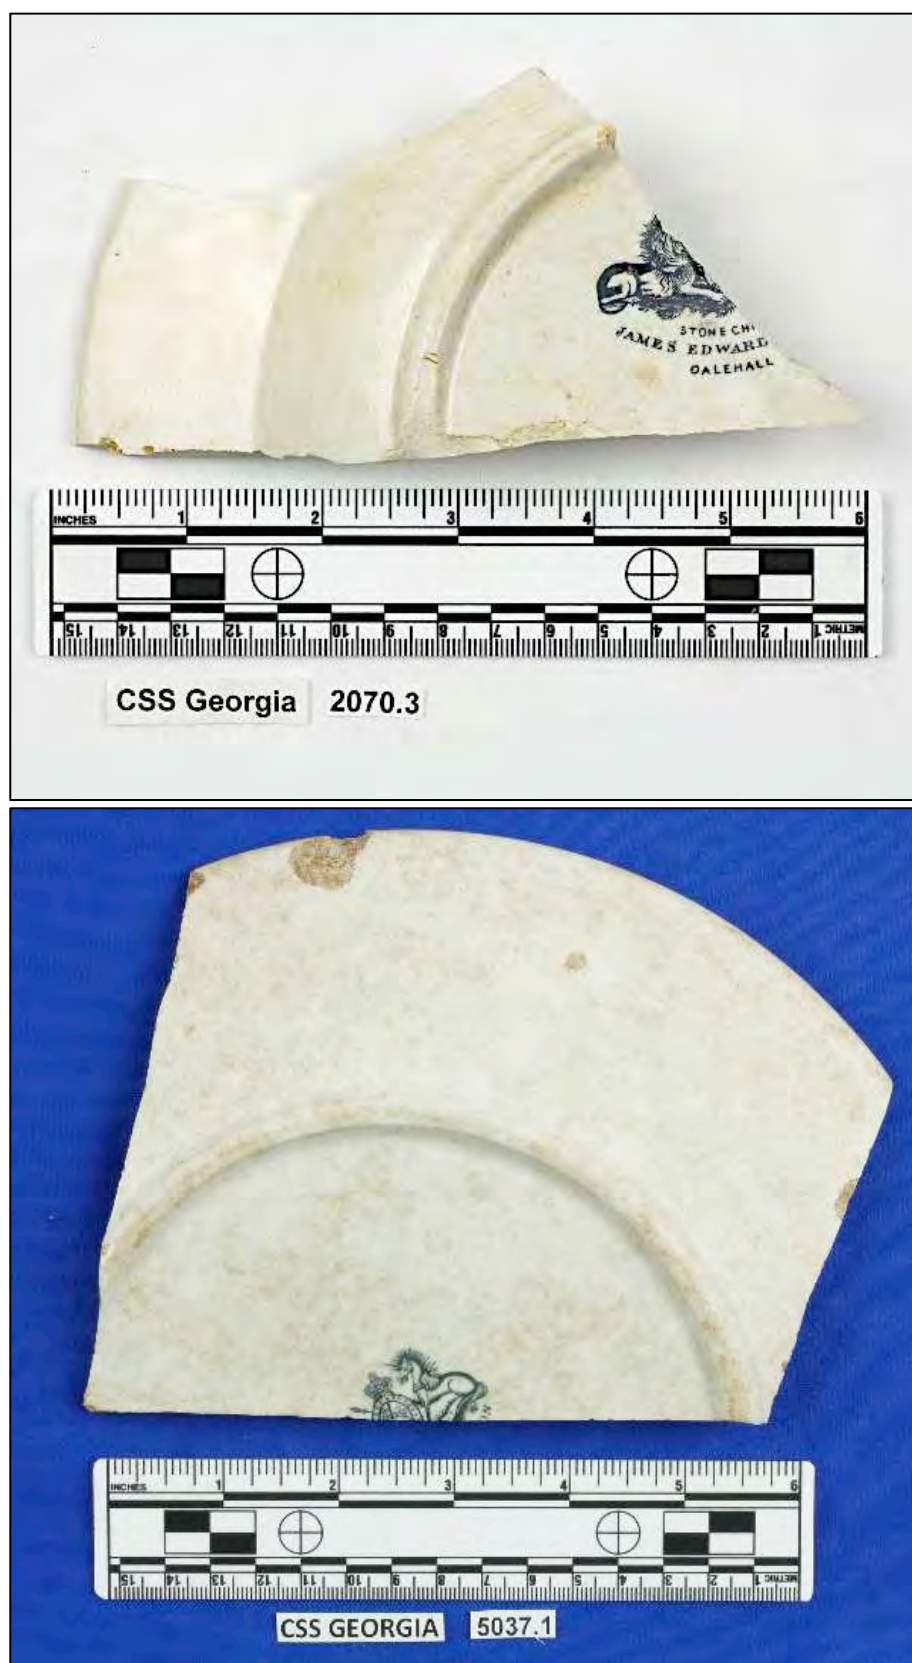
Figure 6-177. Examples of partial James Edwards & Son. maker's markings on recovered artifacts (Artifact 2070.03 [top] and 5037.01 [bottom]).

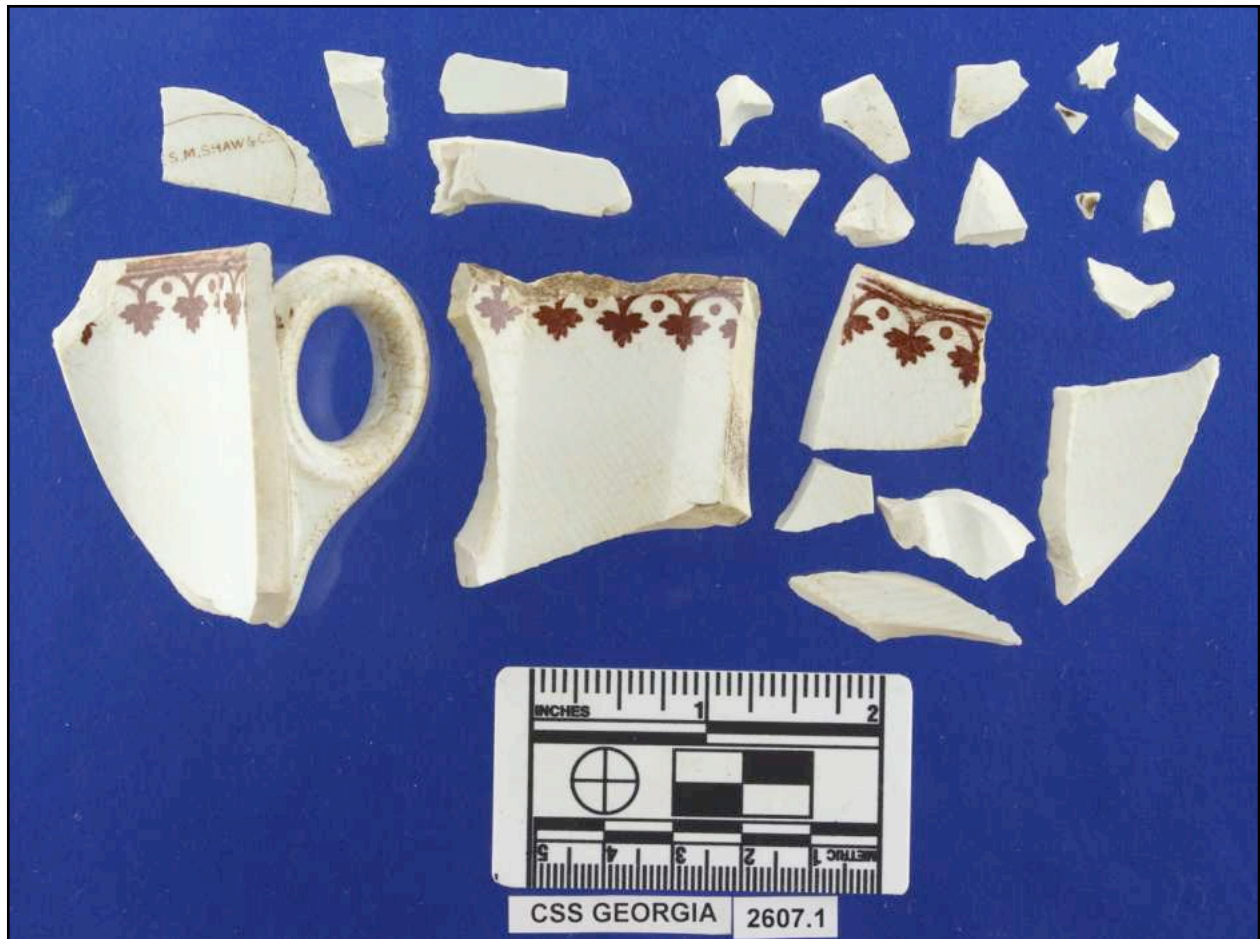
Figure 6-178. James M. Shaw & Co. mug recovered from Unit 19-J (Artifact 2607.01).

It is interesting to note that Artifact 2607.1 had the maker's mark "JAMES.M.SHAW & Co." (Figure 6-178). James M. Shaw & Co. produced china and glassware for hotels, clubs, and institutions starting in 1838, and incorporated in 1895 (Blaszczuk 1994). The U.S. Navy began purchasing china from James M. Shaw & Co., out of New York in the 1890s (thepirateslair.com). Hotelware (actually vitrified stoneware) pieces like this were common, mass-produced and widely used tableware during the early twentieth century (Meyers 2016:110). This type of pottery was known for being extremely durable, which made it useful in restaurants and hotels (thus the names "hotelware" and "restaurantware"). Hotelware is still commonly used today. Although no date is printed on the stamp, James M. Shaw & Co. was sold to Nathan Straus in 1938, indicating a manufacture date prior to that date.

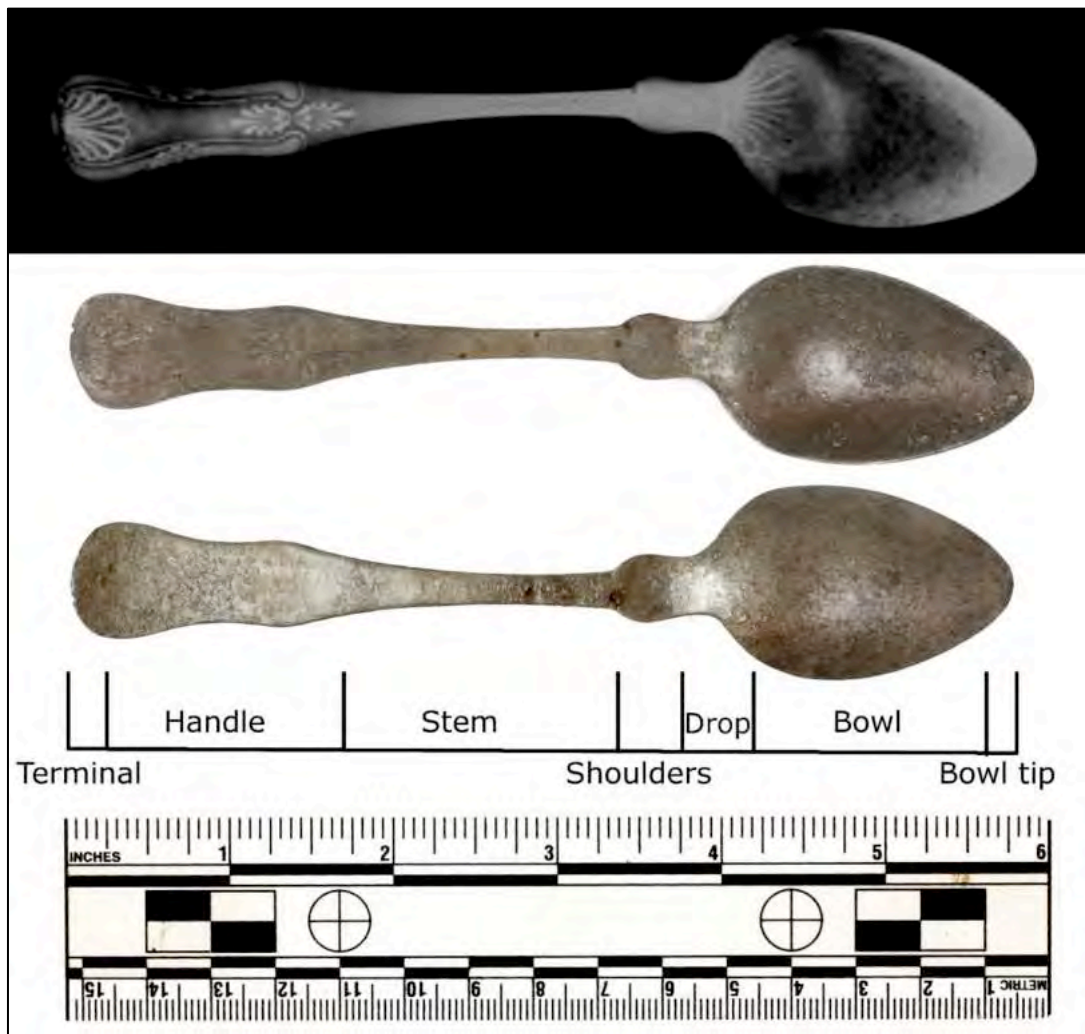
Figure 6-179. Spoon Type 1, bearing the “Kings Pattern,” and represented by a single spoon, Artifact 2881.1. The image includes a diagram of the parts of a spoon (courtesy of CRL, Texas A&M University).

Spoon Type 1 (Figure 6-179) is represented by a single spoon (Artifact 2881.1) with a fiddle-shaped handle with a shell at the terminal and a honeysuckle device between the handle and stem, rounded shoulders, and a shell drop pattern; the tip of the bowl is narrowed. The pattern on the handle, most easily seen in the x-ray image, is known as the “Kings Pattern” (O’Keefe-Coulson 2014). Although the pattern is distinct, it is a popular pattern that has been produced from the early nineteenth century to present day. According to XRF analysis, this is one of two artifacts that contain silver; further analysis would be needed to determine whether the silver is part of the alloy, or if the artifact was silver-plated.

This spoon is the only pewter artifact with a definite maker’s mark, which would allow for the date or date range of manufacture to be determined. Unfortunately, the mark is difficult to discern by visual inspection or with the X-ray image due to wear and spots of corrosion; the mark may say “EASTERN,” “EASTMAN,” or “DRASTMAN.” Two companies that were founded at the beginning of the twentieth century used a variation of “EASTERN” to mark their goods: the Eastern Carolina Silver Company, which used the mark “EASTERN,” and the American Silver Company, which used the mark “EASTERN SILVER CO.” (Woodhead 1991:6, 68). Further research is needed to determine the manufacturer of this spoon.

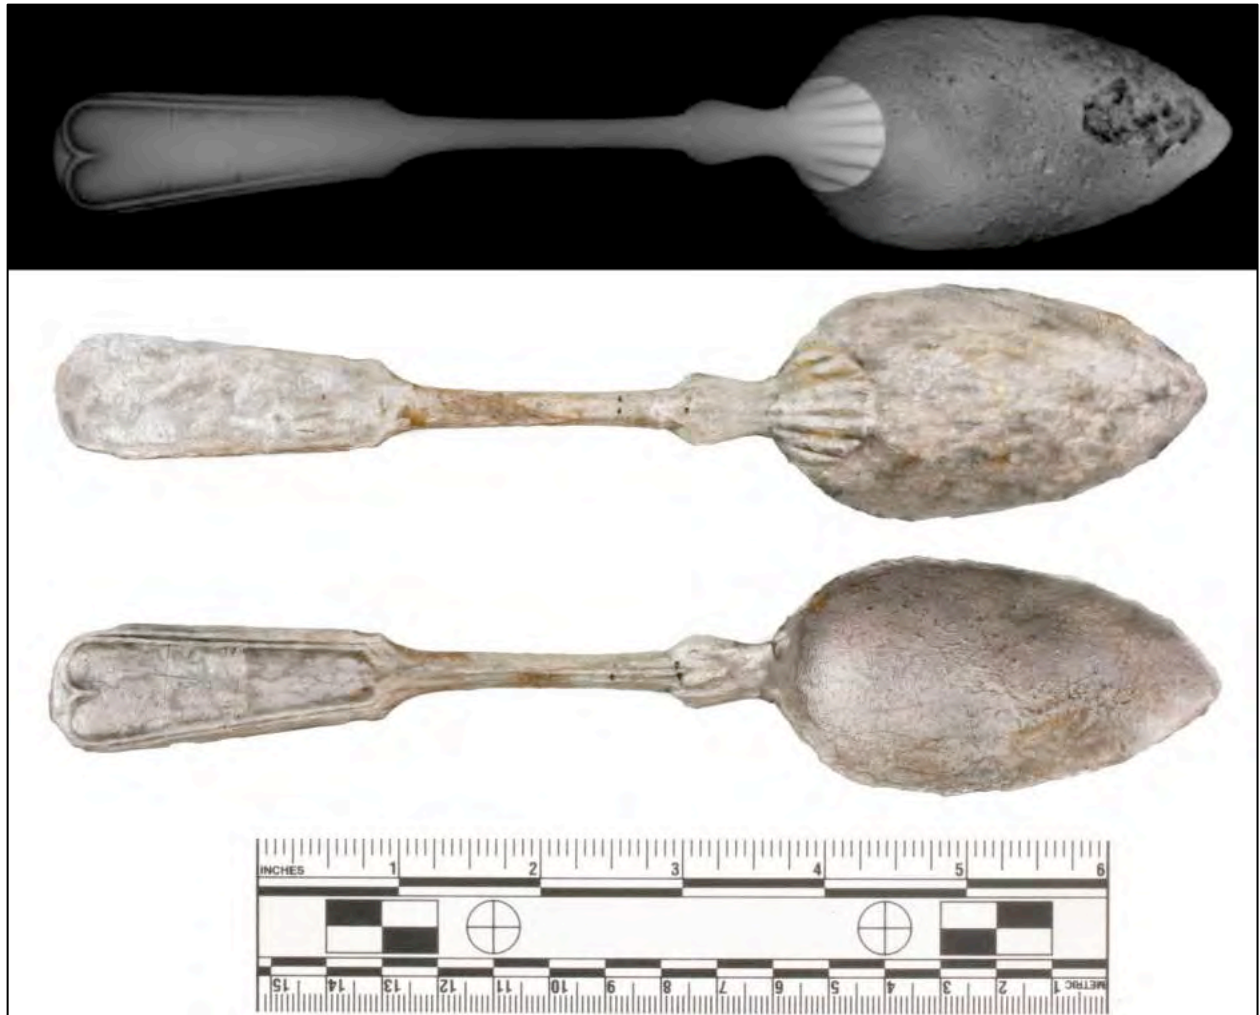
Figure 6-180. Spoon Type 2, characterized by the shell-drop pattern and simple lines on the stem and handle. This type is represented in Artifacts 2700.8, 2768.5 (*this image*), 2780.3, and 2553.3 (courtesy of CRL, Texas A&M University).

Similar to the first type, Spoon Type 2 (Figure 6-180) is represented by a fiddle-shaped handle, rounded shoulders, a shell drop pattern, and a narrow bowl tip. Rather than the Kings Pattern, lines extend from the shoulders to the terminal ending, in the case of the only intact example that is not heavily worn, in a simple heart-shaped pattern. This spoon type is represented by three intact or mostly intact spoons and one handle without a bowl. In addition, two spoon bowls, both broken at the drop, may represent either this type or the third type since they do not have handles; they have been grouped here because they are from the same unit as the handle without a bowl.

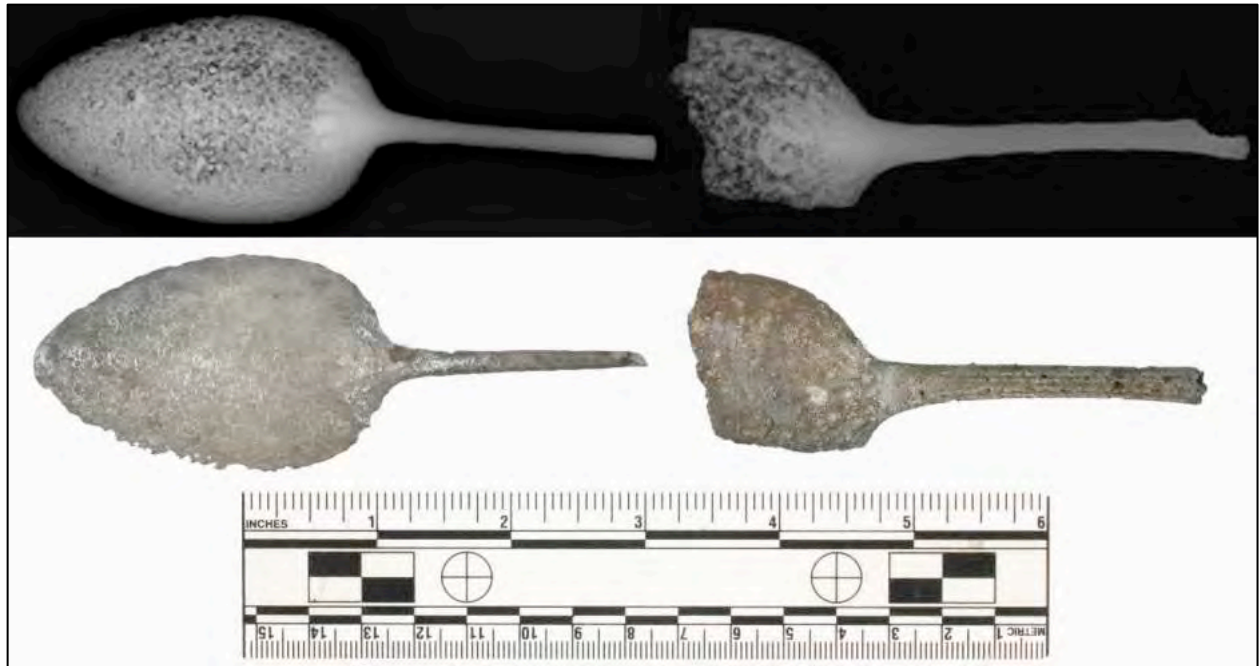
Figure 6-181. Spoon Type 3, characterized by a shell drop pattern and a lack of defined shoulders. This type is represented in Artifacts 1983.18, 2760.2, 2783.6 (*left*), and 2853.3 (*right*; courtesy of CRL, Texas A&M University).

Spoon Type 3 (Figure 6-181) is represented by a shell drop pattern, narrowed bowl tip, and the lack of a shoulder protrusion, making the shoulders and stems of these spoons appear skinny in comparison to the first types. Of the four spoons that make up this type, none is complete, but it is possible that some of the handles without bowls (Spoon Type 4) correspond to these bowls.

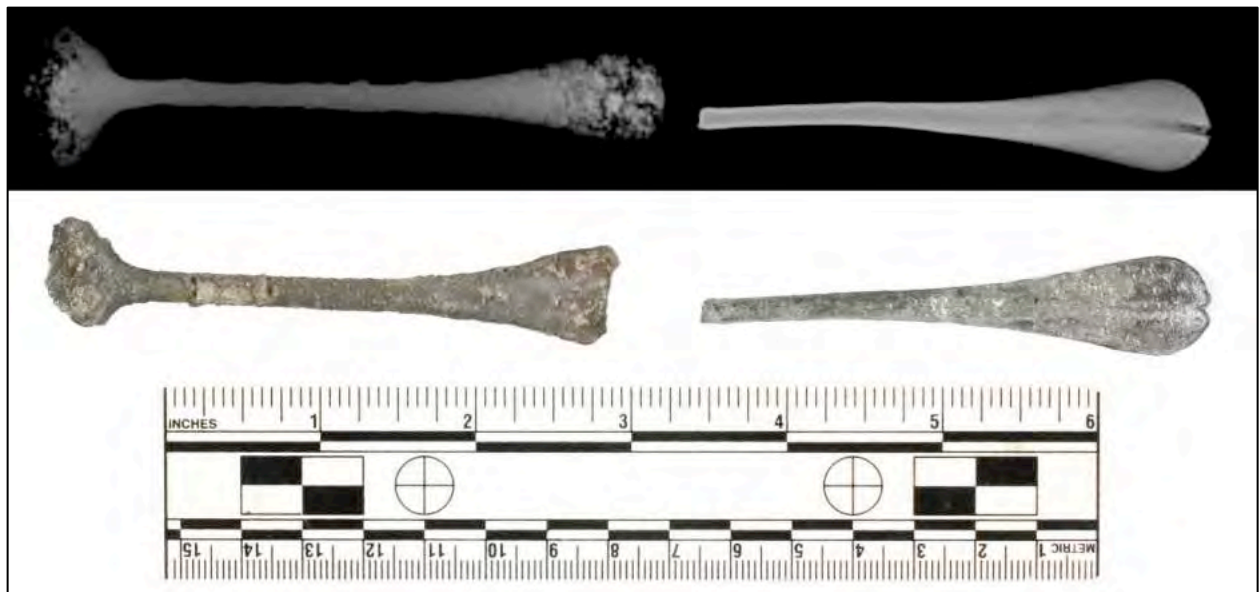
Figure 6-182. Spoon Type 4, characterized by a rounded terminal, is characterized by a lack of defined shoulders, and little to no decoration. This type is represented in Artifacts 2016.1 (*right*), 2695.5, and 2796.5 (*left*; courtesy of CRL, Texas A&M University).

Spoon Type 4 (Figure 6-182) is represented by four handles without bowls: all have rounded ends; no shoulders; and almost no decoration. One handle (Artifact 2016.1) does appear to have a slight indent running down the center. The most worn handle (Artifact 2796.5) is the only one

of the handles that includes the drop, which may have a shell pattern, but it is too worn to be certain. Collectors' catalogs generally date the earliest examples of the rounded terminal to the early eighteenth century.

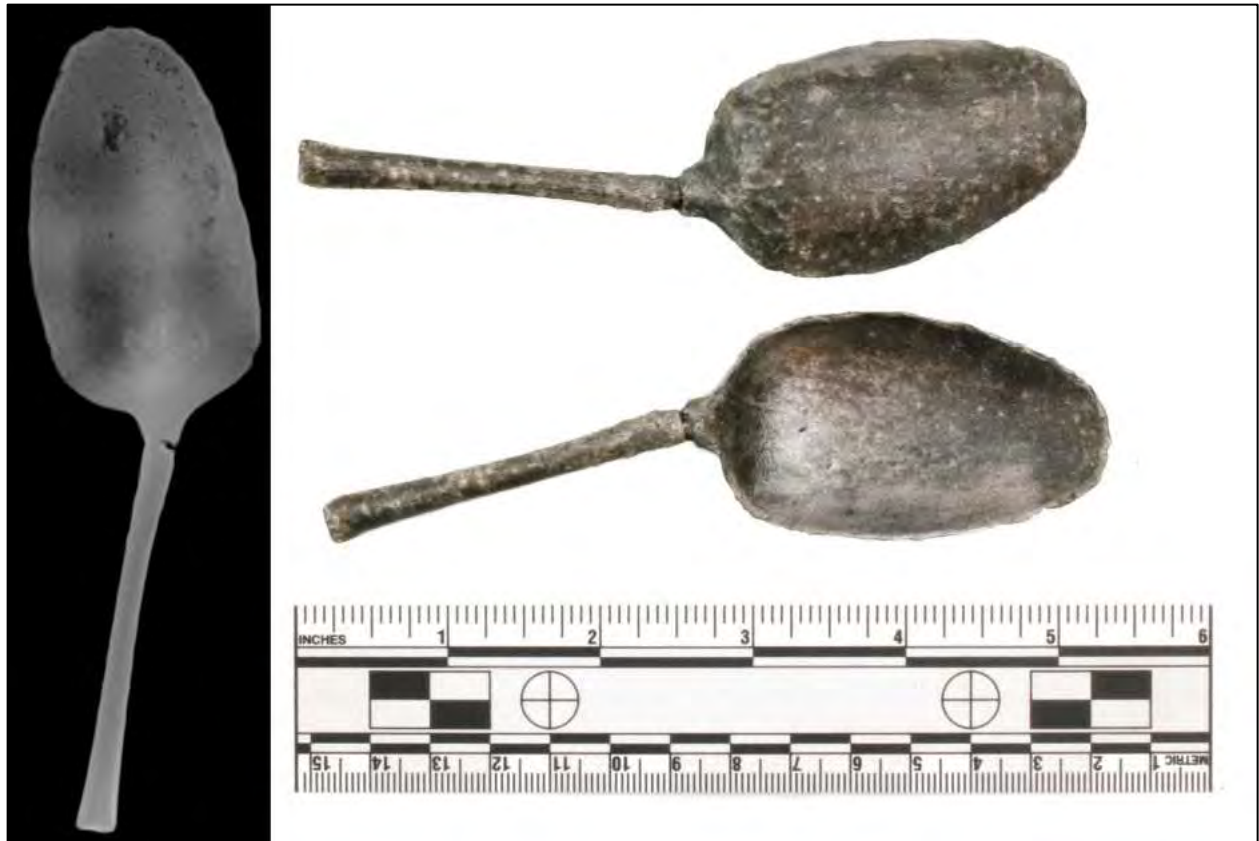
Figure 6-183. Spoon Type 5 is characterized by a rounded stem and a narrow, blunt bowl tip. Represented by Artifact 2692.4 (courtesy of CRL, Texas A&M University, College Station, TX).

Spoon Type 5 (Figure 6-183) is defined by a long, narrow, but not pointed, bowl and a rounded stem, resembling a seventeenth century “slip top” style, though the bowl is more elongated than most of the examples found (Moore 1999:5-7). The XRF shows a possible maker’s mark or decoration near the drop, but it is too worn to be certain.

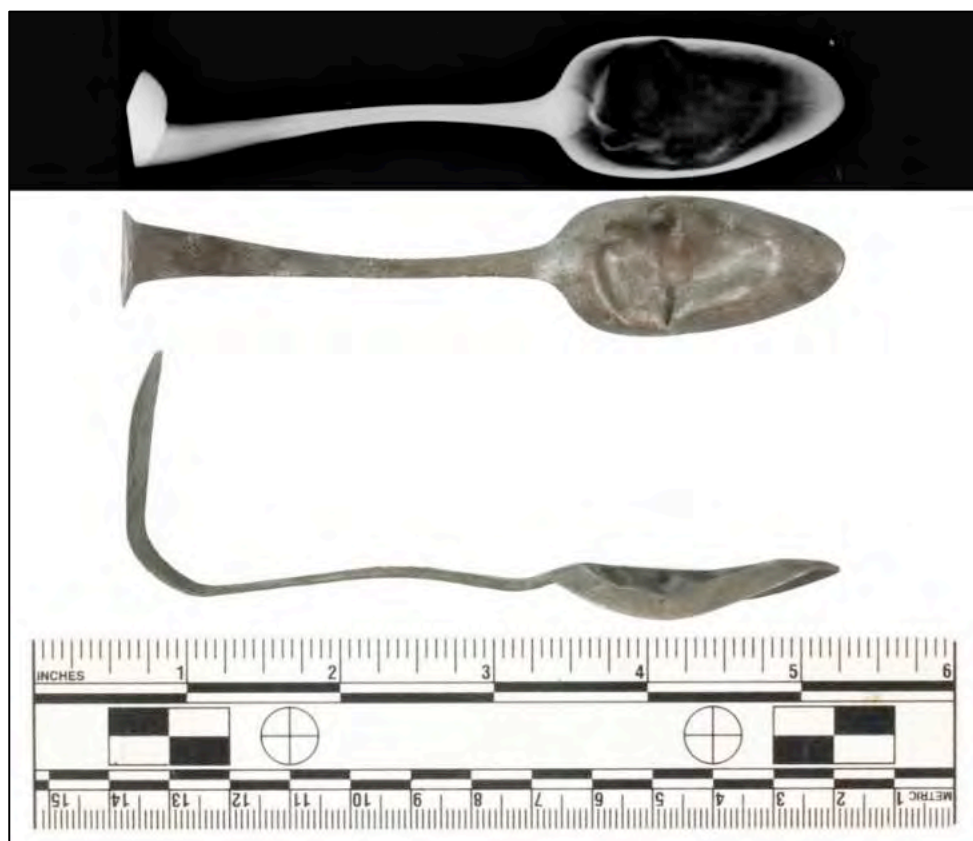
Figure 6-184. Spoon Type 6, characterized by a rounded terminal and a lack of decoration. This type is represented in Artifact 2742.13 (courtesy of CRL, Texas A&M University).

Spoon Type 6 (Figure 6-184) is represented by a single intact spoon (Artifact 2742.13), and defined by a rounded terminal, a lack of decoration along the handle and stem, and a long, narrow bowl. The metal is also thinner than that of the other spoons. This is the only other pewter artifact that was silver plated or contained silver in the alloy.

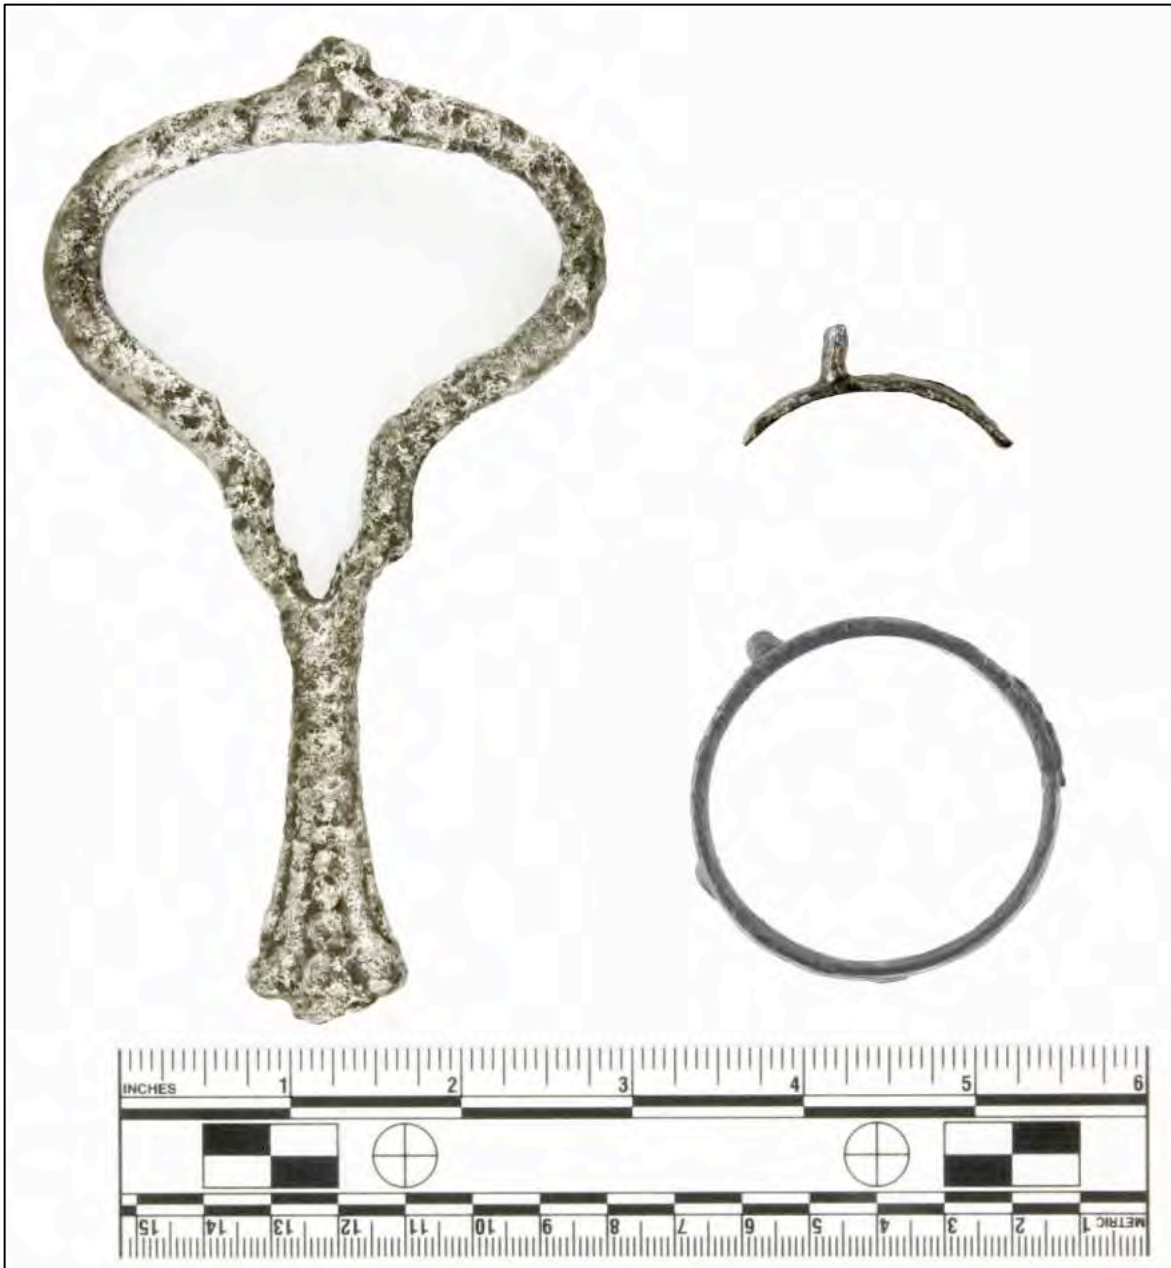
Figure 6-186. Artifact 1366, a cruet stand handle (*left*), and possible rings that would hold condiments, Artifacts 2492.3 (*above*) and 2432.1 (*below*). One additional ring fragment, Artifact 2352.8, did not survive conservation (courtesy of CRL, Texas A&M University).

One long, handle-shaped pewter artifact (Figure 6-186) has been identified as the handle for a cruet stand, which would have held condiments such as salt, pepper, oil, and vinegar. At the time of writing, the author has not yet found an exact match for the handle. However, similar sets may indicate other pieces of the set that have been recovered. For example, one intact pewter ring and two ring fragments may be the devices that held glass condiment containers. Originally, it was thought that these small rings may be finger rings for oil lamps; however, the intact ring has four attachment points, and no examples of lamps have been found that have more than two points that connected the ring to the rest of the lamp. If there are several rings in a cruet stand that connect to each other in a circle, as well as to an inner and outer ring for additional support, that could explain the four connection points.

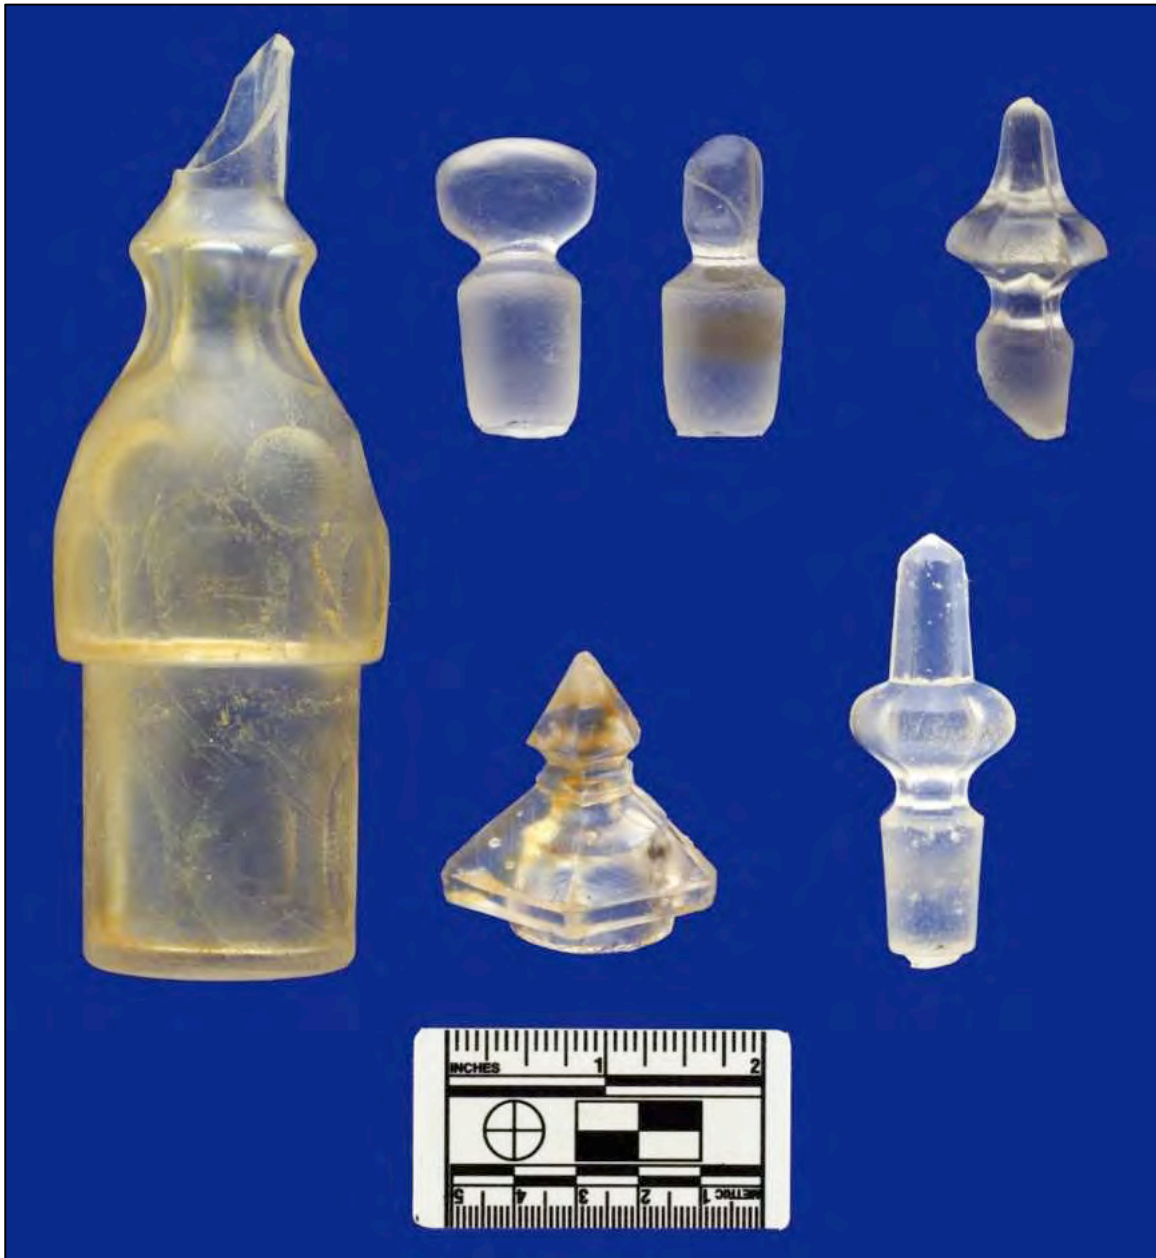
Figure 6-187. Glass artifacts that may belong to cruet or decanter sets: 1546 (*left*), 2326.7 (*top center*), 2329.1 (*top right*), 2477.2 (*bottom center*), and 2480.10 (*bottom right*; courtesy of CRL, Texas A&M University).

Additionally, it may be possible to attribute some of the glass fragments from the site of the CSS *Georgia* to a cruet set (Figure 6-187). Artifact 1546 is a thick-walled, strangely shaped bottle with a small base of a diameter that would allow it to fit into one of the rings; glass fragments similar to this bottle were found in several units across the site. Seven glass bottle stoppers, divided into four categories, were recovered, and may belong to cruet or decanter sets. Four of these stoppers, represented by Artifact 2326.7 in Figure 6-187, are of slightly different sizes, but all are made of clear glass with a rounded, rectangular top. Artifacts 2329.1 and 2480.10 both have elongated, faceted tops. Artifact 2477.2 has a pointed top, but the base is large and hollow, and appears that it would be placed over a bottle rather than inserted into it.

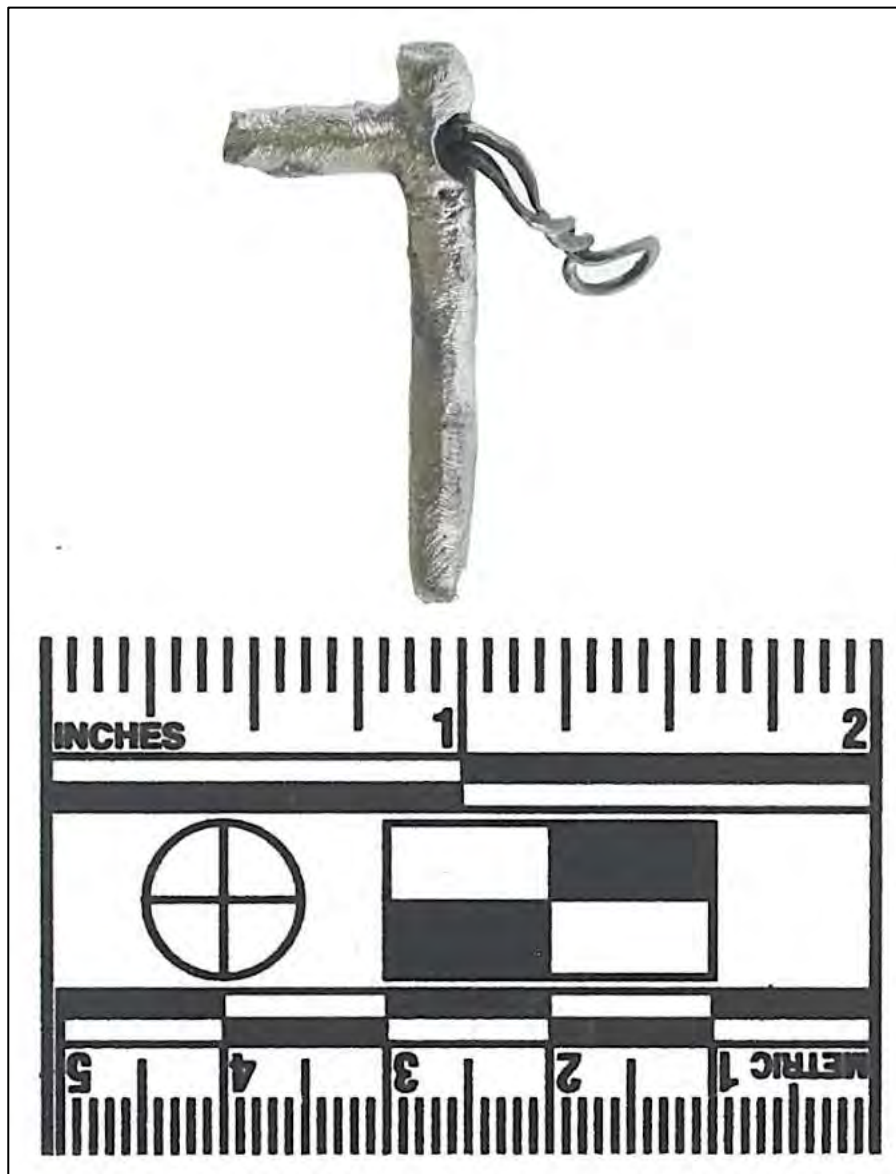
Figure 6-188. Three pewter friction primers were recovered from the site: 2251.5, 2499.11 (*this image*), and 2733.1 (courtesy of CRL, Texas A&M University).

A friction primer is a simple device, designed to light a cannon from a distance by inserting the primer into the vent tube and pulling a wire (Manucy 1985:26-27). The tube was filled with gunpowder, while a spur on one end contained antimony sulphide and potassium; a roughened copper wire was inserted in this spur and stuck out the other end, looped and twisted to allow for easy removal. The powder and the friction composition would be separated by lacquer, and when the wire was pulled, the roughened wire would start the ignition process. Although several copper alloy friction primers were recovered from site, three were made of pewter, but with copper alloy wire (Figure 6-188). At the time of writing, the author has not found mention of pewter friction primers, though tinned boxes for friction primers are common. Pewter, just like copper alloys, is malleable and non-sparking; although copper and quill were by far the most common materials used for friction primers, perhaps the difference between the two metals was negligible in some cases.

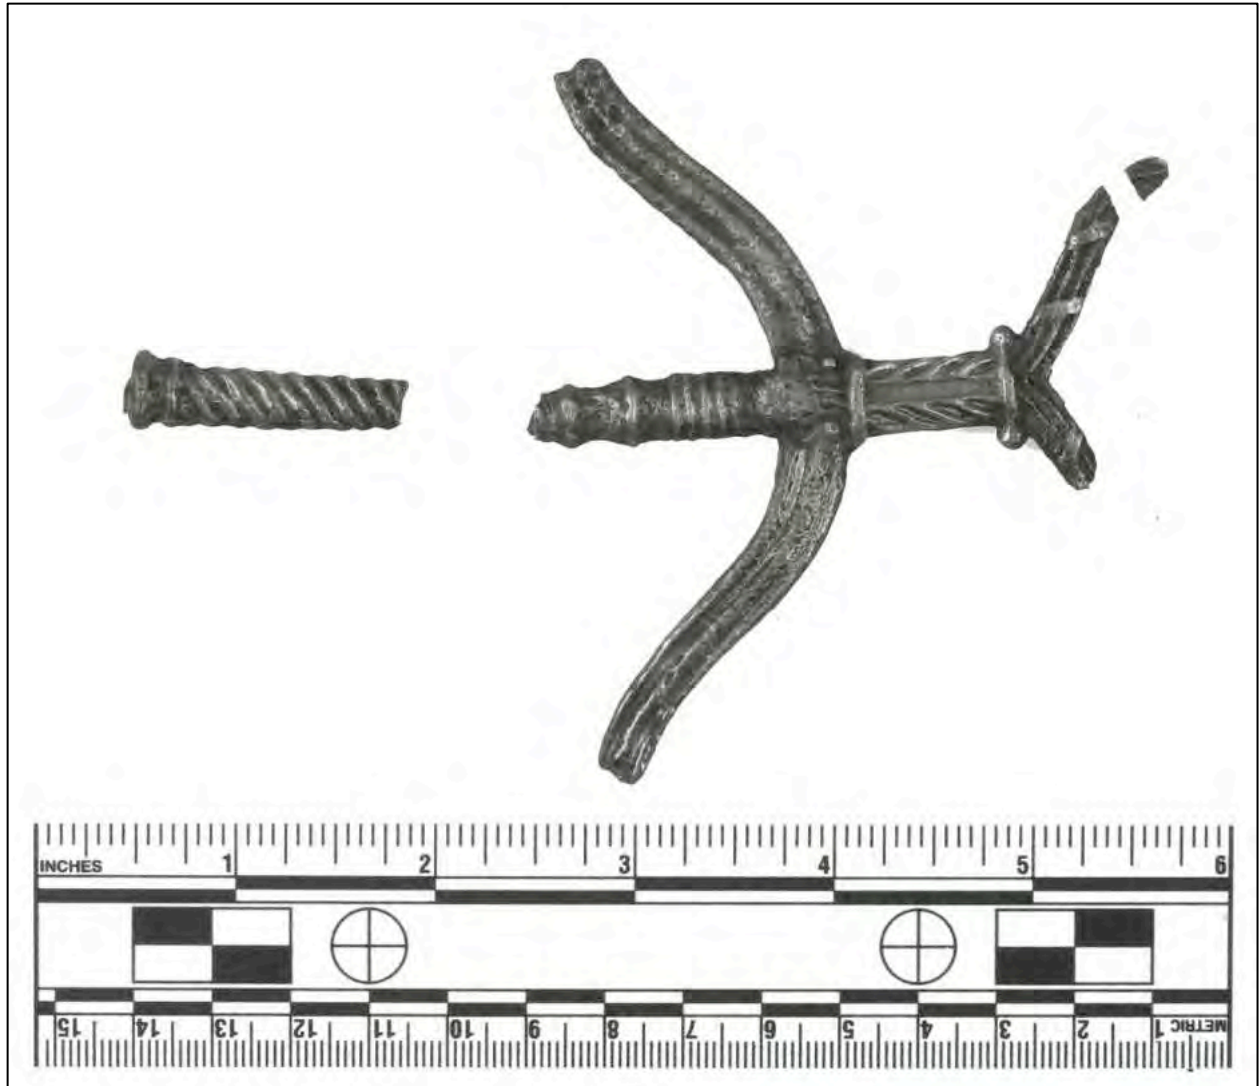
Figure 6-190. Artifact 2286.4, an unidentified pewter artifact (courtesy of CRL, Texas A&M University).

Seven small pewter fragments—perhaps solder or window coming, but they easily could have broken off much larger artifacts—have not been identified. One of the most decorated pewter artifacts (Figure 6-190) remains a mystery. It is composed of a mostly ovular central rod, and two sets of relatively flat “arms” at different angles; the entirety of the artifact is decorated in lines in different orientations and thicknesses. Field notes suggest it belongs to an oil lamp, but no close matches have been found. Although it’s of a similar size to the cruet set handle (Artifact 1366) it is not nearly as robust—in fact, it broke in two areas during treatment. The delicate nature of the artifact may indicate that it was not made for utilitarian tasks, such as a cruet stand or lamp, or may simply be an effect of corrosion.

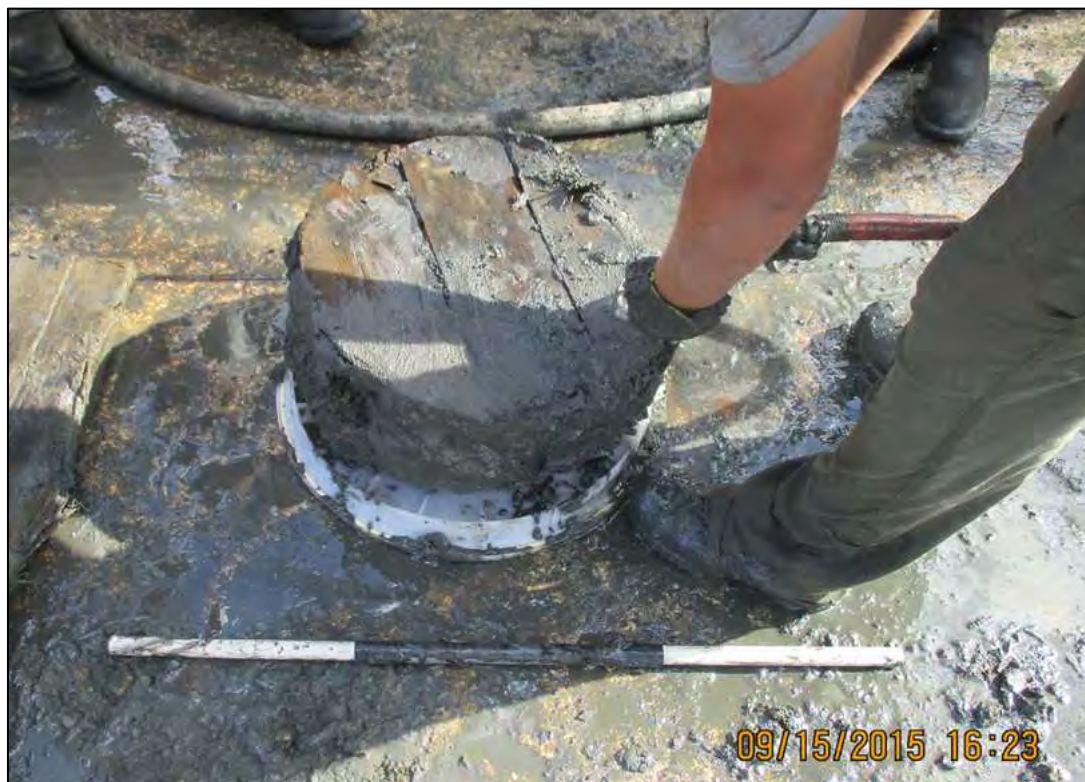
Figure 6-192. A complete cask of pine resin. A naval store, it would have been employed for vessel maintenance.

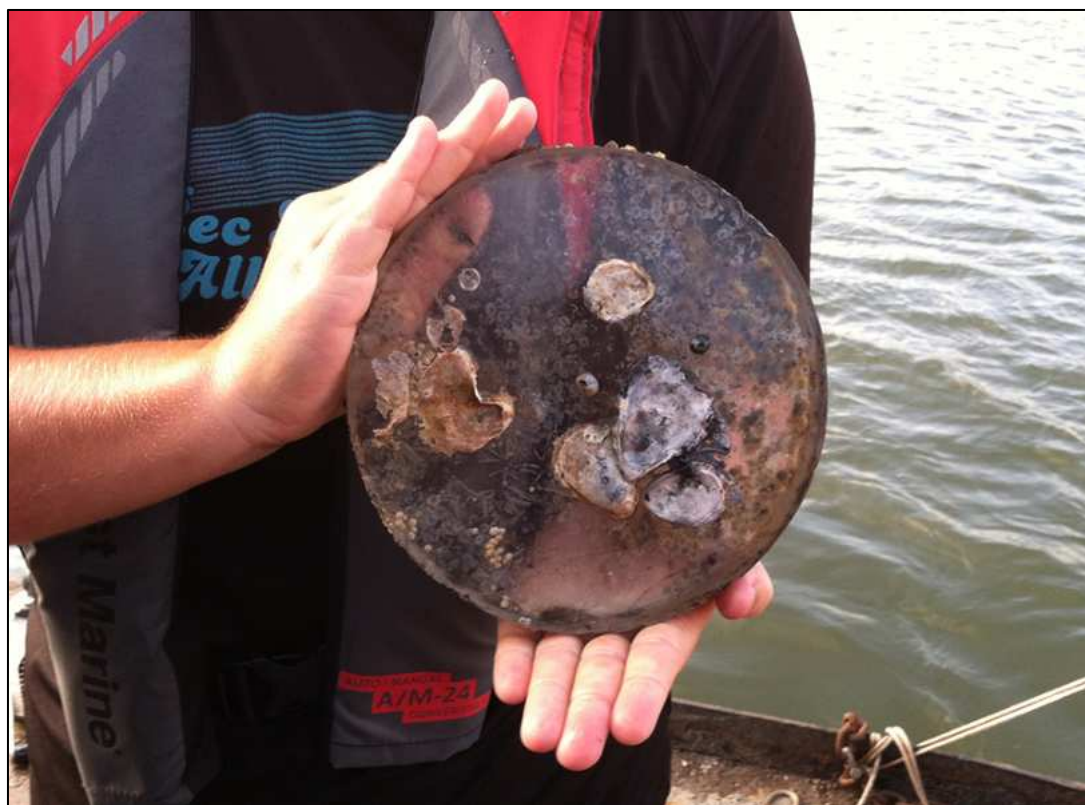
Figure 6-193. Eight-inch wide, 2-inch thick, glass deck-prism.

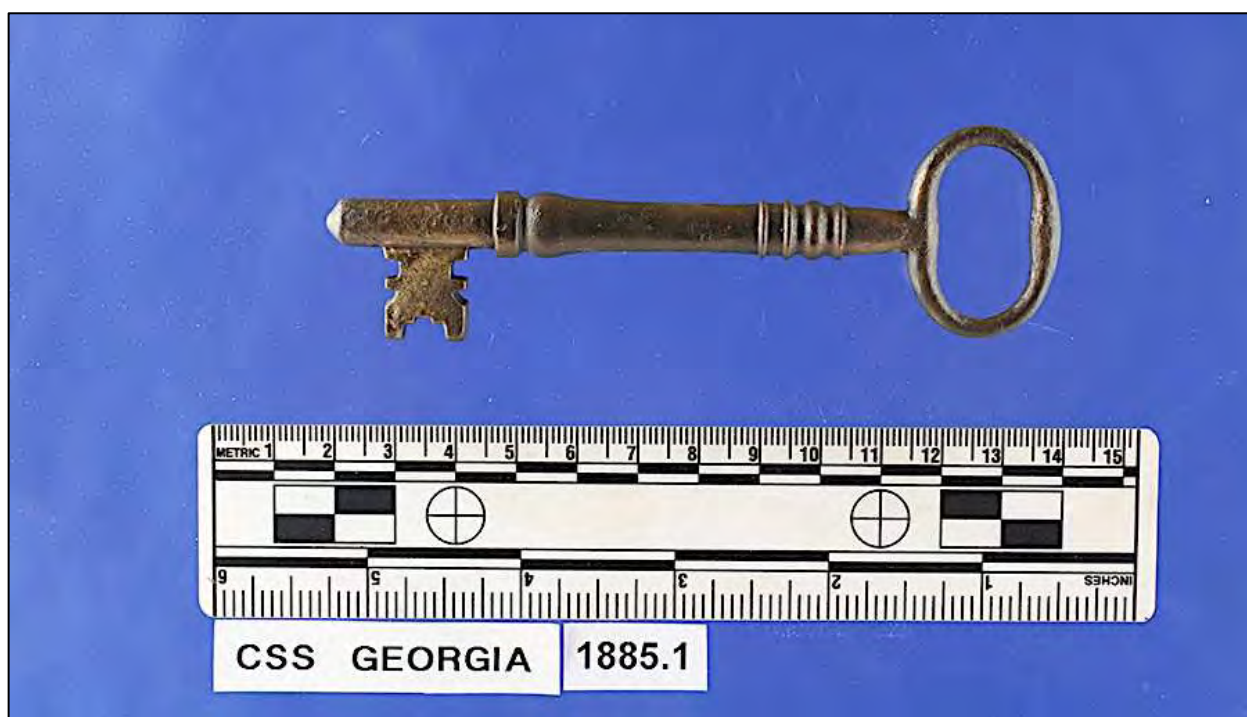
Figure 6-201. Bronze “skeleton” key (conserved).

“Miscellaneous Items” is not a true functional group; rather it is a “catchall” category that includes various items that cannot readily be placed in any of the above-mentioned groups. Numerous Miscellaneous Items were recovered that are extremely interesting. Many are personal items and some are one of a kind, such as a telescoping spyglass (Figure 6-191). Items associated with the ship itself include a complete cask of pine resin, a naval store for hull maintenance (Figure 6-192), and a 2-inch thick glass deck-prism (Figure 6-193). The prism is interesting in that it must have been built into the upper deck atop the casemate to allow light in. Other items include game items including a wooden domino (Figure 6-194), and a possible chess piece made out of a Maynard Bullet (Figure 6-195), eight kaolin smoking pipe bowls (Figures 6-196 to 6-199), three views of one of the several sets of leg irons recovered from the site (Figure 6-200), and a bronze “skeleton” key (Figure 6-201).

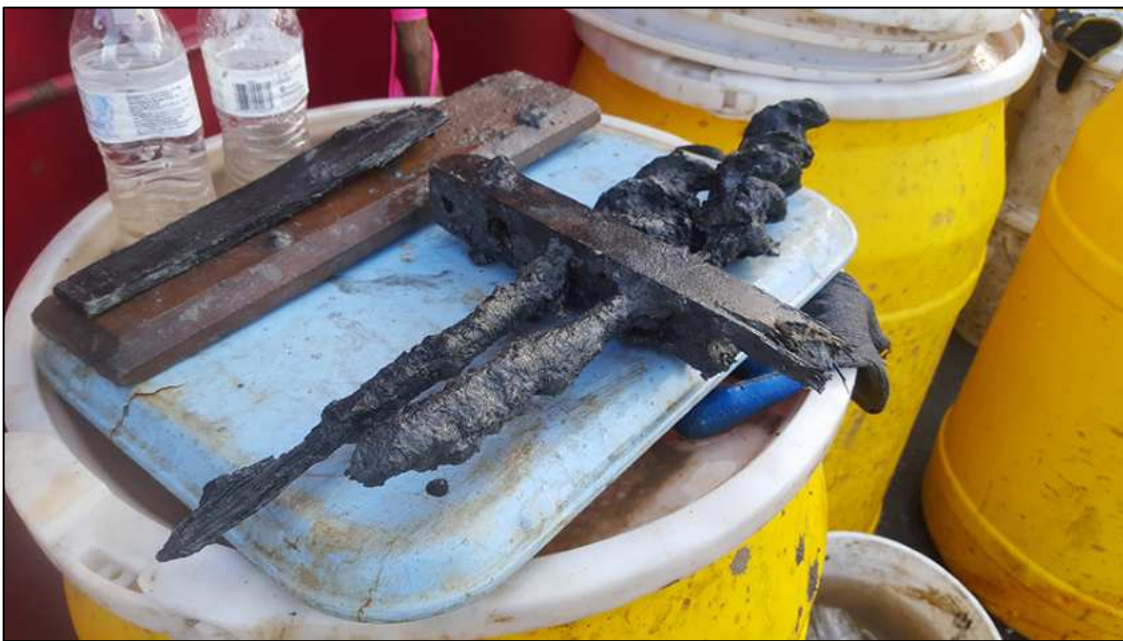
Figure 6-220. Artifact 2160.10, two auger bits recovered still in their wooden holder.

Illustrated in Figure 6-220, these two augers were still in their wooden “holder” at the time of recovery. Similar to what would hold them in any woodworking shop then or today, this holder was not available for study.
