CSS *GEORGIA*
ARCHEOLOGICAL DATA RECOVERY AND MITIGATION
FOR THE SAVANNAH HARBOR EXPANSION PROJECT (SHEP),
CHATHAM COUNTY, GEORGIA AND JASPER COUNTY, SOUTH CAROLINA

**FINAL DRAFT REPORT
OCTOBER 2019**

Stephen R. James, Jr. and Gordon P. Watts

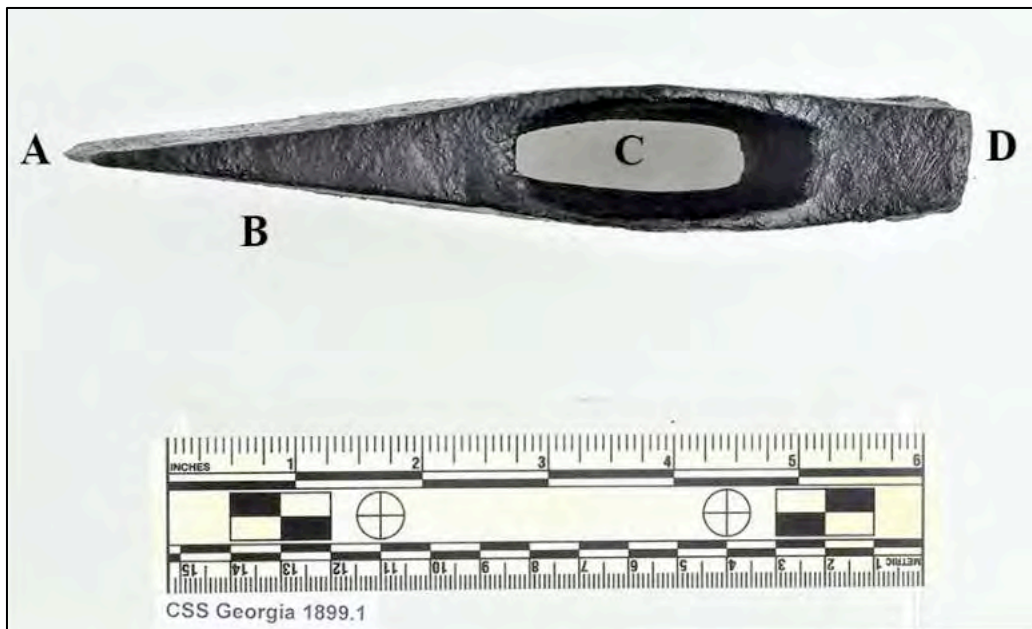
Figure 6-222. Felling axe recovered from the CSS *Georgia*. Axe parts as follows: (a) bit, (b) cheek, (c) eye, and (d) poll (courtesy of CRL Texas A&M University). Labels follow terminology in Blackburn (2000:6).

This axe head (Figures 6-221 and 6-222) is classified as a felling axe with a similar configuration to the Kentucky and intermediate Anglo-American axe patterns (Mercer 2000; Heavrin 1999:113-115). The axe head has a length of 7.11 inches, a width of 4.01 inches and a thickness of 1.06 inches. The bit has a width of 4.21 inches and thickness of 0.07 inches. The poll of the axe has a length of 3.40 inches and a thickness of 0.79 inches. The eye of the axe has length of 2.36 inches and a width of 0.83 inches. The axe head weighs 4.20 pounds. Corrosion appears mostly on the bit most likely from the stress put on the cutting edge by continual use. A portion of the wood from the haft of the axe was recovered, removed, and then conserved separately.

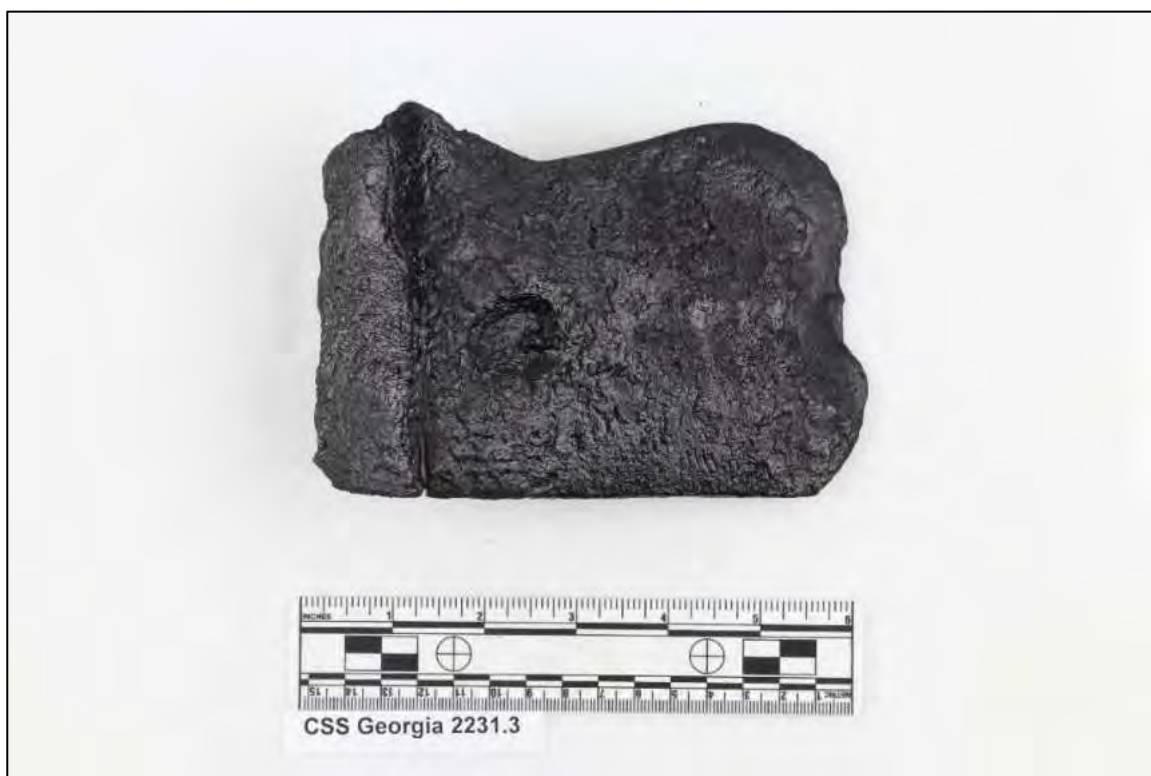
Figure 6-223. Artifact 2231.3 felling axe (courtesy of CRL Texas A&M University).

This axe head (Figures 6-223 and 6-224) is classified as an Anglo-American felling axe with a round eye and no pole (Heavrin 1999:112-115). The axe head has a length of 5.96 inches, a mid-section width of 3.99 inches and thickness of 0.80 inch. The cheek to bit measured 3.95 inches in length and had a width of 3.51 at the base of the cheek with a thickness of 0.62 inches. The max width for the bit had a width of 4.04 inches and a terminal width of 3.72 inches. The eye of the axe had a length of 2.01 inches and a width of 1.70 inches. The axe head weighed 2.55 pounds. This axe head suffers from intense corrosion and other damage. The bit is heavily corroded with a sizeable portion missing while part of the eye is no longer intact. The corrosion is most likely due to stress from use with the cutting edge. The missing portion may also be due to stress corrosion from the bending of the metal around the haft of the axe during its construction. A portion of the wood from the handle of the hammer was recovered, removed, and then conserved separately.

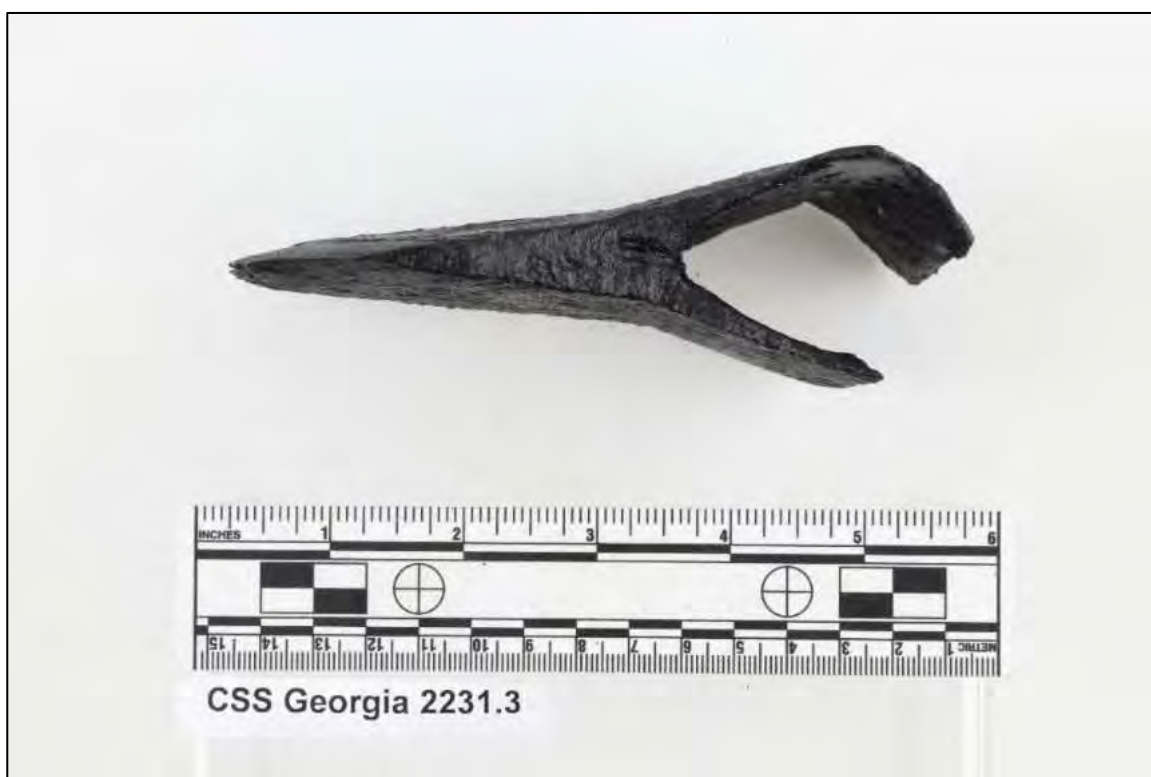
Figure 6-224. Artifact 2231.3 felling axe (courtesy of CRL Texas A&M University).

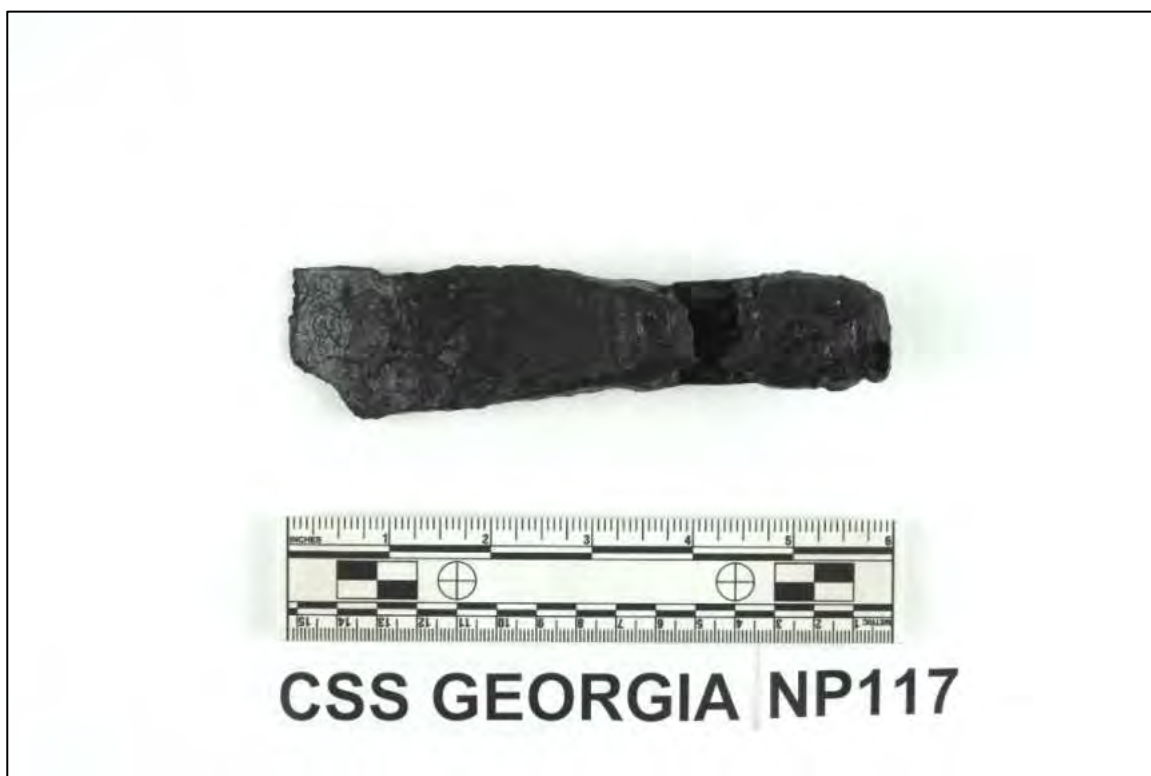
Figure 6-225. Artifact NP 117 potential tomahawk (courtesy of CRL Texas A&M University).

This axe head (Figures 6-225 and 6-226) was rather difficult to classify in that it did not fit the known description of any distinctive class of axes. However, it does have a somewhat similar form to that of a tomahawk containing a hammer poll. Examples of this type of axe include lathing hatchets and shingling hatchets (Peterson 1965:31). The axe head has a length of 5.85 inches. The bit has a width of 1.51 inches. The eye of the axe had a length of 1.10 and a width of 0.60 inches. The poll has a width of 0.93 inches. The head had a maximum thickness of 1.07 inches, the bit had thickness of 0.13 inches, and the poll had a thickness of 0.93 inches. The axe head weighed 1.00 pound. The axe is missing approximately a third of the bit, as well as a section of the eye is also missing. The locations of these missing portions indicate stress corrosion is the most likely culprit.

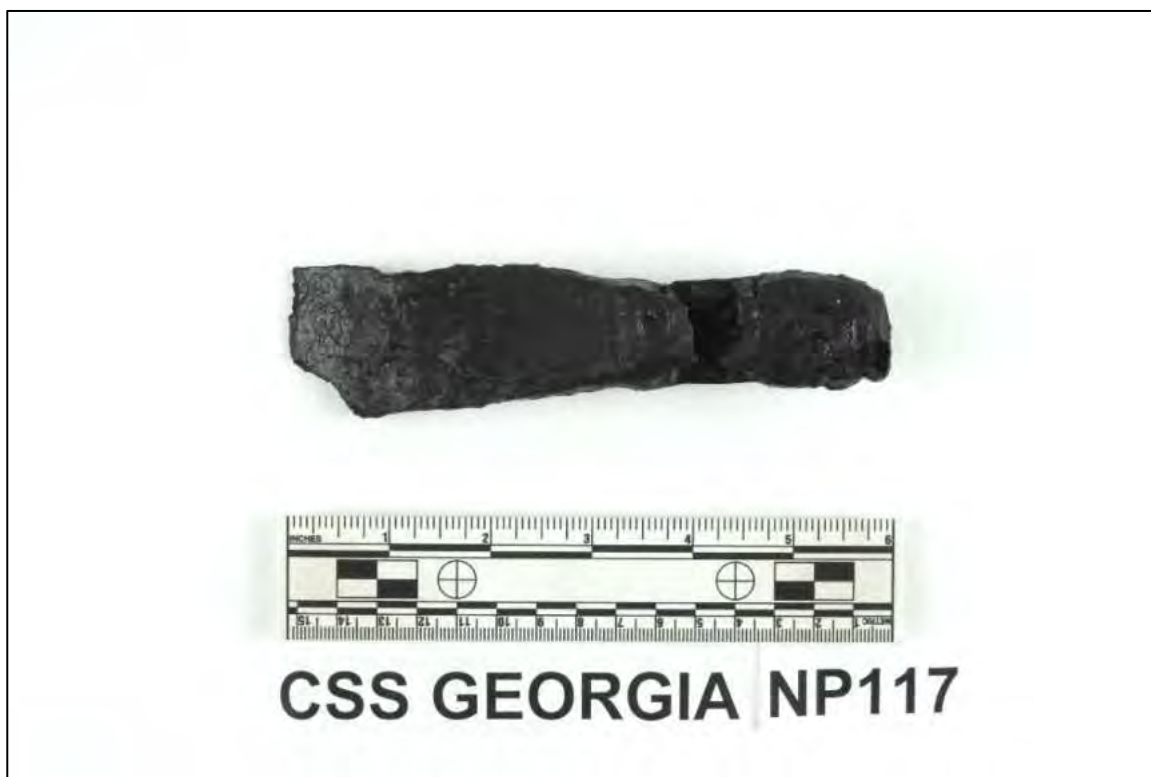
Figure 6-226. Artifact NP 117 potential tomahawk (courtesy of CRL Texas A&M University).

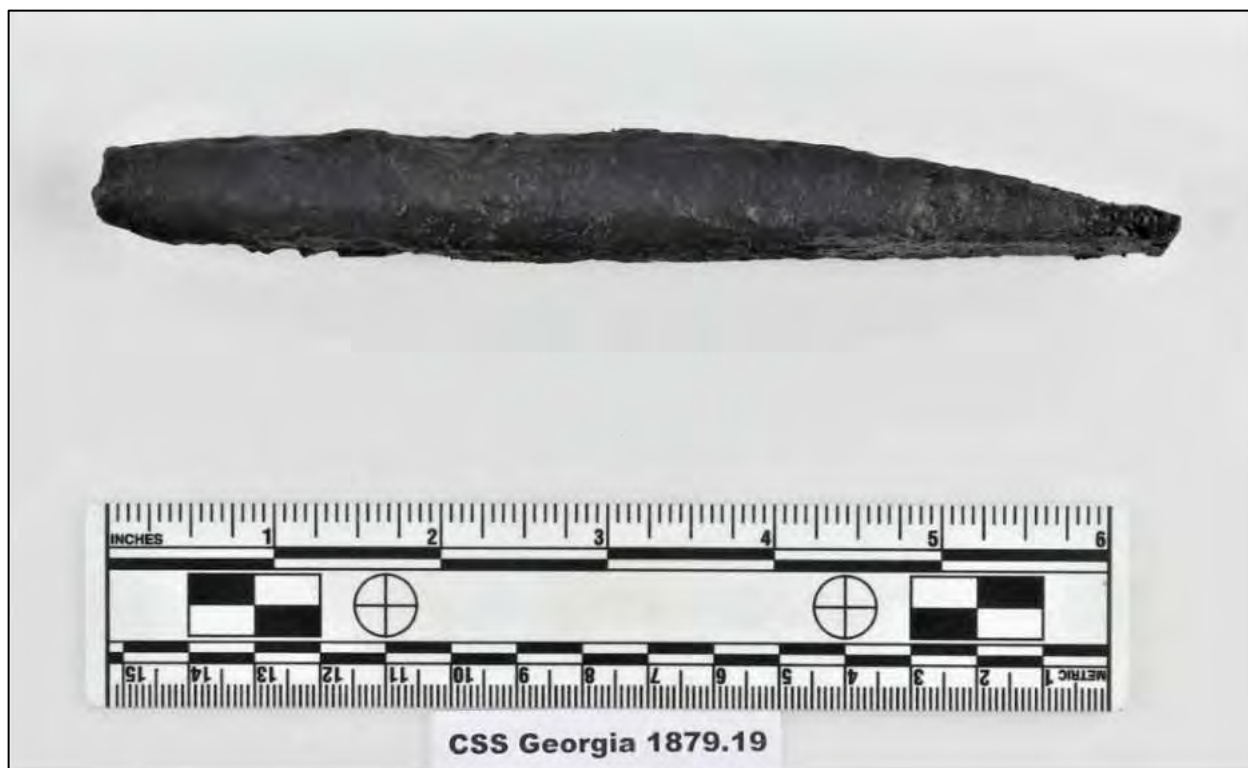
Figure 6-227. Artifact 1879.19 is a cold chisel (courtesy of CRL Texas A&M University).

Artifact 1879.19 is a cold chisel found in association with adjustable wrench Artifact 1879.19 (Figure 6-227). The chisel almost has the appearance of being single-beveled, but is probably just a double-beveled chisel, like Artifact 2923.10, that has bent at the bit post-deposition. Overall, the chisel is about 6.50 inches long. The bit is about 3.00 inches long and 0.63 inches wide at the cutting edge of the bit. The stock is badly worn, but it can be seen to be octagonal in cross-section. The diameter of this stock is about 0.70 inch where most well preserved, and the length is about 3.50 inches.

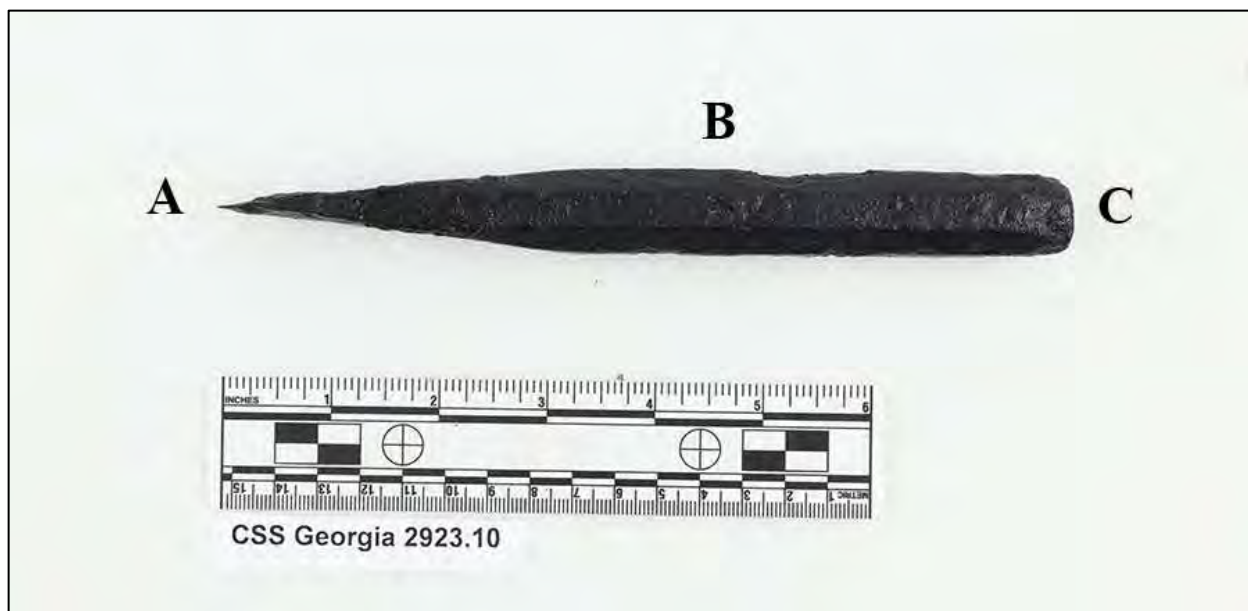
Figure 6-228. Artifact 2923.10 cold chisel parts as follows: (a) bit, (b) stock, and (c) head (courtesy of CRL Texas A&M University). “Bit” follows Light (2007:105), whereas “Stock” and “Head” follow Scientific American (1884:32).

Artifact 2923.10 is a cold chisel (Figure 6-228). Overall, the chisel is about 7.81 inches long. The bit of the chisel is about 3.06 inches long, with a width at the cutting edge of about 0.87 inches. The stock is octagonal in cross-section, with a diameter of about 0.75 inch and a length of approximately 4.75 inches.

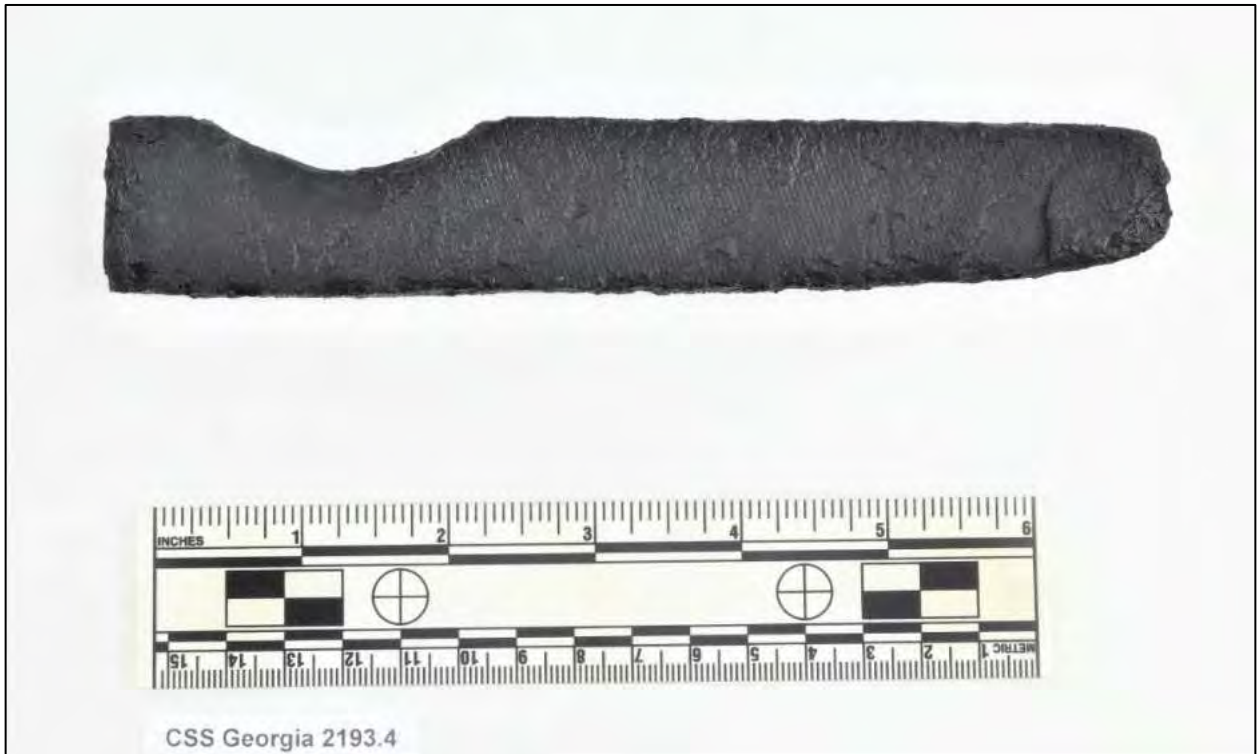
Figure 6-230. Single-Cut Coarse Straight Flat File (courtesy of CRL Texas A&M University).

This file (Figure 6-230) is designated as a single-cut coarse straight flat file (Blackburn 2000:56). The file appears to have not undergone any significant damage; however, the file does not have a tang. Instead of a tang the teeth cover the entire surface of the file and there appears to be a groove cut out of the belly of the file where one might grasp it. The length of the file is 7.28 inches. The width at the heel is 1.14 inches, the width at the point is 0.87 inch at the point, and

the width at the groove is 0.81 inch. The thickness at the heel is 0.28 inch and the thickness at the heel is 0.24 inch. The file weighs 0.55 pounds. The file is most heavily corroded around the edges, most likely from the stress of being worked with in those areas.

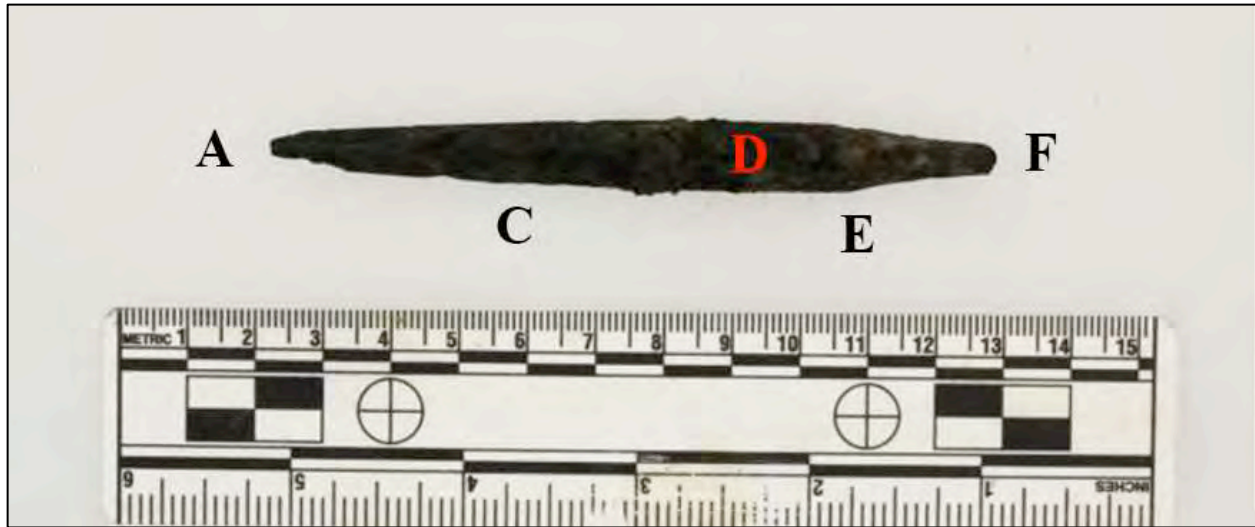
Figure 6-231. Single-cut second-cut tapered triangular file parts as follow: (a) point, (b) side, (c) edge, (d) belly, (e) heel, and (f) tang. Labels follow terminology in Blackburn (2000:55; courtesy of CRL Texas A&M University). Note that metric units are on top of scale bar.

This file (Figure 6-231) is designated as a single-cut second-cut tapered triangular file (Blackburn 2000:56-57). The file has length of 4.01 inches and a width of 0.39 inches. The length of the belly is 3.18 inches and the length of the tang is 0.83 inch. The heel has a width of 0.33 inch. The file weighs 0.05 pounds. Corrosion could not be accurately determined at the time of recording because the artifact was still partially concreted.

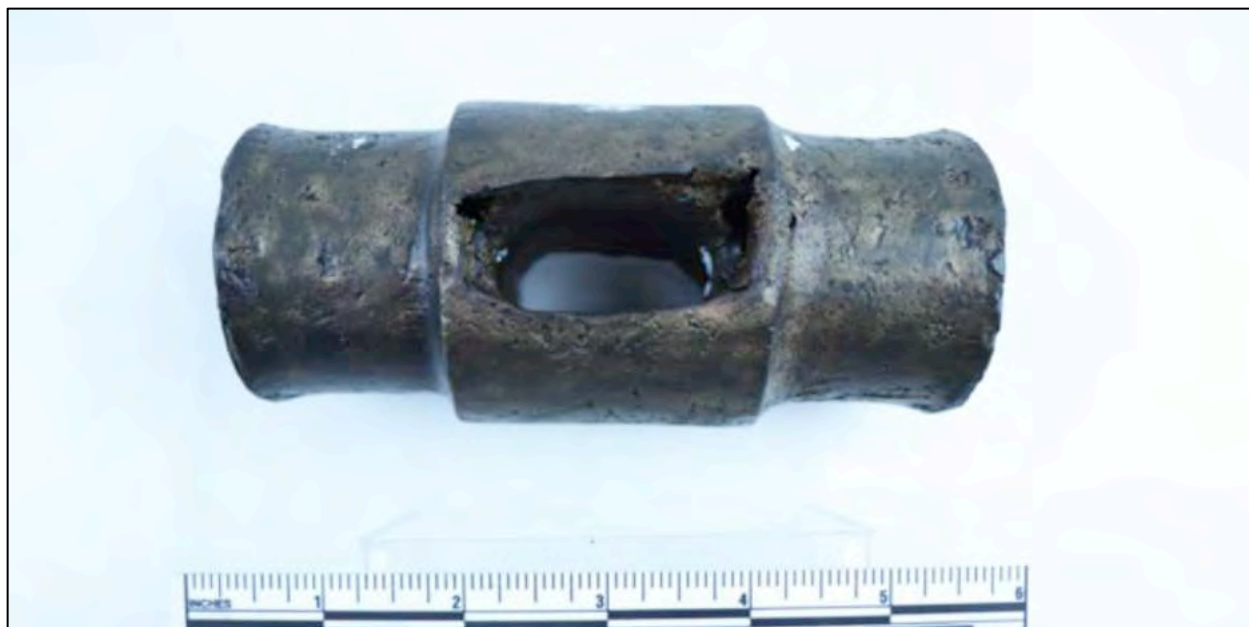
Figure 6-232. Artifact 1899.2 is an anti-sparking brass hammer (courtesy of CRL Texas A&M University).

This hammerhead (Figure 6-232) is the only hammerhead in the collection made of brass, not iron. Similar hammerheads are typically used in metal work, as they do not disfigure the work (Blackburn 2000:69). This particular hammerhead, however, is believed to have been a non-sparking hammer used in relation to opening the gunpowder barrels on the CSS *Georgia* (Jim Jobling personal communication, 2019). The hammerhead has a length of 5.61 inches with a mid-section width of 2.48 inches and mid-section thickness of 2.24 inches. The necks of the hammerhead have a width of approximately 2.00 inches and a thickness of approximately 2.12 inches. The faces of the hammerhead have an average diameter of approximately 2.20 inches. The eye of the hammerhead has a length of 1.99 inches and a width of 0.92 inches. The hammerhead weighs 6.05 pounds.

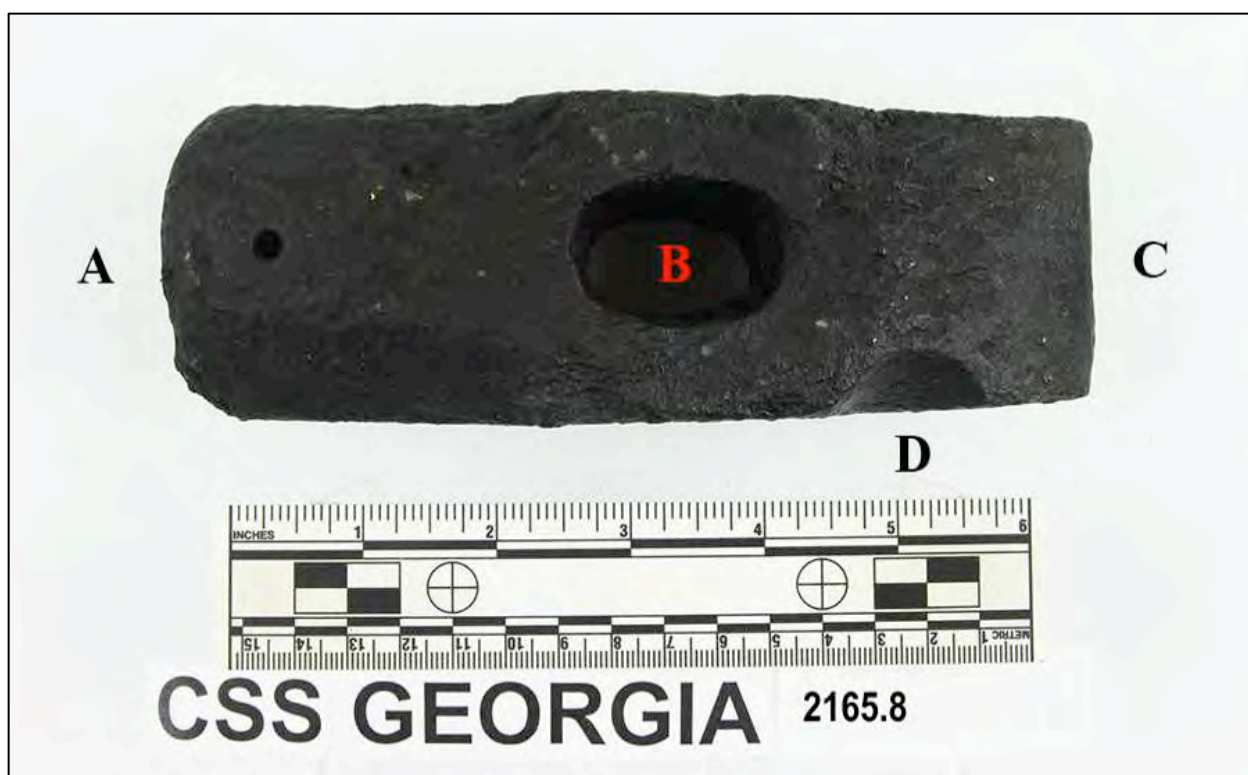
Figure 6-233. Cross-pein sledgehammer hammerhead parts as follows: (a) face, (b) eye, (c) pein, and (d) chamfer (courtesy of CRL Texas A&M University). Labels follow terminology in Blackburn (2000:67).

This hammerhead (Figure 6-233) is designated as a cross-pein sledgehammer (Blackburn 2000:72). The hammerhead has a max length of 7.5 inches, a max width of 2.52 inches, a max thickness of 2.36 inches, and a weight of 9.75 pounds. The eye of the hammerhead has a length of 1.63 inches and a width of 1.10 inches. The chamfers on the pein portion of the hammerhead have a length of 0.99 inches and a width of 1.50 inches (Bealer 1976:159). The chamfers on the face portion of the hammerhead have a length of 2.29 inches and a width of 0.68 inch. The width of the pein was 1.91 inches. The base of the pein is 2.16 inches thick, the mid-section of the pein is 1.17 inches thick, and the curve at the tip of the pein was 0.27 inch. The face of the hammerhead has a vertical diameter of 2.05 inches, and horizontal diameter of 2.55 inches. A typical handle for this type of hammer would have measured between 16 inches and 3 feet, increasing with the weight of the hammerhead (Blackburn 2000:72).

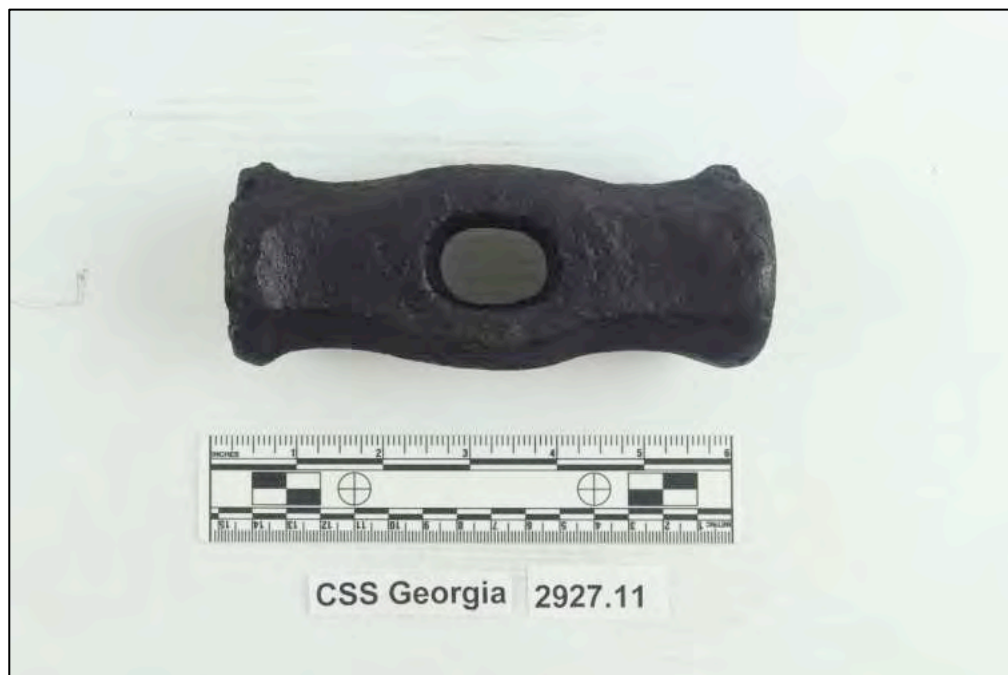
Figure 6-234. Artifact 2927.11, a forging hammer (courtesy of CRL Texas A&M University).

This hammerhead (Figure 6-234) is designated as a forging hammer, most likely used in blacksmithing (Light 2007:121). The hammerhead has a length of 5.44 inches and a mid-width of 2.08 inches. The average width of both necks is less than 1.73 inches. The eye of the hammer has a length of 1.38 inches and a width of 0.94 inch. The faces of the hammer have an average diameter of approximately 2.01 inches. The hammerhead has a weight of 4.00 pounds. The faces of the hammer are slightly flared out in a mushrooming formation; this is due to the stress put on the faces of the hammer from use. It also appears as though the initials “C.W.” were stamped into the hammerhead near the eye. The handle of the hammer would have measured somewhere between 1 and 1.5 feet (Light 2007:121). It should be noted also that in reference to classifying the hammer, the actual term applied by the blacksmith whom created it could have varied and differed from person to person. This variability in terminology stems from differentiating personal preferences between blacksmiths and early catalogues, as well as a tendency of blacksmiths to denote the same name to different types of hammers (Light 2007:121).

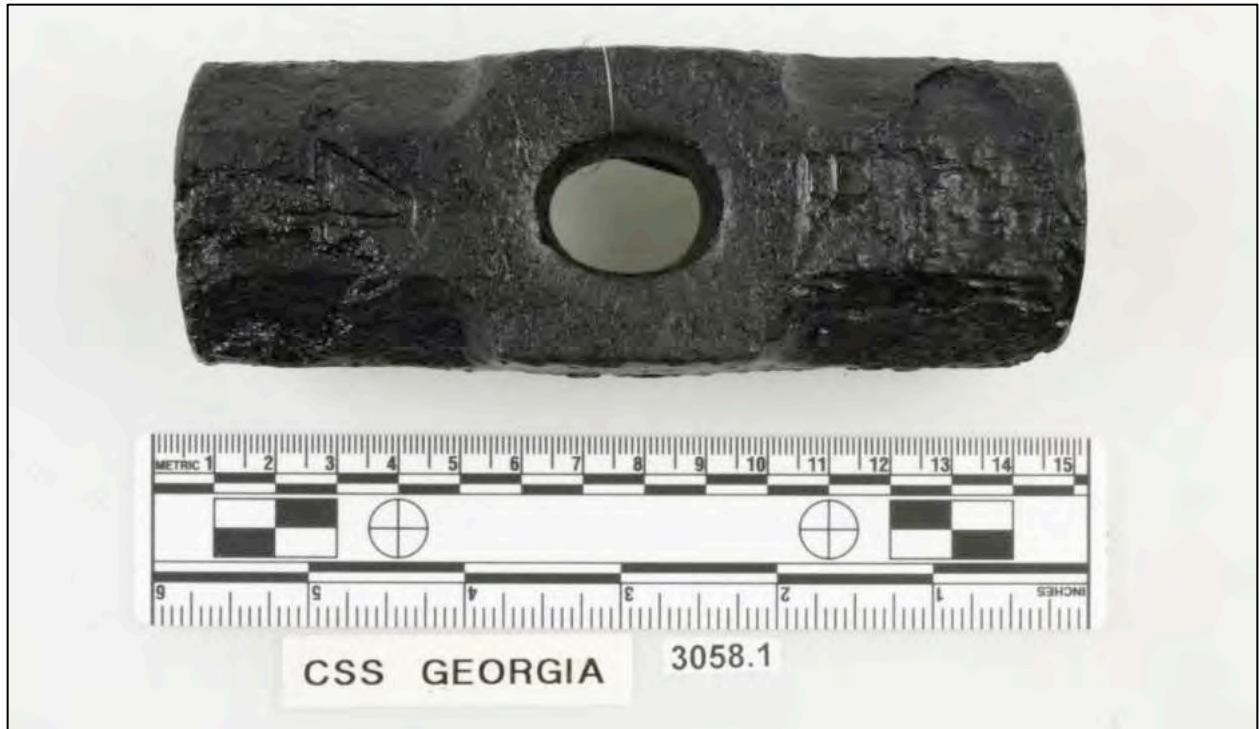
Figure 6-235. Artifact 3058.1 is a “double-faced” or “engineer’s” hammer. Note that the scale bar is positioned with metric at top in this photo (courtesy of CRL Texas A&M University). Note the cast “4” at left.

This hammerhead (Figure 6-235) is designated as a “double-face” or “engineer’s” hammer and was most likely used in metalwork such as blacksmithing (Bealer 1976; Blackburn 2000:69). The hammerhead has a length of 5.13 inches and a width of 1.82 inches. The eye of the hammer has a length of 1.03 inches and a width of 0.77 inch. The necks of the hammer have a width of approximately 1.79 inches. The faces of the hammer have an average diameter of approximately 1.69 inches. The hammerhead has a weight of 3.30 pounds. Notably, it appears as though there has been a “4” stamped into the hammerhead near the eye most likely indicating its weight. Additionally, it appears though a pair of initials is also stamped in the hammerhead on the opposite side of the eye as the 4. The stamped initials may possibly read “LE,” however, they are not clearly distinguishable as stress corrosion has heavily damaged this area of the hammer. A portion of the wood from the handle of the hammer was recovered, removed, and then conserved separately. The handle would have averaged around 16 inches in length (Blackburn 2000:69).

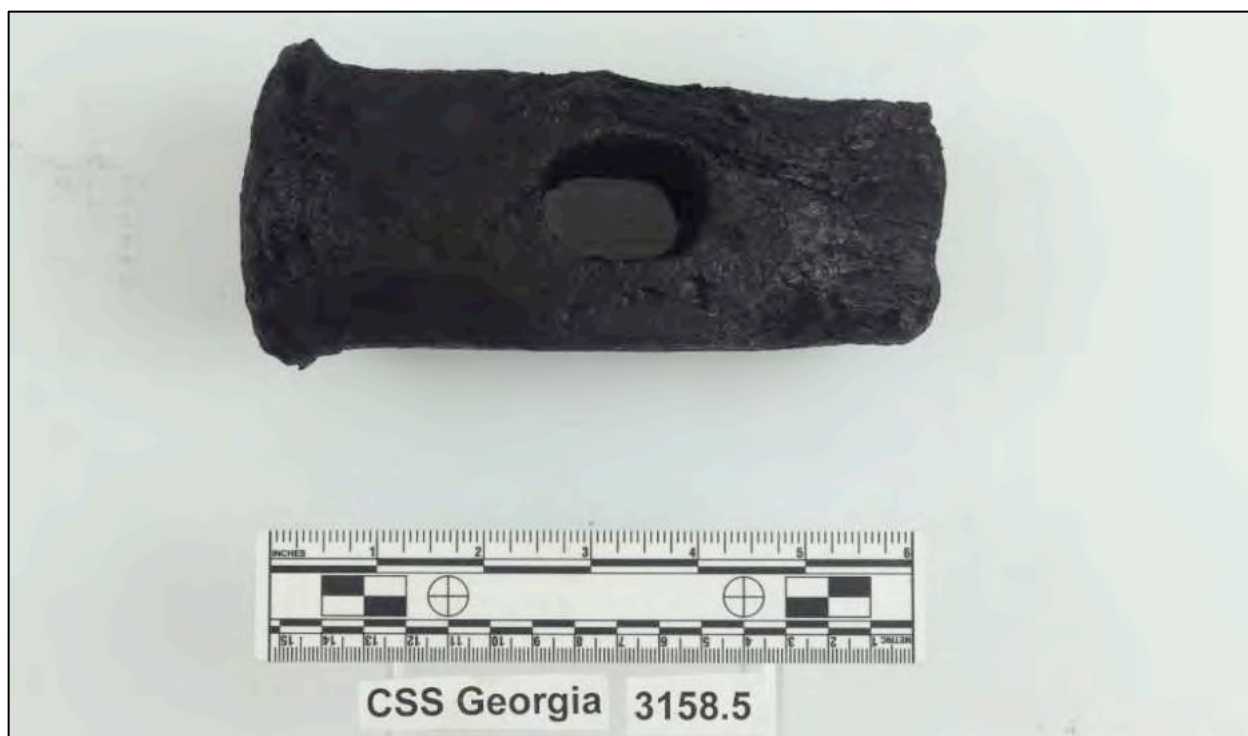
Figure 6-236. Artifact 3158.5, a cross-pein sledgehammer (courtesy of CRL Texas A&M University). Labels follow terminology in Blackburn (2000:6).

This hammerhead (Figure 6-236) is classified as a cross-pein sledgehammer (Blackburn 2000:72). The hammerhead has a length of approximately 6.75 inches, a max width at the mid-section of 2.60 inches and a thickness of 2.64 inches. The eye of the hammerhead has length of 1.56 inches and a width of 1.22 inches. The pein of the hammerhead has a width of 2.38 inches and a thickness of 0.90 inch. The face of the hammer has a diameter of approximately 3 inches. The chamfers on the sides of the hammerhead are highly corroded but have an average width of approximately 0.94 inch. The hammerhead has a weight of 8.60 pounds. The handle for this hammer would have ranged between 16 inches and 3 feet (Blackburn 2000:72). Overall the hammerhead is in a very poor condition suffering from high levels of surface corrosion, especially compared to the other hammer specimens recovered from the CSS *Georgia*. The high levels of corrosion possibly indicate that this particular tool saw an immense amount of use and stress compared to the other hammerheads. Most of the corrosion pertains to the work areas of hammerhead such as the face and pein, with the face suffering from an exceptionally exaggerated flared mushrooming affect that is a direct result of high levels of repeated use with that surface.

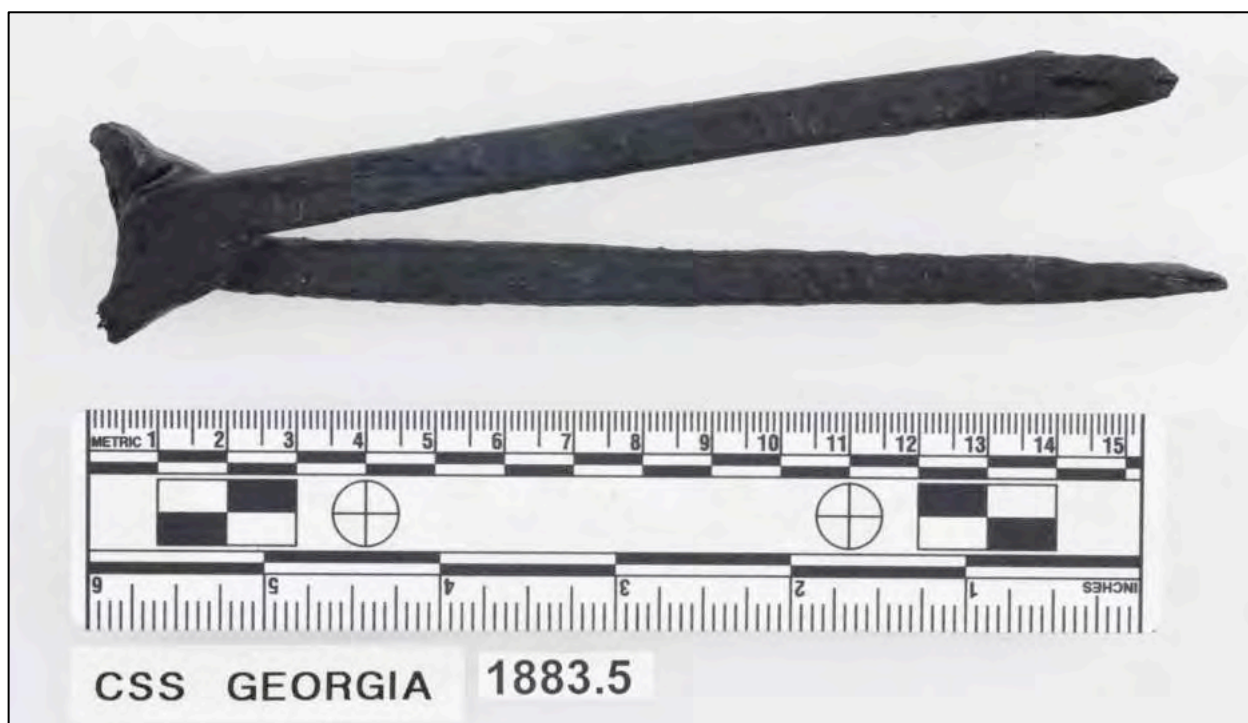
Figure 6-237. Artifact 1883.5, "plier handles" (courtesy of CRL Texas A&M University).

A single artifact, Artifact 1883.5, has been identified as a pair of plier handles (Figure 6-237). This tool is included here for thoroughness, but because it was already at NHHC when this research began, the authors have not had the opportunity to personally examine this artifact. Therefore, a detailed, meaningful analysis is beyond the scope of this research.

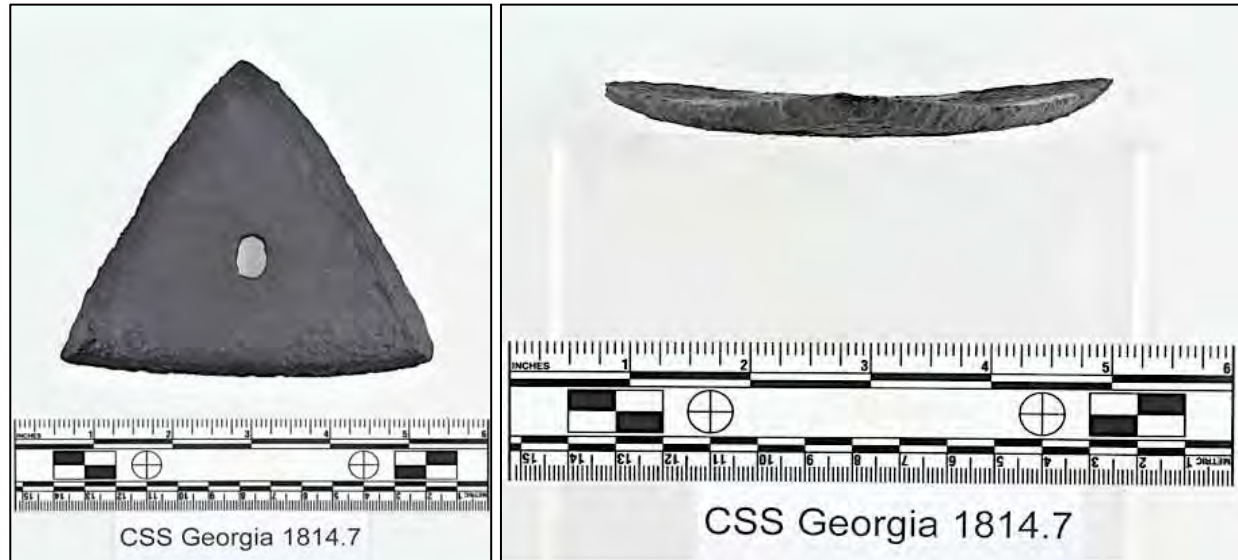
Figure 6-238. Scraper head Artifact 1814.7 (courtesy of CRL Texas A&M University).

Scraper plate Artifact 1814.7 was found in isolation (Figure 6-238). Due to the well-preserved state of this scraper plate over its surface and at the central hole, it appears to have been a replacement head. This head is immediately distinct from the other scrapers. First, it is extra thick, at a thickness of 0.20 inch. This head is also marked by a steeper bevel at the edges compared to the other scraper plates. The central hole is also ovoid in shape, measuring 0.63 inch long by 0.34 inch wide. Unlike the other plates, essentially flat, this scraper head is curves downward on the unbeveled bottom face, with the arcs radiating from the central hole toward the three corners. The three sides of the plate measure 4.75, 4.74, and 4.72 inches.

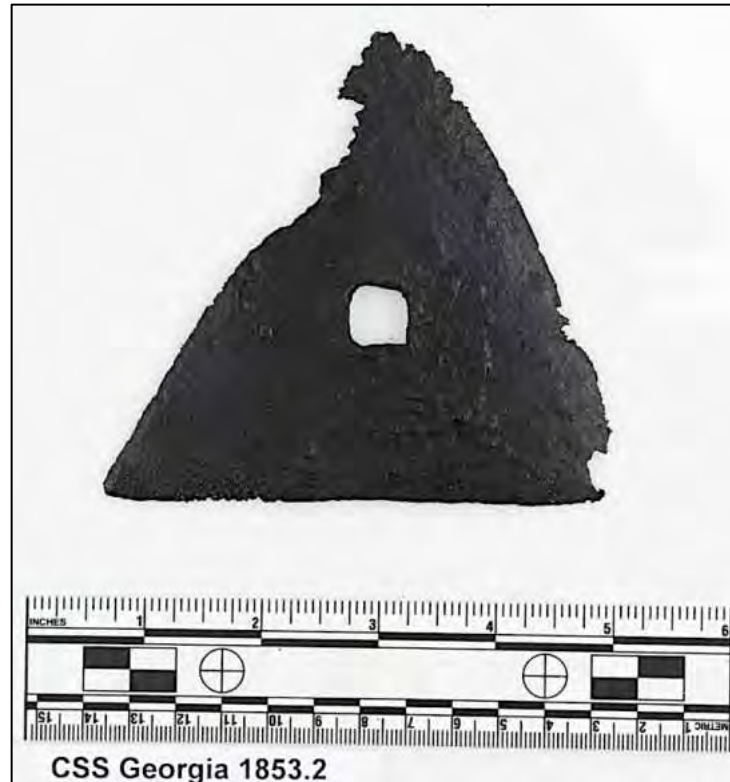
Figure 6-239. Artifact 1853.2, a scraper head (courtesy of CRL Texas A&M University).

Scraper head Artifact 1853.2 is an example of the more common thin-plate scrapers, with a head thickness of 0.08 inch (Figure 6-239). This head was found in isolation, and has a well-preserved, square shank hole measuring 0.43-x-0.43 inch. Due to the nature of the find and the state of its preservation, it's possible that this was a spare scraper head. None of the sides are entirely intact, but they have minimum measurements of 4.25, 4.75, and 4.50 inches.

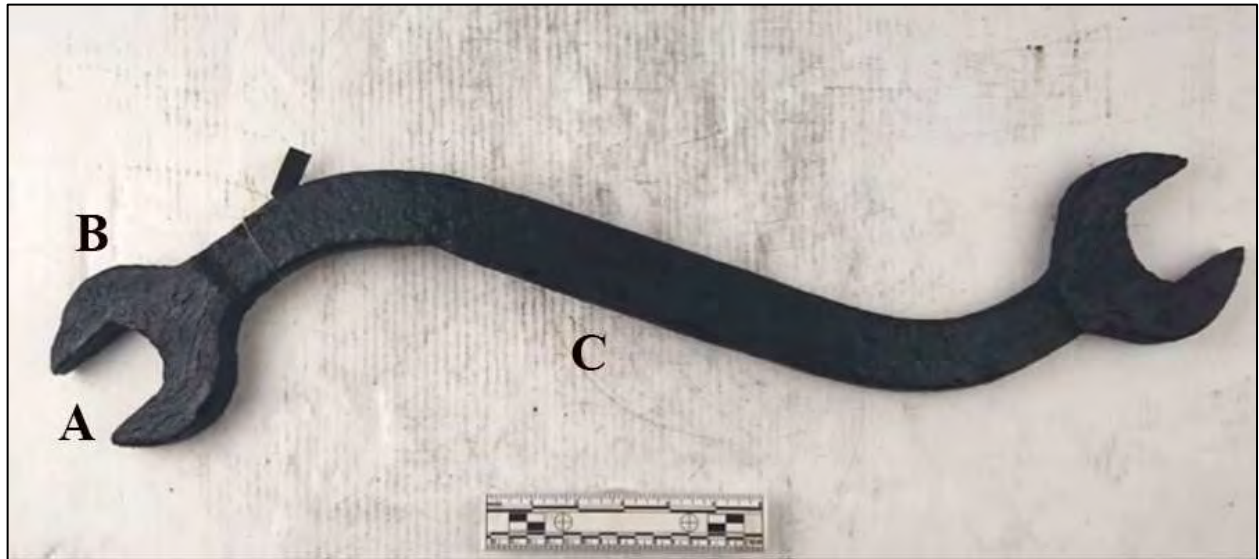
Figure 6-241. Artifact 1879.12, an s-wrench, parts as follows: (a) jaws, (b) head, and (c) handle. Labels follow Richardson (1890:37, 40; courtesy of CRL Texas A&M University).

Wrench Artifact 1879.12 is an S-wrench (Figure 6-241). One end of this wrench is a 1¾-inch set of jaws, while the other is a 2¹/₁₆-inch set of jaws. These jaws are within heads that both about 0.87 inch thick, with a diameter of about 4.00 inches for the 1¾-inch head, and a diameter of about 4.25 inches for the 2¹/₁₆-inch head. The wrench handle is about 0.55 inch thick. This

wrench has an overall length from edge to edge of about 26.13 inches. Edge-to-edge length is used for S-wrenches in this report rather than along the body for the sake of simplicity.

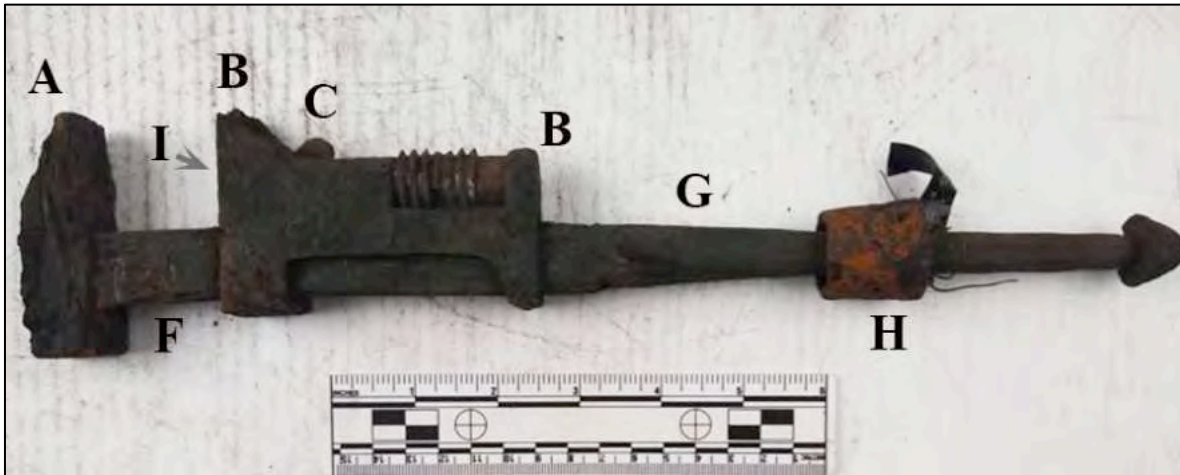
Figure 6-242. Artifact 1879.19, adjustable wrench, parts as follows: (a) upper/fixed jaw, (b) lower/movable jaw assembly, (c) “projection” to engage auxiliary jaw, (d) screw, (e) thumb piece, (f) bar, (g) rod, (h) ferrule, and (i) auxiliary jaw/gripper (obscured in this photo). Labels follow Hyde (1885a; 1885b), while “ferrule” and “rod” are applied from typical definitions of these terms (courtesy of CRL Texas A&M University).

Artifact 1879.19 is an adjustable wrench (specifically a “screw wrench”) found in association with chisel Artifact 1879.19 (Figure 6-242). Specifically, this appears to be an example Joseph Hyde’s “Gripping Screw Wrench” (Figure 6-243). In 1855, Joseph Hyde filed two screw wrench patents for components that were incorporated into this screw wrench (Don Haury personal communication, 2019). In Letter Patents No. 12510, Hyde claimed his patent of the “auxiliary jaw or gripper,” which the wrench-handler could engage by setting the small tab on the lower jaw (Hyde 1855a:2). This gripping jaw allowed Hyde’s wrench to serve as a pipe wrench in addition to its use in twisting nuts. Hyde’s second patent, Letter Patents No. 13617, claimed a mechanism consisting of an eccentric shaft and “thumb piece” (Hyde 1855b:1). The eccentric shaft ran through the screw in the wrench’s lower jaw, and by rotating the thumb piece, the eccentric shaft engaged and disengaged the screw from the teeth-like rack of the bar. This allowed for the width of the jaws to be adjusted either by sliding the lower jaw on the bar, or by raising and lowering the screw on the rack to the desired size. Whereas the original patent for the eccentric shaft/thumb piece pairing positioned the thumb piece outside of the lower jaw, it moved inside to a place directly below the screw by 1857, with the combination of the patents in the gripping screw wrench. As indicated by the advertisement in Figure 6-25, Gray Brothers, a New York manufacturer, was the only producer of this wrench, at least in 1857 (Lovell’s Canada Directory 1857). These wrenches are mentioned again, however, in the United States Navy Department’s annual report of 1862, where the Hyde’s gripping screw wrench is included in an order for 42 screw wrenches (U.S. Navy Department 1862:658). A full examination of how a wrench produced in New York ended up on a Confederate shipwreck is beyond the scope of this research, but the historical and technological evidence makes it clear that Hyde’s gripping screw wrench was a useful, multipurpose wrench with a long working life. Such qualities make it quite plausible that a Confederate engineer already had such a wrench prior to the Civil War, though a number of other explanations for its presence on the CSS *Georgia* might be offered. Interestingly, surviving examples of the Hyde’s gripping screw wrench are rare, with one wrench

Although this wrench has been identified with considerable precision, measurements will be given for thoroughness. The fixed upper jaw is approximately 0.83 inch thick by 0.75 inch wide by 2.75 inches long. The lower jaw is about 3.63 inches long and 0.88 inch wide, with an auxiliary jaw that is about 0.20 inch wide. Measuring the width of the jaw opening as found during conservation, it appears that this wrench may have been last set to a width between $1\frac{1}{2}$ and $1\frac{7}{8}$ inches. An exact determination is difficult due to some deterioration of the upper jaw and a slight misalignment of the lower jaw. The screw appears to have been engaged with the rack, judging from a quick x-ray (Figure 6-244).

The bar of this wrench is about 5.88 inches long with dimensions of about 0.51-x-0.71 inch. A small portion of rack is visible on the bar below the lower jaw assembly. At the end of the bar, a rod is set slightly off-center. This originally would have been covered by a wooden handle, as evident from the Gray Brothers advertisement and what appears to be a small amount of wood still attached to the rod. The ferrule that once capped this wood handle now hangs loose on the rod. Two pinholes are present in the ferrule that would have been used to help fix it to the wood handle. These both measure about 0.04 inch in diameter, with one set about 0.16 inch up the side of the ferrule, and the other set at about 0.39 inch. There is about a 90-degree angle between these holes. The rod tapers from a diameter between 0.55 and 0.63 inch at the top to 0.24 inch at the bottom.

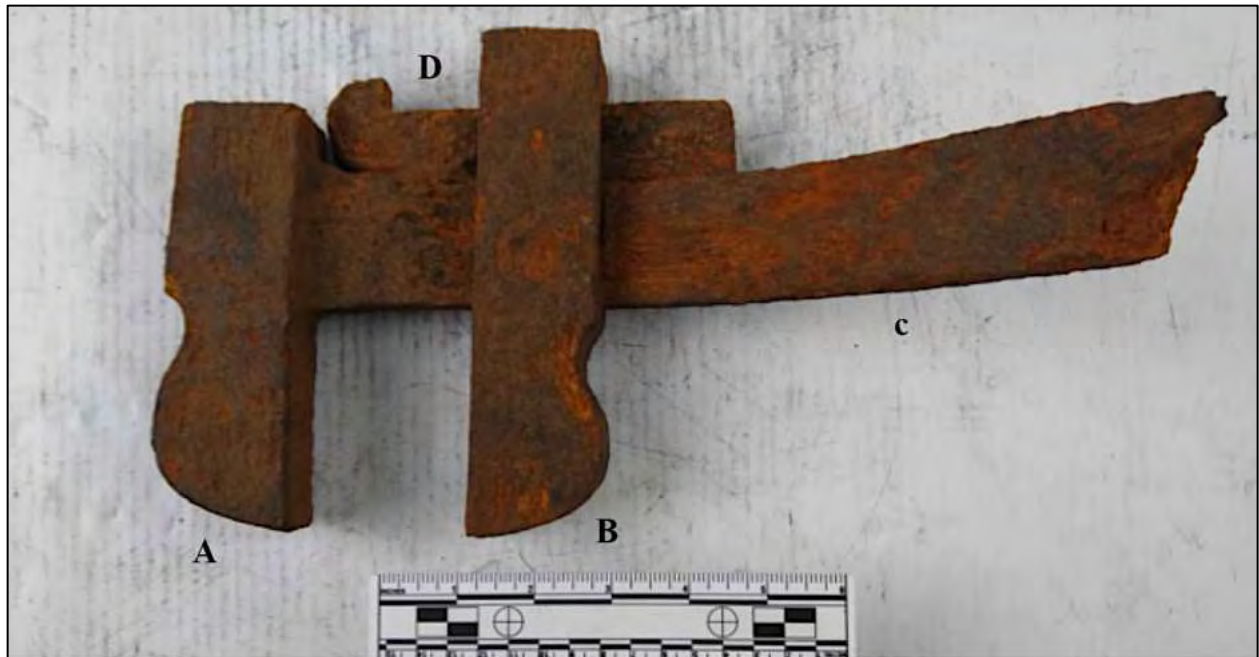
Figure 6-245. Artifact 1899.20, an adjustable wrench, parts as follow: (a) upper jaw/fixed jaw, (b) lower jaw/moving jaw, (c) bar, and (d) gib wedge. Because some parts of this adjustable wrench are functionally comparable to screw wrench Artifact 1879.19, labels (a), (b), and (c) follow Artifact 1879.19, while (d) is taken from Richardson (1890:42; courtesy of CRL Texas A&M University).

Artifact 1899.20 is an adjustable wrench (Figure 6-245). The upper jaw is fixed, while the lower jaw is adjustable. The wrench bar and a “gib” wedge run through an opening in the center of the adjustable jaw. There do not appear to be any rack teeth on the bar, so the lower jaw was perhaps set in place entirely by tightly setting the wedge. This wrench is still undergoing conservation as of this writing, so it is possible that some detail is still obscured, although concretion appears to be nearly absent from this artifact at this point.

Both jaws have a width of about 1.75 inches, and are similar in thickness as well, having a thickness of about 1.75 inches between the bar and the grooves on the outside faces of the jaws and a thickness of about 1.88 inches in front of the groove. The only significant difference between the jaws is that the lower jaw is longer: the upper jaw has a length of about 5.88 inches, while the lower jaw is about 7.00 inches long. At the time of recording, the wrench has become fixed with its jaws open to a width of about $2\frac{3}{8}$ inches. The bar is rectangular, with a thickness of about 0.47 inches. This bar is preserved for a length of about 12.75 inches. The wedge measures about 5.88 inches long and about 0.47 inches wide.
