CSS *GEORGIA*
ARCHEOLOGICAL DATA RECOVERY AND MITIGATION
FOR THE SAVANNAH HARBOR EXPANSION PROJECT (SHEP),
CHATHAM COUNTY, GEORGIA AND JASPER COUNTY, SOUTH CAROLINA

**FINAL DRAFT REPORT
OCTOBER 2019**

Stephen R. James, Jr. and Gordon P. Watts

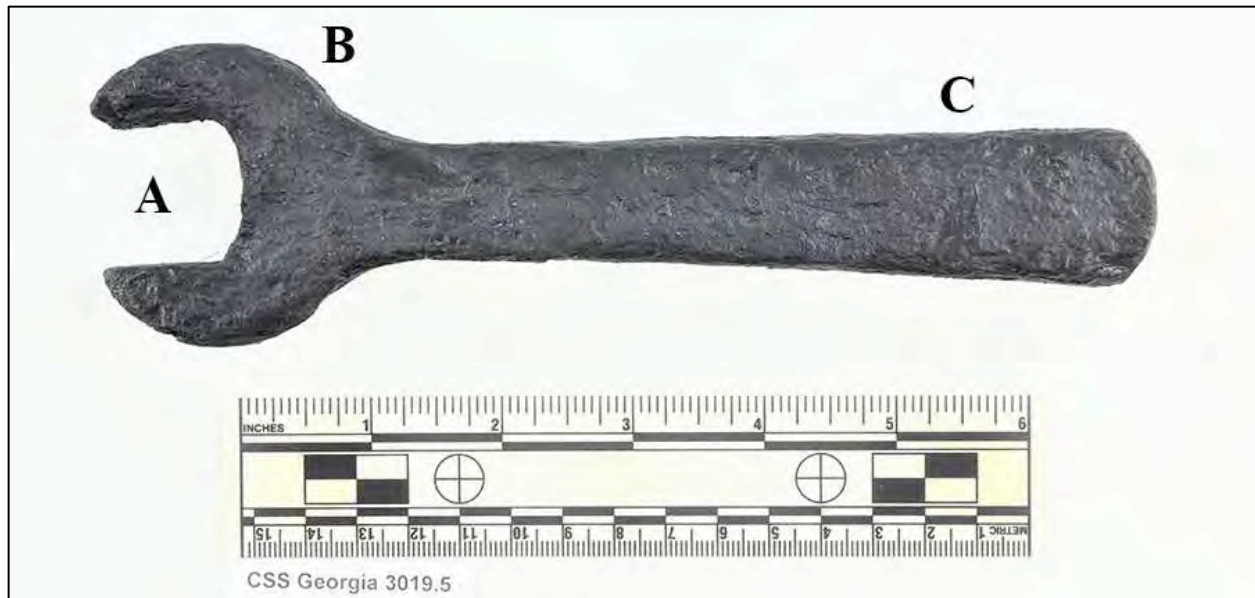
Figure 6-246. Artifact 3019.5, a wrench, parts as follows: (a) jaws, (b) head, and (c) handle. Because the parts are functionally the same as that of an S-wrench, labels follow Artifact 1879.12 (courtesy of CRL Texas A&M University).

Artifact 3019.5 is a small, one-sided, open-ended wrench (Figure 6-246). The jaws of this wrench were probably $1\frac{1}{16}$ inches wide. The head has a diameter of about 2.25 inches, and a thickness of about 0.51 inch. The handle of this wrench is about 0.43-inch thick, and widens from about 0.79 inch at the head to 1.10 inches at the base of the handle. Overall, this wrench has a length of about 8.00 inches.

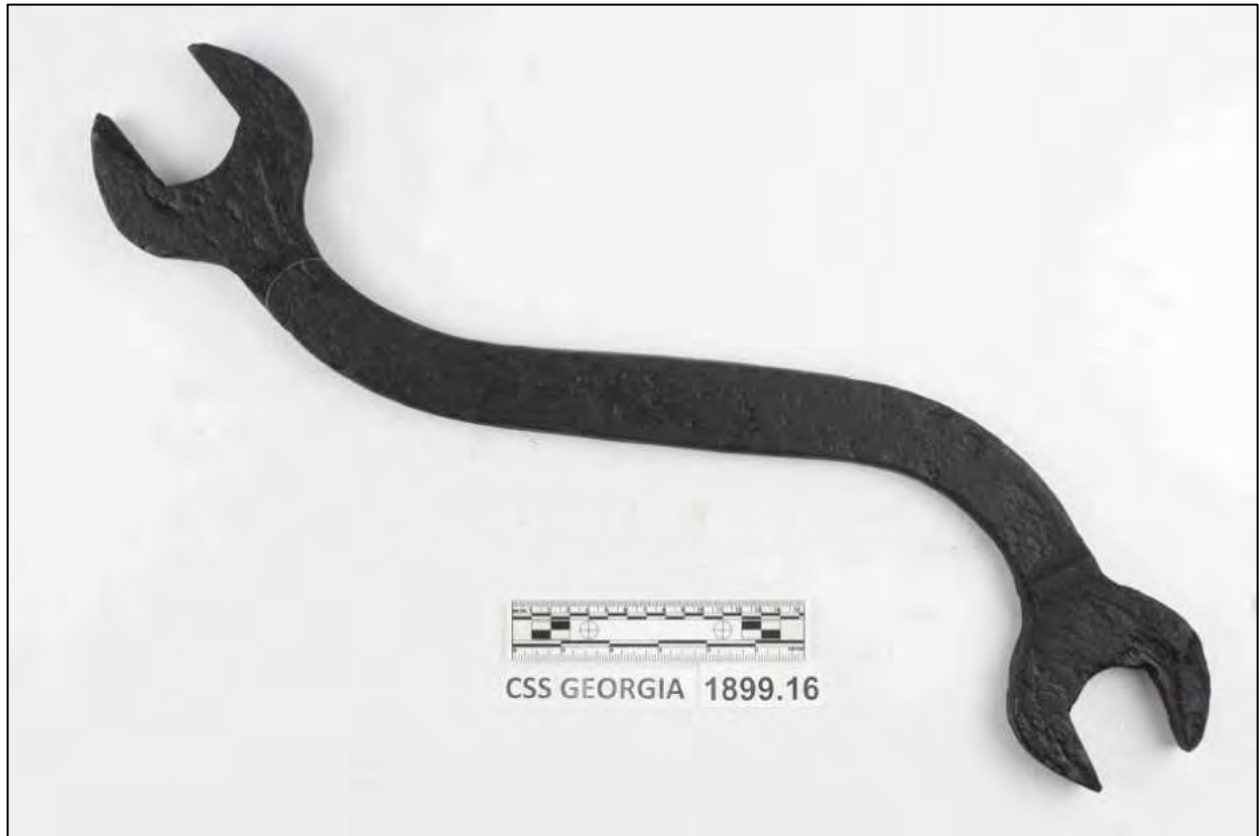
Figure 6-247. Artifact 1899.16, an S-wrench. Please note that the metric side of the scale bar is right-side up in this image (courtesy of CRL Texas A&M University).

Artifact 1899.16 is an S-wrench (Figure 6-247). It is already at NHHHC and could not be studied by the authors. Measuring jaw size from the photo alone poses too much imprecision.

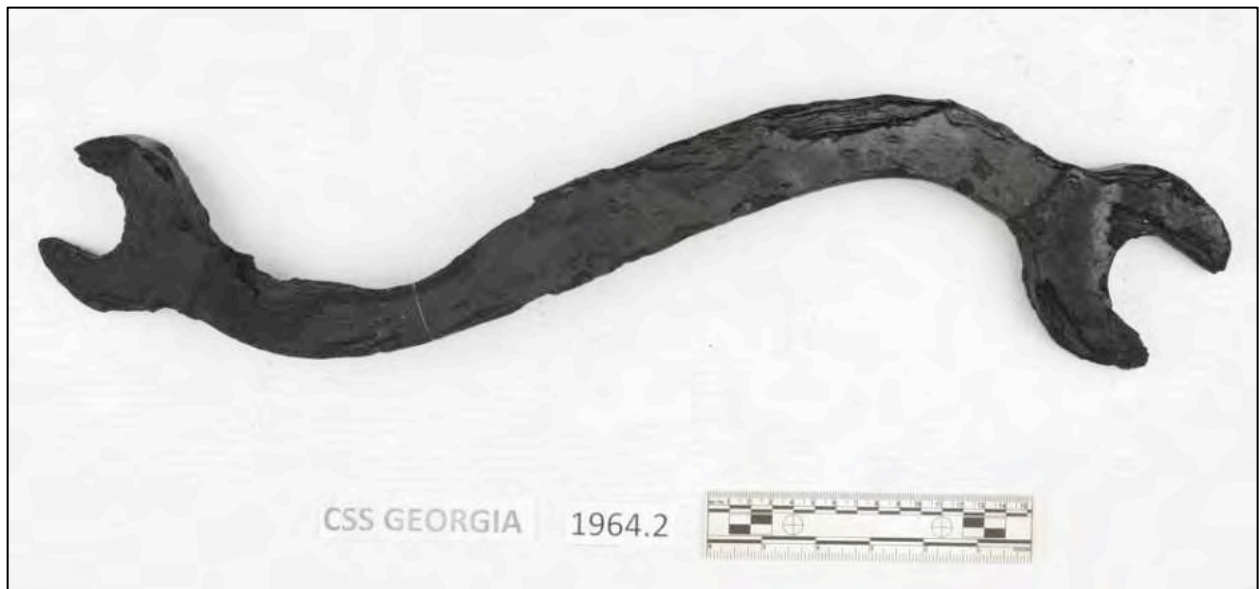
Figure 6-248. Artifact 1964.2, an S-wrench. Please note that the metric side of the scale bar is right-side up in this image (courtesy of CRL Texas A&M University).

Artifact 1964.2 is an S-wrench (Figure 6-248). It is already at NHHHC and could not be studied by the authors. Measuring jaw size from the photo alone poses too much imprecision.

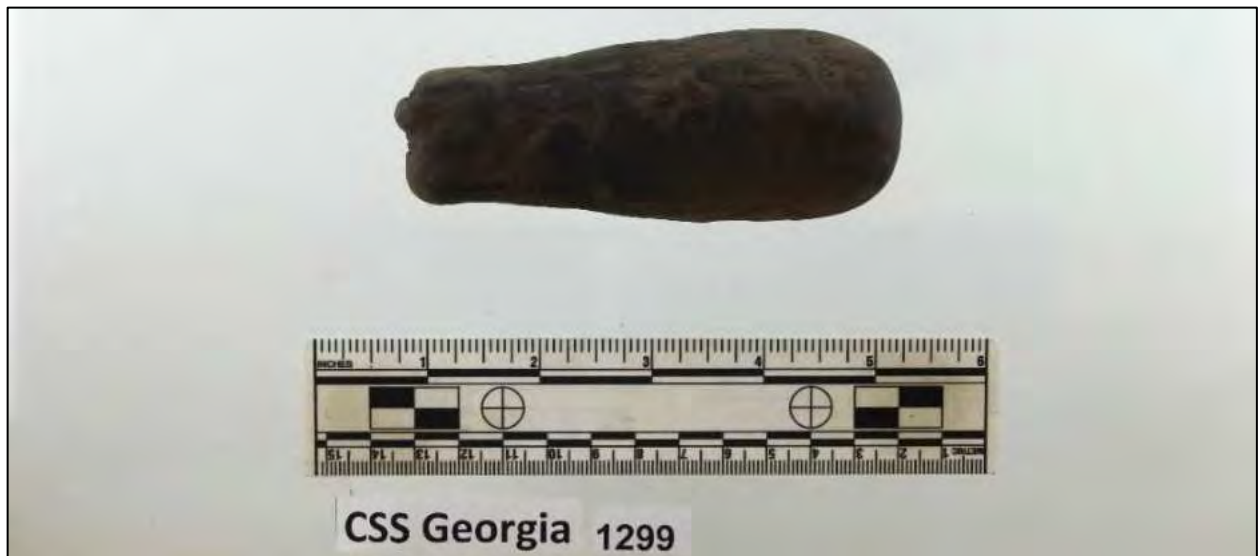
Figure 6-249. Artifact 1299, a tool handle (courtesy of CRL Texas A&M University).

This artifact (Figure 6-249) appears to be a wooden tool handle possibly resembling a handle belonging to a handheld awl, chisel, or gouge (Blackburn 2000:4-5, 36). The handle has a length of 4.26 inches with a max width of 1.61 inches at the base, and a minimum width of 1.10 inches at the tool portion. The handle weighs 0.16 pound.

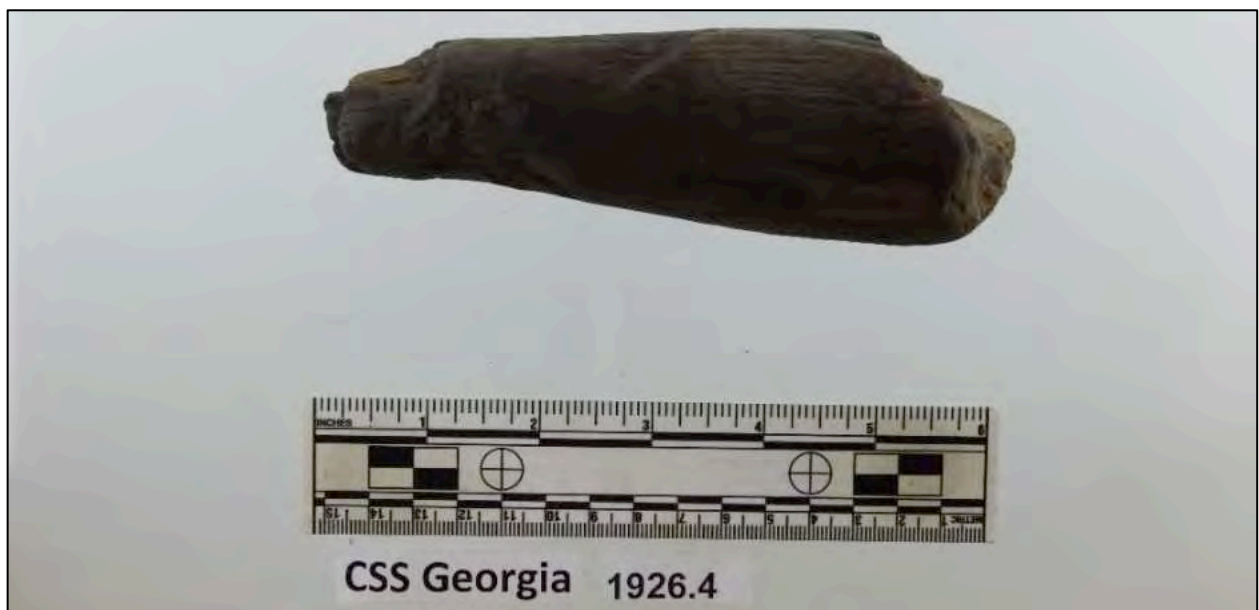
Figure 6-250. Artifact 1926.4 , a tool handle (courtesy of CRL Texas A&M University).

This artifact (Figure 6-250) appears to be a wooden tool handle possibly resembling a handle belonging to a handheld awl, chisel, or gouge (Blackburn 2000:4-5, 36). The handle has a length of 5.82 inches with a max width of 1.53 inches at the base, and a minimum width of 0.92 inch at the tool portion. The handle weighs 0.25 pound.

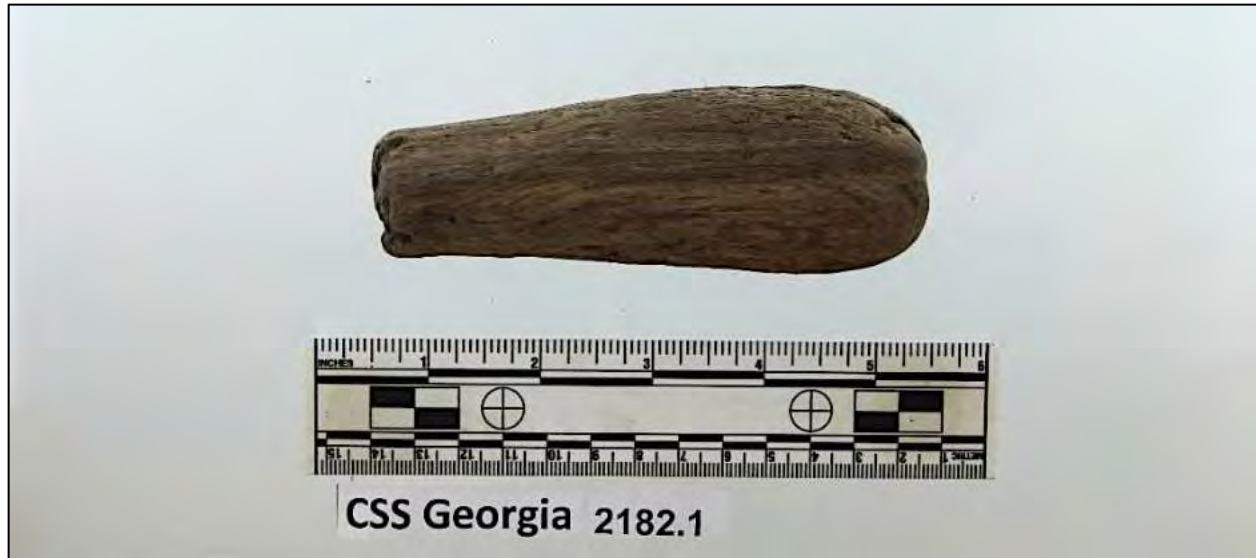
Figure 6-251. Artifact 2182.1, a tool handle (courtesy of CRL Texas A&M University).

This artifact (Figure 6-251) appears to be a wooden tool handle possibly resembling a handle belonging to a handheld awl, chisel, or gouge (Blackburn 2000:4-5, 36). The handle has a length of 4.73 inches with a max width of 1.63 inches at the base, and a minimum width of 1.13 inches at the tool portion. The handle had a maximum thickness of 1.19 inches at the base and minimum thickness of 0.82 inch near the tool portion. The handle weighs 0.11 pound.

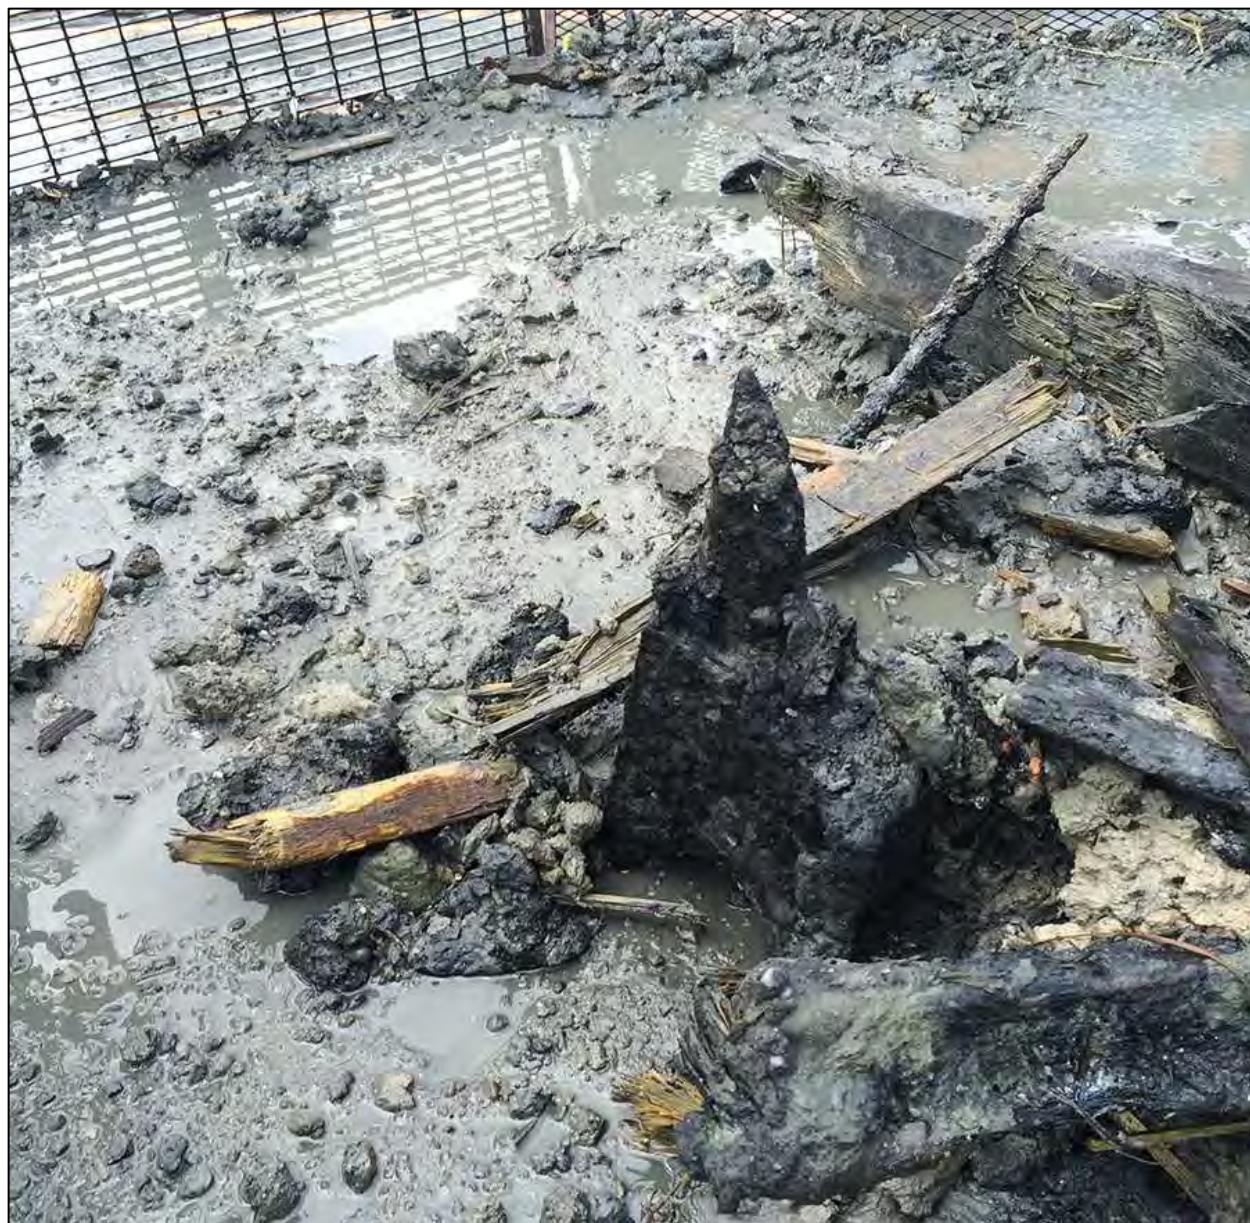
Figure 6-252. Artifact 1843.02, the anvil recovered in Unit 6-E.

Perhaps one of the most surprising tools recovered was an anvil (Figure 6-252). Still in conservation and not available for study, Artifact 1843.02 was recovered from Unit 6-E and only photographed at the time of Mechanized Recovery of Artifacts but not measured. A much-needed tool for blacksmithing, and one that would not be unexpected on an ironclad, other blacksmithing tools are present like the forging hammer (see Artifact 2927.11). It is expected that the *CSS Georgia* would have had a small blacksmith furnace on board, but evidence to this effect was not observed.

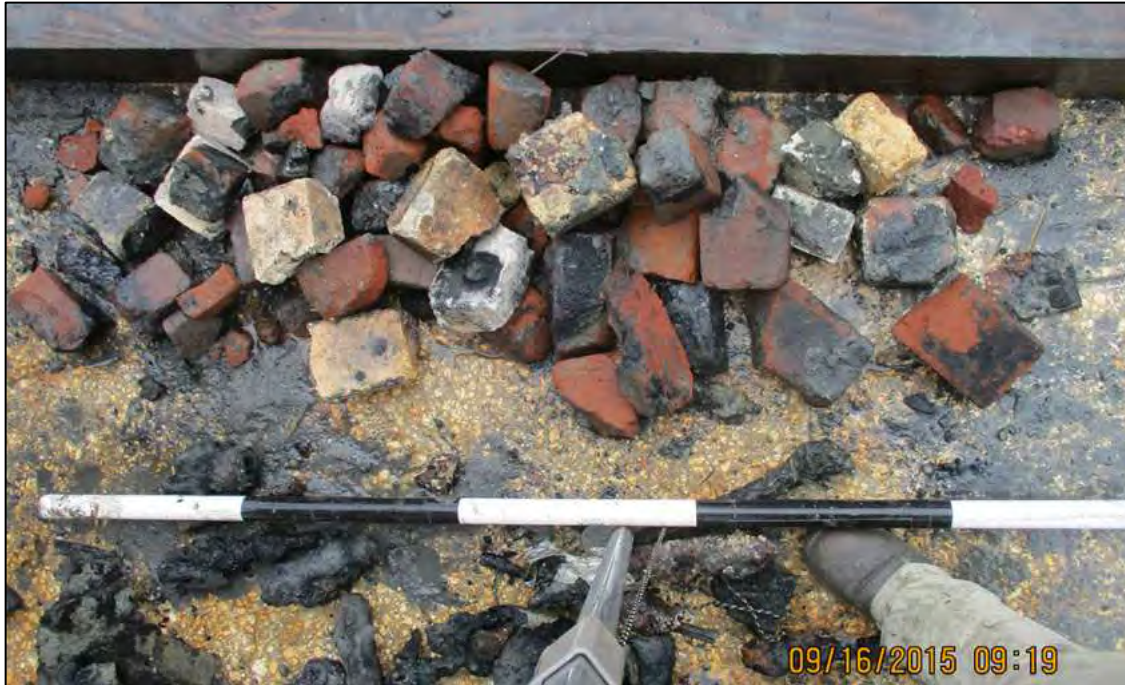
Figure 6-254. Recovered from Unit 7-E, miscellaneous brick fragments from the CSS *Georgia* depicting multiple brands and styles. These were reburied.

Figures 6-254 and 6-255 show bricks recovered in a single grab and show the sheer number recovered, as well as the variety. However, recovery of this nature was specific to Units 6-E, 7-E, and 8-E, a provenience that contained a preponderance of boiler components, indicating that the majority of brick appeared to be associated with the boiler (Figures 6-256 and 6-257). While other brick may have been associated with the vessel's stove or blacksmithing area, this is unsubstantiated in the archaeological record, and it is assumed these would have not had the sheer numbers as those associated with the boiler.

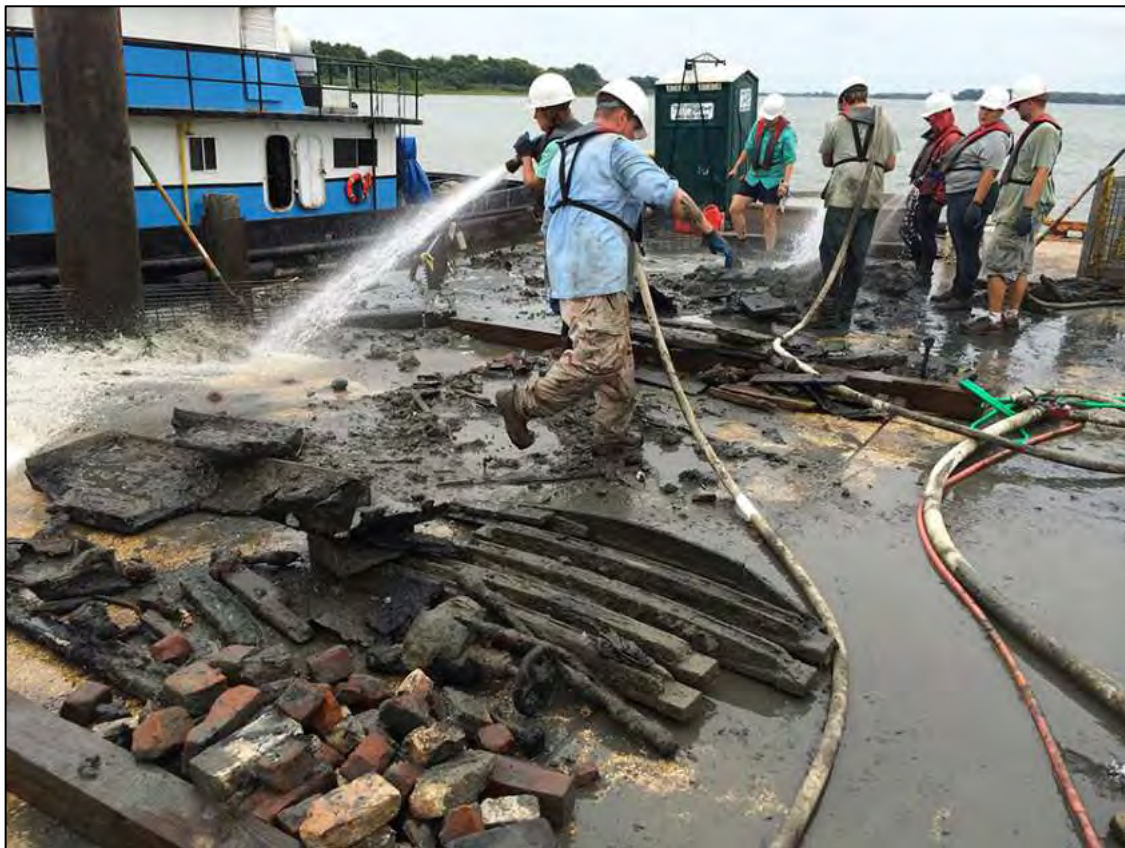
Figure 6-255. Recovered from recovered a single grab, the recovery includes numerous firebricks and brick fragments, as well as boiler fire grates and plating from Unit 7-E just south of the West Casemate.

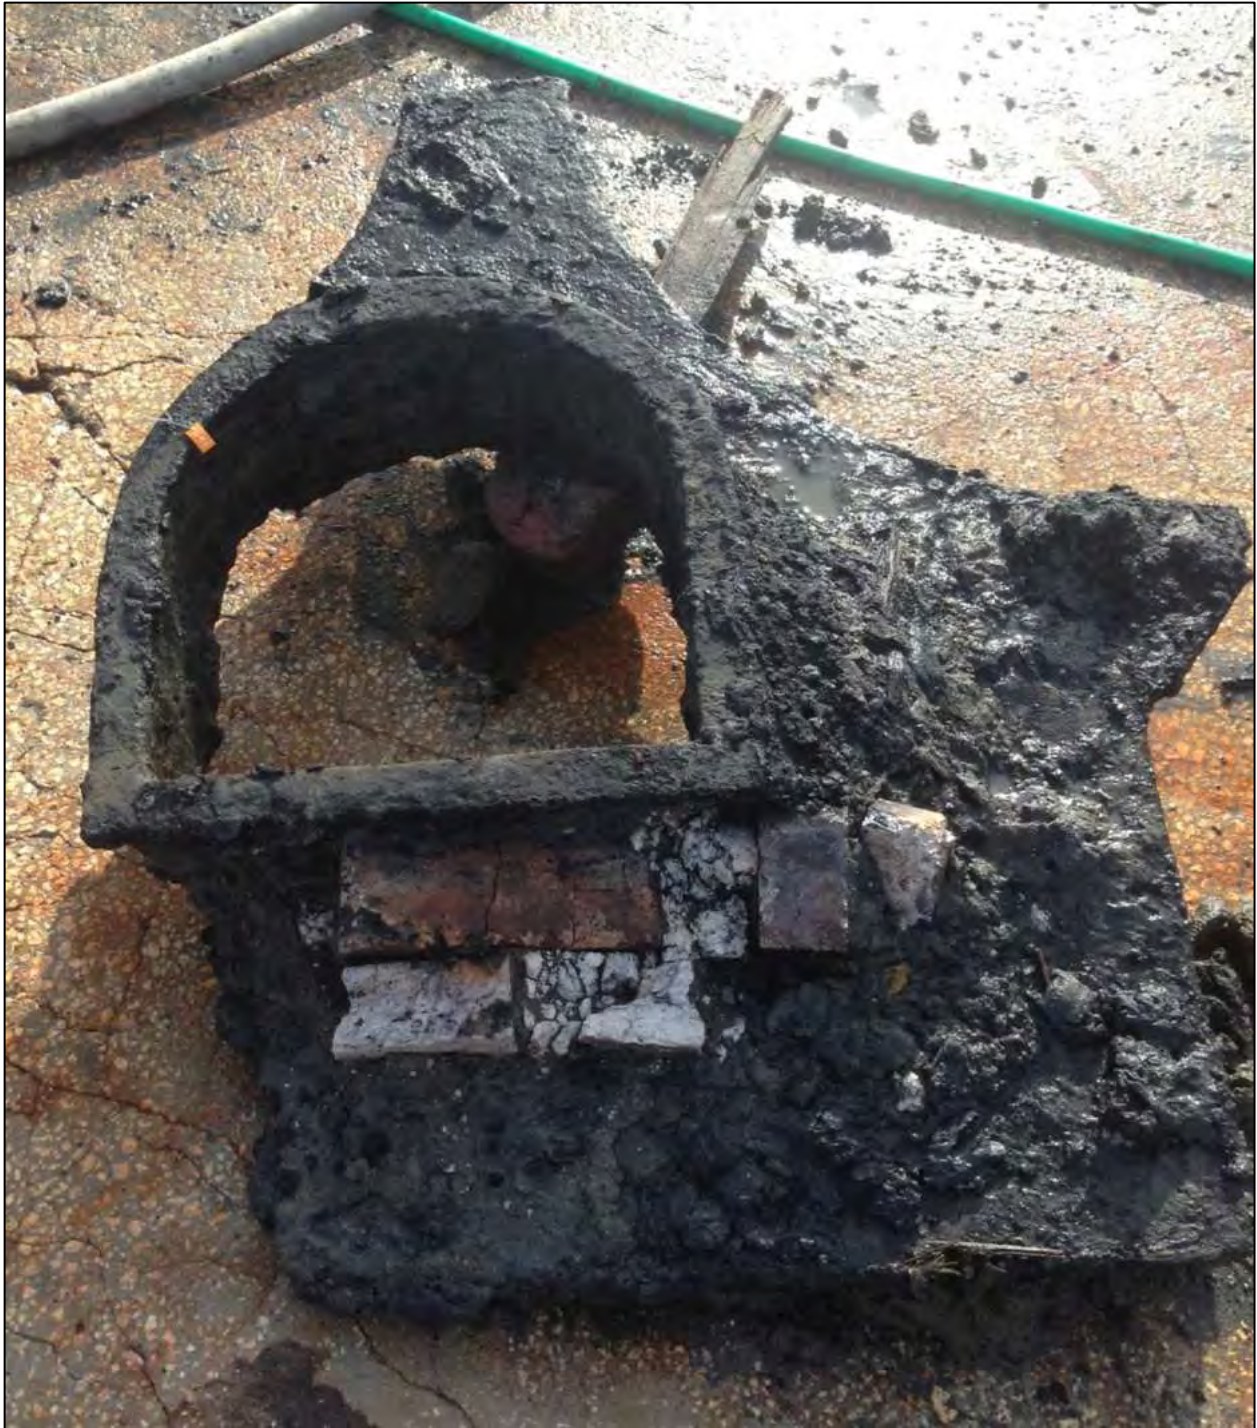
Figure 6-257. Firebrick still attached to the inside of the boiler face just below one of the doors. Notice the white and cracked nature of the brick, indicating extreme heat. Artifact 1844.02 is from Unit 6-E just south of the West Casemate.

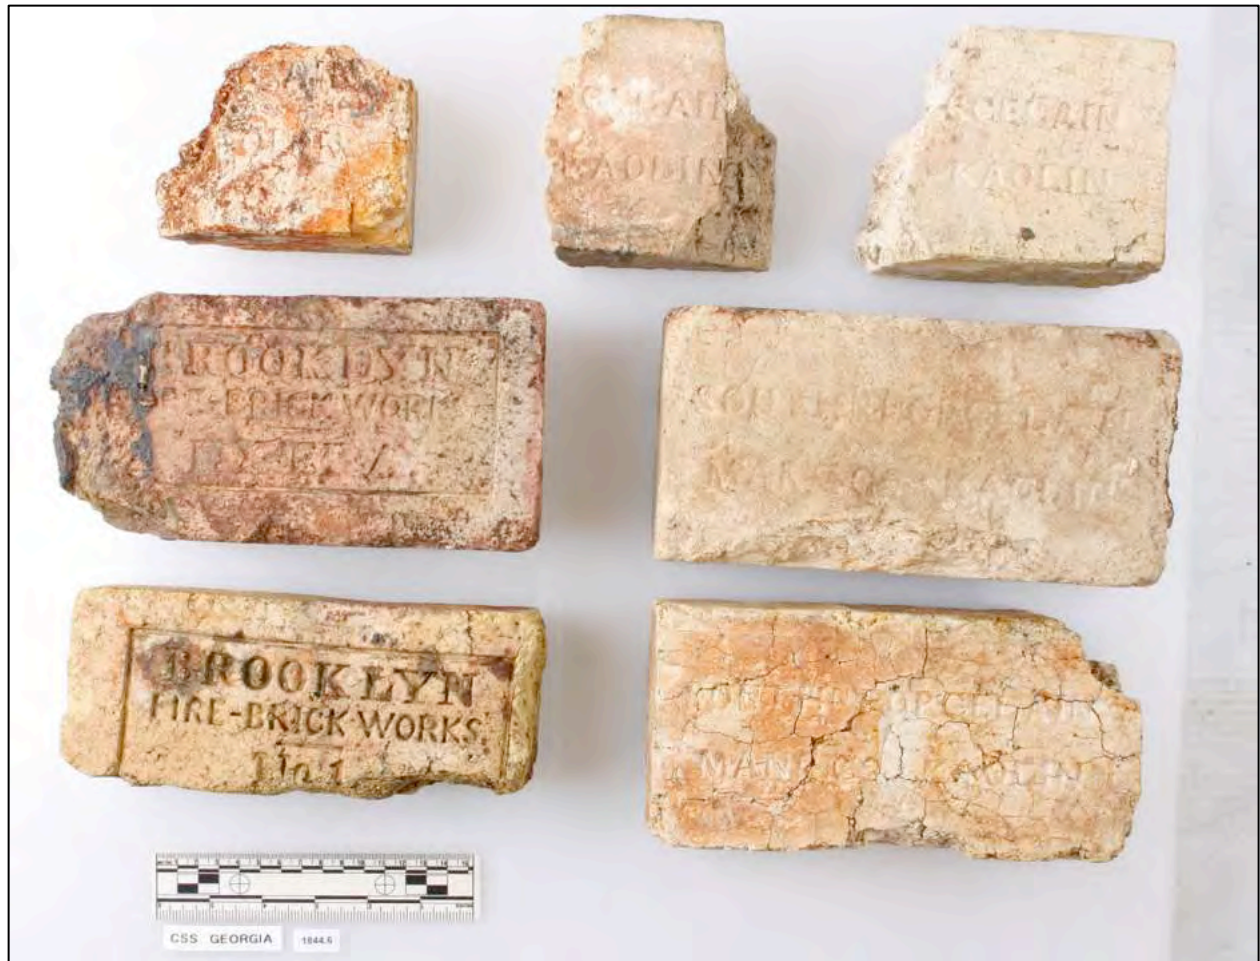
Figure 6-258. Miscellaneous recovered firebricks and brick fragments from the *CSS Georgia* depicting multiple brands and styles. Artifact 1844.6 from Unit 6-E, the presence of both Brooklyn Fire-Brick Works firebrick and Southern Porcelain Manufacturing Company firebrick from the same provenience as numerous boiler fragments indicates that both were associated with the boiler.

Firebrick is distinct from other types of brick due to the fact that it is made from specific clays that sometimes take more intensive processing than basic types. Firebrick can be exposed to much higher temperatures and are designed to be used in kilns, ovens, and other situations where an insulator is needed to contain excessive heat (withstanding temperatures ranging from 1,100° to well over 3000° Fahrenheit). Due to this, firebrick is more expensive to make and therefore more expensive to buy (Gurcke 1987:99). In the context of the *CSS Georgia*, firebrick would have been present in the construction of the boiler as the crucial lining and insulation component though they can be used as building brick if needed. Illustrated in Figure 6-258 and discussed below, several types or makes of firebrick were recorded on the site.

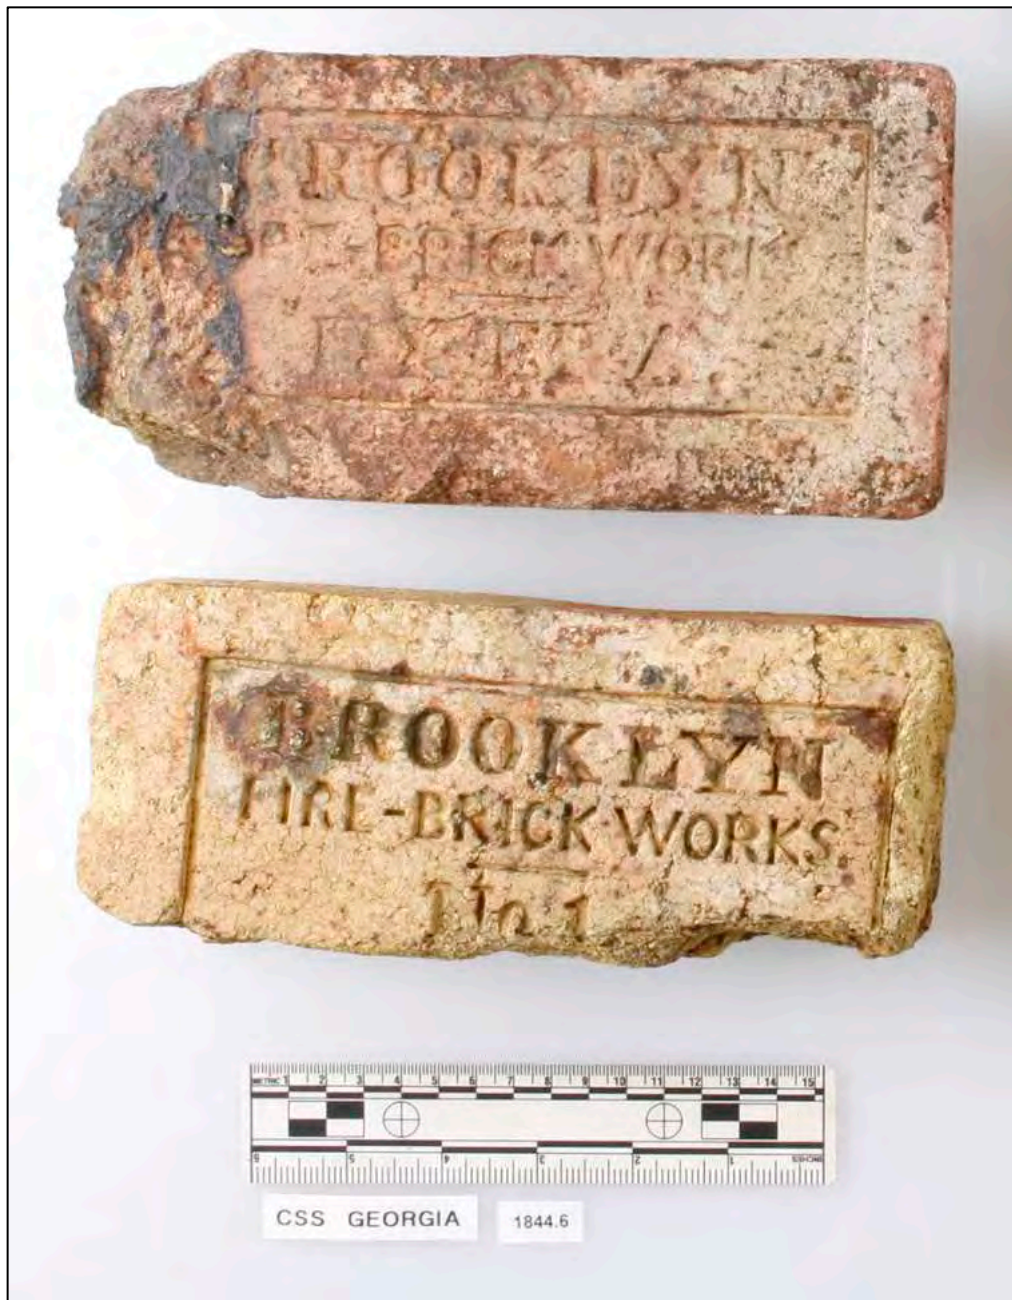
Figure 6-259. Examples of the two styles of Brooklyn Fire-Brick Works brick recovered from the *CSS Georgia*, “Brooklyn Fire-Brick Works, Extra” (top), and “Brooklyn Fire-Brick Works, No. 1” (bottom).

The Brooklyn Fire-Brick Works is the most common maker's mark seen on the recovered and conserved section of bricks from the *CSS Georgia* and shows at least two different marks from this company that can be discerned (Figure 6-259). The refractory was established in 1854, in Brooklyn, New York and advertised high-grade brick and industrial material (Brooklyn Fire-Brick Works 1900:1-4). The Brooklyn Clay Retort and Fire-brick Works storehouse can still be found at its original location because it was restored and is now home to the Carvart Glass Company. Their association with boiler components suggests they were utilized in the boiler.

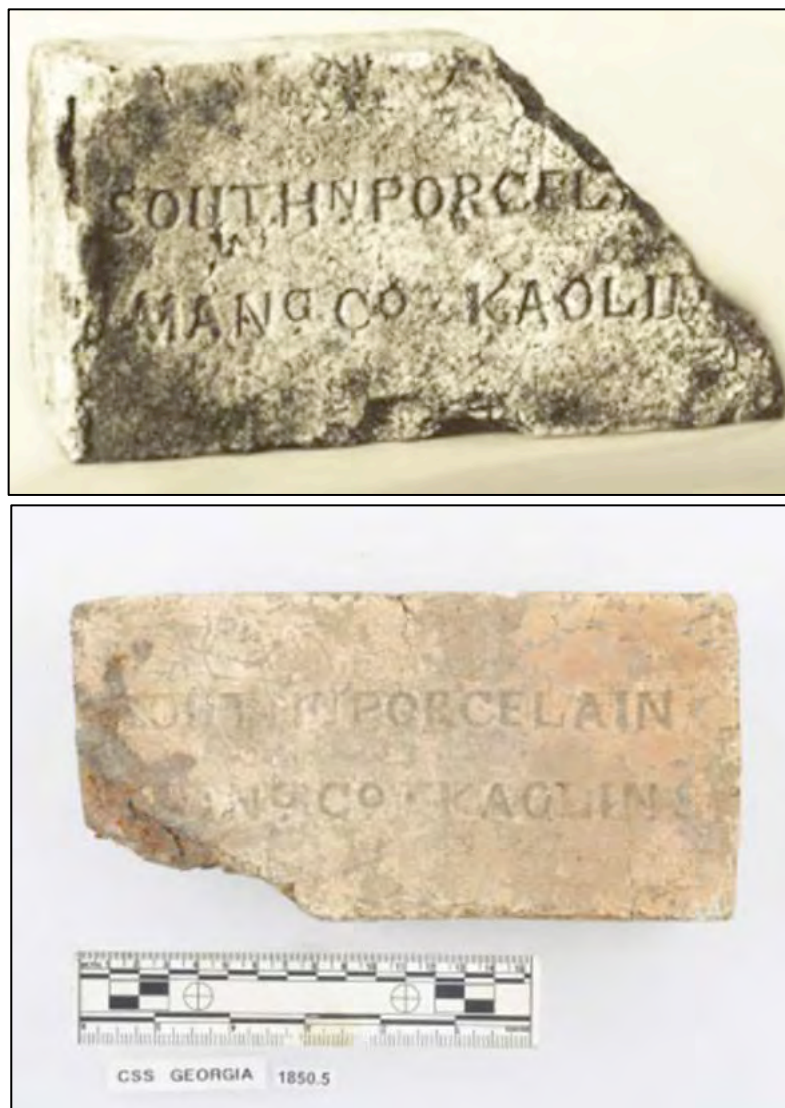
Figure 6-260. Two examples depicting the Southern Porcelain Manufacturing Company firebrick. Top: from a private collection (Stradling 1996:3). Bottom: Southern Porcelain Manufacturing Company Firebrick example recovered from the *CSS Georgia*, Artifact 1850.5 from Unit 8-E.

The Southern Porcelain Co. was a small company out of Kaolin, South Carolina, just south of the city of Bath, near Augusta on the Savannah River. It was founded in 1856 by William H. Farrar who came from Vermont with a few of his brick masons from the U.S. Pottery Company. They utilized the very light-colored clay that was native to the Edgefield pottery district for a multitude of products, including firebricks, which could and most likely were easily shipped down river to the City Savannah. During the Civil War, the company was recognized as the Southern Porcelain Manufacturing Company, which is represented by unique makers' marks seen during that time period (Figure 6-260). The company did not last long, as it was destroyed by fire in 1864 (Stradling 1996:1-3). The Southern Porcelain Manufacturing Company bricks that have been recovered from the *CSS Georgia* have some of the best-preserved sections of makers' marks and are easily identified by their much lighter color and distinct material. Their association with Brooklyn Fire-Brick Works and boiler components suggest they were utilized in the boiler (see above).

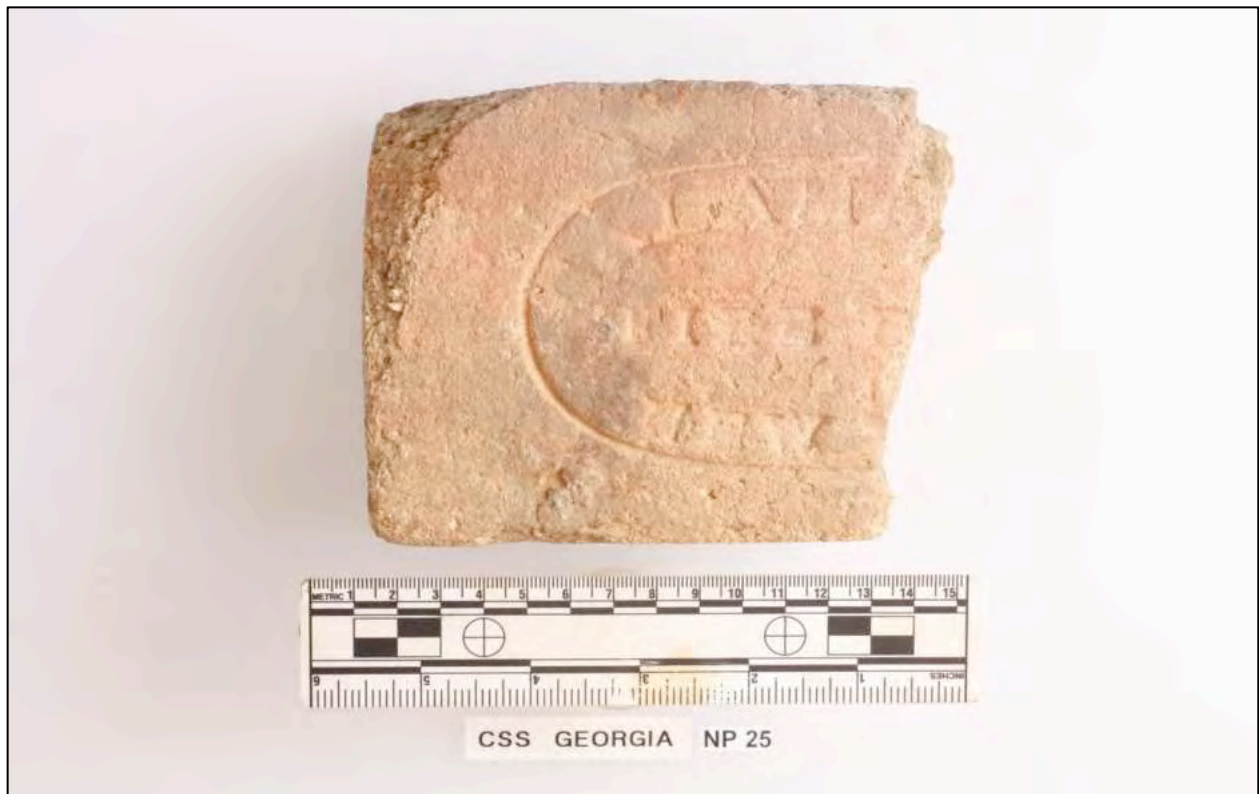
Figure 6-261. Firebrick with an unidentified oval border maker's mark from the CSS *Georgia*. Artifact NP 25.

The brick in Figure 6-261 can be seen to retain approximately half of the maker's mark with the lettering encompassed by an oval border. The word "FIRE" and subsequent letter "B" in the center identifies it as a firebrick (as well as its lighter, generally yellowish appearance that many firebricks have). The top lettering is less distinct and could be any of the three "LAN," "LAH," or "LAM." The "NEW" of most likely New York or New Jersey on the third line is also fairly distinct. This brick could possibly belong to the Lahey Company of Fishkill, New York that operated before and during the Civil War (deNoyelles 1982:245). The spacing and estimate of the remaining stamp based on the curvature of the oval would suggest that the name "LAHEY" would fit in the space, but as no representation of the Lahey bricks have been found, there is no way to type it definitively.

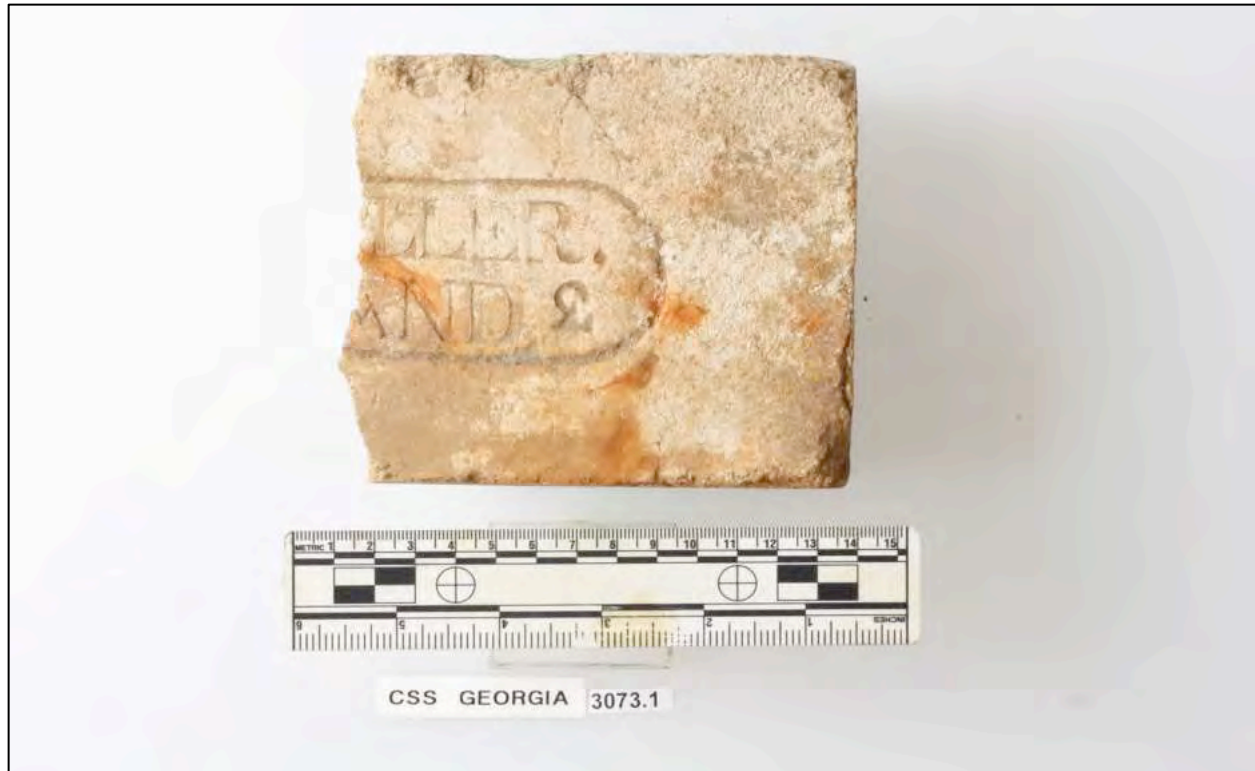
Figure 6-262. Unidentified “LLER.ND3” firebrick maker’s mark recovered from the CSS *Georgia*. Artifact 3073.1.

The brick in Figure 6-262 also shows roughly half to three-quarters of a maker's mark. The letters "LLER." can clearly be seen on the top line, and the letters "AND" are shown directly underneath the top letters. An inverted "3" can also be seen next to the "D." Unfortunately, although there are some references in historical sources to a Weller Manufacturing Co. and multiple Keller and Miller companies spanning from New York to Ohio, no solid reference to a firebrick company fitting the description has surfaced as of yet.

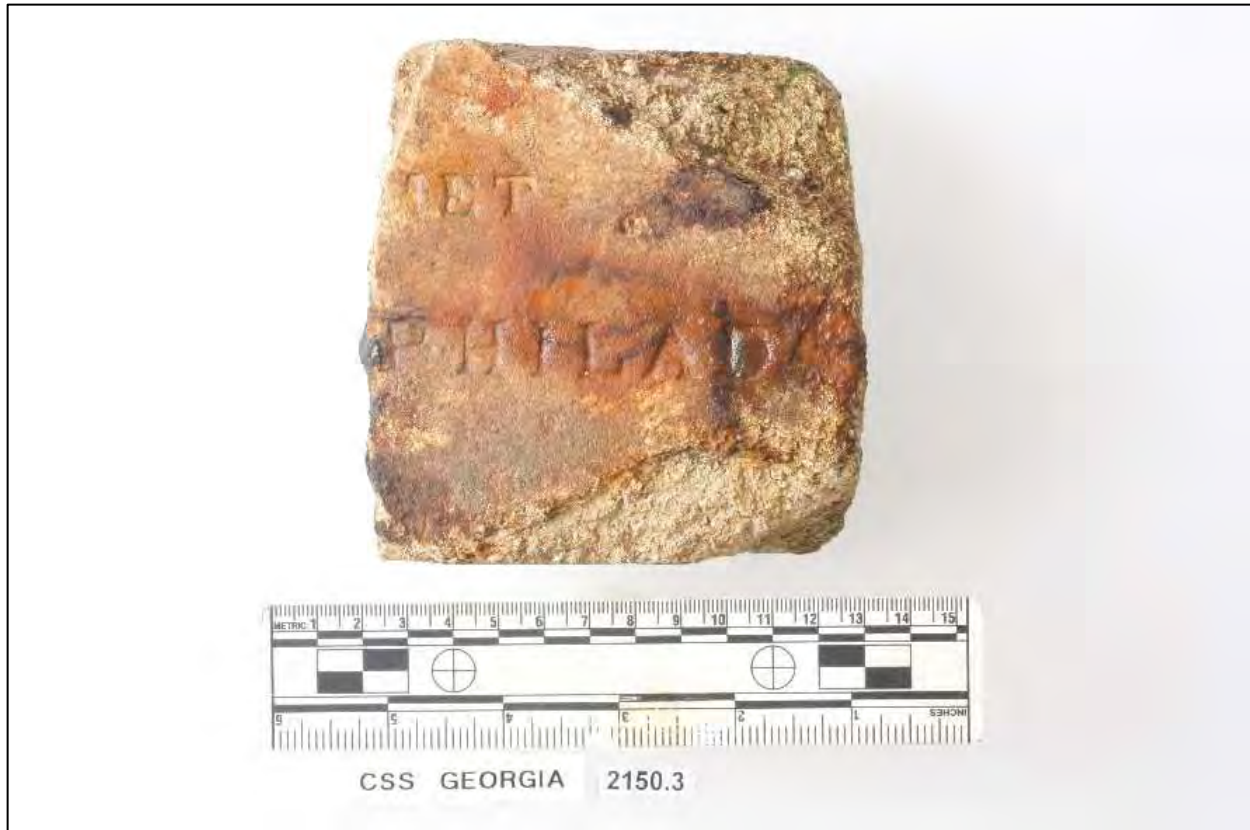
Figure 6-263. Unidentified “PHILAD” firebrick brand recovered from the CSS *Georgia*.

The final unidentified mark of the brick currently having been recovered is a small fragment (Figure 6-263). Although this brick is much less intact than the previous examples, the letters “PHILAD” can be seen on the bottom line suggesting the City of Philadelphia as the origin of manufacture. The top letters are smaller and harder to determine and could possibly be “MET,” “KET,” “HET,” or “NET.” The right edge and relative position of the text on the upper line suggests the termination of the brick that could make the “PHILAD” lettering an abbreviation for the city. In Philadelphia, Pennsylvania, there was a fairly prominent firebrick company by the name of Newkumet and Melick that operated next to the residence of John Newkumet who served as a Union Colonel in the Civil War (Hunt 2007:128). The “MET” on the top line of the mark could refer to this company, but again, there is no reference to the style of the mark from this company, and there were many firebrick refractories operating out of Philadelphia.

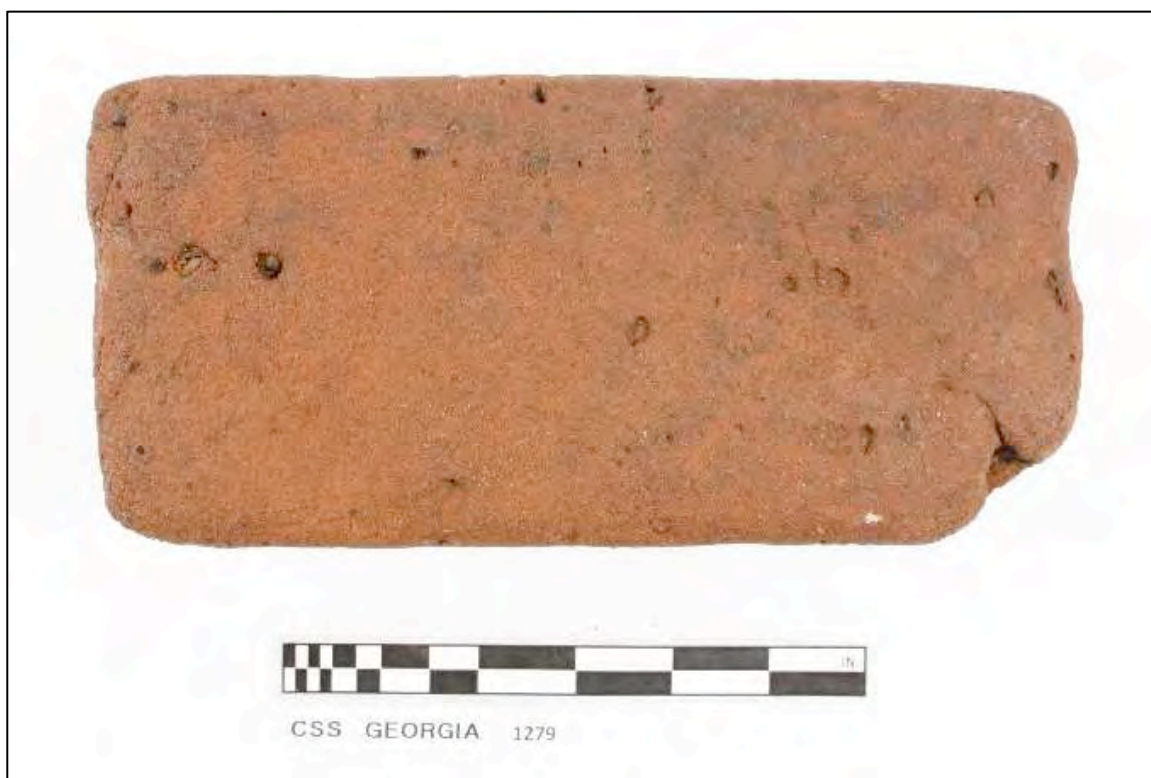
Figure 6-264. Example of complete red brick recovered from the CSS *Georgia*, Artifact 1279.

While the majority of the marked bricks and brick fragments are firebricks, there are many more fragments and whole bricks that are not marked and are made of a variety of different clays. Some of these can be determined to be separate from firebrick due to their coloring as well as the more porous nature of the material. The firebricks, it seems, maintained more of the sharp pressed edges, as well as their markings than their basic brick counterparts. Many of the generic bricks are red, which is consistent with a more common building material (Figures 6-264 and 6-265). There are some nicks and scraps, which could be seen as cut marks, but the fact that they have been through abandonment, wrecking, and possibly multiple salvage operations, it is difficult to say for sure whether these scrapes and chips are from their manufacture.

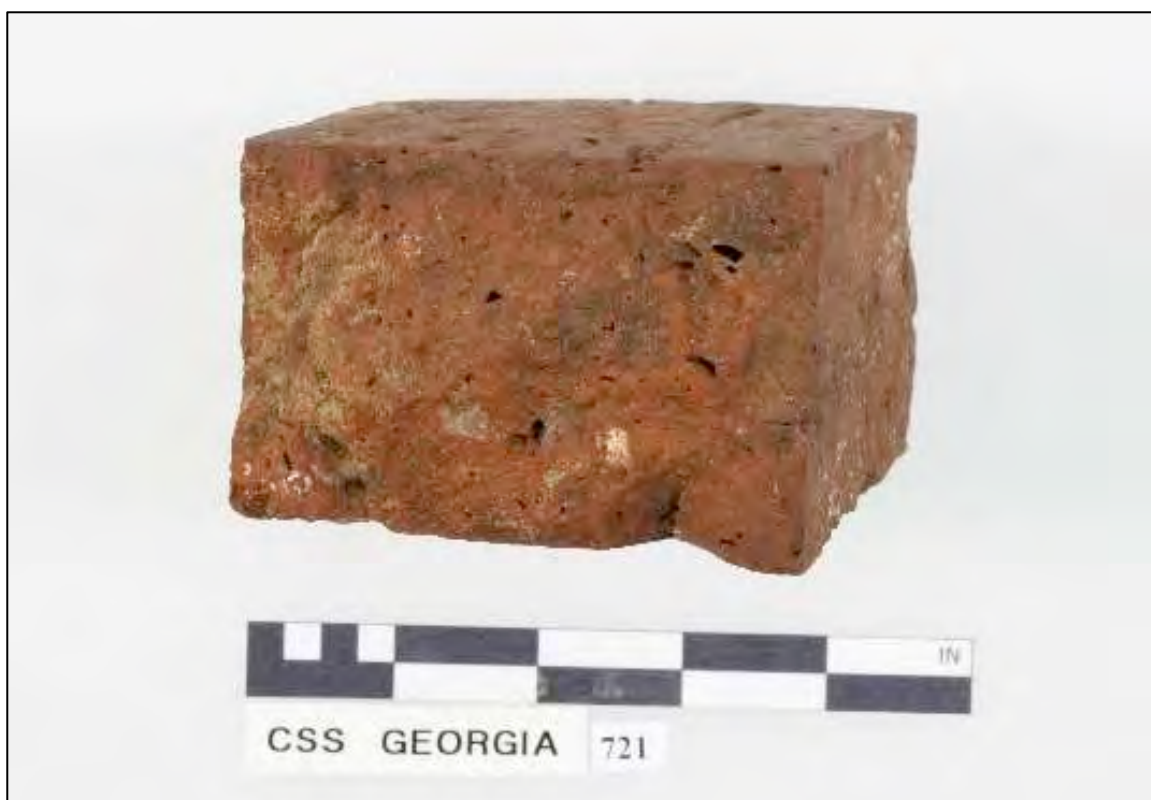
Figure 6-265. Example of red brick fragment recovered from the CSS *Georgia* showing interior matrix, Artifact 721.

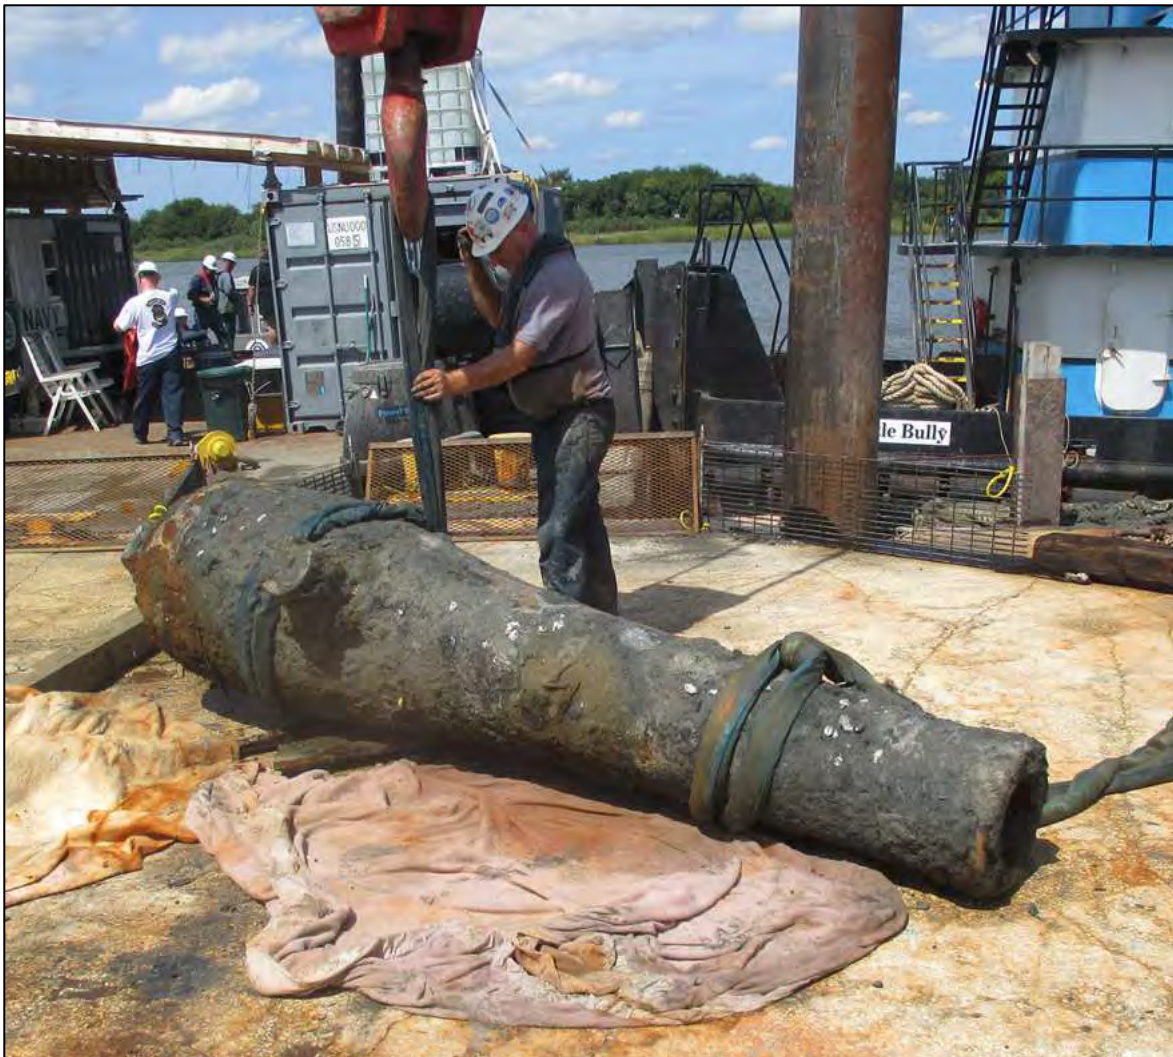
Figure 6-267. Cannon No. 5, a IX-Inch Dahlgren cannon (Artifact 1823.11) deposited on deck after being grappled from Unit 6-F, just to the northwest of Cannon 2. Mr. Paul Hankins, head of Donjon for the project, is directing the crane to lift it from the deck.

Five cannon were recovered from the CSS *Georgia* site during the 2015 field season, two IX-Inch Dahlgren cannon, two 6.4-inch single-banded Brooke rifles, and a small cast iron 6-pounder. Designated in the field and on project maps as Cannon Nos. 1 to 5, four of the cannon were brought up by MDSU-2 divers during the Large Artifact Recovery phase discussed above. The fifth cannon, Cannon No. 5, a single unknown and buried IX-Inch Dahlgren was unexpectedly found during Mechanized Recovery of Artifacts (Figure 6-267; Table 6-10). Written by James Jobling, this section describes the five guns in detail.
