CSS *GEORGIA*
ARCHEOLOGICAL DATA RECOVERY AND MITIGATION
FOR THE SAVANNAH HARBOR EXPANSION PROJECT (SHEP),
CHATHAM COUNTY, GEORGIA AND JASPER COUNTY, SOUTH CAROLINA

**FINAL DRAFT REPORT
OCTOBER 2019**

Stephen R. James, Jr. and Gordon P. Watts

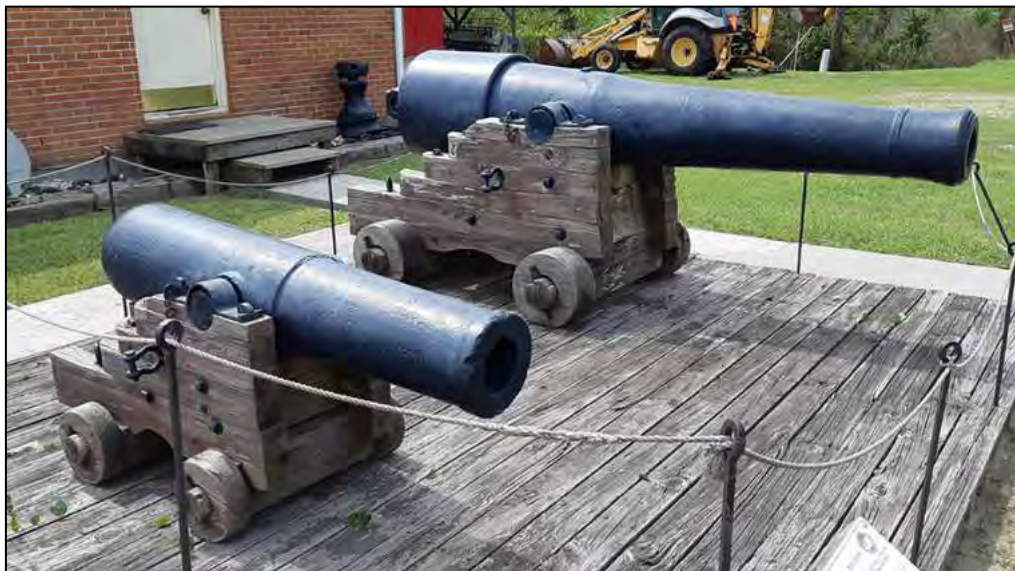
Figure 6-268. 6.4-inch Brooke rifle and a cast iron 24-pound flank howitzer recovered in 1986 and on display at Fort Jackson.

In 1986, diving exploration work was undertaken by the US Army Corps of Engineers–Savannah District, and the Coastal Heritage Society, in an effort to learn more about the vessel. Illustrated in Figure 6-268, two cannon, a 6.4" Brooke rifle and a cast iron 24-pound flank howitzer, were recovered along with a large number of ordnance (Babits 1989).

Babits goes on to describe the larger gun as a Model 1846 32-pounder, single banded, and rifled to 6.4 inch in the Brooke fashion. The gun is considerably shorter (~ 20") than usual, as it was not originally cast as a Brooke rifle. This cannon was the No. 2 Port Gun on the CSS *Georgia*, as the markings closely match the April 1863 Inventory (Babits 1989, Swanson and Holcombe 2007). The second cannon is attributed to A.N. Miller, a local foundry owner, who cast a number of cannon for the Confederacy (Babits 1989:6, Daniel and Gunter 1977:88). When looking at this particular cannon in the summer of 2015, the late John Robertson, of the Coastal Heritage Society, passed comment to the author that the howitzer was a poor casting. On closer examination, one could see that the trunnions were of a different size and slightly out of alignment, and the bore was not perfectly centered.

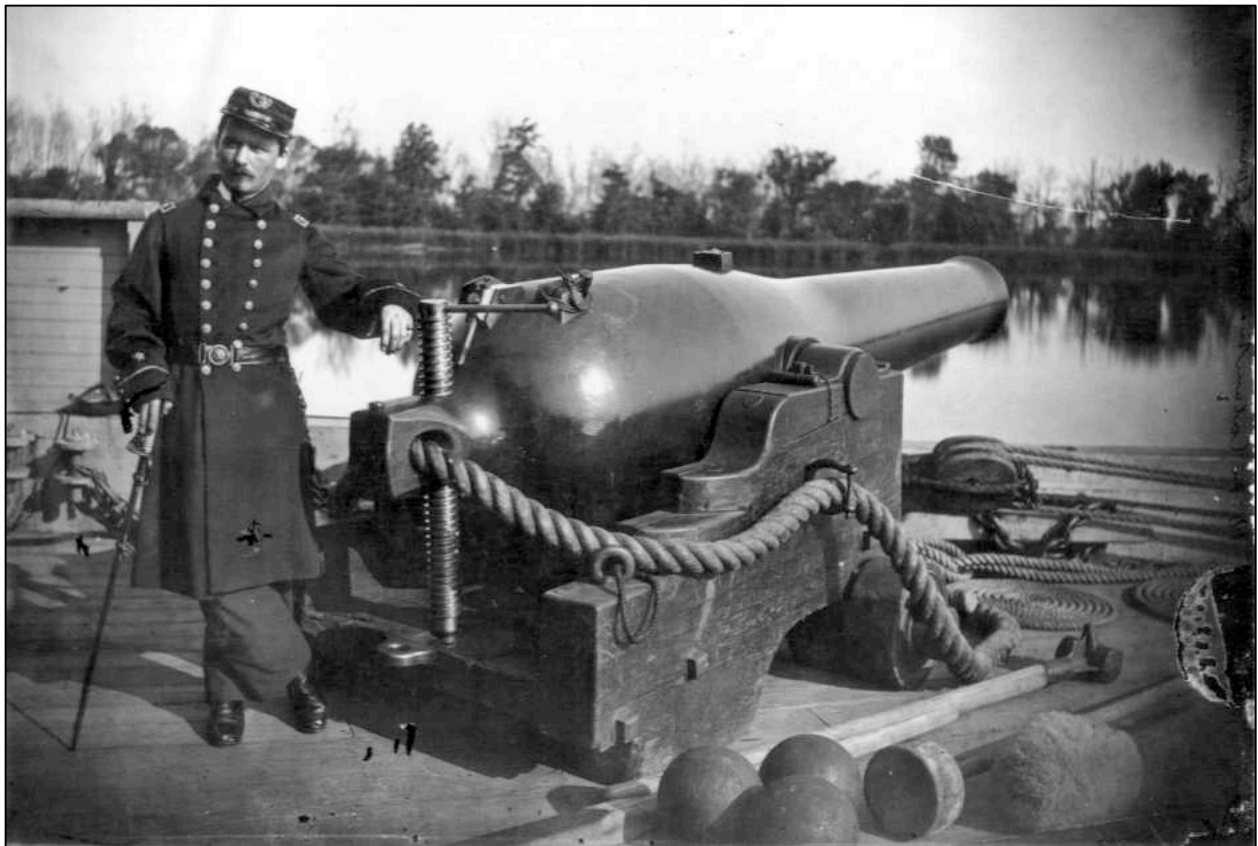
Figure 6-271. Dahlgren cannon on a Marsilly carriage on the *USS Hunchback* (U.S. National Archives Photo No. 111-B-2016, Brady Collection).

Illustrated in Figure 6-271, nominal bore lengths for the IX-inch, including the round-bottom Gomer chamber 9 inches long, were 107.325 inches. The drawings show a trunnion of 7.2 inches in diameter and 7.2 inches in length. These were to fit a two-truck Marsilly wooden carriage, parts of which were recovered from the site. There were two vents and lock lugs on the dorsal surface (shown in detail below). The lateral vent on the right was initially drilled through, while the left vent was only partially drilled so as to indicate the correct angle. The left lock lugs were left solid, or the slot filled with zinc. The right vent, when eroded to 0.400 inch, was closed by molten tin, zinc or lead and the left vent drilled through. A post-Civil War letter states that the IX-inch shell-guns “have always been cast solid and bored out.” A crew of 17, including a powder boy/monkey, served the IX-inch shell gun when in pivot or used singly (Olmstead et al. 1999:84).

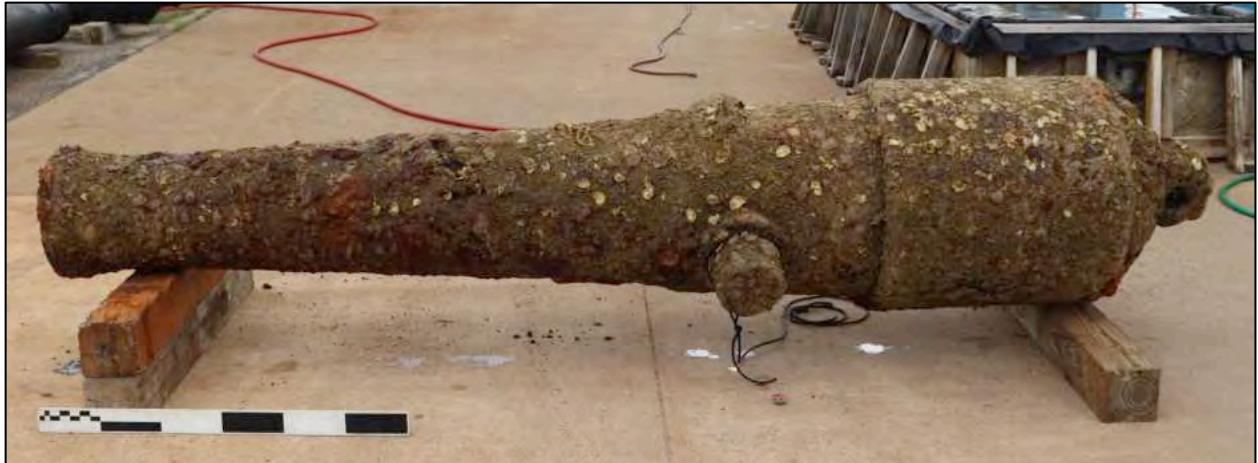
Figure 6-274. Concreted Brooke rifle from the *CSS Georgia* (Cannon No. 3, Artifact 1611) immediately after recovery, showing the distinctive shape and characteristics of the Brooke rifle.

The distinctive shape of his guns (Figure 6-274) indicates an acknowledgement, along with many other gun founders such as Joseph Reid Anderson, Theophilus Alexander Blakely, and John A. Dahlgren, that a hemisphere is the strongest cap for a cylindrical pressure vessel. He also understood, along with Daniel Treadwell, Blakely, and Robert Parker Parrott, the gain in strength from adding wrought iron banding around a cast iron tube.

With minor exceptions, existing heavy rifled cannon of his design may be identified by five conspicuous features (Olmstead et al. 1999:125):

1. A fully hemispheric breech contour
2. One to three layers of butt-welded reinforcing bands, each finished to about 6 inches wide and 2 inches thick; subsequent layers, when used, were “shrunk upon the first, breaking [covering] the joints”
3. A plain tapered chase, extending from the fore end of the reinforcing bands to the muzzle
4. Practical Confederate “dispensing with the turning of the exterior surface of the Gun”—in as much that the exteriors remain rough; those from the Selma foundry usually reveal the joints of the seven-section vertical foundry flasks
5. Seven-groove rifling of righthand twist and “triangular” grooves, henceforth identified as “Brooke rifling” (Figure 6-275)

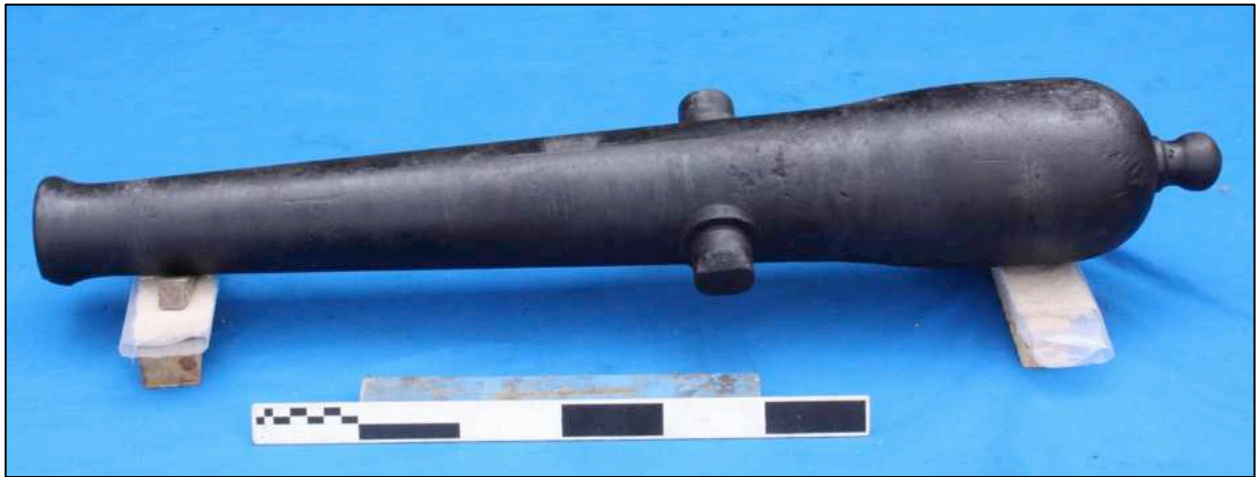
Figure 6-280. Recovered 6-pounder cannon, Cannon No. 1, Artifact 1610, the *CSS Georgia*'s aft spar deck gun; scale in feet.

during recovery at 6 feet 5 inches in length (Figure 6-280). Figure 6-281 shows the left trunnion is marked August 1862. Observe that the “6” in 1862 is reversed left to right. The only way to accomplish this error is to use a foundry pattern stamp, which is reversed for use on molds. Figure 6-282 shows the right trunnion is marked with “Noble Brothers Co” on top with “Rome GA” underneath.

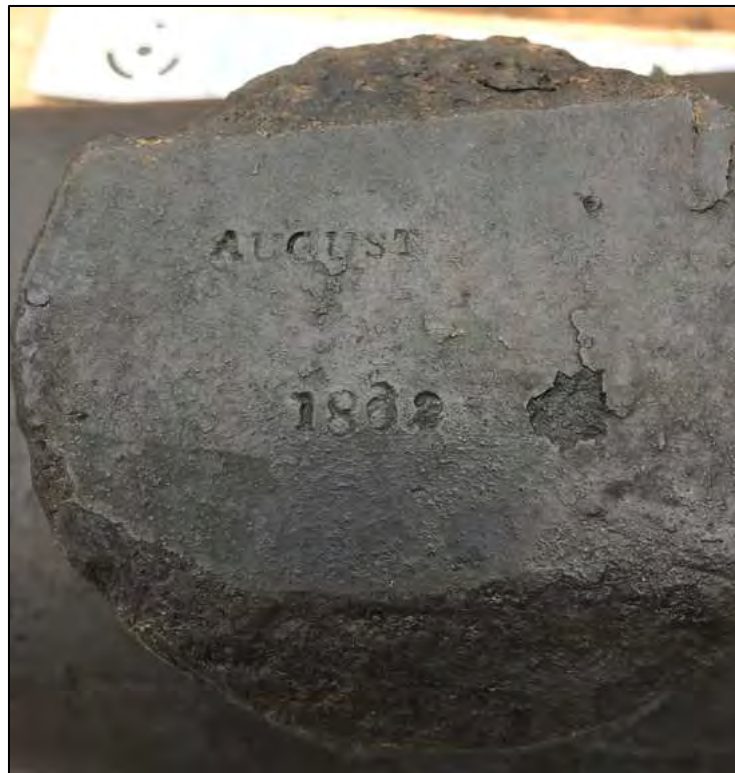
Figure 6-281. Left trunnion of recovered 6-pounder cannon marked August 1862. Observe the “6” in 1862 is reversed left to right. The only way to accomplish this error is to use a foundry pattern stamp, which is reversed for use on molds.

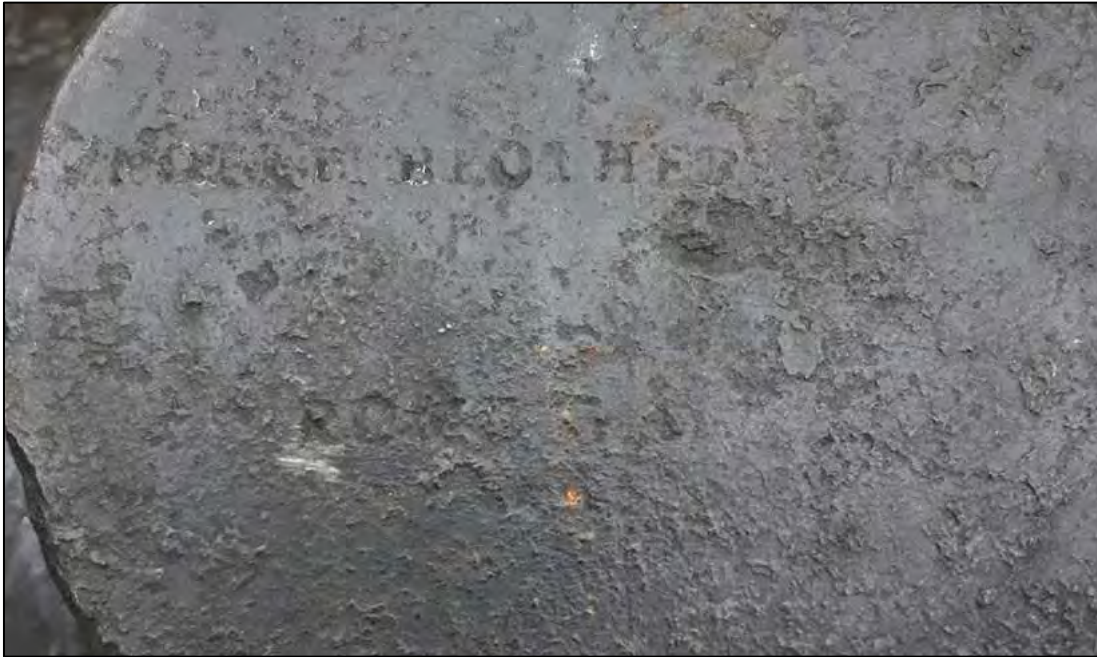
Figure 6-282. Right trunnion of recovered 6-pounder cannon marked with “Noble Brothers Co” on top with “Rome GA” underneath.

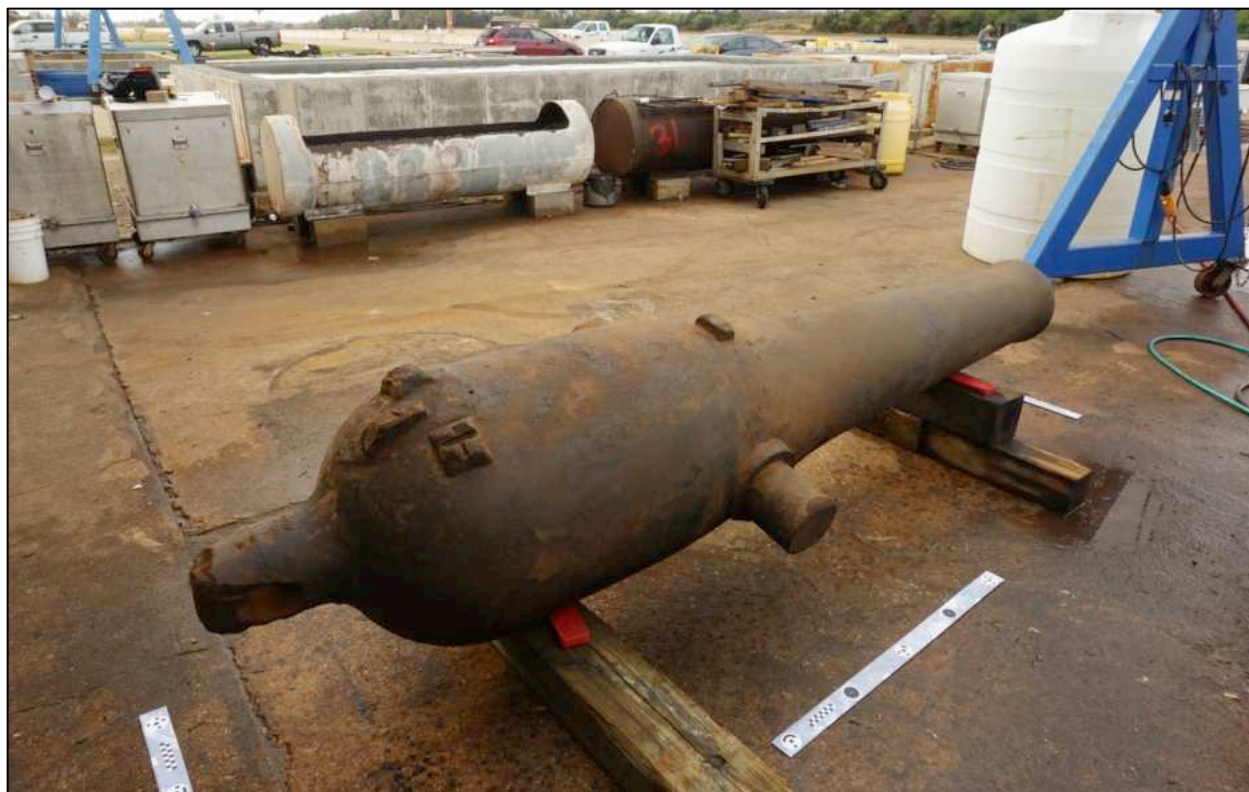
Figure 6-283. IX-Inch Dahlgren, Cannon No. 2, Artifact 1612, removed from electrolysis for recordation.

Two Dahlgren cannon were recovered from the site, Cannon Nos. 2 and 5, and two are recorded as being on the CSS *Georgia* in 1863. Illustrated in Figure 6-283, Cannon No. 2 (Artifact 1612) was recovered from Unit 10-D. This cannon was identified based on records as the No. 1 Port Gun on the vessel, a IX-Inch Dahlgren recorded as having the following markings when first placed on the CSS *Georgia*:

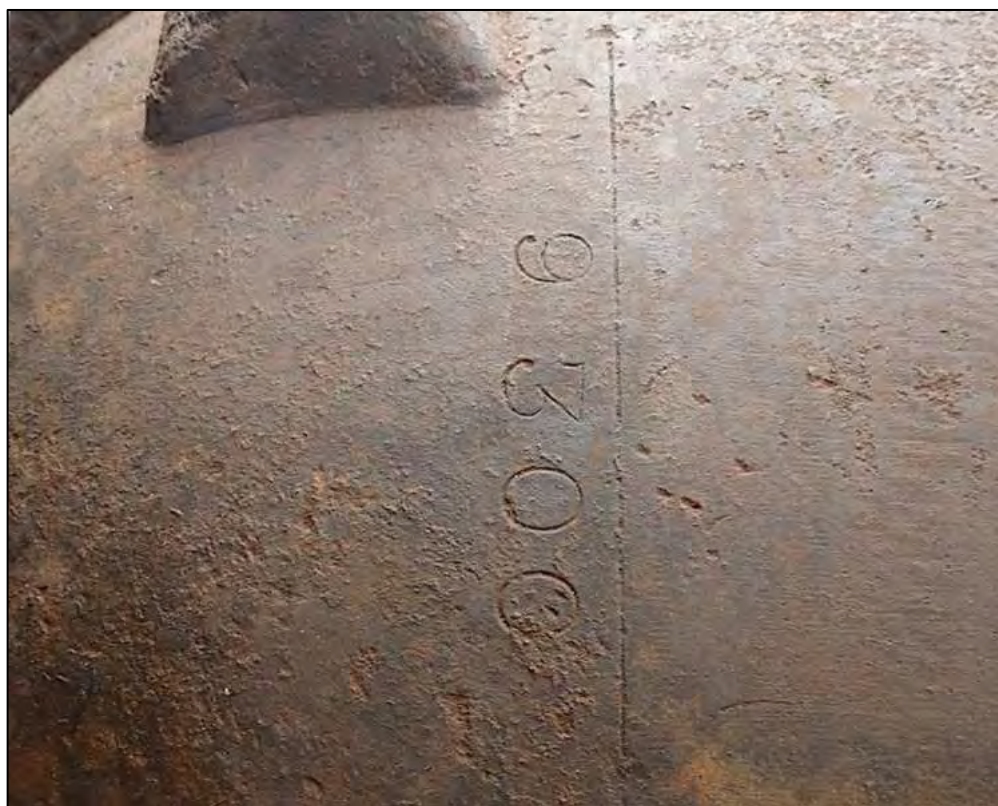
Figure 6-284. IX-Inch Dahlgren, Cannon No. 2, Artifact 1612, showing a weight of 9,300 pounds stamped in line with the breech. Right percussion lock lug at top left.

Taken out of electrolysis for recordation, the gun had an overall length of 11 feet. Figure 6-284 shows the gun’s weight as 9,300 pounds, stamped parallel to base ring on the breech, which matches the recorded weight, while the muzzle is stamped with “1389,” which also matches the original record for the vessel’s No. 1 Port Gun (Figure 6-285). Illustrated in Figures 6-286 and 6-287 are the trunnions. The left trunnion, heavily corroded, is marked with what appears to be a possible 1 and 8, and then a possible 6. The right trunnion is marked on the top line with “JRA” for Joseph R. Anderson, and underneath “TF” for the Tredegar Foundry, all of which match the original record.

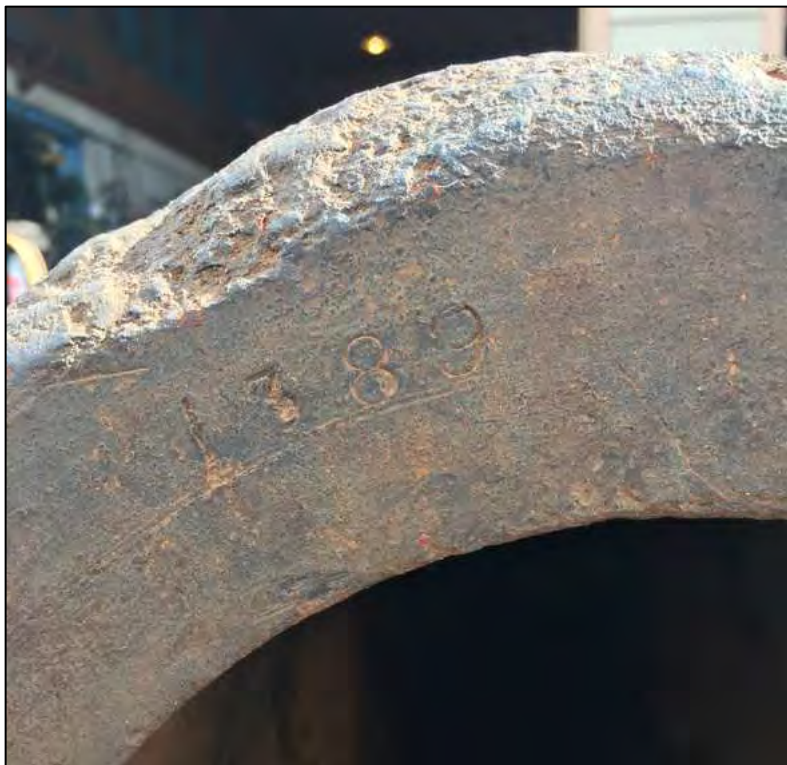
Figure 6-285. IX-Inch Dahlgren, Cannon No. 2, Artifact 1612, the breech stamped with “1389,” which is the foundry number.

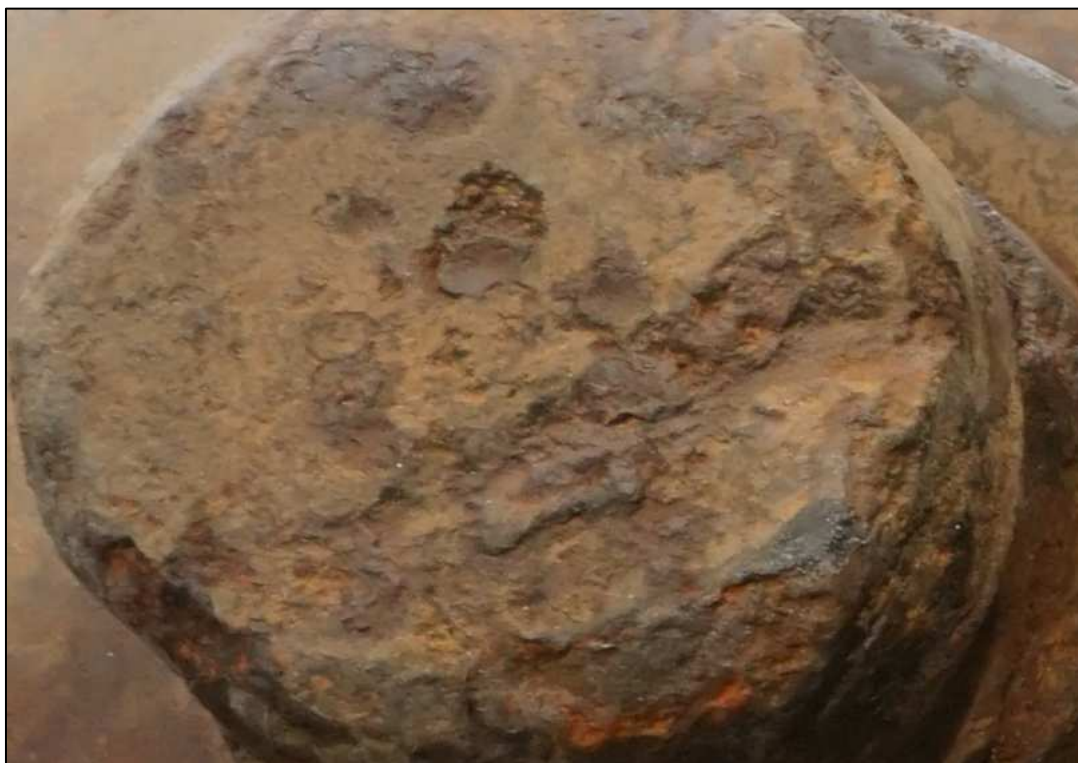
Figure 6-287. Left trunnion of IX-Inch Dahlgren, Cannon No. 2, Artifact 1612, marked with what appears to be a 1 and 8, and then a 6.

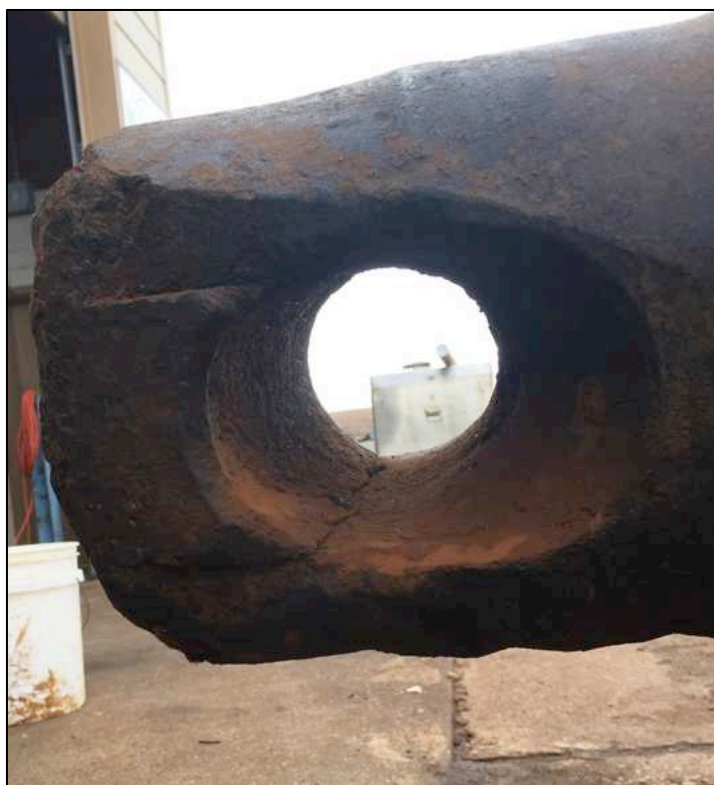
Figure 6-288. View of cascabel showing it is a composite or has an insert completing the circular opening for rope.

Figure 6-288 is a photograph of the cascabel showing it is a composite or has an insert completing the circle for rope, while Figure 6-289 is shows the tangent sight mount (or lug), as well as two percussion lock mounts (or lugs). As discussed above, the lateral vent on the right was initially drilled through, while the left vent was only partially drilled so as to indicate the correct angle. The left lock lugs were left solid, or the slot filled with zinc. The right vent, when eroded to 0.40 inch, was closed by molten tin, zinc, or lead and the left vent drilled through.

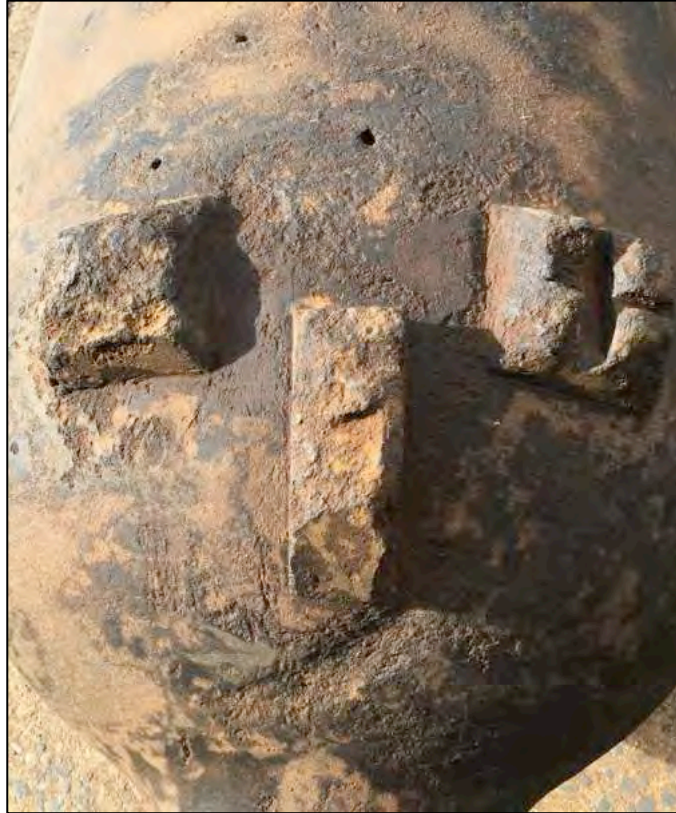
Figure 6-289. Tangent sight mount (or lug; center), as well as two percussion lock mounts (or lugs; left and right). Cuts or impressions on right lock lug indicate that it was employed at the time of scuttling; note touch hole.

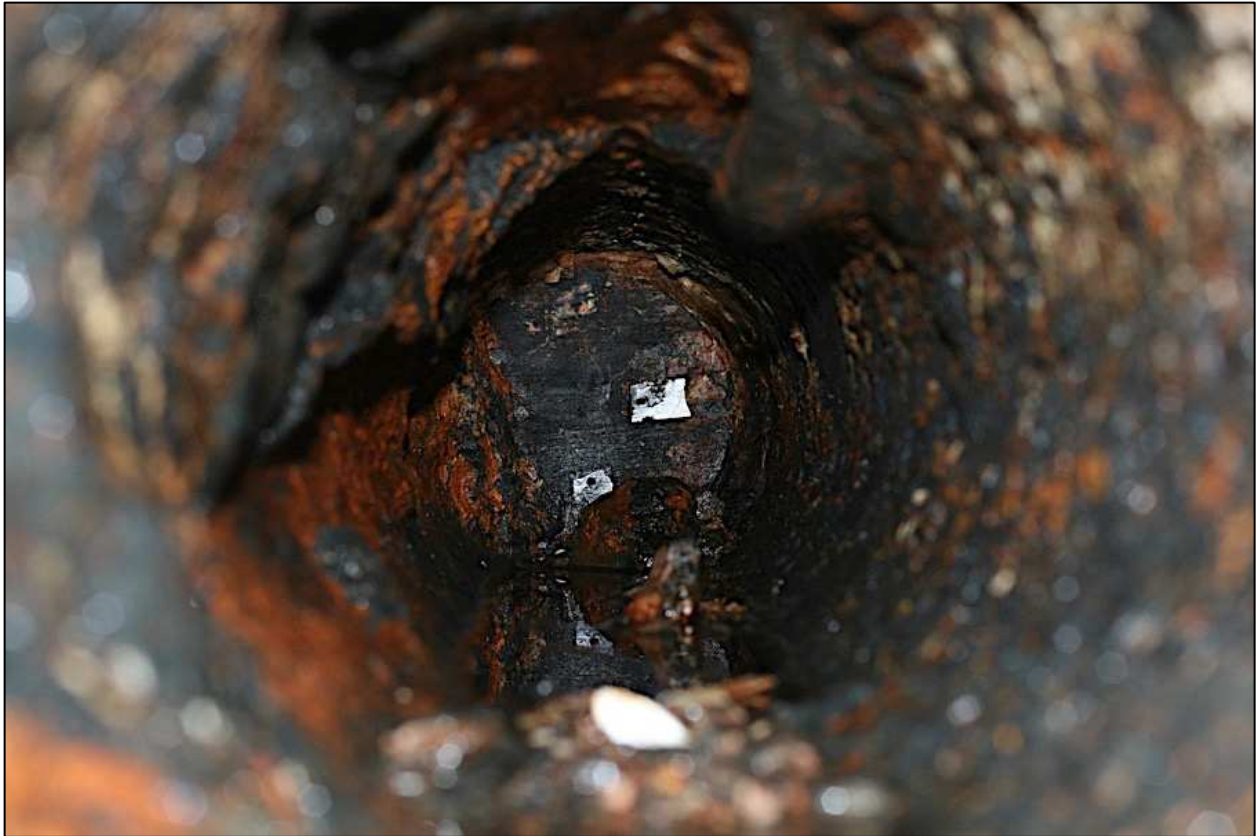
Figure 6-290. Looking down the bore of the IX-Inch Dahlgren, Cannon No. 5, Artifact 1823.11, at the sabot of the inverted shell.

At the time of writing, the cannon bore has been cleaned nearly down to the breech. Before the vessel was scuttled, a 9-inch shell was placed backwards down the bore, so as to prevent it from being fired safely. The wooden sabot pictured in Figure 6-290 has been removed successfully, but the shell is being stubborn and resisting all removal efforts. The sabot is presented in the DMM section below.

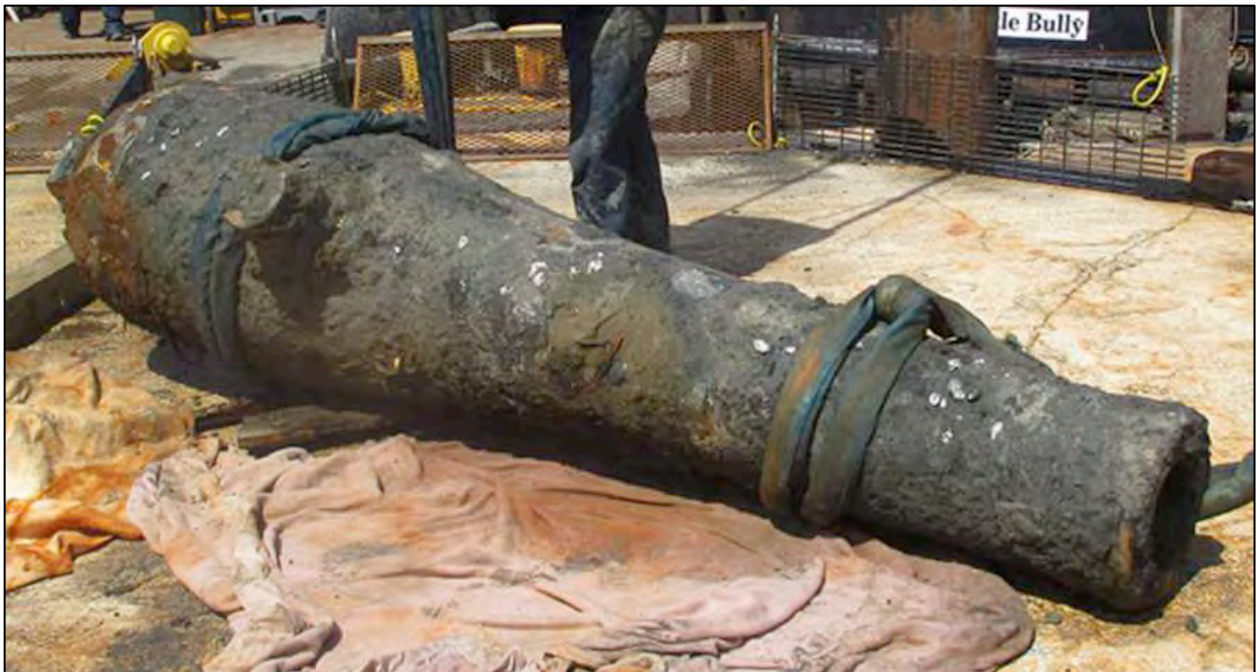
Figure 6-291. IX-Inch Dahlgren, Cannon No. 5, Artifact 1823.11 was recovered from Unit 6-F.

Cannon No. 5 (Artifact 1823.11; Figure 6-291) was identified based on records as the No. 4 Port Gun on the vessel, a IX-Inch Dahlgren was recorded with the following markings when first placed on the CSS *Georgia*:

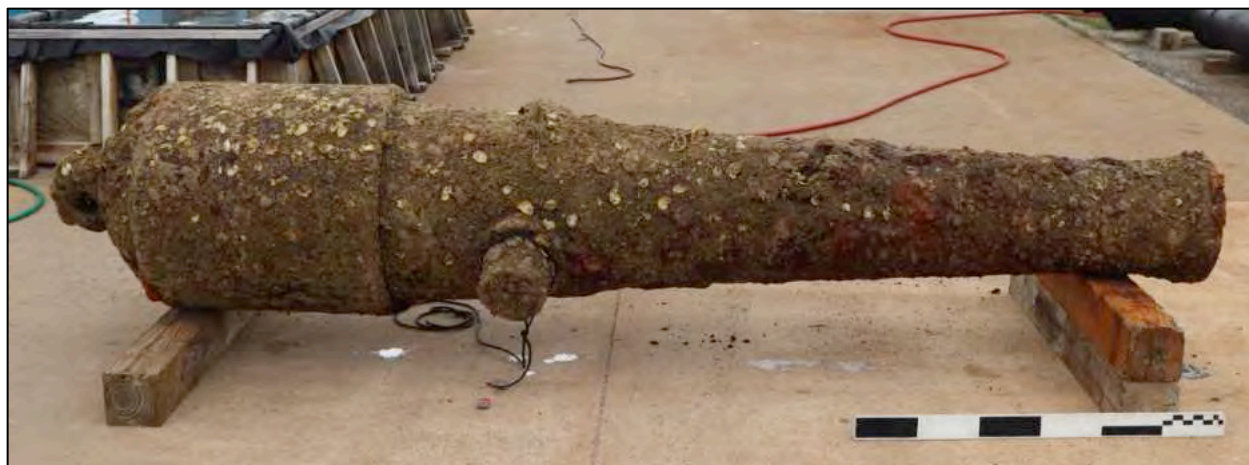
Figure 6-292. 6.4-inch Brooke rifle, Cannon No. 3, Artifact 1611 recovered from Unit 8-D, pre conservation.

Recovered from Unit 8-D, Figures 6-292 and 6-293 show the concreted gun prior to electrolysis and then taken out of electrolysis for recordation. A bronze dispart gun sight, the only sight found attached to any of the guns, is visible on the cleaned gun. Guns sights are discussed below.

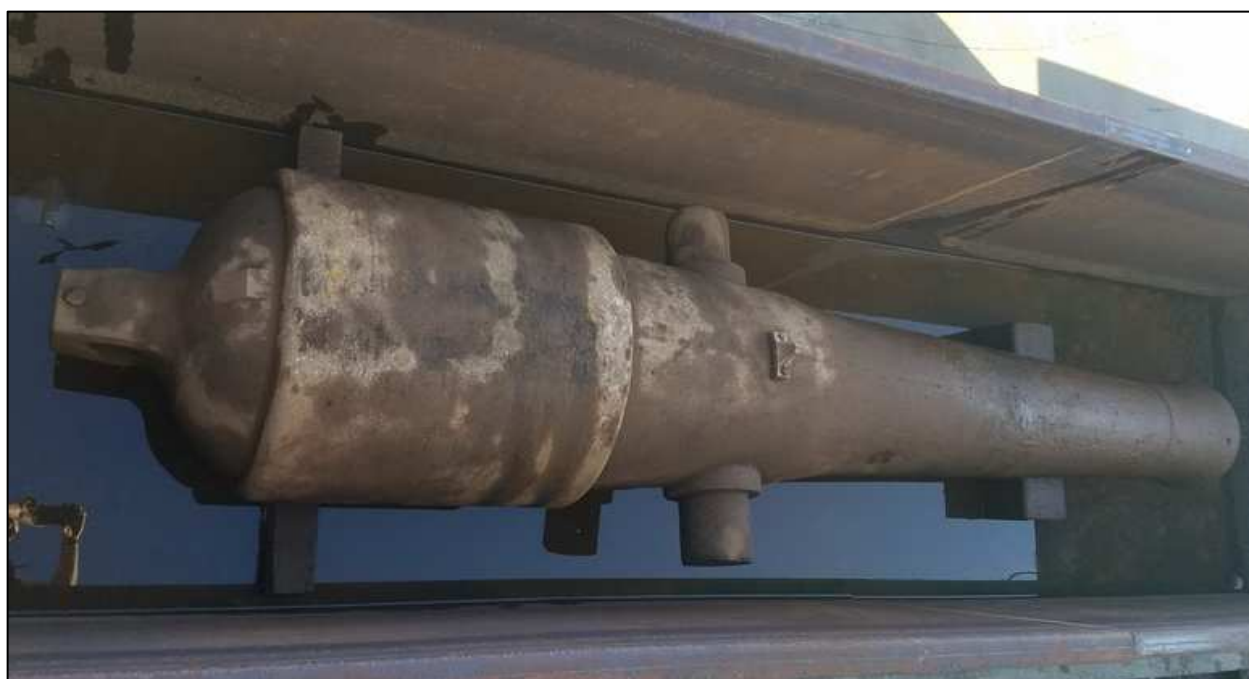
Figure 6-293. 6.4-inch Brooke rifle, Cannon No. 3, Artifact 1611 during electrolysis. The dispart sight, the only one found attached to any of the guns, is visible on the cleaned gun above the trunnions.

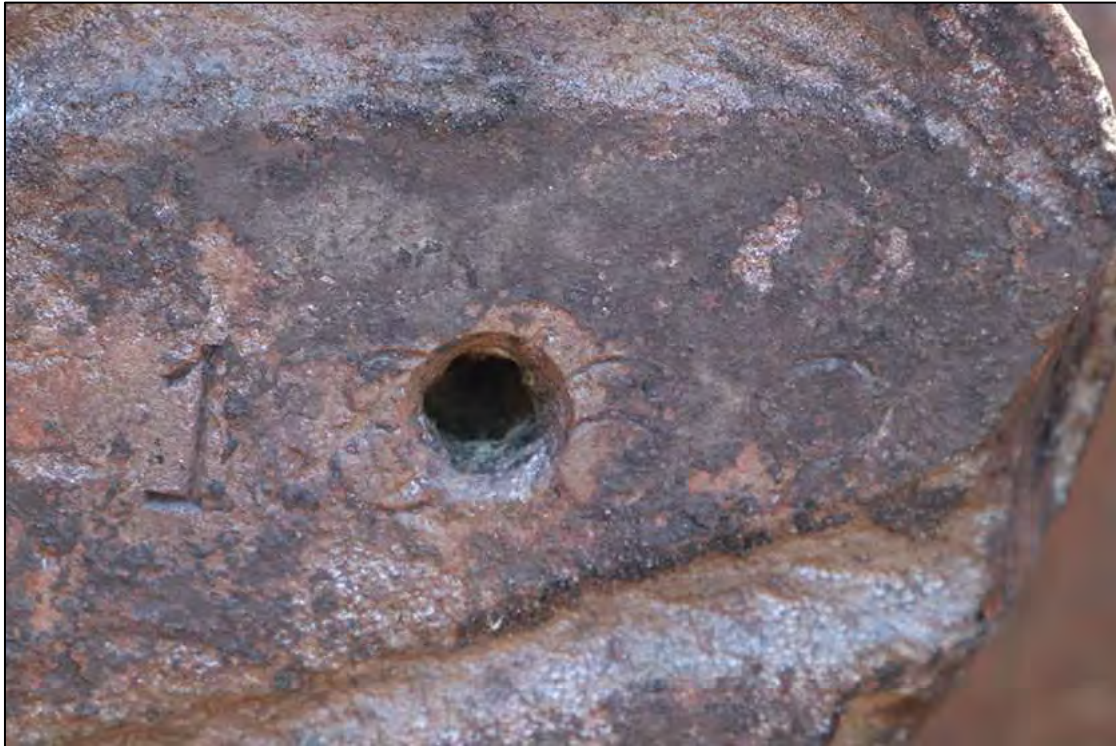
Figure 6-294. Left trunnion of 6.4-inch Brooke rifle, Cannon No. 3, Artifact 1611 marked with “1862,” the year it was produced. Note the threaded hole present in the center face of the stamp, placed after stamping; its purpose is unknown.

Measured at the time of recovery, the gun had an overall length of 10 feet 8 inches. Illustrated in Figures 6-294 and 295 are the trunnions. The left trunnion is marked with “1862,” the year it was produced. Interestingly, it has a threaded hole present in the center face of the stamp, drilled after it was stamped; its purpose is unknown. The right trunnion is marked on the top line with “JRA” for Joseph R. Anderson, and underneath “TF” for the Tredegar Foundry, all of which match the original record.

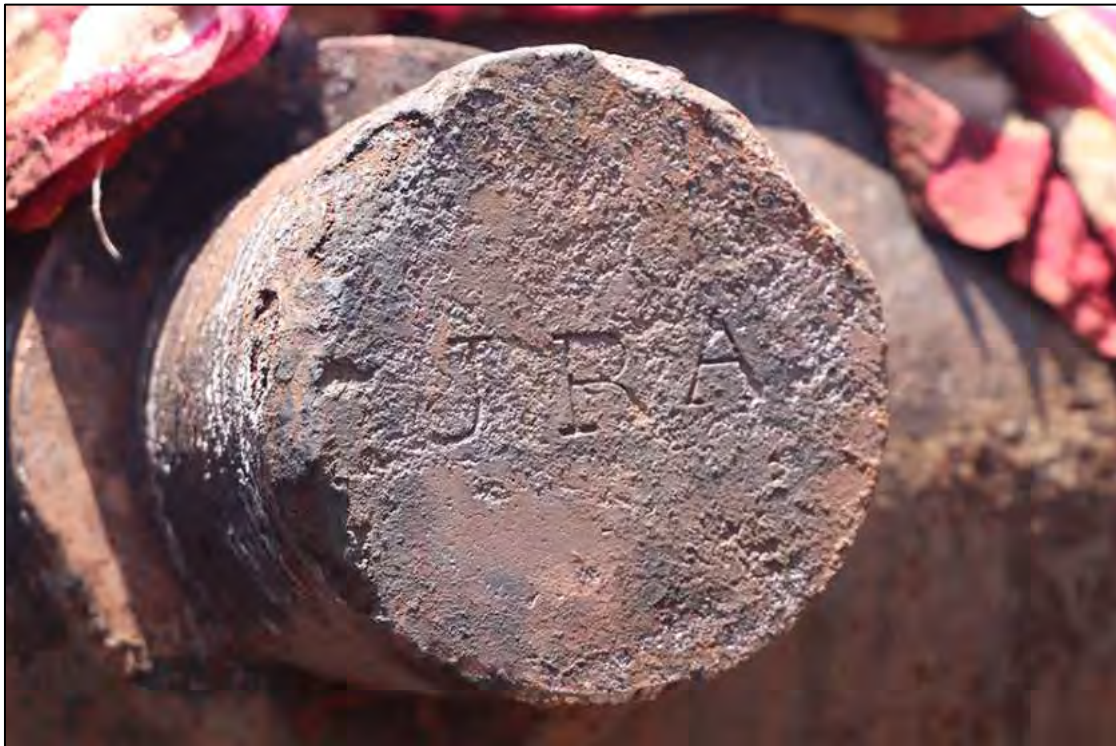
Figure 6-295. Right trunnion of 6.4-inch Brooke rifle, Cannon No. 3, Artifact 1611 stamped with the “JRA” foundry mark for John R. Anderson, owner of the Tredegar Iron Works in Richmond, Virginia, where it was produced.

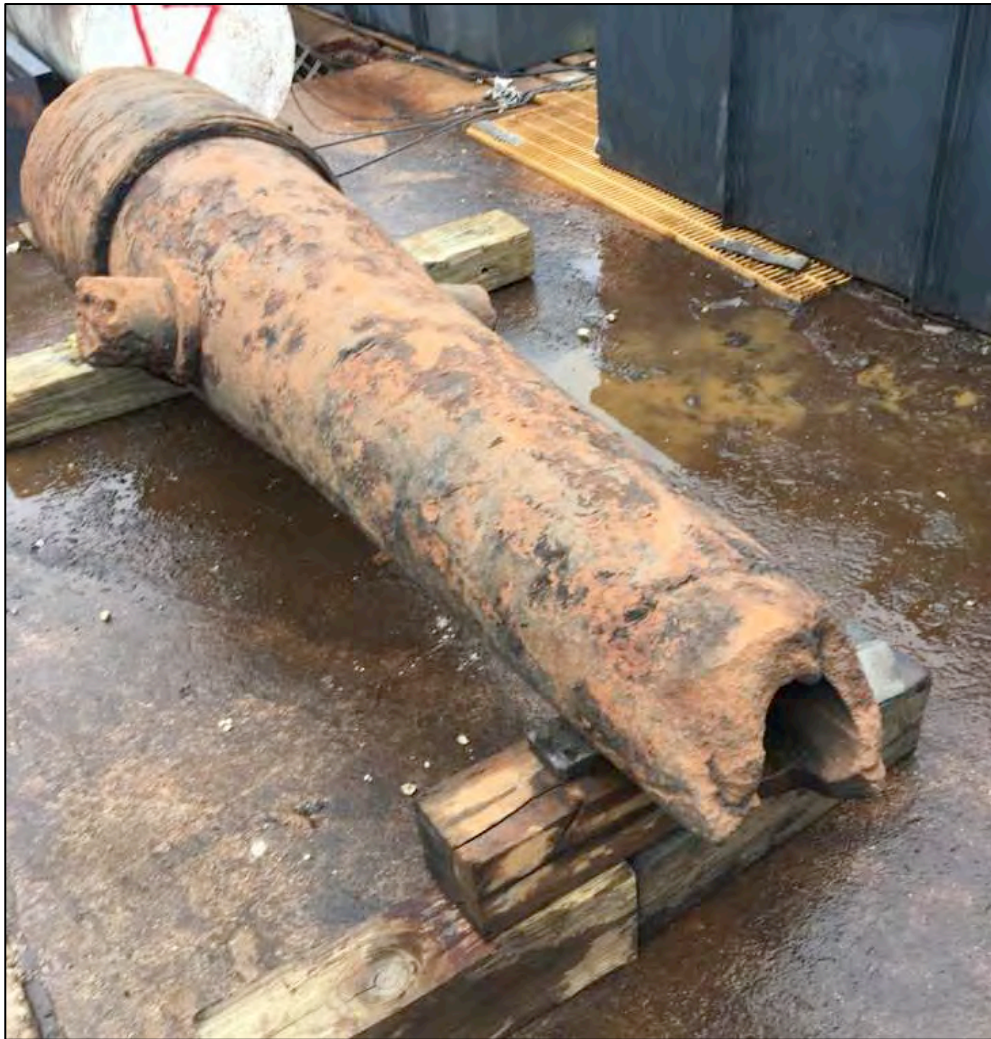
Figure 6-296. 6.4-inch Brooke rifle, Cannon No. 4, Artifact 1613 taken out of electrolysis for analysis. As a result of one of two muzzle explosions aboard the CSS *Georgia* thought to be the result of defective shells, the remaining length is just under 10 feet.

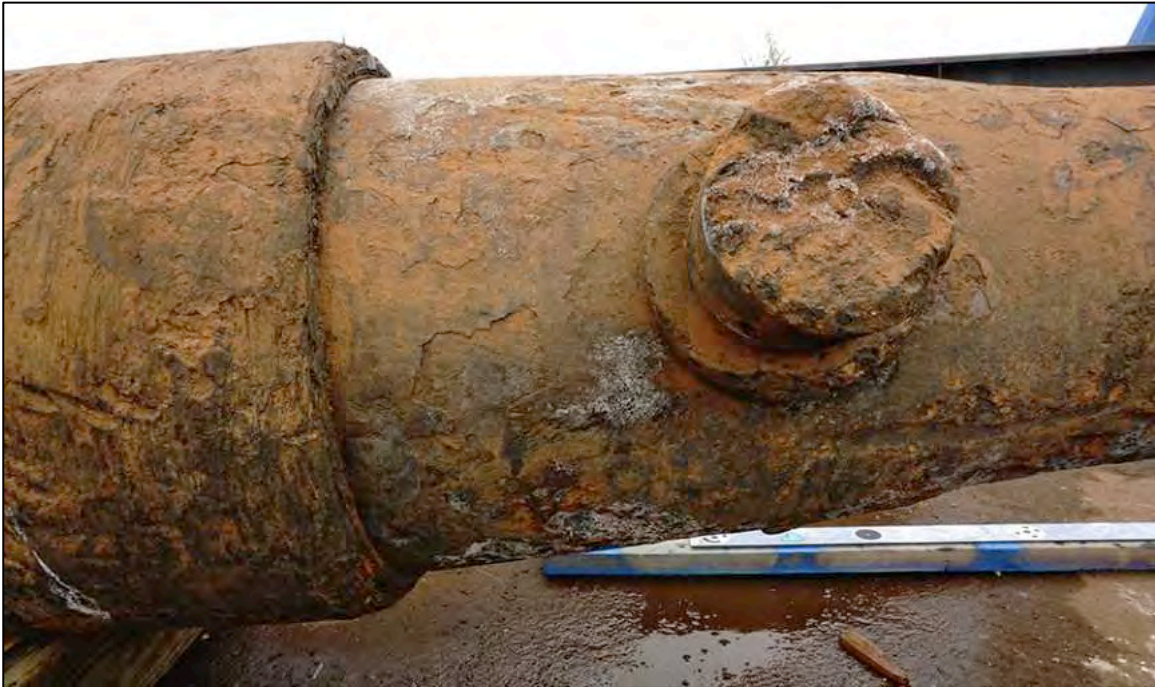
Figure 6-297. Right trunnion of 6.4-inch Brooke rifle, Cannon No. 4, Artifact 1613 showing extreme corrosion precluding observation of foundry markings.

Because of severe corrosion (Figure 6-297), no markings remain on the gun. While the corrosion has erased any trace of markings, it does allow us to see the wrought iron breech banding in relationship to the cast iron of the cannon tube (Figure 6-298). Damaged by corrosion as well, the cannon is also missing part of its muzzle as is evidenced in Figure 6-296. As discussed above, there were two muzzle explosions on board the CSS *Georgia* thought to be

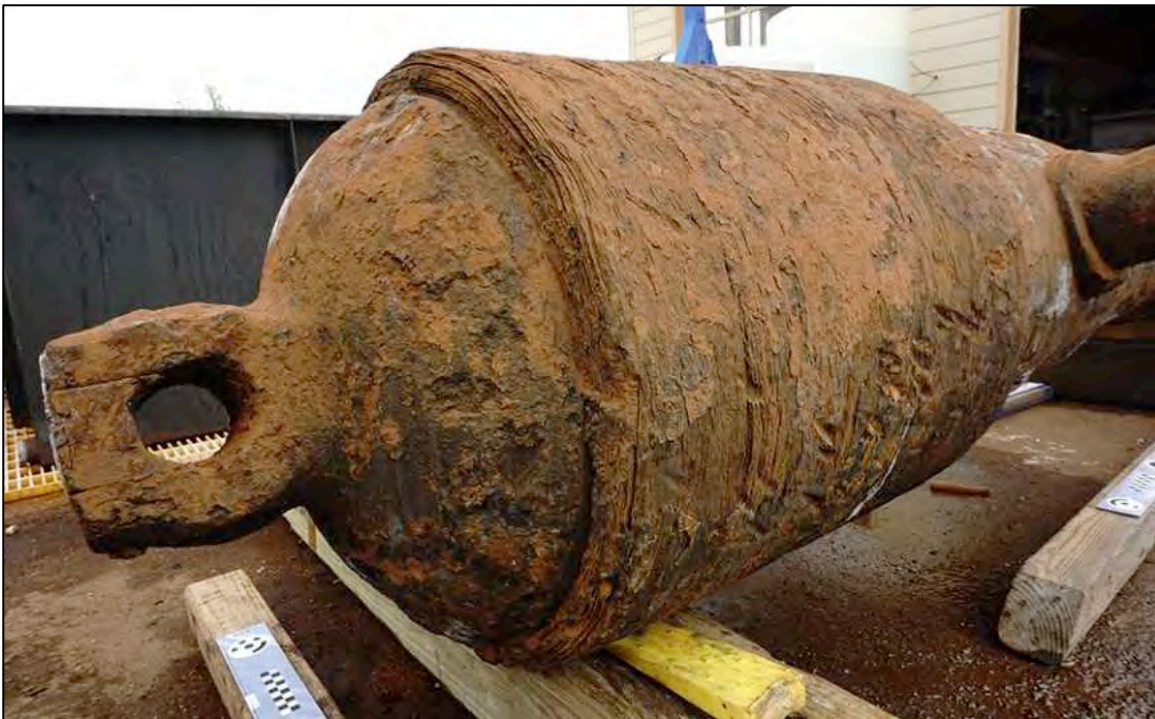
Figure 6-298. Breech of 6.4-inch Brooke rifle, Cannon No. 4, Artifact 1613 showing layered wrought iron breech banding in relationship to the cast iron of the cannon tube. Note the similarity to the insert completing the circular opening for rope of Cannon No. 2 (Artifact 1612) in Figure 6-288.

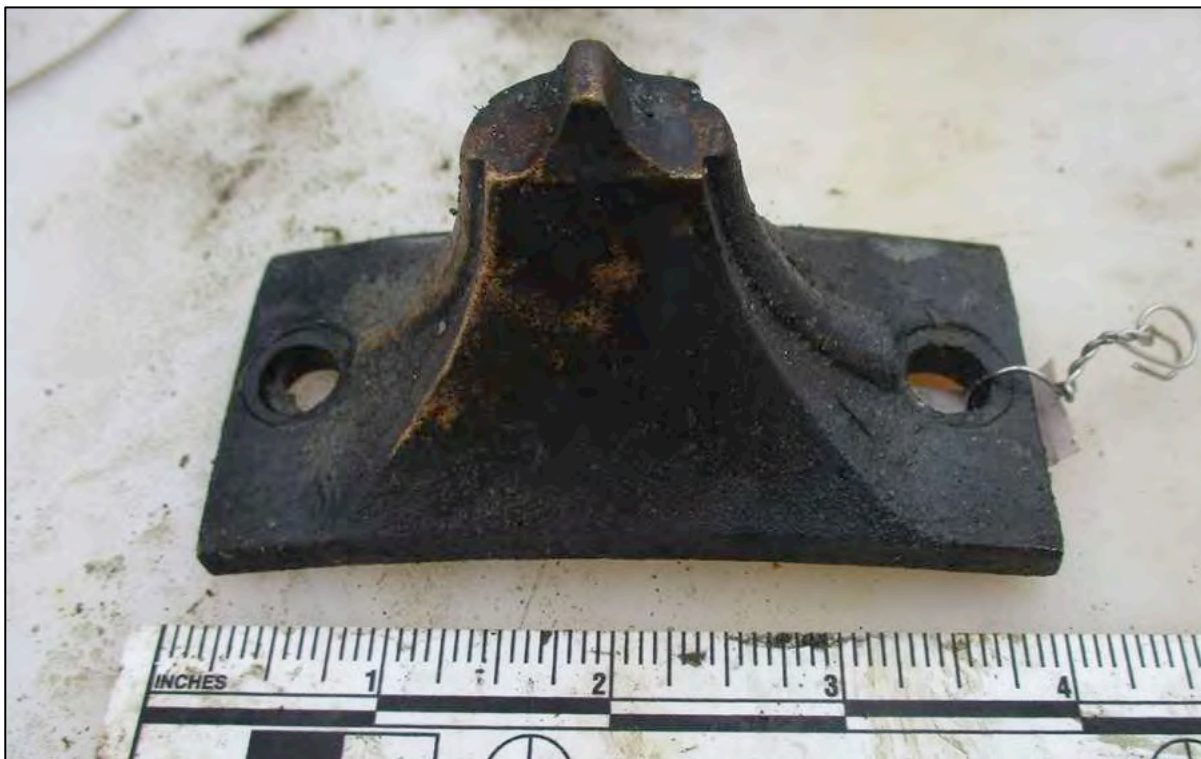
Figure 6-299. Dispart sight recovered from CSS *Georgia*.

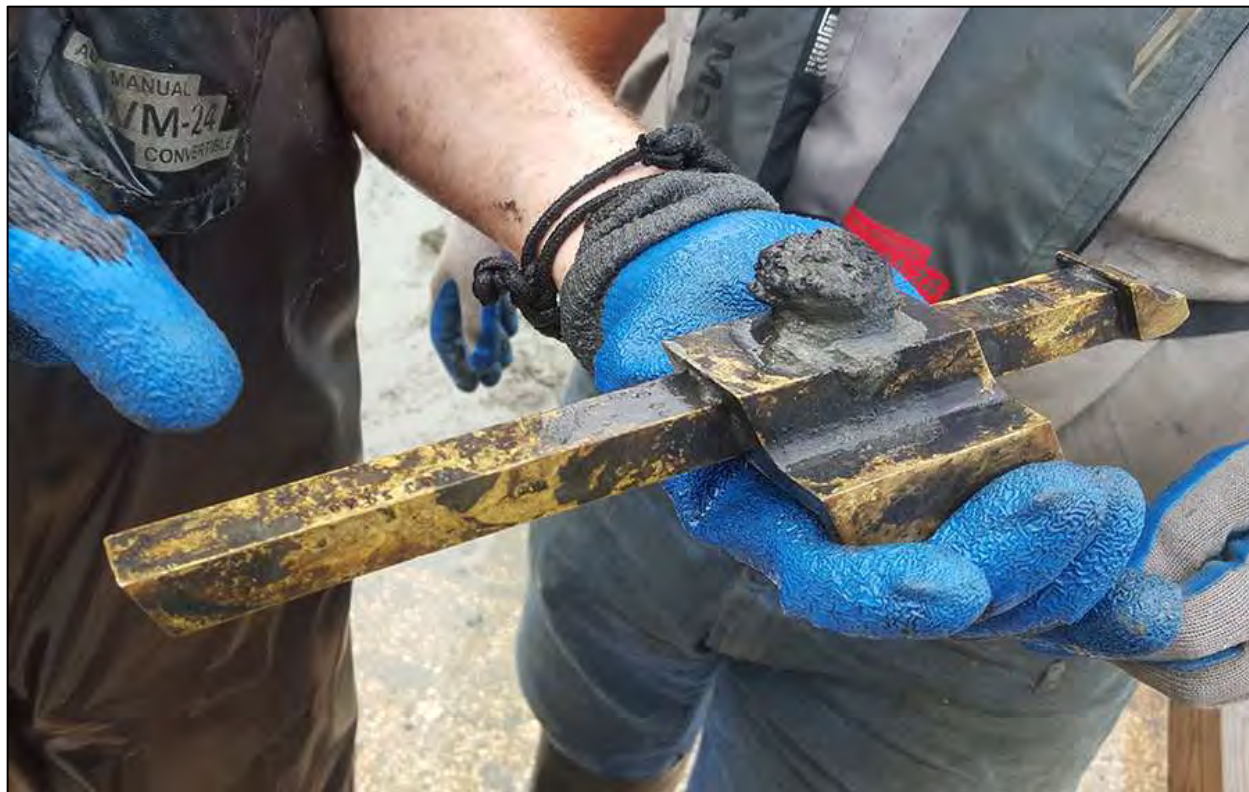
Figure 6-300. Tangent sight recovered from the CSS *Georgia*.

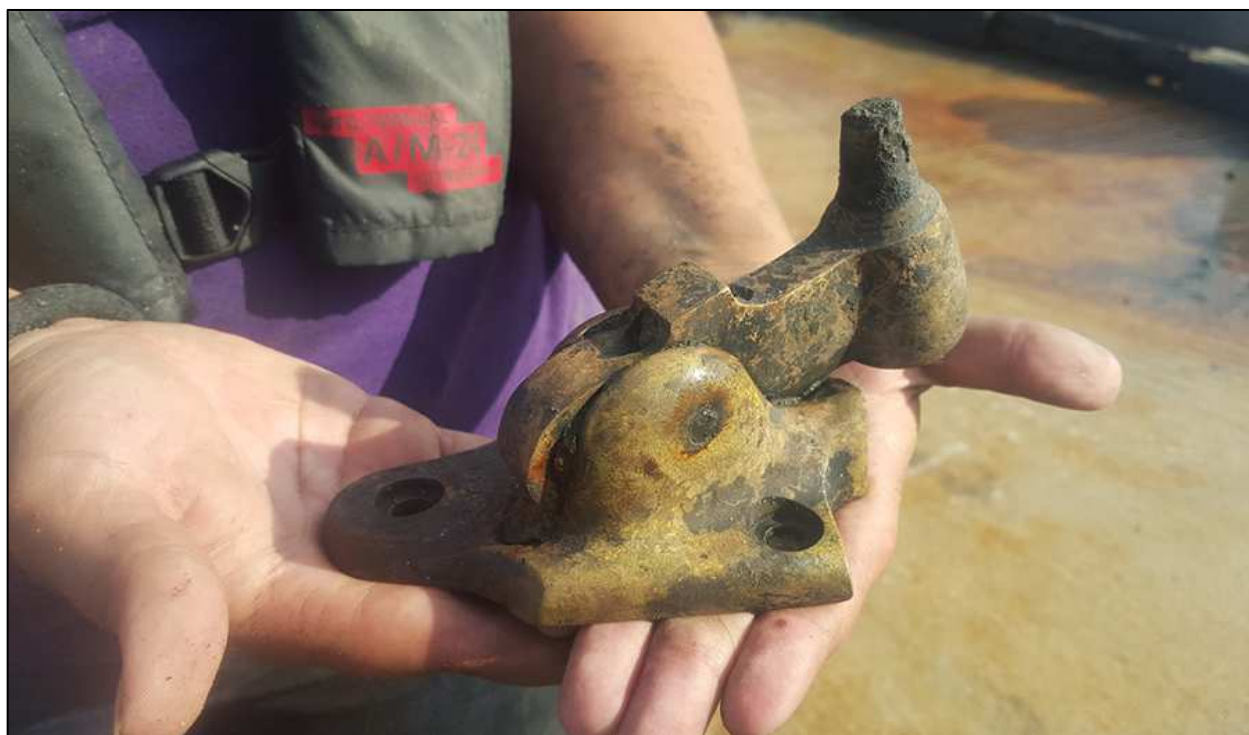
Figure 6-301. Percussion lock/hammer recovered from the CSS *Georgia*.

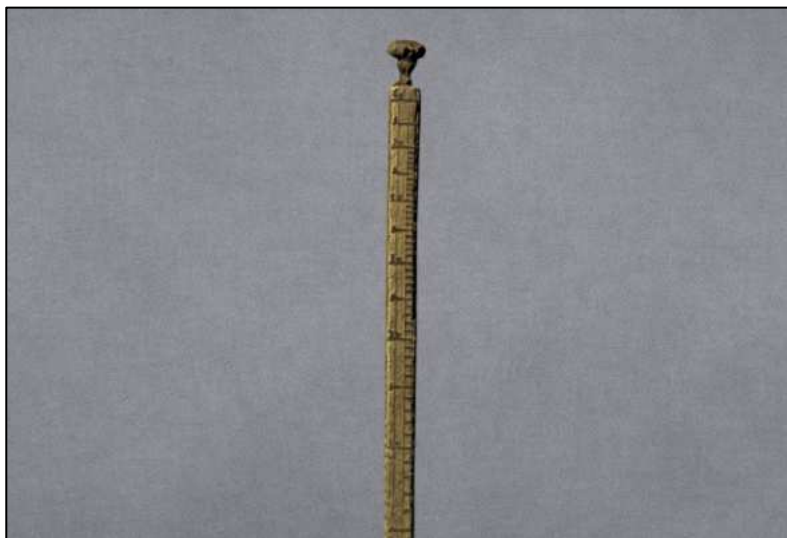
Figure 6-304. Spanish “gunner’s bar” from Douglass Beach Wreck Site (courtesy of Florida Division of Historical Resources).

the muzzle. The difference (called “*el vivo*” by the Spanish) between the two marks, with an adjustment for the base ring (which was higher than the vent), was calculated and fixed using a small wedge of proper size (Manucy 1949:76-77). Archaeologists working at the 1715 Spanish Douglass Beach Wreck in Florida recovered a brass “gunner’s bar” (Figure 6-304) now being conserved by the Florida Bureau of Archaeological Research (Jessica R. Stika electronic communication, 2017). The surface of this artifact is graduated and seems appropriate for the aforementioned process.
