CSS *GEORGIA*
ARCHEOLOGICAL DATA RECOVERY AND MITIGATION
FOR THE SAVANNAH HARBOR EXPANSION PROJECT (SHEP),
CHATHAM COUNTY, GEORGIA AND JASPER COUNTY, SOUTH CAROLINA

**FINAL DRAFT REPORT
OCTOBER 2019**

Stephen R. James, Jr. and Gordon P. Watts

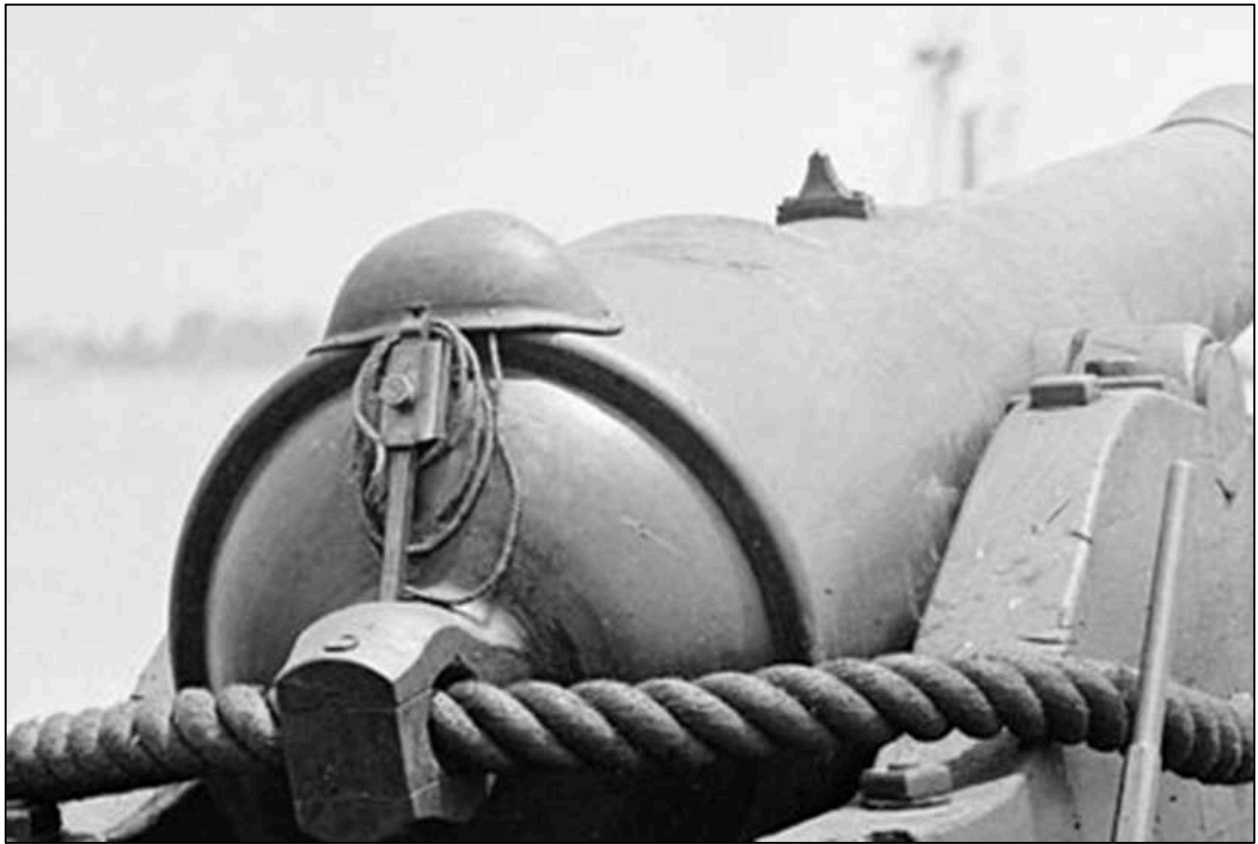
Figure 6-312. Brooke Rifle on the CSS *Teaser* showing the location of the tangent sight above the cascabel, and dispart sight forward in the center of the gun. Note the percussion lanyard placed around the tangent sight and that runs under the percussion lock cover for firing (as presented in Miller and Lanier 1911:77).

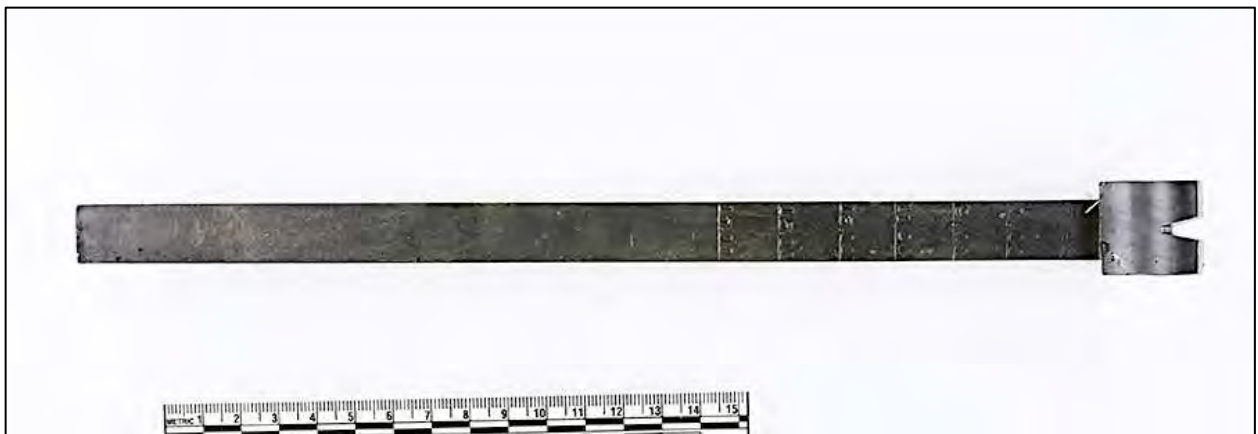
Figure 6-314. Artifact 2160.9 - L.: 11.3 in. (28.7 cm), W.: 0.6 in. (1.5 cm), W. of head: 0.9 in. (2.3 cm), L. of head: 0.7 in. (1.8 cm). Typical graduated tangent scale. Graduations are from right to left: 340, 700, 900, 1100, 1300, 1500, and 1700.

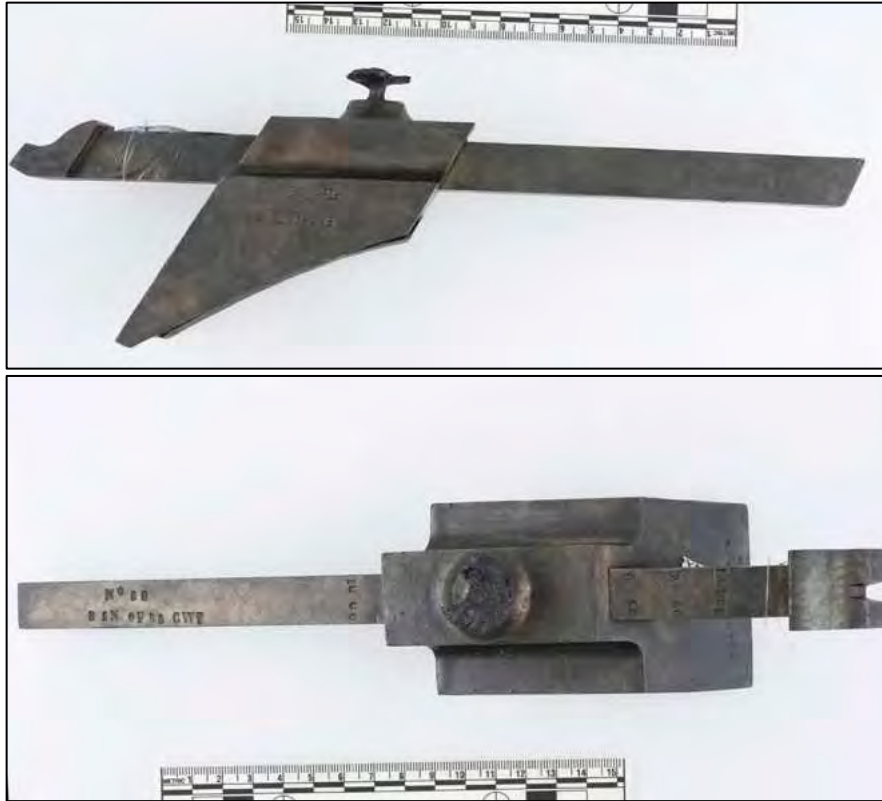
Figure 6-315. Artifact 1892.3 – Top and Side View – Width of “box” 2.4 in. (6.1 cm), Diameter of screw hole: 0.2 in. (0.5 cm), Width of tangent scale: 0.6 in. (1.5 cm), Length of tangent scale: 10.5 in. (26.7 cm). Typical tangent sight. Stamps on scale read: NO 58, 8 IN. OF 55 CWT. Lowest graduation on scale is 260. Largest graduation on scale in 1860. Screw to secure tangent scale still present.

An idea of the composition of the CSS *Georgia*’s battery is given by other markings on these artifacts. Three of the nearly complete tangent sights are marked with the type of gun on which they were mounted. The front of sight box Artifact 1874.5 (see Figure 6-318) reads: NO 3 of 6600. This can represent the manufacturing number or, more likely, the type of gun on which the sight was mounted. Two of the 32-pounders on board the CSS *Georgia* in 1863 were of 66 hundredweight (7,392 pounds or 3,353 kilograms) and this tangent sight might have belonged to one of them. The front of the sight box of sight Artifact 1856.10 (see Figure 6-317) reads: 8 IN. 56 CWT. The head of the graduated scale reads: 8 IN. SHELL...7 LBS. The bottom of the graduated scale of sight Artifact 1892.3 (see Figure 6-315) reads: 8 IN OF 55 CWT.

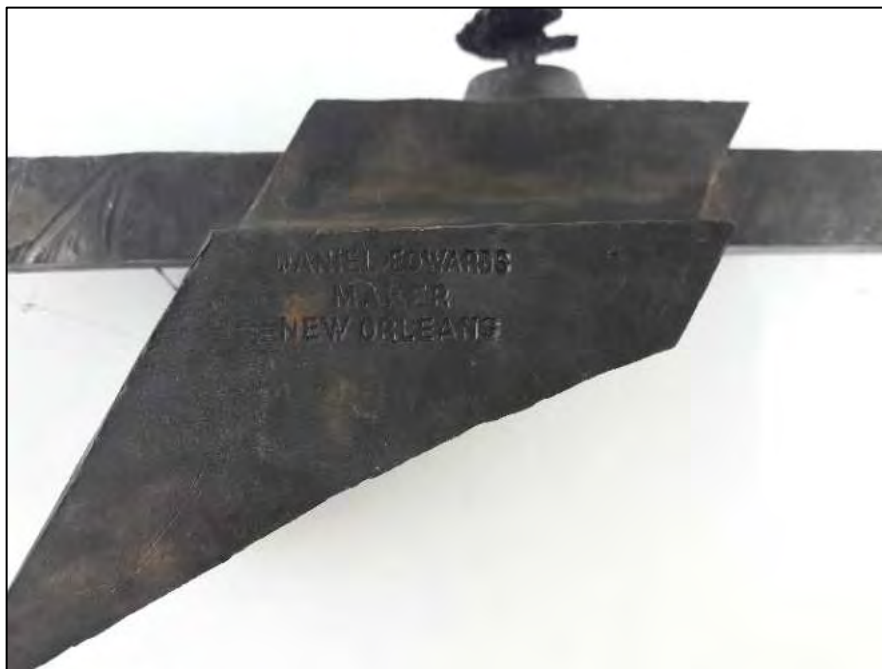
Figure 6-316. Artifact 1892.3 - Maker's mark on the side of the tangent “box” reads: DANIEL EDWARDS, MAKER, NEW ORLEANS.

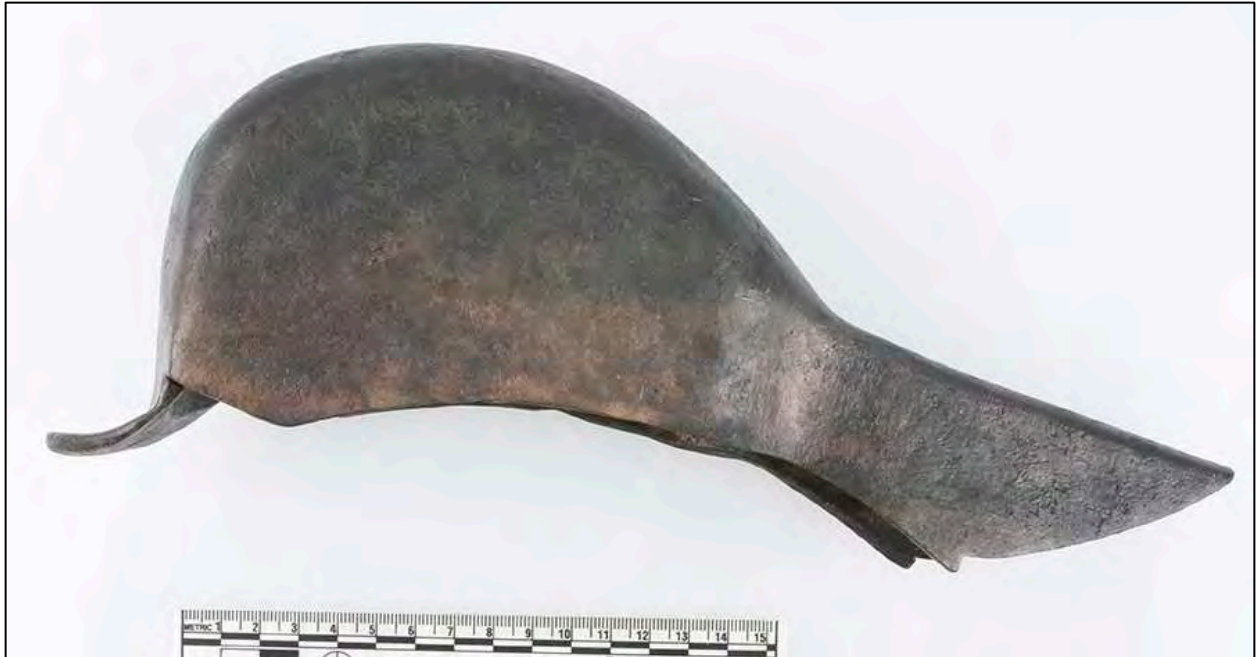
Figure 6-317. Artifact 1972.1 - Max. width: 2.7 in. (6.9 cm), Max. length: 11 in. (27.9 cm). Distinct shape of a Tangent cover. Narrow section is slightly bent. Stamp on top of artifact reads: NO 79.

dispart sights, only four sights have been found because one sight and cover go together. It was standard practice to place covers over dispart and tangent sights when they were not in use (Tucker 1989:40). The collection of tangent sights consists of two covers, Artifact 1972.1 (see Figure 6-316) and 1850.17 (see Figure 6-321), two sight “boxes,” Artifact 978 (see Figure 6-319), and Artifact 2997.4 (see Figure 6-320), one graduated tangent scale (Artifact 2160.9), and three nearly complete tangent sights consisting of both box and scale sliding through it (Artifacts 1856.10, 1892.3, and 1874.5). No marking on any standalone sight covers or boxes match the numbers on the standalone scale or on the nearly complete tangent sights.

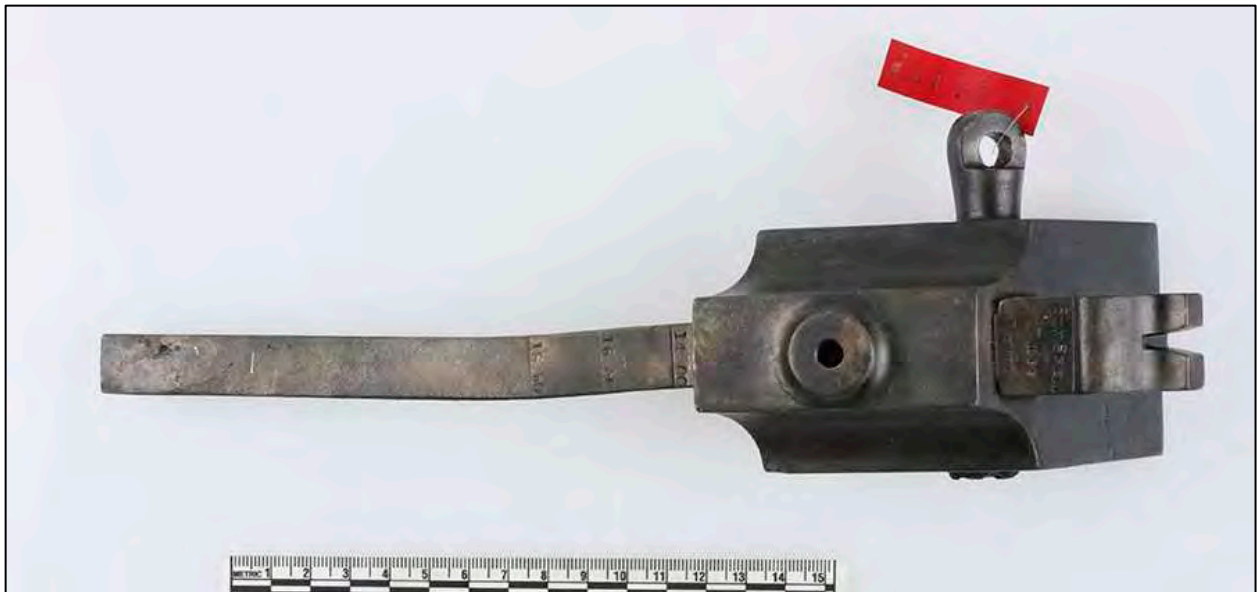
Figure 6-318. Artifact 1856.10 - W. of "box": 2.3 in. (5.8 cm), Diameter of screw hole: 0.3 in. (0.8 cm), W. of tangent scale: 0.6 in. (1.5 cm), L. of tangent scale: 10.5 in. (26.7 cm). Typical tangent sight. Tangent scale slightly bent. Largest graduation is 1860. Stamps on head read: 8 IN. SHELL, 7 LBS. LEVEL. Stamps on "box" read: NO: 112 8 IN. 56 CWT.

Out of the entire collection of gun sights, three artifacts have number 112 engraved on their surface: the dispart sight cover Artifact 1881.28 (see Figure 6-327), dispart sight Artifact 1855.6 (see Figure 6-323), and tangent sight Artifact 1856.10, which has a stamp that reads: 8 IN. SHELL, 7 LBS. LEVEL (see Figure 6-317). It is very likely they belong to the same system of sights mounted on the 8-inch shell gun because the U.S. Navy Bureau of Ordnance and Hydrography had made it mandatory for guns to be equipped with a dispart sight at the second reinforce of the gun and a tangent sight at the breech since 1848. Although Confederate naval ordnance differed from Union naval ordnance in some ways, their systems were still based on standard U.S. Navy systems because many naval officers, including John Mercer Brooke, a distinguished artillerist and U.S. Navy veteran of twenty years’ service, defected to the Confederacy when the Civil War began and took their experience, knowledge, and skills with them (Tucker 2002:6; Brooke 2002:viii-ix, 13-14). Further, because it was preferable to conduct naval engagements at long distances during the first half of the nineteenth century (Ward 1861:122; Holley 1865:203-204) and the new system of tangent and dispart sights was deemed revolutionary and indispensable by anyone who placed any value on long-range accuracy (Beauchant 1828:15-17; Jeffers 1850:143), this system was used and developed by northern gunners as well as their southern rivals.

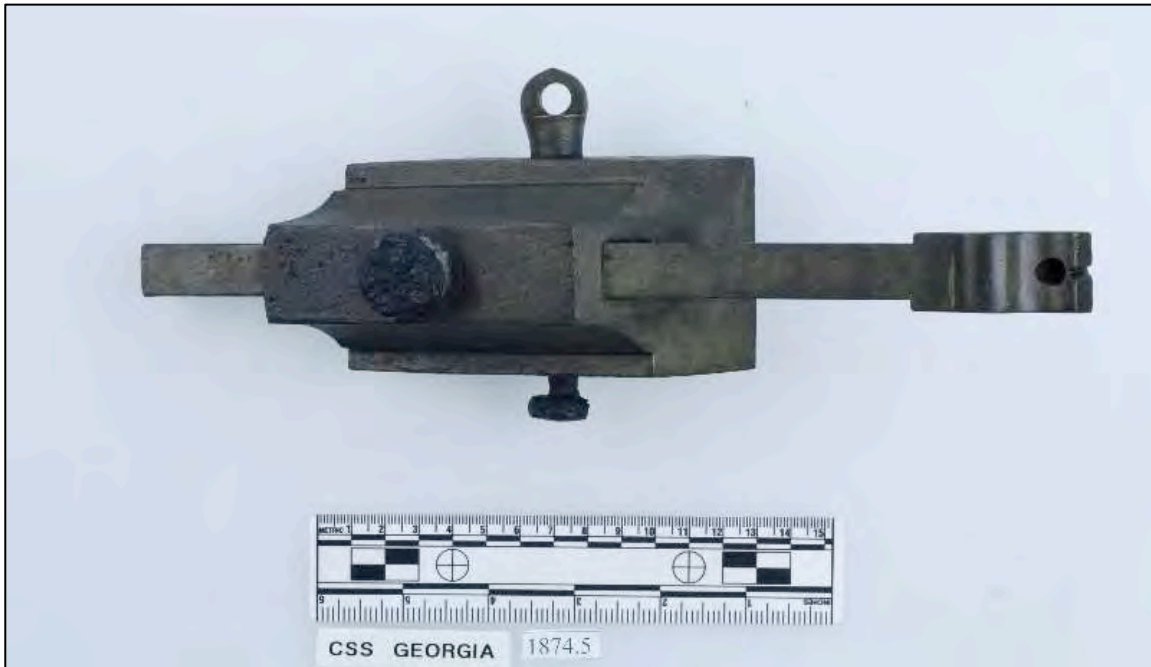
Figure 6-319. Artifact 1874.5 - W. of “box”: 2.4 in. (6.1 cm), W. of tangent scale: 0.6 in. (1.5 cm), L. of tangent scale: 10.9 in. (27.7 cm). Has a slightly different appearance from the other tangent sights. The head of the scale is perforated with a small hole. Graduations are in degrees. Stamp on scale reads: NO. 3 OF 66- and then it cuts off. Stamp on “box” reads: NO 3 OF 6600.

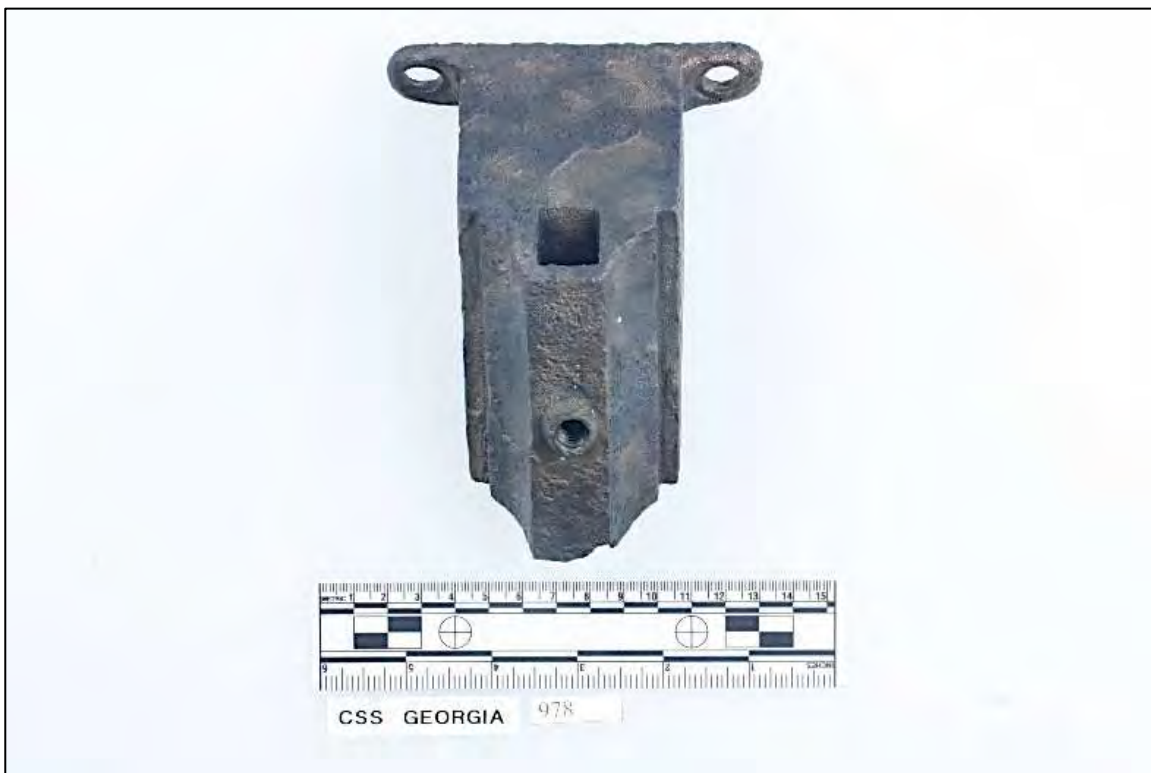
Figure 6-320 Artifact 978 - L.: 5.75 in. (14.6 cm), W.: 2.5 in. (6.4 cm), Diameter of screw hole: 0.3 in. (0.8 cm), W. of scale opening: 0.7 in. (1.8 cm). Tangent sight “box” has two fastener holes at the sides towards the front, presumably for attachment to naval gun.

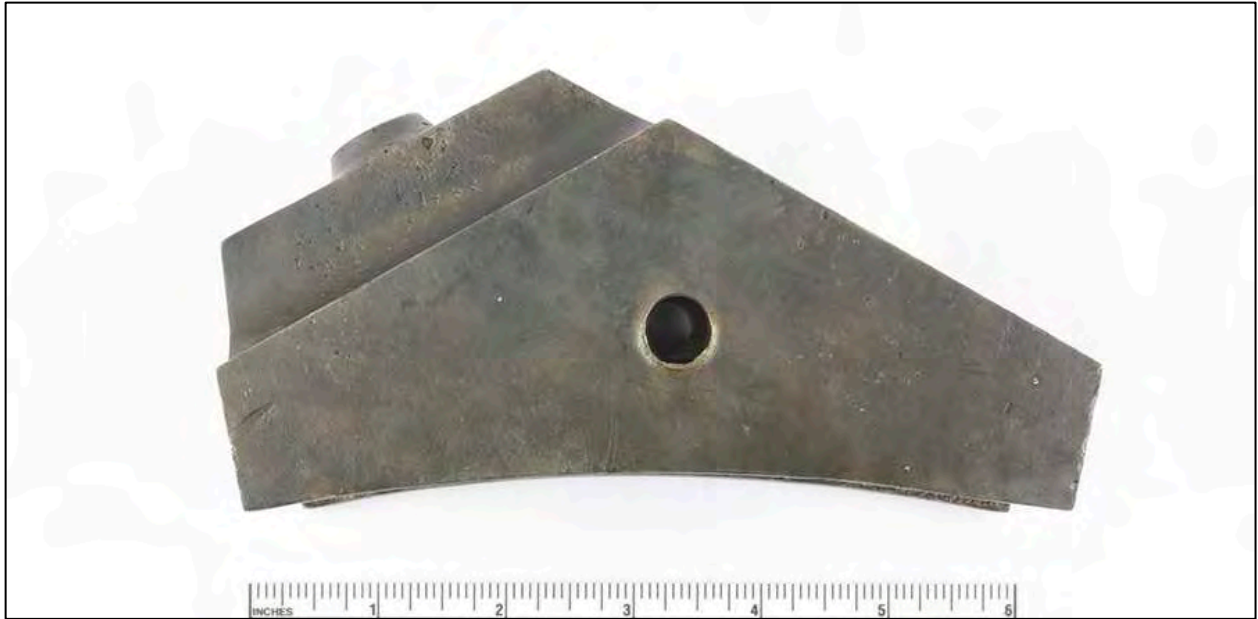
Figure 6-321. Artifact 2997.4 – Side View. Length 5.8 in. (14.8 cm), Width 2.5 in. (6.4 cm), Diameter of screw hole: 0.3 in. (0.8 cm), Width of scale opening: 0.5 in. (1.3 cm). Shape resembles that of the previous sight “boxes” from previous tangent sights except for CSSG 978. Barely any damage, no marks, no stamps.

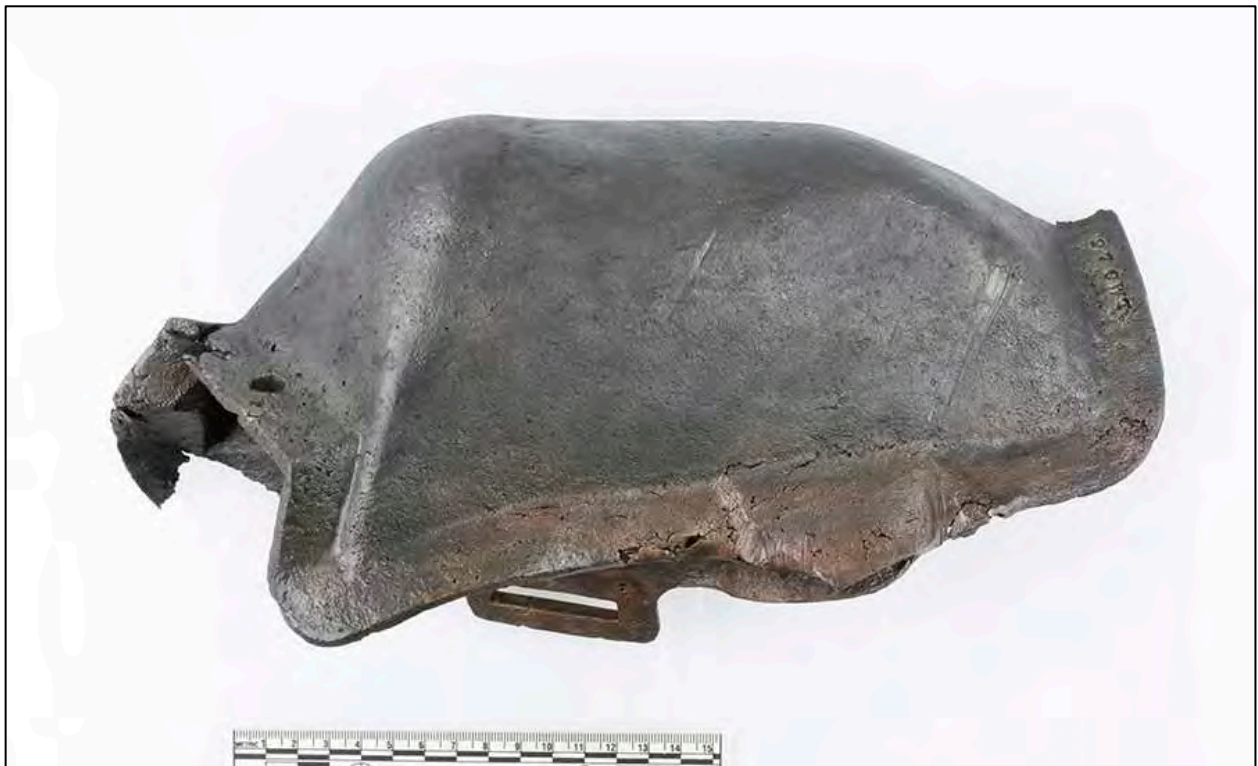
Figure 6-322. Artifact 1850.17 – Tangent cover - Length 12.3 in. (31.2), Width of narrow opening on side: 0.3 in. (0.8 cm). Extremely distorted. Stamp on outer edge reads: 27 CWT.

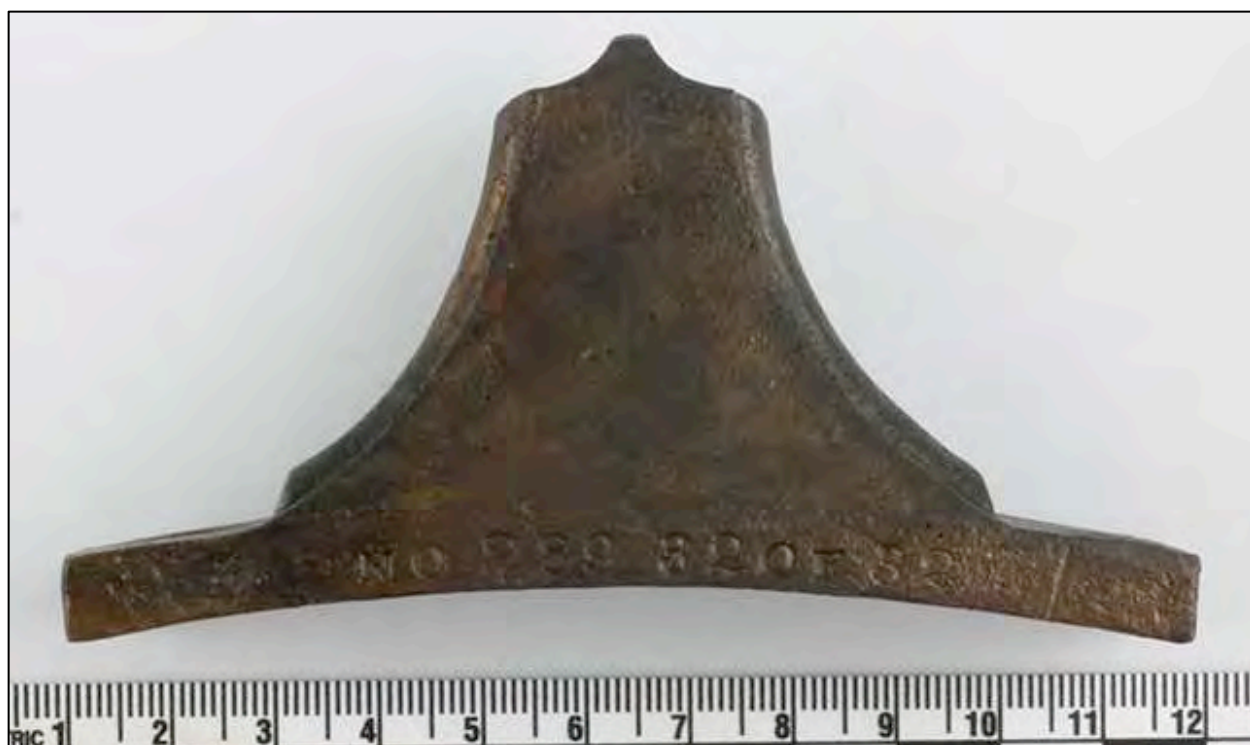
Figure 6-323. Artifact 2994.8 - Height: 2.0 in. (5.1 cm), W. of base: 1.3 in. (3.3 cm), L. of base: 4.0 in. (11 cm). Typical dispart sight. Stamp on the base reads: NO. 289 32 of 32 meaning 32 sights were made in that "batch."

The gun sights recovered from excavations of the CSS *Georgia* include as many as four dispart (front) sights and eight tangent (breech) sights. The collection of dispart sights consists of four sights, Artifact 2994.8 (see Figure 6-322), Artifact 1855.6 (see Figure 6-323), and two artifacts with the number 1856.14 (see Figures 6-324 and 6-325) and one dispart sight cover Artifact 1881.28 (see Figure 6-327). However, the marking on the cover reads: US WNY 112 (see Figure 6-327). This number is the same as the number on the base of one of the dispart sights: Artifact 1855.6 (see Figure 6-323). Therefore, even though there are five pieces associated with

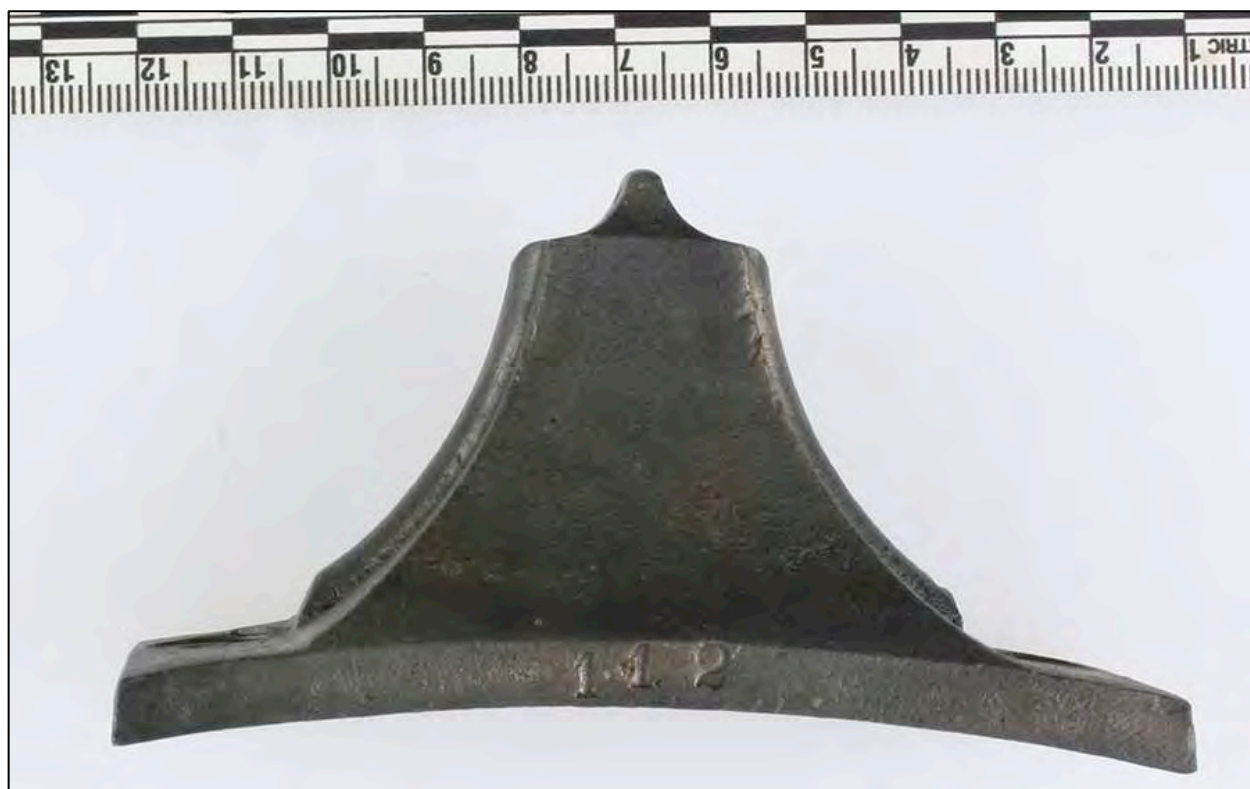
Figure 6-324. Artifact 1855.6 - Height: 2.0 in. (5.1 cm), W. of base: 1.8 in. (4.6 cm), L. of base: 3.9 in. (9.9 cm). Typical dispart sight. Stamp on base reads: 112.

Dispart sight Artifact 1855.6 (see Figure 6-323) had a base-to-apex height of 2 in. (5.1 cm), which further supports the assertion that it was meant to work in tandem with tangent sight

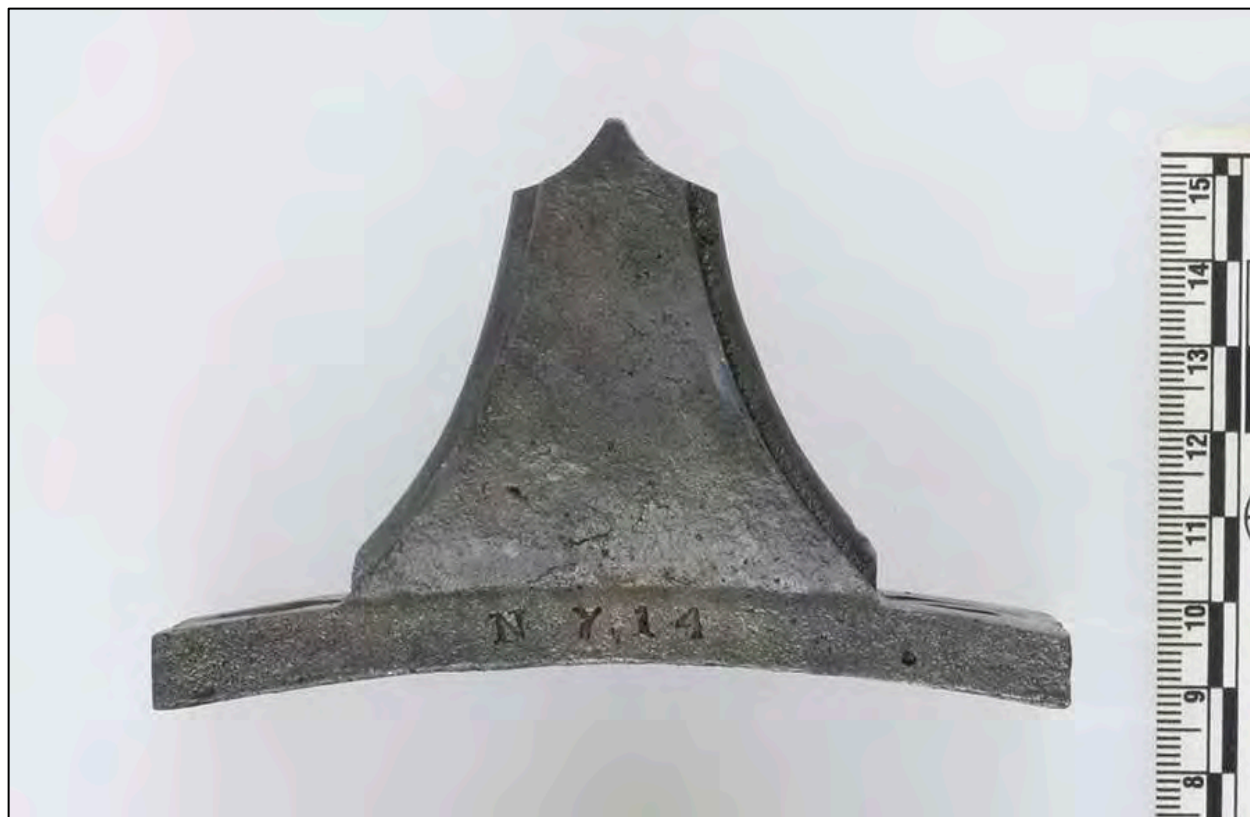
Figure 6-325. Artifact 1856.14 (1 of 2) - Height: 2.4 in. (6.1 cm), W. of base: 1.4 in. (3.6 cm), L. of base: 3.9 in. (9.9 cm). Typical dispart sight. Tallest in the collection. Stamp on base reads: 714.

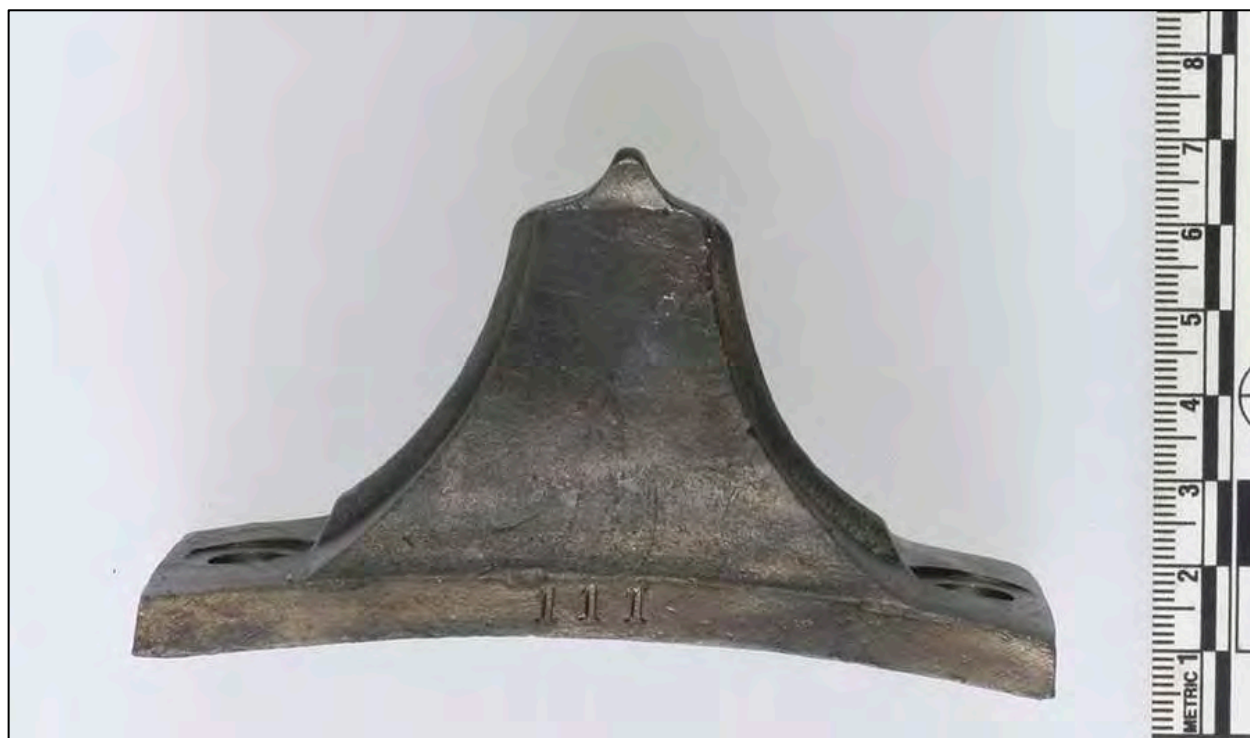
Figure 6-326. Artifact 1856.14 (2 of 2) - Height: 2.0 in. (5.1 cm), W. of base: 1.7 in. (4.3 cm), L. of base: 3.9 in. (9.9 cm). Typical dispart sight. Stamp on base reads: 111.

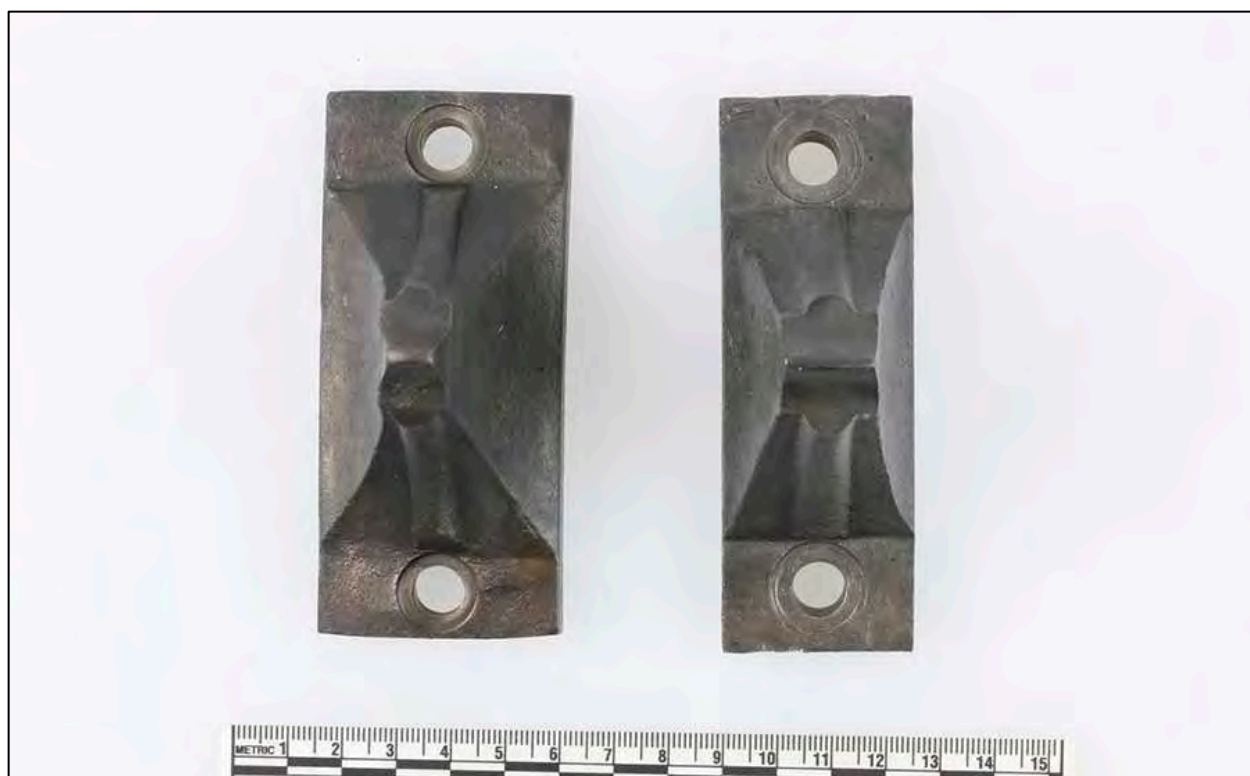
Figure 6-327. Top view of Artifact 1856.14. At left is dispart sight marked with 714 (see Figure 6-325 above), and at right sight marked with 111 (see Figure 6-326 above)

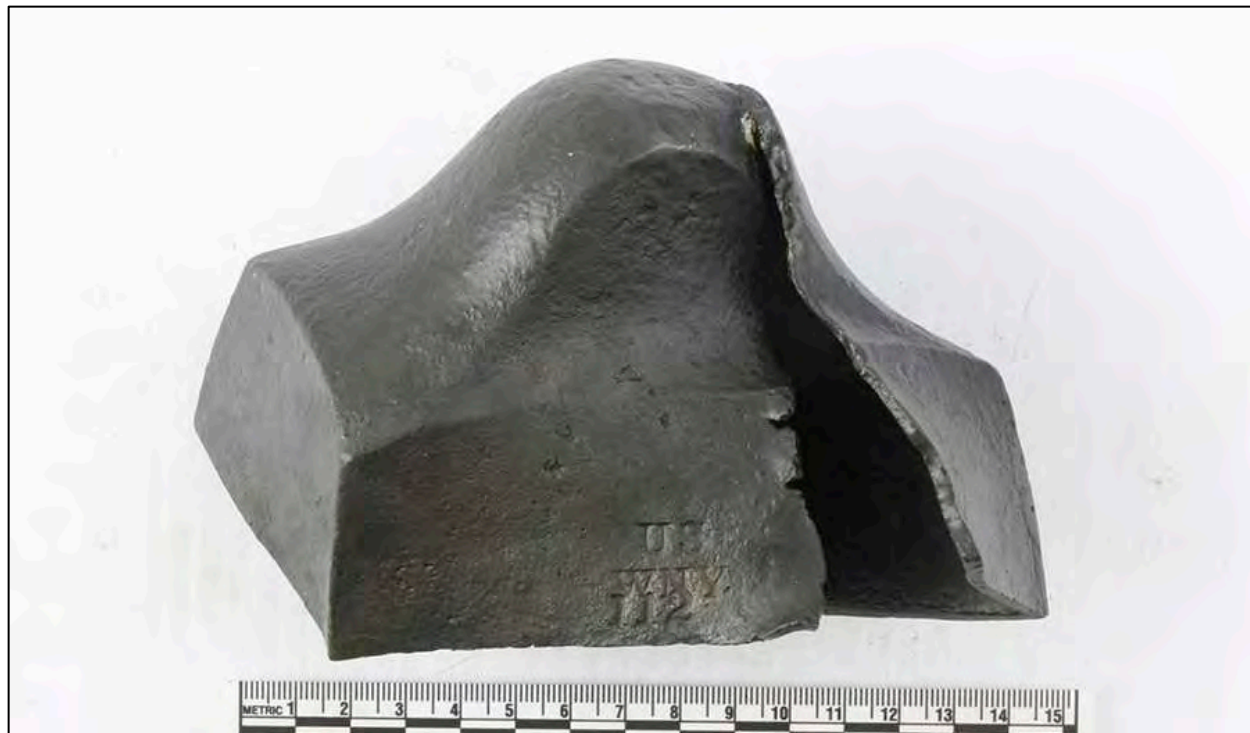
Figure 6-328. Artifact 1881.28 - Max. height: 3.9 in. (9.9 cm), Max. length: 6.3 in. (16.0 cm). Dispart sight cover. Shape is distorted. Stamp on base reads: US WNY 112. Stamp at the top reads: 112.

The dispart sight, tangent sight, and cover marked with the number 112 (Artifact 1855.6, Artifact 1856.10, and Artifact 1881.28, respectively) may all have been manufactured at this very foundry because the tangent sight Artifact 1856.10 is identical in almost every feature to tangent sight Artifact 1892.3, which has the maker’s mark, and all three pieces of gun furniture likely came in a set due to having the same mark (and due to other factors previously explained). There was only one foundry in New Orleans named for Daniel Edwards during the majority of the nineteenth century. It is reasonable to assume that a maker’s mark with this city listed as its business location on a brass artifact, a metal in which the business specialized, indicates the source of at least these four components of the gun furniture of the CSS *Georgia*’s battery. Further, because the 8-inch shell guns were likely produced by the Fort Pitt and West Point Foundries in Pittsburgh, Pennsylvania and West Point, New York according to marks on their cascabels, their gun sights might have been replacement pieces produced after these guns were acquired by the Confederacy.

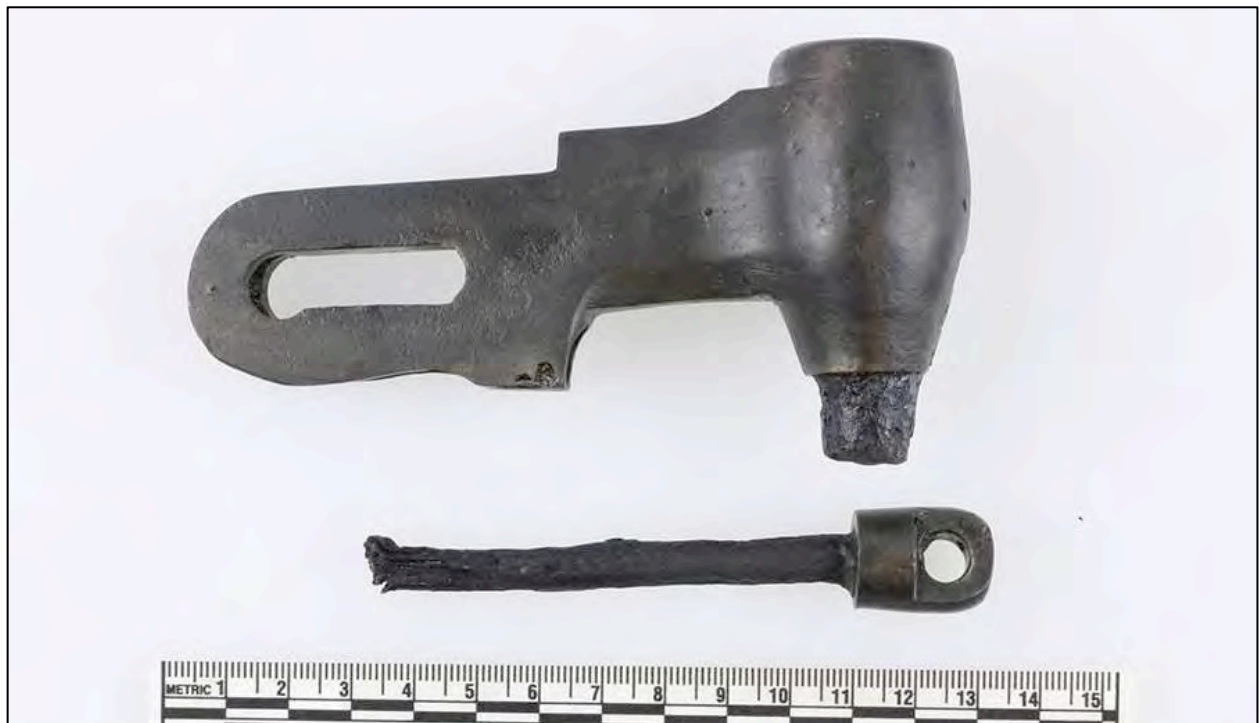
Figure 6-332. Artifact 2997.3 - L. of shaft: 3.2 in. (8.1 cm), L. of shaft opening: 1.4 in. (3.6 cm), Diameter of "hammerhead": 1.3 in. (3.3 cm), L. of iron "nipple": 0.5 in. (1.3 cm), Diameter of iron "nipple": 0.6 in. (1.5 cm). Sliding lock. Axial bolt traveled the length of the opening in the shaft. The "hammerhead" seems to be damaged by explosion from the vent.

Hidden's greatest achievement did not come until 29 April 1842 when he patented the design for a sliding lock. This lock had an elongated slot in its shank through which traveled an axial bolt. One quick pull of the lanyard caused the head to strike the vent and instantly slide out of the way of the explosion by the movement of the axial bolt along the shank as the lanyard was still being pulled (Figure 6-331; Simpson 1862:295). This lock was adopted by the British and modified by Colonel William Dundas in 2 October 1846. Enoch Hidden sold all the rights of his patent to the U.S. Navy on 3 April 1848 for \$1,200 (Gaede 1998:117).

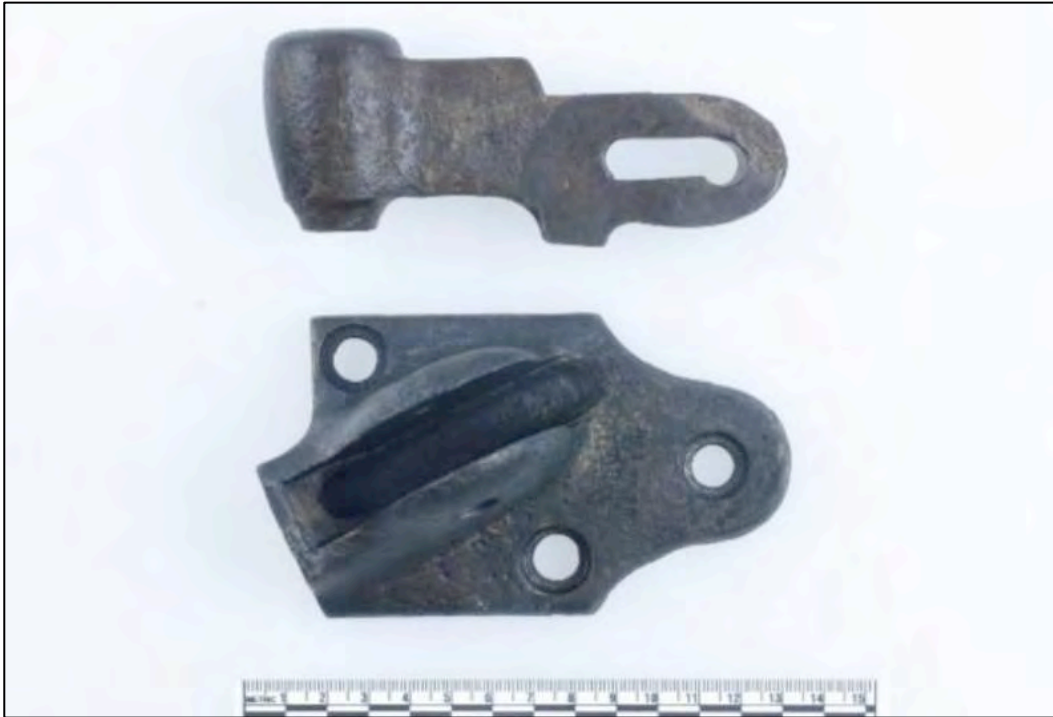
Figure 6-333. Artifact 1335 - Lock measurements: L. of shaft: 3.4 in. (8.6 cm), L. of shaft opening: 1.4 in. (3.6 cm), Diameter of “hammerhead”: 1.3 in. (3.3 cm), Diameter of “hammerhead” perforation: 0.4 in. (1.0 cm). Sliding lock with perforated “hammerhead.” Base measurements: L.: 5.1 in. (13.0 cm), W.: 2.9 in. (7.4 cm). Typical percussion lock base. Contains three fastener holes for attachment to gun.

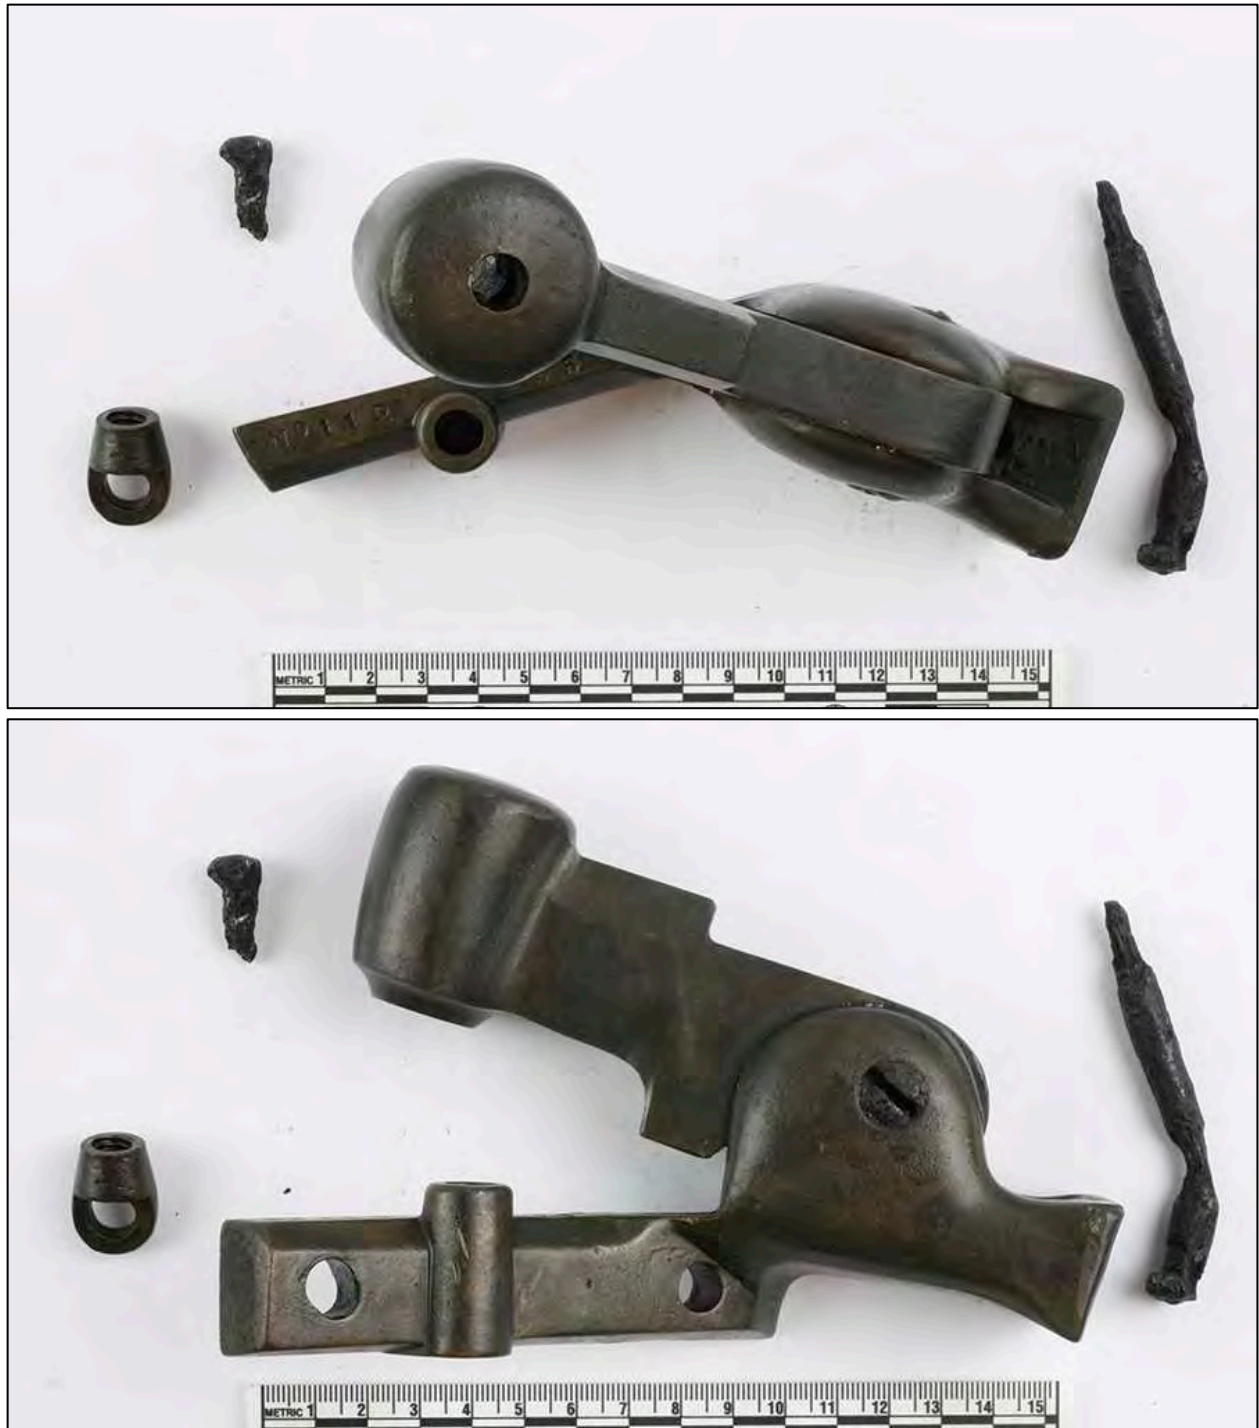
Figure 6-335. Artifact 2994.6 - Top and side views. Lock measurements: L. of shaft: 3.4 in. (8.6 cm), Diameter of “hammerhead”: 1.4 in. (3.6 cm), Diameter of “hammerhead” perforation: 0.4 in. (1.0 cm). Opening in shaft is not visible due to being stuck to the base or not present altogether. The “hammerhead” is perforated. Base measurements: L.: 3.8 in. (9.7 cm), W.: 0.9 in. (2.3 cm), Thickness: 0.6 in. (1.5 cm). Stamps on base read: NO. 112 55. Mark on the inside face reads: XIII (top panel).

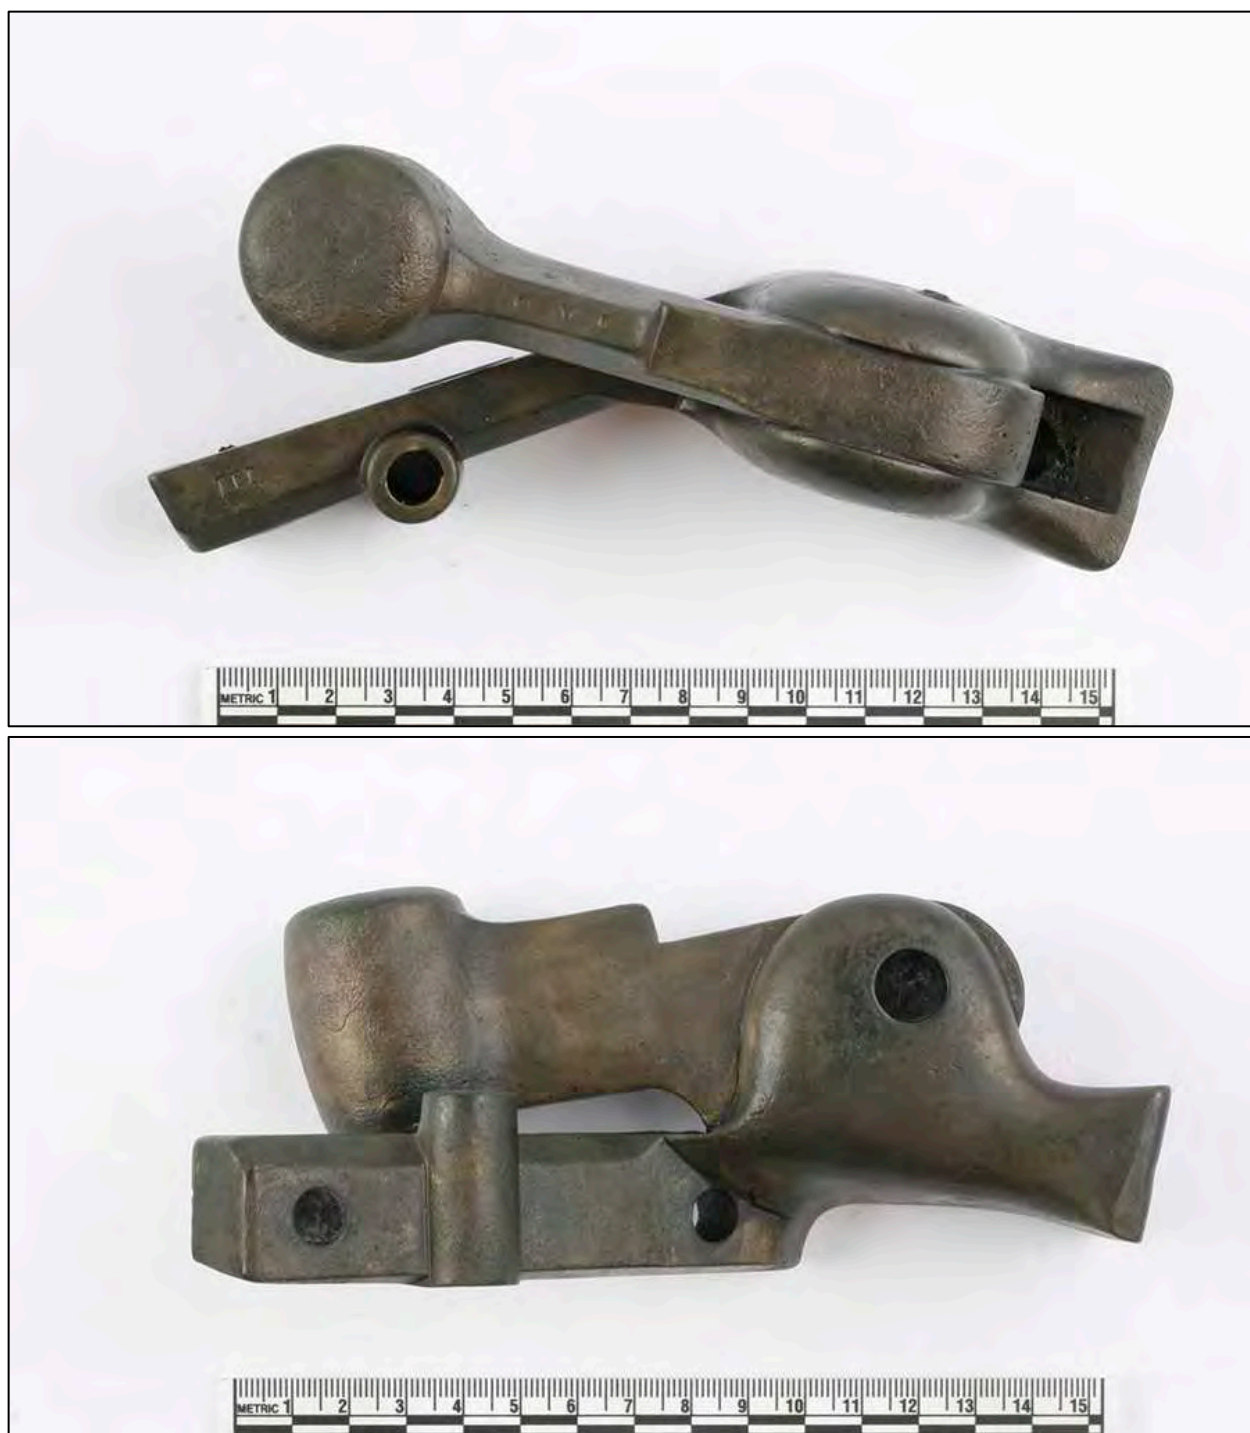
Figure 6-336. Artifact 2156.3 - Lock measurements: L. of shaft: 3.5 in. (8.9 cm), Diameter of “hammerhead”: 1.3 in. (3.3 cm). Lock with no perforation on “hammerhead.” Stamps on the shaft read: J A D US (top panel). Base measurements: L.: 4.0 in. (10.2 cm), W.: 0.9 in. (2.3 cm), Thickness: 0.6 in. (1.5 cm). Base has stamp that reads: 111.
