CSS *GEORGIA*
ARCHEOLOGICAL DATA RECOVERY AND MITIGATION
FOR THE SAVANNAH HARBOR EXPANSION PROJECT (SHEP),
CHATHAM COUNTY, GEORGIA AND JASPER COUNTY, SOUTH CAROLINA

**FINAL DRAFT REPORT
OCTOBER 2019**

Stephen R. James, Jr. and Gordon P. Watts

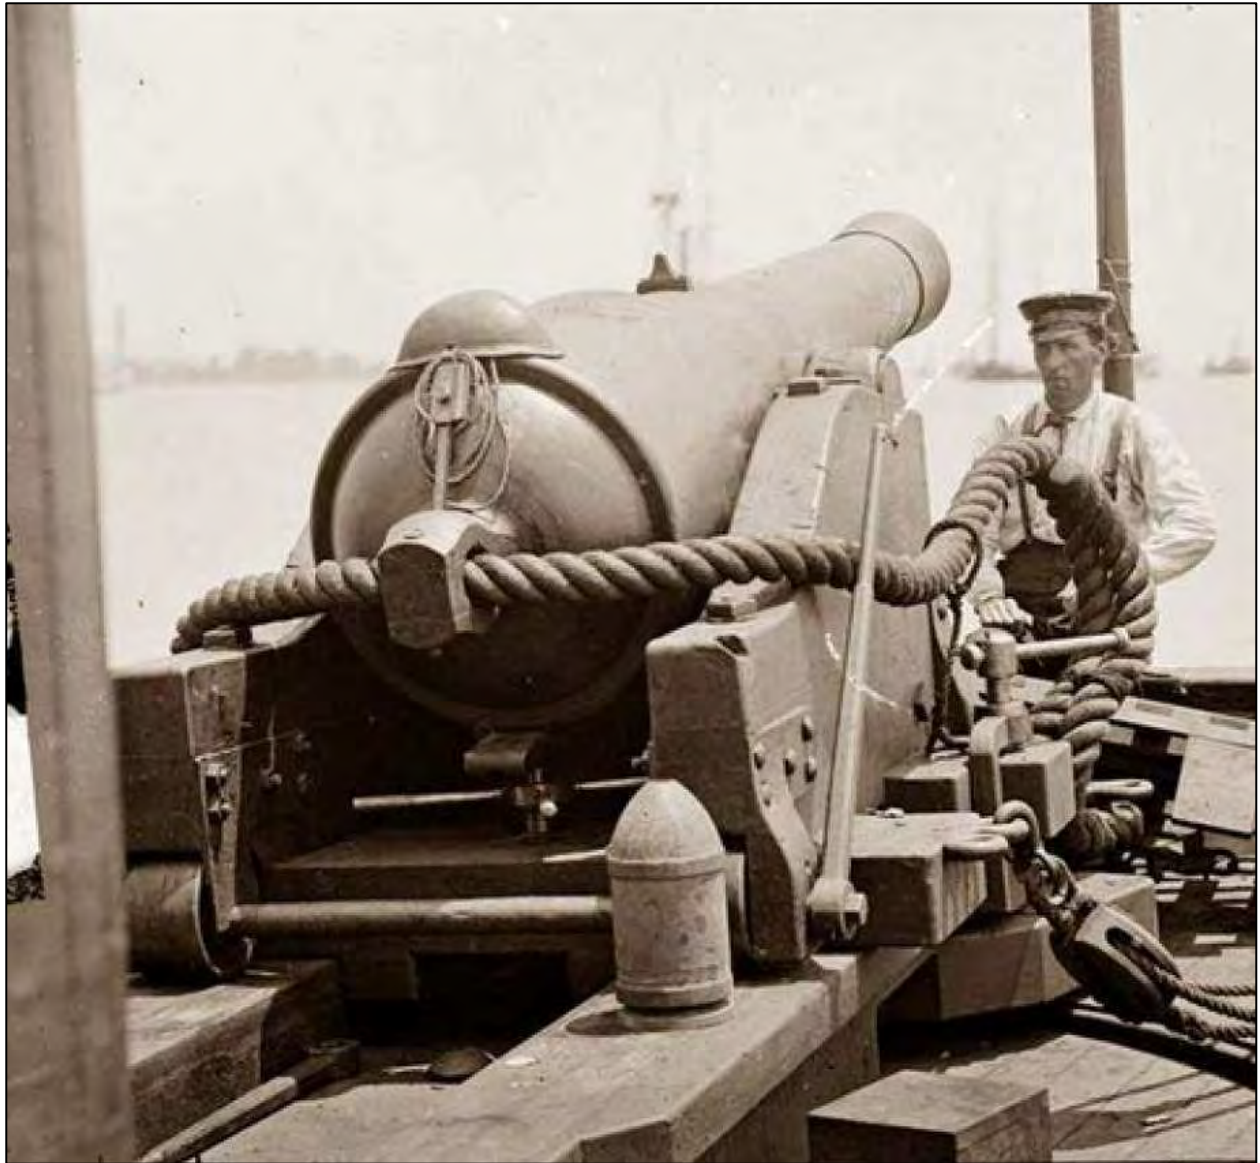
Figure 6-338. Brooke Rifle and pivot carriage on the *CSS Teaser* (Miller and Lanier 1911:77).

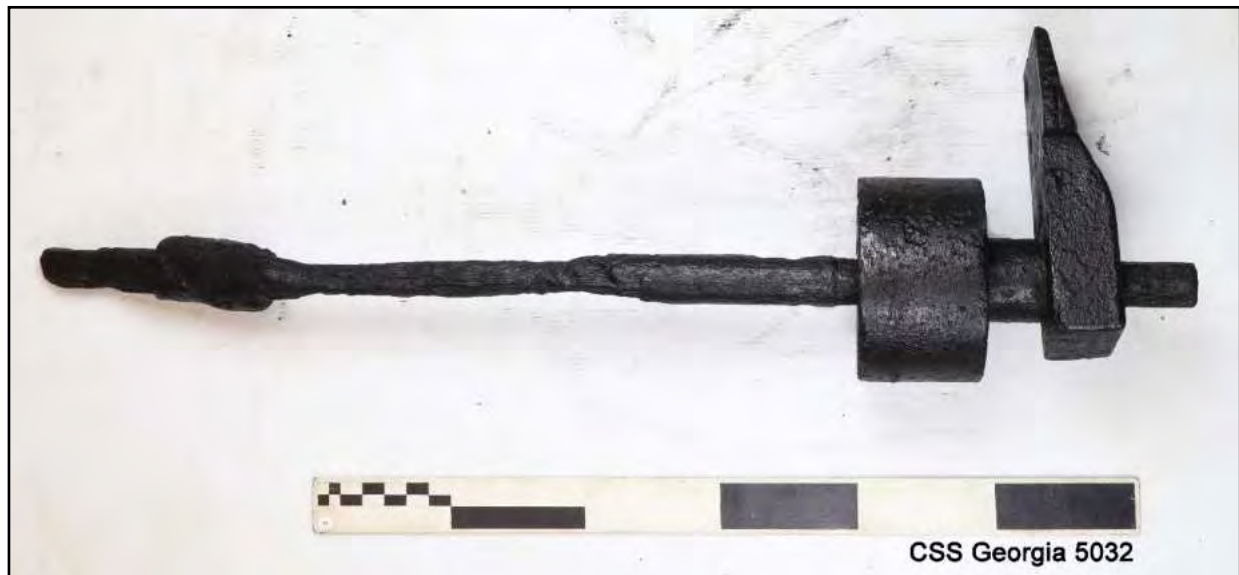
Figure 6-343. Gun carriage axle, truck (wheel), and journal plate recovered from Unit 9-K (Artifact 5032). Note, as evidenced by this type of journal plate, this wheel and axle belonged to the top carriage, and not the lower pivot carriage.

Two types of trucks, or wheels, were associated with the pivot carriage. As previously explained, four trucks were mounted to the top carriage, while four more trucks were connected to the lower pivot carriage. The distribution of trucks recovered from the site is illustrated in Figure 6-342, which shows that the trucks followed a relatively random scatter across the site. Like the gun carriage components in general, this followed the same pattern as the many of the other recovered artifacts. In terms of differentiating between the top carriage trucks and the lower pivot carriage trucks, the best identifier is the journal fixing them to the frame. Of course, this was only possible when the truck and journal (and probably axle) were articulated during recovery. In this assemblage, it seemed that the top carriage trucks were a different size and shape from the lower pivot carriage trucks. Figure 6-343 shows an example articulated truck, axle, and journal belonging to a top carriage. Note the journal, and how its shape mimicked the size of the one next to the large wrench in Figure 6-343. All trucks and associated journals are presented in Table 6-13.

Figure 6-374. Possible Marsilly carriage truck recovered from Unit 18-BB (Artifact 1584). Note the boxing on the right side of the truck. The tapered appearance differs from the cylindrical boxing found on the pivot gun carriage axle seen in Figure 6-343.

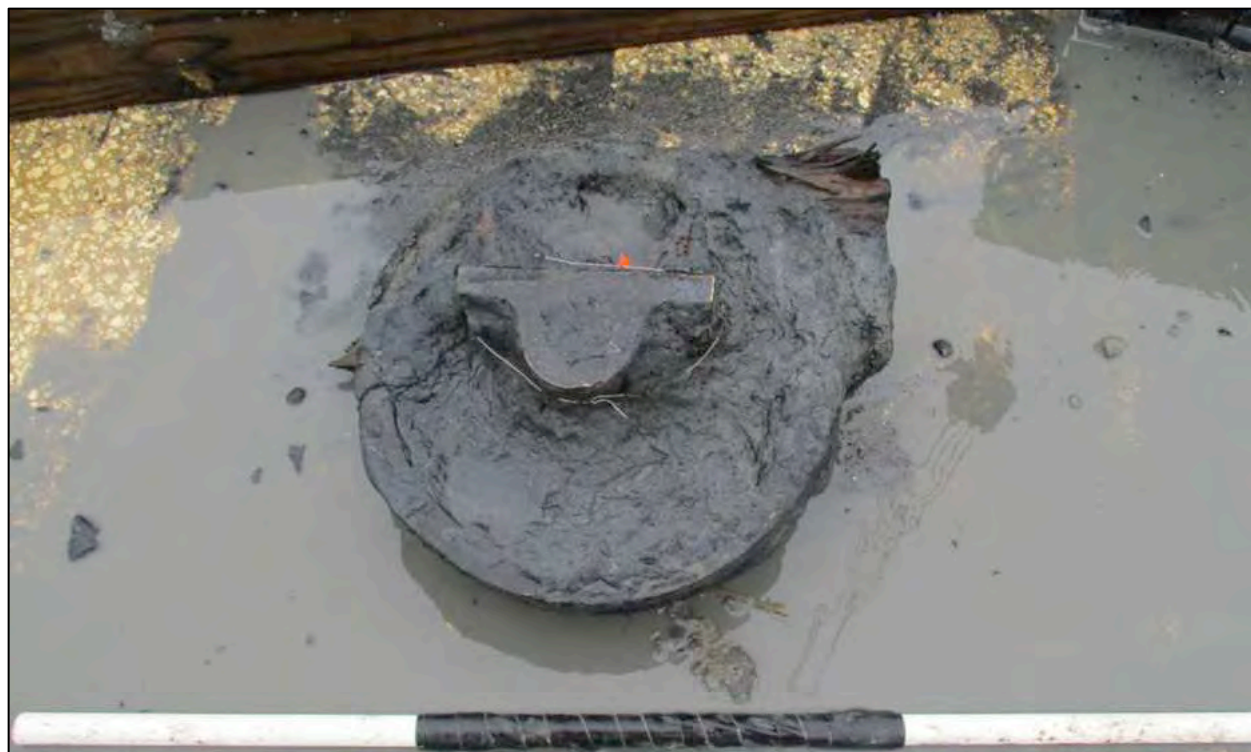
Figure 6-344. Pivot carriage truck, Artifact 2934.01, immediately after mechanized recovery from Unit 7-F (Artifact 2934.01). Compare this Figure 6-345 below.

The pivot carriage trucks had a small fixed axle (Figures 6-344 and 6-345), as opposed to top carriage trucks (see Figure 6-345), which had an aperture through which the axle ran. Top carriage trucks rotated around their axles, with two trucks per axle rotating in unison. Pivot carriage trucks rotated as one piece along with their axle. The pivot carriage trucks recovered from *CSS Georgia* tended to be about 15 inches in diameter and 2.5 inches thick. The upper gun carriage trucks were much thicker but smaller in diameter (about 8 inches in diameter and 5.5 inches thick). As shown in Table 6-13, nine top carriage trucks and 16 pivot carriage (lower) trucks were located. This is curious, as according to the schematics, there should be only four trucks for each lower pivot carriage. Either some trucks were spares, or they may have been used on additional carriages.

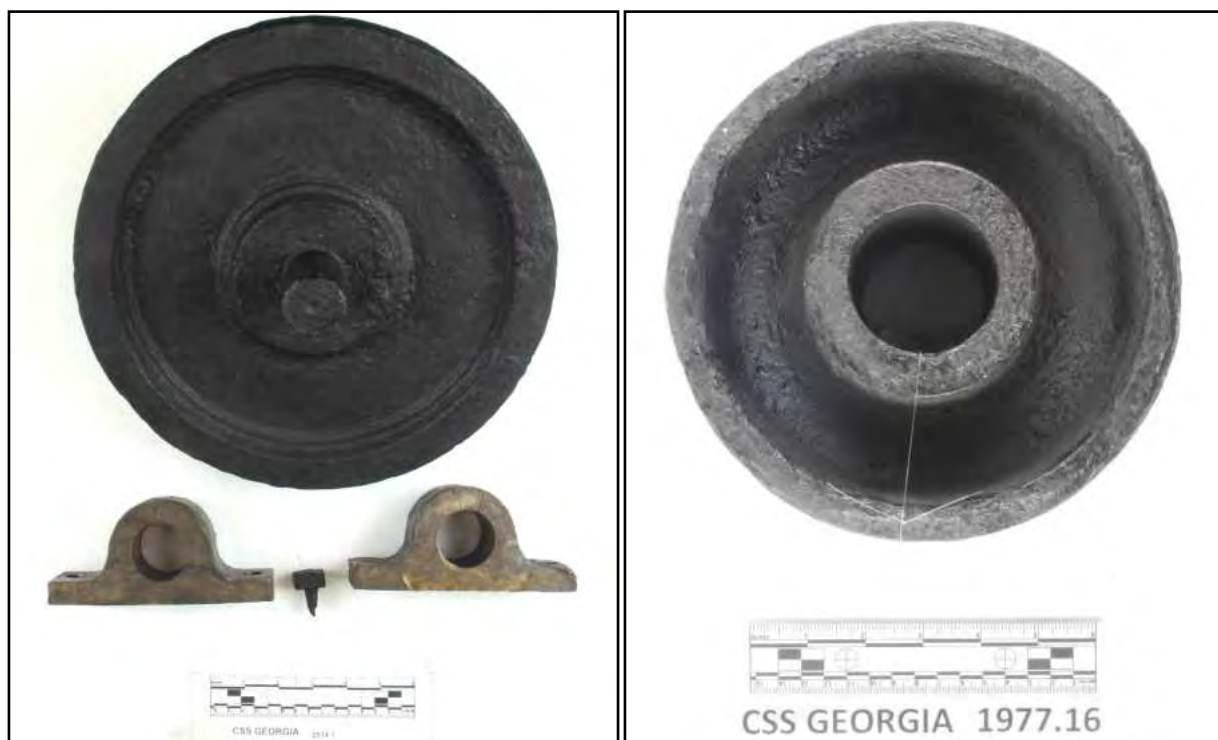
Figure 6-345. Pivot carriage truck and small copper-alloy journals recovered from Unit 7-F (Artifact 2934.01, left) compared to a top carriage truck recovered from Unit 7-A (Artifact 1977.16, right).

In addition to the numerous trucks, there are two types of journals associated with pivot carriage trucks. There are the small bronze trucks (Figure 6-345), and the much larger iron journals (Figure 6-346) with associated fasteners. It is possible that the iron journals were an adaptation. Although cupreous alloys would likely have been the preferred material (due to the corrosive properties of iron), iron was likely to construct this type of journal as copper became scarce during the war (Still 1969:56). The axle of the truck sat directly on top of a pin running through the journal, and the assembly likely needed plenty of grease to spin freely.

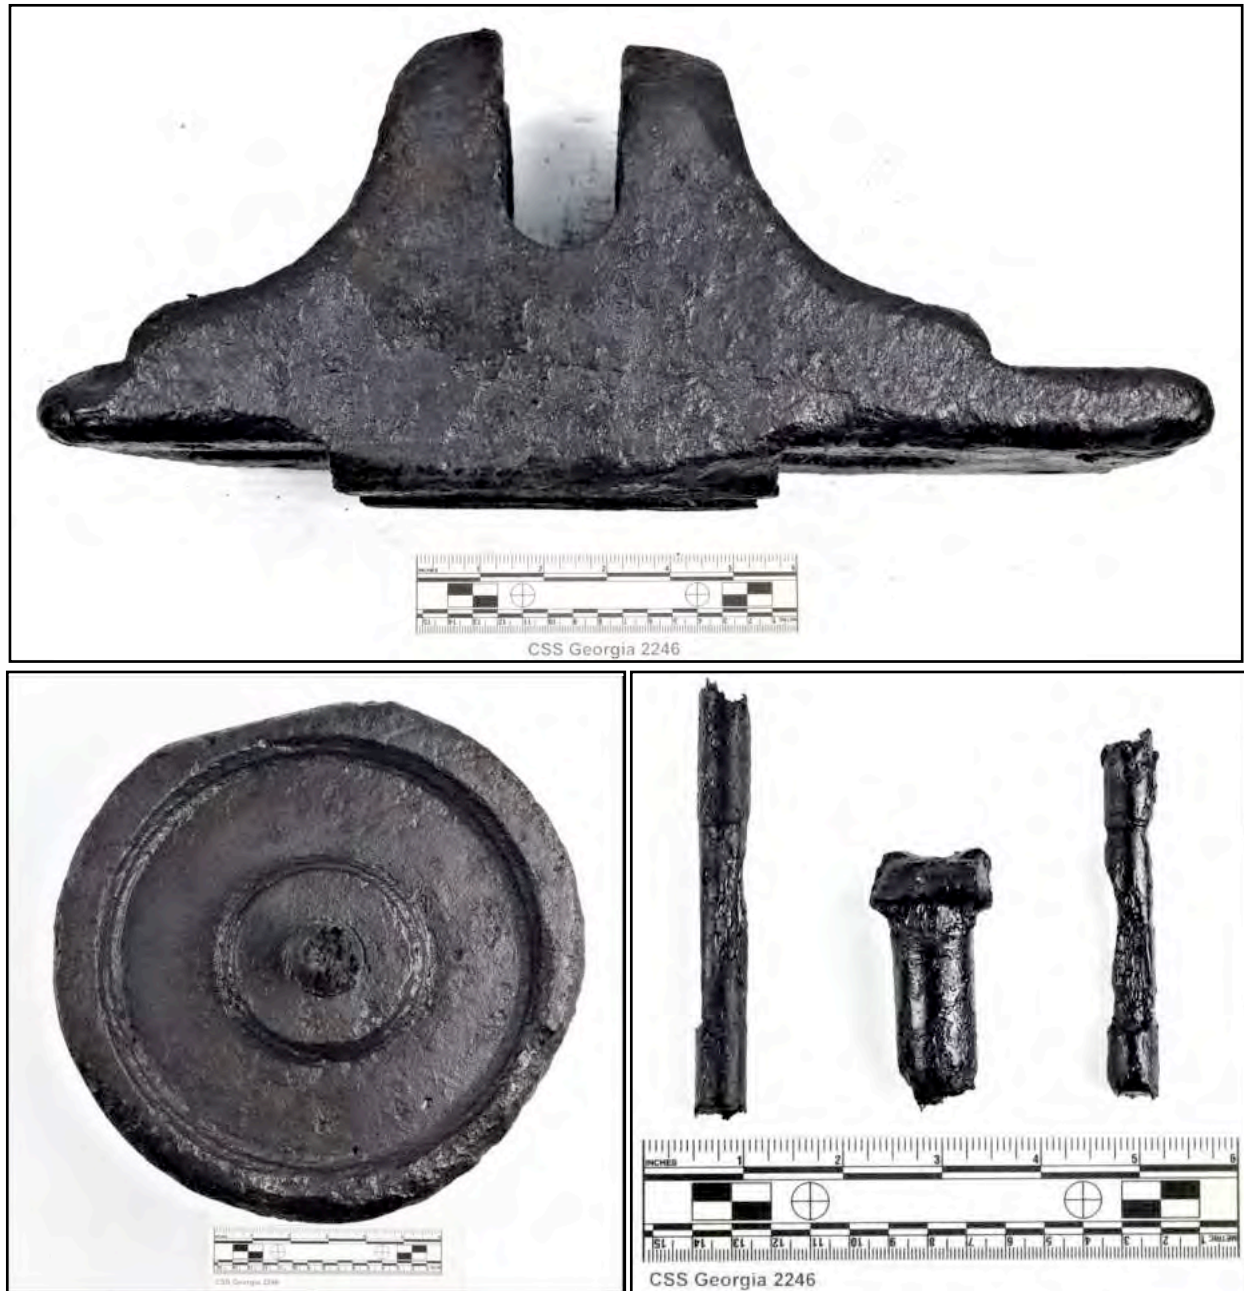
Figure 6-346. Pivot carriage truck (bottom left) with iron journal (top) and fasteners (bottom right) recovered from Unit 14-B (Artifact 2246).

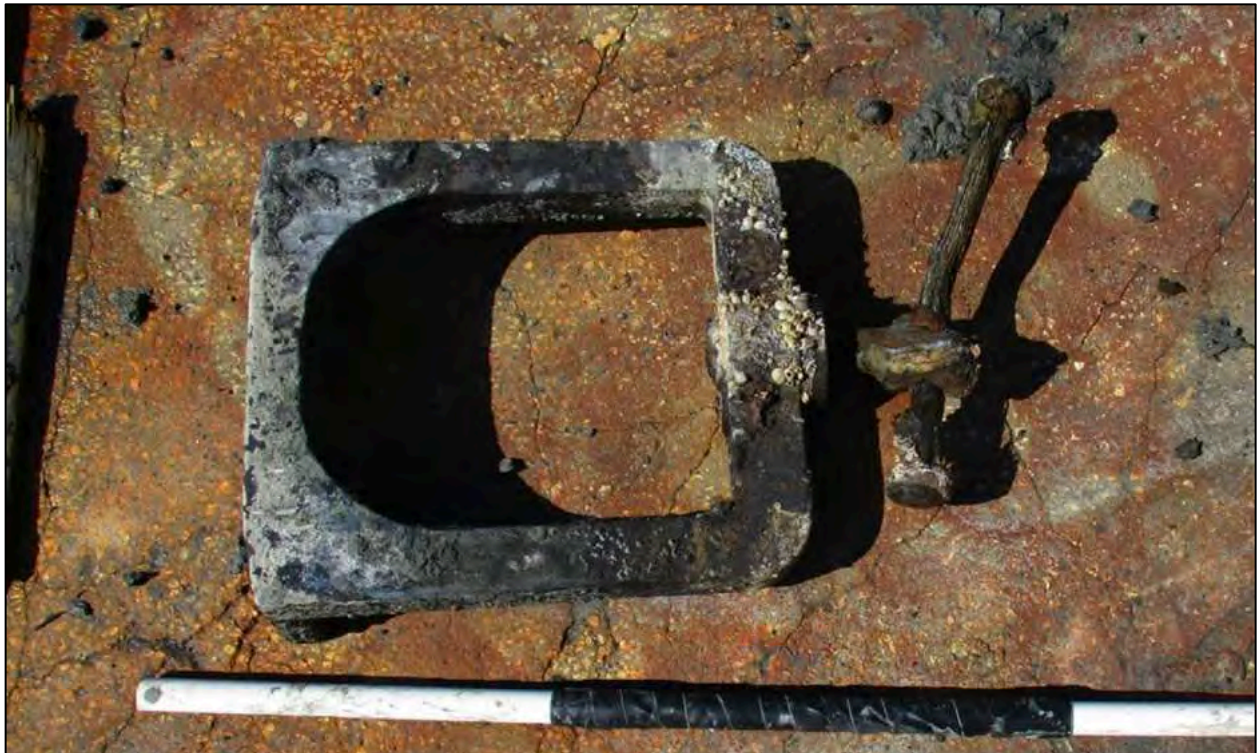
Figure 6-347. Carriage compressor immediately after mechanized recovery from G-15. Note the still intact compressor screw and tightening rod.

Compressors were used as a brake on pivot carriages. The bottom lip of the compressor fit against a wooden projection (the compressor batten) on the pivot carriage. The upper part of the compressor was attached to the middle transom of the top carriage. When screwed down (Figure 6-347), it compressed the compressor batten and middle transom, increasing friction (Simpson 1862:138). Six compressors were recovered during the two field seasons. Of these, four were made of cupreous alloys (Figure 6-348), and the other two were made of iron. The compressors were similarly sized, roughly 16 inches wide, and may well reflect the compressor pairs from three pivot carriages, one with iron compressors and the other two with cupreous-alloy compressors. Like the pivot carriage journals, iron may have been used in this case due to lack of access to copper during the war. As only two pivot carriages are known to have been in use (one for each Brooke rifle), it is possible that the third pair were there as an emergency replacement.

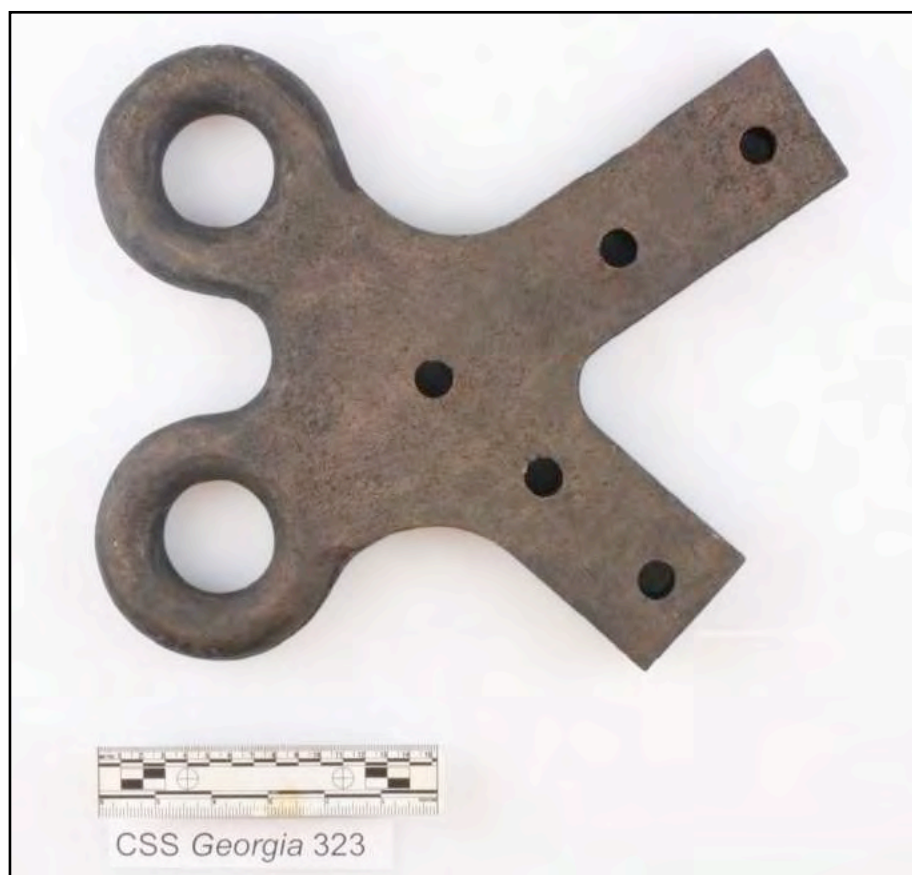
Figure 6-349. Eyes for tackle recovered from Unit 12-E (Artifact 323).

Eyes for tackle, specifically, helped adjust the angle of the gun for training and targeting. This unique and easily identifiable artifact is shaped like an asymmetrical “X,” with two eyes extending roughly 90 degrees apart, and mounting plates extending from each eye (Figure 6-349). The mounting plates were bolted to the rear transom (see Figures 6-338 and 6-339 for an example of eyes for tackle mounted to a pivot carriage). The recovered eyes for tackle varied in composition, with two made of cupreous alloy and two made of iron. Just like the compressors, iron may have been used as copper became less accessible. These fixed eyes were fairly robust, averaging 1.5 inches in thickness, with an overall length and width of about 15 inches.

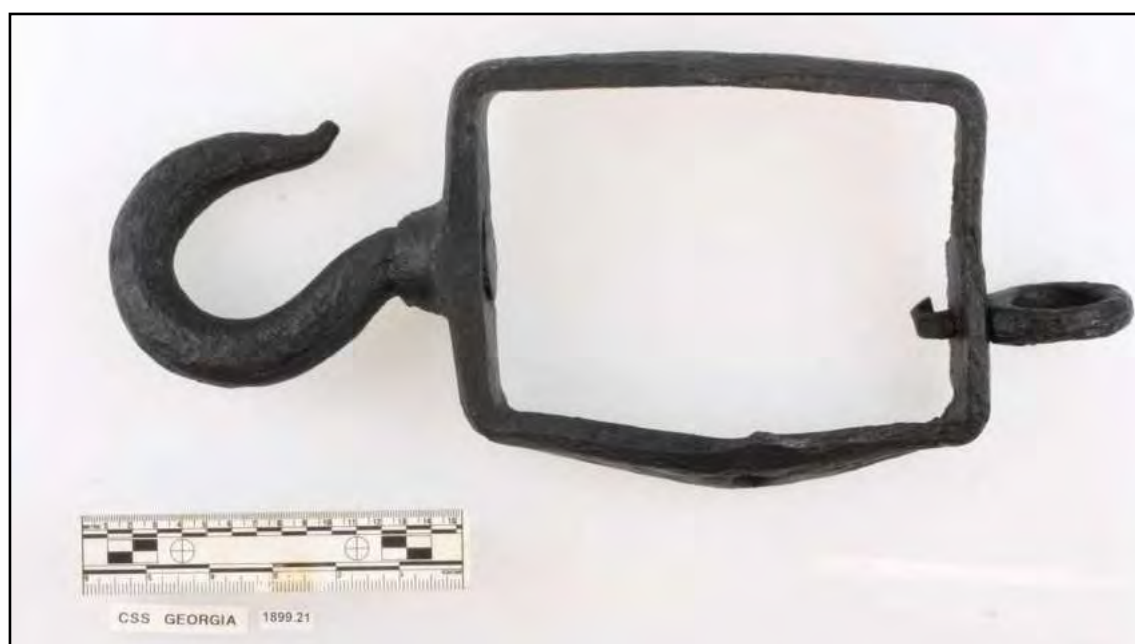
Figure 6-350. Block and stiff swivel hook recovered from Unit 6-C (Artifact 1899.21).

Other than the eyes for tackle, there were 94 database entries for tackle-related artifacts (including sheaves, hooks, pulleys, and blocks). An example of a conserved block is shown in Figure 6-350 and another type immediately after recovery is shown in Figure 6-351. As the *CSS Georgia* was not a sailing vessel, many of these were likely employed as gun-related tackle. Of the database entries, 60 consisted of or included hooks. All of the hooks were composed of iron. 24 entries included sheaves. Sheaves were iron or wood, although most (20) were wooden (see

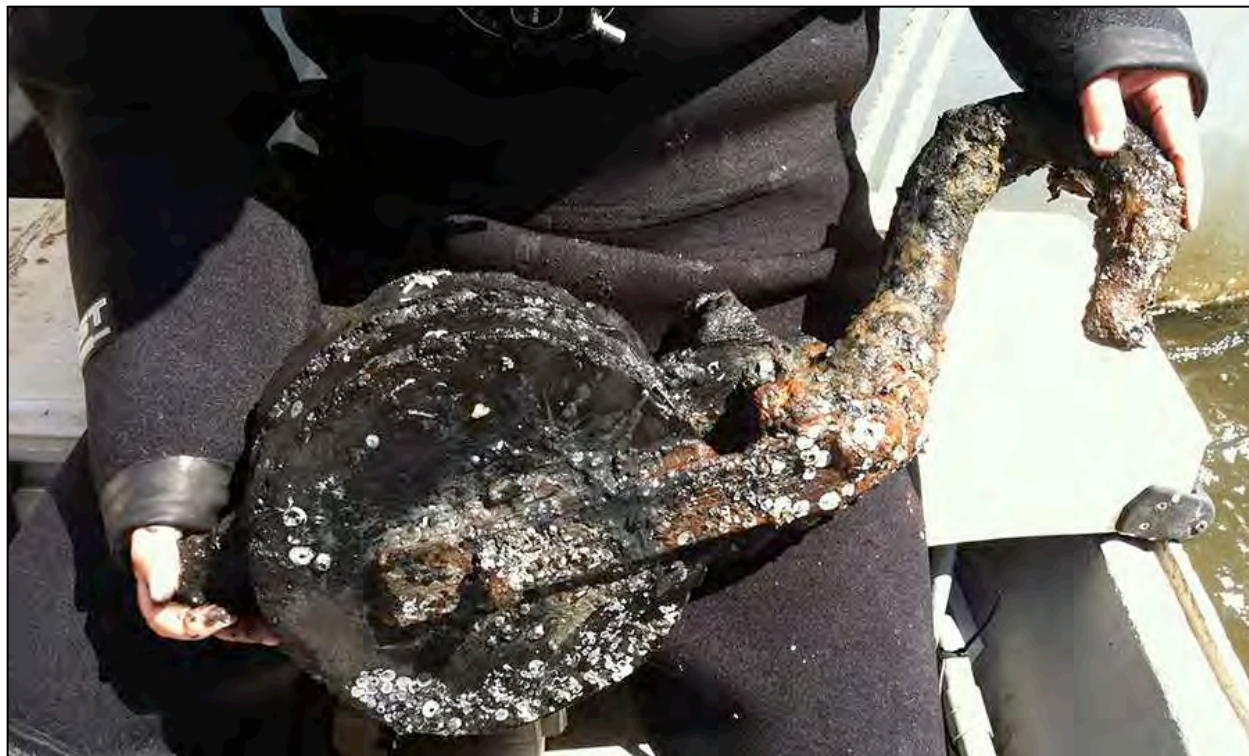
Figure 6-351. Shown immediately after recovery, another type of tackle, most likely associated with a gun carriage.

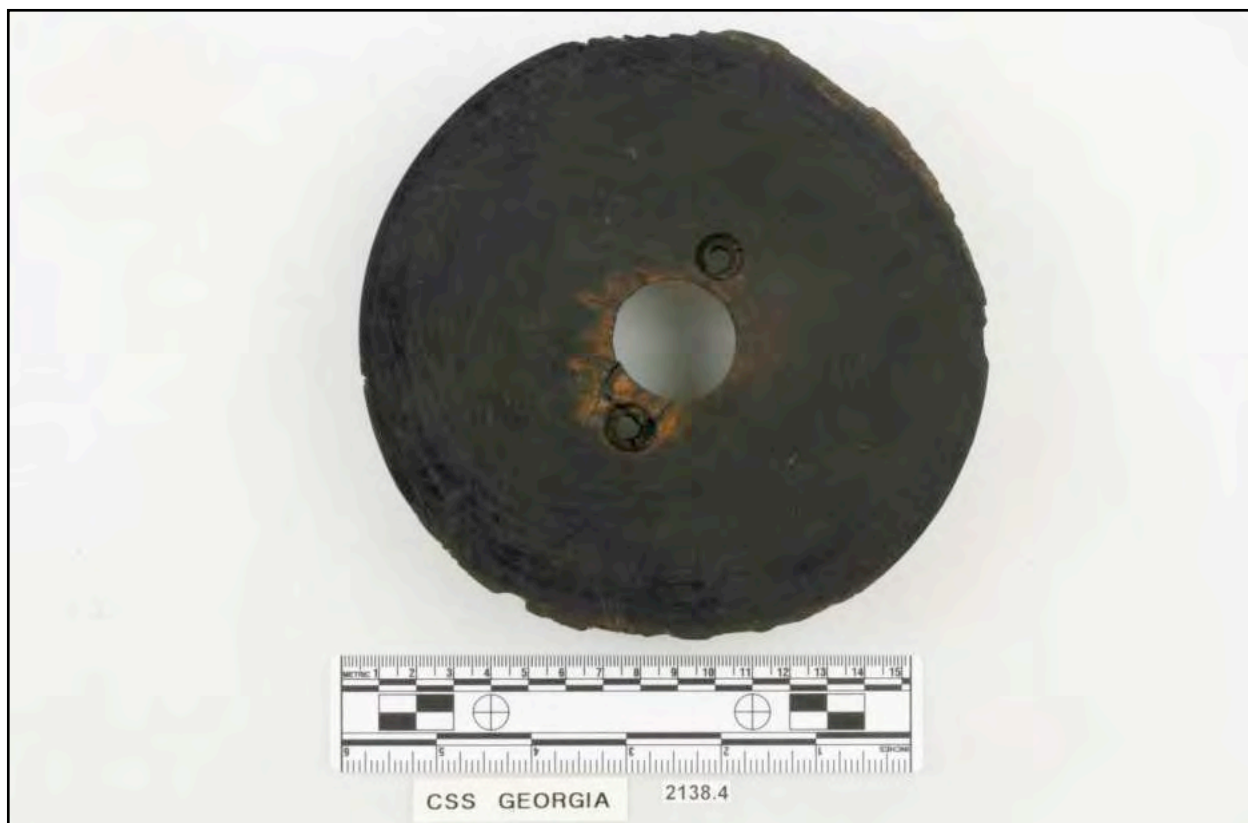
Figures 6-352. Wooden sheave recovered from Unit 6-G (Artifact 2138.04).

Figure 6-352 for an example of a wooden sheave). These numbers do not include Artifact 1866.06, recorded as a possible wooden truck, which may be a sheave.

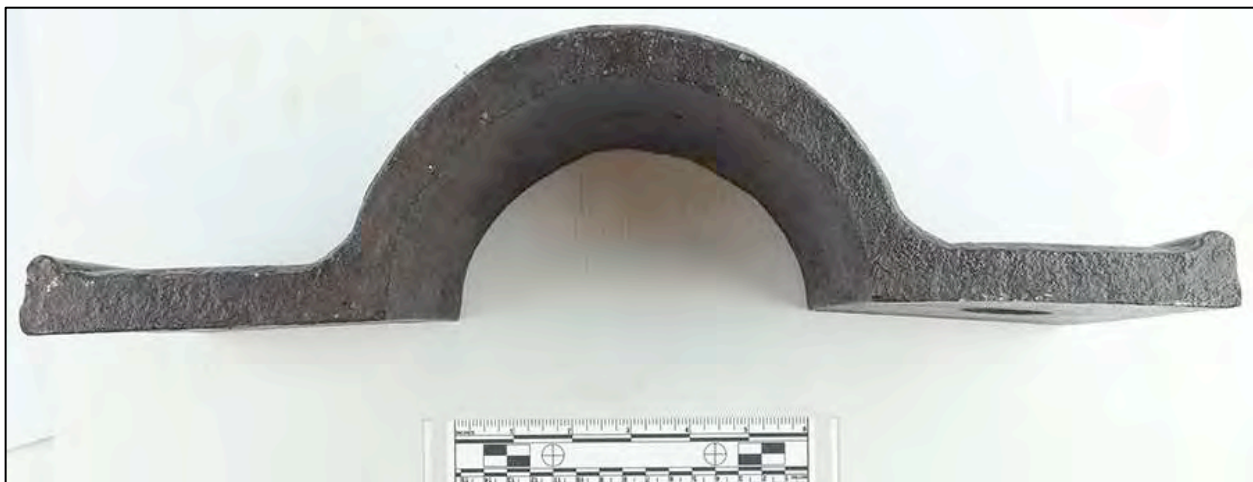
Figures 6-353. Brass cap square recovered from Unit 10-D (Artifact 370). Side view.

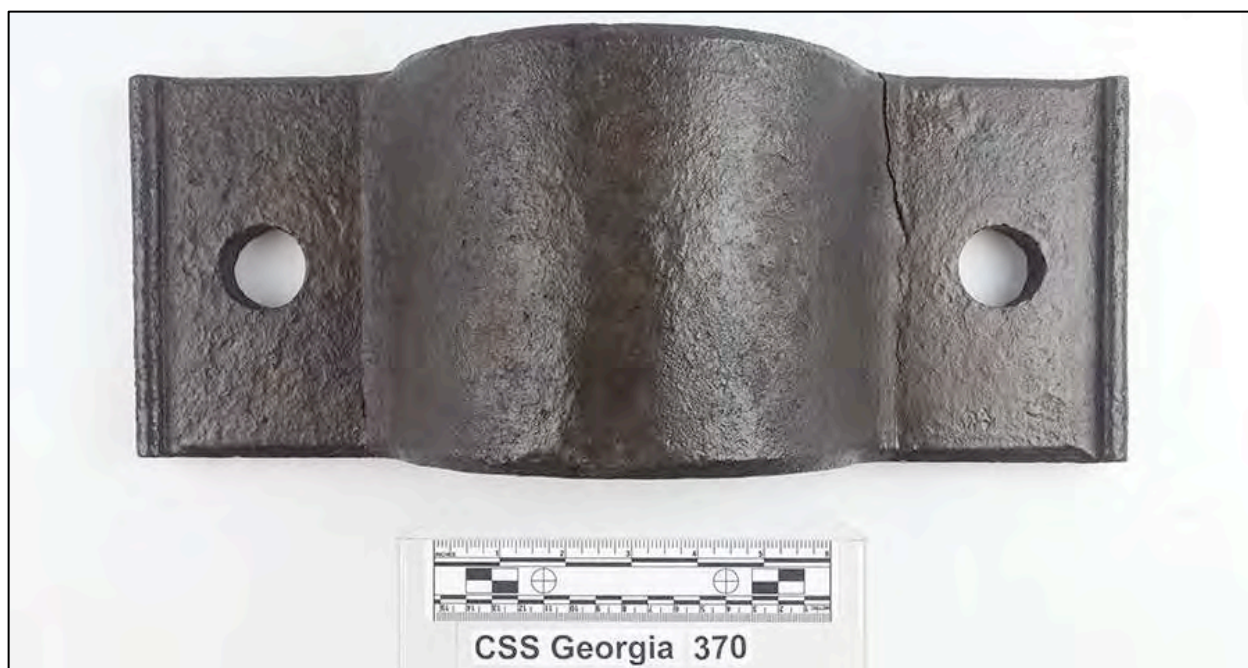
Figures 6-354. Brass cap square recovered from Unit 10-D (Artifact 370). Top view.

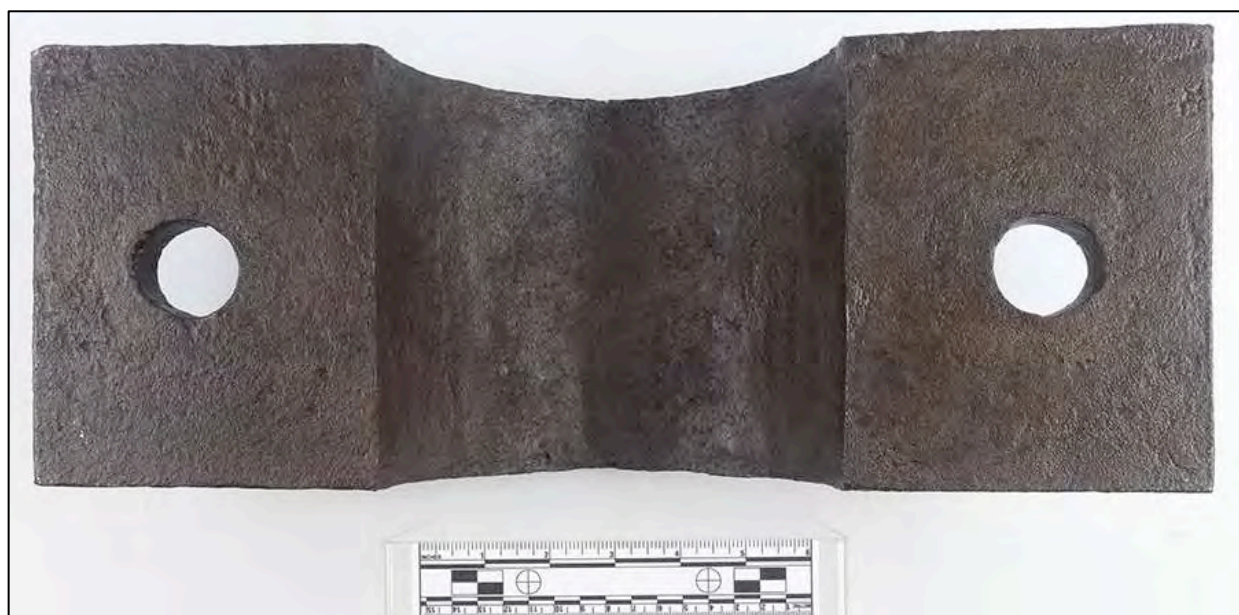
Figures 6-355. Brass cap square recovered from Unit 10-D (Artifact 370). Bottom view.

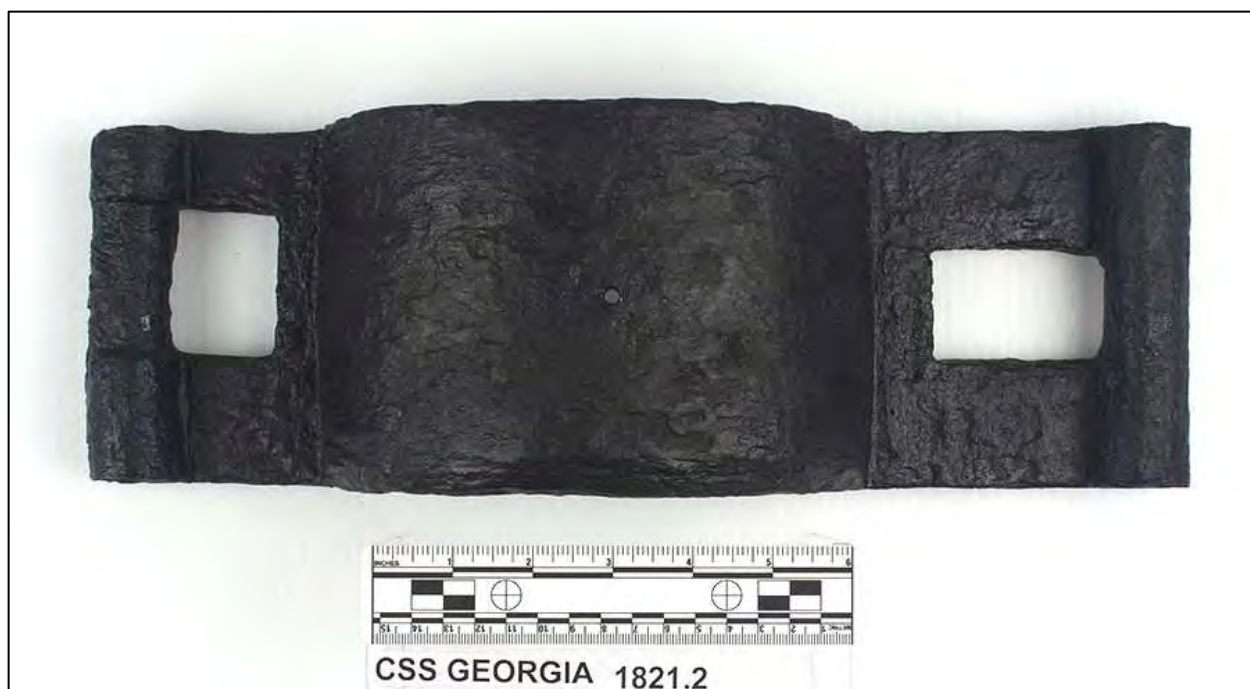
Figures 6-356. Iron cap square recovered from Unit 7-G (Artifact 1812.02).

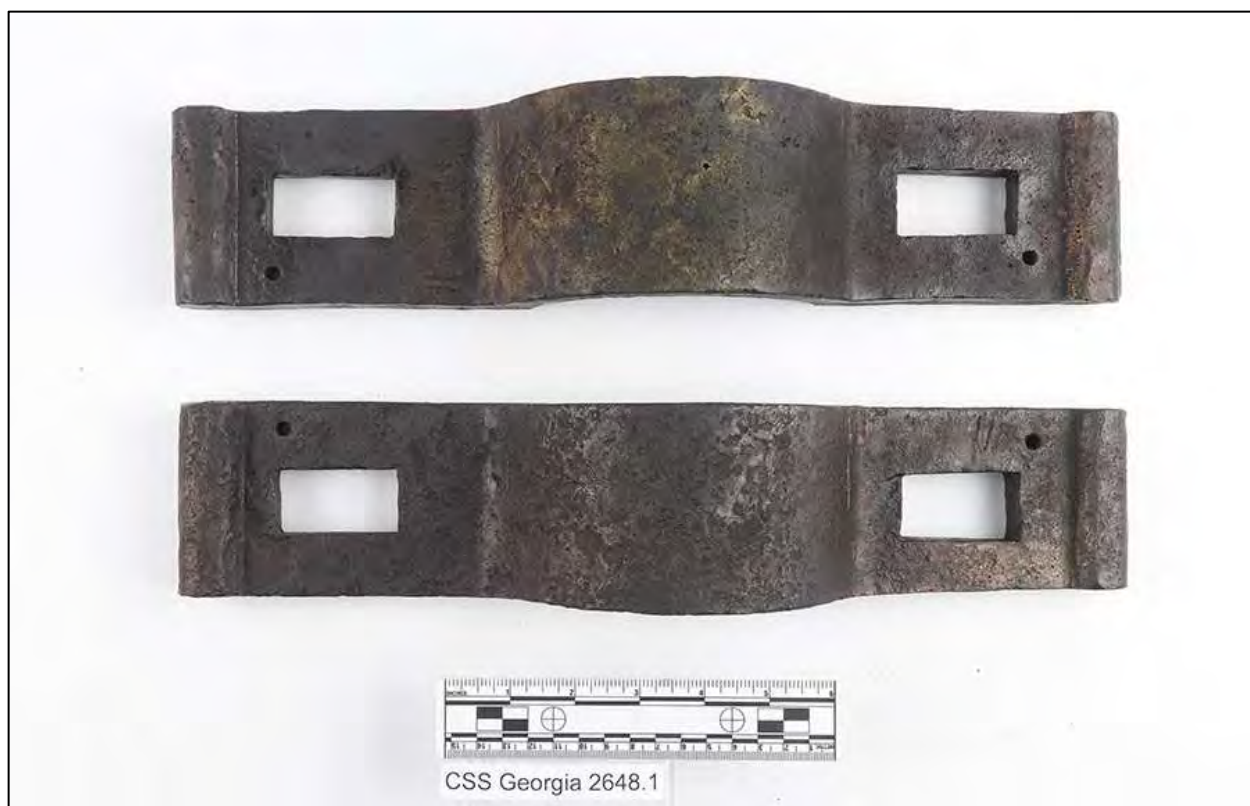
Figures 6-357. Small copper-alloy cap squares recovered from Unit 22-L (Artifact 2648.1). Top view. Note the rectangular fastener holes and smaller width compared to Artifact 370 or 1812.02.

Very little evidence is available for the 6-pounder carriage. Based on the size of the gun and the recovered cap squares (see Figures 6-357 and 6-358) it is assumed that the 6-pounder was mounted to a traditional four-truck carriage (Figure 6-377). The trucks, likely made of wood, were not extant. No other materials known to be associated with this carriage have been identified.

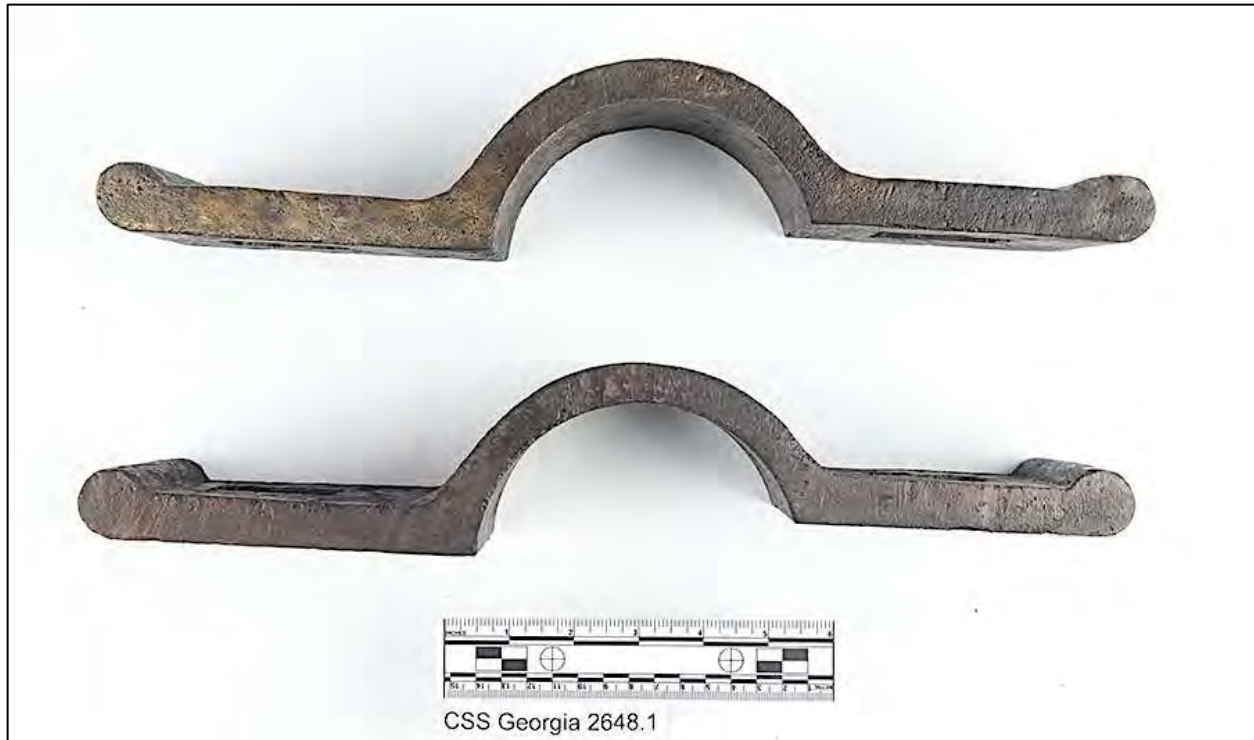
Figures 6-358. Small copper-alloy cap squares recovered from Unit 22-L (Artifact 2648.1). Side view. Note the rectangular fastener holes and smaller width compared to Artifact 370 or 1812.02.

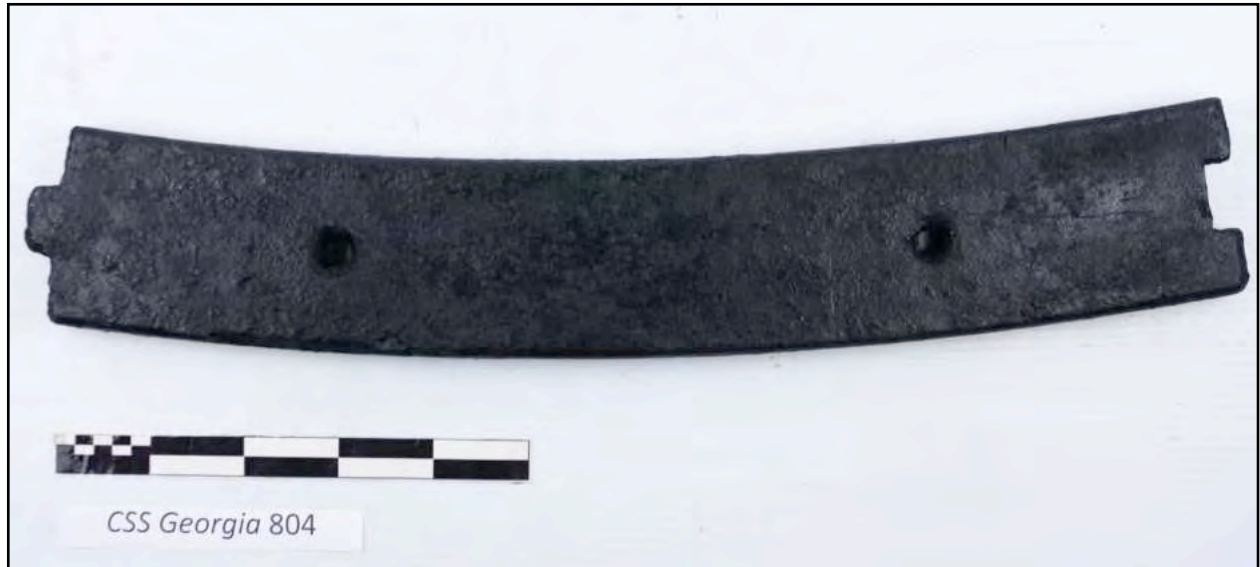
Figures 6-359. Section of pivot-carriage track recovered from Unit 10-E (Artifact 804). Note the notches at either end for fitting pieces together, as well as holes for fastening track pieces to the deck.

Approximately 24 sections of pivot-carriage track were recovered from the site. Due to the linear shape, it is possible that pieces in poor condition were identified as rail, so the actual amount recovered is difficult to know. Track pieces were roughly 5 inches wide, 1.5 inches thick, and 25 inches long. The tracks were fixed to the deck with fasteners (through pre-made holes, as seen in Figure 6-359), allowing the pivot carriage trucks to traverse constructed paths on the vessel. As previously stated, these paths enabled gun training as well as repositioning to and from port and starboard. The tracks also reduced damage to the deck that would have resulted from the trucks rolling directly over planking timbers.

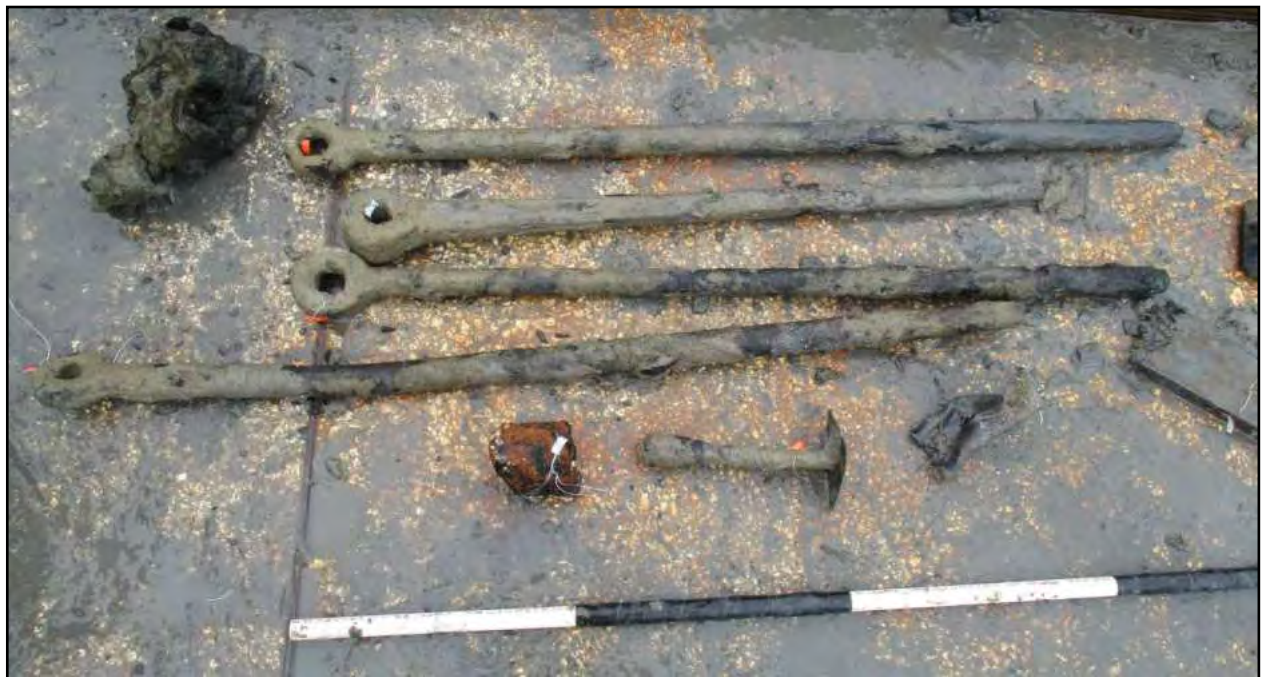
Figures 6-360. Field photograph of gun carriage wrenches recovered from Grab G-58, Unit 9-E.

The artifact database listed 30 entries for wrenches, and of these, four were specifically listed as gun carriage wrenches. All gun carriage wrenches were recovered from Grab G-58 in Unit 9-E (Figures 6-360 and 6-361). They measured roughly 43 inches long. Many wrenches from other areas of the site had degraded, so their original lengths were unknown. It should be noted that some of these wrenches may actually be concreted rods with hard eyes (used for tackle), but until conservation is complete this cannot be determined.

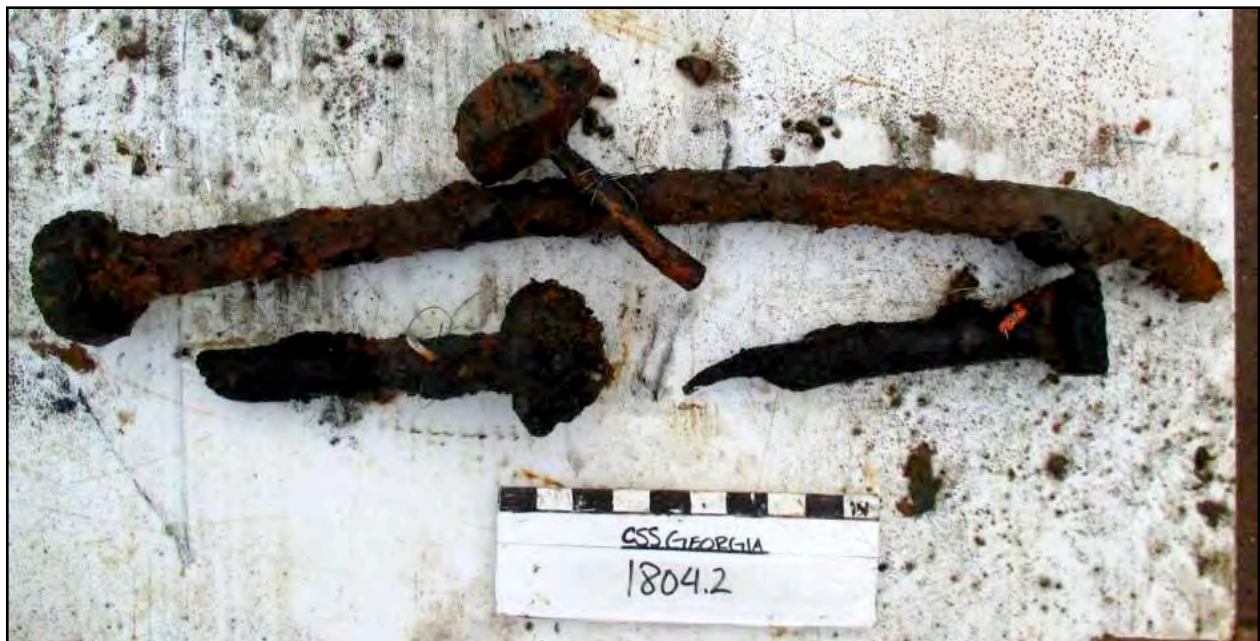
Figures 6-362. Field photograph of gun carriage fasteners recovered from Unit 9-F, associated with the Marsilly carriage cheek (Artifact 1804.2).

Some fasteners were identified as associated with gun carriages due to their size, or if they were found articulated or associated with other gun carriage components. Large bolts ran vertically (and sometimes horizontally) through the carriage, reinforcing the structure. Many smaller fasteners attached cap squares, journals, tackle, etc. to the carriage frame. The database listed nine fasteners specifically as gun carriage fasteners, five of which were found in the Marsilly carriage cheek (four of which are shown in Figures 6-361). There were likely many more, but positively identifying them as associated with gun carriages, or as fasteners at all, can be difficult following years of deterioration underwater. The artifact database listed 801 entries including the word “fastener,” with a total quantity of 1,018 individual artifacts associated with those entries.

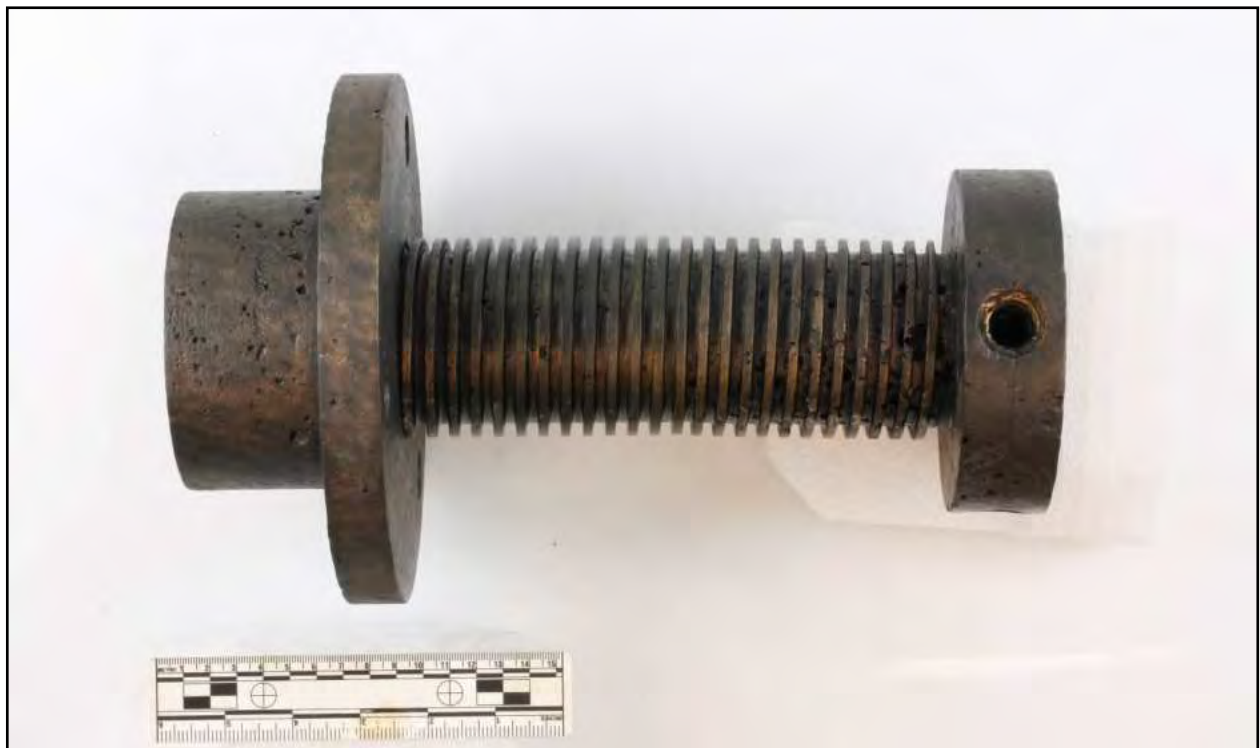
Figure 6-363. Elevation screw recovered from Unit 8-D (Artifact 1580).

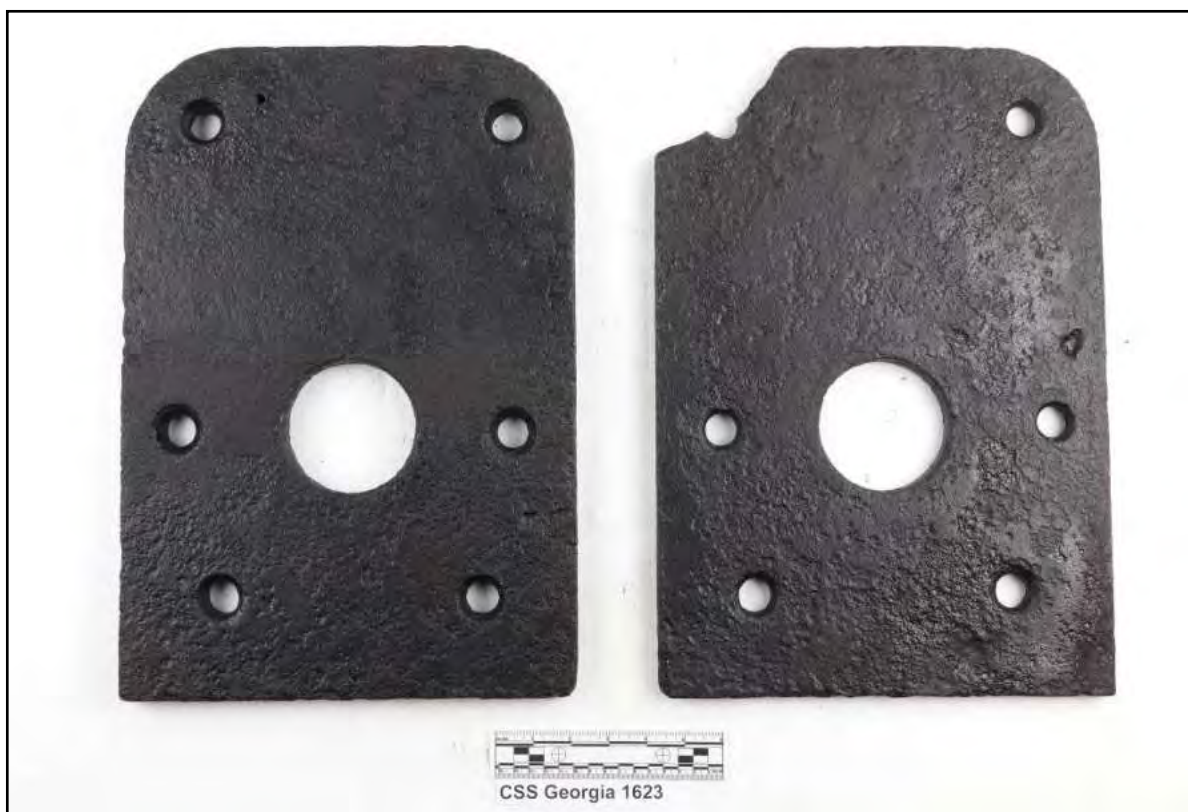
Figure 6-366. Pivot plate (Artifact 1623).

Artifacts related to the pivot (Figure 6-365), about which the entire carriage rotated, were also recovered. One pivot assembly (Figures 6-366 and 6-367), two pivot plates, and one broken end of a pivot pin were identified. Figure 6-368 shows what the assembly looked like after recovery, and before it was separated for conservation.
