CSS *GEORGIA*
ARCHEOLOGICAL DATA RECOVERY AND MITIGATION
FOR THE SAVANNAH HARBOR EXPANSION PROJECT (SHEP),
CHATHAM COUNTY, GEORGIA AND JASPER COUNTY, SOUTH CAROLINA

**FINAL DRAFT REPORT
OCTOBER 2019**

Stephen R. James, Jr. and Gordon P. Watts

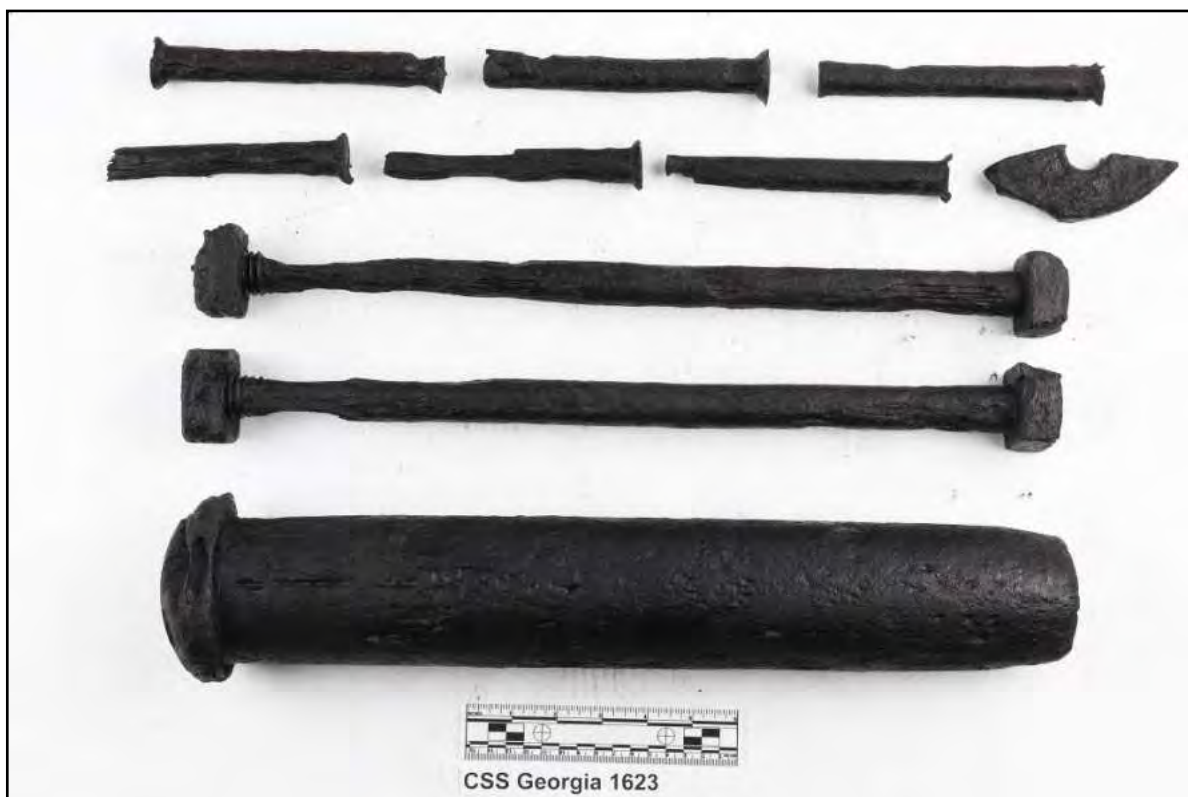
Figure 6-367. Pivot pin and fasteners.

Artifacts related to the pivot (Figure 6-365), about which the entire carriage rotated, were also recovered. One pivot assembly (Figures 6-366 and 6-367), two pivot plates, and one broken end of a pivot pin were identified. Figure 6-368 shows what the assembly looked like after recovery, and before it was separated for conservation.

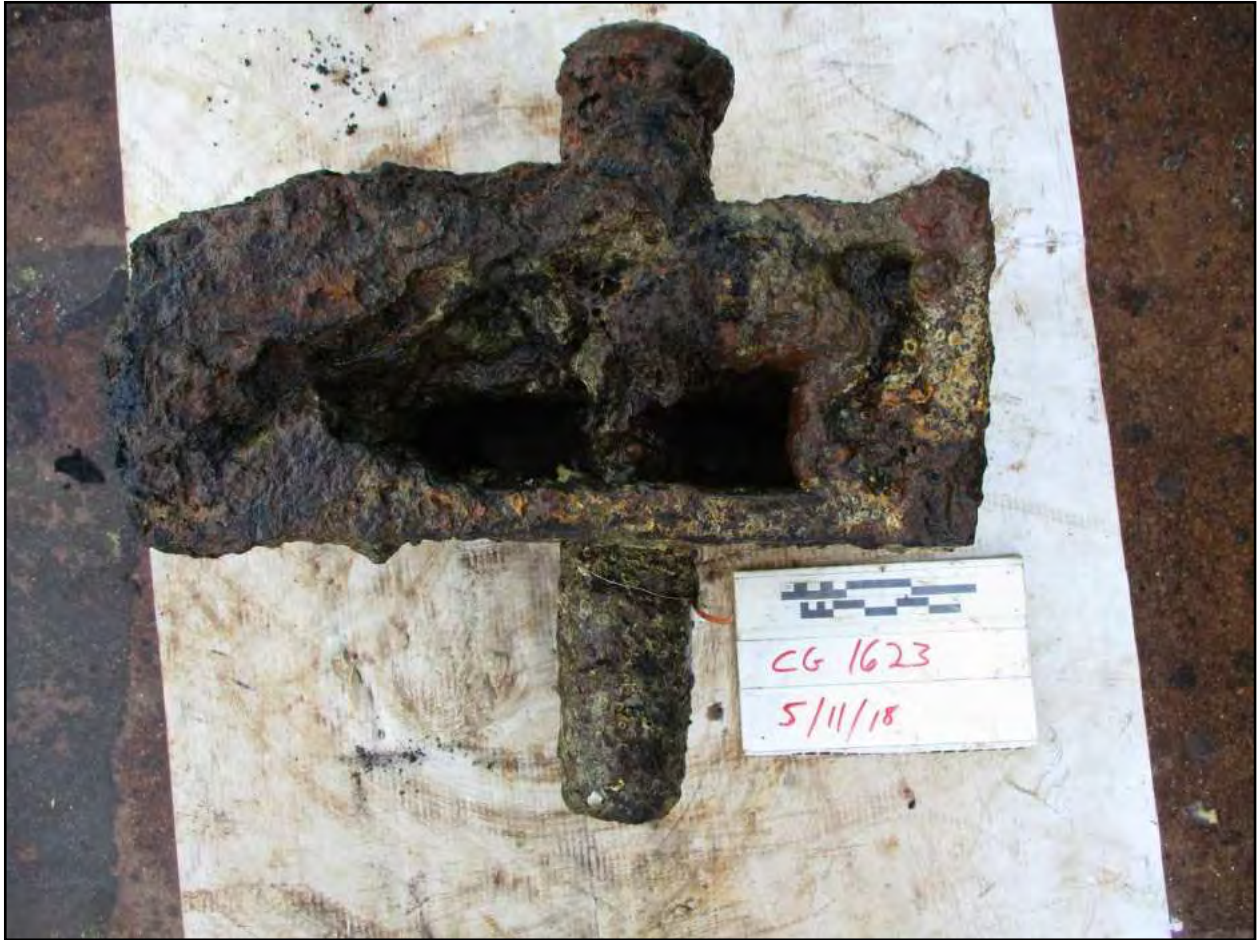
Figure 6-368. Pivot assembly articulated after recovery (Artifact 1623).

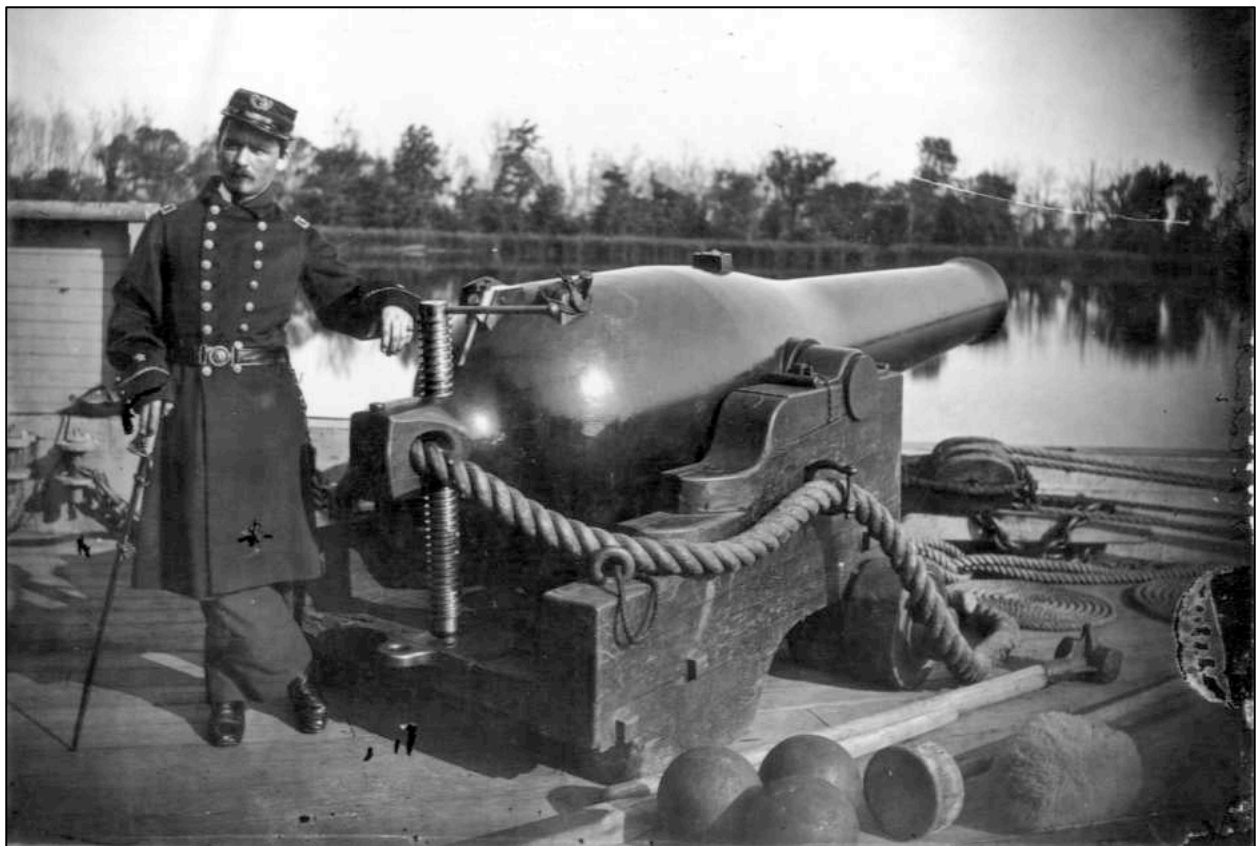
Figure 6-369. Dahlgren cannon in a Marsilly carriage on the *USS Hunchback* (U.S. National Archives Photo No. 111-B-2016, Brady Collection).

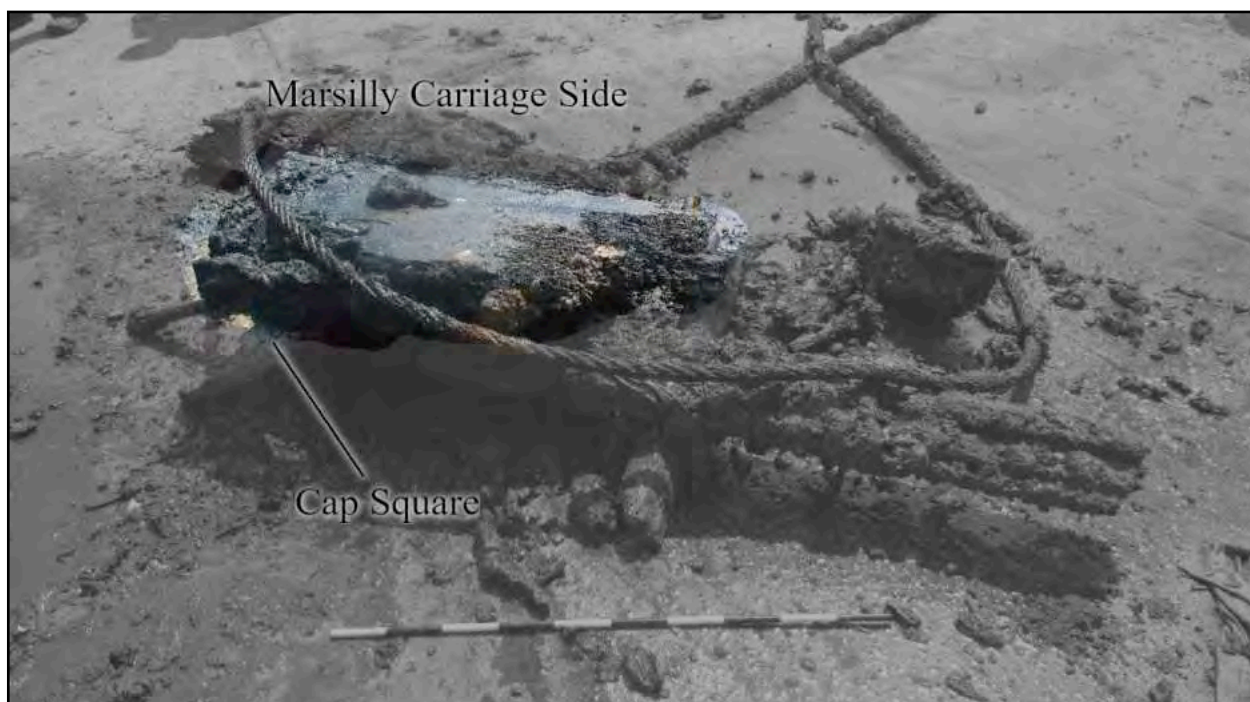
Figure 6-373. Marsilly gun carriage cheek (including cap square) recovered from Unit 9-F (Artifact 1804.03). The remainder of the photo has been desaturated to highlight the gun carriage piece.

Another Marsilly gun section, known as the "cheek" (one side of the carriage and a cap square) was recovered from Unit 9-F (Figure 6-373). This section was also undergoing conservation treatment at the time of analysis. Unfortunately, this means that little additional information was available about it, and only a few field photographs like the one below were available. However, the cap square and associated fasteners were intact (as visible in the photograph), so the piece will yield additional information once conserved.

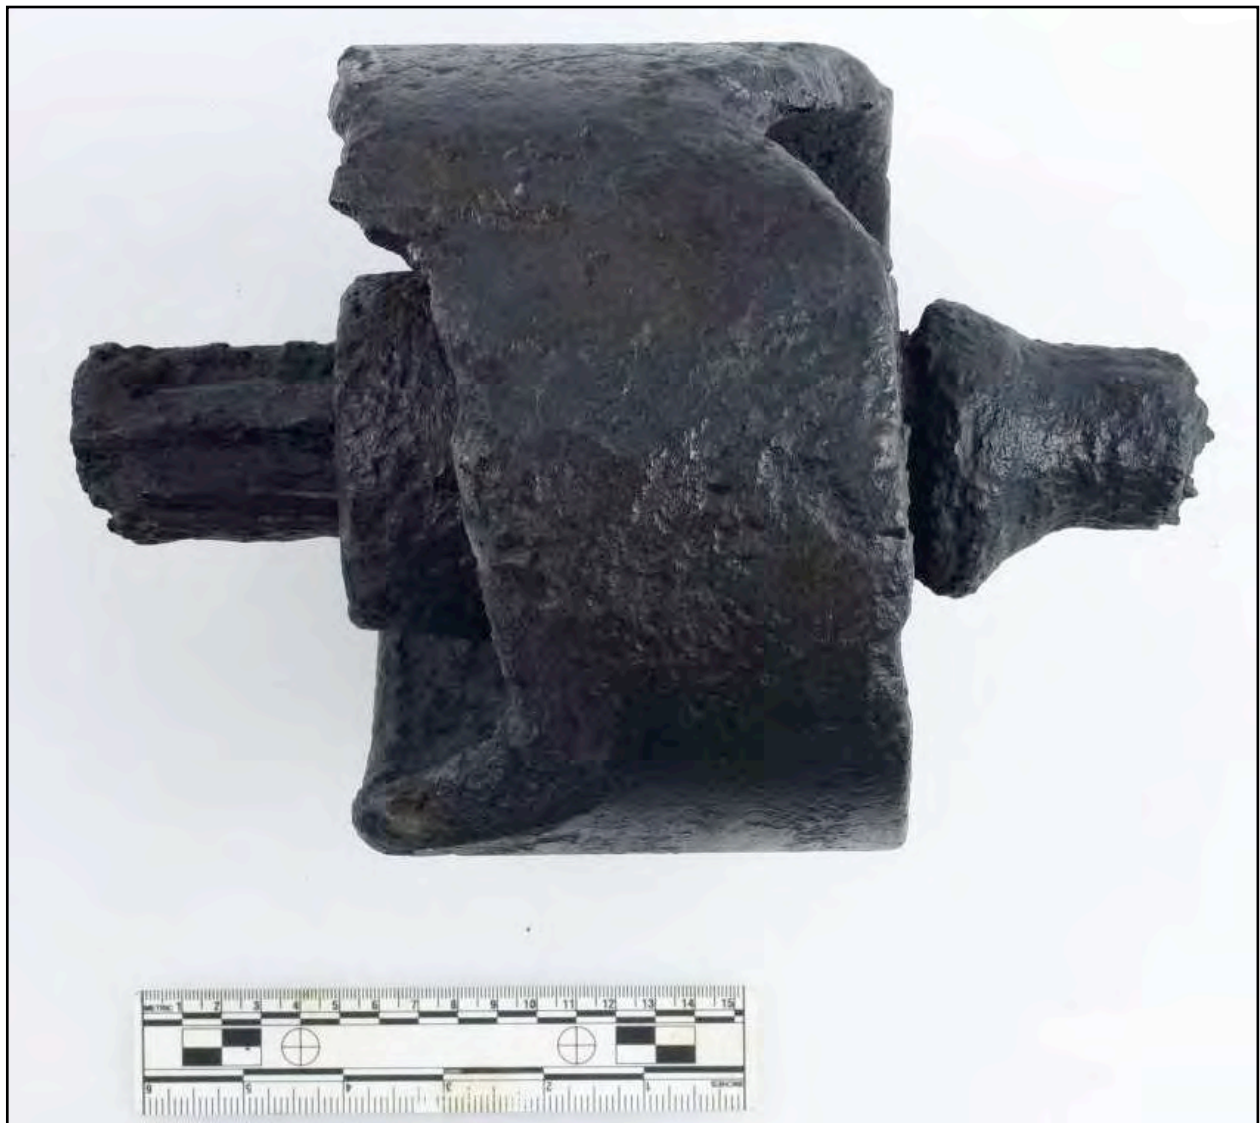
Figure 6-374. Possible Marsilly carriage truck recovered from Unit 18-BB (Artifact 1584). Note the boxing on the right side of the truck. The tapered appearance differs from the cylindrical boxing found on the pivot gun carriage axle seen in Figure 6-343.

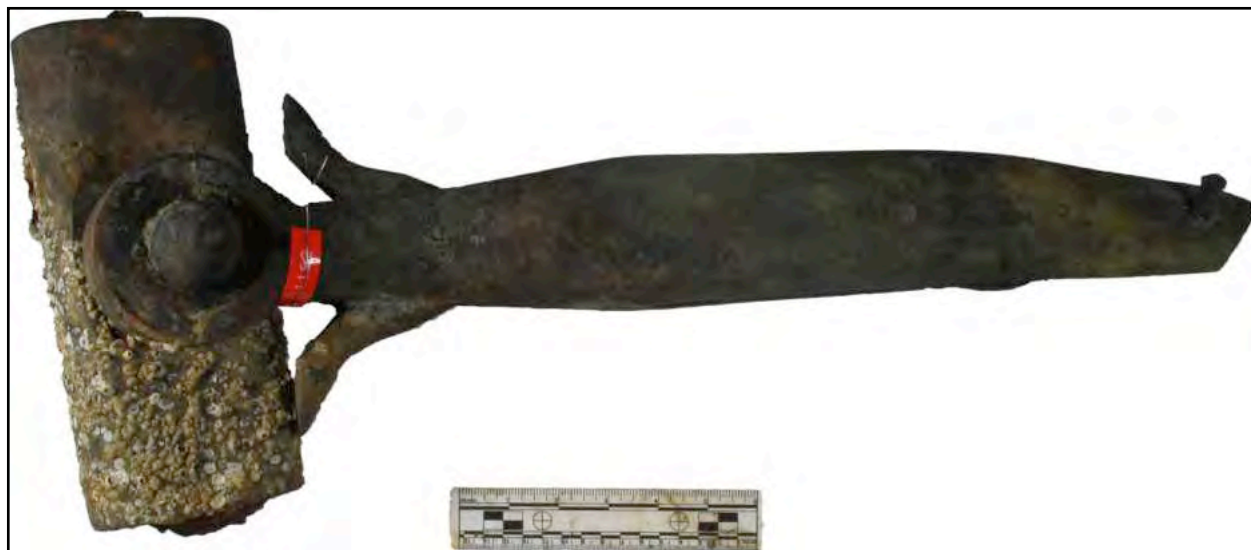
Figure 6-375. Marsilly carriage handspike recovered from Unit 13-B (Artifact 1192).

Marsilly-carriage roller handspikes were used to train the guns in the direction of their targets. The handspike was hooked to the rear of the carriage, and used as a lever to raise the back so that the entire carriage could be rotated. Unlike carriages with rear trucks, Marsilly carriages relied on the roller handspikes for running in and out as well as training (U.S. Navy Department 1860:51-52). One handspike was recovered from the site, and although the wooden dowel had deteriorated over time, the metal components were intact and articulated (Figure 6-375). See Figure 6-376 for a diagram illustrating proper use of the roller handspike.

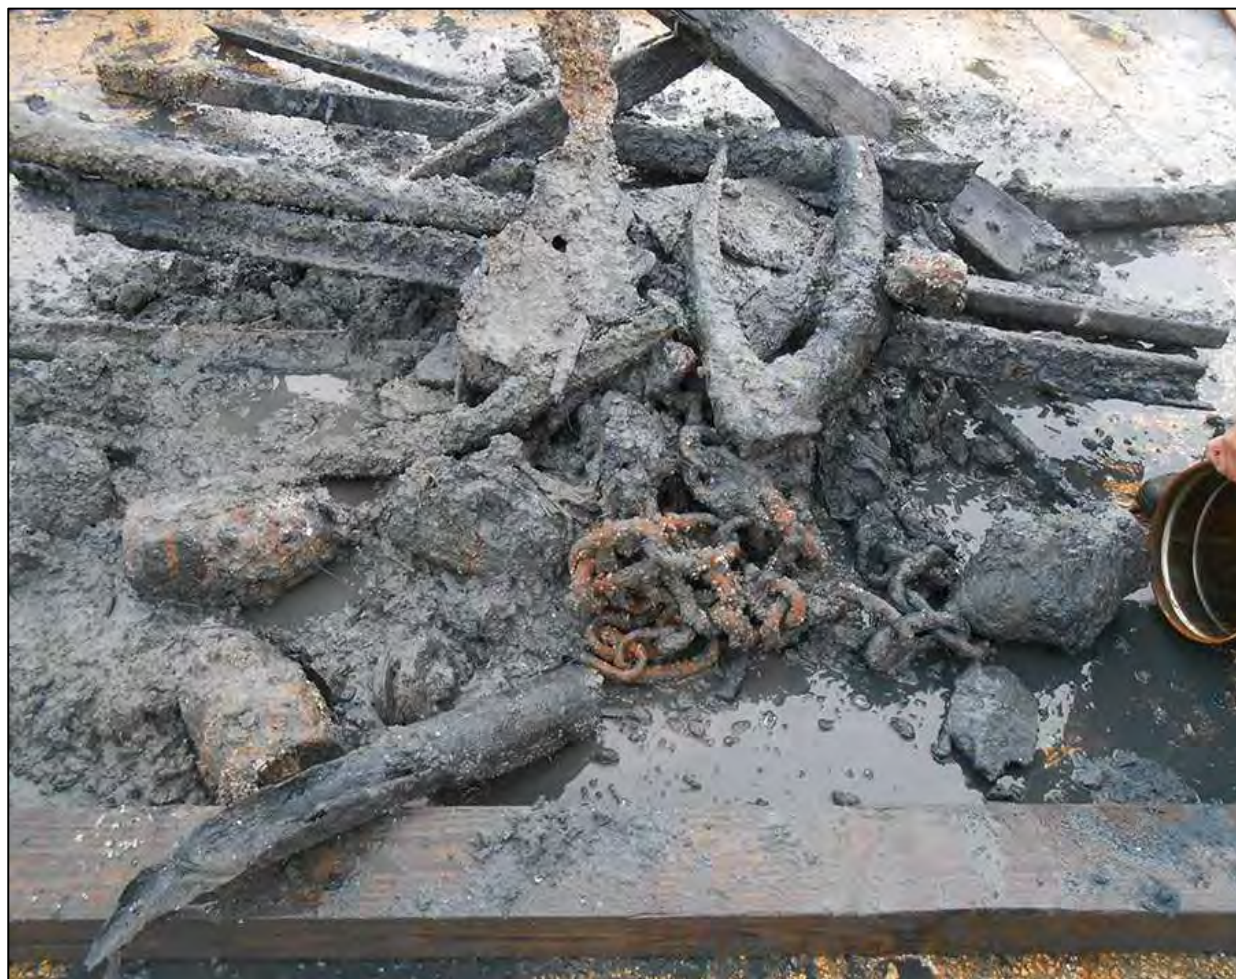
Figure 6-378. Material recovered with grab G-208 showing at least three of the five Brooke shells (lower left and next to bucket right) and one spherical Dahlgren shell (far left), along with rail, chain and other assorted artifacts.

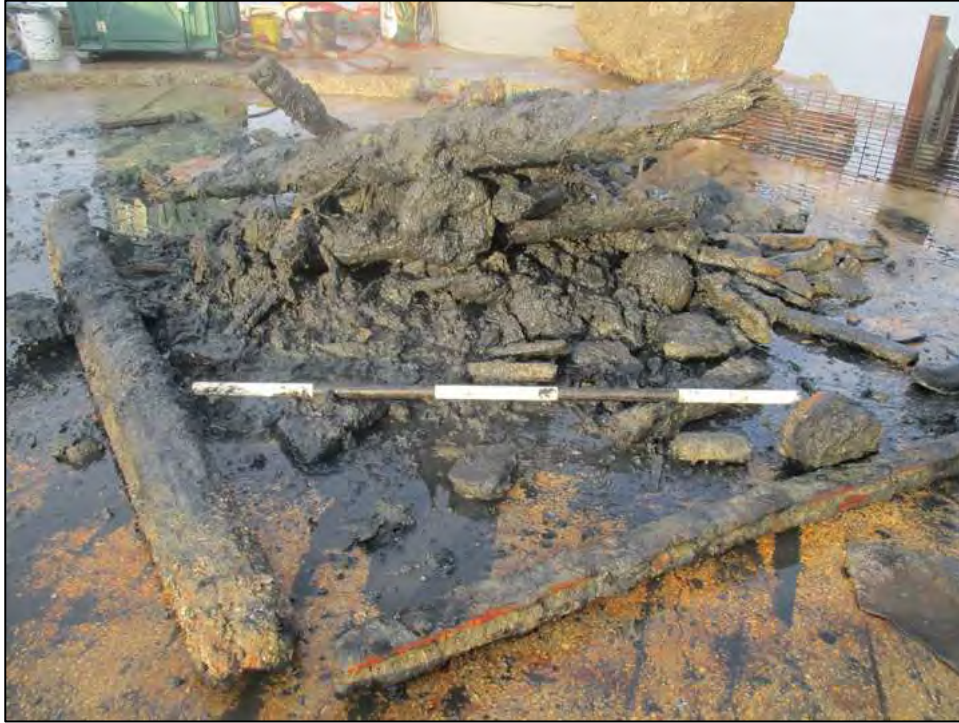
Figure 6-379. Material recovered with Grab G-201 showing numerous artifacts including rail, timber and brick. A Dahlgren shell can be clearly seen in the middle right of the photograph.

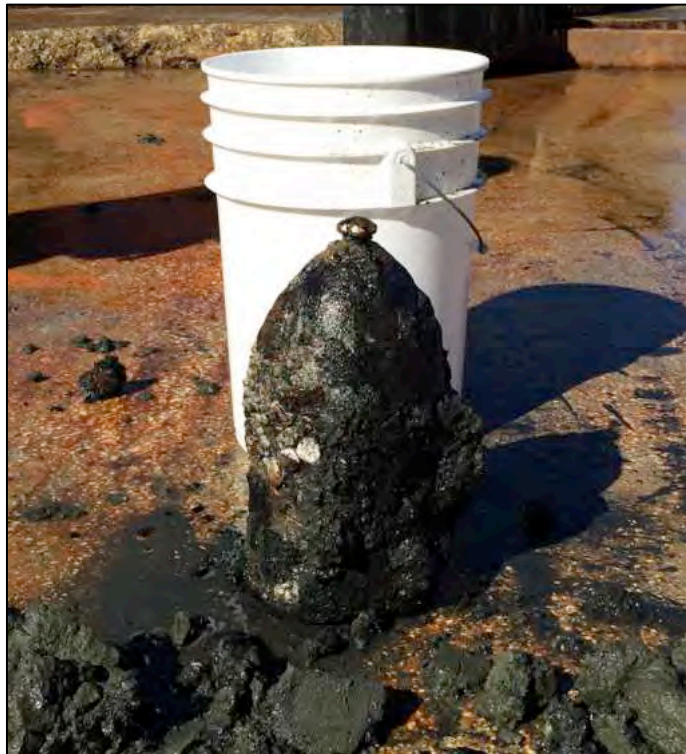
Figure 6-380. Brooke shell recovered with Grab G-482, photographed prior to placement in bucket. The shell and small amount of sediment were all that were recovered with Grab G-482. Note the shell's shiny brass Archer fuze.

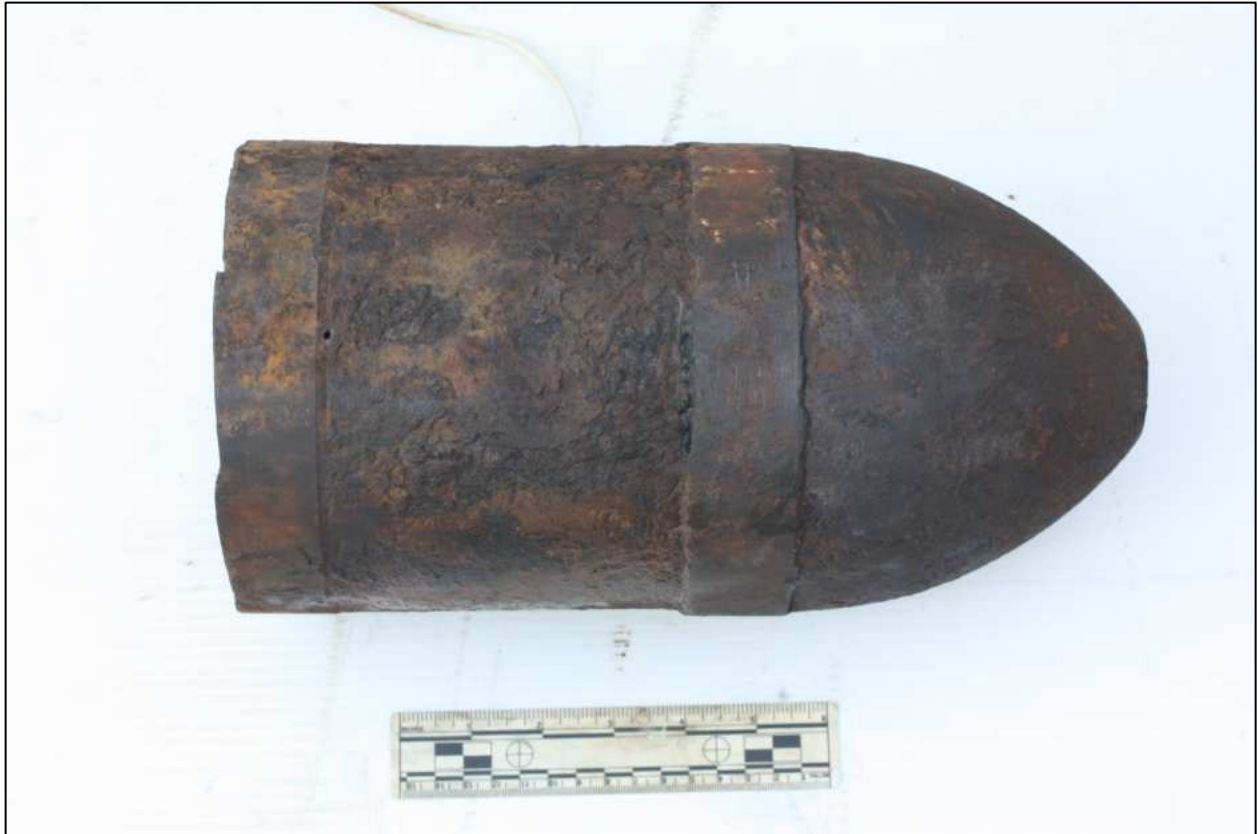
Figure 6-386. Brooke 6.4-inch ratchet disc sabot shell, Artifact 2364.13, during electrolysis. Note the ratcheted end, left, and the bourrelet band center.

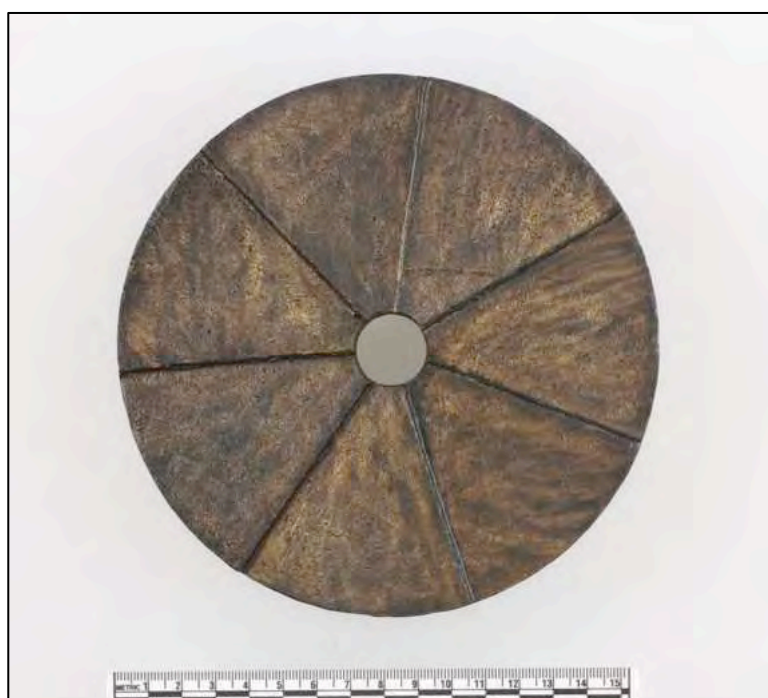
Figure 6-388. Brooke copper ratchet disc sabot, Artifact 1609. Differing from the sabot above, it lacks the inset circle surrounding the bolt hole.

Several recovered sabots and sabot bolt removed from a Brooke shell are presented in Figures 6-3876 to 6-389. The sabot may be simply described as a shallow copper saucer, bowl or basin with a hole in the center (see Figure 6-389). These Brooke ratchet disc sabots were, however, part of a state of the art munition that was difficult to cast and to mate with the base of the projectile body (Bell 2003:155). The overall diameter of the piece was measured at 6.3 inches and height at 1.44 inches. At the center is a 0.875-inch diameter hole to accommodate the bolt that would secure the sabot to the base of the Brooke shell. In cross section profile the top of the 'saucer' begins with a 0.19-inch wide flat rim. The profile then angles down steeply to the interior before a gradual rise increases the thickness to 0.75 inch at the bolt hole. The relatively flat exterior of the 'saucer' has seven angled planes that are an inverse match to the seven angled planes at the base of the shell and are intended to mate with that base in a close fit, the surfaces of all the many facets in direct contact. This would include both the seven angled surfaces and the seven short vertical walls at the lines defining the adjoining edges of those angled surfaces. The threaded bolt that then secured the fitted sabot to the base of the shell was made of iron and 2.37 inches long with a square head 1.19 inches on a side and 0.55 inch thick. The square-headed bolt has a conical end ahead of the threads. The threaded portion extends half the overall length of the bolt, leaving a smooth shaft for the 0.62-inch between threads and base of the bolt head (Figure 6-390).

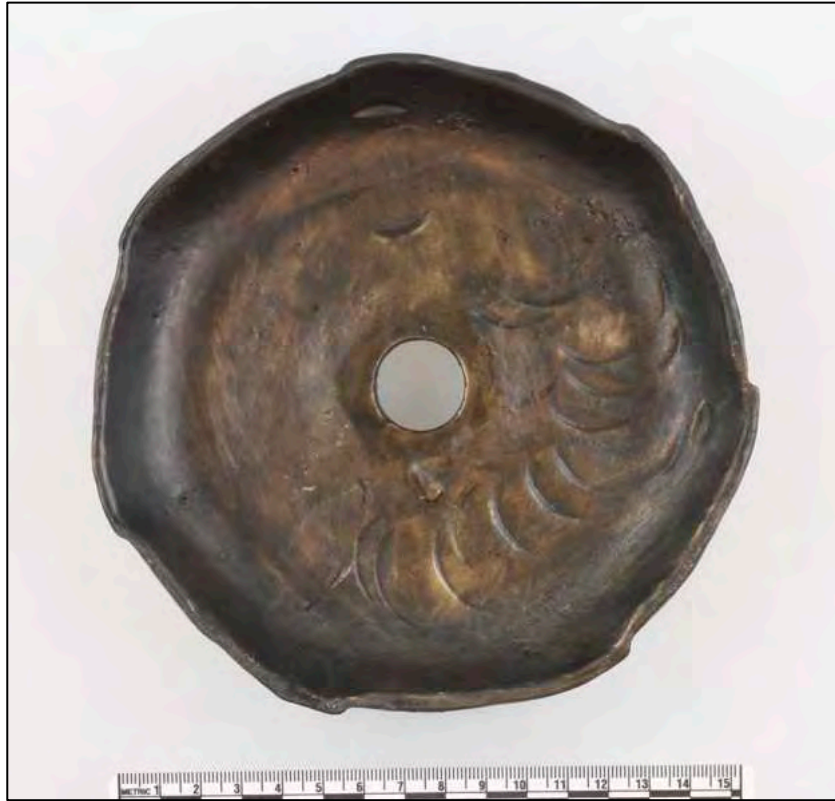
Figure 6-389. The shallow copper saucer, bowl or basin appearance of the aft face of a Brooke copper ratchet disc sabot, Artifact 794. Interestingly, this is a spent or fired sabot indicated by the grooving on its exterior side. The hammer marks may have been a result of fitting the sabot onto the shell prior to firing.

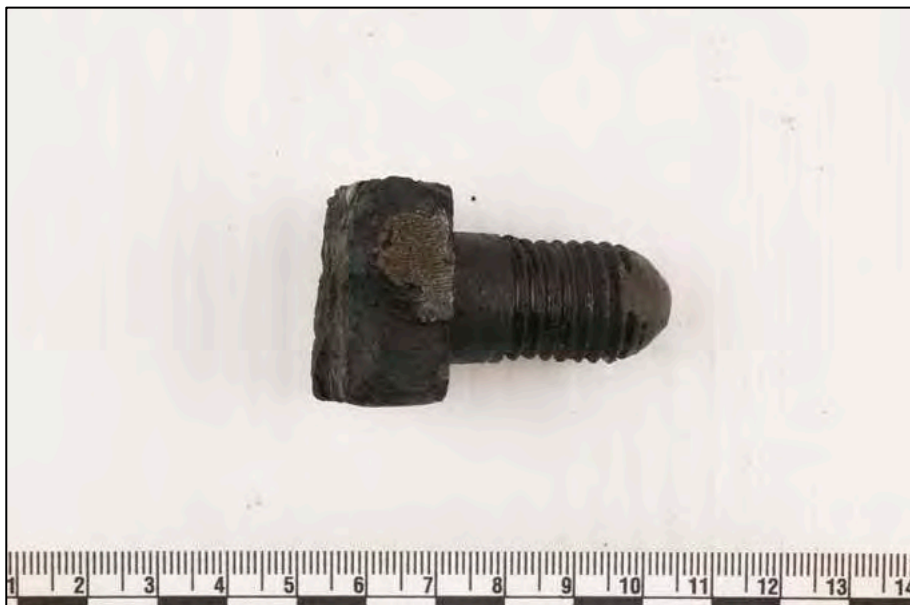
Figure 6-390. The square-headed iron bolt employed to fasten the sabot (see above) to the Brooke round, Artifact 2086.6.

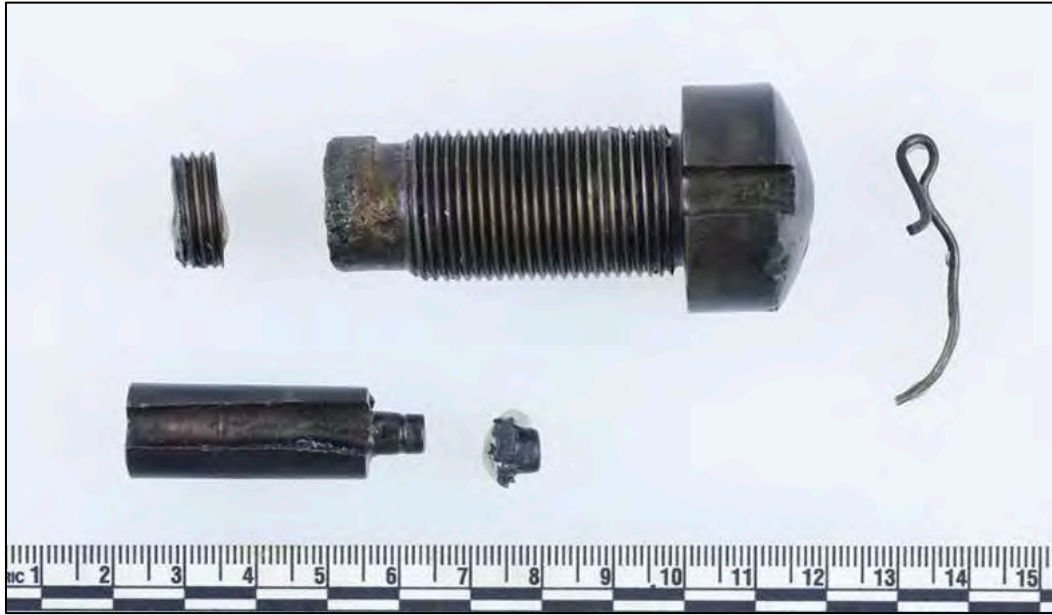
Figure 6-391. Archer safety pin percussion fuze from CSS *Georgia* after conservation showing all components. Artifact 4091 from Brooke Shell Artifact 4091. Internal slide with percussion cap at bottom.

As a representative example of a CSS *Georgia* Archer fuze from among the fuzes that have completed conservation, a fuze was selected for examination and photography that had been deactivated, disassembled and that included all its principle components in a relatively good state of preservation; as may be seen in Figure 6-391. This sample Archer fuze had been removed from one of the recovered Brooke shells and shares that shell's identification and provenience (Artifact 4091). The Biemeck "Thick Head, Type 1" Archer fuze is an assembly of five metal components most commonly made of copper and only occasionally made of brass due to the scarcity of that alloy in the Confederacy (the south lacked a native source of tin). These components consist of the main body, an internal slide, percussion cap, threaded retaining plug, and, removable safety pin. The overall length of the main body of the representative fuze was measured at 2.15 inches with 1.46 inches of that length below the head having the threads that secured the fuze in the matching threaded fuze hole on the 6.4-inch Brooke shell.

A small off-center hole for the removable safety pin was drilled through the treaded portion at a right angle to the main axis and just below the base of the head. The interior has a centered 0.44-inch diameter cylindrical hollow to accept the internal slide with percussion cap. This hollow interior stops at the head and is threaded at the open end for the retaining plug. The head on the main body of the fuze is a 1.25-inch diameter cylinder with 0.5-inch vertical sides surmounted by a convex top that adds an additional 0.19 inch for an overall thickness to the head of 0.69 inch. The large diameter of this head provided solid seating on the Brooke shell, and its thickness gave a substantial anvil for the percussion cap to strike. The fuze head had both a 0.19-inch wide screwdriver slot across the top, and, vertical 0.25-inch wide lug notches (spanner slots) on the sides that would fit a naval fuze wrench; for driving the fuze into the fuze hole on the nose of the Brooke shell.

The second largest component of the fuze assembly was the internal slide, which fit within the 0.44-inch diameter hole in the main body of the fuze. The slide had a percussion cap nipple at the head end and a hole, central to the axis, which led from the nipple to the base of the slide in a direct line toward the base of the fuze and the powder chamber of the Brooke shell. The slide was secured within the fuze body by the threaded retaining plug (or end cap). The plug prevented the slide from being thrown into the powder chamber of the Brooke shell when the gun was fired. Of note, the threaded retaining plug was a more secure option than more fragile pins used on other fuzes of the period (Biemeck 2013:240). The plug had two spanner holes for driving it into the threaded base of the fuze body, and a central hole to permit fire from the percussion cap to carry through to the bursting charge in the powder chamber of the shell.

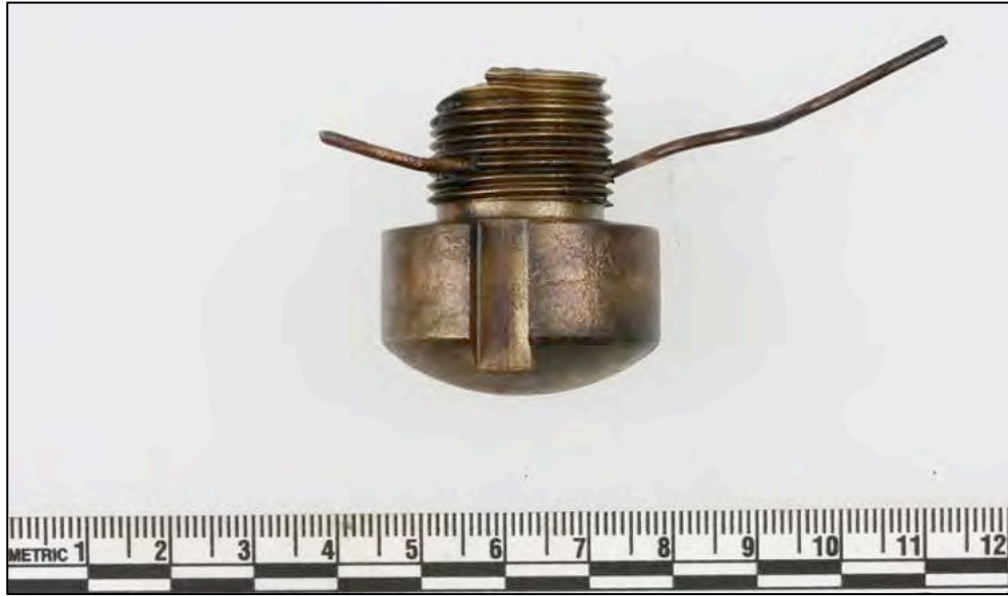
Figure 6-392. Side view of a conserved but broken Archer fuze showing the position of the safety pin or wire, Artifact NP5.

The final metal component of this Archer fuze was the removable safety pin. The pin was inserted sideways through the fuze in the off-center hole drilled below the head and through the threaded portion of the main body of the fuze, as may be seen in Figures 6-392 and 6-393 showing a bent safety pin within a broken fuze. When the safety pin was in place it blocked the slide, thereby preventing premature detonation of the shell by restricting the percussion cap from impacting the head end of the slide chamber. The pin was a significant safety feature designed by Dr. Archer and found on most fuzes that followed his pattern (Biemeck 2013:240). When the safety pin was in place it not only prevented premature detonation but, by noticeably preventing the fuze from being seated onto the nose of the Brooke shell, provided munitions handlers and gun crews with visual confirmation the shell was ‘safe’. In combat the safety pin would be removed, the archer fuze would be seated on the 6.4-inch Brooke shell using a screwdriver or naval fuze wrench before loading the live/armed shell into the gun. When the shell was fired from the Brooke gun and the Archer fuze properly struck an object at the end of its flight the slide would slam the percussion cap against the head of the fuze firing the mercury fulminate within the percussion cap. The detonation of the percussion cap would immediately ignite a solid flash composition or instantaneous flash wick within the central hole in the slide, transmitting fire down the fuze through the hole in the retaining plug and into the powder chamber thus detonating the shell.

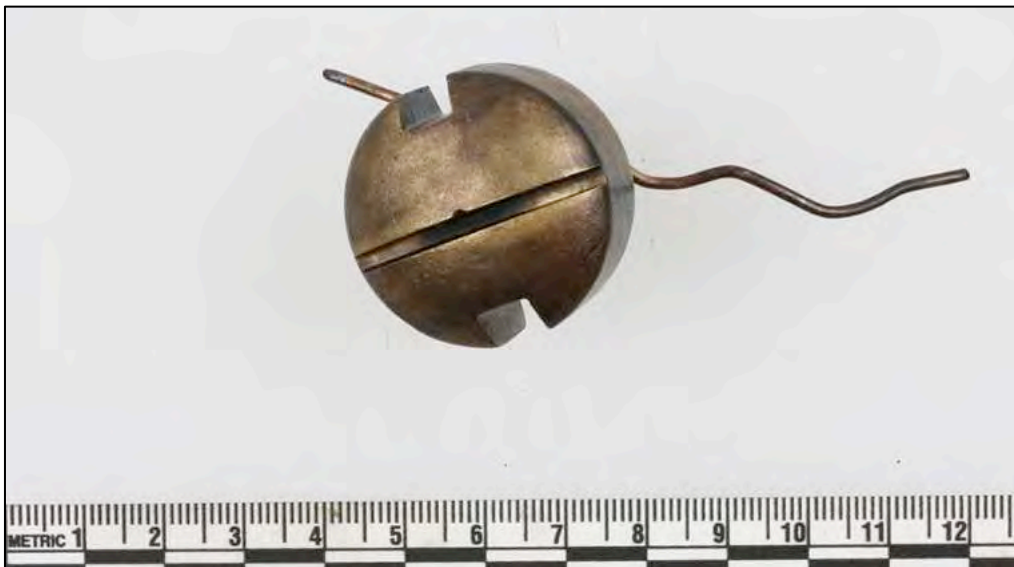
Figure 6-393. Top view of the Archer fuze clearly showing the off-center position of the safety pin or wire, Artifact NP5. Also note facets for screwdriver or naval fuze wrench.

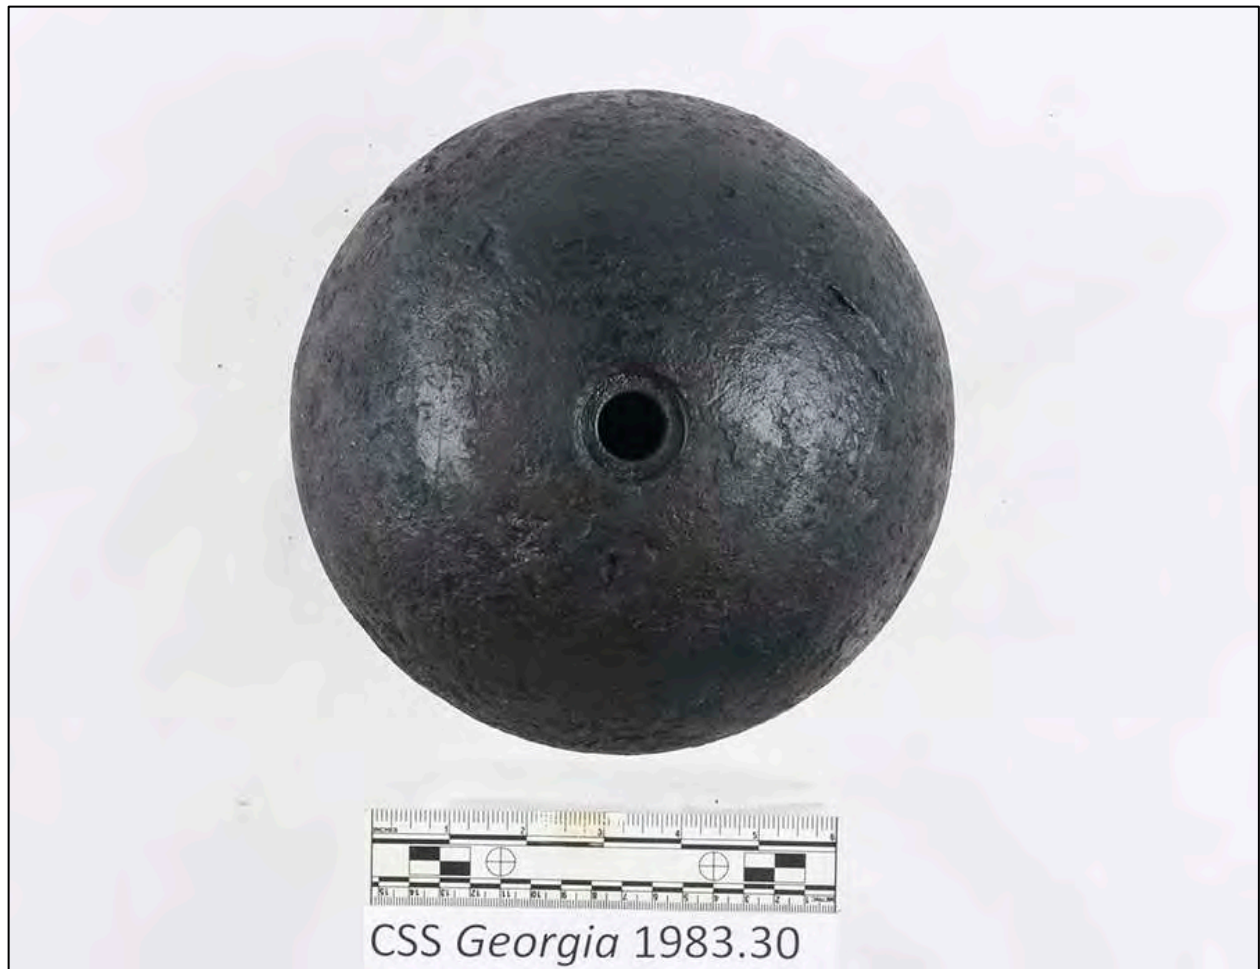
Figure 6-394. Spherical shell for IX-Inch Dahlgren recovered from the CSS *Georgia*, Artifact 1983.3. Its fuze has been removed.

Sixty-nine spherical 9-inch shells were recovered. Many of those shells have completed conservation and an example is presented here as Figure 6-394. The diameters of a half dozen selected shells from among those that have completed conservation were measured and ranged from 8.73 to 8.8 inches. Many of the shells had brass bushings in the fuze wells and one of those (Artifact 1983.3) had a small anchor stamp as may be seen in Figure 6-395. The bushing of shell had a measured outside diameter of 1.25 inches and a threaded interior diameter of 0.75 inch. The depth of the fuze well was measured at 2.50 inches, perhaps indicating the interior had a flat surface at the top of the shell. Biemeck discusses four patterns for the interiors of Dahlgren shells (Biemeck 2013:495). An initial experimental model had a spherical interior without any

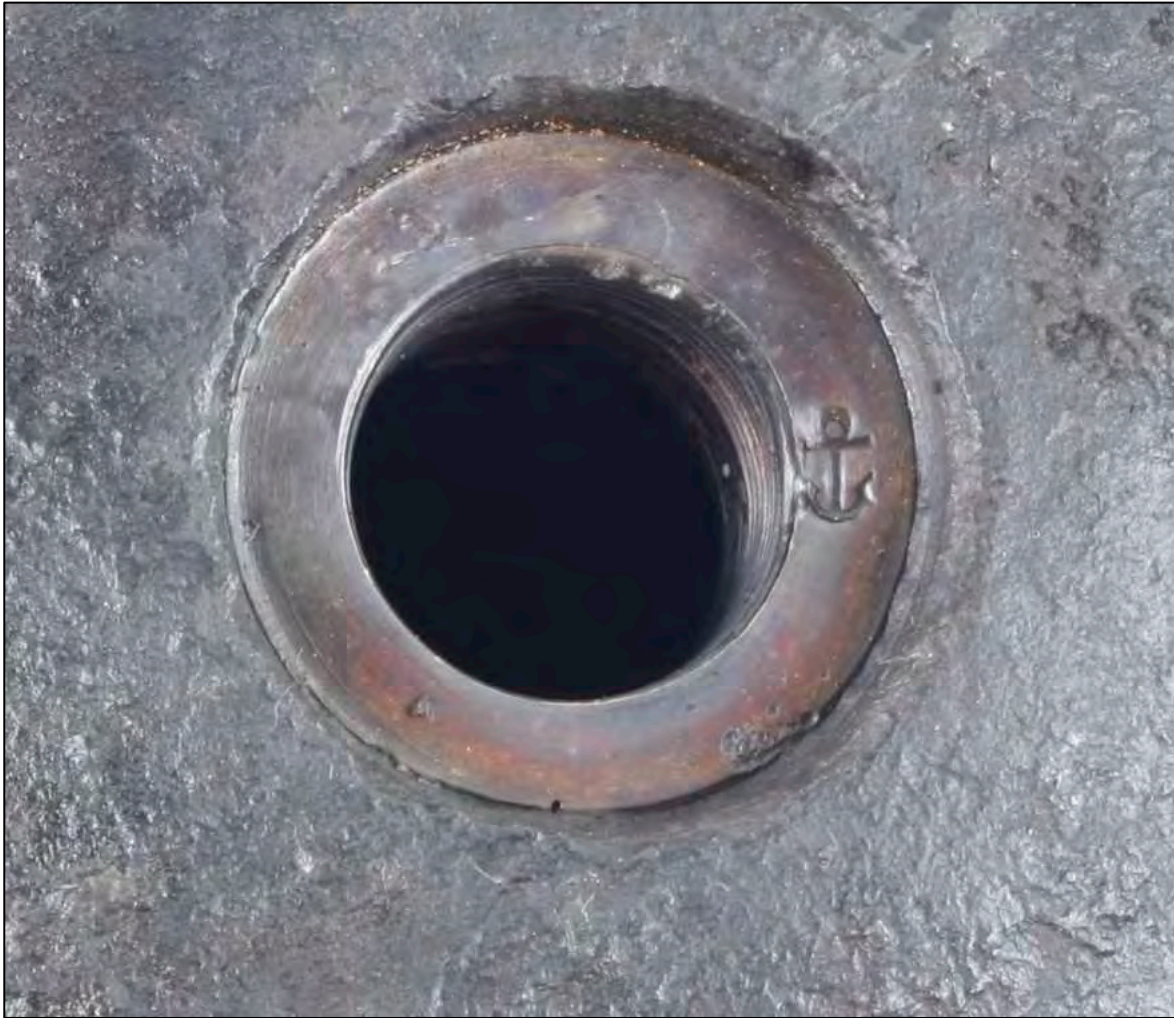
Figure 6-3954. Anchor stamp in the fuze well bushing of a spherical IX-Inch Dahlgren shell.

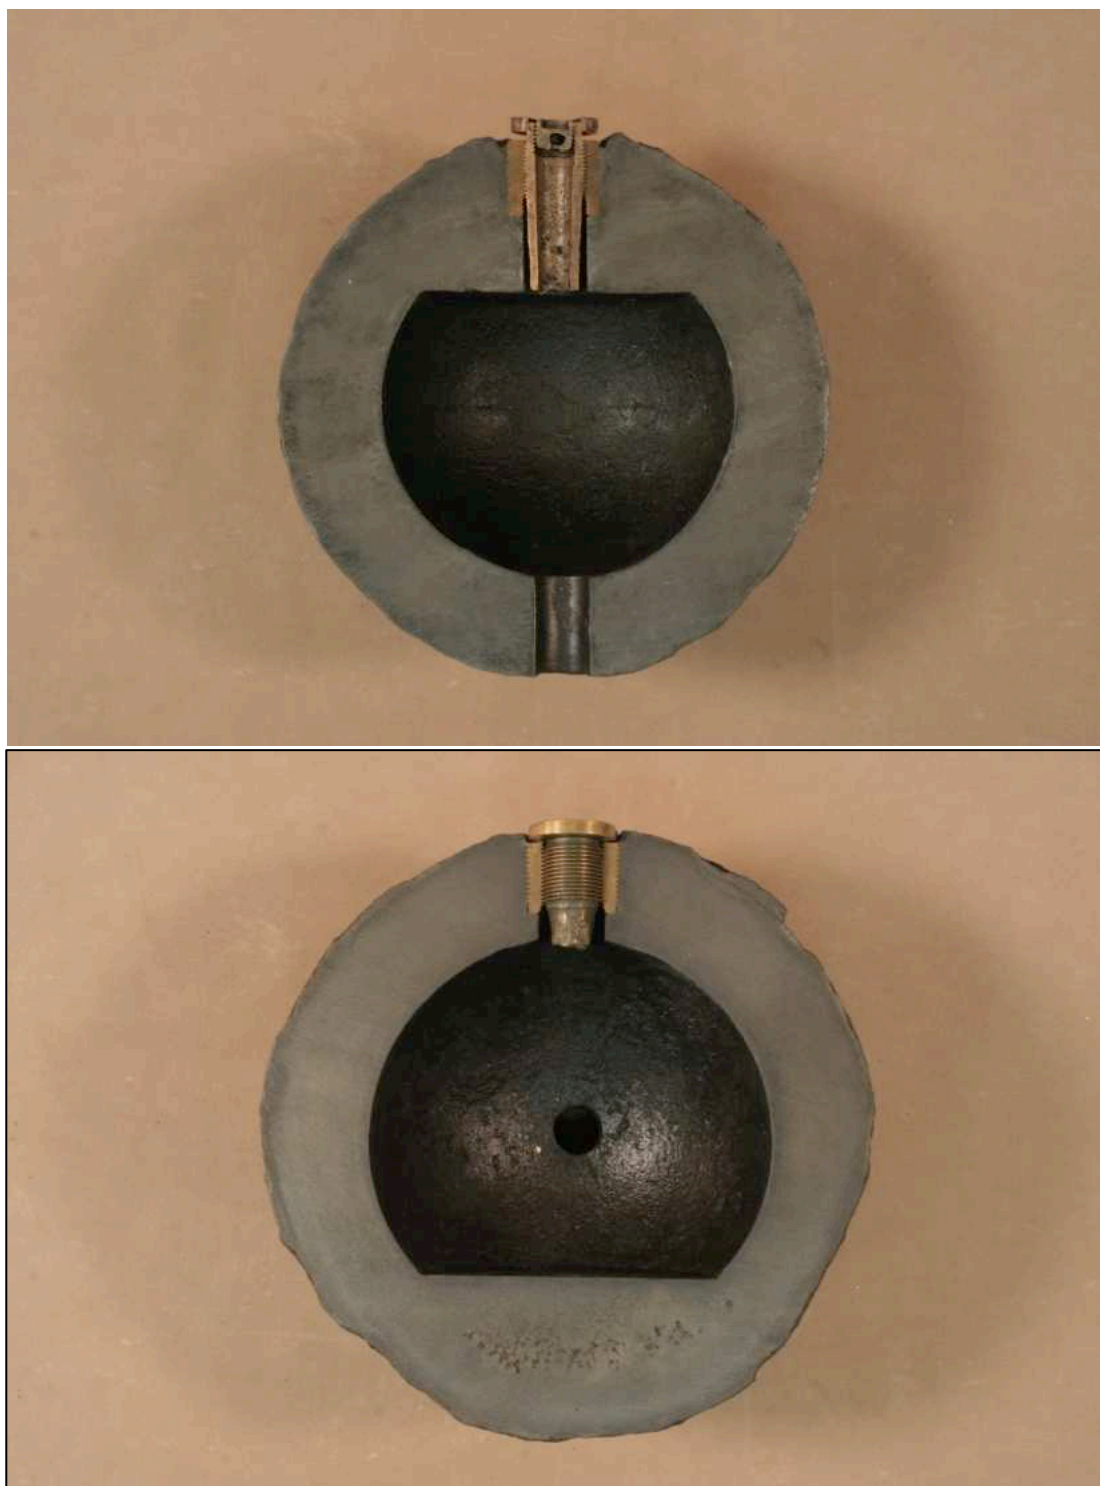
Figure 6-396. Sectioned 8-inch Columbiad shell (top) and IX-Inch Dahlgren shell (bottom) from the USS *Westfield*. Note the top 'flat' on the Columbiad and bottom 'flat' on the Dahlgren; also note severe deterioration on lower end of Dahlgren's water-cap fuze due to hydrogen sulfide gas generated by deterioration of the shell's black powder (as presented in Biemeck 2013).

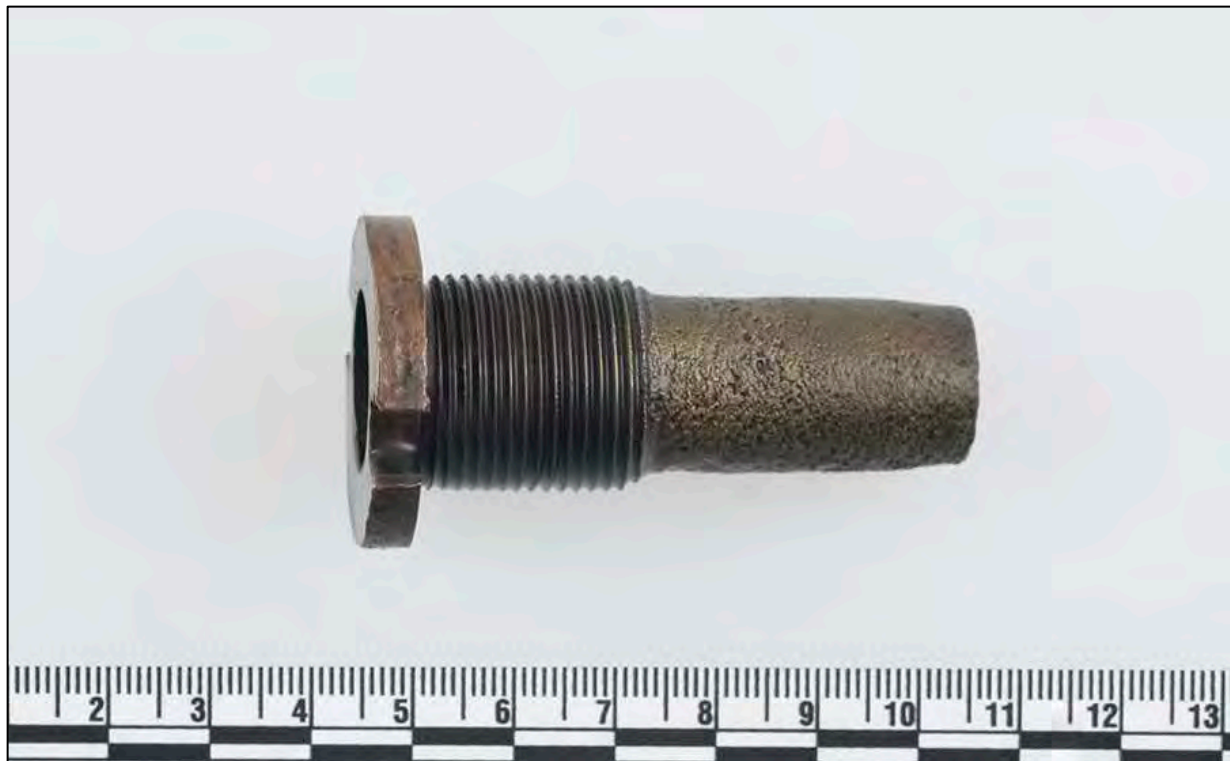
Figure 6-397. Alger pattern naval water-cap time delay fuze from the spherical IX-Inch Dahlgren shell above, Artifact 1983.30.

A representative example of a CSS *Georgia* water-cap fuze was selected for examination and photography from among a limited number of such fuzes that have completed conservation, and it is presented here in Figure 6-397. This water-cap fuze was recovered separate from any IX-Inch Dahlgren shell during mechanical recovery (Artifact 1983.3, see shell above). A complete unused example of a water-cap time fuze would consist of four metal components: the copper main body, copper water-cap, lead safety patch, and, lead base plug. Example 1983.3 had the main body, water-cap and safety patch. No examples of the lead base plug have been identified from among the fuzes and shells. The water-cap of this fuze remains within the main

body. The main body of the fuze would have contained, within its hollow interior, the slow-burning composition that would have ignited the bursting charge within the Dahlgren shell. This main body has an overall length of 2.44 inches, matching both the Jones and Biemeck examples (see above). As already noted, the flanged head exhibits no observable stamps or markings as might be expected on a pre-war or Union Navy fuze. This head measures 1.25 inches in diameter with a flange thickness of 0.19 inch and has two square lug notches (spanner slots) on the perimeter to accept a wrench for threading the fuze into the shell. The top of the head has a recessed area, 0.75 inch in diameter, for accepting the lead safety patch and retains (not removed in conservation) the water-cap in a (presumably) threaded hole of 0.56-inch diameter. From below the water-cap, and down to the base of the main body, is a fuze channel that measures 0.44 inch diameter at the base. The exterior below the flanged head is threaded for the first 0.94 inch and has a smooth slightly tapered surface for the remaining 1.31 inches down to the discharge end of the main body. The water-cap that remains threaded within the main body is the essential component of the Cyrus Alger design. This water-cap measured 0.56 inch in diameter and has two square lug notches (spanner slots) on the sides, similar to those on the head of the main body but proportionally smaller. The top of the water-cap has a shallow flat recessed area measuring 0.37 inch in diameter, also similar to the safety patch recess on the head of the main body of the fuze but serving a different function (see below). At the bottom of the flat recess in the top of the water-cap are three small holes. These holes are the ends of flash channels that follow a crooked (zigzag) path through to the bottom of the water-cap and the interior of the main body. The two remaining metal parts of a complete fuze assembly, the safety patch and safety plug (missing) were made of lead. The missing safety plug would have been in the lower end of the main body to seal the fuze from the environment and to prevent an accidental detonation of the bursting charge if an installed fuze were prematurely ignited. When the shell was fired from a gun, the plug was knocked loose by the rapid acceleration exposing the powder train of the fuze.
