CSS *GEORGIA*
ARCHEOLOGICAL DATA RECOVERY AND MITIGATION
FOR THE SAVANNAH HARBOR EXPANSION PROJECT (SHEP),
CHATHAM COUNTY, GEORGIA AND JASPER COUNTY, SOUTH CAROLINA

**FINAL DRAFT REPORT
OCTOBER 2019**

Stephen R. James, Jr. and Gordon P. Watts

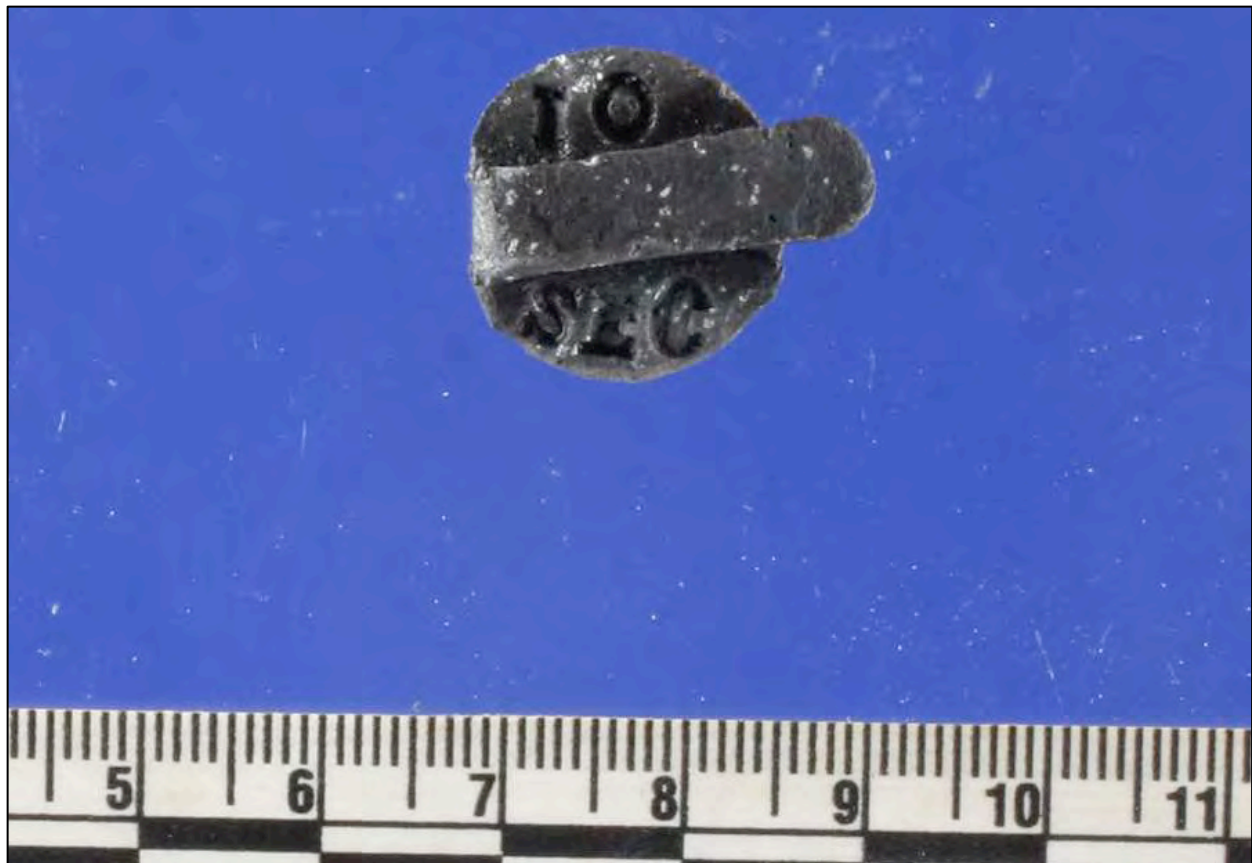
Figure 6-398. Lead safety cap in place on the head of an Alger water-cap time delay fuze that retains an intact pull-tab and displays clear “10”/“SEC” time delay markings, Artifact 2357.1.

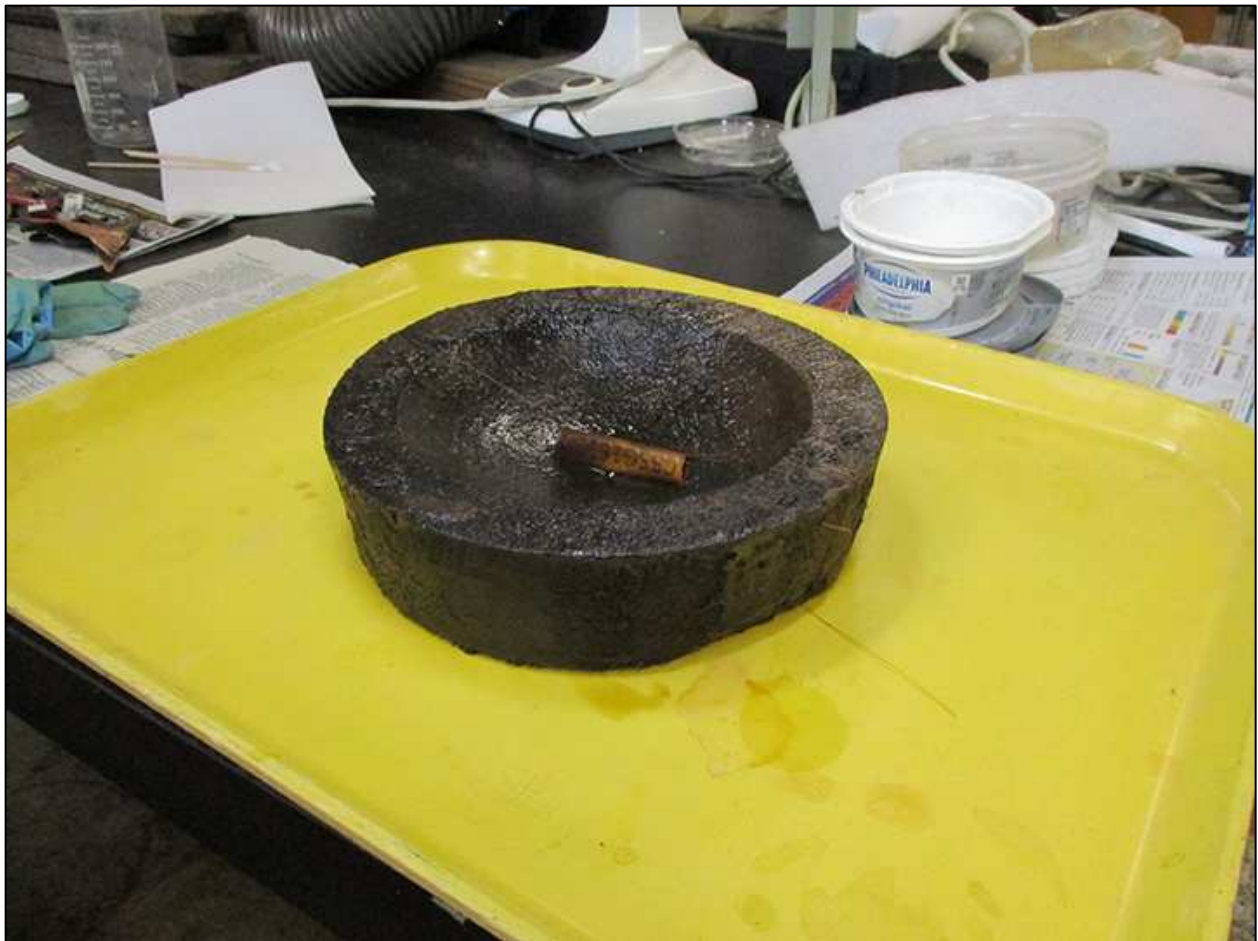
Figure 6-399. Artifact 1621.1, the only wooden sabot recovered for a IX-Inch Dahlgren shell on the site. It was recovered when trying to remove a round placed backward into Cannon No. 5 to render the cannon unusable at the time of scuttling. Still in conservation.

Similar to the Brooke rounds and the 6-pounders discussed below, the IX-Inch Dahlgren shell would have required a sabot for firing from the gun. However, only a single sabot for a 9-inch ball was recovered. Illustrated in Figure 6-399, it was still attached to a round placed backward into Cannon No. 5 to render the cannon unusable. Probably only still present because it was protected inside the cannon, it was recovered at CRL Texas A&M University in their attempt to remove the shell. Figure 6-400, a IX-Inch Dahlgren shell seated on its wooden sabot, shows what the shells on the CSS *Georgia* would have appeared. It is attached with thin iron bands that have been tightened or cinched down with twine. As stated at Civilwarartillery.com, “In the case of a smoothbore projectile a wooden sabot, made of poplar, basswood, linden, or other close grained wood, was used to hold the projectile with its fuze forward and in the center of the bore. Solid shot had the sabot attached with two crossed tin straps. If the wooden sabot was tied to a cartridge bag, the entire round was then referred to as fixed ammunition” (Civilwarartillery.com 2019).

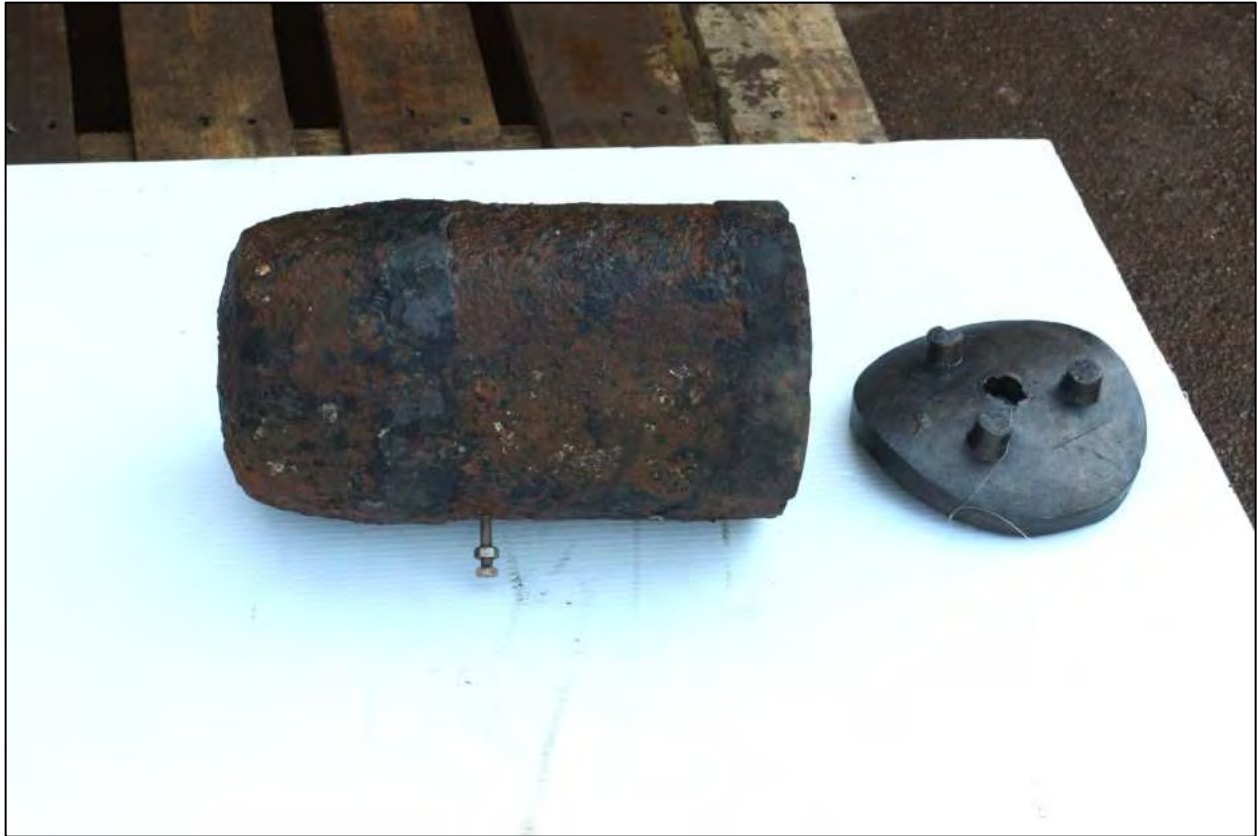
Figure 6-401. Solid cast iron Tennessee bolt with sabot (modern nut and bolt on lower side of projectile are for electrolytic reduction as part of the conservation process), Artifact 2416.5.

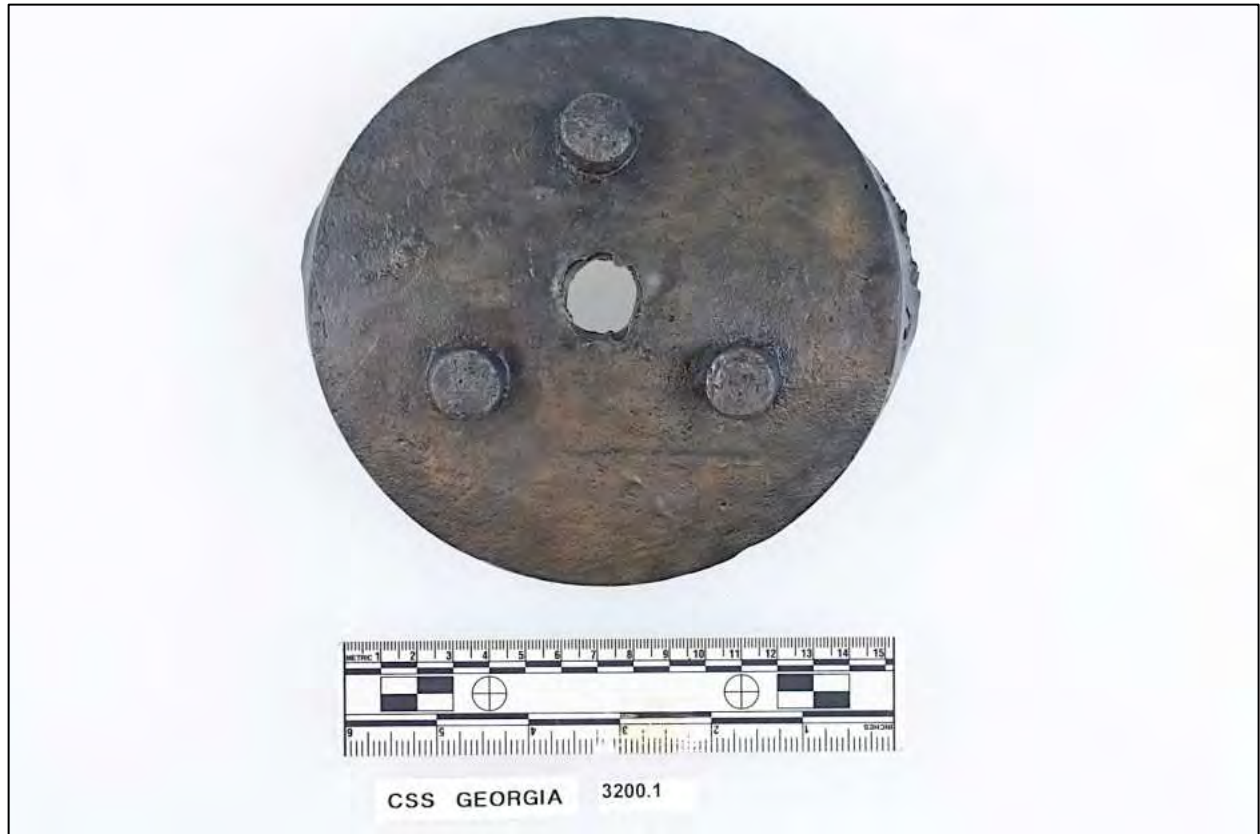
Figure 6-402. Tennessee pattern solid copper sabot with its three distinctive studs, Artifact 3200.1.

It is the stud holes in the base of the bolt and the studded copper sabot that specifically identify a munition as being among Capt. Gibbon's Tennessee projectiles. The solid copper Tennessee sabot (Artifact 3200.1) found separate from any bolt has received full conservation. This solitary sabot was examined and photographed, and is presented here in Figure 6-402. Although distorted, this one example is basically a 6.25-inch diameter disk, 0.625 inch thick. That disk was once of a shallow 'saucer' or 'dish' shape, convex on the top (studs) and concave on the bottom. The concave bottom of the examined sabot is plain, with no features except a 0.75-inch diameter hole at the center. This hole would have accepted the bolt that secured the sabot to the base of a projectile. On the convex (top) surface of the sabot are the three studs of about 0.75-inch diameter that inserted into the correlating holes on the base of a bolt. As with the holes on the projectile, the centers of the studs are a uniform distance from the center of the disk (1.75 inches) and spaced equidistant from each other. The studs are circular and somewhat conical, tapering narrower from base to flat top. Additionally, the sides of the studs closest to the center of the disk are shorter (0.5 inch) than the opposite sides closest to the outside of the disk (0.69 inch), likely representing a compensation for the convex curvature of the top of the sabot. It should be noted that the measured distance from sabot center to studs (1.75 inches) is 0.11 inch greater than the measured distance from center of base to center of holes (1.56 inches) on the projectile. This is perhaps due to the distorted state of the sabot affecting the measurement, but it is also possible the examined solitary sabot (recovered separately) does not match the specific Tennessee bolt examined and measured.

It has been suggested that the distorted shape of the examined sabot is due to it having been on a bolt that was fired from a gun (6.4-inch Brooke). However, an examination of photographs of various Tennessee bolts and shells indicates the distortion is due to forces other than those exerted by discharge from a piece of artillery. In three photographic examples of 6.4-inch Tennessee projectiles specifically identified by Bell as having been fired, the attached sabot had been thoroughly and completely flattened flush against the base of the projectile, eliminating the original saucer/dish shape and showing none of the distortion apparent on the recovered example (Bell 2003:413, 419, 421). In the flattening of a Tennessee sabot by the pressure exerted on it by the black powder detonation in a gun the overall diameter of the copper sabot disc is enlarged to engage the rifling of the gun's barrel. The examined sabot displays a smooth edge with no obvious signs of having engaged the lands and grooves of a rifled gun. In two of the three photographs of fired projectiles presented by Bell the effect of rifling on the Tennessee sabot is clear. Additionally, in another photograph of an unfired Tennessee projectile the sabot has not been flattened (retaining significant separation between outer edge of sabot and base of projectile) and, yet, this unfired sabot displays a bend or distortion very much like that of the recovered example (Bell 2003:420).

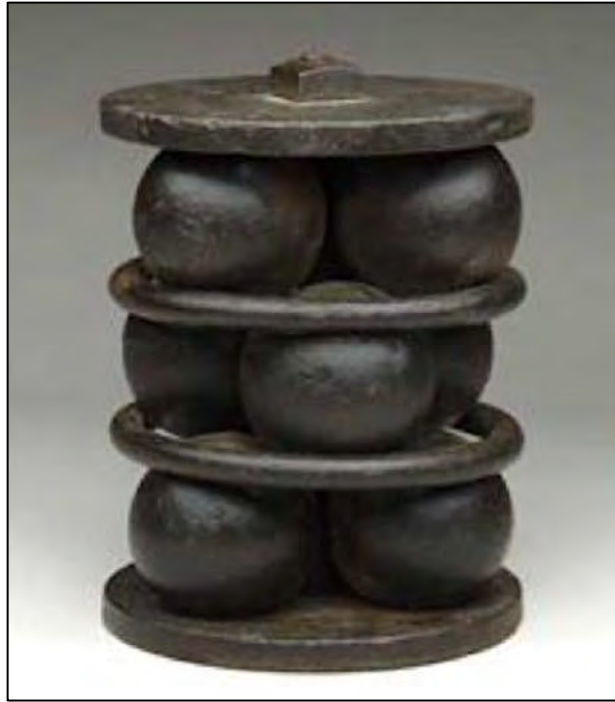
Figure 6-403. Illustration of a “US 32-POUNDER STAND OF GRAPE with nine iron balls surrounded by two rings and the top and bottom plate and center bolt.” Sold at Auction October 4, 2005 for \$3,100 (as presented at icollector.com 2019).

A Grape stand was a more recent development that was heavier and more expensive to produce than quilted. A typical grape stand had fifteen iron components: nine solid shot, two plates, two iron rings, nut and bolt. The shot were bound in three tiers between top and bottom plate with the iron rings between the tiers to hold the shot in place when the bolt was secured through the plates and along the centerline of the tiers of shot (Figure 6-403). Shot, plates and rings were, of necessity, carefully fashioned in diameters to match the bore diameter of the gun for which they were intended. The end plates had depressions on their interior surfaces to cup and hold the shot. These plates were made of wrought iron rather than cast so as not to shatter when fired. Both quilted grape and grape stand were designed to break apart when discharged from a gun. While the relatively smaller solid iron shot of grape were not expected to penetrate the hulls of warships or do serious structural damage, grape served a dual purpose in naval warfare. As with use in field combat, grape served as an anti-personnel munition, although, relative to land engagements, the effect in naval warfare was diminished by protection afforded by solid gunnells, hammock netting and the fact that a significant portion of an opposing crew might be serving below deck on traditional warships, or, by the solid armor of the new ironclads. As an additional purpose in naval warfare grapeshot was of sufficient size to cause severe damage to rigging (lines, blocks, spars and sails), guns, gun carriages and accessory equipment, potentially affecting the outcome of an engagement with the un-armored wooden warships that were still a standard of navies in the mid-nineteenth century (Bell 2003:99, 100; Biemeck 2013:538, 539).

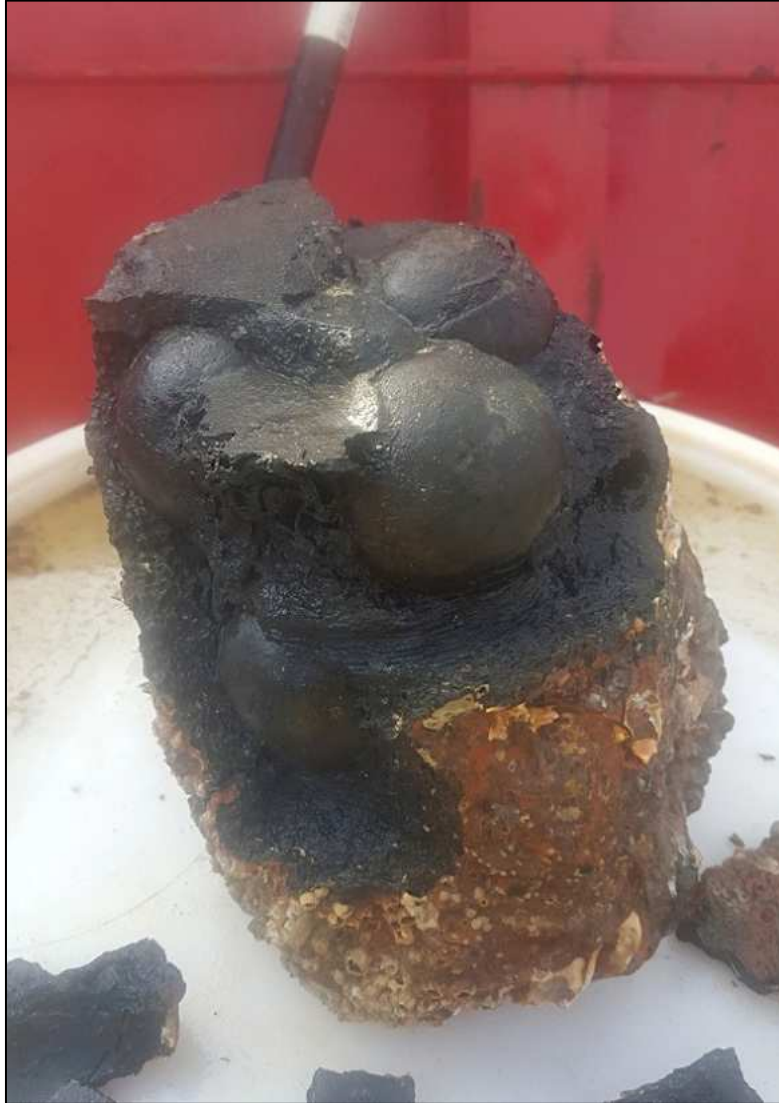
Figure 6-404. Numerous complete stands of grape shot were also recovered, as well as partial stands and loose shot.

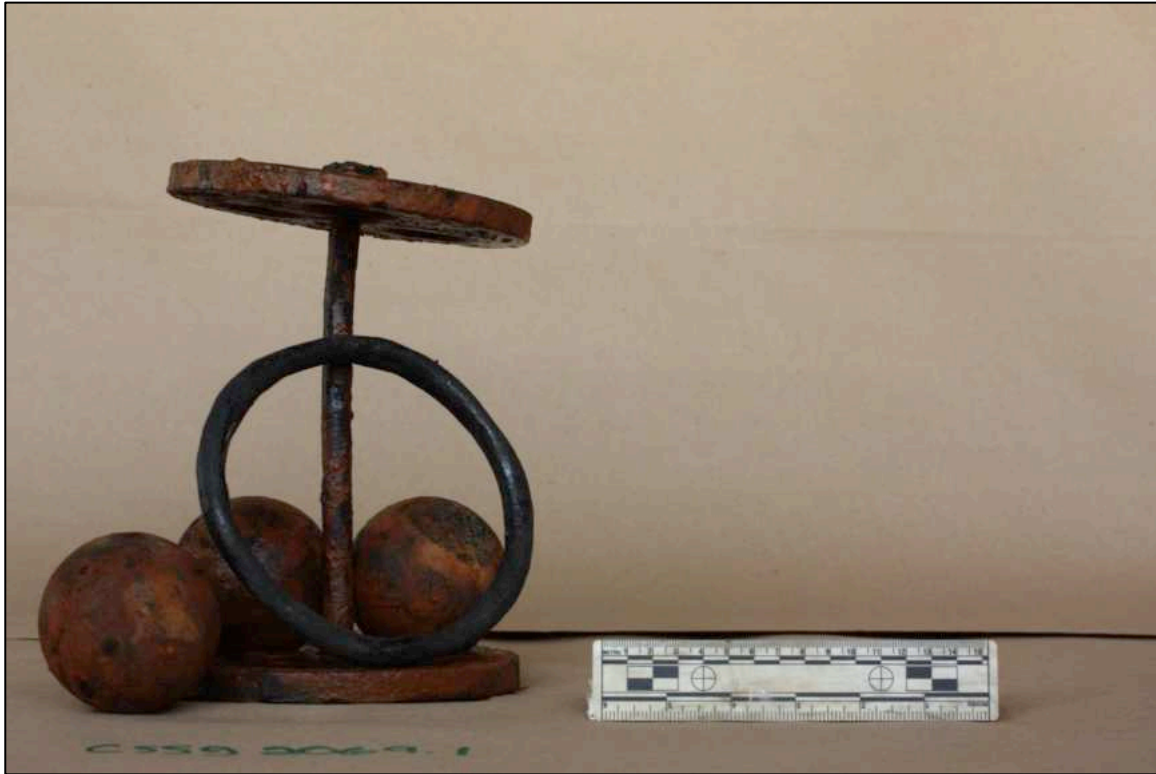
Figure 6-405. Grape stand in the mechanical cleaning stage of conservation, showing end plates, bolt, reconstructed ring and three of the nine shot, Artifact 2069.1.

The grape stand undergoing conservation (Artifact 2069.1) was measured and photographed as the only complete stand that had been cleaned and mostly disassembled and available for examination. It is presented here as Figure 6-405. As can be seen in the photograph the two end plates remain connected to the bolt. The stand had the standard nine matching shot. These measured 2.85 inches in diameter, closely conforming to the maximum (2.90 inches) and (considering surface lost to corrosion) minimum (2.86 inches) diameters for 32-pounder (6.4-inch) grape as presented by both Bell and Biemeck based on Confederate specifications (Bell 2003:100; Biemeck 2013:539). It should be again noted that for grape, both stand and quilted, the shot "...had to be cast precisely to fit within the diameter of the projectile" (Bell 2003:100). The top and bottom wrought iron plates were 0.51-inch thick and 6.125 inches in diameter. Both plates had the interior indentations to help secure the top and bottom tiers of shot; these indentations measured 0.36 inch deep and 1.625 inches in diameter, conforming to a segment of a sphere the diameter of the shot. The metal of the two rings of this grape stand had been lost to graphitization; however, one of those rings was replicated with a casting made from the concretion that had formed around it. That casting measured 6 inch in diameter with a cross

section measuring from 0.45 to 0.55 inch. The bolt that held the assembly together measured 8.75 inch long with a 0.5-inch diameter. The nut that remained threaded to the bolt measured 1.0 inch square and 0.5 inch thick. The head end of the bolt, which remains fused to the bottom plate, appears to have been beveled and countersunk to provide a flat/flush surface to the bottom of the bottom plate.

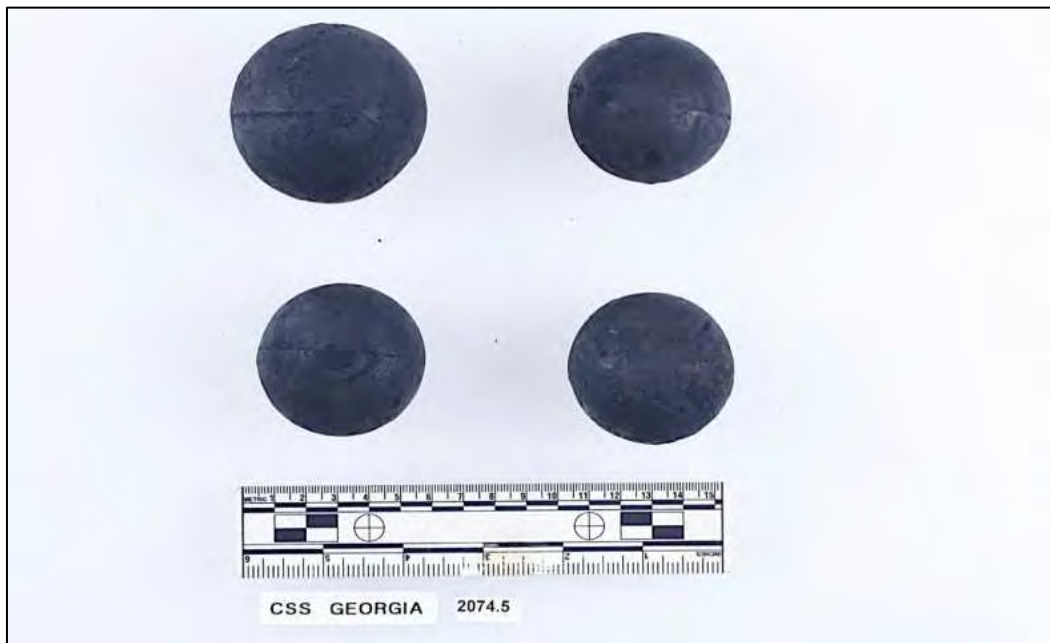
Figure 6-406. Examples of small iron shot indicative of the presence of canister rounds, Artifact 2074.5.

selected as a representative sample (Artifact 2075.4), a similar set of four shot (Artifact 2074.5) may be seen in Figure 6-406. These seven shot measured from 2.02 inches in diameter (two examples) at the small end to 2.41 inches for the largest, with only the two smallest having the same diameter. The shot in canister did not require the specified and standardized uniformity of grape. While the can that held the shot would be fabricated to close tolerances to fit the bore of a specific gun, the shot within the can could be of any smaller size. Surviving examples of both 6.4-inch and 9-inch Confederate canister rounds are presented in Bell, who specifically mentions their use in the 6.4-inch Brooke and IX-Inch Dahlgren (Bell 2003:94, 96). Of interest in Bell's text on 6.4-inch canister, he notes that a canister in this caliber was recovered from the CSS *Neuse* in North Carolina (Bell 2003:94). Of greater interest, Bell records that the iron shot in both 9-inch canister and 32-pounder (6.4-inch) canister were 2.06 inches in diameter, a close match to the 2.02- to 2.41-inch diameters of the measured small iron shot from the CSS *Georgia* (Bell 2003:96).

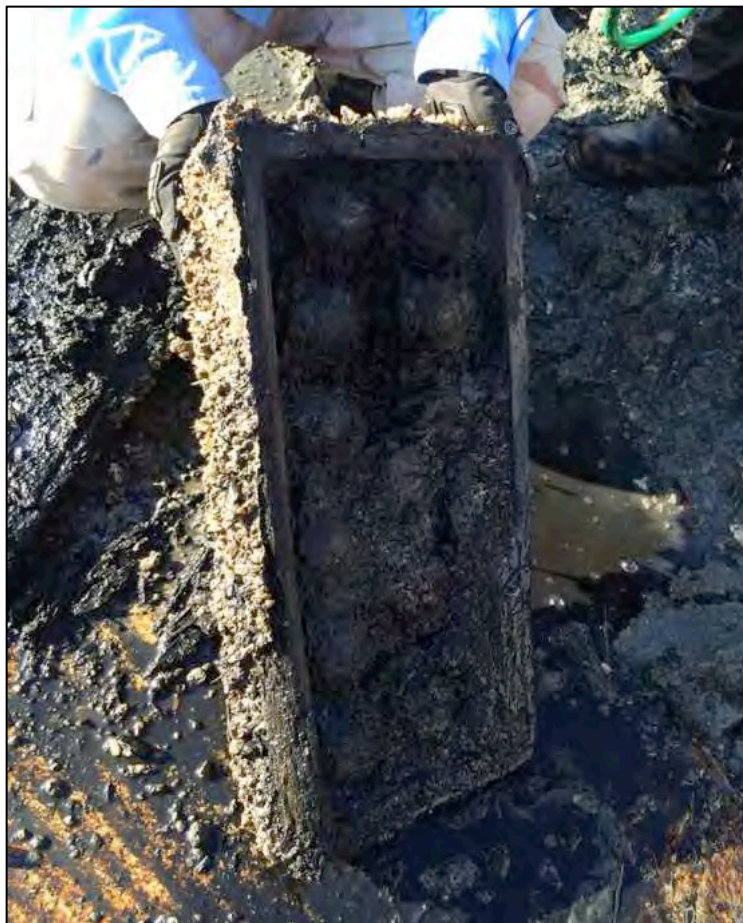
Figure 6-408. Wooden box at time of recovery with cover removed revealing fourteen 6-pound shot, Artifact 3264.1.

Included among the artifacts recovered from the CSS *Georgia* were solid shot presumed to be for the 6-pounder gun, Cannon No. 1 that had been located east of the East Casemate. These shot are represented by Artifact 4001 and Artifact 3264.1 in the inventory. Figure 6-407 shows provenience of all recovered 6-pounder shot. Artifact 4001 is a single isolated piece of solid shot (Artifact 4001), remarkable in that it is the only isolated 6-pounder shot recovered. Artifact 3264.1 (Grab G-620), however, was one of the truly extraordinary finds: an intact and largely complete wooden box containing 6-pounder shot. When the heavily encrusted board covering the box was removed it was revealed that the box contained fourteen iron 6-pounder shot bound in a concretion, as can be seen in Figure 6-408, a photograph taken soon after the box had been deposited on the deck of the barge.

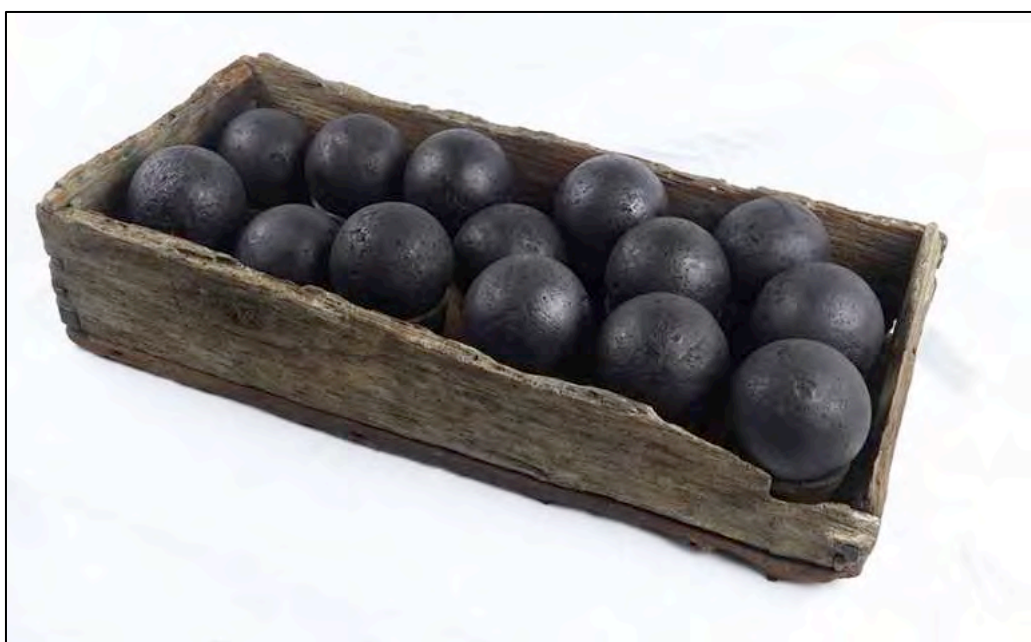
Figure 6-409. 6-pound munitions case following conservation with shot and wood sabots revealed, Artifact 3264.1.

Following recovery, the box of shot was placed in wet storage pending conservation. At present the box and its contents have reached various points in the conservation process. Mechanical cleaning has been completed for all parts of the assemblage and the iron shot has finished conservation. During mechanical cleaning the box was found to contain not only iron 6-pounder shot but also an accompanying wood sabot for each, as can be seen in Figure 6-409. Conservation for the wood box and wooden sabots is ongoing and, presently, unavailable for direct examination.

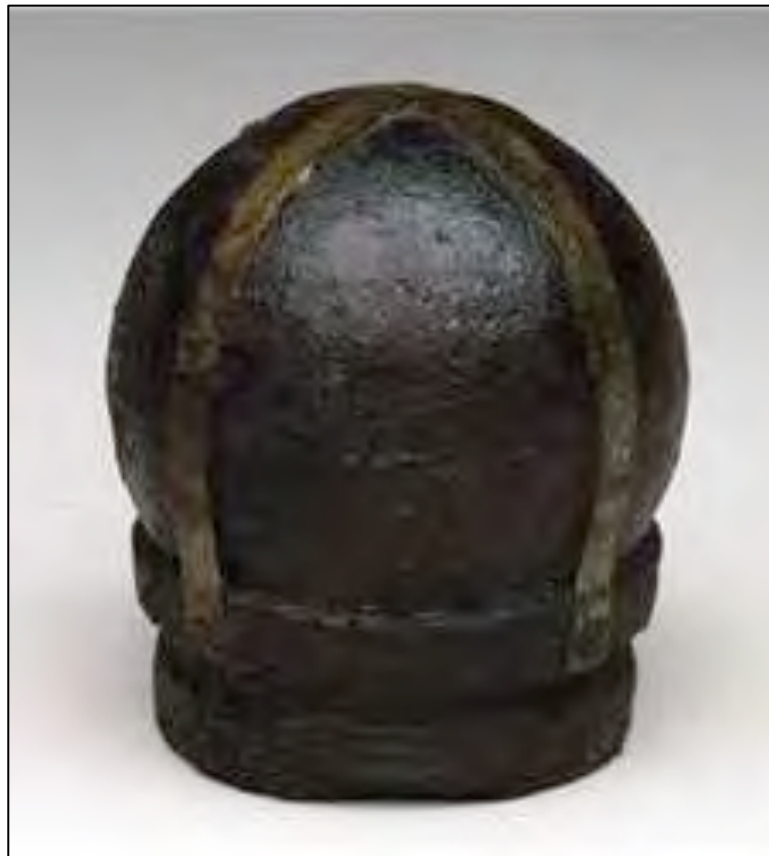
Figure 6-410. Photograph of a 6-pounder solid shot recovered from the Oconee “Professionally conserved...Tin straps very good to fine and wood sabot in fine condition.” Sold at Auction October 4, 2005 for \$3,600 (As presented at icollector.com 2019). Note it has cylindrical-type sabot.

The 14 solid iron shot from the box have completed conservation and were available for examination. One representative example (Inventory 3264.1.6B) was measured at 3.5 inches in diameter and was noted to have a visible mold line around approximately three quarters of its circumference. The remaining 13 shot were of similar size and appearance. The measured diameter may be less than the original standard diameter for 6-pounder shot (3.58 inches) due to corrosion loss. Similarly, an original weight for a “6-pounder” of 3.58-inch diameter would have been 6.1 pounds, while this example weighed 3.83 pounds. Four other conserved shot from the box (3264.1.2B, 3264.1.4B, 3264.1.7B and 3264.1.10B) weighed between 3.99 pounds (.2B) and 5.41 pounds (.10B). This substantial weight loss is likely due to graphitization of a portion of the cast iron in each 6-pounder shot. Each of these solid cast iron shot were nested in a matching sabot within the munitions box. Only small remnants of the sheet metal strapping that would have secured shot to sabot were recovered during conservation. Comparative examples recovered from a nearby freshwater location had them. There have been recoveries of 6-pounder shot, each complete with sabot and two sheet metal straps wrapped over the projectile and secured to the wood sabot with square nails. These recoveries were reportedly made from the Oconee River at Milledgeville, Georgia (State Capital 1804-1868; Dickey and George 1993:28), and period references support the likelihood of the Oconee River recovery, recording that Col. William Hawly’s 3rd Wisconsin Infantry threw “170 boxes of fixed artillery ammunition” into the Oconee River in November of 1864 (O.R., 1902:207, 212, 248-49). Presented in Figure 6-410, an example of one of the sabots recovered from the Oconee River closely resembles a type of sabot recovered with the 6-pounder munitions box.

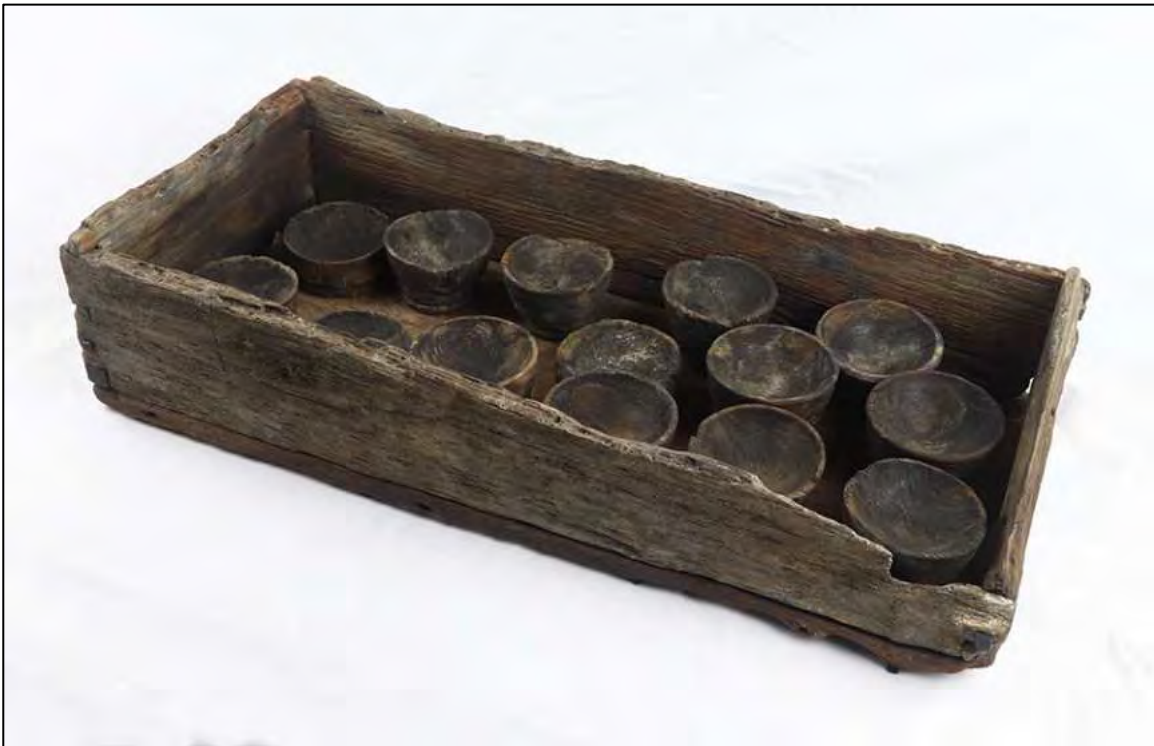
Figure 6-411. The 14 6-pounder sabots after conservation, showing both predominant tall conical type and the three examples of the short cylindrical form, Artifact 3264.1.

The sabots found mated to each of the fourteen 6-pounder shot were recovered from within the concretion that filled the interior of the munitions box. The sabots are generally well preserved with some apparent material loss and possible distortion. The sabots came in two distinctly different type. Both types and the whole assemblage of fourteen sabots may be seen in Figures 6-411 to 6-143, a photograph taken after mechanical cleaning. The predominant type, with eleven examples, may be described as a tall, truncated cone, while the remaining three sabots may be described as short and cylindrical. Both types were lathe turned and both had flat bases opposite a cupped end that closely conformed to the shape of 6-pounder shot. The tall sabots had a base end that measured approximately 2.25 inches in diameter; that diameter expanded to c.3-inch over a c.2.75-inch rise to the thick lip of the shot cup (all measurements are approximate and based upon photographs as the sabots were in conservation and unavailable for direct examination). At the lower end of each tall sabot are three grooves that would have accommodated cord used to secure the powder charge to form a complete round of fixed ammunition. The three examples of short sabot were basically cylindrical in shape with vertical sides. These short sabots measured only about 1.25 inches tall but with a larger diameter, at c.3.37-inch, than the maximum for the tall sabots, and, closer to the measured 3.5 inches in diameter of the 6-pounder shot. With the shorter stature, it is perhaps natural the short sabot design incorporated only one groove for securing the powder charge. It is the short sabots from the CSS *Georgia* munitions box that that bare a close resemblance to comparative examples recovered from the Oconee River at Milledgeville, Georgia, and it may be appropriate to speculate a common origin. Both tall and short sabots appear to have noticeable differences in comparison to others from the same type within the group. Whether these differences are due to their original manufacture or to deterioration and distortion from more than a century of submergence is presently uncertain. As with other artifacts and artifact groups, the completion of conservation will allow detailed examination of the sabots and a study of the materials and construction of the rare and extraordinary 6-pounder munitions box.

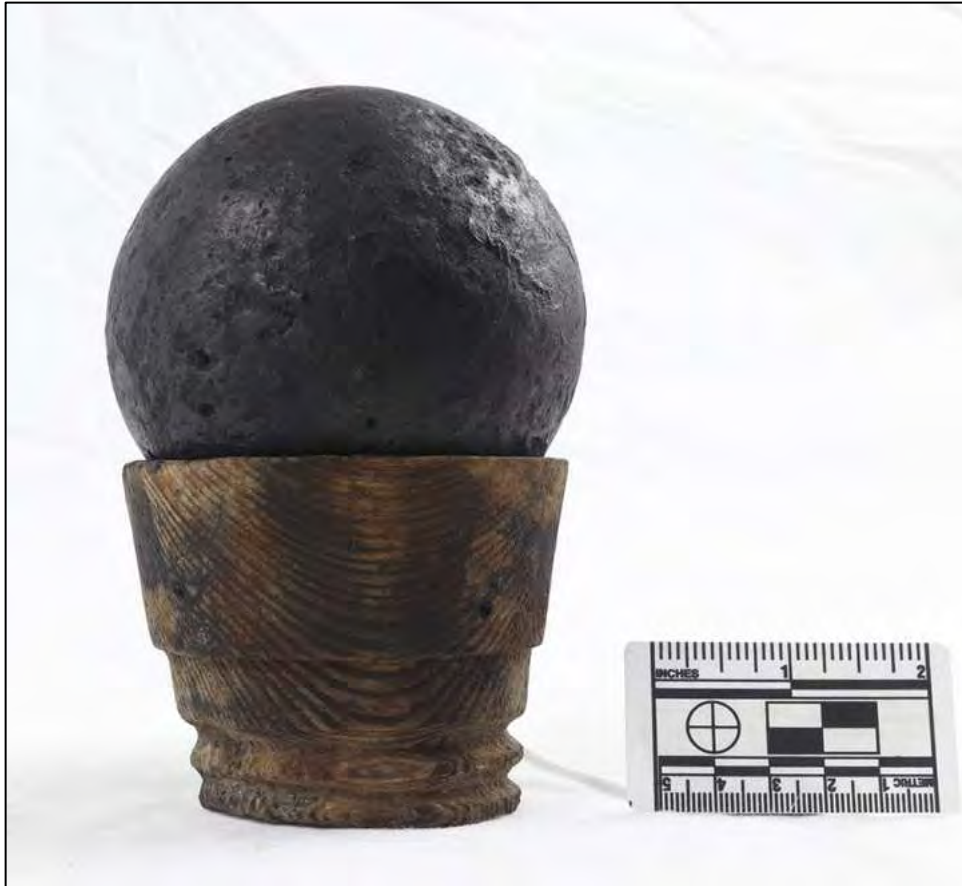
Figure 6-412. 6-pounder shot with one of the eleven tall conical sabots, Artifact 3264.1.3AB.

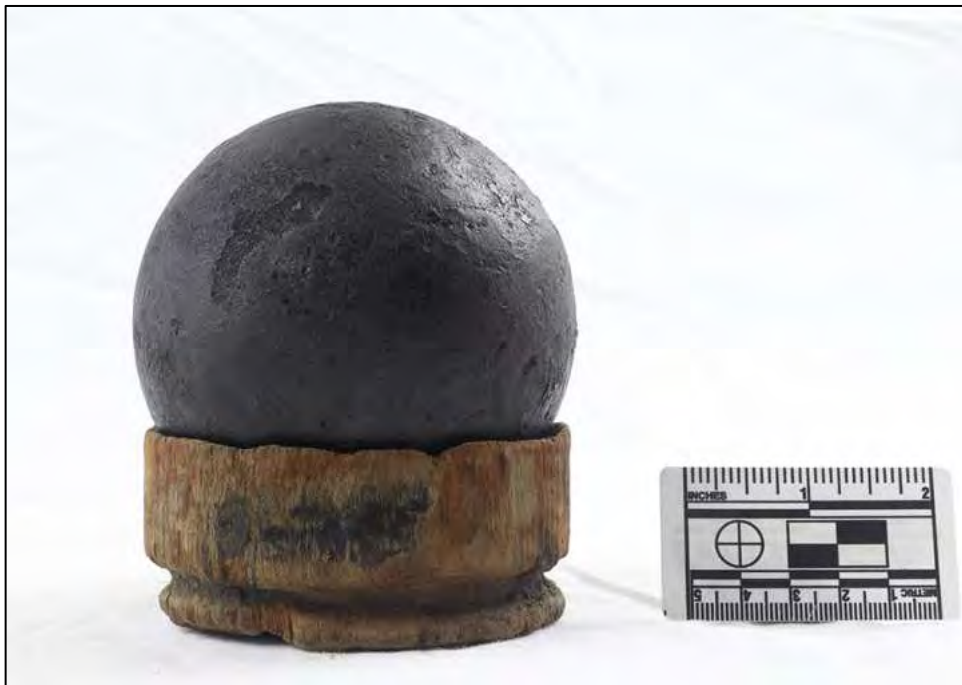
Figure 6-413. 6-pounder shot with one of the three short cylindrical sabots, Artifact 3264.1.2AB. Compare this sabot with the complete example shown in Figure 6-408 above.

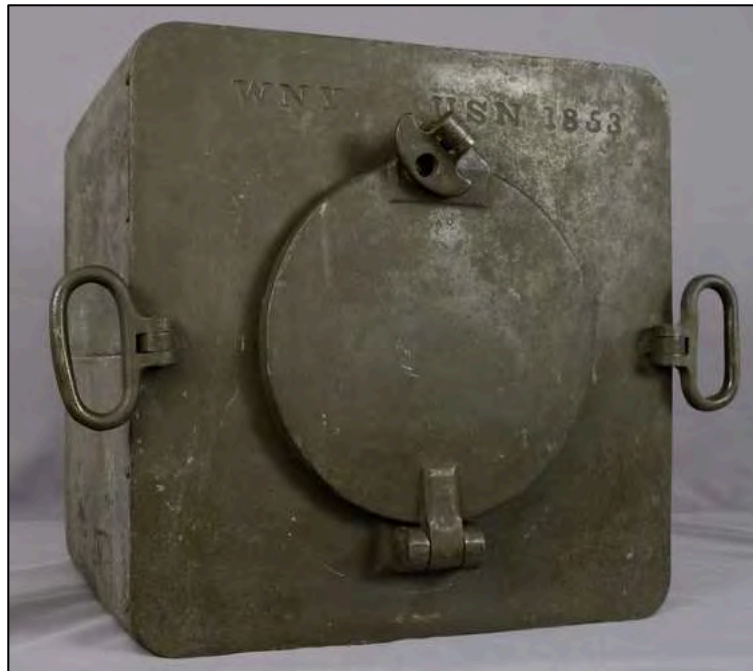
Figure 6-414. U.S. Navy Powder Tank, 16-x-14 inches, Copper Alloy. NHHC-1990-129-A, Artifact Collection photograph number (as presented at Flickr.com 2019).

A number of Powder Tank components were recovered from the site. Employed to safely contain and store gunpowder in the form of charges for the guns or cartridges for small arms, Powder Tanks were generally square bronze and copper boxes of varying capacity. Illustrated in Figure 6-414, the tank tops had two handles along with a central, circular lid that was hinged on one side with a screwable toggle that tightly fastened the lid to the box. The lid was fitted with a gasket that sealed onto a lip on the circular opening. As stated in the 1866 Ordnance Instructions for the United States Navy:

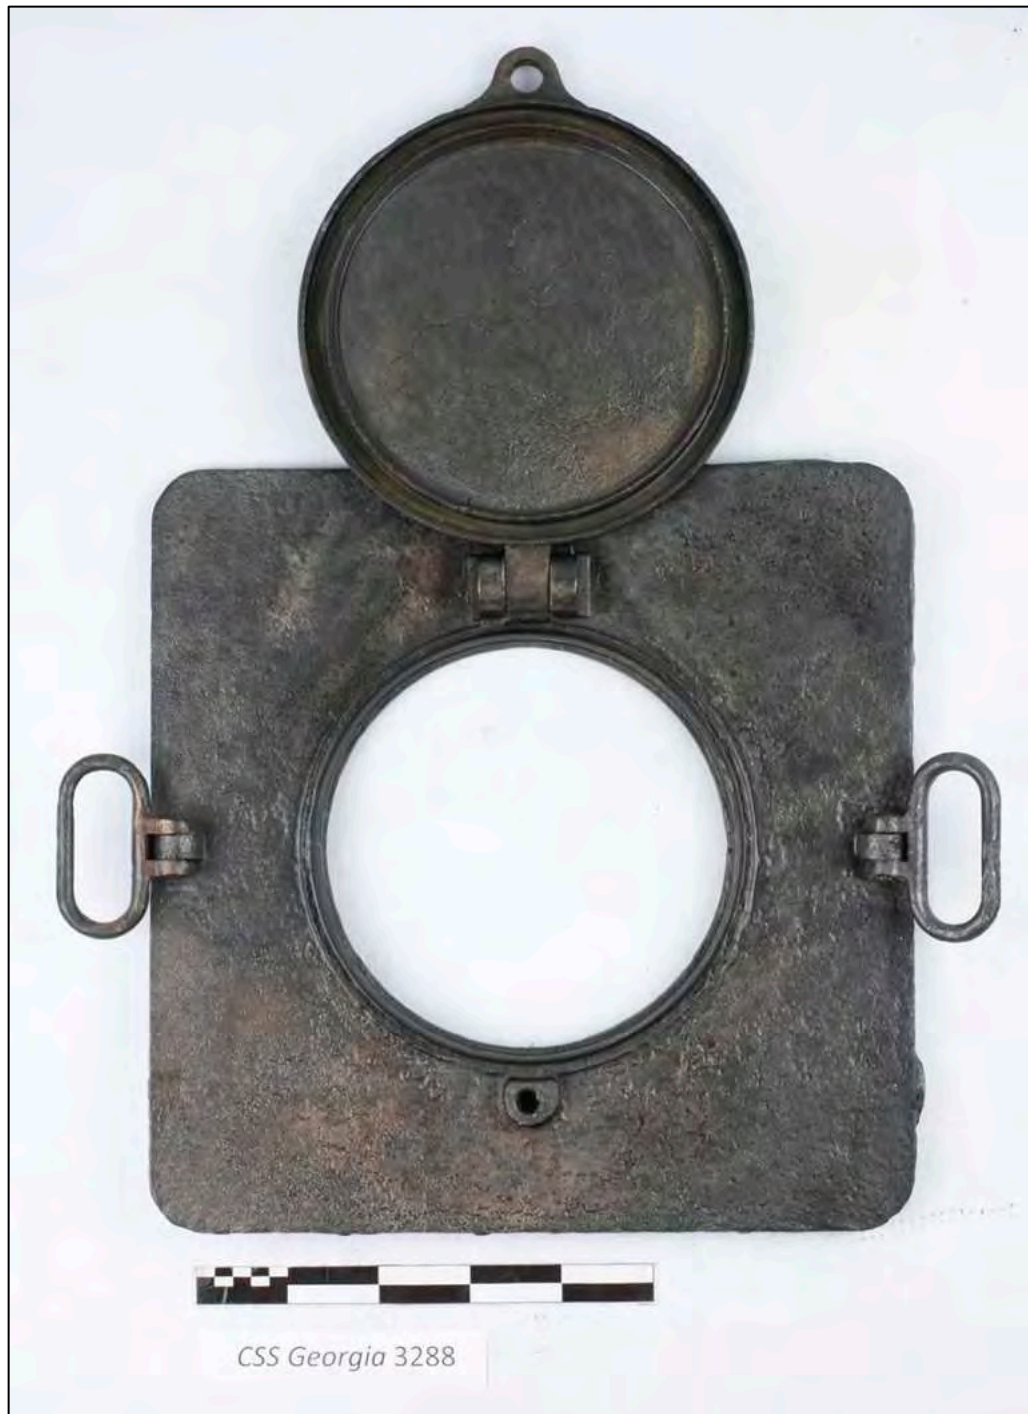
Figure 6-416. Powder tank top showing the handles and the circular opening and the still extant, hinged lid. Note the rubber-gasket lined channel on the lid that seats onto and seals over the raised lip around the circular opening.

Figures 6-416 to 6-418 shows Artifact 3288, a complete Powder tank top with handles and the circular opening and the still extant, hinged lid. Note the rubber-gasket lined channel on the lid that seats onto and seals over the raised lip around the circular opening. Figure 6-419, Artifact 268, is a complete powder tank base.

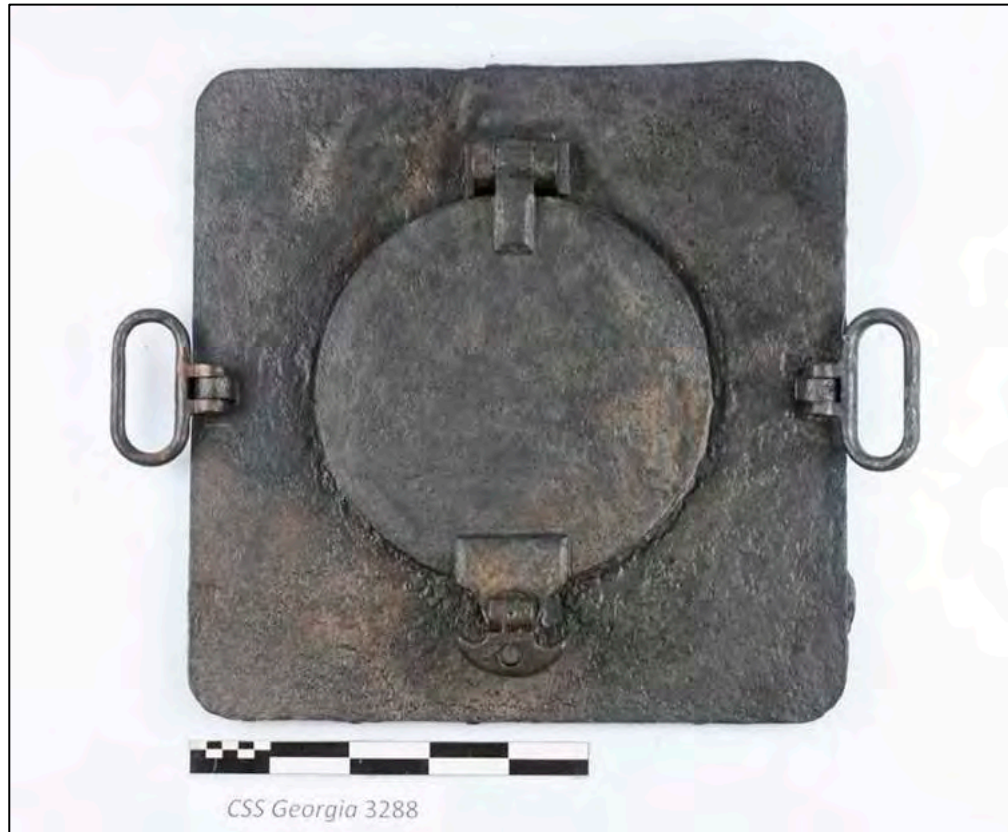
Figure 6-417. Powder tank top showing the handles and the still extant, circular hinged lid with closing screw toggle, and handles. Artifact 3288. Compare this with Figure 6-415 above, an exact match.

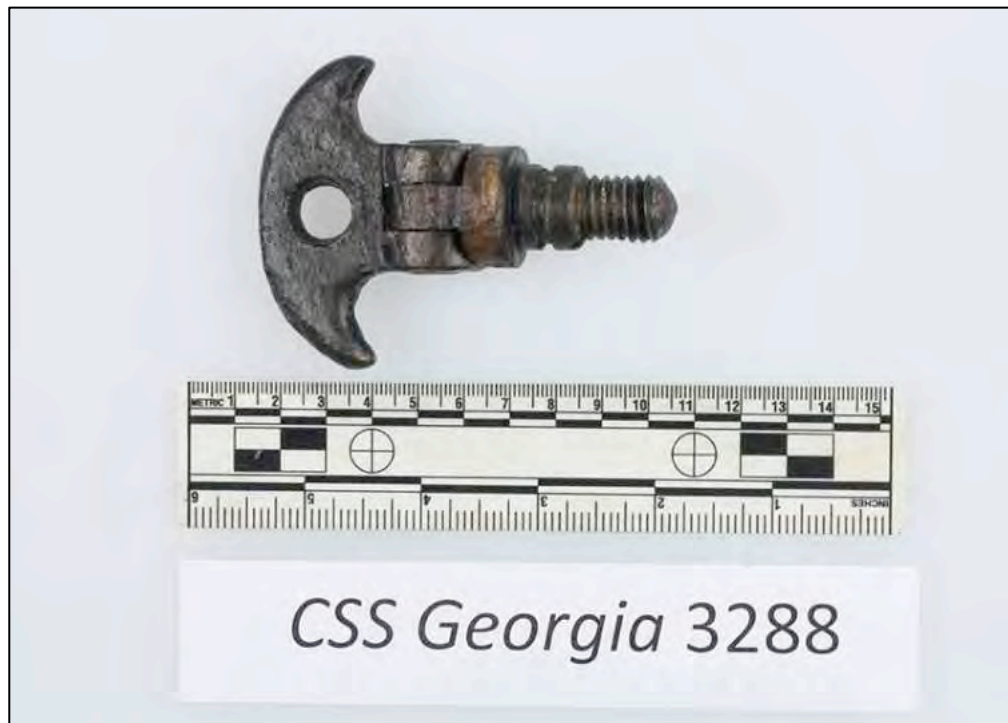
Figure 6-418. Powder tank lid toggle screw employed to tighten lid to top of tank. Artifact 3288, an exact match with that seen in Figure 6-413 above.

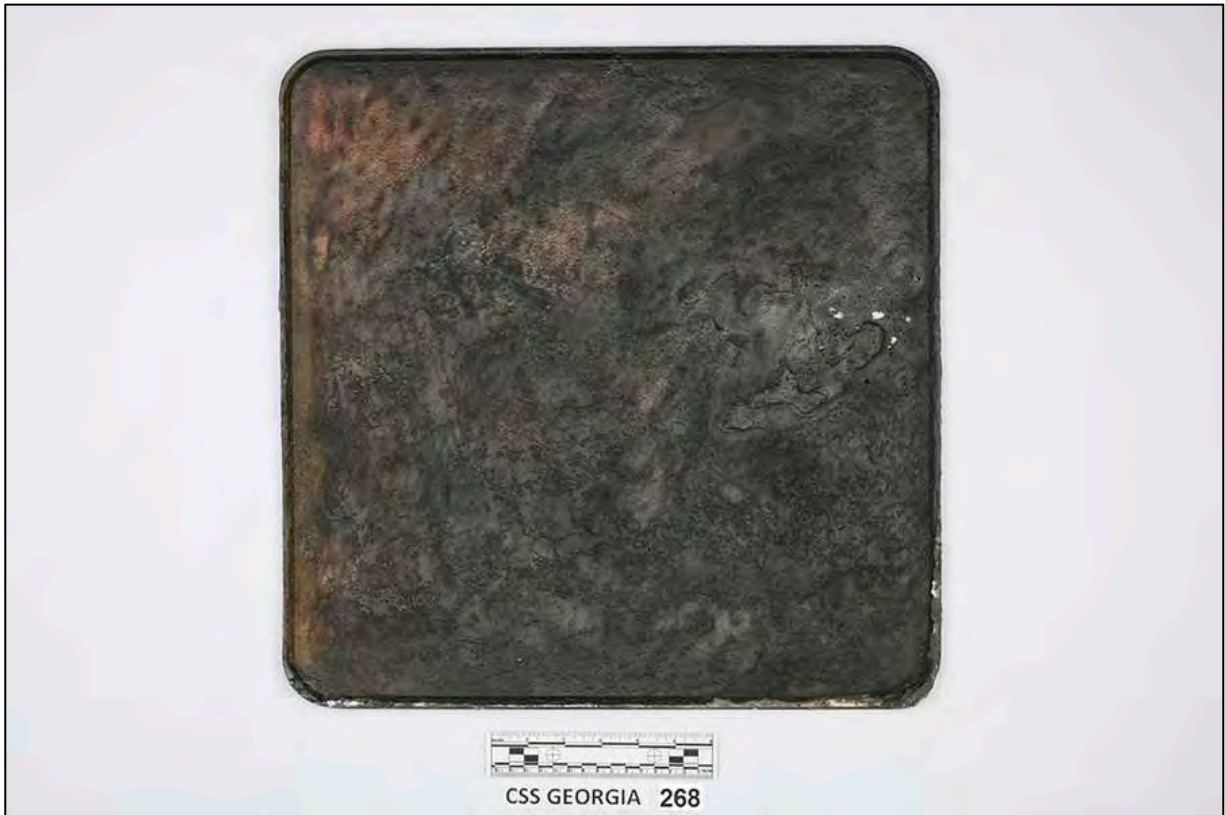
Figure 6-419. Powder tank base interior showing the raised lip that the side would have soldered to.
