CSS *GEORGIA*
ARCHEOLOGICAL DATA RECOVERY AND MITIGATION
FOR THE SAVANNAH HARBOR EXPANSION PROJECT (SHEP),
CHATHAM COUNTY, GEORGIA AND JASPER COUNTY, SOUTH CAROLINA

**FINAL DRAFT REPORT
OCTOBER 2019**

Stephen R. James, Jr. and Gordon P. Watts

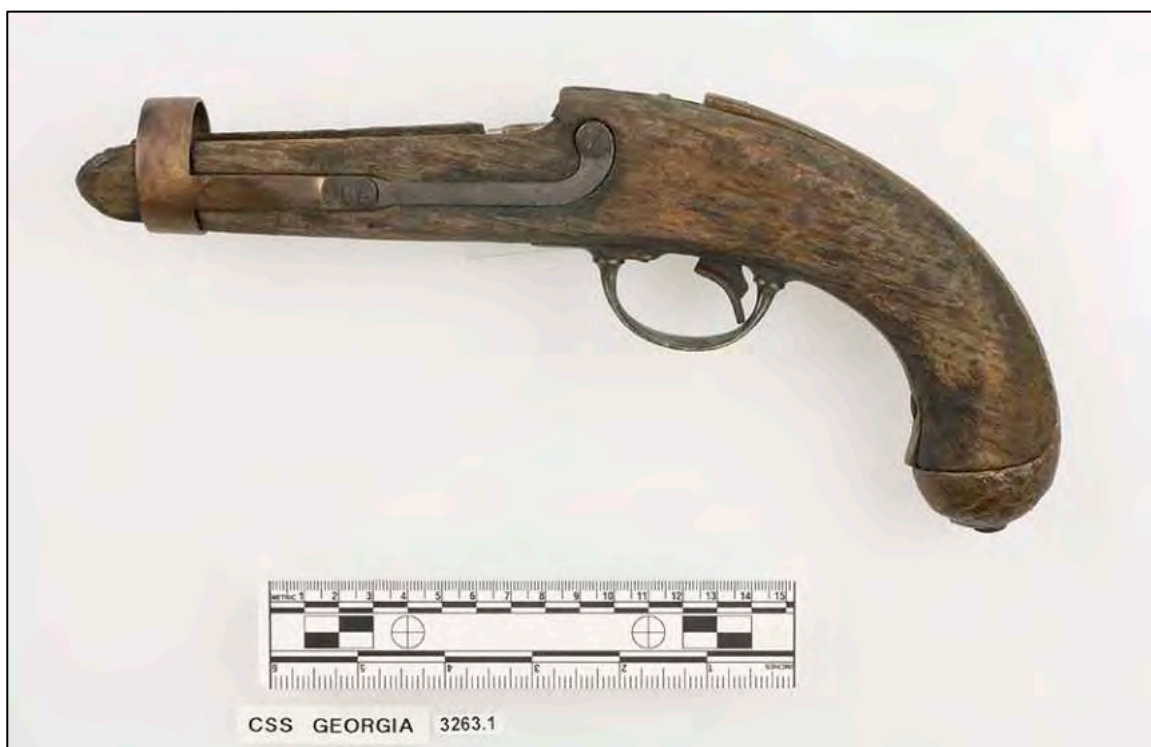
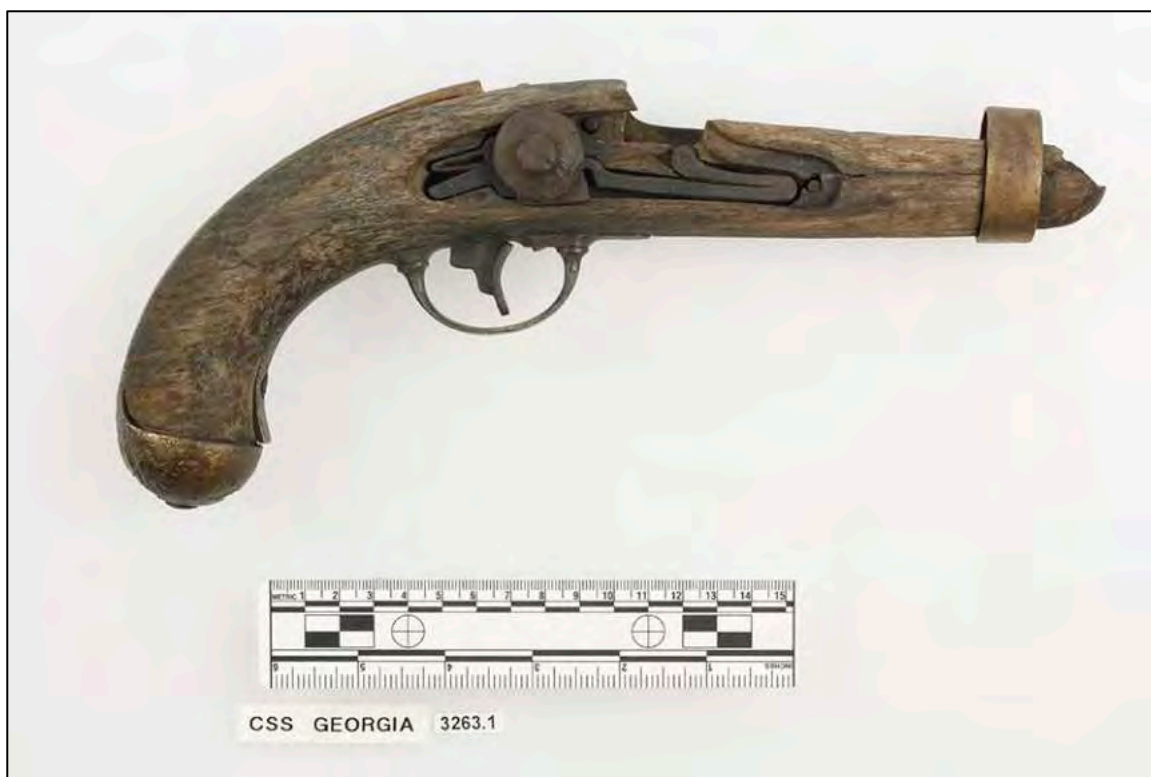
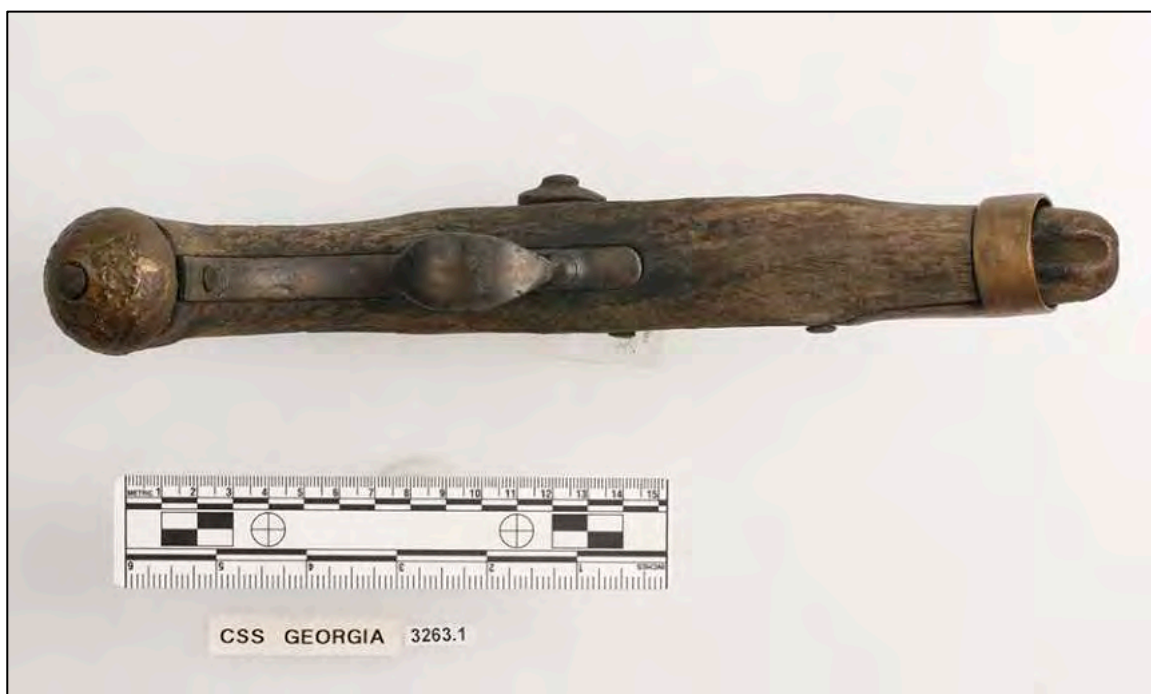
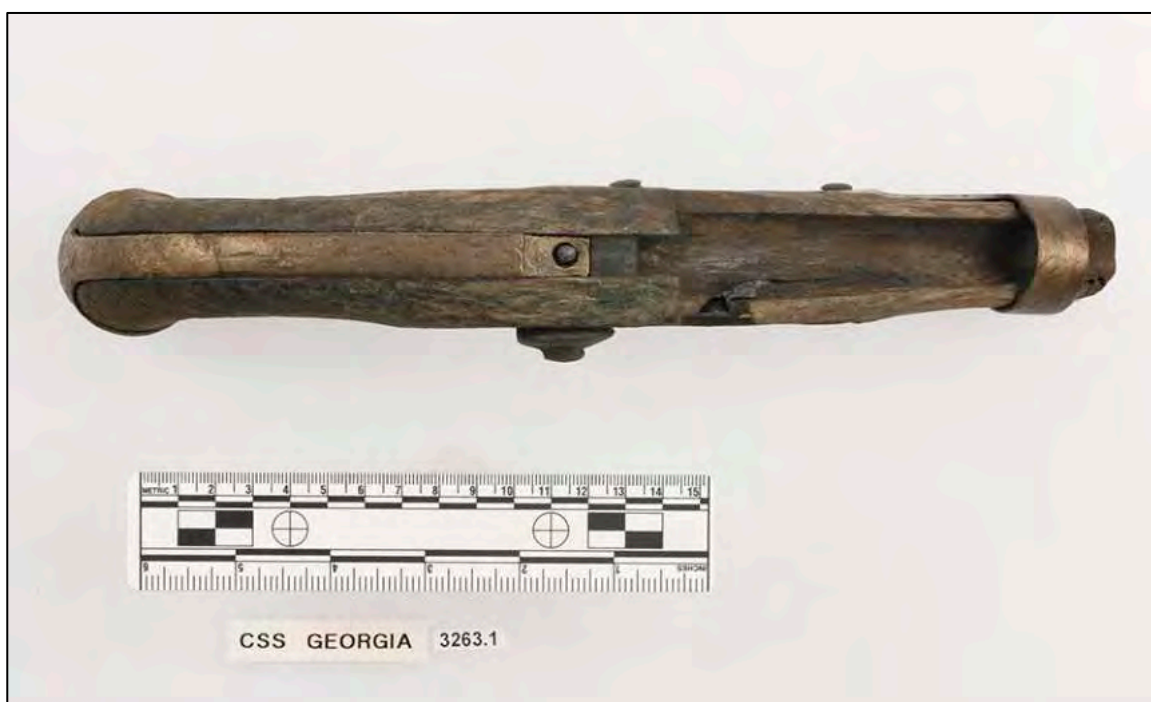
Figure 6-421. Artifact 3263.1. Side view.

Figure 6-422. Artifact 3263.1. Opposite side view.

Figure 6-423. Artifact 3263.1. Bottom view.

Figure 6-424. Artifact 3263.1. Top view.

At this time, the wooden handle and brass components of the pistol are undergoing conservation treatment. A more in depth analysis will be possible once all conservation efforts are completed and the pistol is reassembled. As seen in Figures 6-421 to 6-424, the brass hardware and wooden handle are present but the barrel, hammer and lock plate are missing, making definitive identification of the caliber and model difficult.

The pistol measures 295 millimeters in overall length and 39 millimeters wide at the stock where the barrel would have been. There is metal reinforcement along the bottom of the handle all the way to the trigger guard, and along the back, terminating where it would have been connected to the barrel, as seen in the figures above as well as the pre-conservation X-ray seen in Figure 6-425. The brass band that wrapped around the barrel and its supporting hardware are present. The band is 18 millimeters, the piece connected to the band is 50 millimeters long by 9 millimeters wide and the unconnected piece measures 74 millimeters long by 7 millimeters wide.

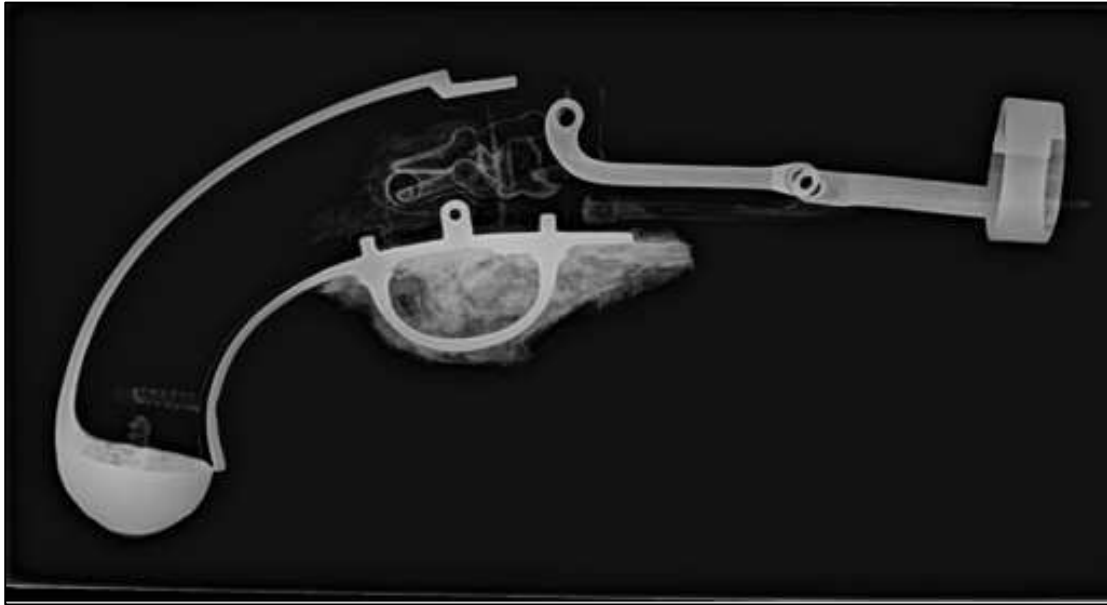
Figure 6-425. Pre-conservation X-ray image of the pistol.

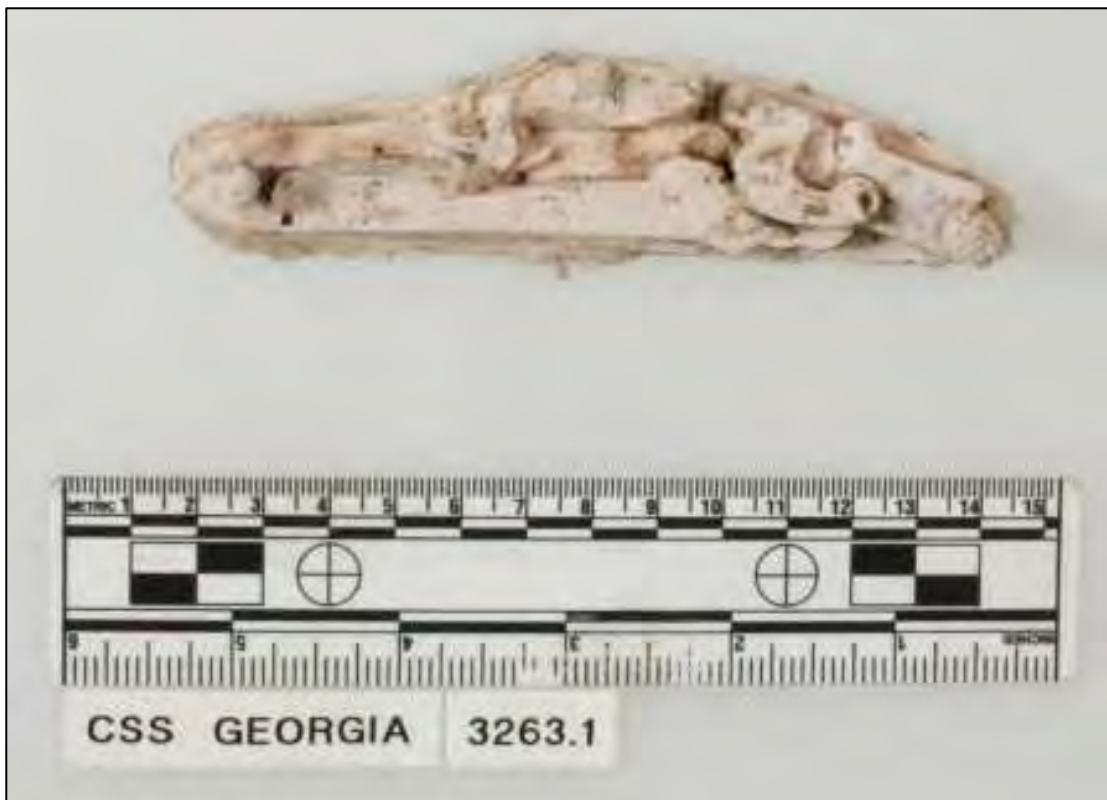
Figure 6-426. Internal mold that depicts the internal workings of the now-absent lock plate.

As seen in Figure 6-426, a cast was created at CRL of the area where the breech and lock plate would have been exposed, and depicts the internal workings of the now-absent lock plate. A comparison between Figure 6-426 and 6-427, a lock plate from a 1842 percussion pistol, may indicate that the recovered pistol is in fact a percussion pistol.

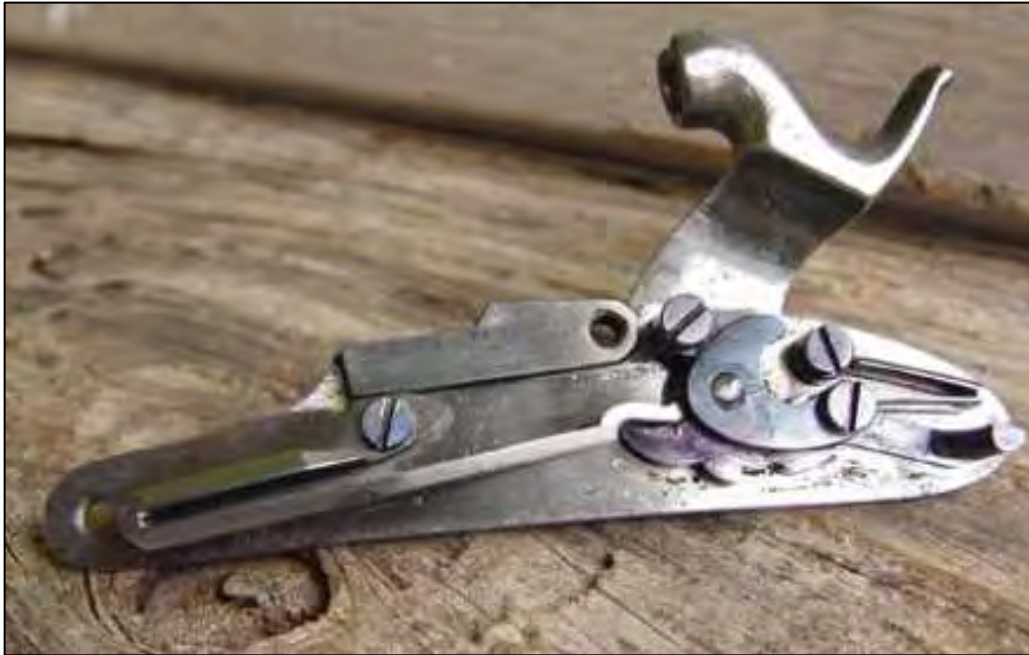
Figure 6-247. Internal view of lock plate from working 1842 percussion pistol (image courtesy of *Guns Magazine*).

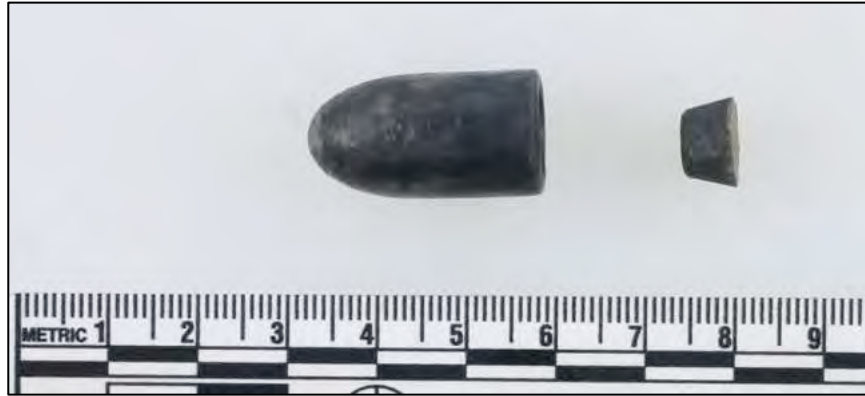
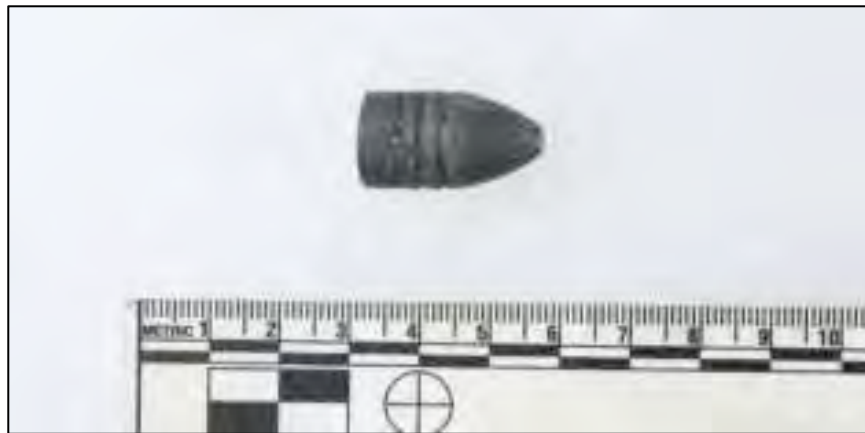
Figure 6-428. Recovered .577 caliber Minie Ball bullets; Artifact 2104.4.

Figure 6-429. Recovered .577 caliber Minie Ball bullets; 2104.4(top) 2599.2 (bottom).

To date, 42 smooth and three 3-ring .577 caliber bullets have been identified as being used by the Enfield muzzle-loading rifle. The two bullets seen in Figures 6-428 and 6-429 are variants of Minie Balls recovered on the site.

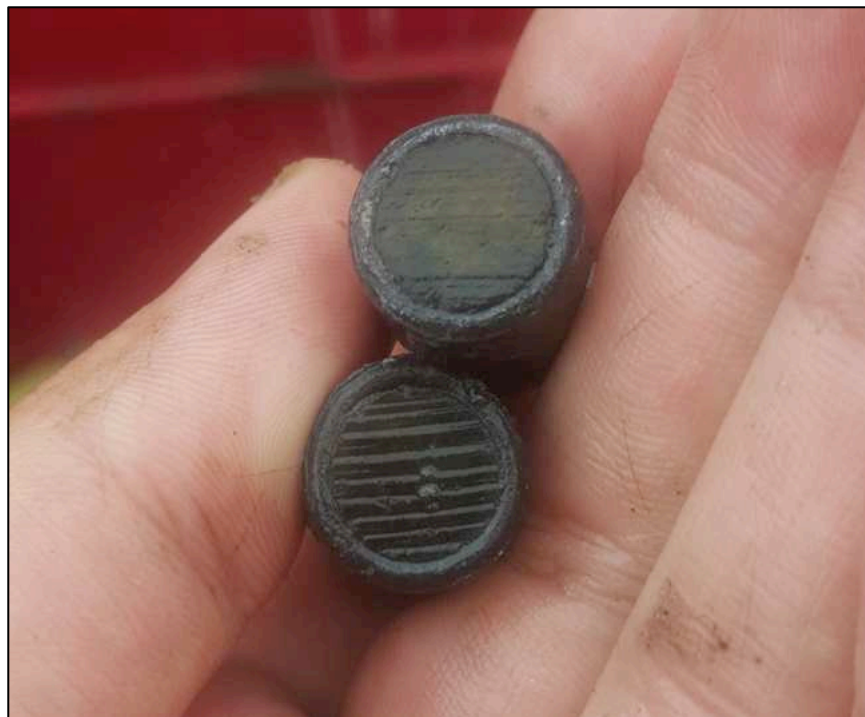
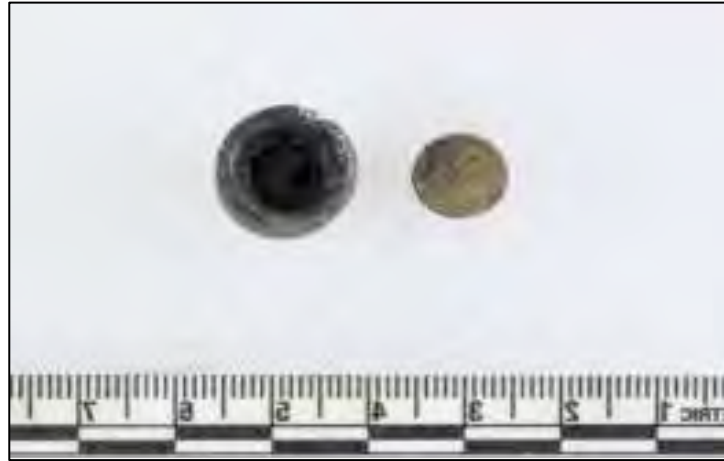
Figure 6-430. End of an Enfield rounds with wooden plugs in place; artifacts number 2104.4.

Figure 6-431. End of an Enfield rounds with wooden plug removed to illustrate the concavity; Artifact 2104.4.

Rifled firearms require a tight fit between the bullet and the bore of the barrel, in order to engage the rifling twist. This twist produced better accuracy and range but created an inherent flaw in all muzzle-loading firearms, slow reloading speeds. Early projectiles were often hammered down the barrel using a specialized ramrod and mallet (Coggins 2004:26). Named for its inventor, Claude Minie, the Minie ball was a later development that countered the inherent problem of muzzle loading rifled firearms. This hollow expanding bullet was slightly smaller than the barrel bore, and had a hollow concavity in which a plug was placed. At the time of firing, this wooden plug would be forced up the bullet, expanding it and engaging the rifling of the barrel (Dougherty 2009:1-2). Early renditions were plugged with lead, but this proved to be inconsistent. In later editions, the lead plug was replaced with soft wood. Figures 6-430 and 6-431 below shows the flat hollow end of an Enfield Minie ball with the plug engaged and with the plug removed.

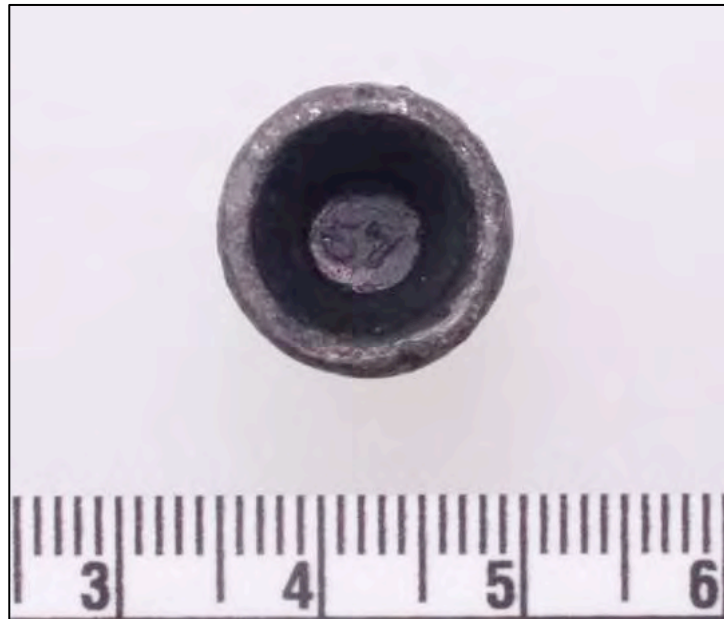
Figure 6-432. "57" stamped on the inside of a .577 smooth bullet; Artifact 2056.1.

The conical shape and concavity of the bullet were accomplished by machine pressing a slug of lead between two punches. For the bullets manufactured in England, the punch that formed the concavity was often engraved with raised lettering as a way to check for wear. These bullets measured 26.5 millimeters long by 13 millimeters wide. Several of the smooth bullets located show a molded “57” on the inside, as seen in Figure 6-432, indicating that at least a few rounds were purchased from England.

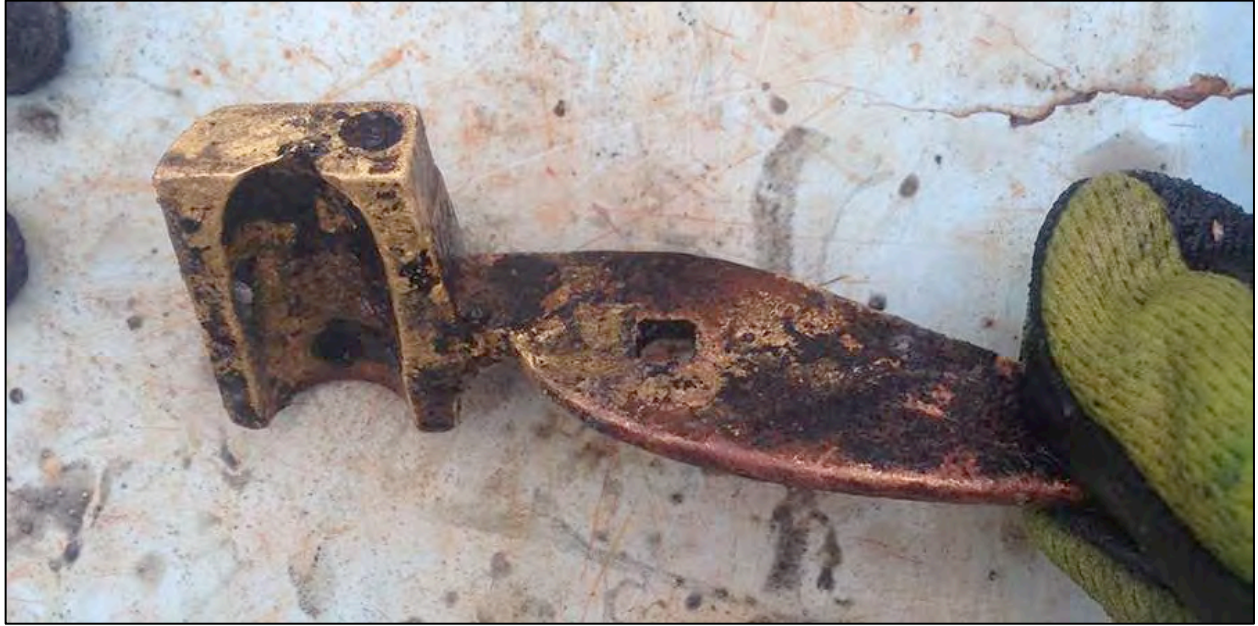
Figure 6-433. Bullet mold for and Enfield round; Artifact 2480.8.

The discovery of a probable bullet mold seen in Figure 6-433 indicates that the sailors and/or soldiers aboard the ship were making smooth Enfield bullets. Only half of the 4-inch long bronze (?) mold has been found, but the shape of the round is clearly visible. Additionally, the internal measurement is 15-x-33 millimeters, nearly matching some of the rounds recovered. There is no raised ring on the inside of the mold indicating it produced smooth .577 rounds. However, the concavity press has not been found.

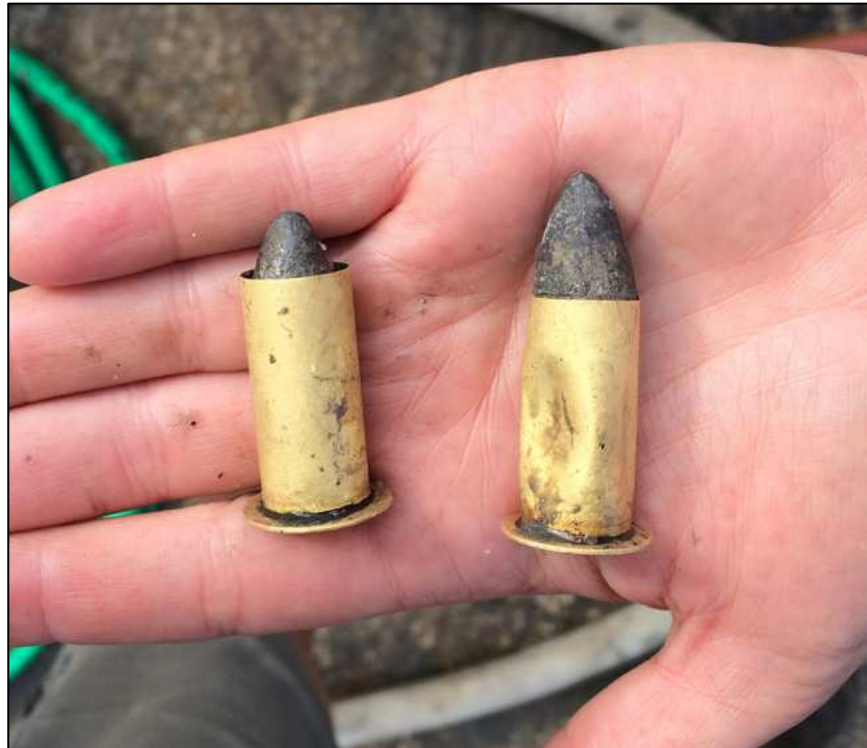
Figure 6-434. Recovered Maynard .50 Caliber cartridges (artifacts 1910.9).

Figure 6-434 is two of the still loaded Maynard cartridges. The cartridges measure 33 millimeters long not including the bullet and 45 millimeters long including the bullet, 13 millimeters wide at the cartridge and a much wider 21 millimeters at the base. The wider bottom disc is unique to Maynard cartridges. Note the center hole seen in Figure 6-435 used for igniting the powder charge.

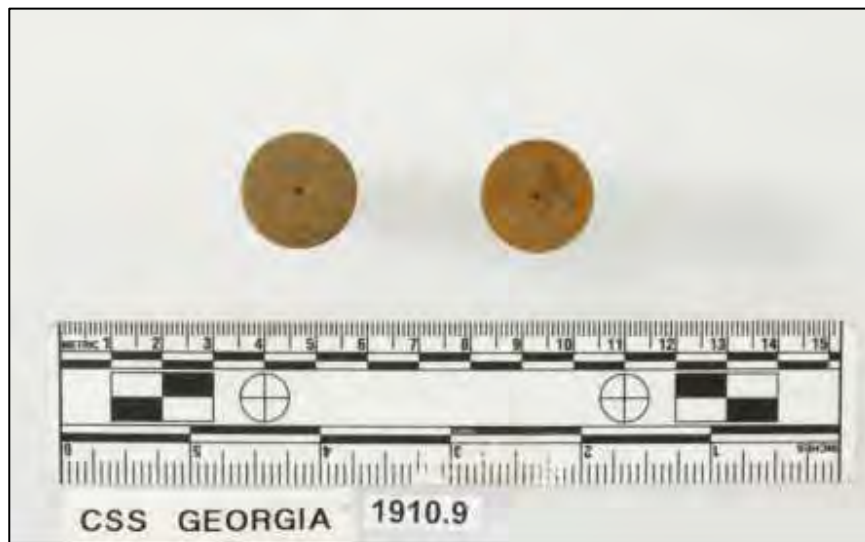
Figure 6-435. Base of the recovered Maynard cartridges.

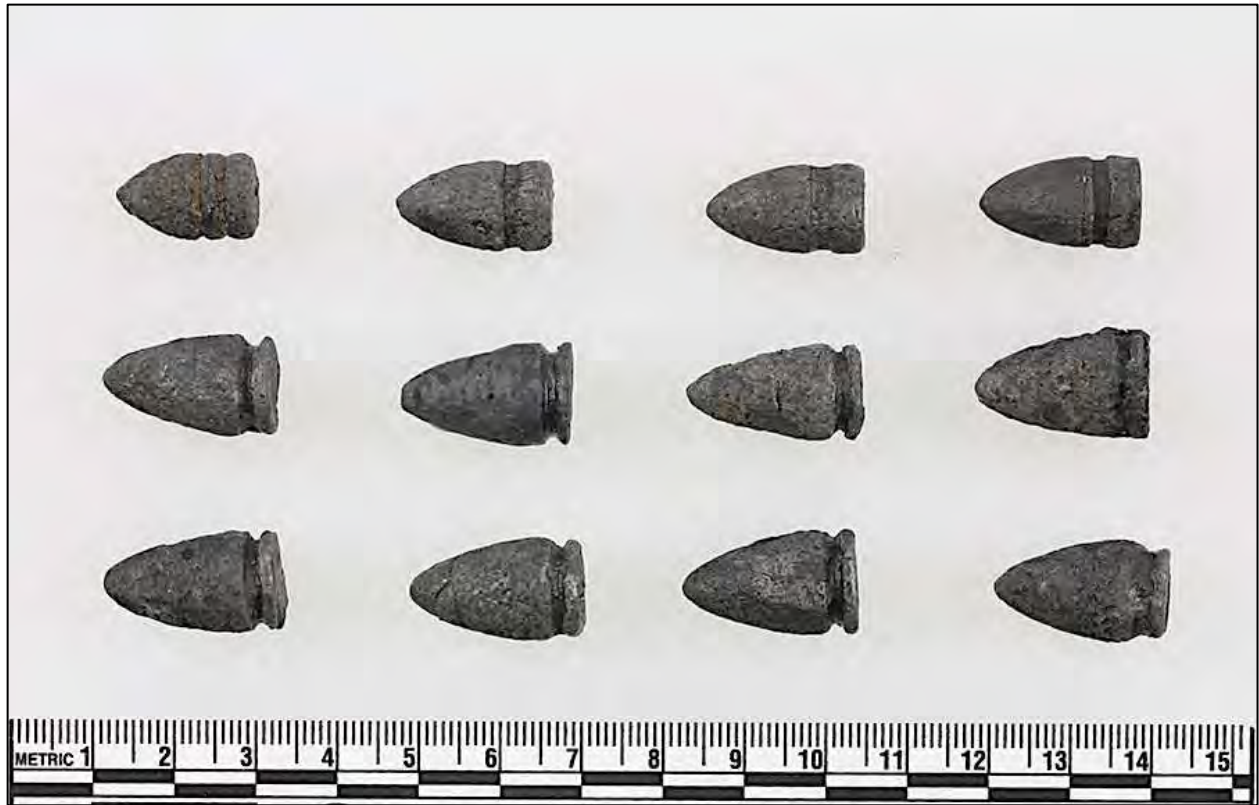
Figure 6-436. Examples of Maynard .50 Caliber bullet variants recovered from the site (note top left is not a Maynard).

Illustrated in Figure 6-436, examples of two Maynard bullet variants have been recovered, both having a single ring but slightly different in shape. One variant has a solid base and a distinct ring. It measures 21 millimeters long by 12 millimeters at the base, and the shape and measurement match previously recorded rounds (Thomas and Thomas 2013:18-19). The second variant of Maynard bullet has a ring located farther up from the solid base. The bullets measures 20 millimeters long and 12 millimeters at the base, still coinciding with previously recorded Maynard bullets (Thomas and Thomas 2013:18-19).

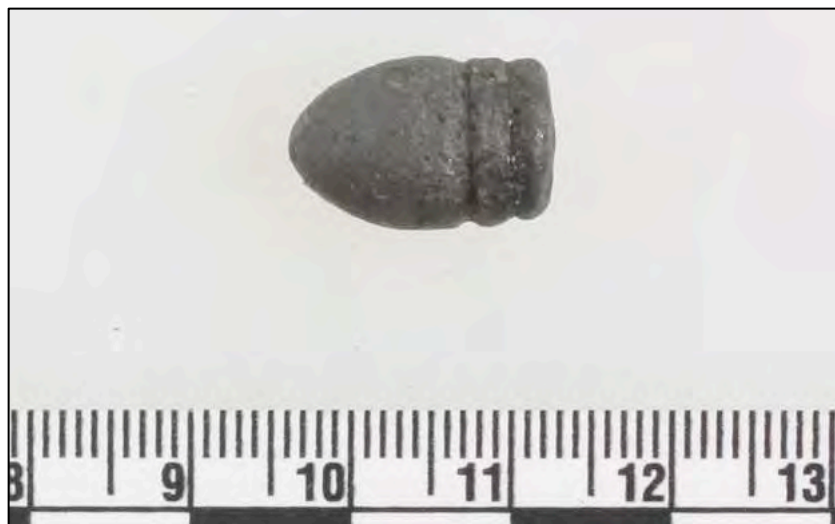
Figure 6-437. Example of the .44 Caliber dual ring bullet, Artifact 1891.6.

To date four .44 caliber dual ring pistol bullets have been recovered. The bullet as seen in Figure 6-437 measure 16.7 millimeters long by 11.2 millimeters wide and have a solid base. Without and evidence of cartridges or makers mark, and with so many similarly shaped and sized bullets of this caliber, it is difficult to determine the bullets manufacturer. It is likely that these rounds were used for the LeMat pattern revolver mentioned in the archival research completed by Mary Beth Reed (n.d.:83), which came in a .44 caliber version (Drury and Gibbons 1993:48).

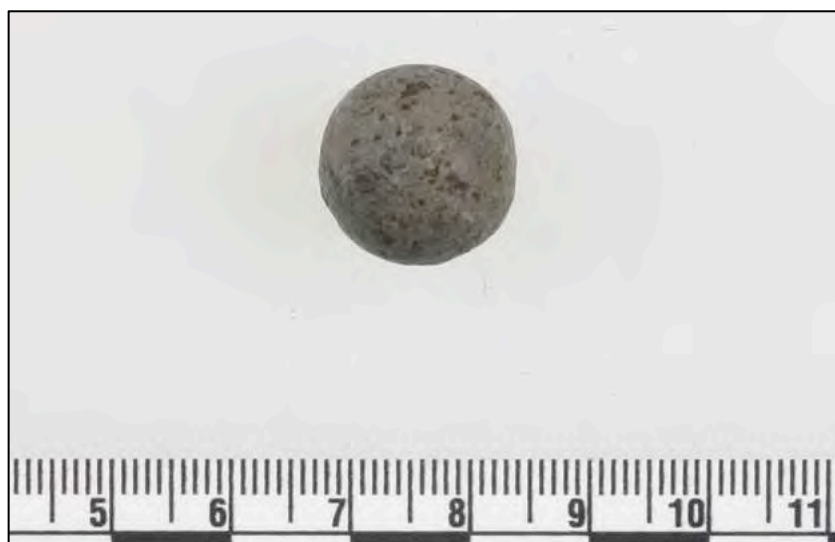
Figure 6-438. 17.2 millimeters ball projectile, Artifact 2690.4.

Fifteen round or ball projectiles were discovered in two different sizes, a 13.2 millimeters and a 17.2 millimeters variant. Neither have any evidence of cartridge or makers mark, so it is difficult to determine manufacture or even what firearm these would have been used for. Figure 6-438 is an example of the 17.2 millimeters size ball projectile. The diameter of 17.2 is close to rounds used in .69 caliber smooth bore rifles although without any evidence of a cartridge it is impossible to reach a definitive conclusion (Thomas and Thomas 2013:49). Figure 6-439 shows the smaller ball projectile.

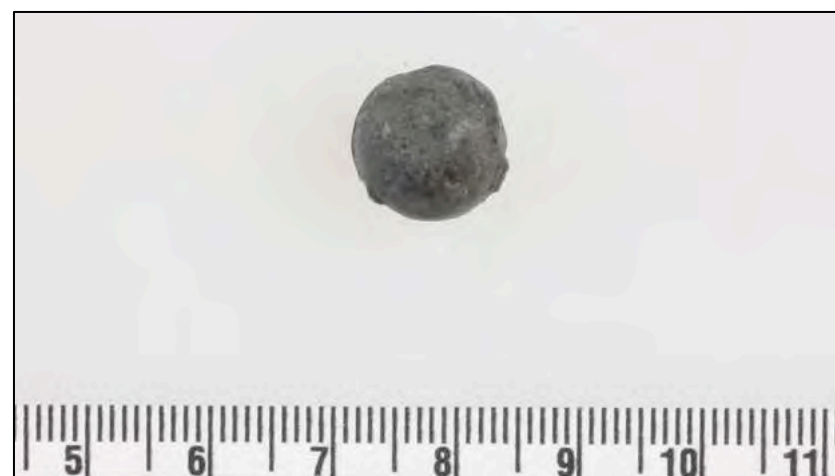
Figure 6-439. Example of the 13.2 millimeters ball projectile, Artifact 2643.4.

The 13.2 millimeters diameter resembles a .5 caliber round possibly used in a pistol such as a LeMat revolver with a smooth bore barrel. However, without any evidence of a cartridge it is not possible to draw a conclusion at this time. It is also important to note that these projectiles may be from an earlier time. Further research into this possibility is required.

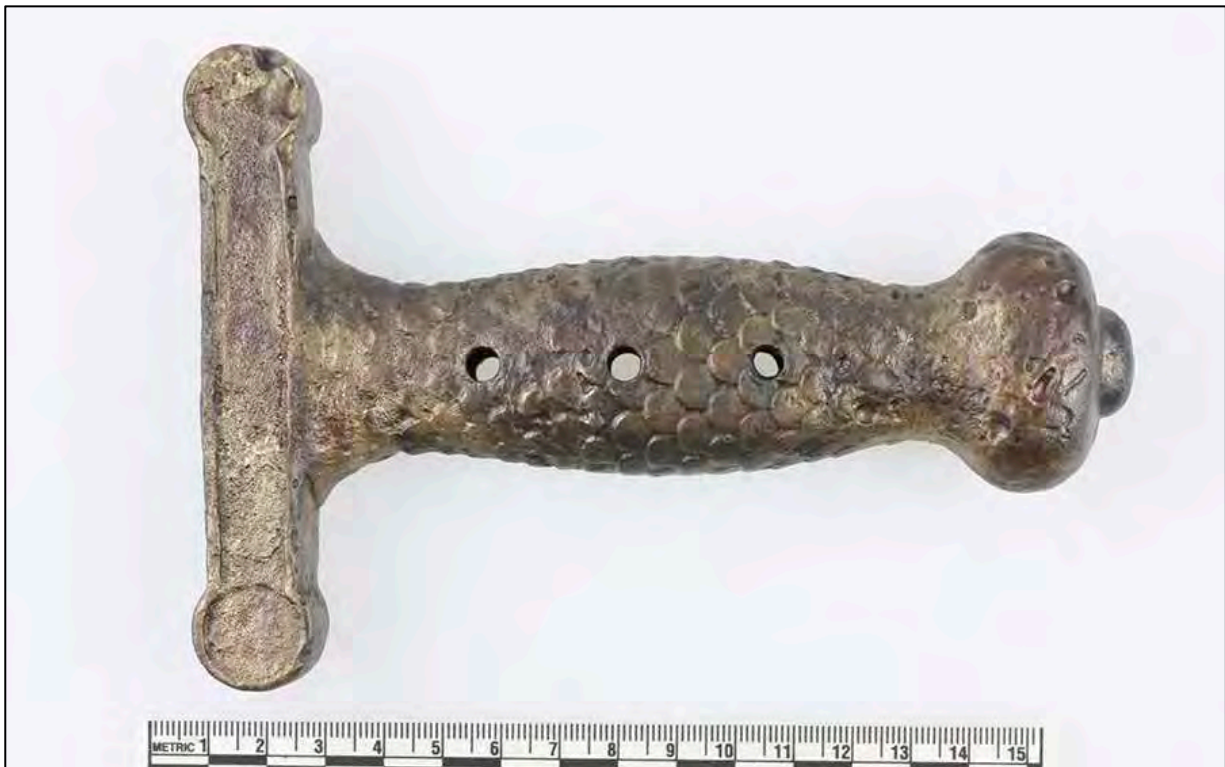
Figure 6-440. 1832 short artillery sword, Artifact 2480.1.

The hilt shown in Figure 6-440, artifact 2480.1, is the more worn of the two. The expected eagle that that should be set in the pommel is missing, the cross guard shows signs of significant wear, and even some of the unique feather-like grip is worn away. There is no evidence of inscriptions. The hilt measures 164.52 millimeters long, 107.25 millimeters wide at the cross guard, and 36 millimeters at the widest point of the grip. The tang, or section where the blade would fit into the hilt, measures 25.89 millimeters long by 7.45 millimeters wide on one end, but 5.4 millimeters wide on the other, indicating this may have been a one sided or blade.

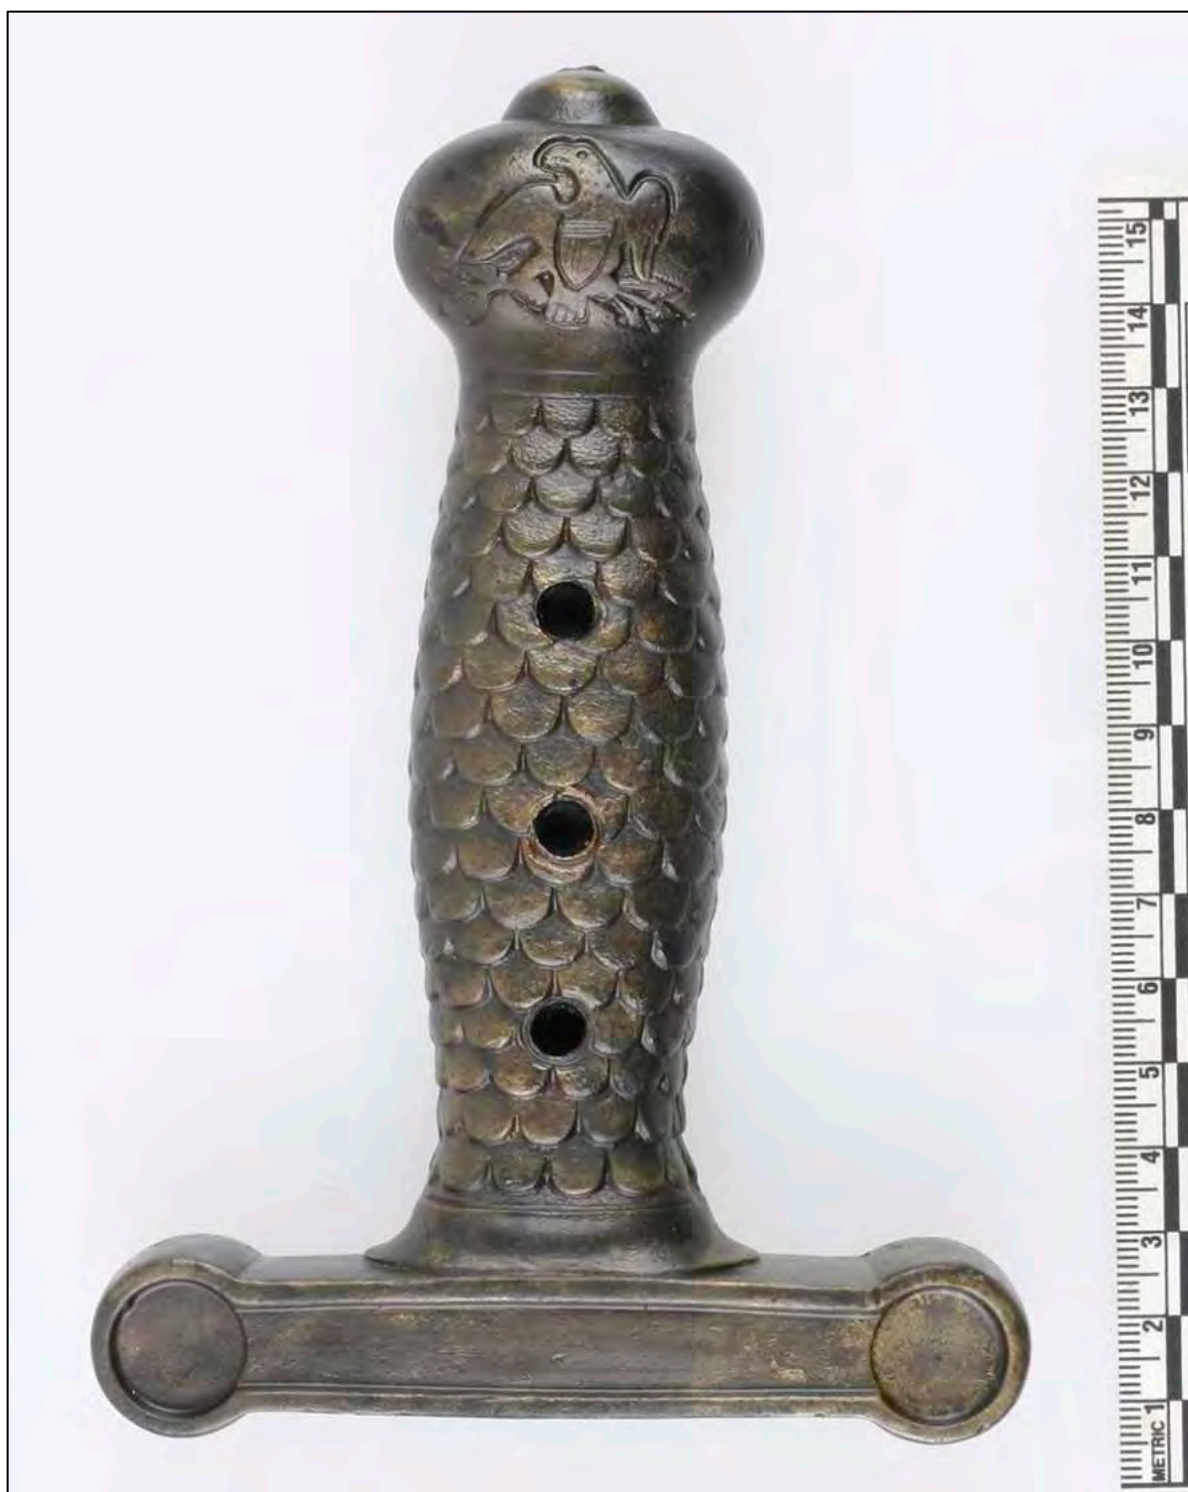
Figure 6-441. 1832 foot artillery sword (Artifact 1851.10).

Figure 6-441 below shows the less worn hilt, Artifact 1851.10. Note that the eagle in the pommel and feather molding of the grip are very well preserved. The hilt still contained the tang, or part of the blade that was inserted into the hilt and fastened with the three bolts seen on the side of the hilt.

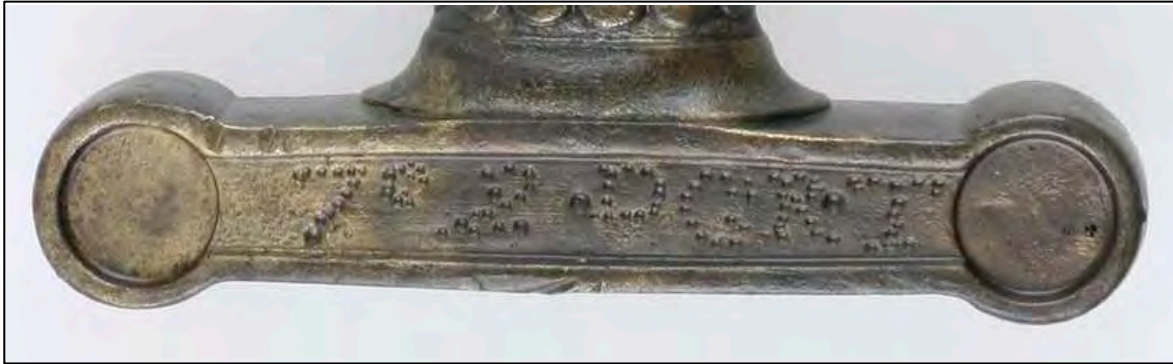
Figure 6-442. Image of cross guard of 1832 foot Artillery sword showing inscription that stands for 7th Company 2nd Georgia Regiment (Artifact 1851.10).

Figure 6-442 clearly shows stippling on the cross guard. The figures “7(c) 2*D GR*T” are plainly visible. These letters stand for 7th Company 2nd Georgia Regiment. This second hilt has the exact measurements as the first shown in Figure 6-440 (164.43 millimeters long by 107.8 millimeters wide at the cross guard and 36 millimeters wide at the grip). The difference in measurement is the tang. The tang measures 26.24 millimeters long by 7.7 millimeters wide. This rectangular shape indicates a double edges sword instead of a single edge. Associated with the sword hilts is a brass scabbard tip (or chape) as seen in Figure 6-443. It measures 106 millimeters long by 49 millimeters at the widest point. These measurements of the chape and position on the two bolt holes seen in Figure 6-440 match known collection pieces used with 1832 short artillery swords (Hickox 1992:1-2).

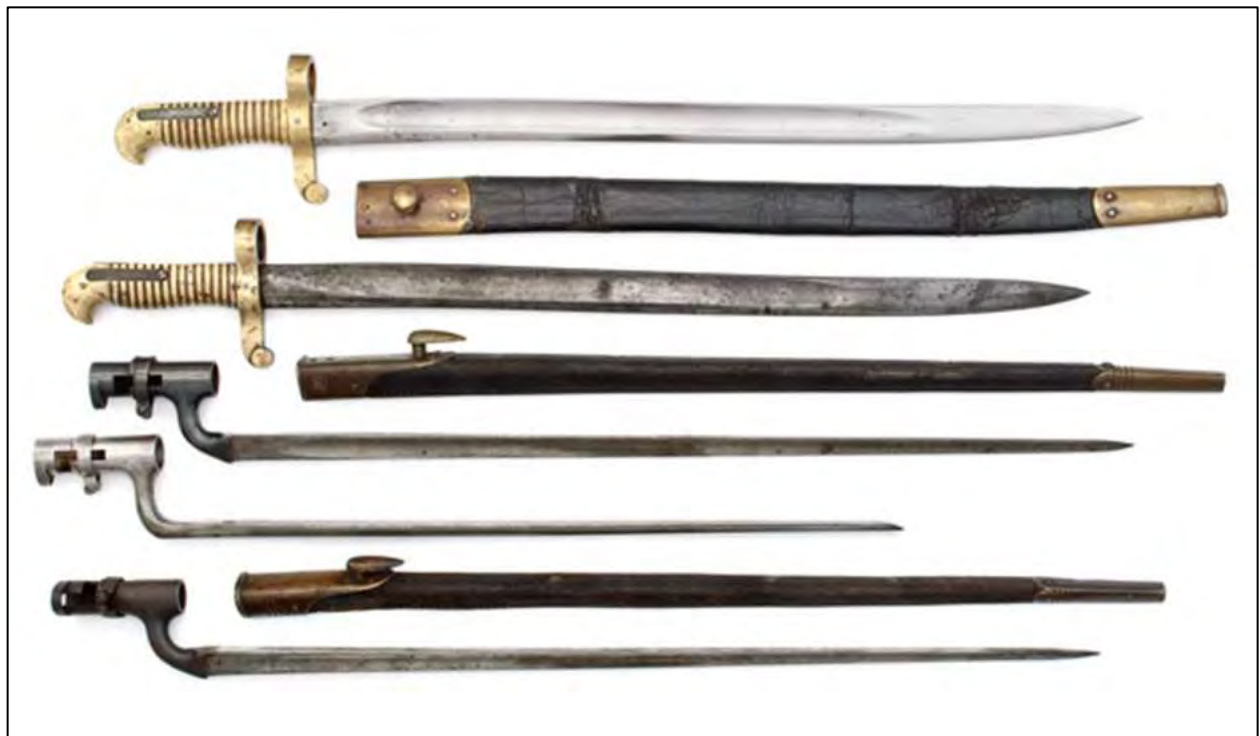
Figure 6-444. Examples of Saber and Socket-type Civil War bayonets, from top to bottom two sabre bayonets, first with a 20" blade and scabbard. Second is a 20" blade, no scabbard. Third are two Martini-Peabody bayonets with a 22" blades and scabbards. Bottom is a .58 cal. socket bayonet with an 18" blade (as presented at Cowan's Auction House 2019).

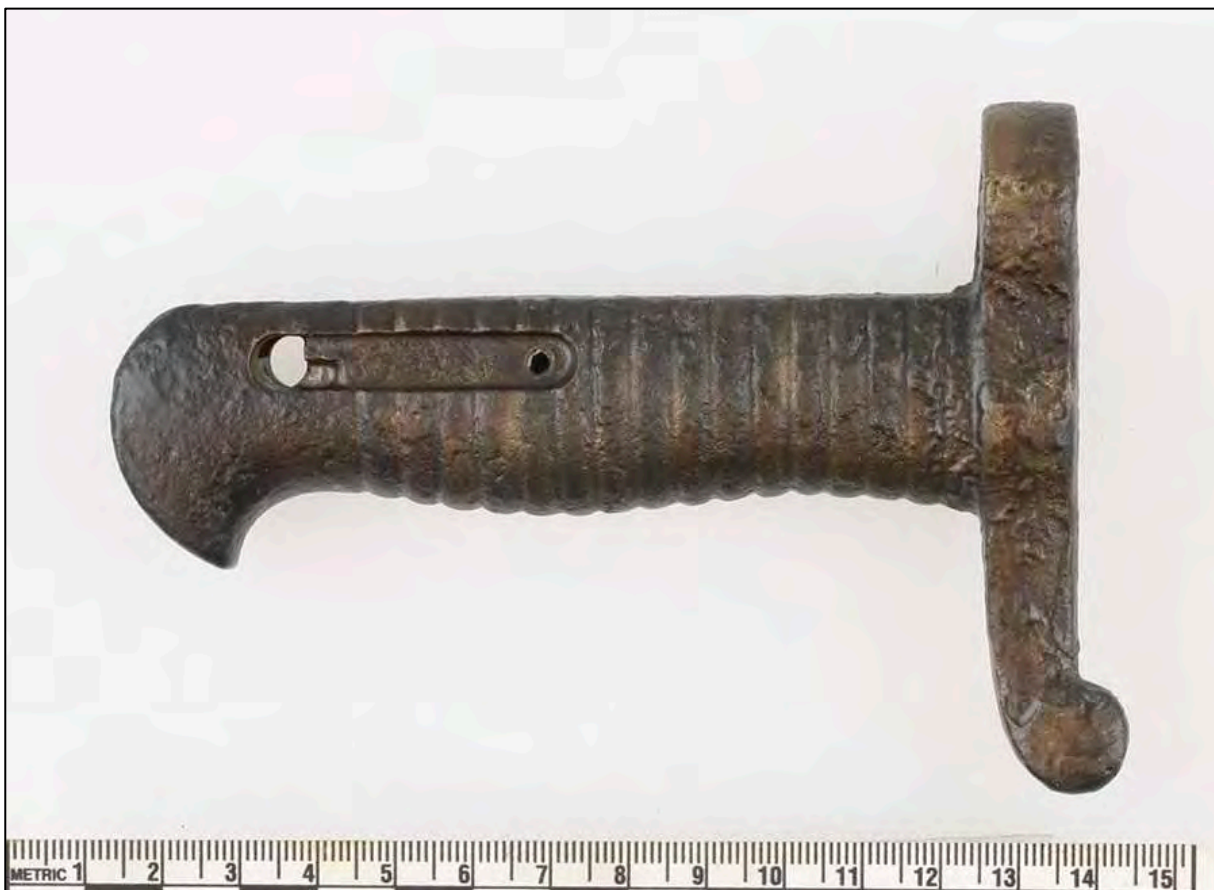
Figure 6-445. PS Justice II rifle bayonet hilt, Artifact 976.

Six bayonet hilts were recovered, all being saber or sword-type bayonets. Ironically no examples of Enfield bayonets have been recovered, as this was the type of rifle found on the ship. At the time of the Civil War, bayonets were basically reduced to ceremonial or intimidation tools. With both saber and socket Civil War bayonet types illustrated in Figure 6-444, socket bayonets that fit directly over the muzzle were rendered obsolete by the multi-purpose sword or saber bayonets (Coggins 2004:24). A saber bayonet was a short sword with a small ring on the side of the cross guard to fit over the muzzle, and a locking and releasing mechanism at the end of the hilt to accept a notch fixed to the rifle (Coggins2004:100-102). Most saber bayonets shared a common design with a few alterations depending on rifle attachment, but with minor modifications they could be fit to almost any rifle. Figure 6-445 is an example of one of the two bayonets originally made for a PS Justice 2 rifle.

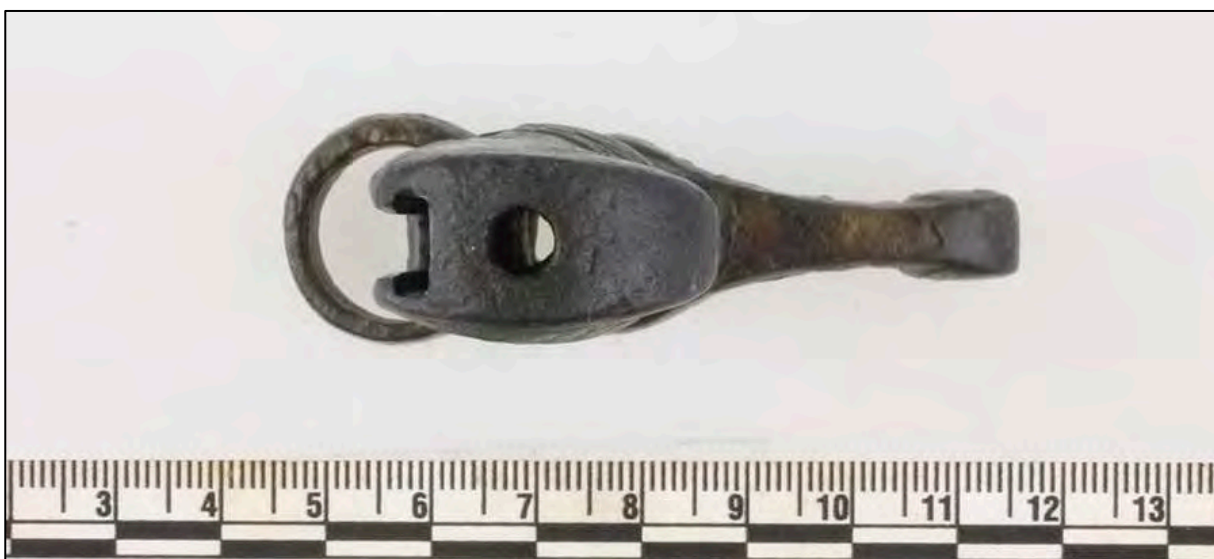
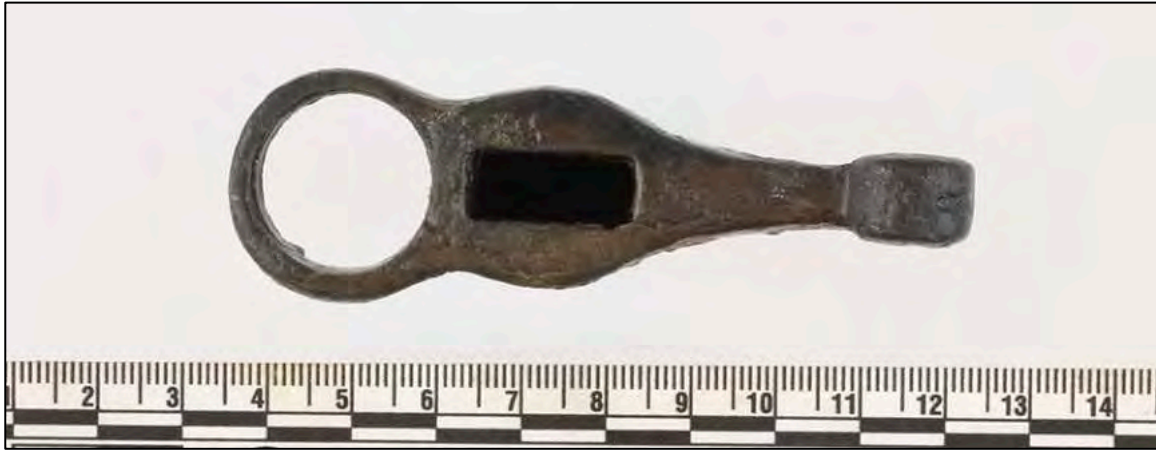
Figure 6-446. PS Justice II showing crosspiece, tang slot and muzzle ring (top), mortise slot and tang bolt (bottom) of Artifact 976.

Figure 6-447. PS Justice II showing crosspiece, tang slot and muzzle ring (top), mortise slot and tang bolt (bottom) of Artifact 976.

These bayonet hilts measure 124 millimeters long by 89 millimeters wide at the crosspiece, and both are missing the lock and release mechanism as seen at the rear of the hilt (Figure 6-446). The inner diameter of the ring that slid over the muzzle as seen in Figures 6-447 is 20.5 millimeters, which could easily accommodate the .58 caliber rifle.

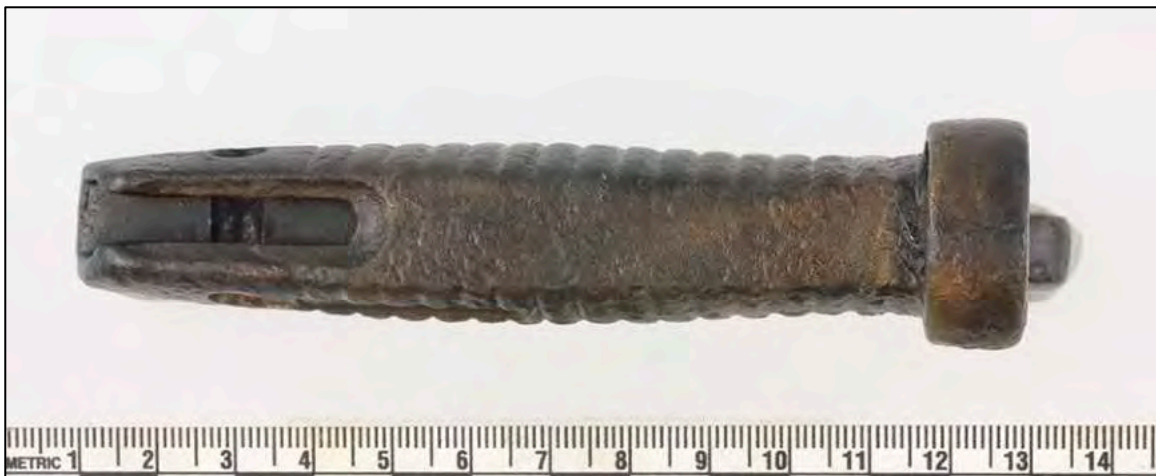
Figure 6-448. PS Justice II showing notch slot near the pommel.

The notch mortise slot seen in Figure 6-448 is curved at the curved end and measures 35 millimeters in length by 7 millimeters wide, a design seen in other PS Justice II bayonets (Graff 2003:60).
