CSS *GEORGIA*
ARCHEOLOGICAL DATA RECOVERY AND MITIGATION
FOR THE SAVANNAH HARBOR EXPANSION PROJECT (SHEP),
CHATHAM COUNTY, GEORGIA AND JASPER COUNTY, SOUTH CAROLINA

**FINAL DRAFT REPORT
OCTOBER 2019**

Stephen R. James, Jr. and Gordon P. Watts

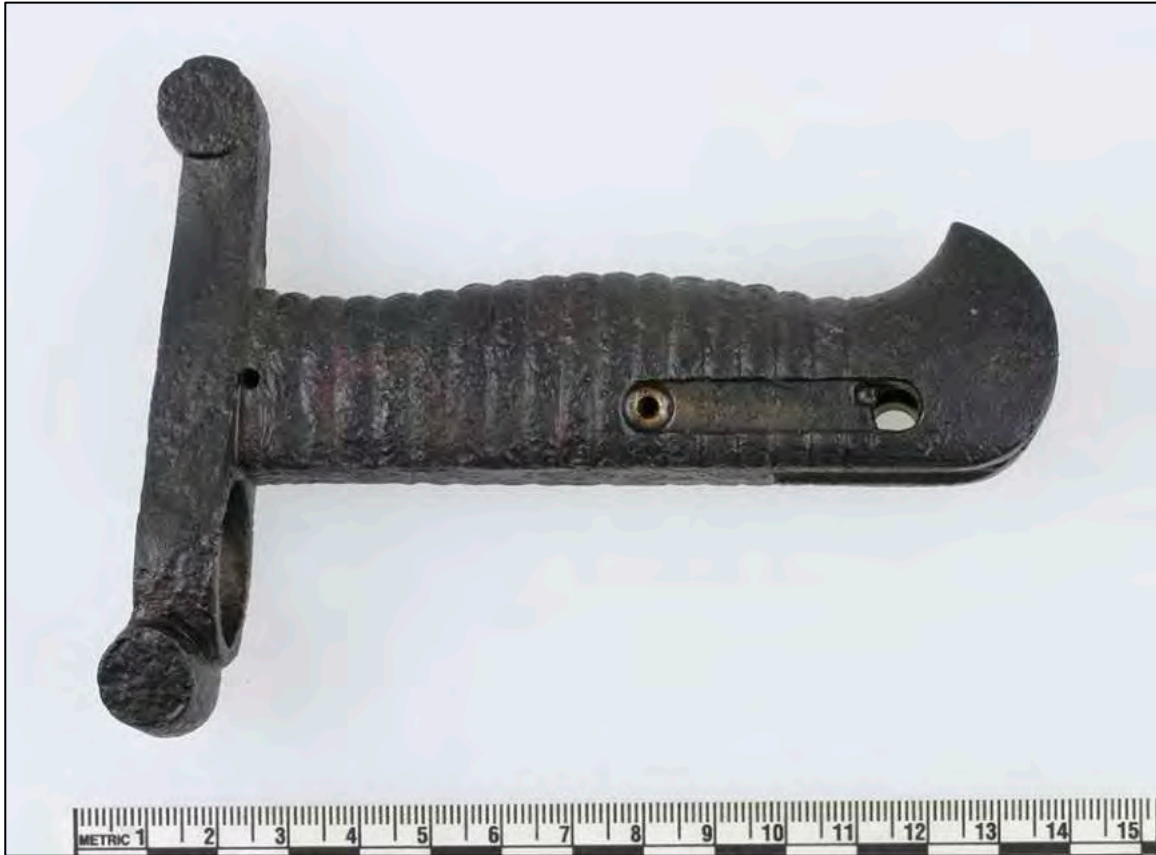
Figure 6-449. Artifact 2103.6, a Mississippi rifle bayonet hilt.

Artifact 2103.6, the bayonet hilt seen in Figure 6-449 was used with an 1855 Mississippi rifle. This hilt is solid brass with the same type of lock and release mechanism seen near the pommel. The hilt measures 122 millimeters long by 94 millimeters wide at the crosspiece. The muzzle ring measures 22.5 millimeters wide, meaning it could easily accommodate a .58 caliber muzzle. Note the addition piece or bracket located on top of the muzzle ring. This piece is unique to Mississippi rifle bayonets of this time period.

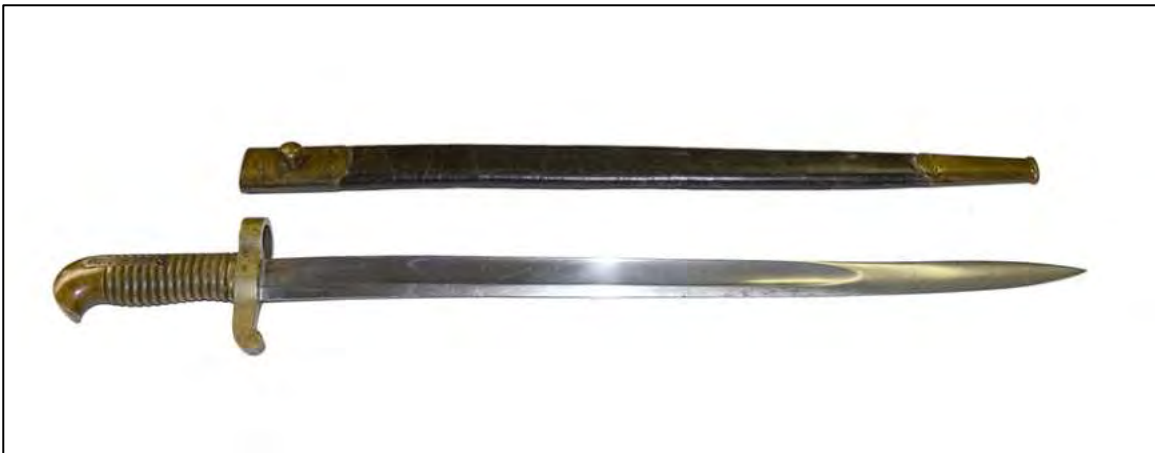
Figure 6-450. Civil War 'Zouave' style Saber Bayonet with Leather Scabbard. Total length of this bayonet is 24 $\frac{3}{4}$ " while the blade itself is about 20" long. Issued with the Remington "Zouave" Rifle, a.k.a. United States Percussion Model 1863 Rifle. Sold at auction for \$350 (as presented in The Horse Soldier 2019).

The next bayonet hilt seen in Figure 6-450 was made for a Remington Zouave rifle. Illustrated in Figures 6-451 through 33, Artifact 2505.7, measures 121 millimeters long and 93 millimeters wide at the crosspiece of the hilt, the muzzle ring measures 23 millimeters wide at the inner diameter which is compatible with a .58 caliber rifle. Unique to this bayonet is a second tang stud found in the middle of the crosspiece. The mortise slot also differs from either the Mississippi or the PS Justice II. It measures 60 millimeters long, 6 millimeters at the widest point near the pommel and 4 millimeters at the narrowest.

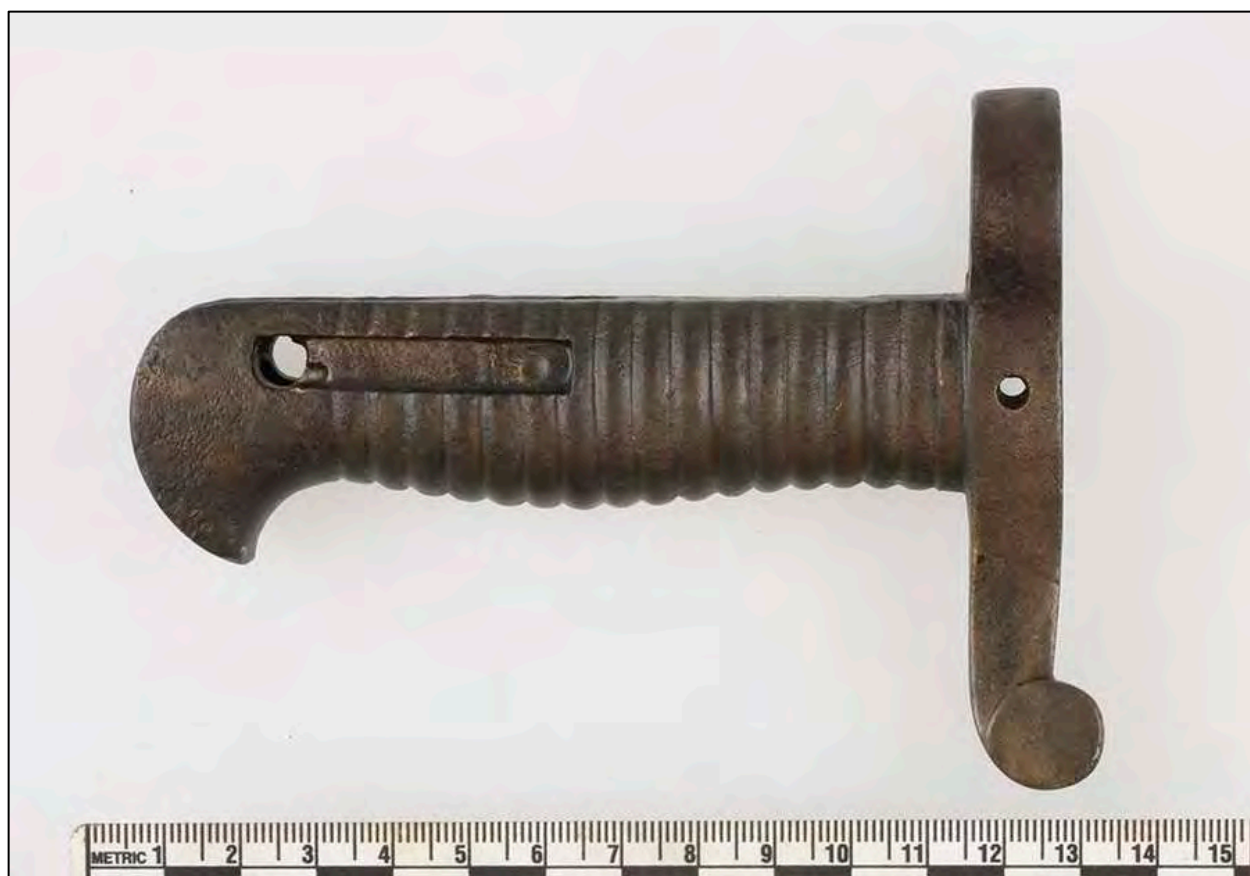
Figure 6-451. Zouave rifle bayonet hilt, Artifact 2505.7.

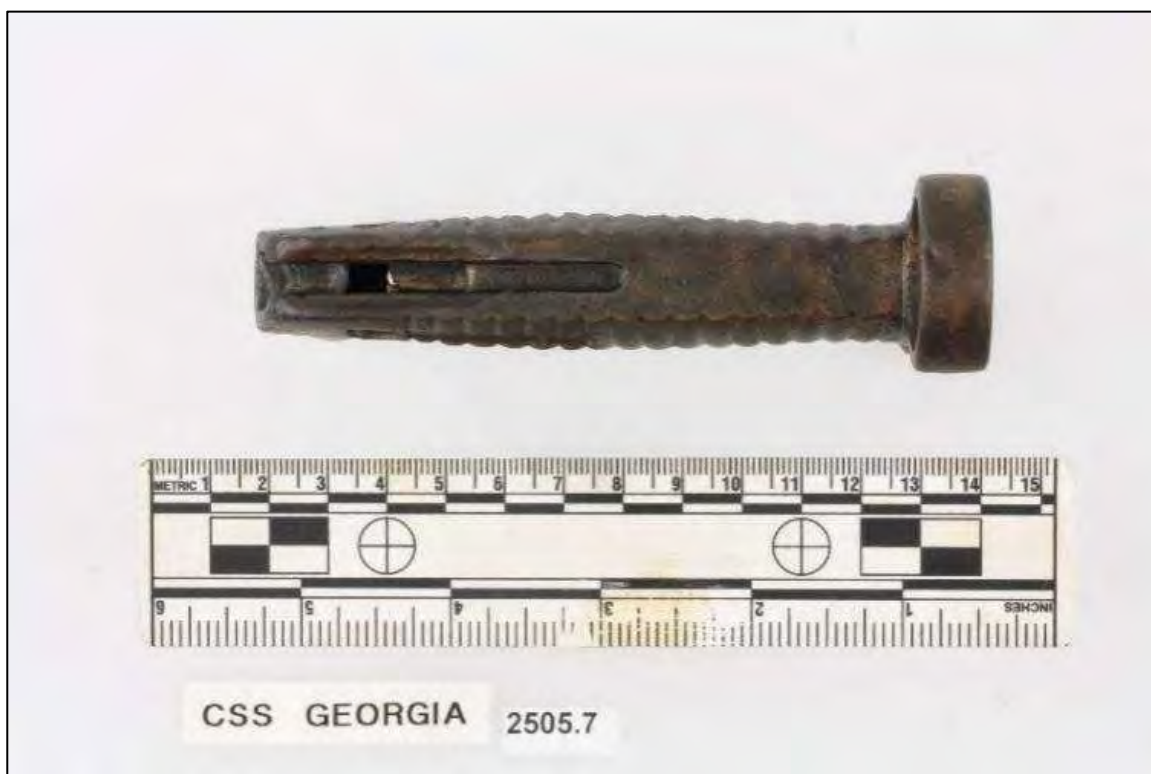
Figure 6-453. Zouave mortise slot.

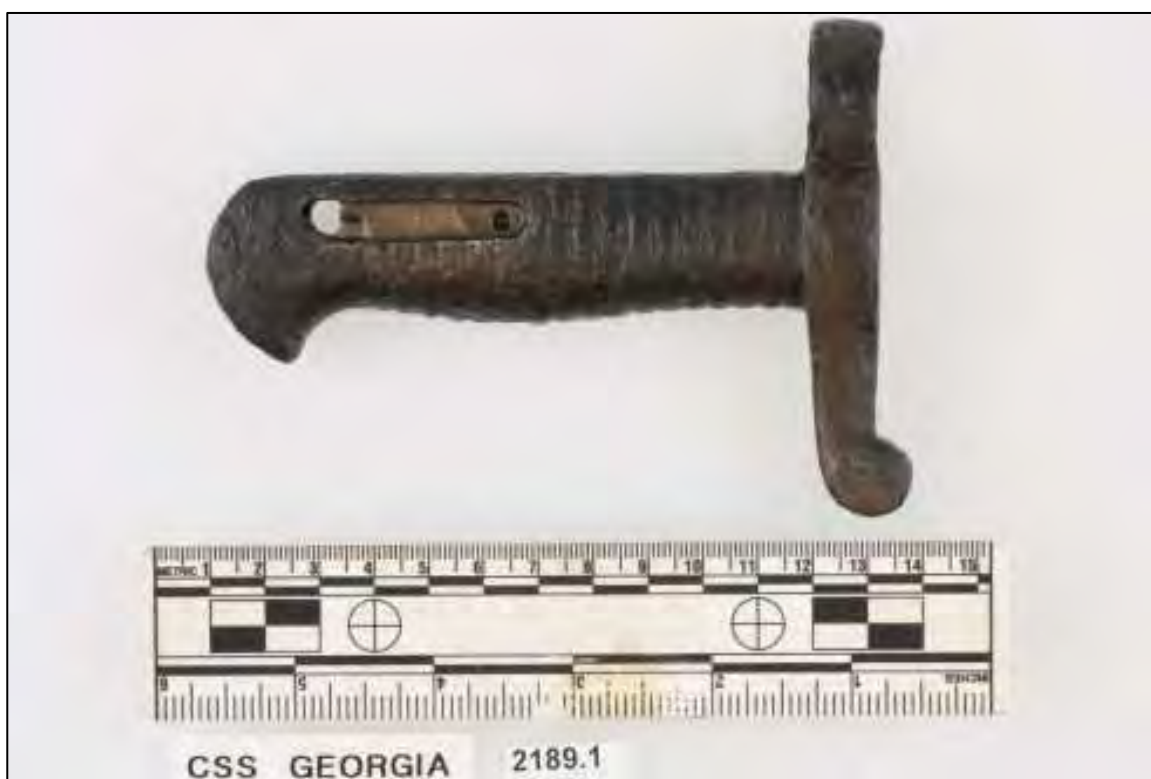
Figure 6-454. Sharps bayonet hilt, Artifact 2189.1.

The next hilt seen in Figures 6-454 to 456 was made for a model 1860 Sharps rifle. The hilt is brass and measures 122.5 millimeters long by 90.5 millimeters wide at the crosspiece, and 18.8 millimeters wide on the inner diameter of the muzzle ring, making this compatible with a .58 caliber rifle.

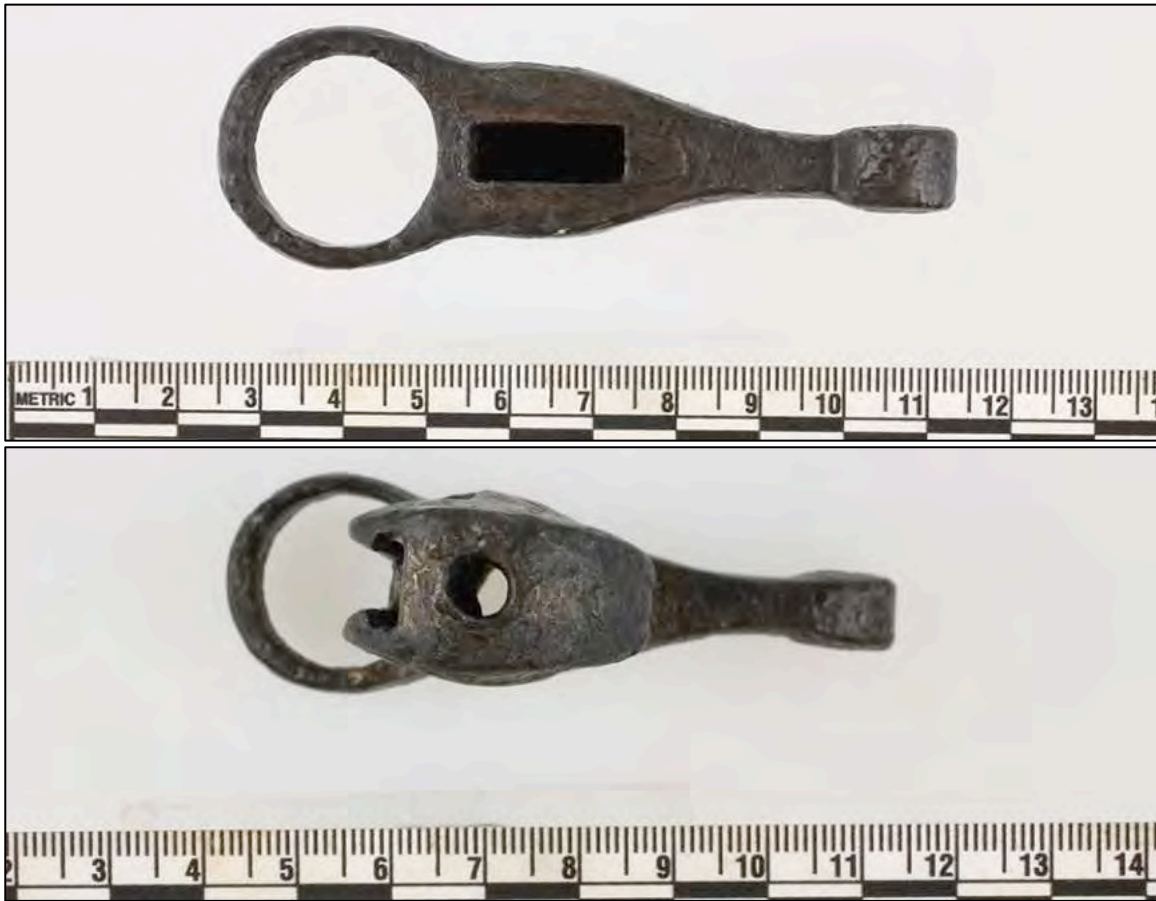
Figure 6-455. Sharps bayonet with muzzle ring, tang slot, crosspiece (top), mortise slot and tang bolt (bottom) visible, Artifact 2189.1.

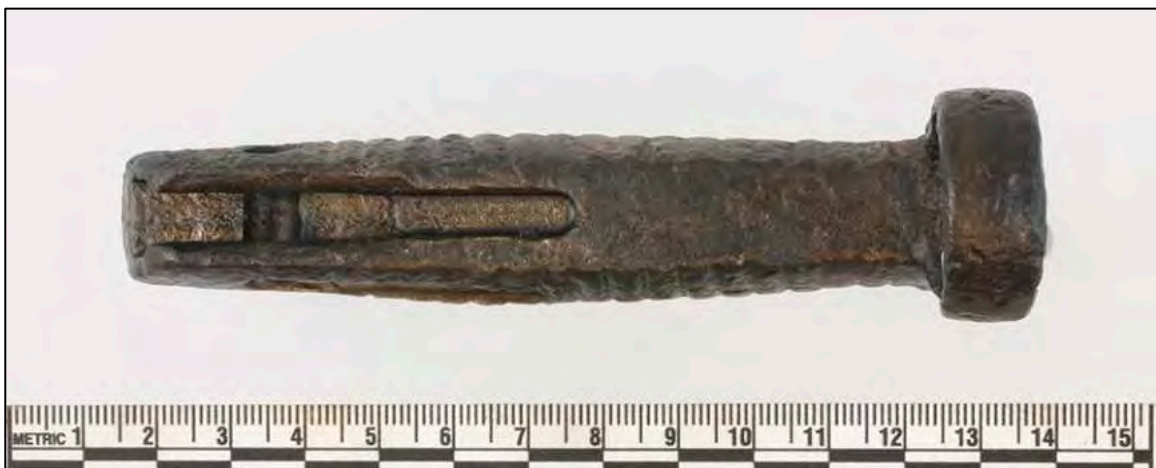
Figure 6-456. Sharps Mortise slot, Artifact 2189.1.

This hilt is made very similar to all the others with one difference, the mortise slot. As seen in Figure 6-456 the mortise slot is much longer than the other examples measuring 58 millimeters long by 8 millimeters at the widest point and 6 millimeters at the narrowest. The design and measurements are similar to known examples.

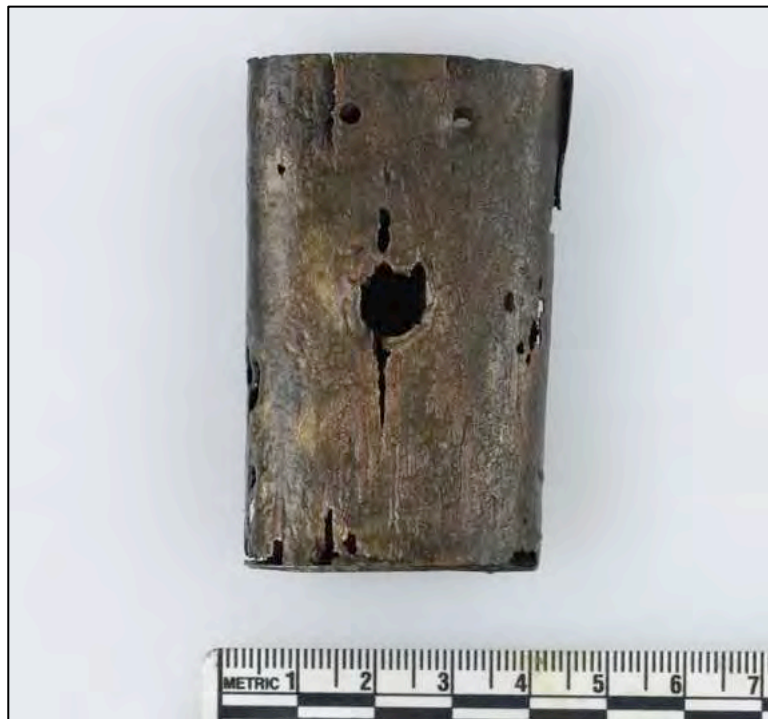
Figure 6-457. Bayonet locket front. Scale in centimeters, Artifact 1824.14.

Also associated with the bayonets is a brass piece of a scabbard called a locket, Artifact 1824.14. A locket is a metal piece either on the top or, in this case, the top of a scabbard, and was set into what is called a frog or small leather holder that was either connected to a soldier's belt or to a strap that was slug over the shoulder. The locket measures 67 millimeters long and 42 millimeters wide. The center hole, as seen in Figure 6-457, would have been where the frog bolt, connecting the scabbard to the frog, would have been. Notice the two small retaining bolt holes at the top of the locket.

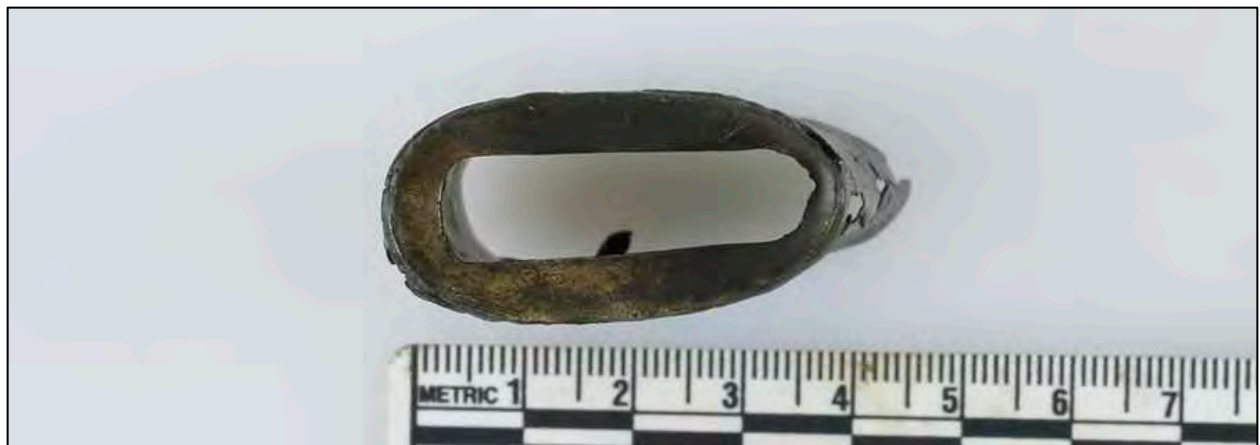
Figure 6-458. Locket "throat," Artifact 1824.14.

Figure 6-458 illustrates the locket's inner dimensions also known as the throat. It measures 33 millimeters wide by 10 millimeters at the widest by 8 millimeters at the narrowest. Without a maker's mark it is impossible to determine the point of origin.

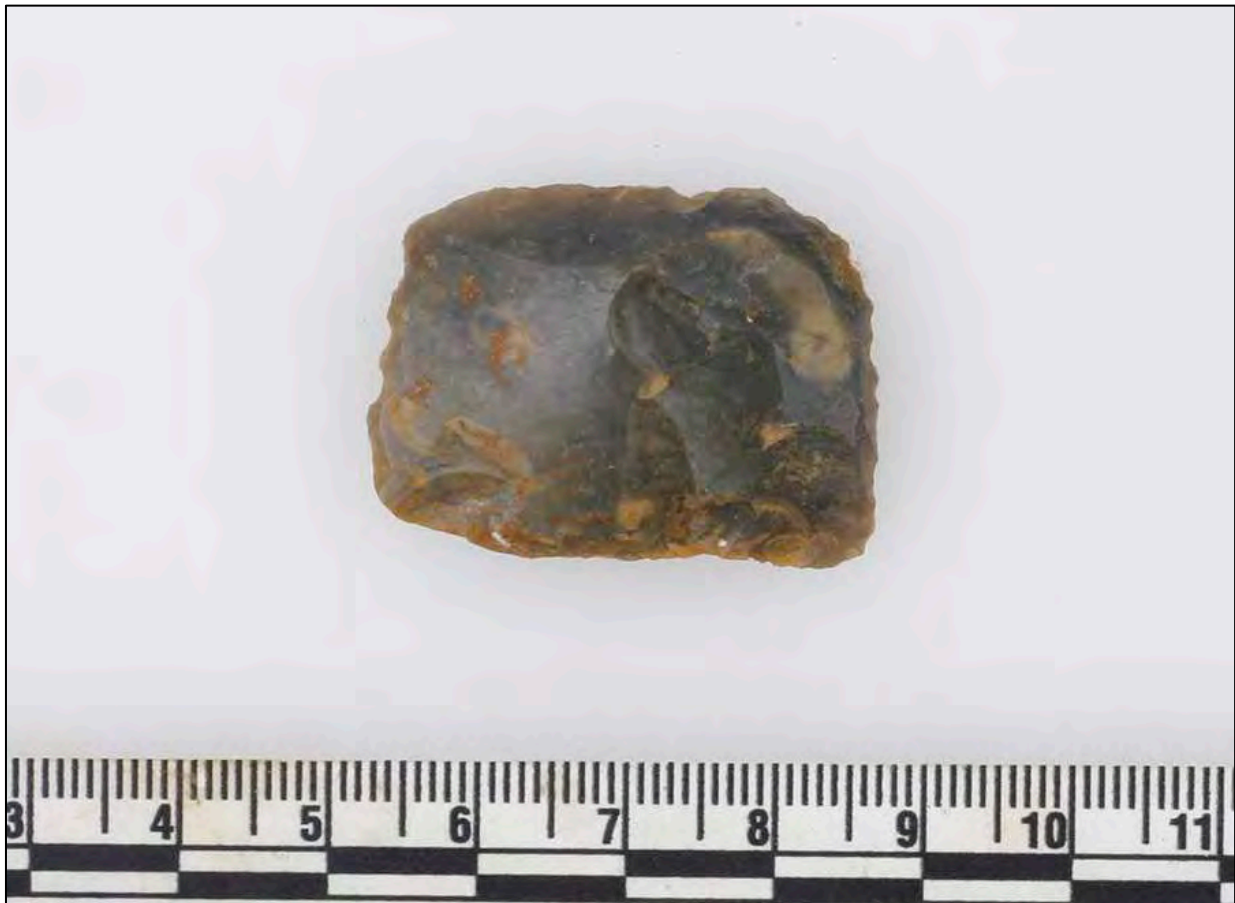
Figure 6-459. English Spall Gunflint. Scale in centimeters, Artifact 2540.2.

Eight gunflints were recovered from the *CSS Georgia*. There are two types, blade and spall, each being of English origin based on their black to dark grey coloration (Witthoft n.d.:36). Figures 6-459 and 6-460 show a spall gunflint. Spall gunflints have several distinguishing characteristics, such as a wedge shape, two ventral surfaces, a bulb of percussion, and show retouching or additional knapping (Blanchette 1975:49) on the edges as seen Figure 6-459. Spall gunflints were produced by striking a core of flint with a hammer to make large flints, then striking those to make smaller flints. These were then retouched for size, shape and a pronounced striking edge (Hamilton 1998:142-145). Figure 6-460 is a closer view of the flint. Note the two ventral surfaces seen upper right and lower left, the bulb or percussion at the bottom, and worked or retouched edges on the right and left sides. The overall shape is rectangular, measuring 33 cm long, 25 cm long and 9 cm at the tallest point.

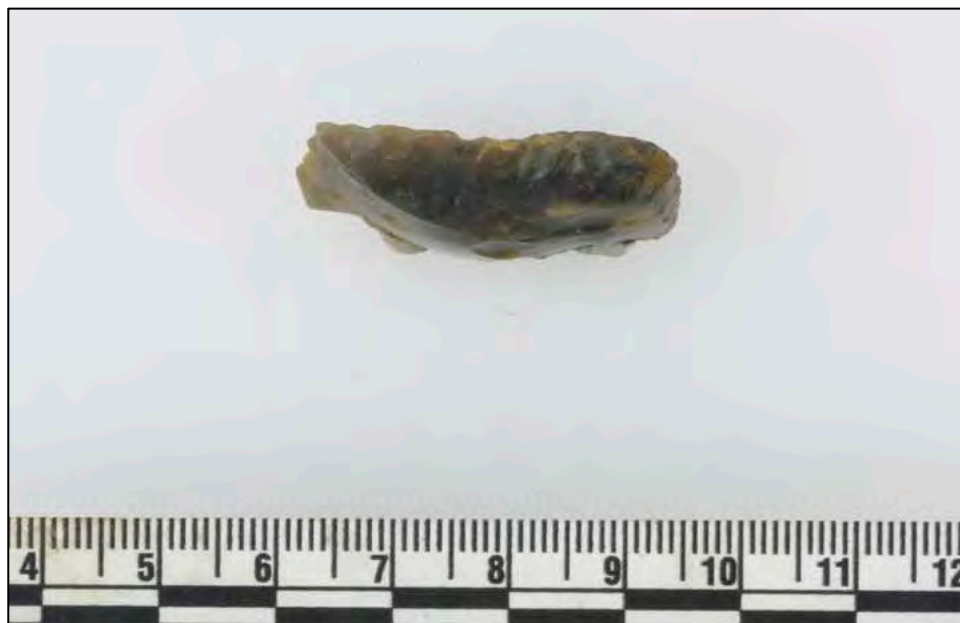
Figure 6-460. Spall gunflint showing wedge shape. Scale in centimeters, Artifact 2540.2.

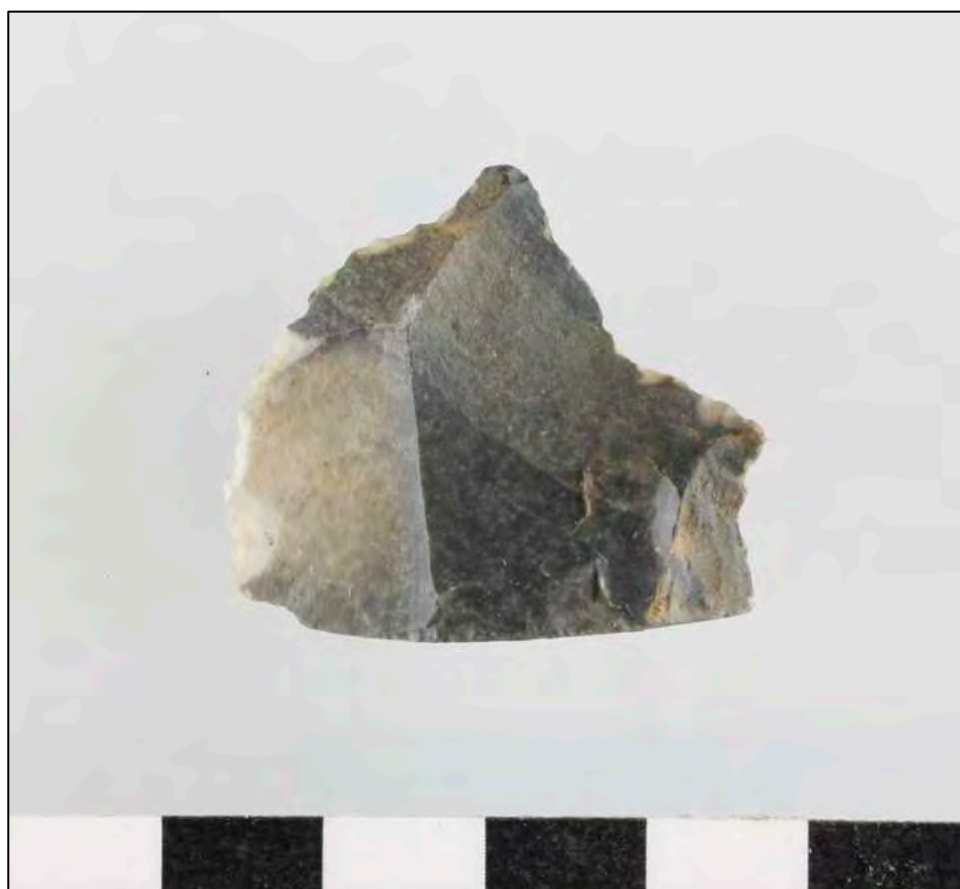
Figure 6-461. Possible blade gunflint. Scale in centimeters, Artifact 2802.9.

One possible blade gunflint has been identified, as seen in Figure 6-461. Blade gunflints were produced by striking a worked or prepared core with a special hammer. The English technique produced flints that square with angular ventral sides and a trapezoidal in cross section. There were usually two blades, with the shorter acting as the heel and the longer acting as the working edge (Hamilton and Emery 1988:13). The recovered gunflint exhibits the angular ventral side. It is roughly trapezoidal in cross section, but appears to be a partial flint. It measures 33 millimeters long by 28 millimeters wide, making it nearly square. It should be stated that this is not a definitive identification as it might represent a prehistoric artifact.

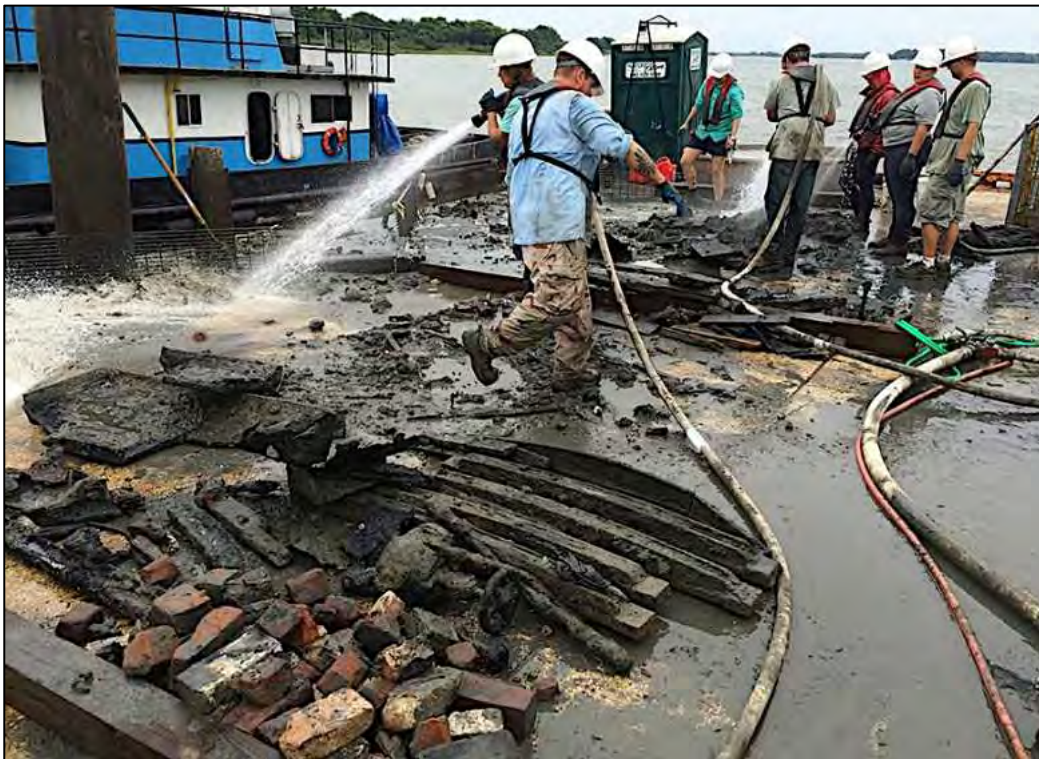
Figure 6-464. Firebrick, fire grates and ash pan or boilerplate fragments recovered from Unit 7-E just south of the West Casemate.

Elements of the boiler that were recovered consisted of fire tubes, grate bars, firebox and ashpit doors, and part of the ashpit base with firebrick (Figure 6-464). As discussed above, numerous firebricks employed within the construction of the boiler were present, those embossed with the makers mark "Brooklyn Fire-Brick Works," the most predominant type, were recovered along with the fire door, tubes, and grates. As stated above, the Brooklyn Fire-Brick Works was

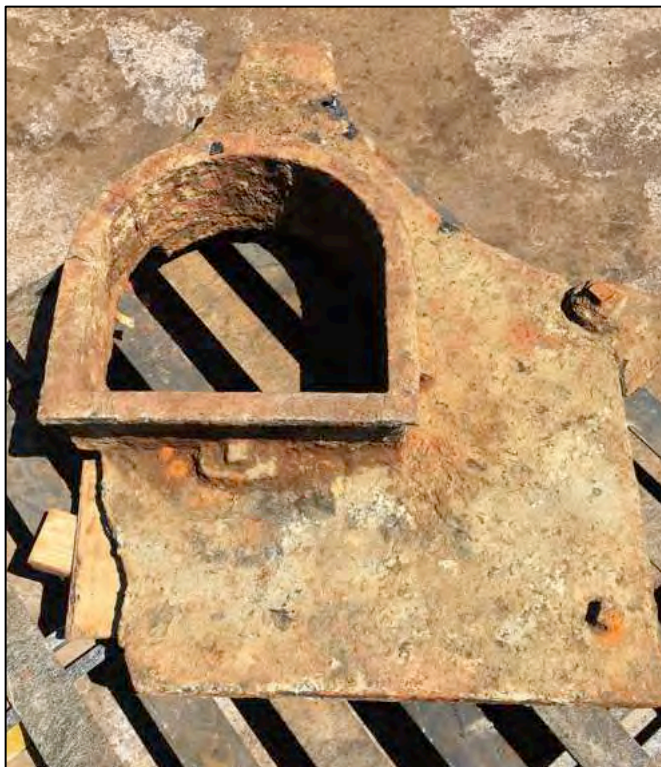
Figure 6-465. Boiler face or front fragment with one of the ashpit doors prior to being placed into electrolysis. Firebrick was still attached to the inside of the boiler face just below door. Artifact 1844.02 from Unit 6-E just south of the West Casemate.

established in 1854, in Redhook, New York. Although only supposition, the bricks could have made their way to Savannah as ballast or perhaps have been built into the boiler for another vessel that was then placed into the CSS *Georgia*. Figure 6-465 illustrates the ashpit door recovered from Unit 6-E.

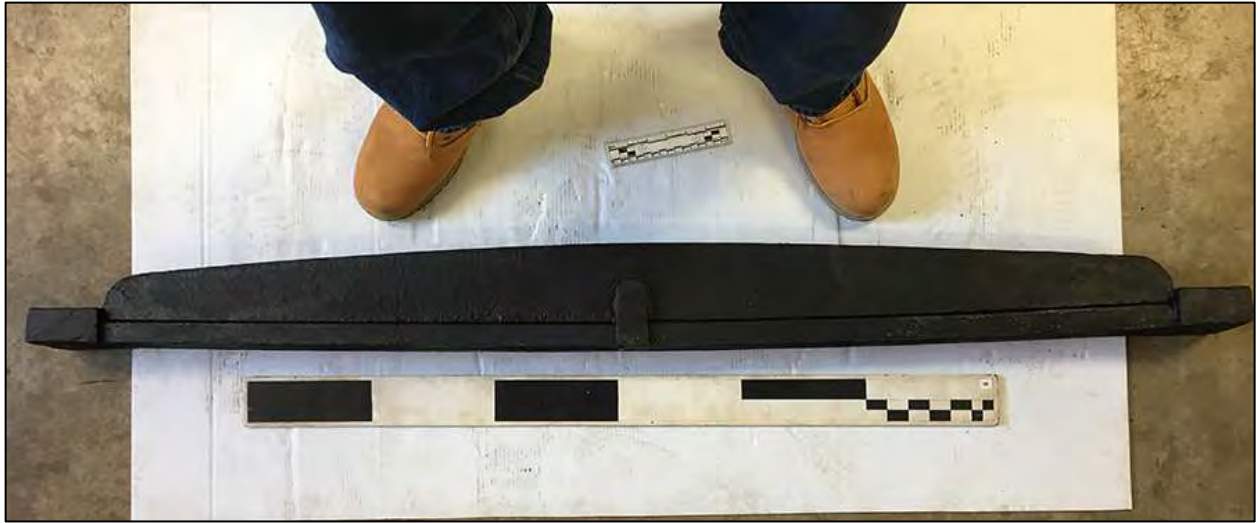
Figure 6-467. Artifact 1844.22, double-veined fire grate, side view.

Two other components of the boiler recovered were fire grates and fire tubes. Illustrated in Figure 6-466 are fire tubes recovered from Unit 7-D during Mechanized Recovery. Just over 10 feet long and 4 inches in diameter, these tubes were recovered from a large concentration identified during initial diving investigations prior to Mechanized Recovery along with heavy iron plate in Unit 7-D. Of the 69 fire grate artifacts recovered approximately 12 are complete, while the rest are fragments, with the complete examples coming mainly from Grid 7-E adjacent from where most fire tubes were recovered. Note Units 7-D and 7-E are immediately adjacent to Unit 6-E where the boiler door was recovered. Illustrated in Figures 6-467 and 6-468, the grates are double-veined and have a standard length of 55 to 56 inches (4.58 to 4.67 feet) and 5 inches high at center. A grate schematic is presented in Figure 6-469.

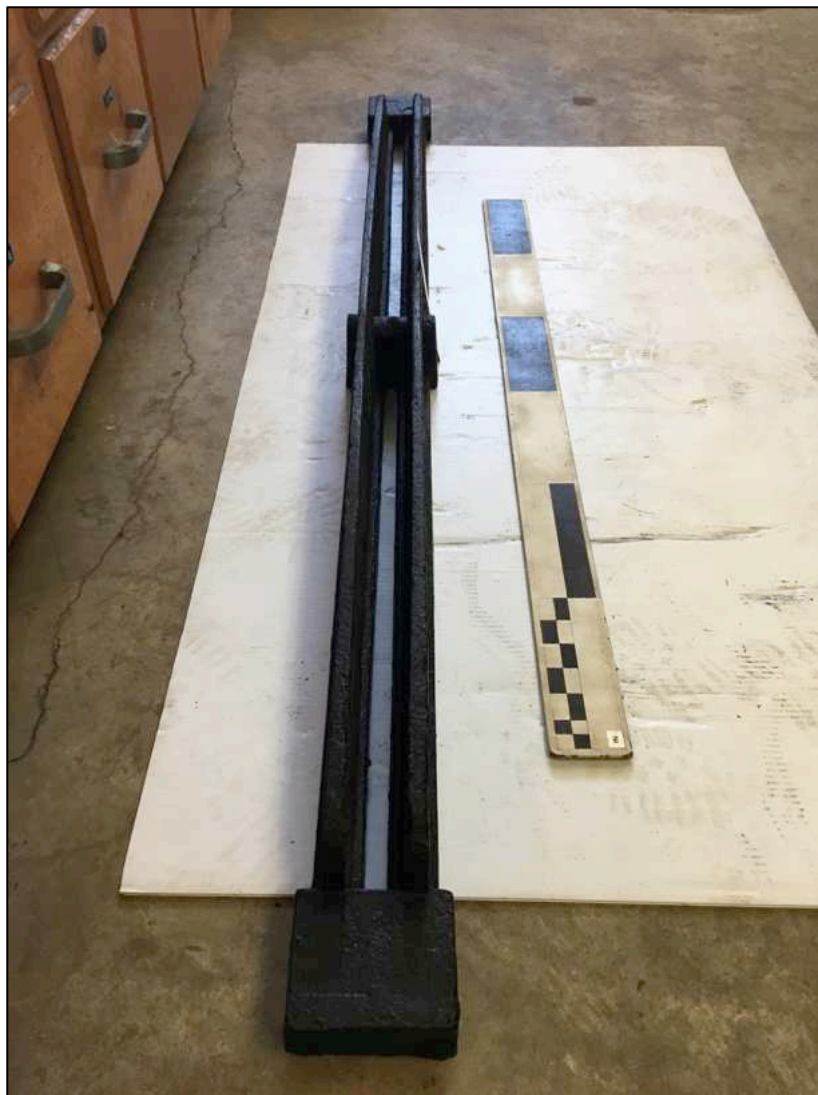
Figure 6-468. Artifact 1844.22, double-veined fire grate, end view.

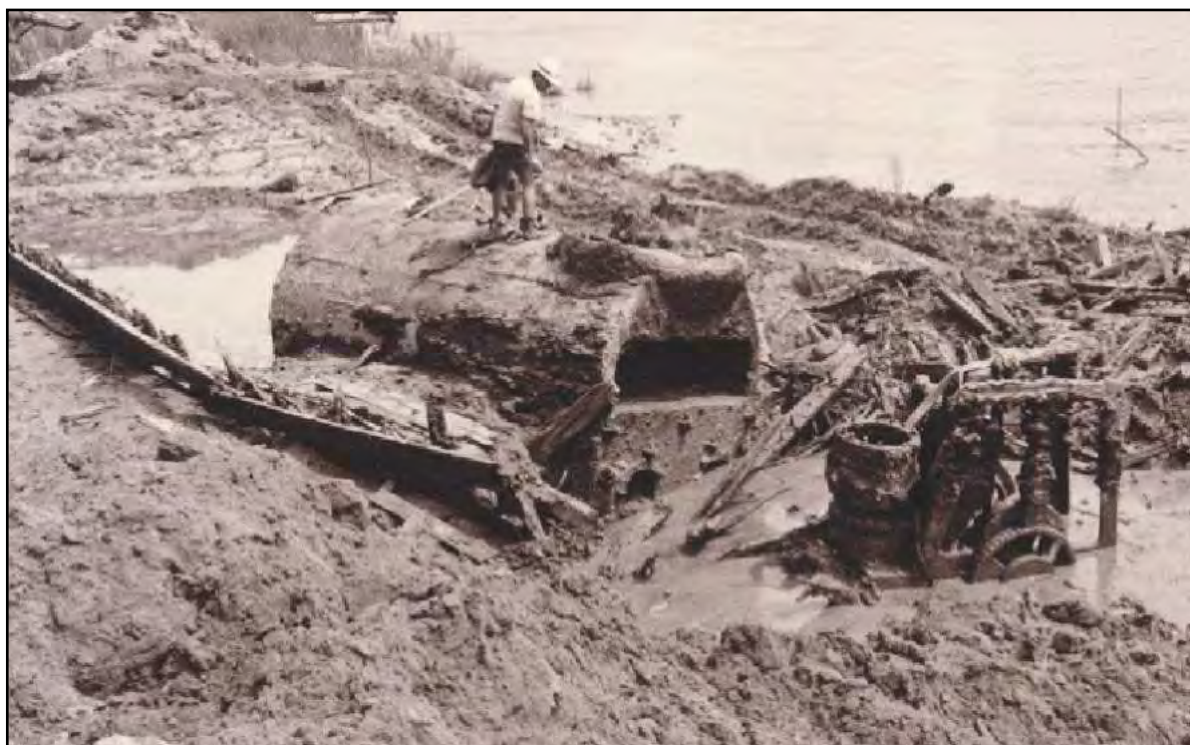
Figure 6-474. Fig Island tug with Stevens-style boiler excavated by TAR in 1992.

The Stevens-style boiler was designed around a rectangular firebox and a horizontal, cylindrical, return, fire tube water chamber (Figure 6-473). This was perhaps the most common U.S. design until the last quarter of the nineteenth century. An excellent example was found in the remains of a nineteenth-century tug excavated on Hutchinson Island across the river from Savannah in 1992 (Figure 6-474). A measured drawing of the Fig Island tug illustrates the boiler size and design (Figure 6-475).

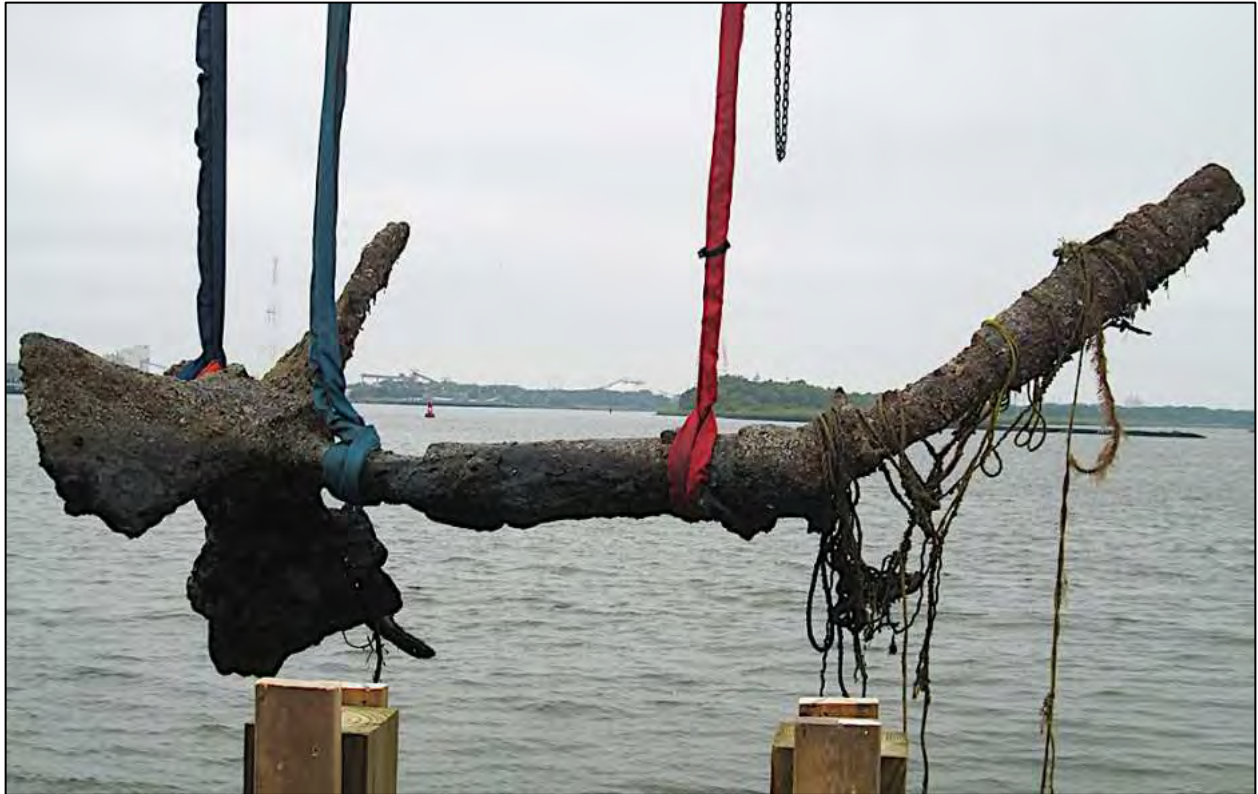
Figure 6-478. Artifact 1614, a triple-bladed propeller, being lifted onto the barge (recovered from Unit 2-F).

Historical sources indicate that the CSS *Georgia* was powered by “a double engine and twin propellers” (Barnwell 1981:203, 206-208; Melton 2002:19). That description has been confirmed by machinery recovered from the salvage site. A single propeller with attached shaft was identified in 2003 and recovered in 2015 (Figures 6-478 to 6-480). The configuration of the shaft bearing and attached struts confirm that the propeller was one of two fitted on either side of the sternpost (Figure 6-481). The diameter of the recovered propeller appears to have been close to 7 feet 2 inches in diameter. The propeller was attached to a section of shaft 13 feet 9 inches in length (Figure 6-482). Only one propeller was present on site.

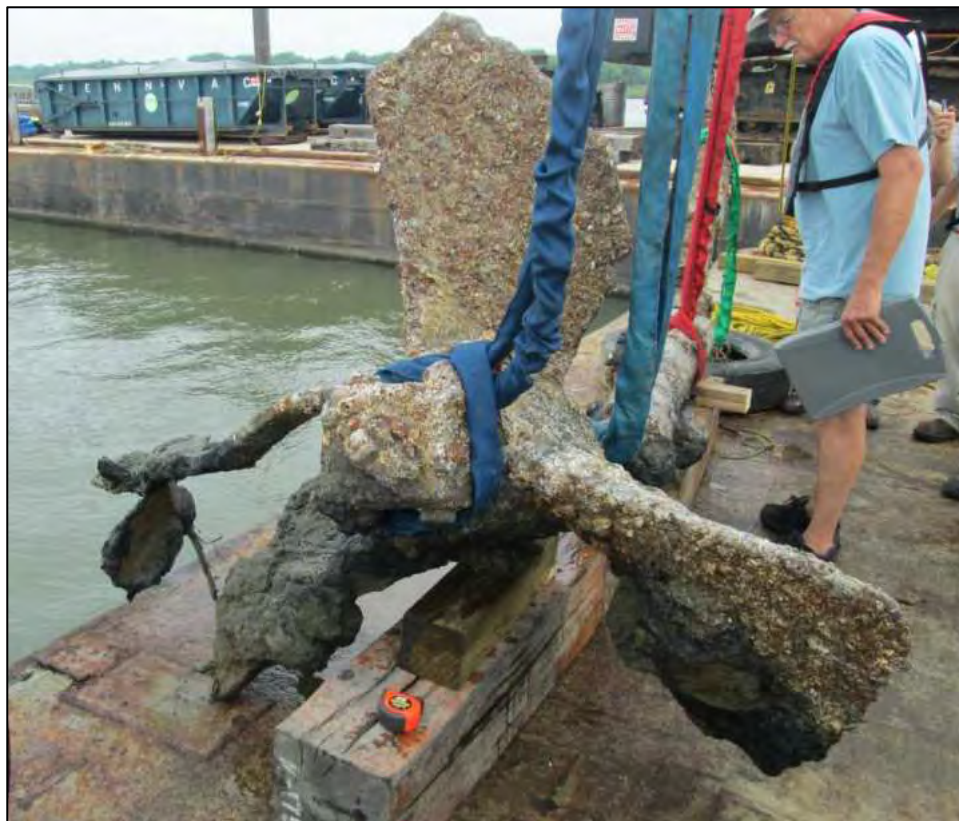
Figure 6-479. End view of propeller showing the hub shaft bushing (center) and remaining strut mount (left).

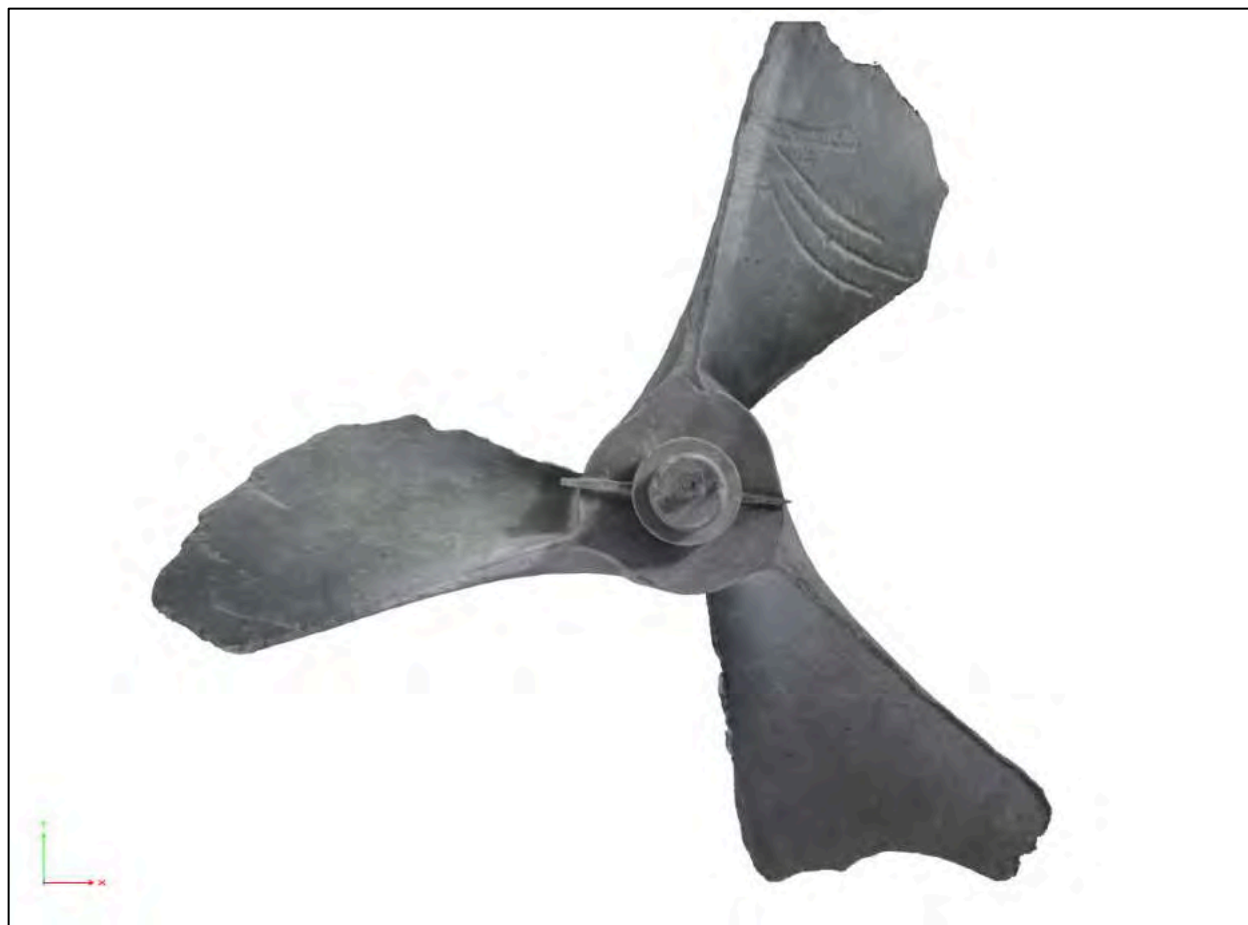
Figure 6-480. 3-D end-on image of Artifact 1614, a triple-bladed propeller recovered from Unit 2-F. Note the broken blades. Shaft bushing and strut mounts removed during conservation; shaft bushing in center of the shaft.

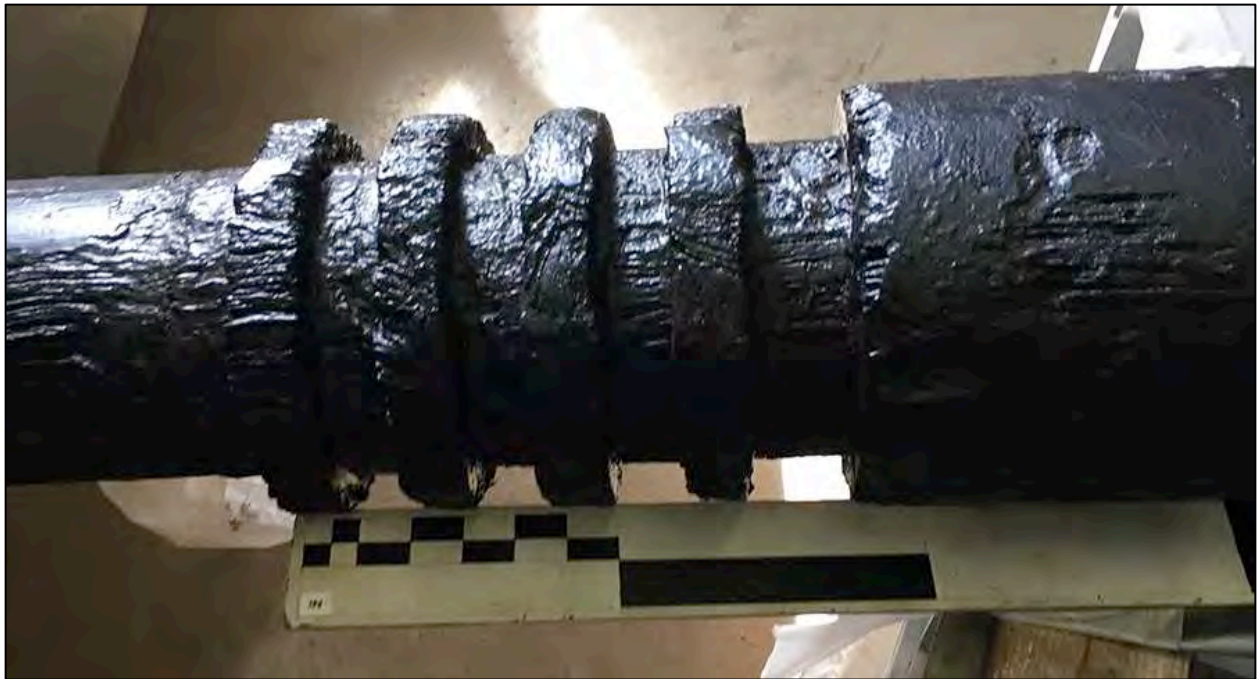
Figure 6-483. Four collars near the end of the propeller shaft that served a thrust bearing.

The propeller shaft was 6 inches in diameter except for two areas. Ten inches aft of the inboard end four collars 8 inches in diameter served a thrust bearing (Figure 6-483). Aft of the thrust collars a 17.5-inch long, 8-inch diameter section of the shaft that could represent a sleeve joining the 6-inch aft section to a short forward section turned down to produce the thrust collars. Nineteen inches aft of the collar is a compression collar for a stuffing gland fitted to the end of a 4-foot 2-inch through-hull fitting. The through-hull was cast with backing plates on the top and bottom to facilitate attachment to the inside of the hull. The plates were cast at a 45-degree angle indicating the angle of the wooden hull.

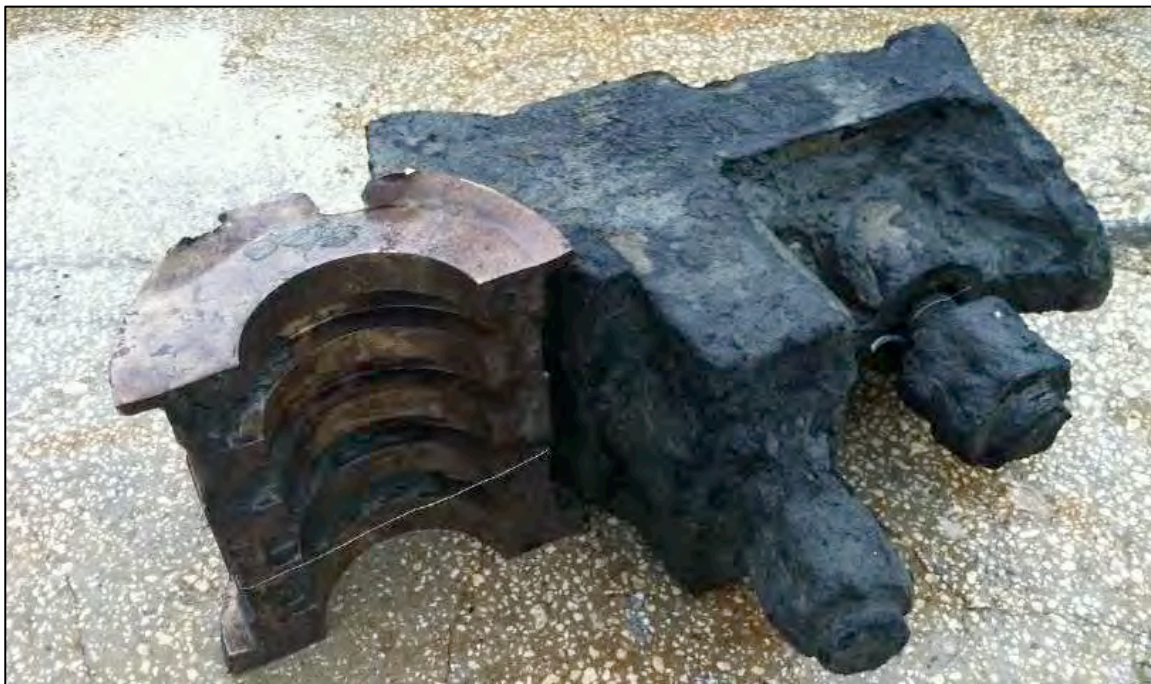
Figure 6-485. Recovered from G-125, Artifact 1909.05, a bearing pillow block recovered from Unit 6-E and half of a four-collared bronze thrust bearing recovered from the same grab that would have attached to the propeller shaft.

Elements were recovered of a pillow block with the thrust bearing was a base and cap matching the four collars on the propeller shaft (Figures 6-484 to 6-487). The cast iron base and cap were fitted for top and bottom sections of the bronze bearing that was held in place by collars fore and aft of the pillow block.

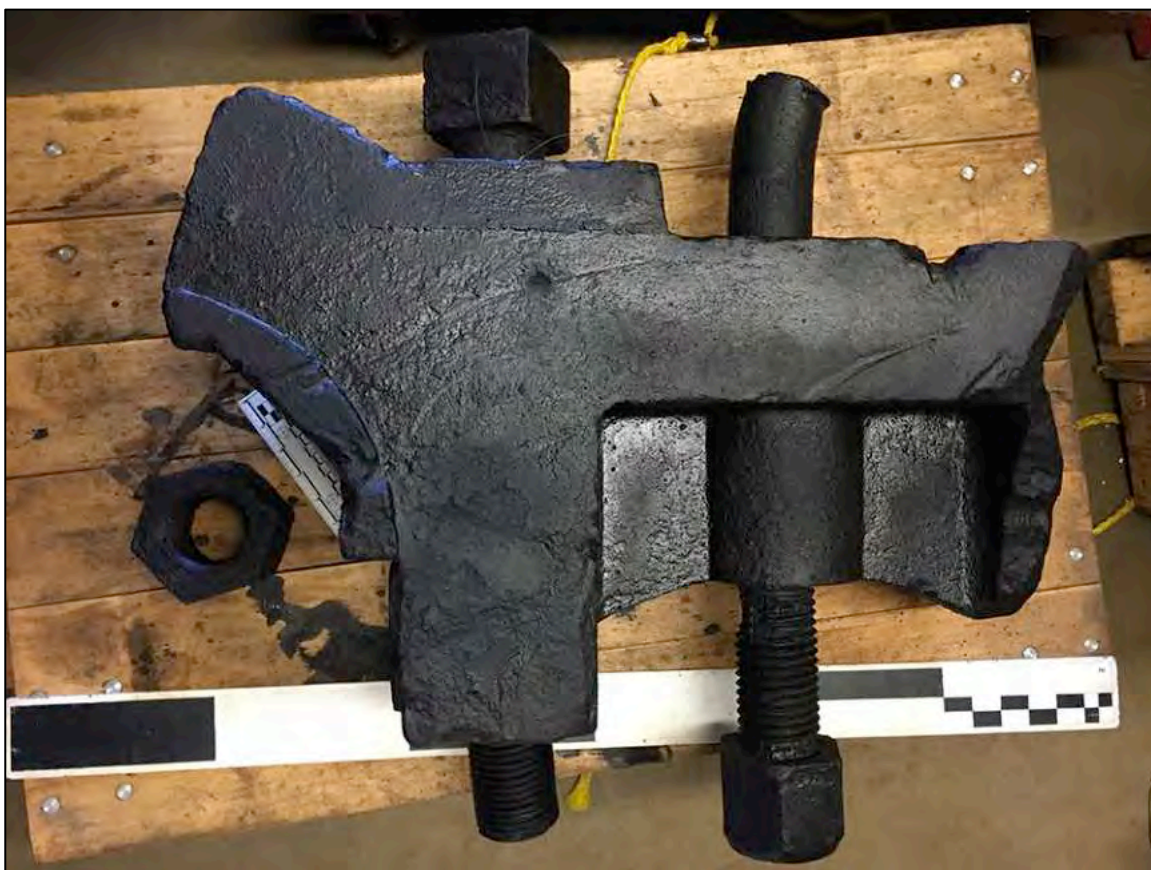
Figure 6-486. Conserved Artifact 1909.05, bearing pillow block recovered from Unit 6-E.

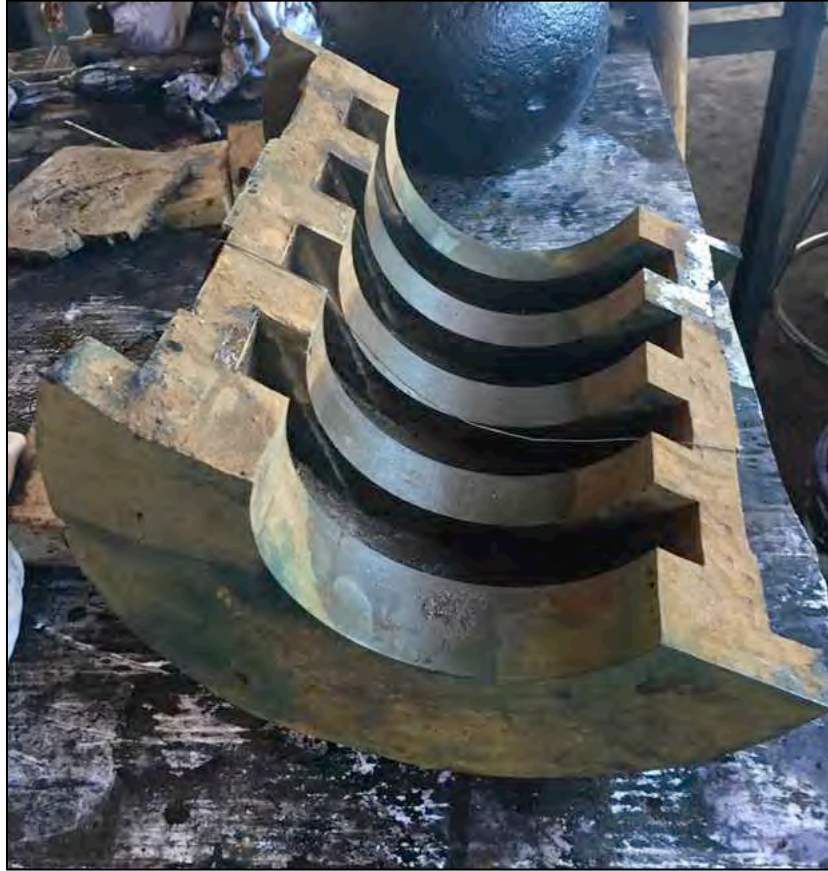
Figure 6-487. Internal view of half of four-collared bronze thrust bearing.
