CSS *GEORGIA*
ARCHEOLOGICAL DATA RECOVERY AND MITIGATION
FOR THE SAVANNAH HARBOR EXPANSION PROJECT (SHEP),
CHATHAM COUNTY, GEORGIA AND JASPER COUNTY, SOUTH CAROLINA

**FINAL DRAFT REPORT
OCTOBER 2019**

Stephen R. James, Jr. and Gordon P. Watts

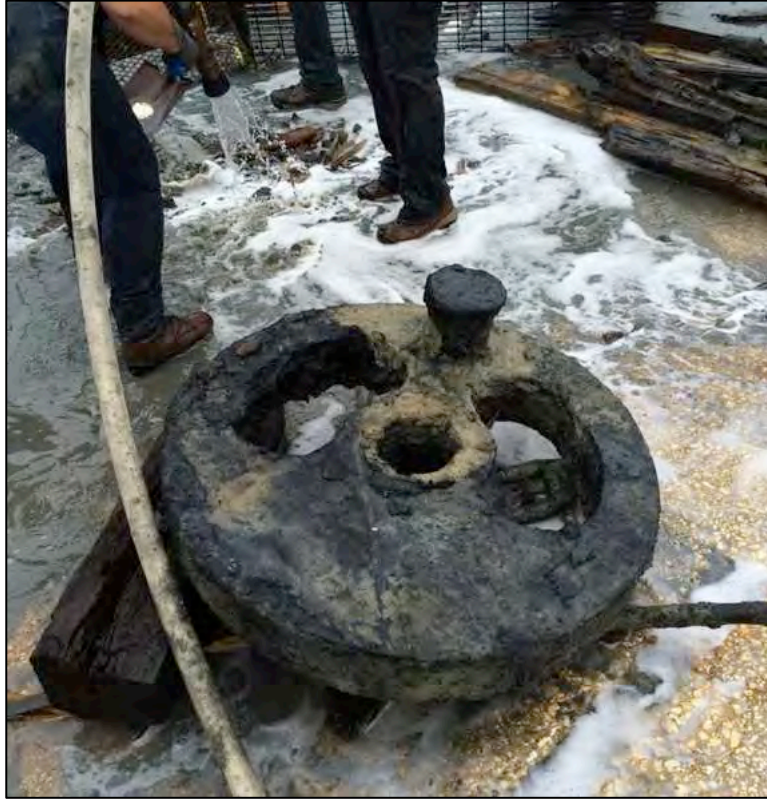
Figure 6-489. Shown at the time of Mechanized Recovery, counterbalance flywheel that was connected to the end one of the vessel's two propeller shafts, and turned by a crank connected to one of the two steam cylinders, which would then turn the propeller. The crank attachment is the projection at top. Artifact 1899.17 recovered from Unit 6-C.

A counterbalance flywheel was recovered from the site in 2015 (Figures 6-488 to 6-490). The flywheel measured 3 feet in diameter and 5 inches thick. The 6-inch wide hole through the center was reinforced in the back and machined for two keys that secured its orientation on the propeller shaft. A second hole 12 inches off center and opposite the counterbalance was fitted with a 5-inch diameter capped shaft for a connecting rod. The shaft was secured to a reinforced area on the back of the flywheel with a key. A series of fourteen 1.25-inch square holes in the back side of the flywheel provided the means of temporarily attaching a lever to rotate the wheel and move as associated piston off bottom and top dead center.

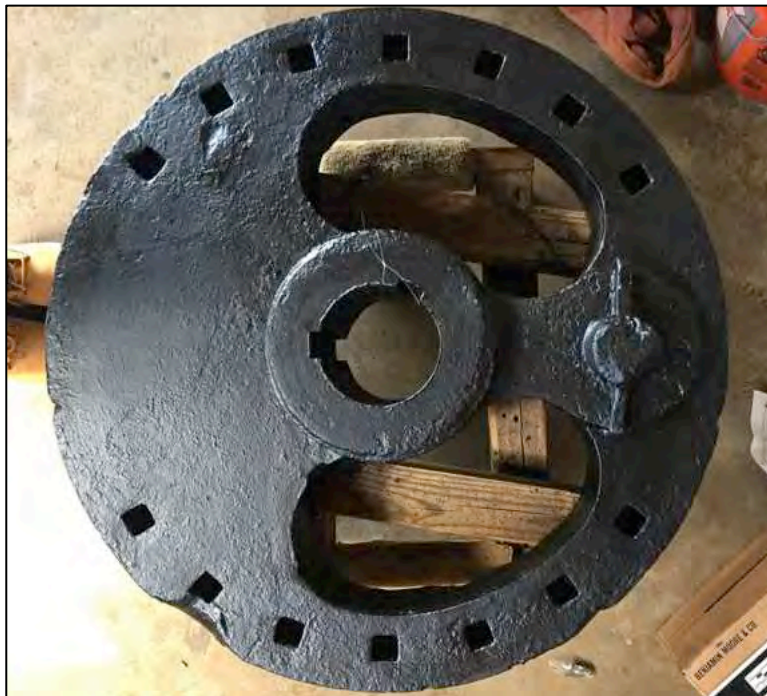
Figure 6-490. Conserved Artifact 1899.17, a counterbalance flywheel recovered from Unit 6-C. Three feet in diameter and 5 inches thick, this is the opposite side from Figure 6-490.

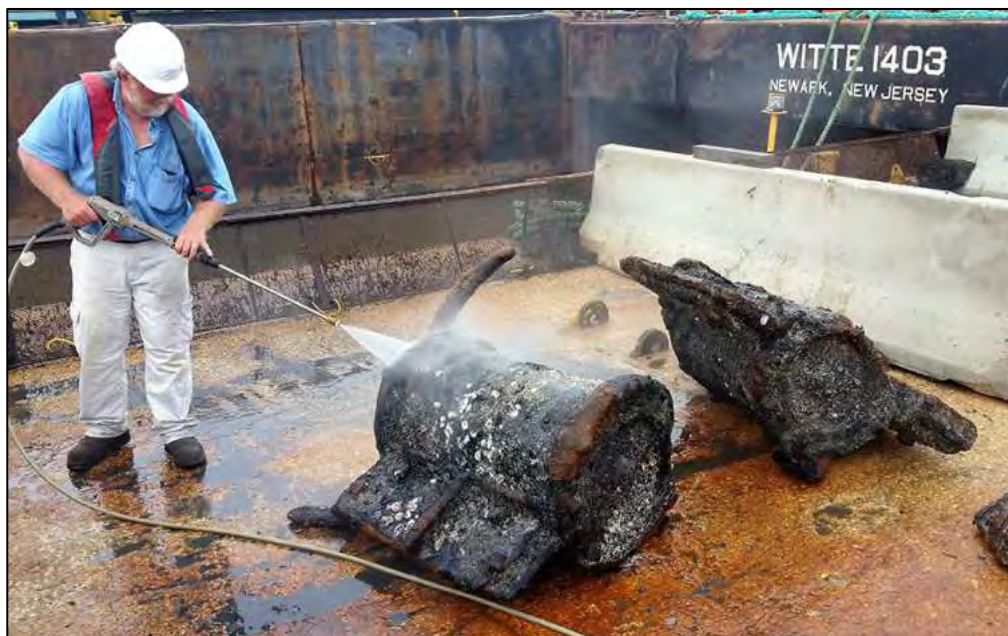
Figure 6-492. Artifacts 5055.01 and 5055.02, steam cylinders, immediately after recovery from Unit 11-CC.

Two steam cylinders were recovered from the site. One, more intact than the other, was used to record design and construction features (Figures 6-492 to 6-495). The steam cylinder measured 33 inches in length including the end plates. Measured at the cylinder head, the maximum diameter was 24 inches. However, the diameter of the cylinder in between the flared ends, excluding a reinforce in the center, was only 18 inches. With 1-inch thick cylinder walls, the bore would be 16 inches. The top of each end of the steam cylinder was cast with ports for steam and exhaust. Where the piston rod exited aft end of the cylinder the end cap was cast to accommodate a stuffing gland. For mounting the cylinder was cast with longitudinal plates. Each of the cast plates was fitted with a base plate that could be fitted into heavy timbers that served as a bed for the machinery. It should be noted that the two steam cylinders located and mapped during the 2003 investigation could not be relocated in 2015, even after extensive searching. Triangulation techniques using the 2003 data were employed as were extensive diver sweeps in the previously mapped locations. Despite these efforts, they were not found in 2015, but would be recovered during the 2017 during Mechanized Clearance in the channel some 90 feet from their original 2003 mapped location, and amazingly together in the same grapple (Figure 6-496).

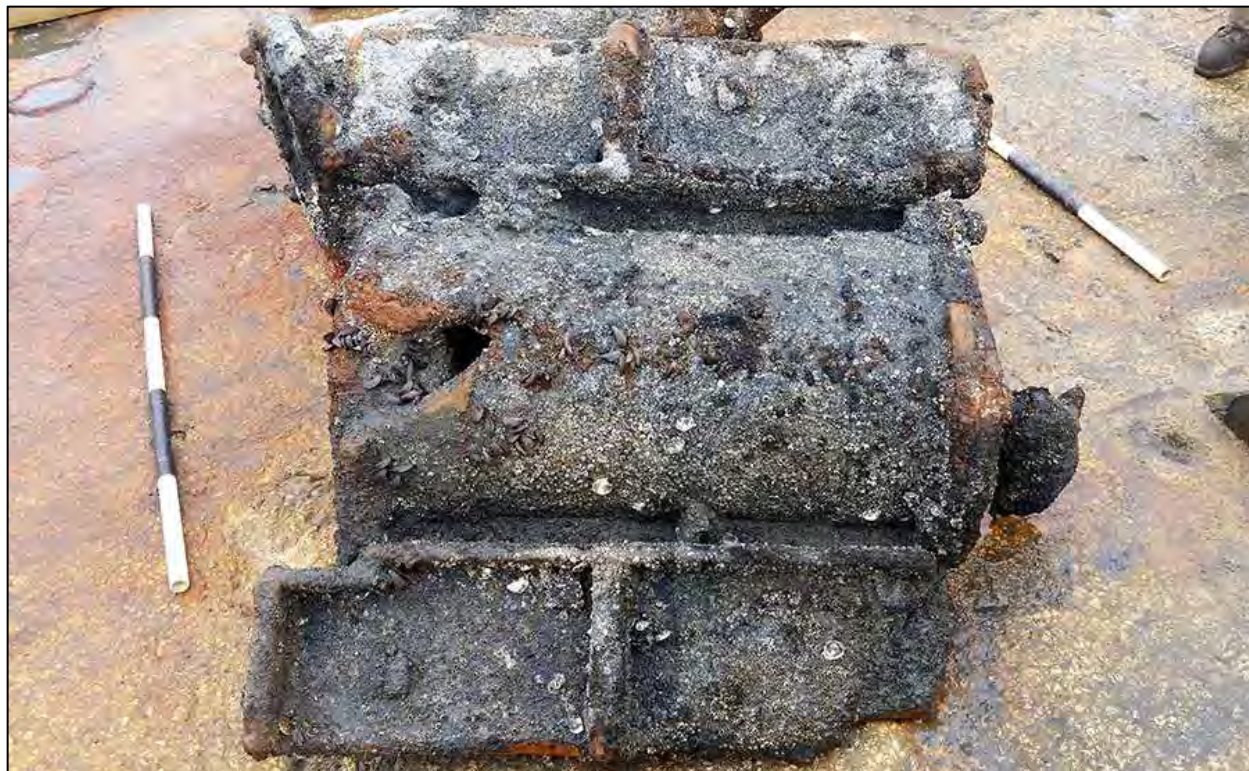
Figure 6-493. View of one steam cylinder.

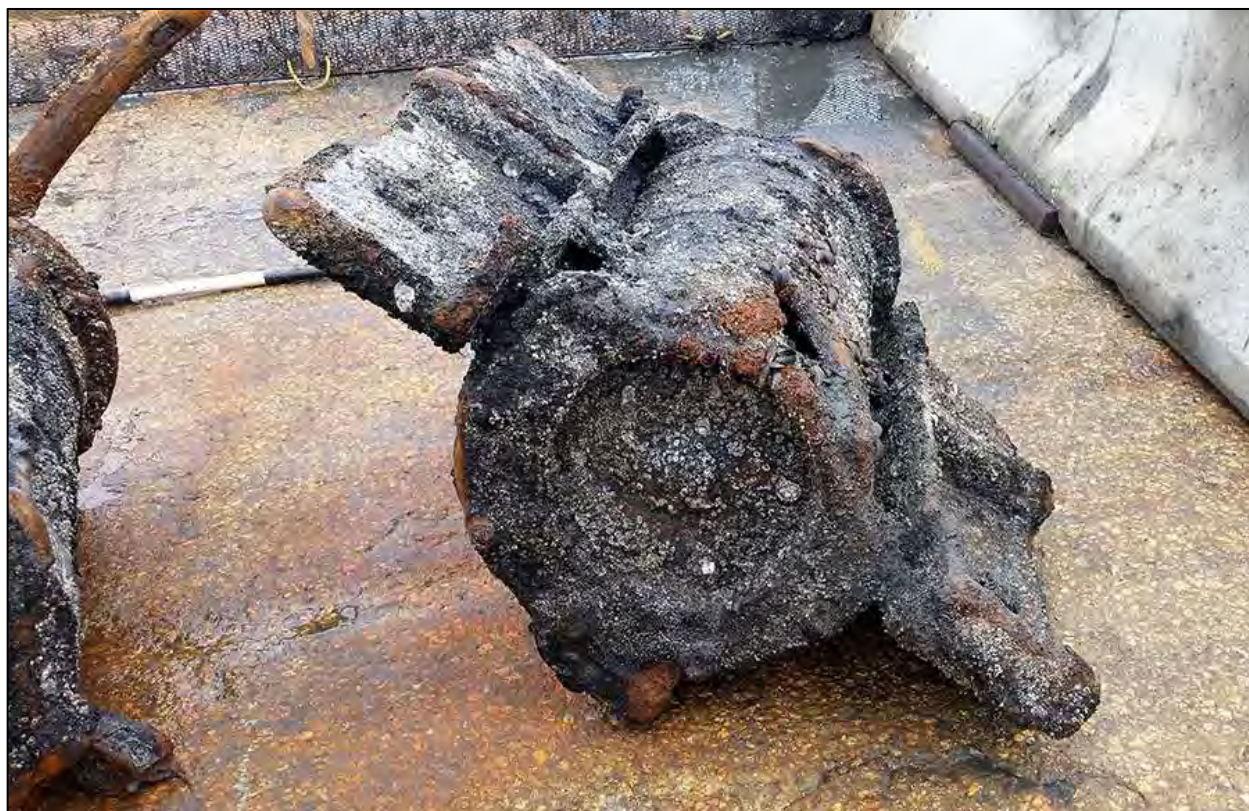
Figure 6-494. View of one steam cylinder end.

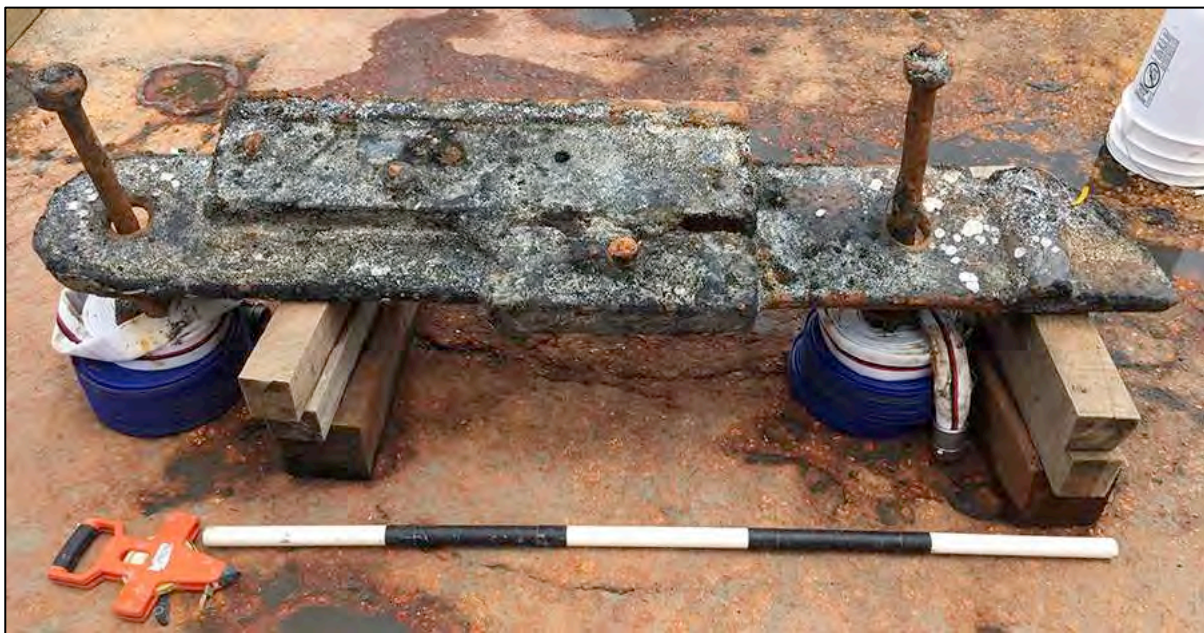
Figure 6-498. View of Artifact 5052.04, a side plate, immediately after recovery in 2017; recovered from Unit 12-BB adjacent to the two cylinders.

One of the heavy cast iron side plates, 6 feet 3 inches long, 12 inches in width, and 2 inches thick, was recovered intact (Figures 6-497 to 6-499). The only one recovered of the four that would have been originally present, the ends of the side plate were drilled and chamfered for special bolts with ball heads that could be tightened to maintain positioning and tension. A 3-foot long, 9.75-inch wide, and 2-inch thick plate was attached to the outboard face of the side plate. That plate lapped 3 inches above the side plate to facilitate mounting the 3-inch wide, 3-foot long crosshead guide. The back side of the side plate was cast with reinforcing that served to stabilize mounting on the engine bed timbers and butting against the longitudinal mounting plates on the steam cylinder.

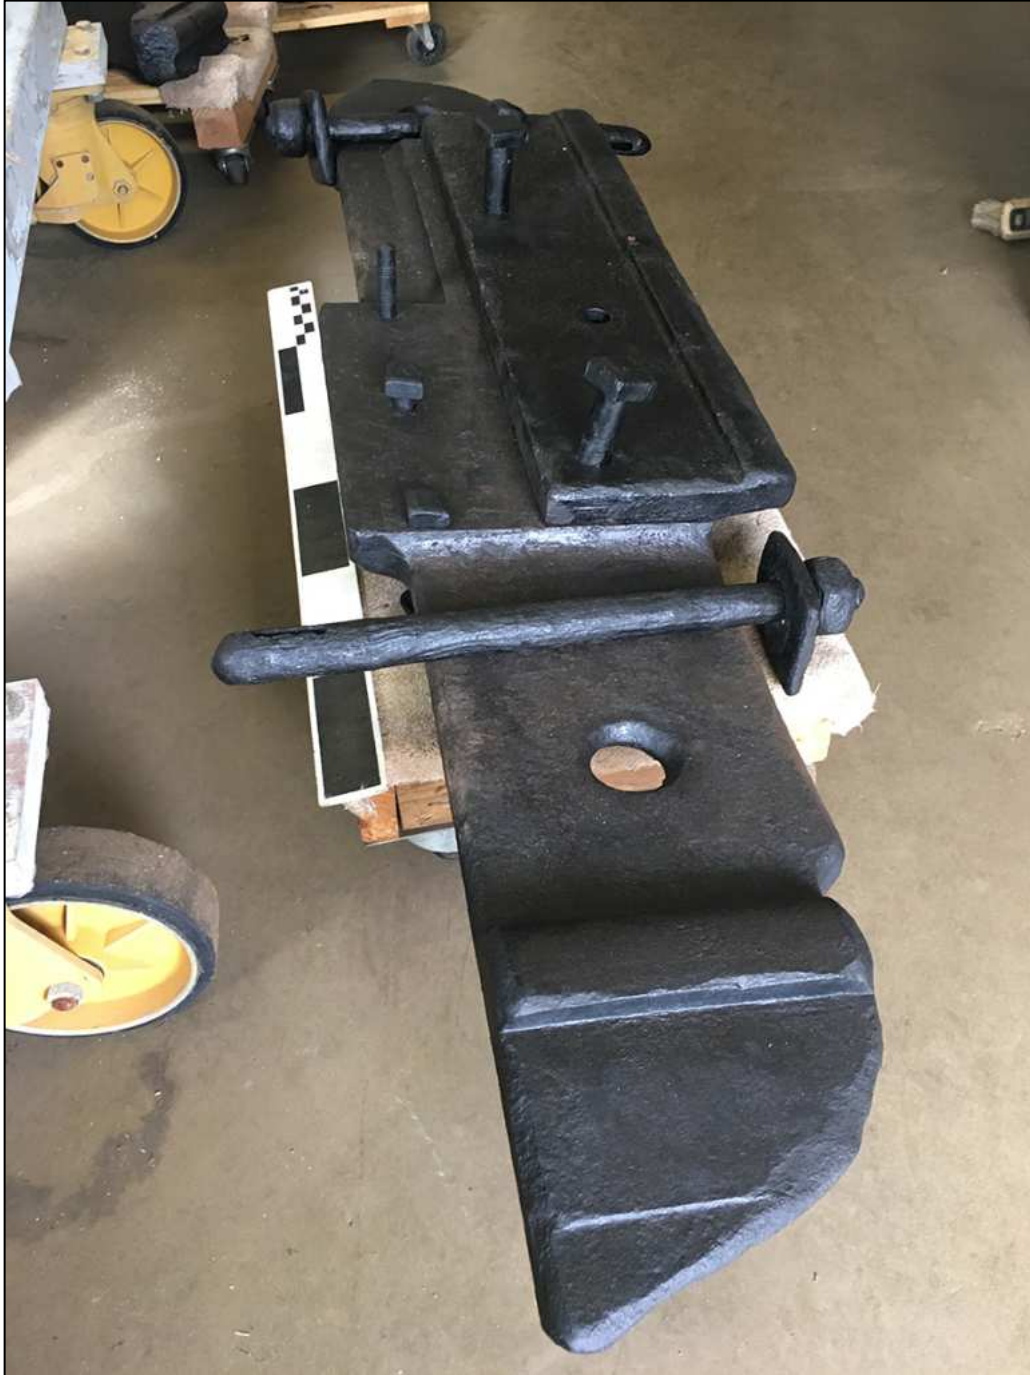
Figure 6-499. View of Artifact 5052.04, a slide plate after conservation; recovered from Unit 12-BB immediately adjacent to the cylinders.

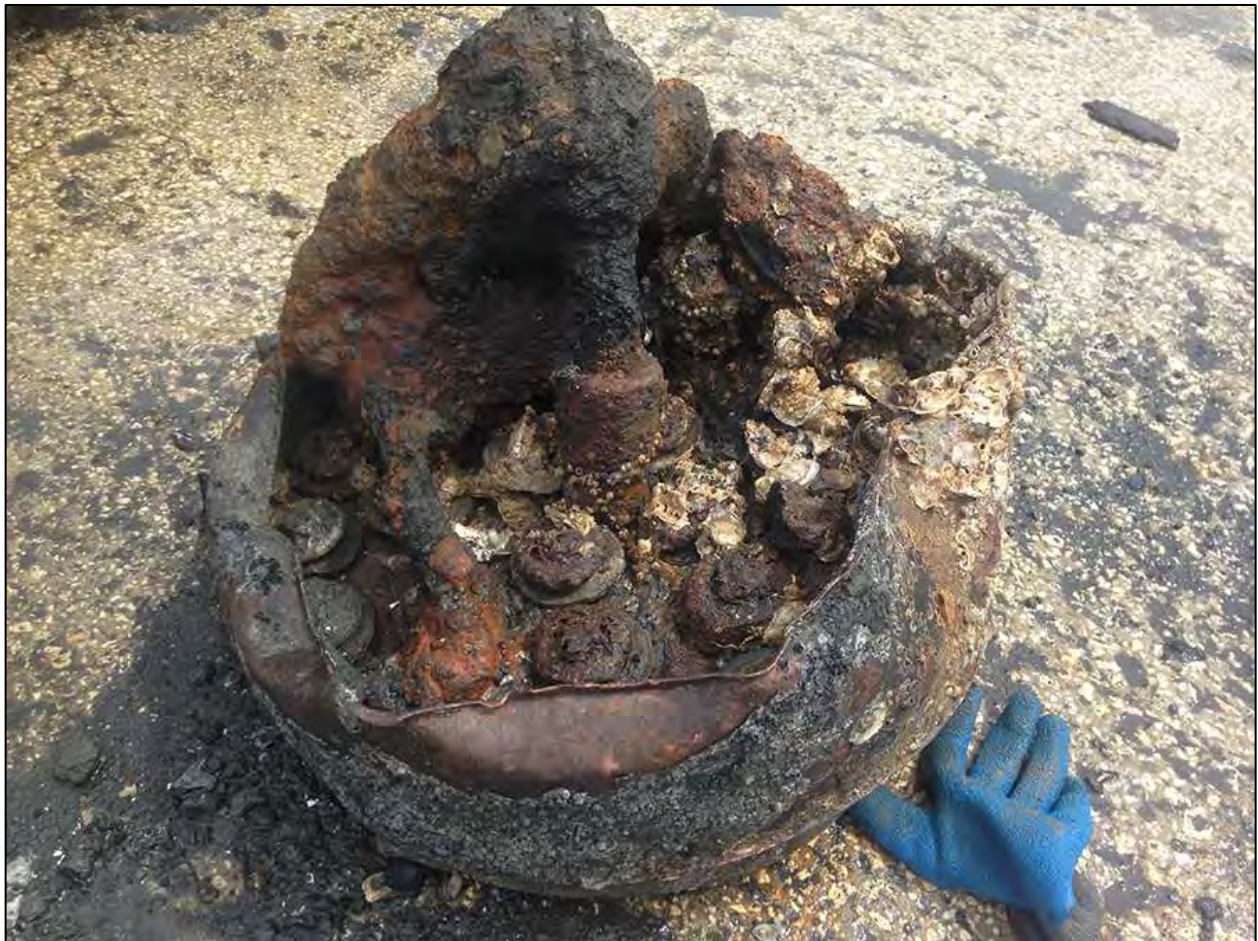
Figure 6-503. Artifact 1861.13, Worthington steam pump component recovered from Unit 5-F. Note the valves and their black circular rubber gaskets, all surrounded by a copper housing.

In addition to the primary elements of steam machinery described here, material recovered from the salvaged site included the remains of a Worthington direct-acting steam pump (Artifact 1861.13; recovered from Unit 5-F). Before cleaning and conservation, the rubber valves in the pump chamber provided a diagnostic clue that led to identification. An illustration of the patented Worthington steam pump was identified in an 1852 issue of the *Proceedings from the Institute of Mechanical Engineering* (Figures 6-501 and 6-502). The remaining pump component consisted of a bronze valve plate containing 33 valves encased in a copper housing, and whose base is a domed cast iron cover (Figures 6-503 to 6-508). Aboard the CSS *Georgia* the Worthington was likely used to pump exhaust steam from one or both of the primary cylinders to a condenser. Another unprocessed example of material from the site illustrates a yet to be identified element of machinery within the Worthington. Until the inspection plate in the end is removed and the interior inspected, it is impossible to determine if the object is a steam drum, a mud drum, or possibly a condenser (Figure 6-509).

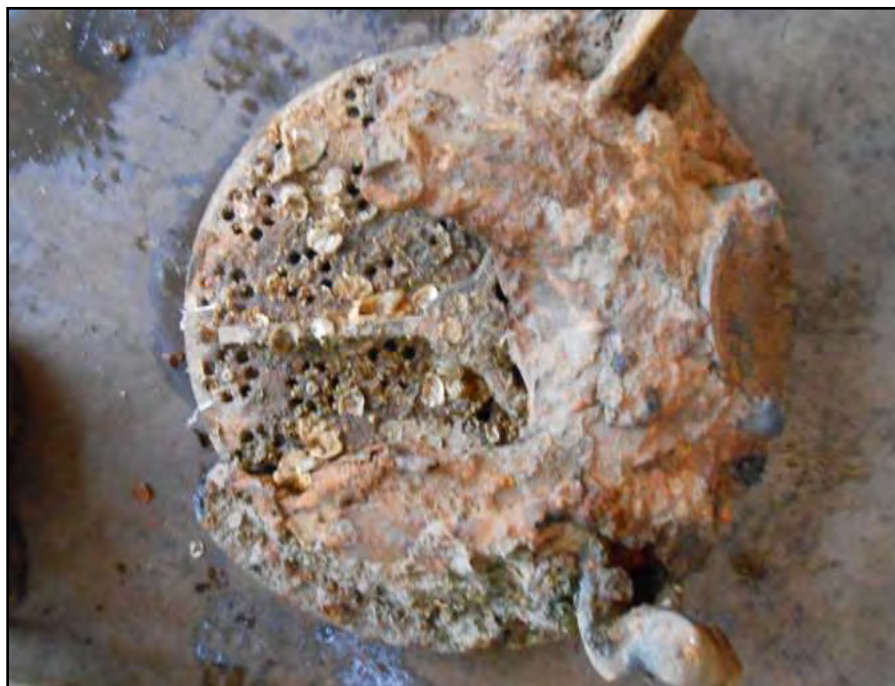
Figure 6-504. Opposite side of the Worthington direct-acting steam pump, Artifact 1861.13. The bronze plate with its valve holes can be seen underneath the concreted iron in Figure 6-505.

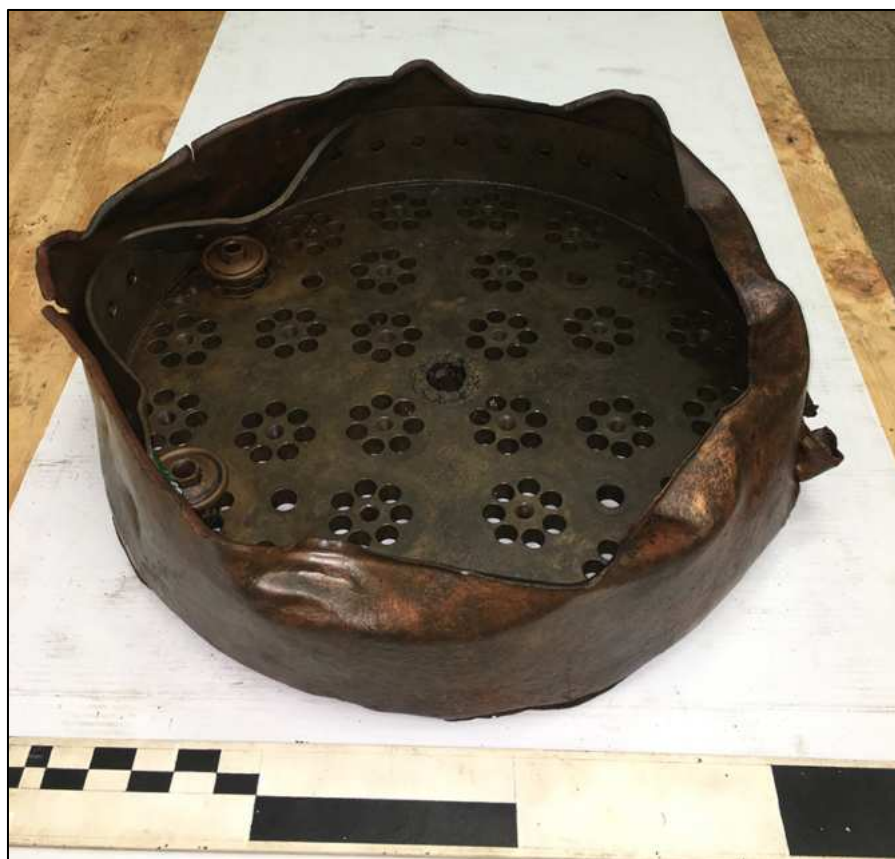
Figure 6-505. Artifact 1861.13 after conservation. Shown are the Worthington direct-acting steam pump copper housing with bronze valve plate. Two valves have been reinserted.

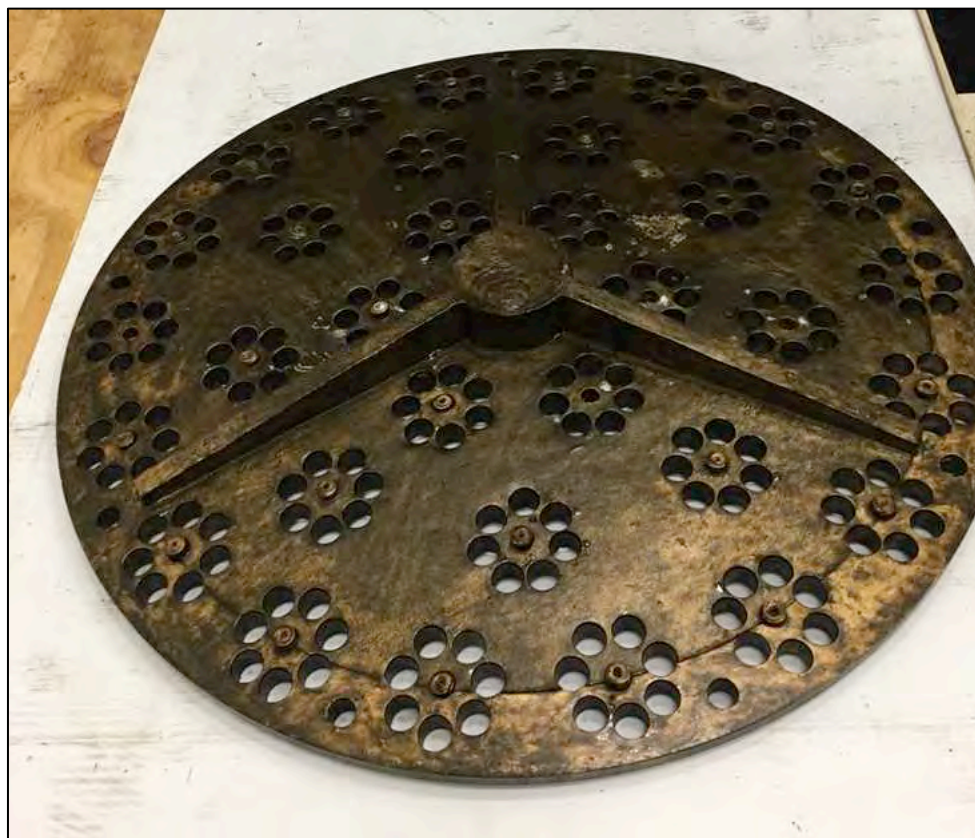
Figure 6-506. Artifact 1861.13, a Worthington direct-acting steam pump plate, bronze valve plate after conservation, base view. The iron covering would have attached to this side.

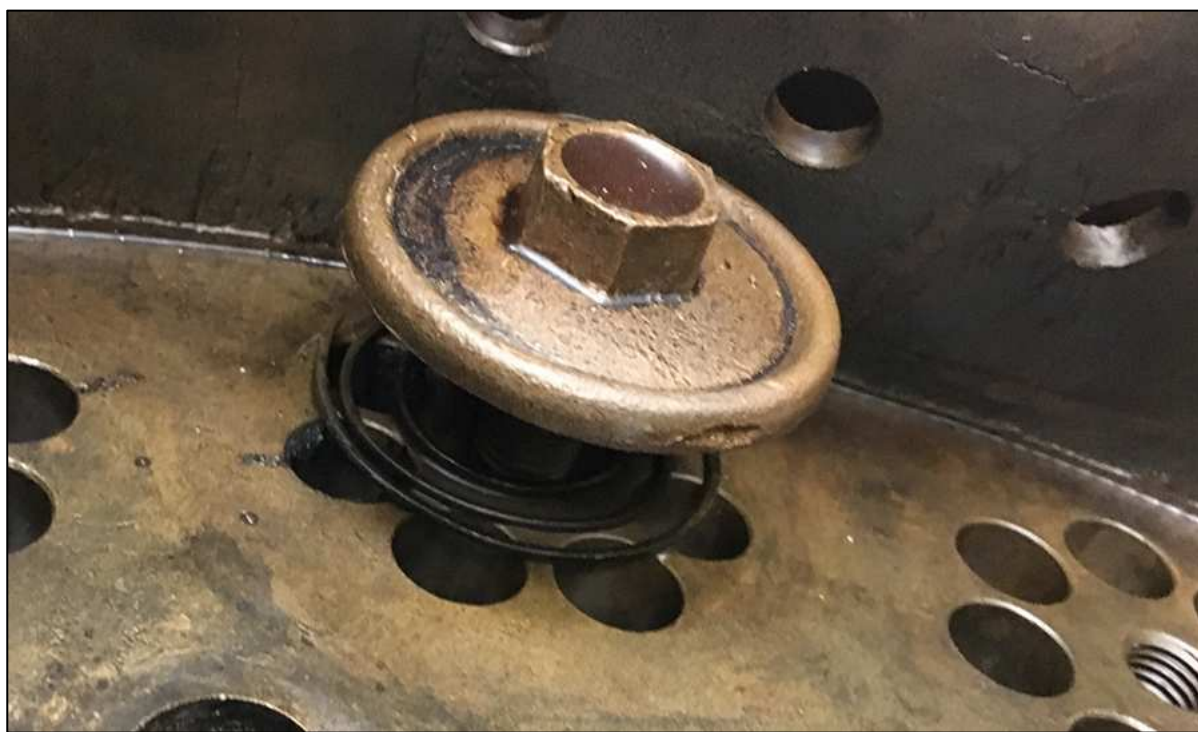
Figure 6-507. Close up of one of the bronze, spring-loaded valves of Artifact 1861.13 put in place after conservation as a demonstration; rubber gasket has been removed.

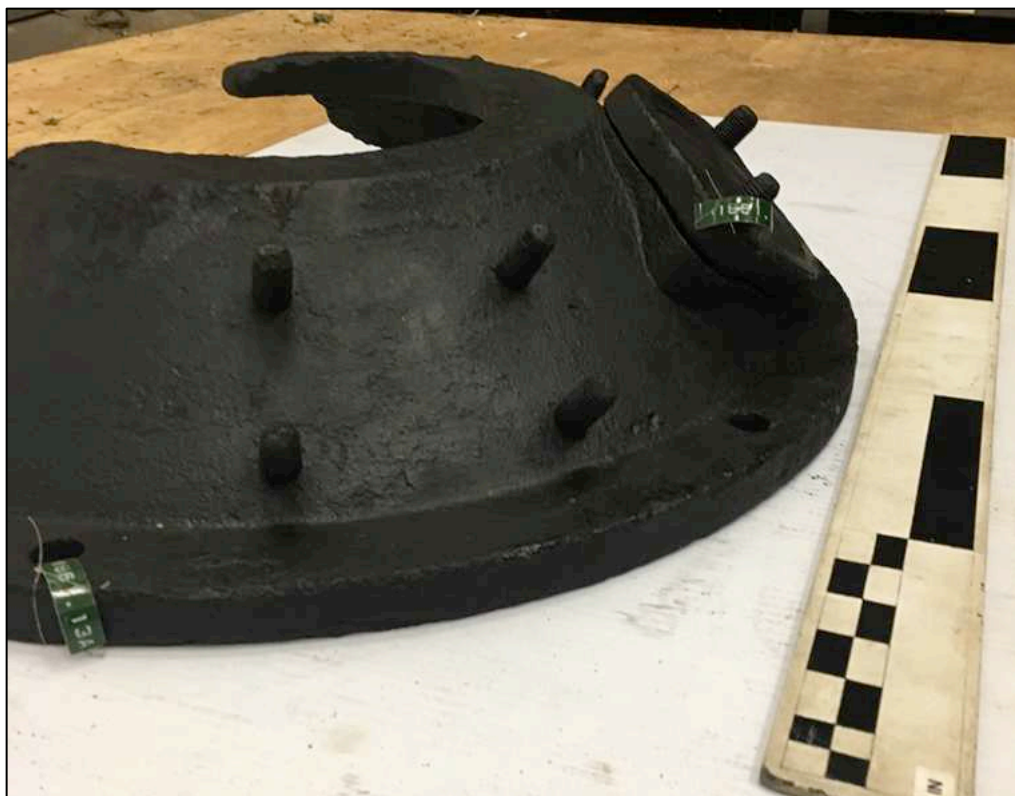
Figure 6-508. Artifact 1861.13, Worthington direct-acting steam pump cast iron cover. This attached to the base of the bronze valve plate above and is thought to represent the bottom of the pump.

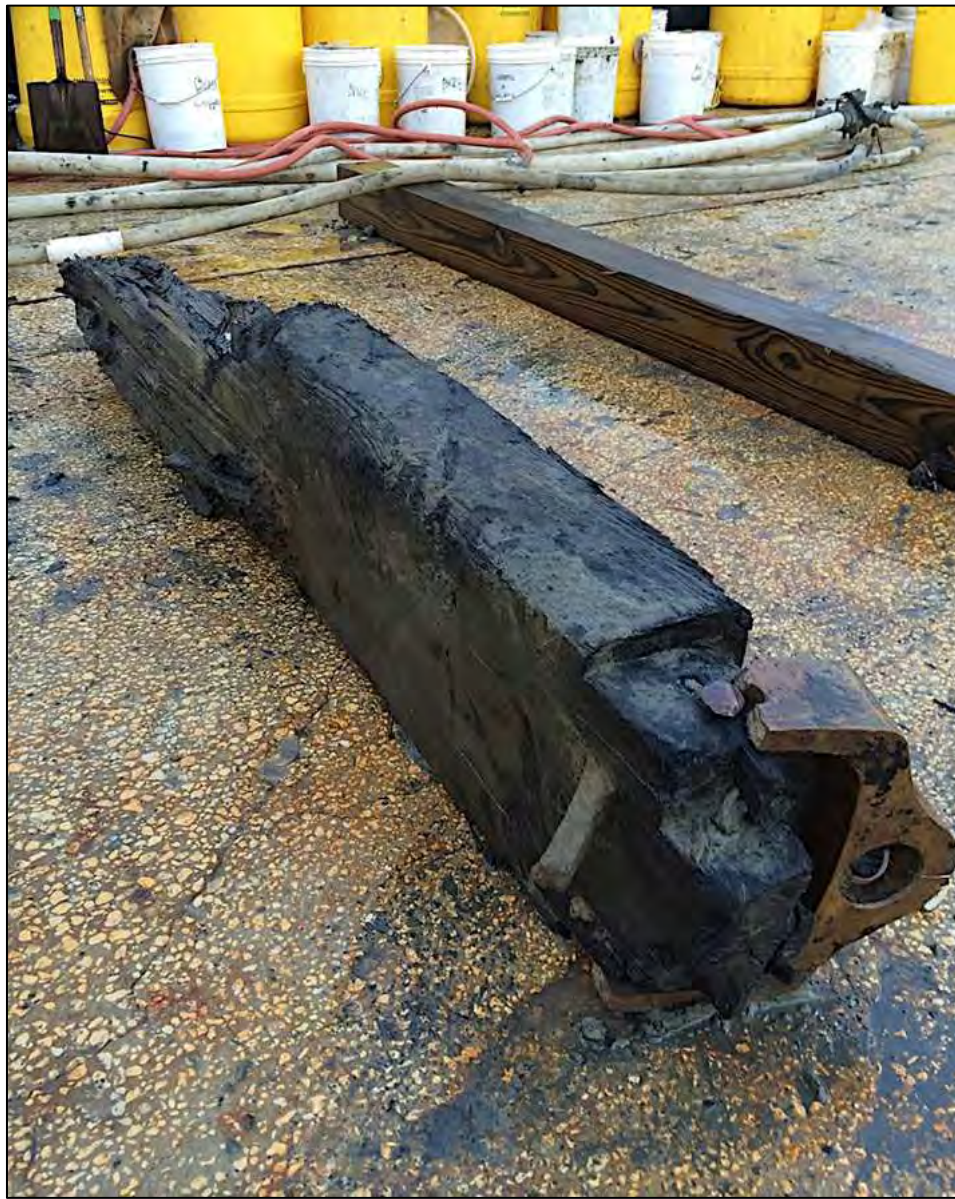
Figure 6-510. Artifact 1905.3, a rudderpost with a bronze gudgeon recovered from Unit 6-E. Note the gudgeon straps have been broken at the bronze drift that fastened it in place.

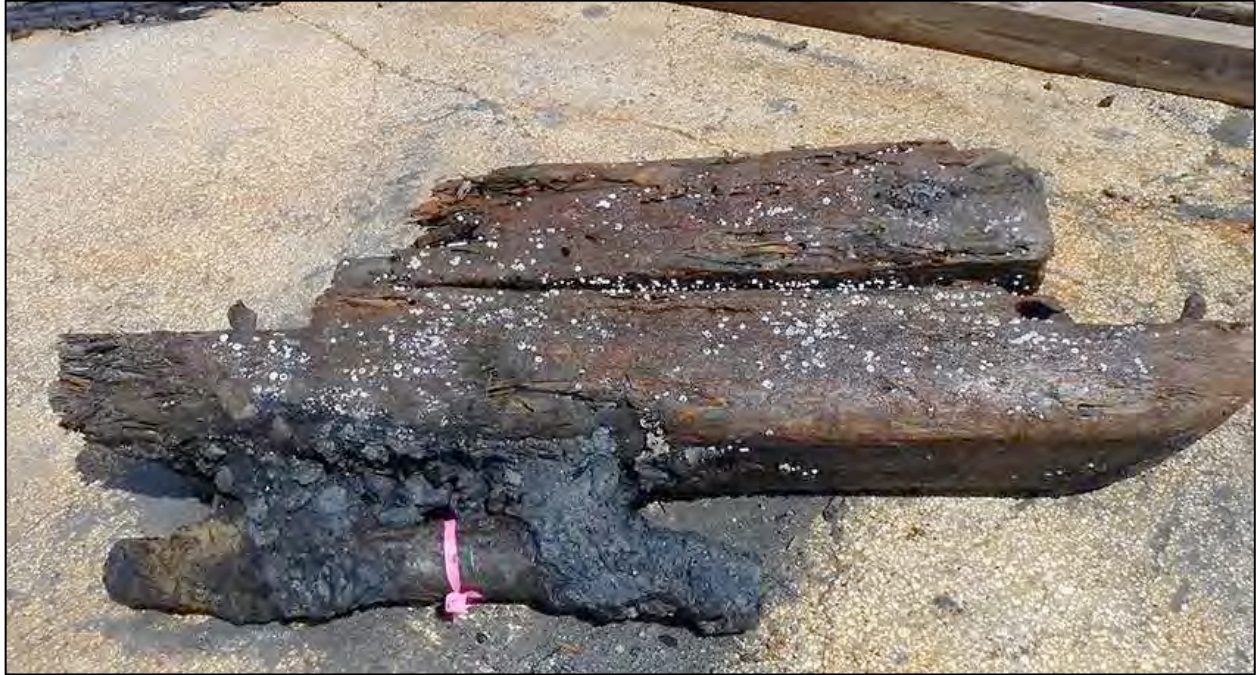
Figure 6-511. Artifact 1953.3, a small section of the side of the deck (or bulwark) with a large iron cleat recovered from Unit 8-F.

Illustrated in Figure 6-511, the only other piece recovered that was identifiable as a hull fragment was Artifact 1953.3, a small section of the side of the deck (or bulwark), identifiable as such because it retained a large iron cleat. The cleat is 3 feet in length and fastened by drift bolts through and atop two 9-inch high 11-inch wide oak timbers. A 3-D model created by CRL of the artifact is presented in Figure 6-512.¹

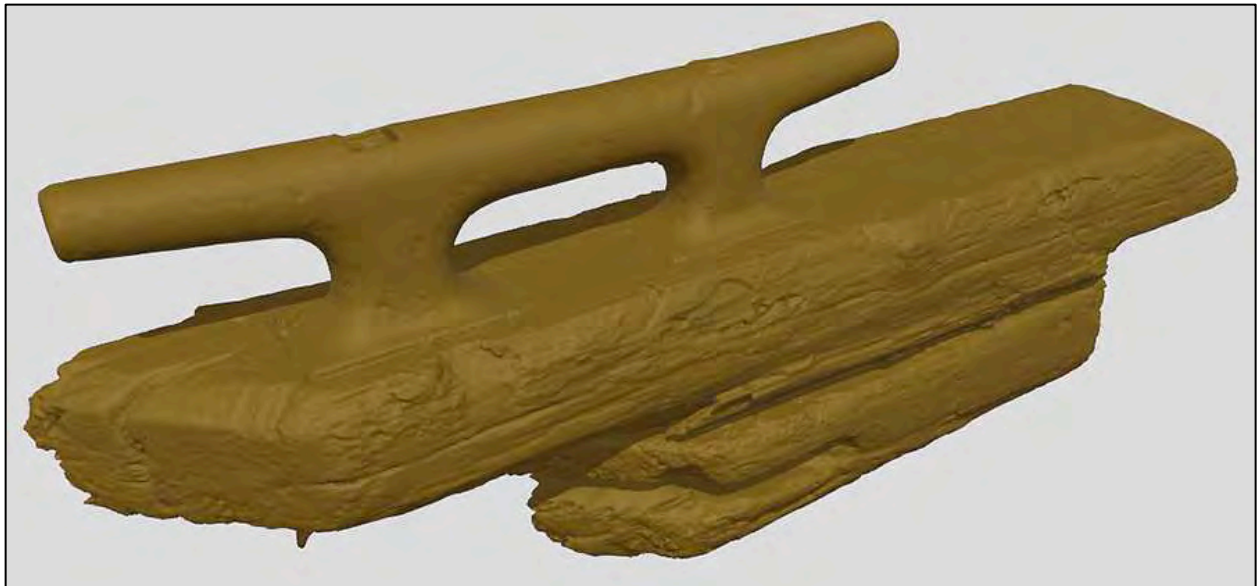
Figure 6-512. 3-D image of Artifact 1953.3, a small section of the side of the deck (or bulwark) with a large iron cleat recovered from Unit 8-F (courtesy CRL Texas A&M University).

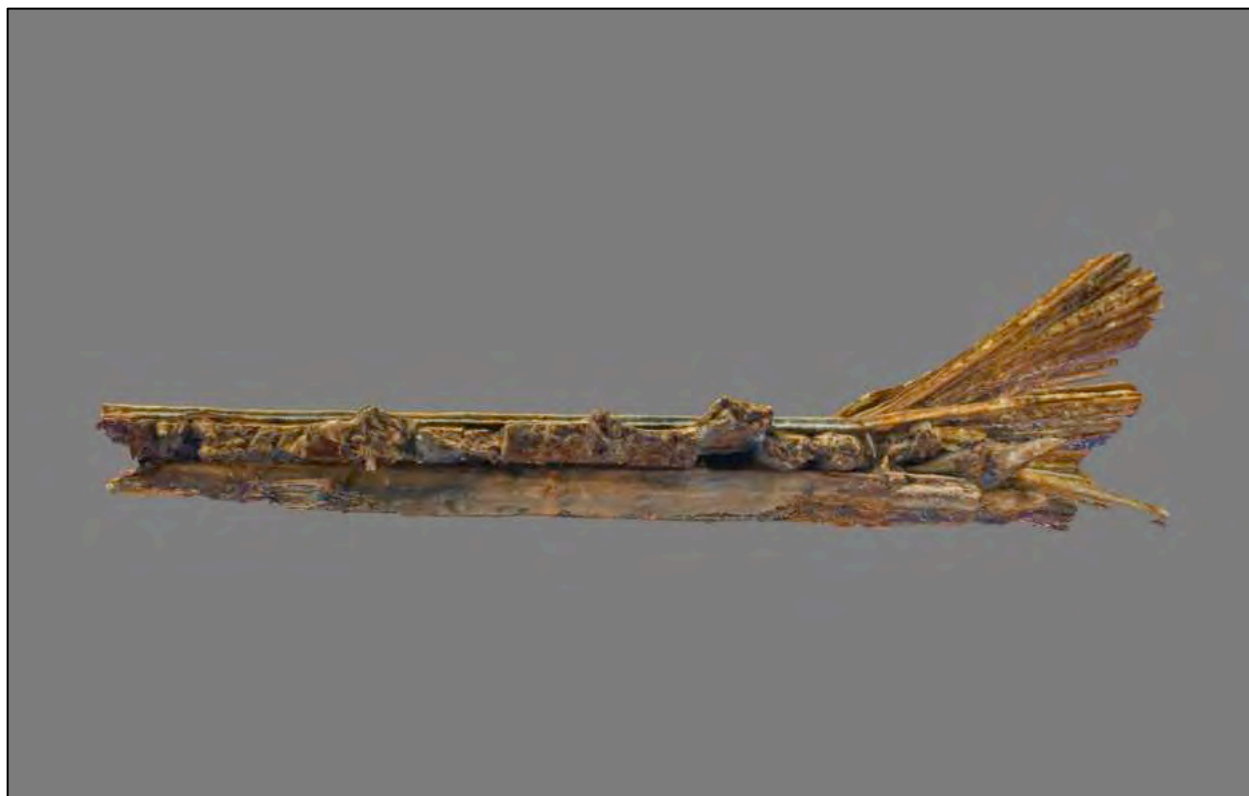
Figure 6-514. Orthomosaic of East Casemate end view, casemate base at left, top at right. Rail is on top of and fastened to 8-inch thick horizontal oak that was attached to 12-inch thick vertical pine timbers (at bottom). The large pine timbers formed the interior wall of the ironclad.

Each section of the recovered casemate was constructed of 24-foot lengths of 3.5-inch high railroad iron rail attached to 8 inches of horizontal oak that was attached to 12 inches of vertical pine timbers (Figures 6-513 and 6-514). The 12-inch pine timbers of the casemate frame were fastened to one another using horizontal drift pins and spikes in a staggered arrangement similar to that employed in the hull of the CSS *Neuse* and CSS *Jackson*. The horizontal courses of 8-inch thick oak were attached to the lower 12-inch thick pine timbers by bolts and treenails. The 16-inch total wood thickness corresponds to historical accounts that her woodwork was about 15 inches of solid timber.

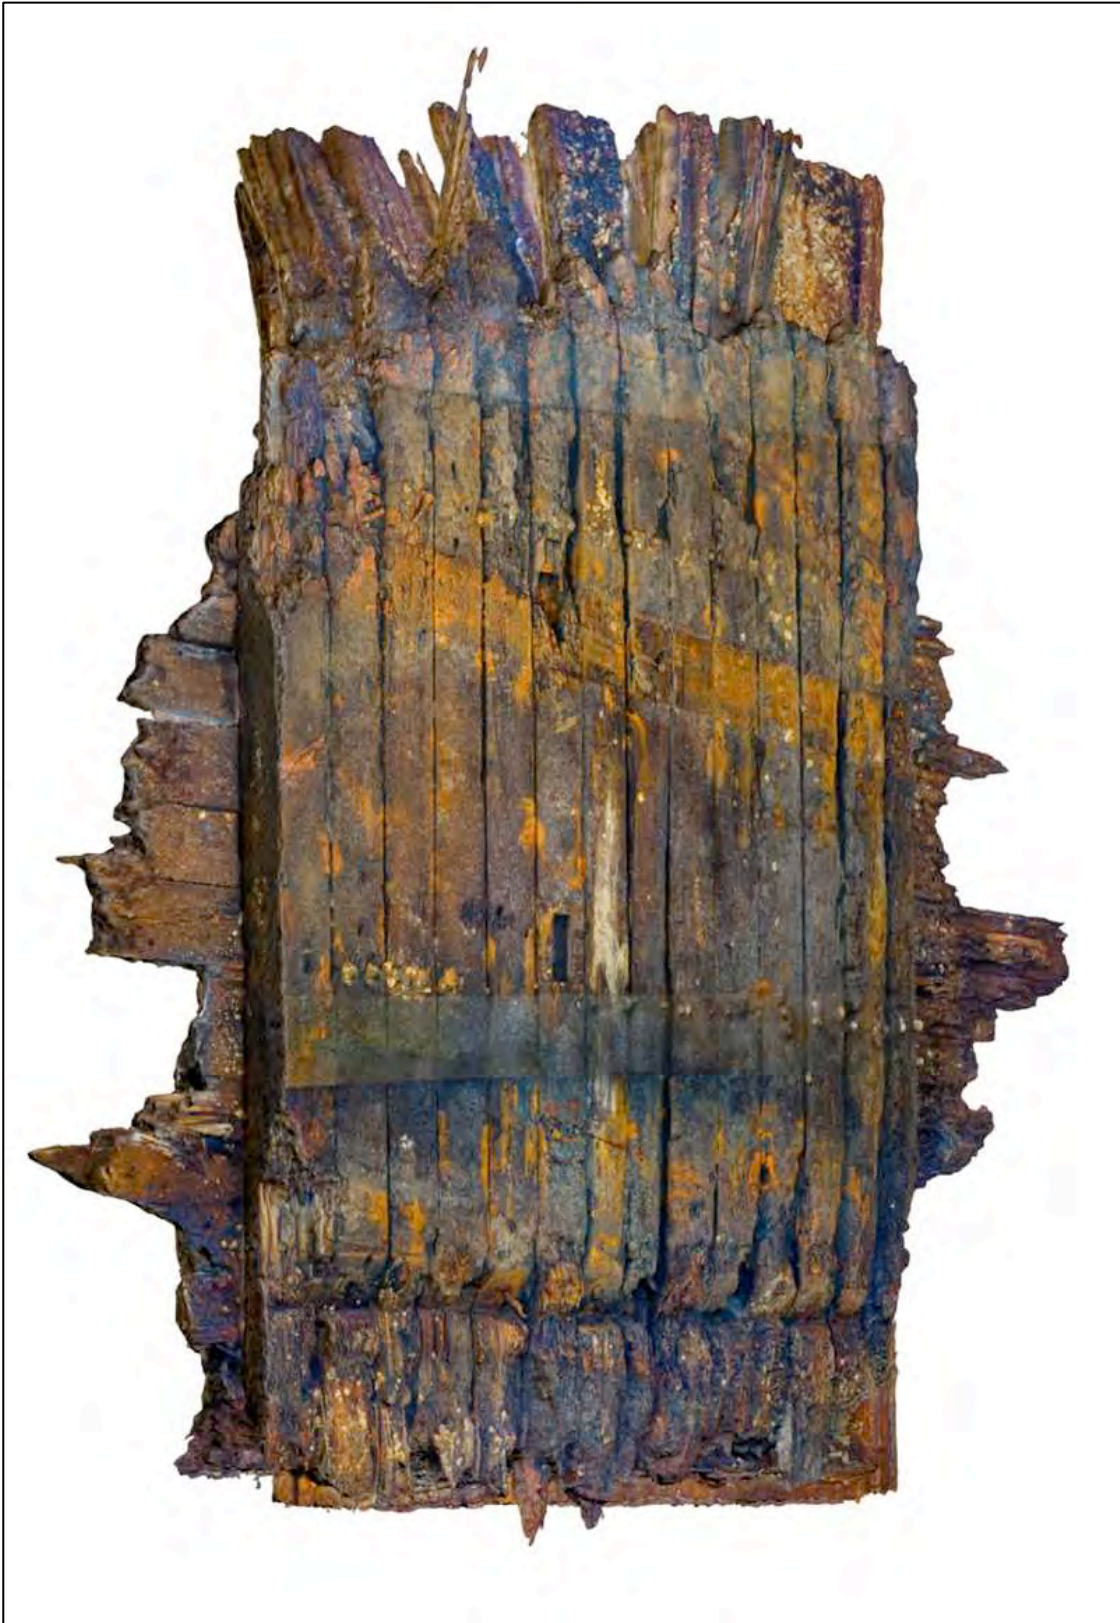
Figure 6-516. Orthomosaic of underside of the East Casemate. Base of the casemate is at bottom. Note the line of deck rebates cut into the vertical pine timbers just above the base. Also note the two vertical mortices cut into the face of one of the timbers near the center, their purpose unknown.

Reconstruction of the casemate was based on 24-foot widths angled at 45 degrees with 2 feet extending below a rebate on the inside of the pine timbers that appears to represent the deck beam joint (Figure 6-515). This rebate was recorded on the internal side of the East Casemate running the entire length near the base of the casemate. It can be seen clearly in Figure 6-516, an orthomosaic taken of the underside of the casemate while it was on its iron lift frame.

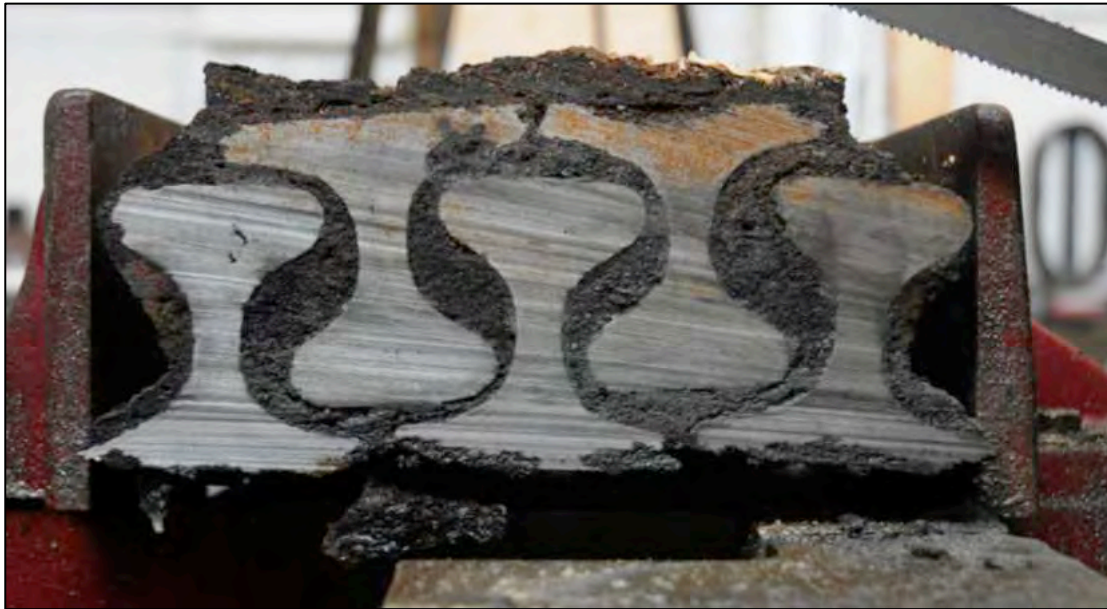
Figure 6-519. Cross section of cut rails for integrity testing showing how the rails were interlocked in two layers, forming a solid flat surface on both sides. Material between rails may be iron fillings as noted above. All rails are shaped alike.

The casemate was armored with 24-foot lengths of railroad iron except at each of its angled ends. It was comprised of two layers of interlocking rails with the first layer of rail fastened upright to the wood backing, and the second layer placed upside down and interlocked between the first layer. With the method illustrated in Figures 6-519 and 6-520, the best description of her armor is given in a June 1862 letter in which states, "...her woodwork is composed of about 15 inches

of solid timber, upon which is a double layer of railroad iron fitting into each other, and then a composition of iron filings and some kind of cement...laid upon the irons so as to cover the inequalities to make it solid and keep it from shaking” (Swanson and Holcombe 2003:74). Analysis of the casemates indicates at least seven different rail profile shapes, including a half rail (Figure 6-521). The half rail was a functional shape, while the other six possibly represent issues associated with different foundries.

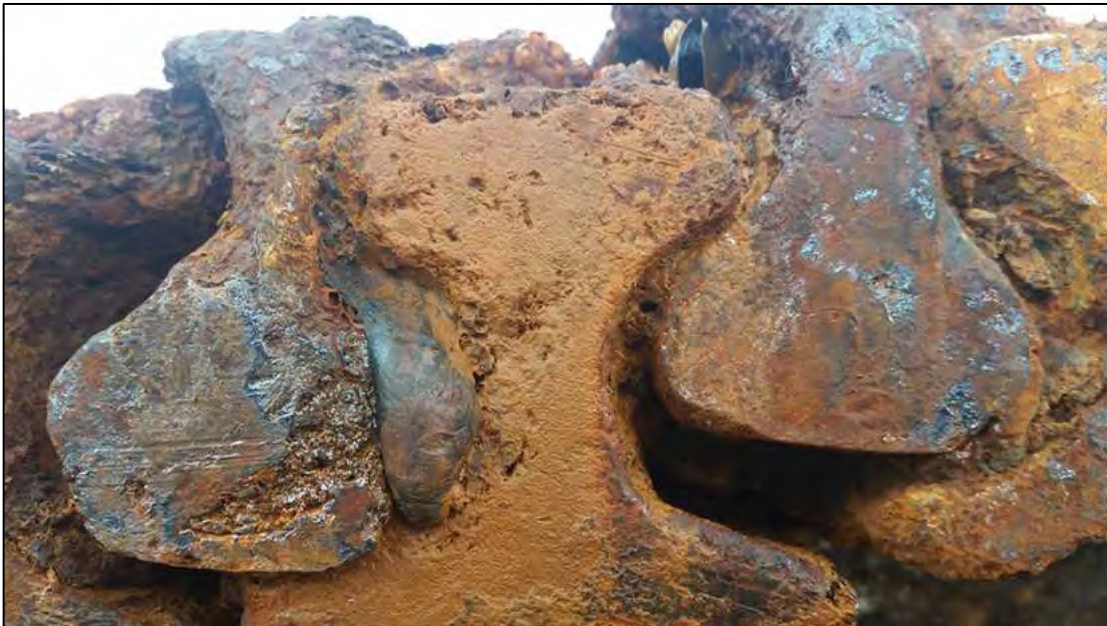
Figure 6-520. Close up of rails showing four different rail shapes. Also note the black pitch which has oozed out due to heat and possible filler to the right, both may represent “...a composition of iron filings and some kind of cement...laid upon the irons so as to cover the inequalities and to make it solid and keep it from shaking” (Swanson and Holcombe 2003:74).

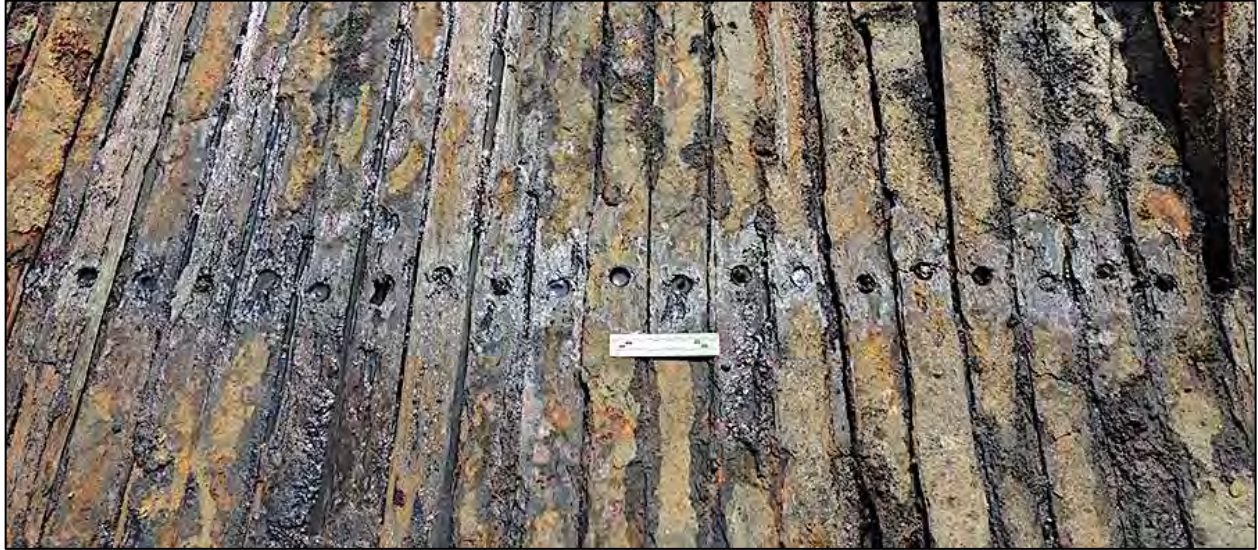
Figure 6-524. Bolts were used to secure the inverted rails to the 8-inch oak and 12-inch pine timbers, the bolts placed through a hole drilled through the center of the inverted rail.

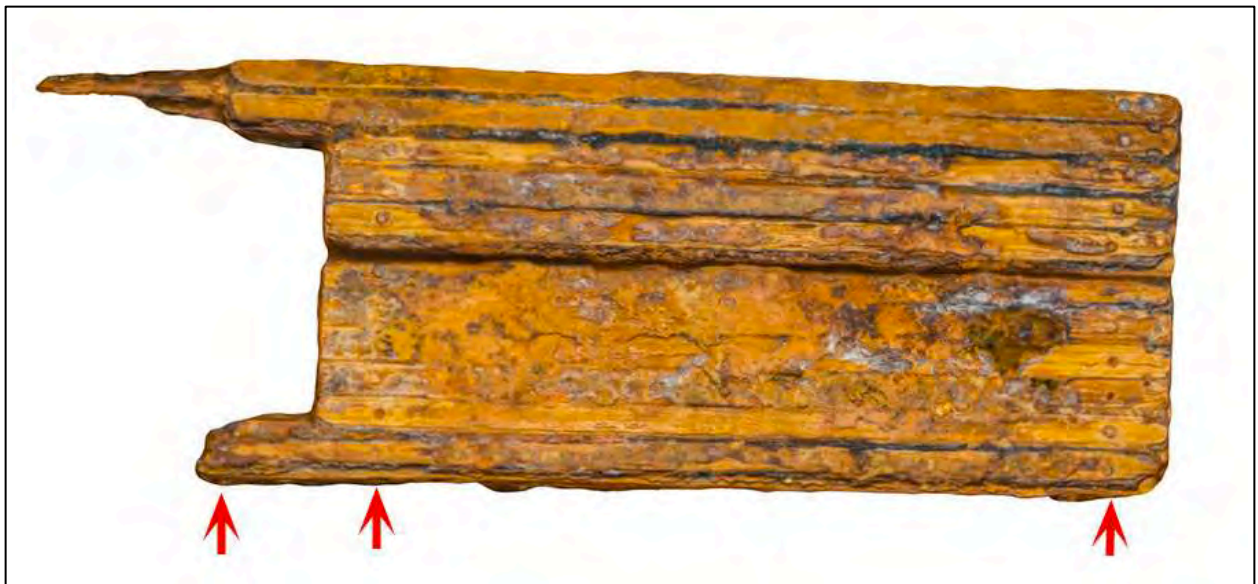
Figure 6-525. Orthomosaic of gunport (Lift WC-7) from West Casemate. At left is the 27-inch wide as-built cut-out for the cast iron gunport. The base of the casemate is at far right. It will be found to be the only gunport on the entire length of the West Casemate. Center arrow marks line of fasteners just to the right of the gunport that is found only below the gunport. The two other arrows point to line of fasteners that go completely across the casemate.

Based on evidence found on the single intact gunport cutout in the casemate, bolts were placed roughly 6 inches above and below the cut rails forming the gunport (Figure 6-525). The actual gunports were formed with cast iron 4 inches thick, 6 feet 1 inch long, and 2 feet 5 inches wide with their outer upper and lower faces beveled with a circular angle on the exterior side (Figure 6-526). The cast gunport sides were formed as half rails to accommodate overlapping and interlocking attachments with adjacent rails on the casemate (Figures 6- 527). The gunport has holes drilled in each of their corners, most likely to fasten to casemate wood backing (Figure 6-528). A schematic of the fastening pattern for railroad rail bolts on the casemate, as well as adjacent to the gun port is presented in Figure 6-529.
