CSS *GEORGIA*
ARCHEOLOGICAL DATA RECOVERY AND MITIGATION
FOR THE SAVANNAH HARBOR EXPANSION PROJECT (SHEP),
CHATHAM COUNTY, GEORGIA AND JASPER COUNTY, SOUTH CAROLINA

**FINAL DRAFT REPORT
OCTOBER 2019**

Stephen R. James, Jr. and Gordon P. Watts

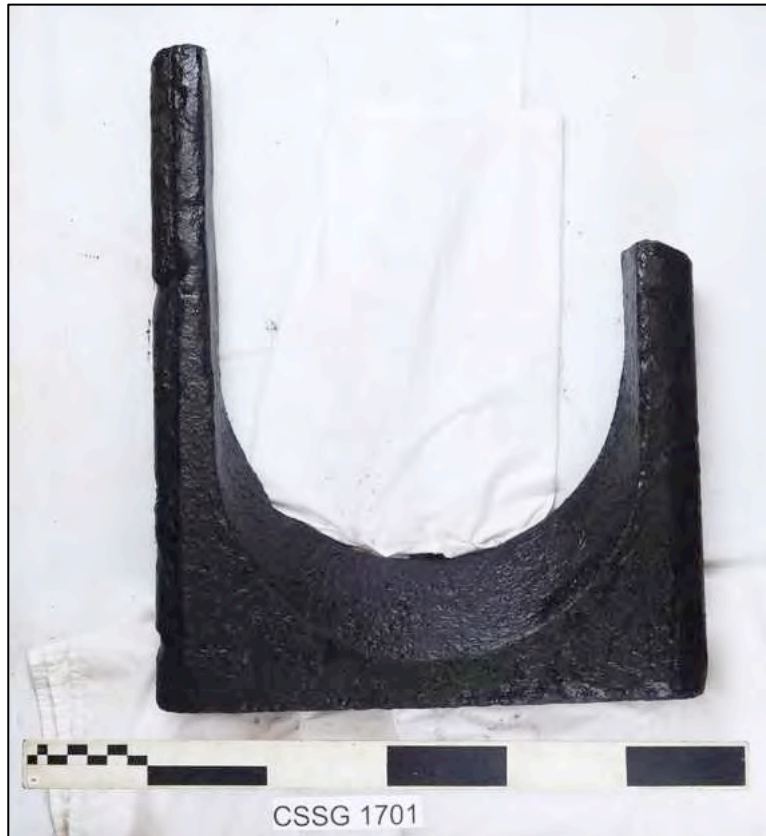
Figure 6-526. Artifact 1701, the actual gunports were formed with cast iron 4 inches thick, 6 feet 1 inch long, and 2 feet 5 inches wide (27 inches) with their outer upper and lower faces beveled with a circular angle on the exterior side.

Based on evidence found on the single intact gunport cutout in the casemate, bolts were placed roughly 6 inches above and below the cut rails forming the gunport (Figure 6-525). The actual gunports were formed with cast iron 4 inches thick, 6 feet 1 inch long, and 2 feet 5 inches wide with their outer upper and lower faces beveled with a circular angle on the exterior side (Figure 6-526). The cast gunport sides were formed as half rails to accommodate overlapping and interlocking attachments with adjacent rails on the casemate (Figures 6- 527). The gunport has holes drilled in each of their corners, most likely to fasten to casemate wood backing (Figure 6-528). A schematic of the fastening pattern for railroad rail bolts on the casemate, as well as adjacent to the gun port is presented in Figure 6-529.

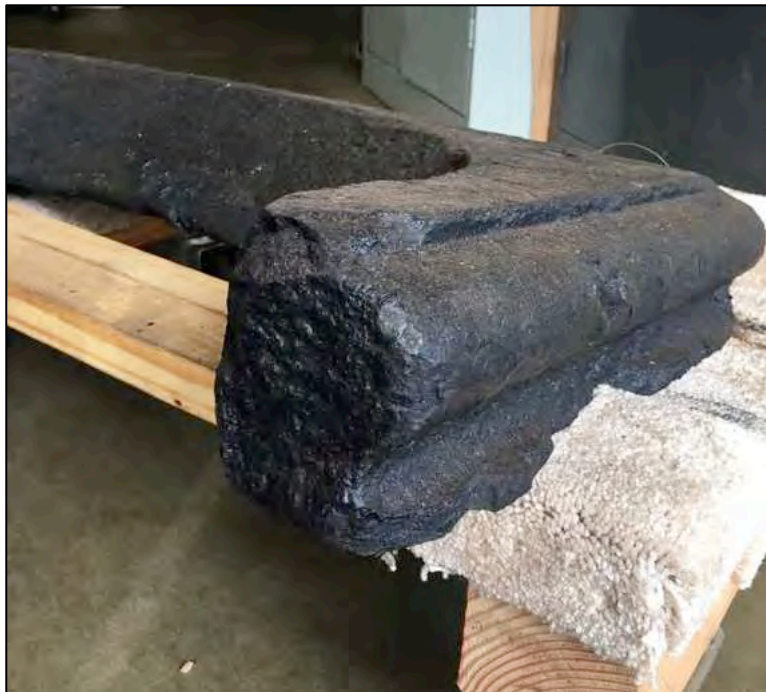
Figure 6-527. Artifact 2049, the gunport sides were cast in the shape of a half section of rail to accommodate overlapping and interlocking attachment with adjacent rails on the casemate.

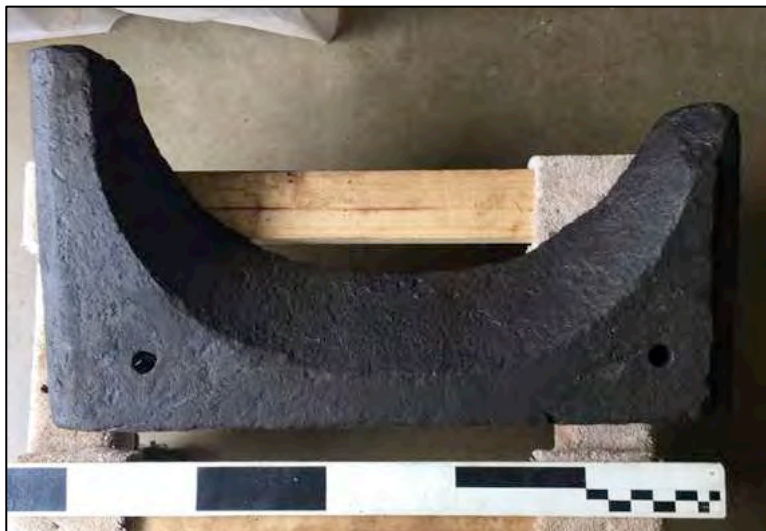
Figure 6-528. Artifact 2049, the gunport has holes drilled in each corner, most likely to fasten the gunport to casemate wood backing.

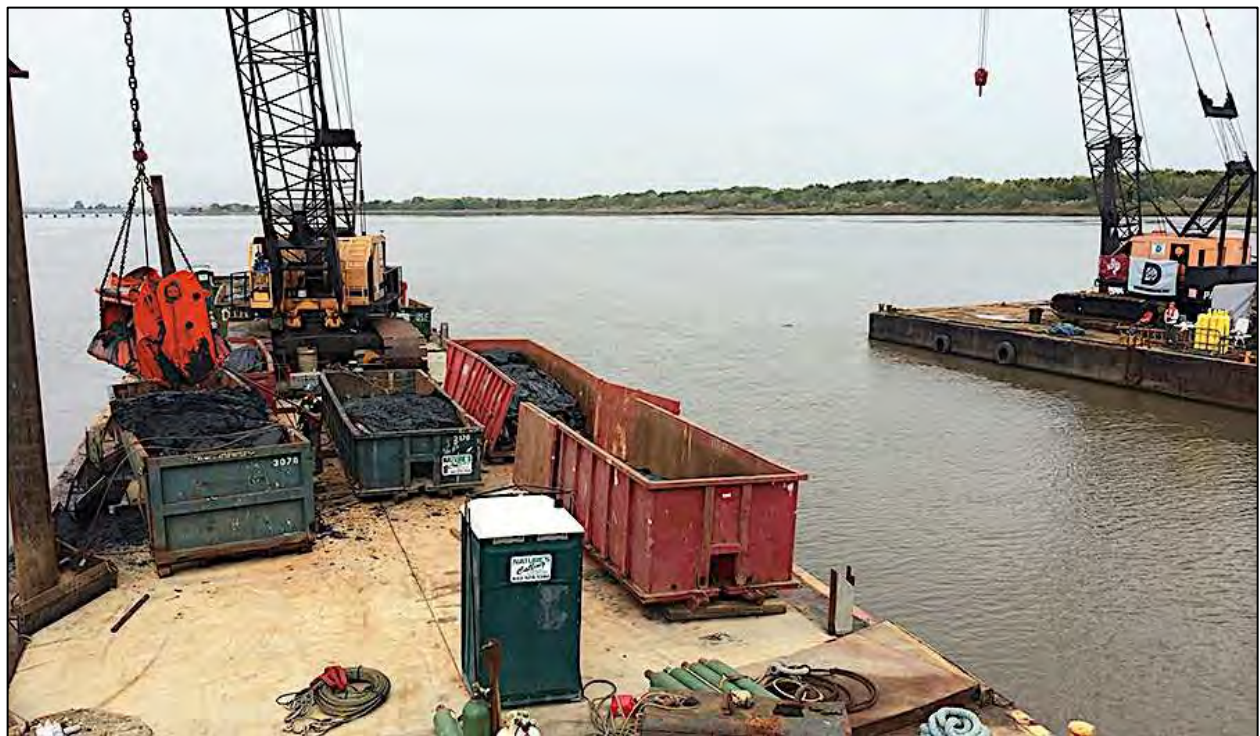
Figure 7-12. Clamshell filling containers with bottom sediments to keep the artifacts in place and enable the containers to sink immediately. Dive barge on the right was employed to send divers for burial verification.

Prior to reburial, a long sheet of plastic was placed in each container to cover the artifacts. Then each roll-off was filled with mud to form an initial layer over the artifacts to keep them in place and to enable the containers to sink immediately. Figure 7-12 shows the containers being filled with the clamshell, and Figure 7-13 shows the consistency of the fill, as it flowed out holes in the container.

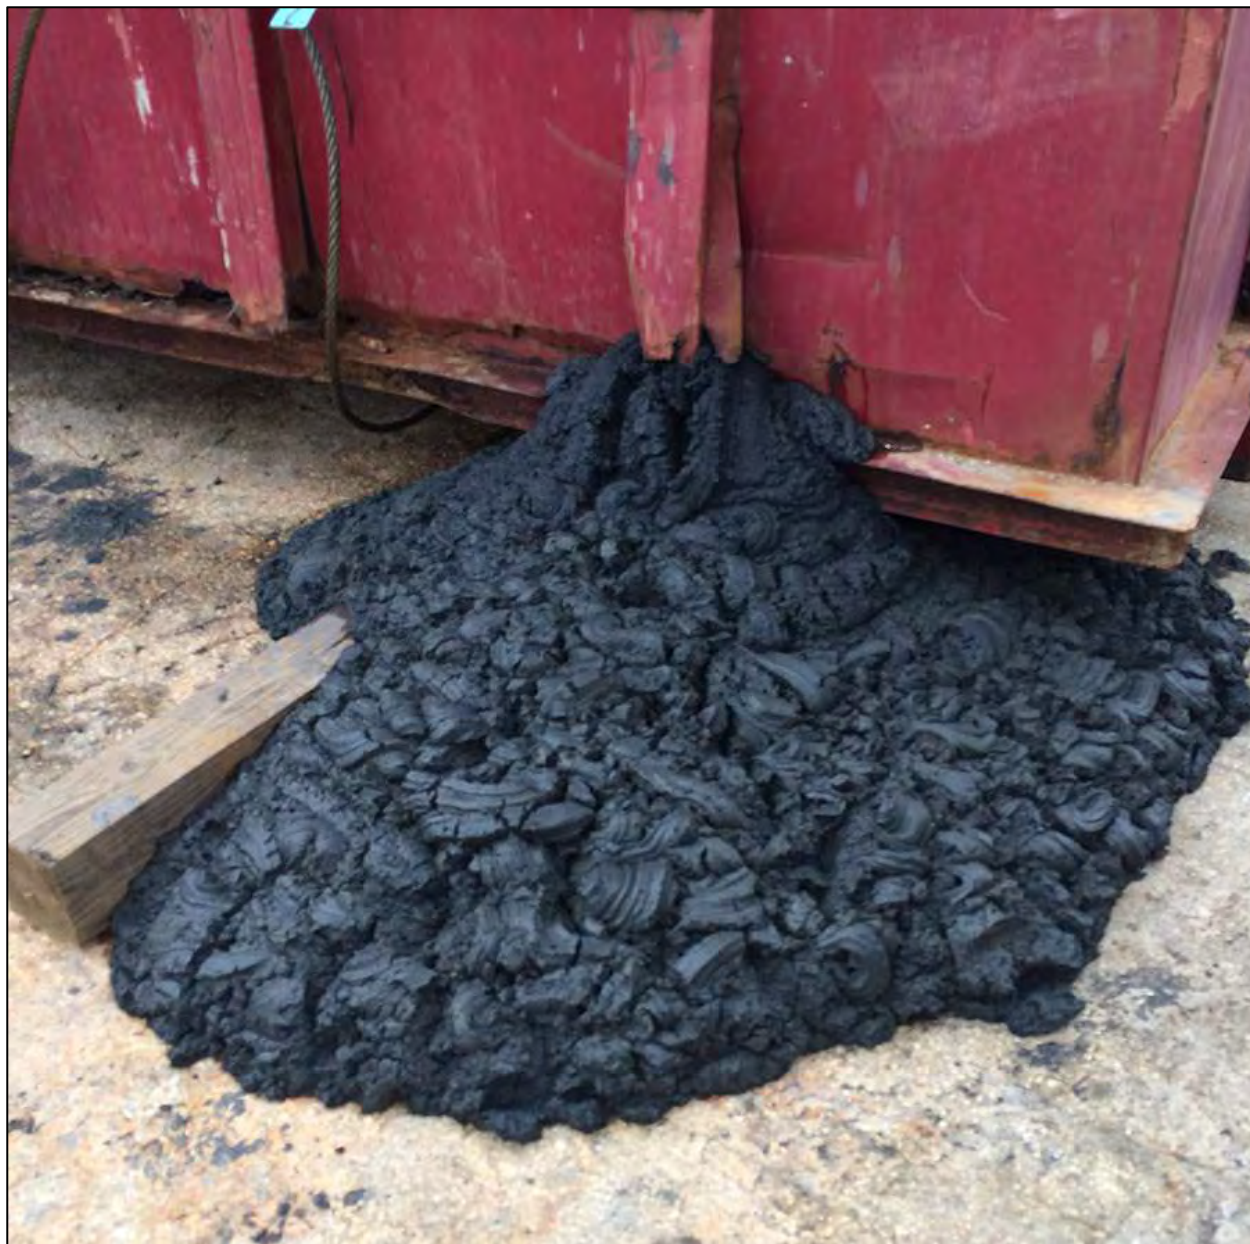
Figure 7-13. This figure shows the consistency of the fill and reflects the consistency of the bottom sediments. Almost an ooze, it covered the artifacts and in spots flowed out holes in the container.

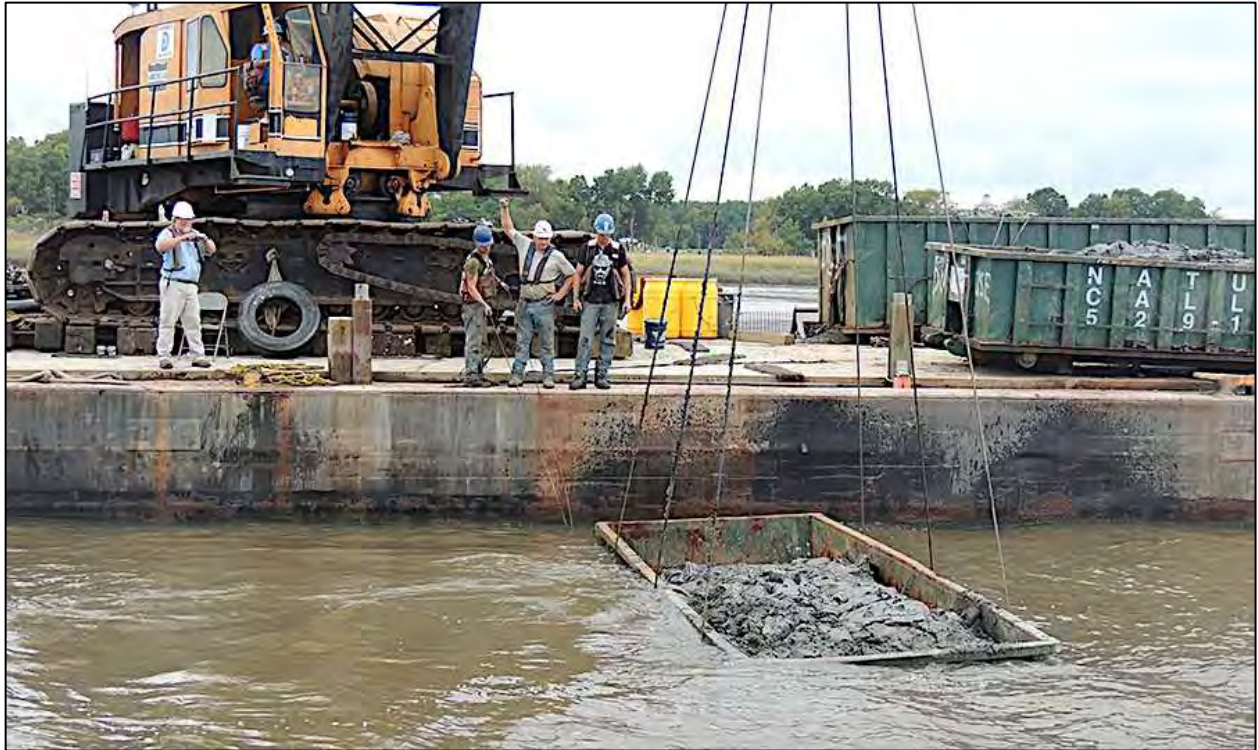
Figure 7-14. All containers were lowered perpendicular to the material barge. Note the mud filling the container.

All placed vertical to the material barge, the first container was lowered to the bottom and let sink in, then lifted and lowered again to allow it to penetrate deeper (Figure 7-14). A sidescan sonar survey was then conducted, the results of which showed the container to be below the riverbed in a crater or depression. A diver was sent in to verify burial, and the diver found that the container sat in a depression and that its top was 3 feet below riverbed grade; however, the top still projected about 6 inches above the bottom of the depression, indicating sediment would be required to cover it.

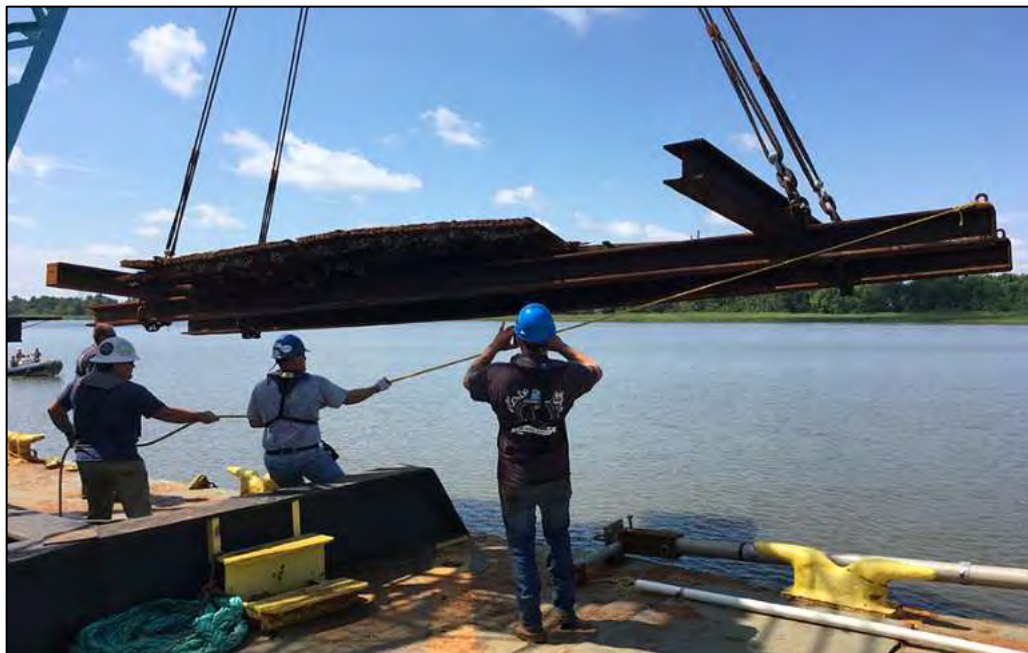
Figure 7-16. Lowering of East Casemate during reburial. The frame and bridle were reburied as well.

The same methodology was conducted for the reburial of four additional artifact-filled containers in 2017, as well as the East and West Casemates (Figures 7-16 and 7-17), although their placements were “offshore” the original line of ten containers. Numbered 97 to 100, the mud-filled container weights were No. 97 at 32 tons, No. 98 at 28 tons, and No. 99 at 26 tons (a weight was not obtained for No. 100). The weight for the East Casemate was 23.5 tons without the iron lift frame (43.5 tons with) and the West Casemate was 40 tons without the frame (60 tons with). The locations of all reburial items are presented in Figure 7-18 and the GPS coordinates are presented in Table 7-01.

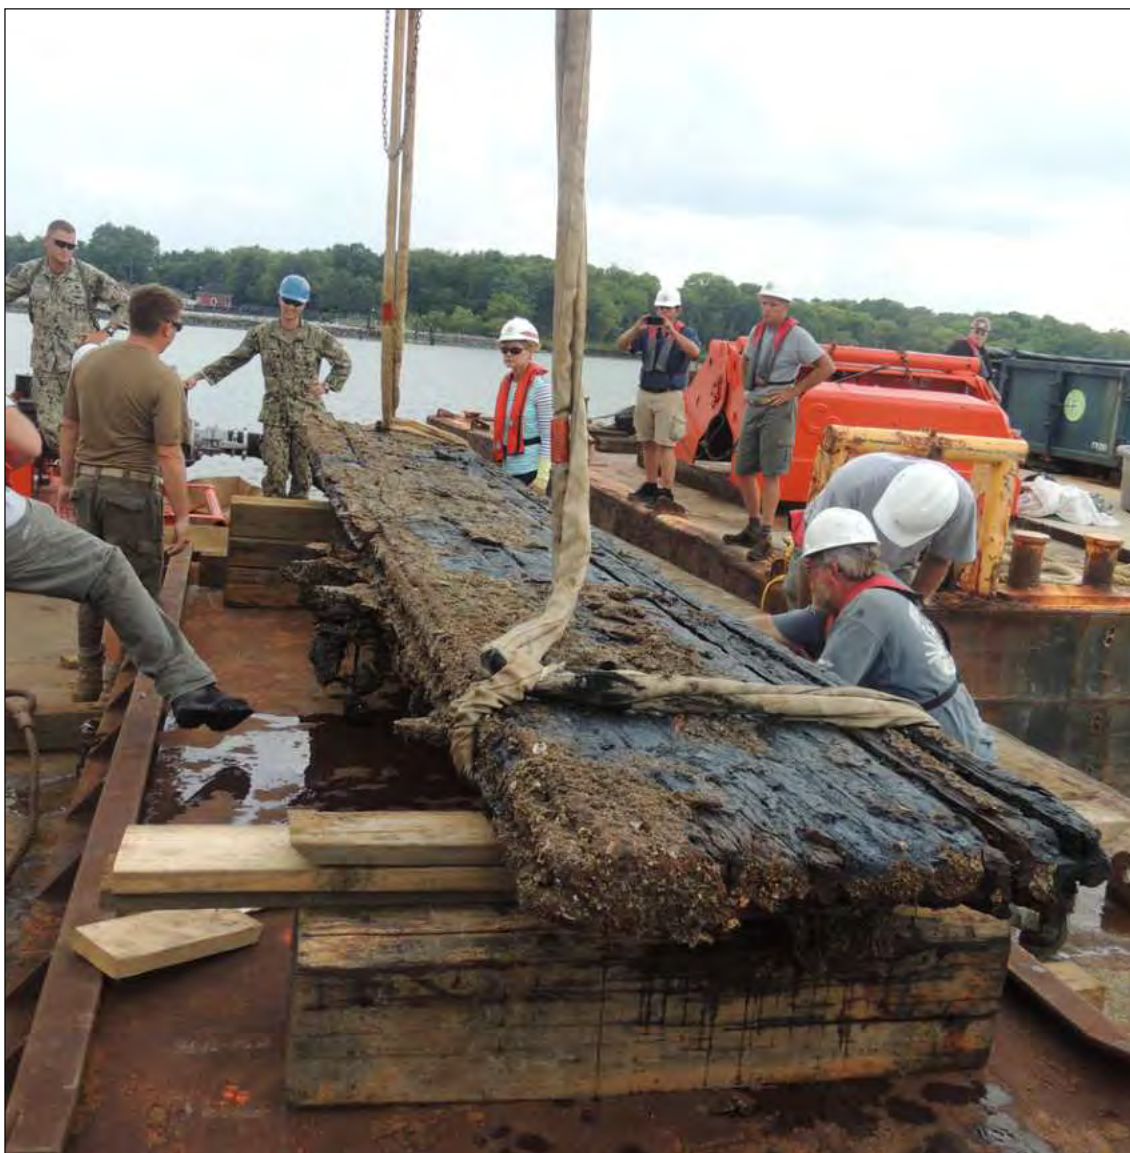
Figure 4. Northern section on East Casemate segment successfully sectioned and raised.

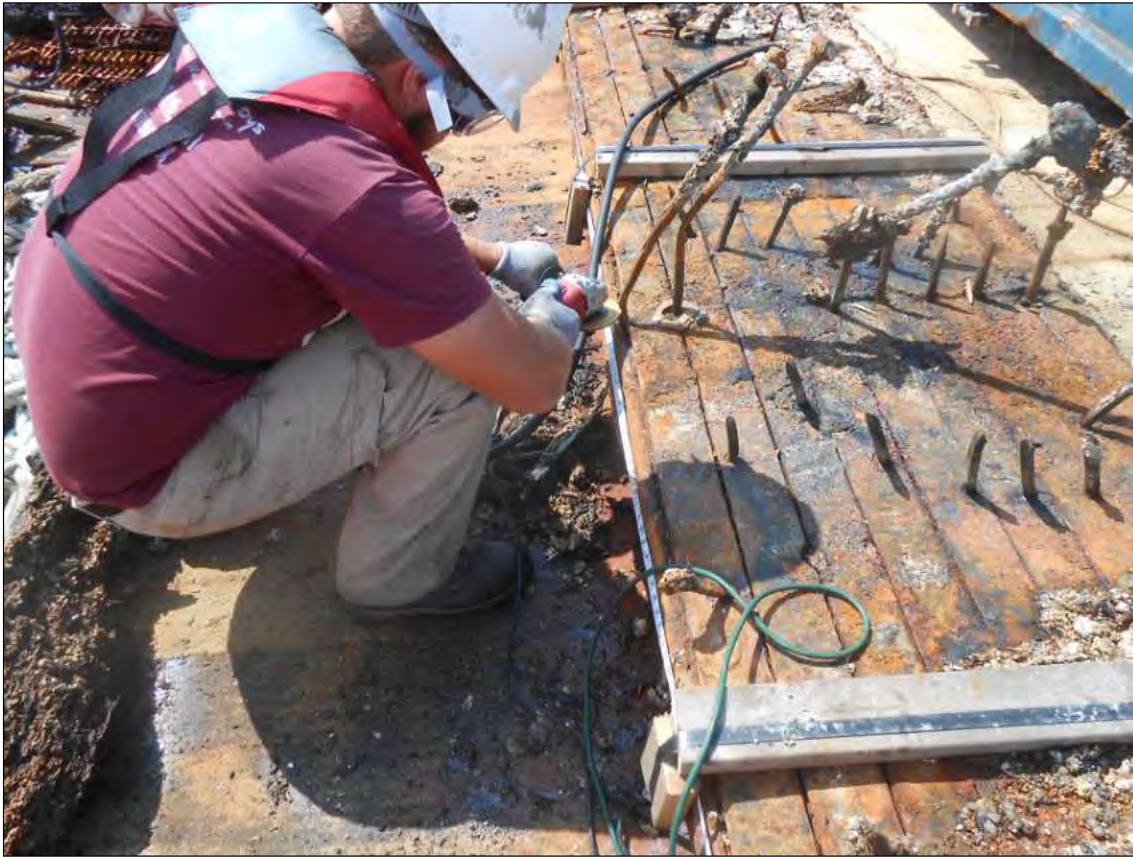
Figure 5. Reverse side of northern segment recovered from East Casemate. Segment has been recorded, banded and is being readied for stabilization. Conservator is cutting away long bolts that secured timbers, and that have to be removed prior to shipping.

3 drops all 6 feet, that also penetrated. Third operation on eastern edge, with 2 drops at 6 feet, that also penetrated. Fourth operation was on the western edge, with 3 drops at 6 feet, and which also penetrated. Then we placed the entire guide gently along the top setting the guide down on segment from one foot to see if it would break free. We could observe on the CODA, the segment slowly moving and angling downward indicating separation. Divers in on next tide observed that section calved off. Rigged the section and it was successfully raised. Segment was recorded, banded, and placed in a roll-off container with water on the Material Barge. No evidence observed of any damage from the mechanism (Figures 4 and 5). Minimal wood was present which helped in the separation process.

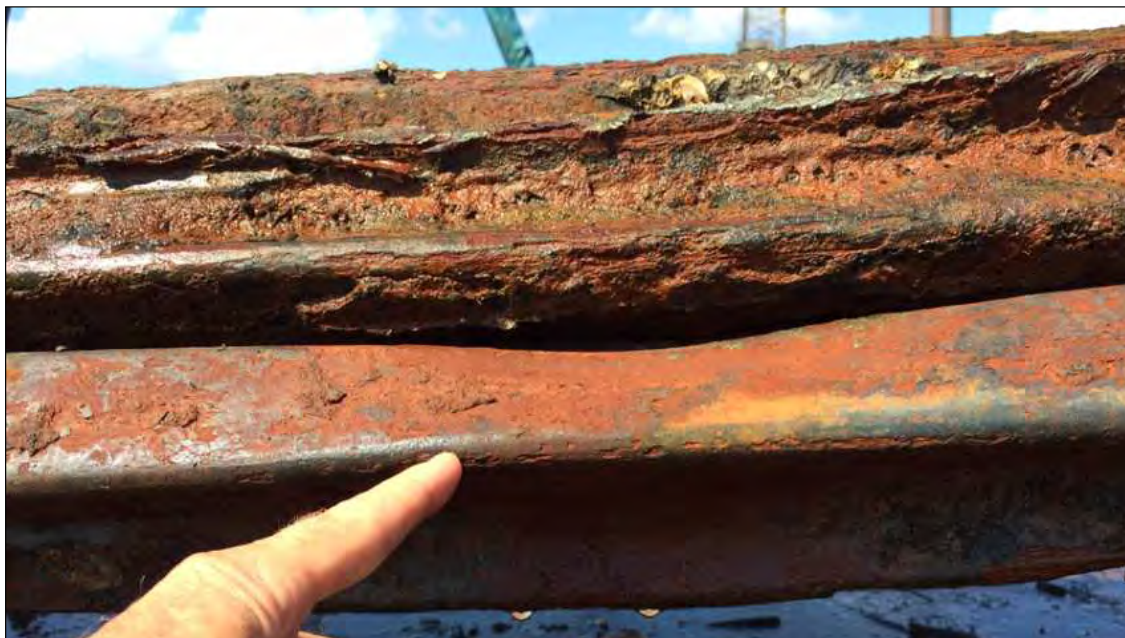
Figure 6. Note bend in railroad iron from blade on edge of southern segment recovered from East Casemate.

A similar operation was conducted the following day on the southern small 16 x 4 foot segment. Five placement locations, all with 8-foot drops. The first placement location was on the downriver end, 2 drops total, that separated through the iron. Second placement location was four foot further west, with 2 drops all from 8 feet the drops successfully separated the iron. Third drop on the center, with 4 drops at 8 feet that also separated. Fourth placement was conducted a little further west, with 2 drops at 8 feet that also separated. Fifth drop location centered on western end, three drops all 8 feet, separated. Similar to the northern segment, we could observe on the CODA the segment slowly moving and angling downward during the latter drops indicating separation. Divers went in and surveyed and rigged the segment for lifting. During the lift, 2 outer rails from one side fell off (were not slung on downriver side – just on upriver end) and the segment collapsed somewhat inward on itself. Brought to surface, the rigging on one end was observed to be unsafe, probably as a result of the 2 rails falling off. The segment was set back down on bottom, re-rigged on the following dive, and brought to the surface. Figure 6 shows that one rail was bent slightly, an effect from the blade drop.

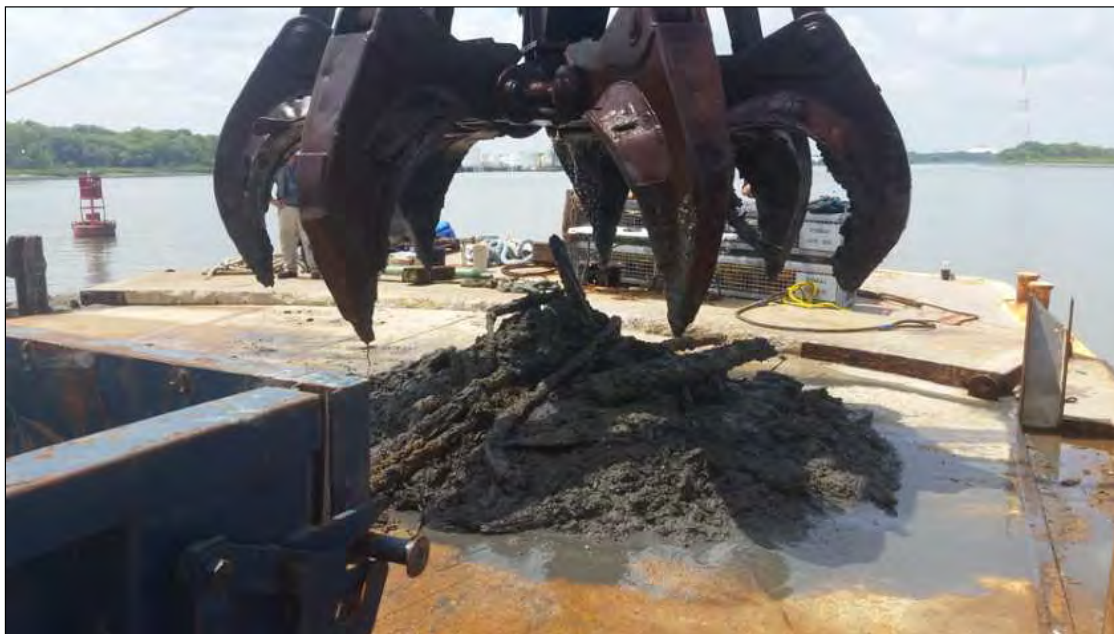
Figure 8. Raising of a Grapple. Grapple G1 surprisingly collected more sediment as well as cultural material than clamshell. Material hosed off of barge to the right and away from wreck site. Grapple sample was easily sorted and washed with no loss of material even with the absence of a screen.

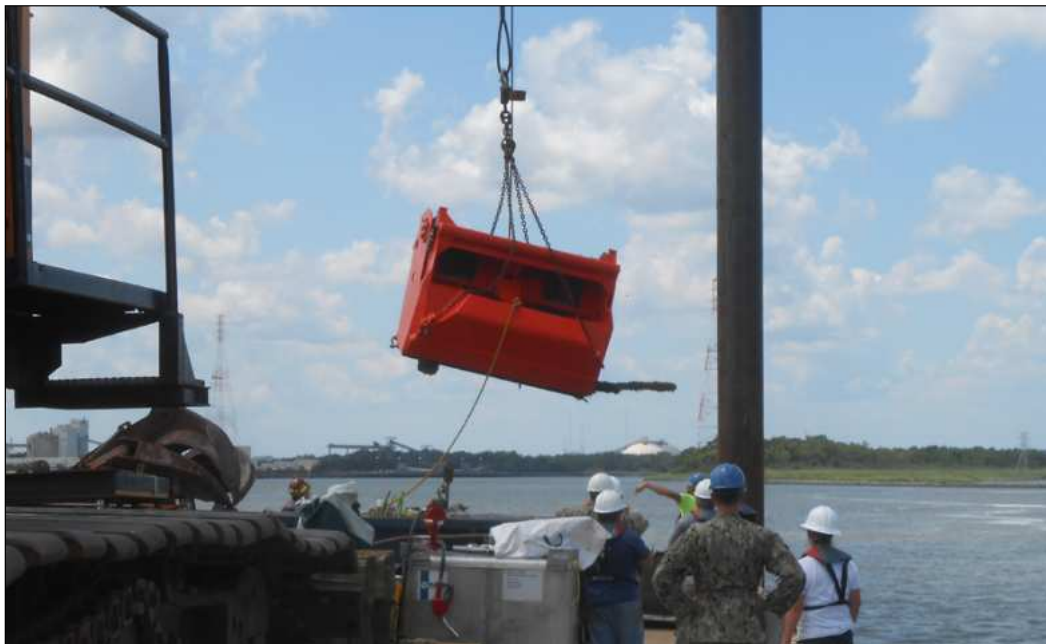
Figure 11. Clamshell grab being deposited into prototype screen.

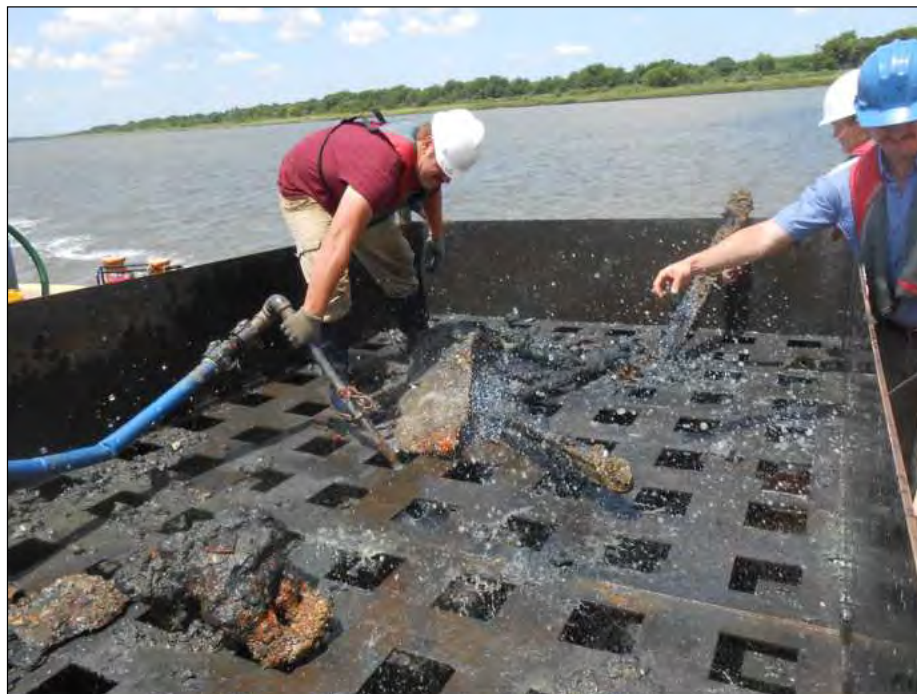
Figure 12. Initial processing of a Clamshell grab. Screen was difficult to access and affected processing efficiency.

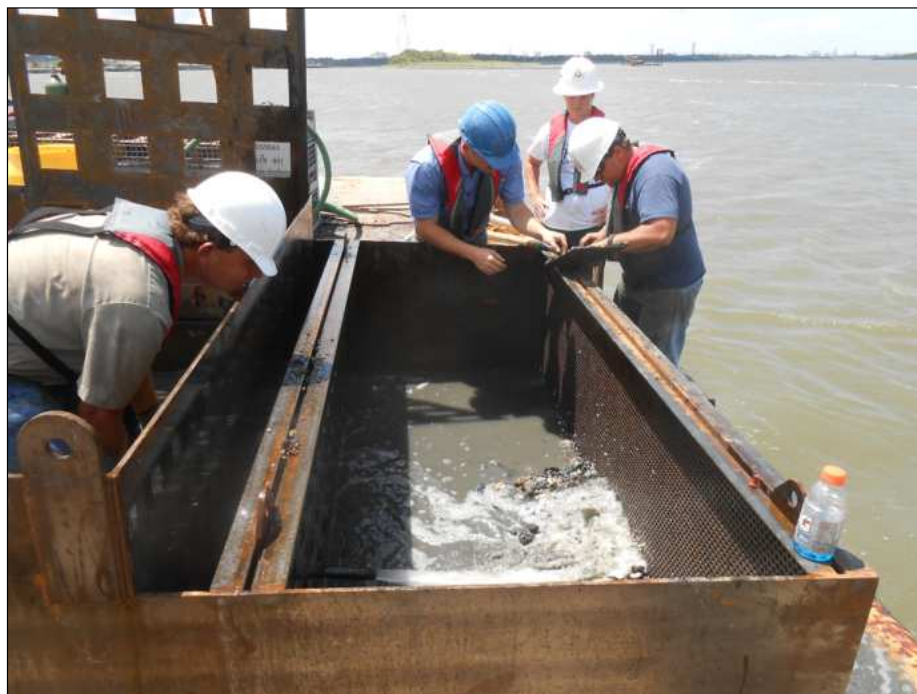
Figure 13. With large 6 x 6 inch screen raised, washing sediment through 2 horizontal screens. Weight and positioning of screens was found to be inadequate with numerous limitations on processing.
