Mardi Gras Shipwreck Project:

Stern Encrustation

Recovery of the Stern Encrustation

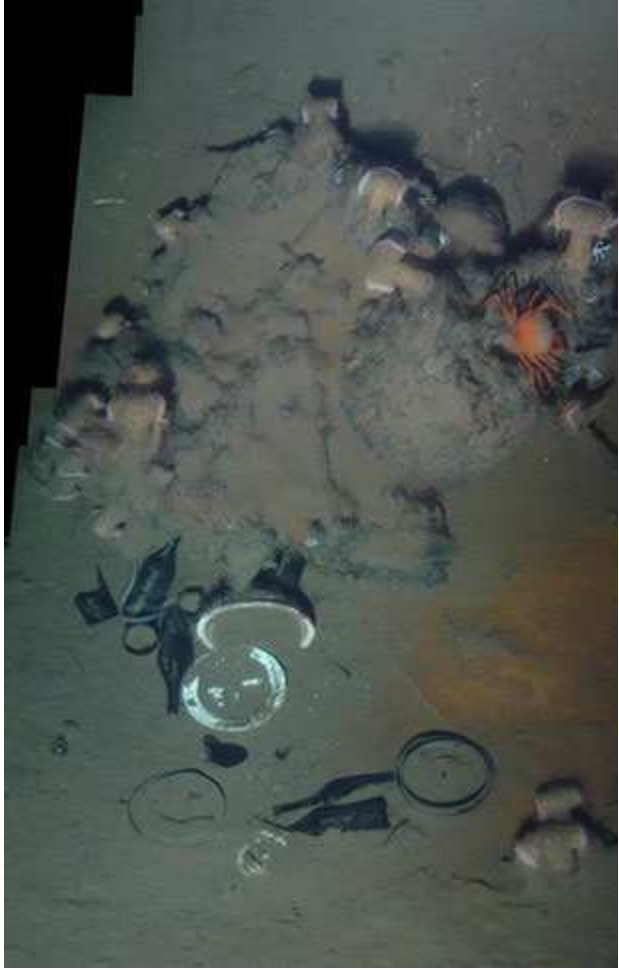
The stern encrustation was recovered from the extreme southeastern end of the site. At left, the encrustation is seen in situ with other adjacent artifacts.

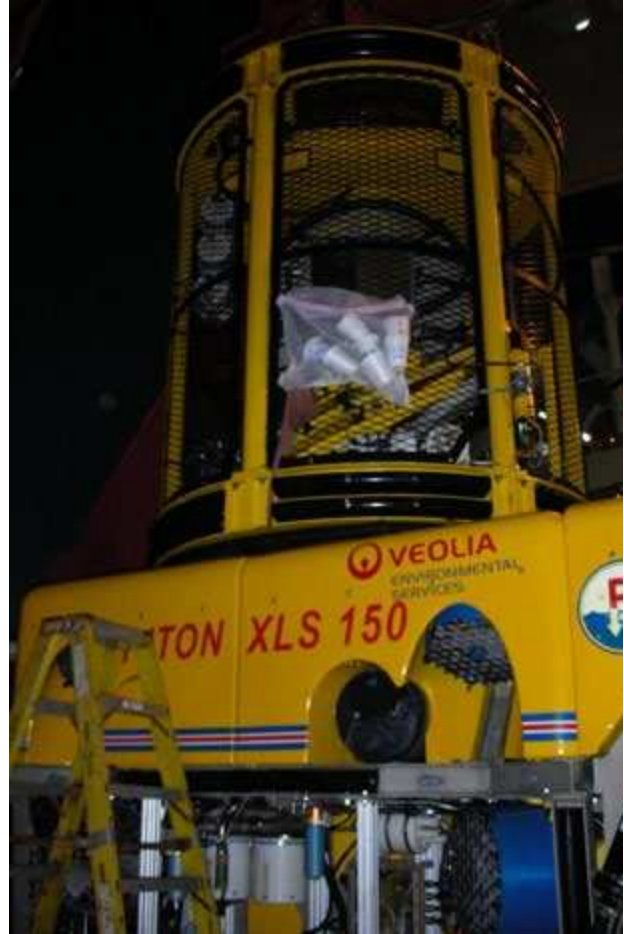
The ROV which was used to investigate the shipwreck site, a Perry Triton XLS-17 provided by Veolia Environmental, is seen at right. The primary tools for artifact recovery were suction pickers, commonly called "sticky feet." Also visible in the picture is a bag of styrofoam cups, which were crushed by the water pressure at the deep site.

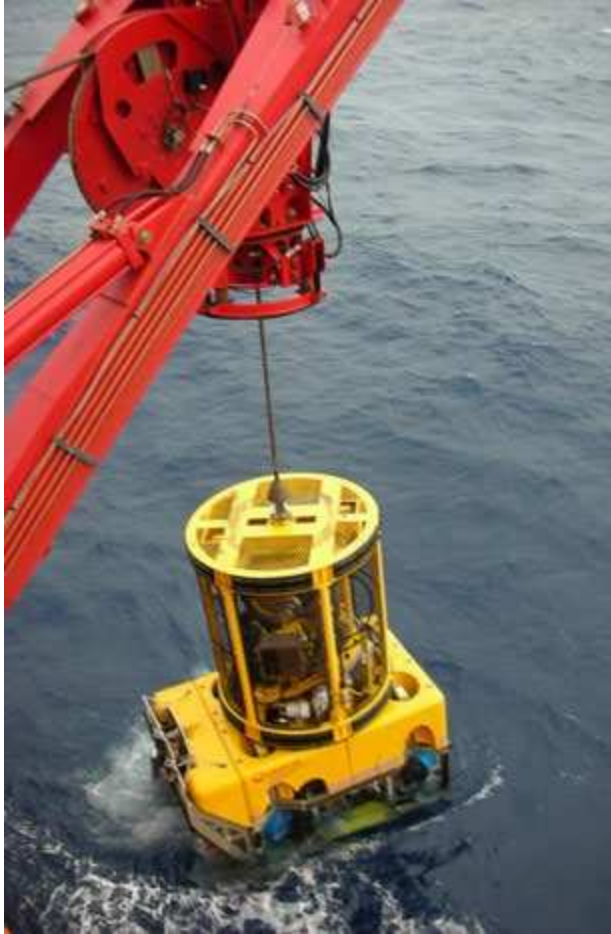
Large Artifact Retrieval Tools, or LARTs were used to recover the stern encrustation and to backfill the site. The LARTs were specially designed for use at the Mardi Gras site by Perry Slingsby Engineering in Houston, Texas and were manufactured under the direction of Veolia Environmental Marine Services.

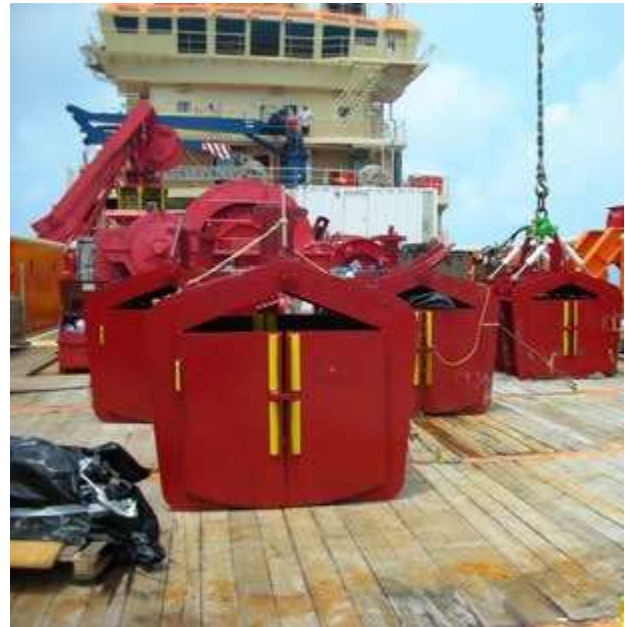
Large Artifact Retrieval Tools, or LARTs were used to recover the stern encrustation and to backfill the site. The LARTs were specially designed for use at the Mardi Gras site by Perry Slingsby Engineering in Houston, Texas and were manufactured under the direction of Veolia Environmental Marine Services.

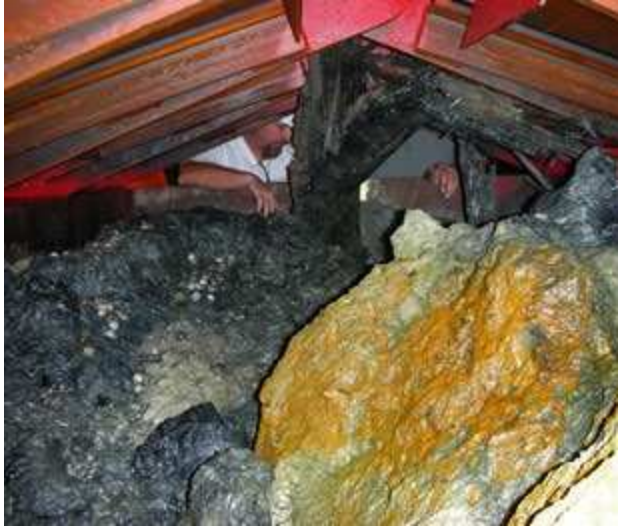
Above, the stern encrustation is seen within the LART that was used to transport the encrustation to the Conservation Research Laboratory at Texas A&M; University.

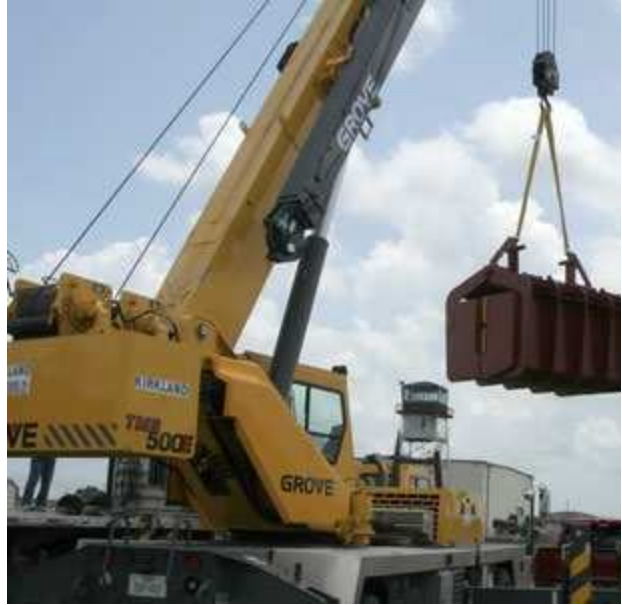
A crane was used to place the large encrustation on the premises of the laboratory, where it could be moved into a specially constructed vat for desalination and conservation.

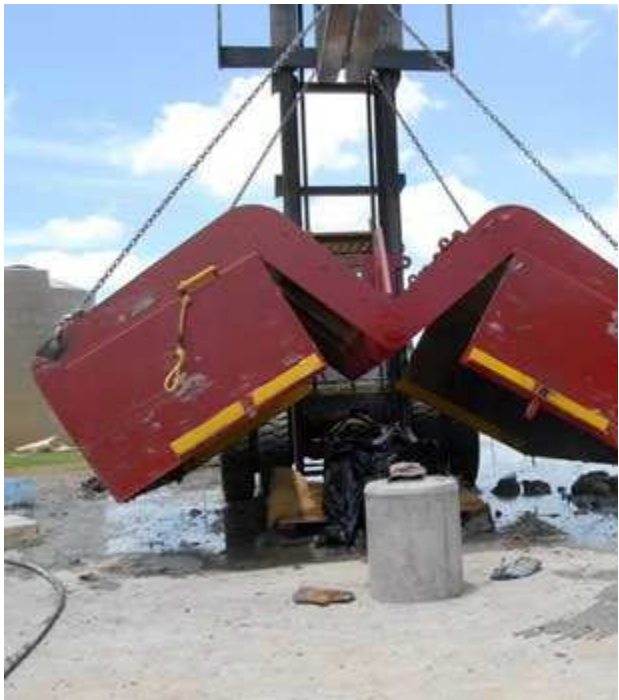
Here, the open LART reveals its "clamshell" construction, and a forklift is maneuvered into place behind the encrustation. To prevent the

encrustation from drying out, it has been wrapped in wet towels and plastic bags.

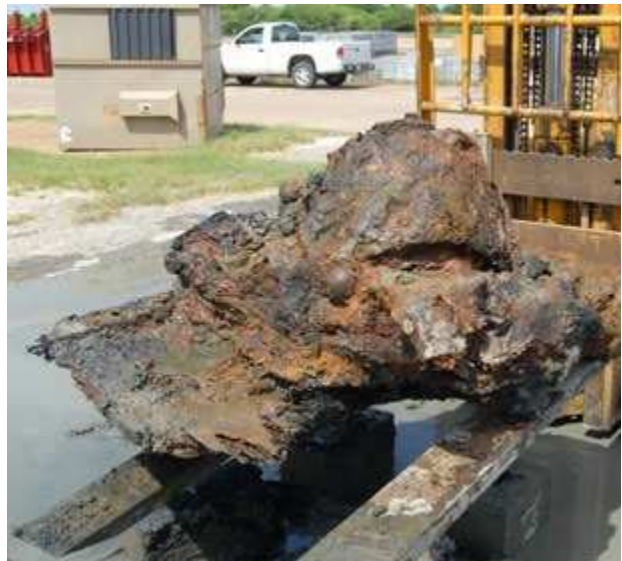
On its way to the desalination vat, the encrustation is exposed only briefly. Lead shot are visible in the middle of this image, and the large dome-like feature at the top of the encrustation can be seen. This was thought to be a kettle, but further work has revealed that

it is a wicker basket which has been preserved by the various iron artifacts it contained.

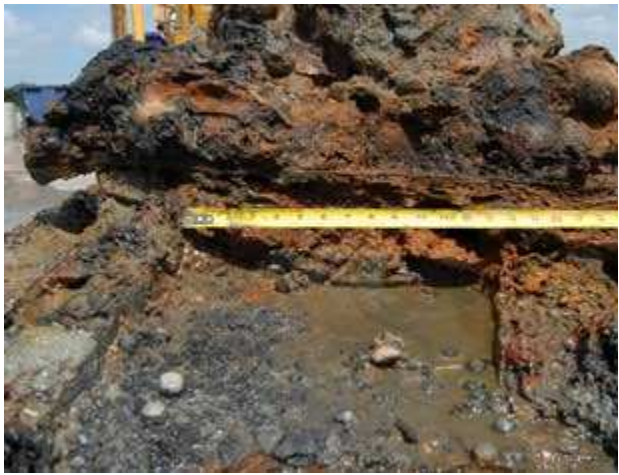
The size of the encrustation can be seen here, as well as two different caliber shot. Both lead and iron round shot have been identified within the encrustation, as well as bar shot.

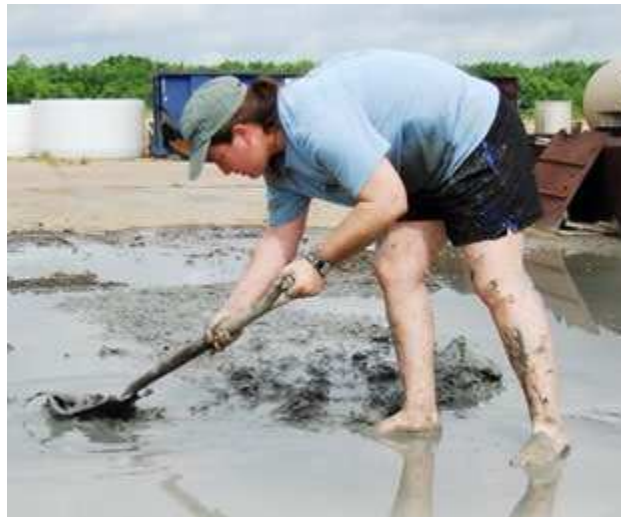
When the encrustation was retrieved from the ocean floor, mud was also brought up from the bottom inside the LART. As this mud may have contained valuable artifacts, it was sifted and examined as well.

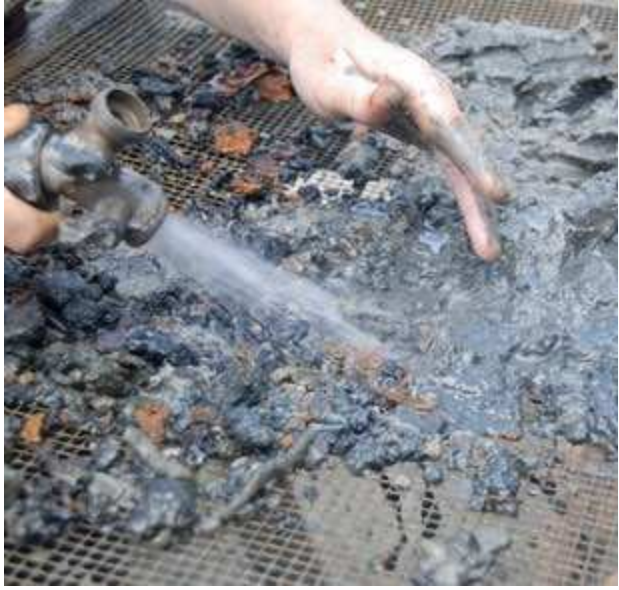
The mud is sifted with the aid of a spray of water, and artifacts are retrieved from a mesh screen. .

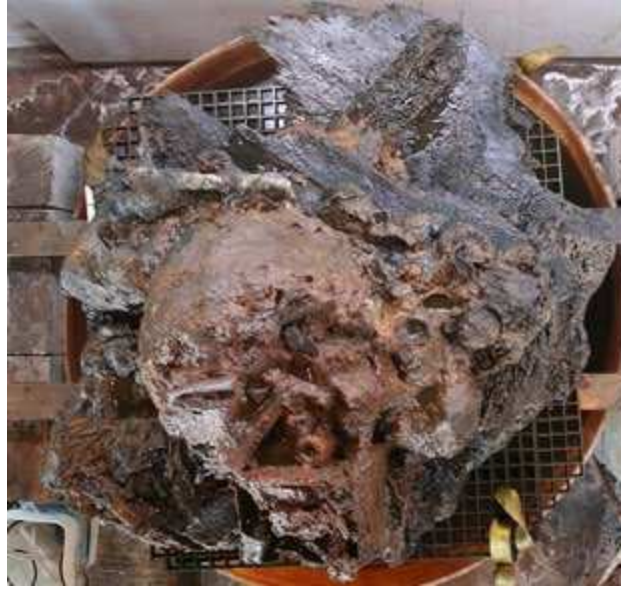
The stern encrustation is seen from above here, as it is prepared to be lowered into the vat where it will undergo desalination and further treatment.

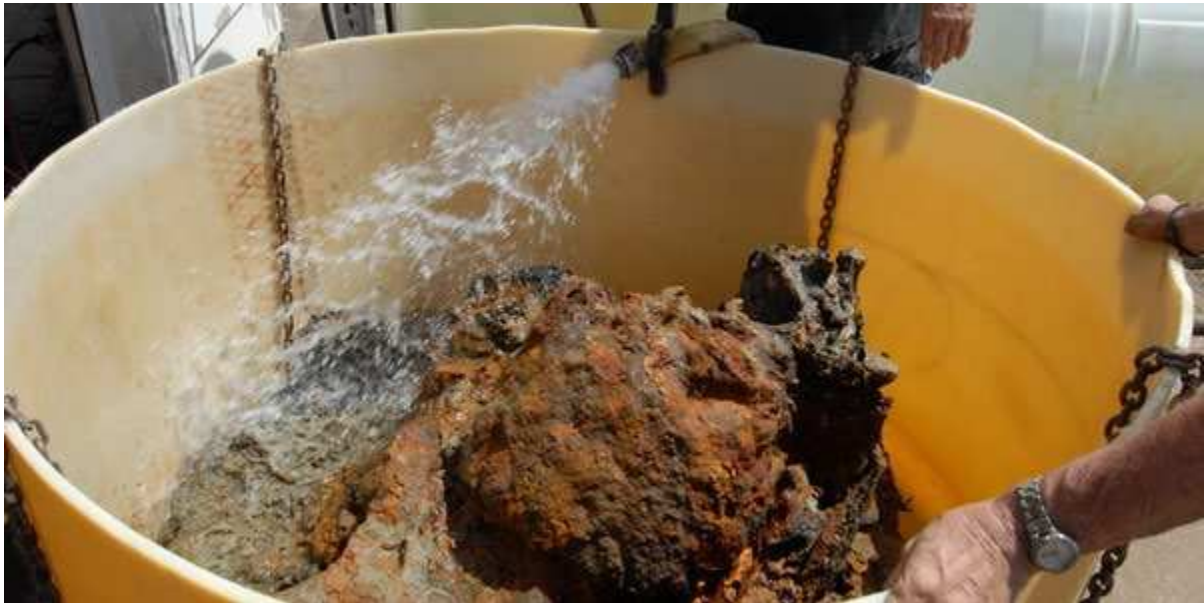
Once inside the vat, the encrustation is covered with tap water to begin the desalination process.

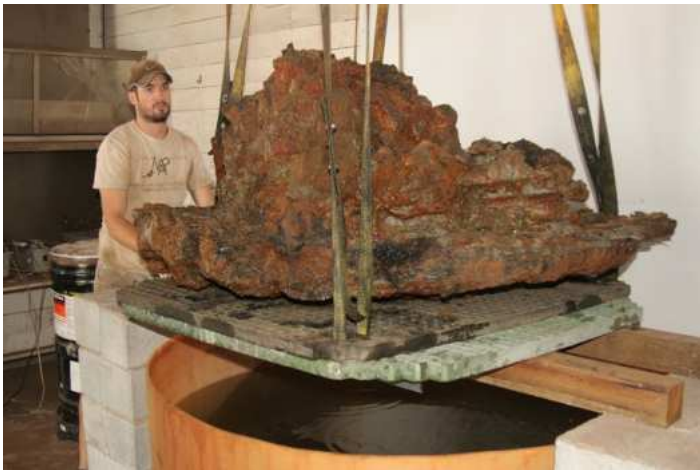
Above, the stern encrustation is lifted from the vat by a conservator at the Conservation Research Laboratory

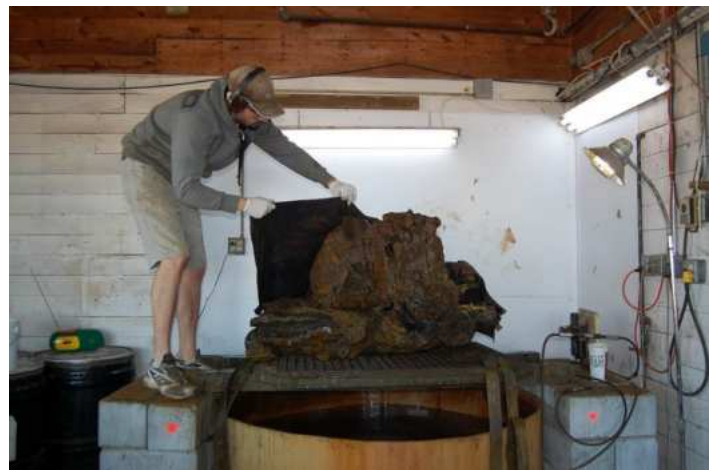
To prevent the encrustation and the associated artifacts from drying out while conservation work is performed, the encrustation must be covered. Here, fabric which has been soaked is used to cover areas of the encrustation which are not currently being investigated.

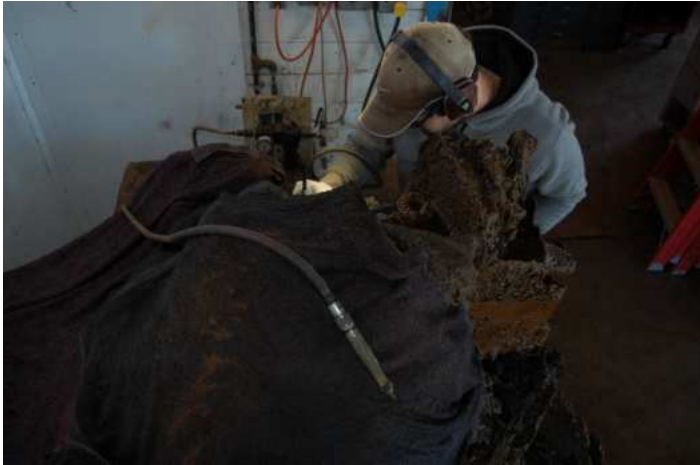
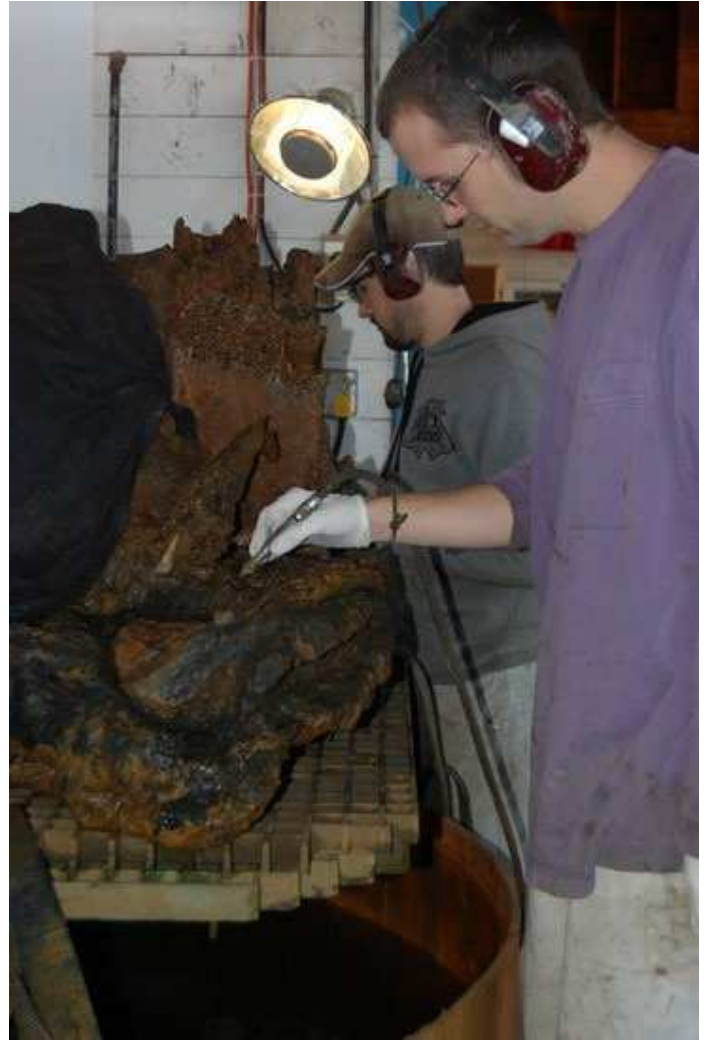
Above: Pneumatic air scribes are used to excavate areas of the encrustation. In the photo at left, a conservator works on the encrustation while another air scribe is visible in the foreground.

Right: X-rays of the encrustation give conservators an idea of the types of artifacts contained within. Here, two conservators work on different areas of the encrustation.

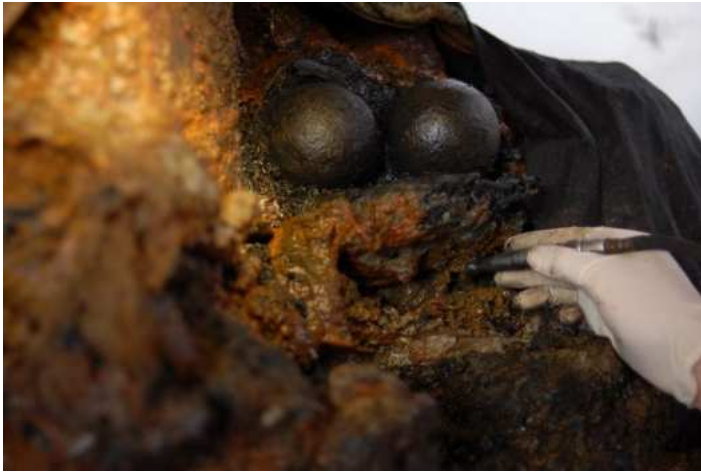
A close-up of the round shot shows their placement within the encrustation. The area surrounding the artifacts has been carefully excavated, but the shot will remain in place, pending further investigation.

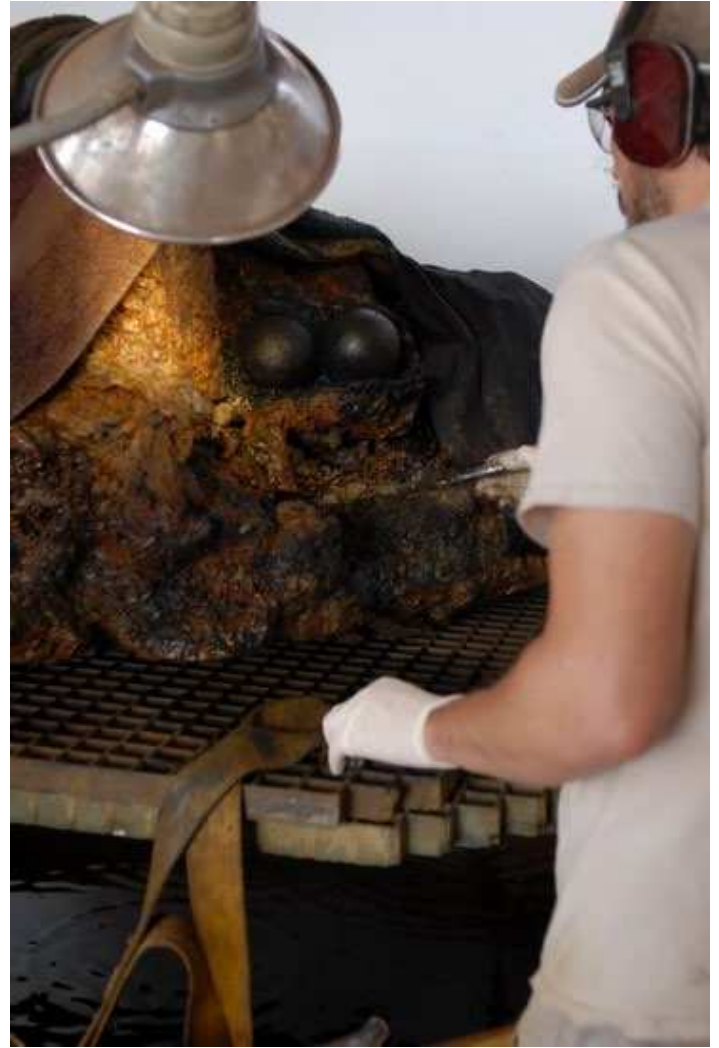
At right, a conservator works in an area containing two round shot, or cannonballs.
The locations of all artifacts must be documented as excavation continues.
