Investigation and Recovery of USS Westfield (Site 41GV151) Galveston Bay, Galveston County, Texas

Document No. 100102a
Atkins Job No. 044118606

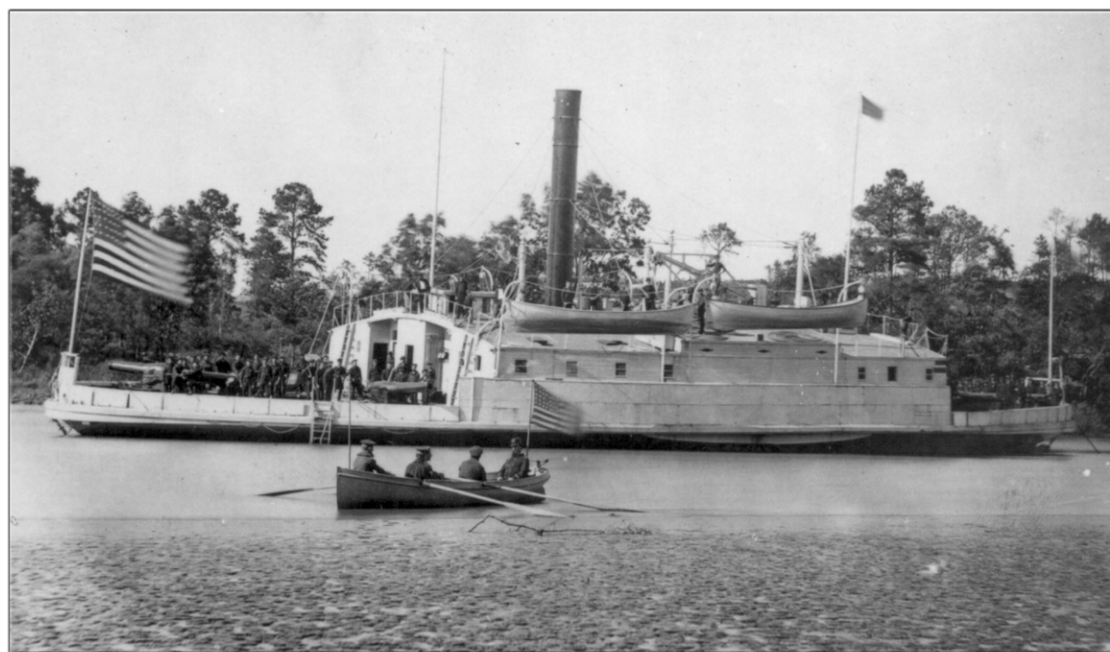
FIGURE 6 (BOTTOM). USS *COMMODORE PERRY* IN 1863
(NATIONAL ARCHIVES, MATHEW BRADY COLLECTION, ARC NO. 524850)

Other U.S. Navy ferry-gunboats such as *Whitehall*, *Ellen*, *Morris*, *Commodore Barney*, and *Commodore Perry* were likewise reinforced with plating, though *Commodore Perry* may be the only of these aforementioned vessels plated along its entire length (Minick 1962). The smaller 2-x-3-ft plates at the bow and stern of *Westfield* (the 1862 Memphis sketch; see Figure 3) suggest the smaller iron “hinged” plates from the gun decks of *Morris*, *Satellite* (a converted tugboat), and *Commodore Perry* (see figures 4, 5, and 6). These vessels employed a type of hinged metal plating that could be raised or lowered at discretion to facilitate use of the cannon. A photograph of *Commodore Perry's* deck shows the treatment of the enclosed deck cabin (Figure 7).

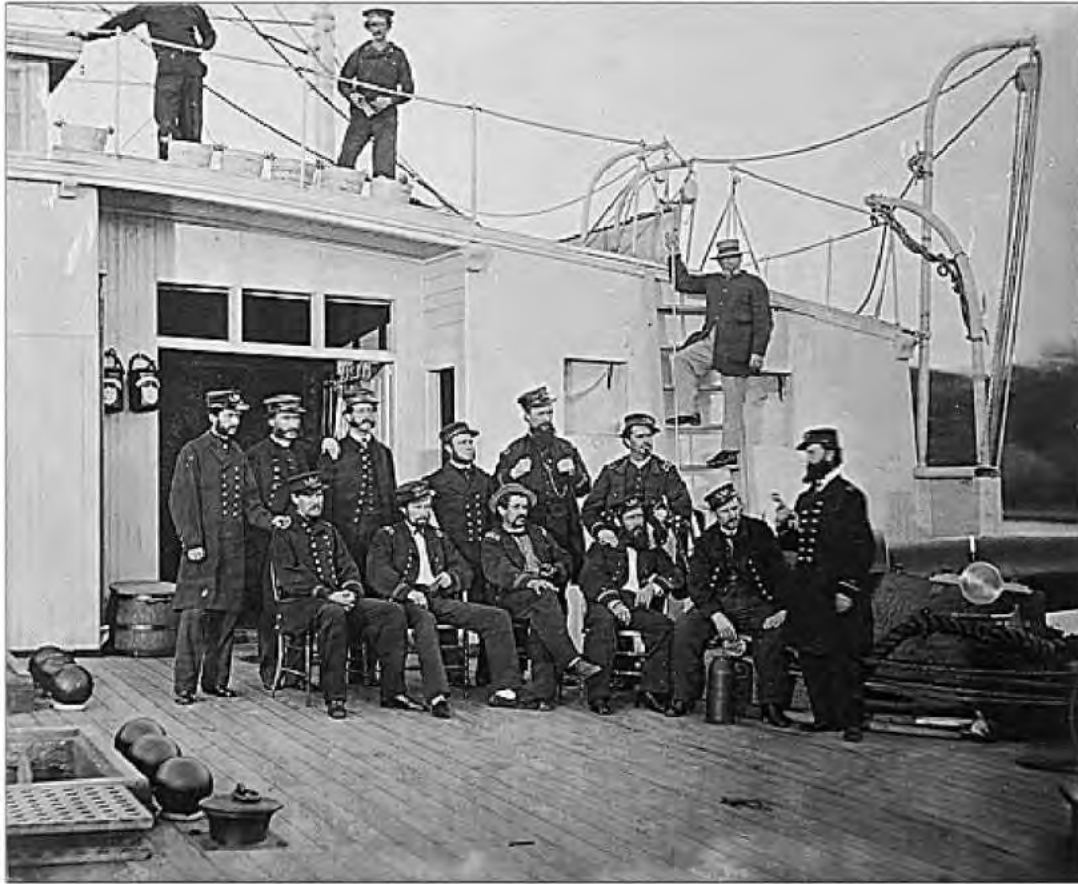
FIGURE 7. DECK OF *COMMODORE PERRY* CA. 1860–1865 (NATIONAL ARCHIVES, MATHEW BRADY COLLECTION, ARC No. 524570)

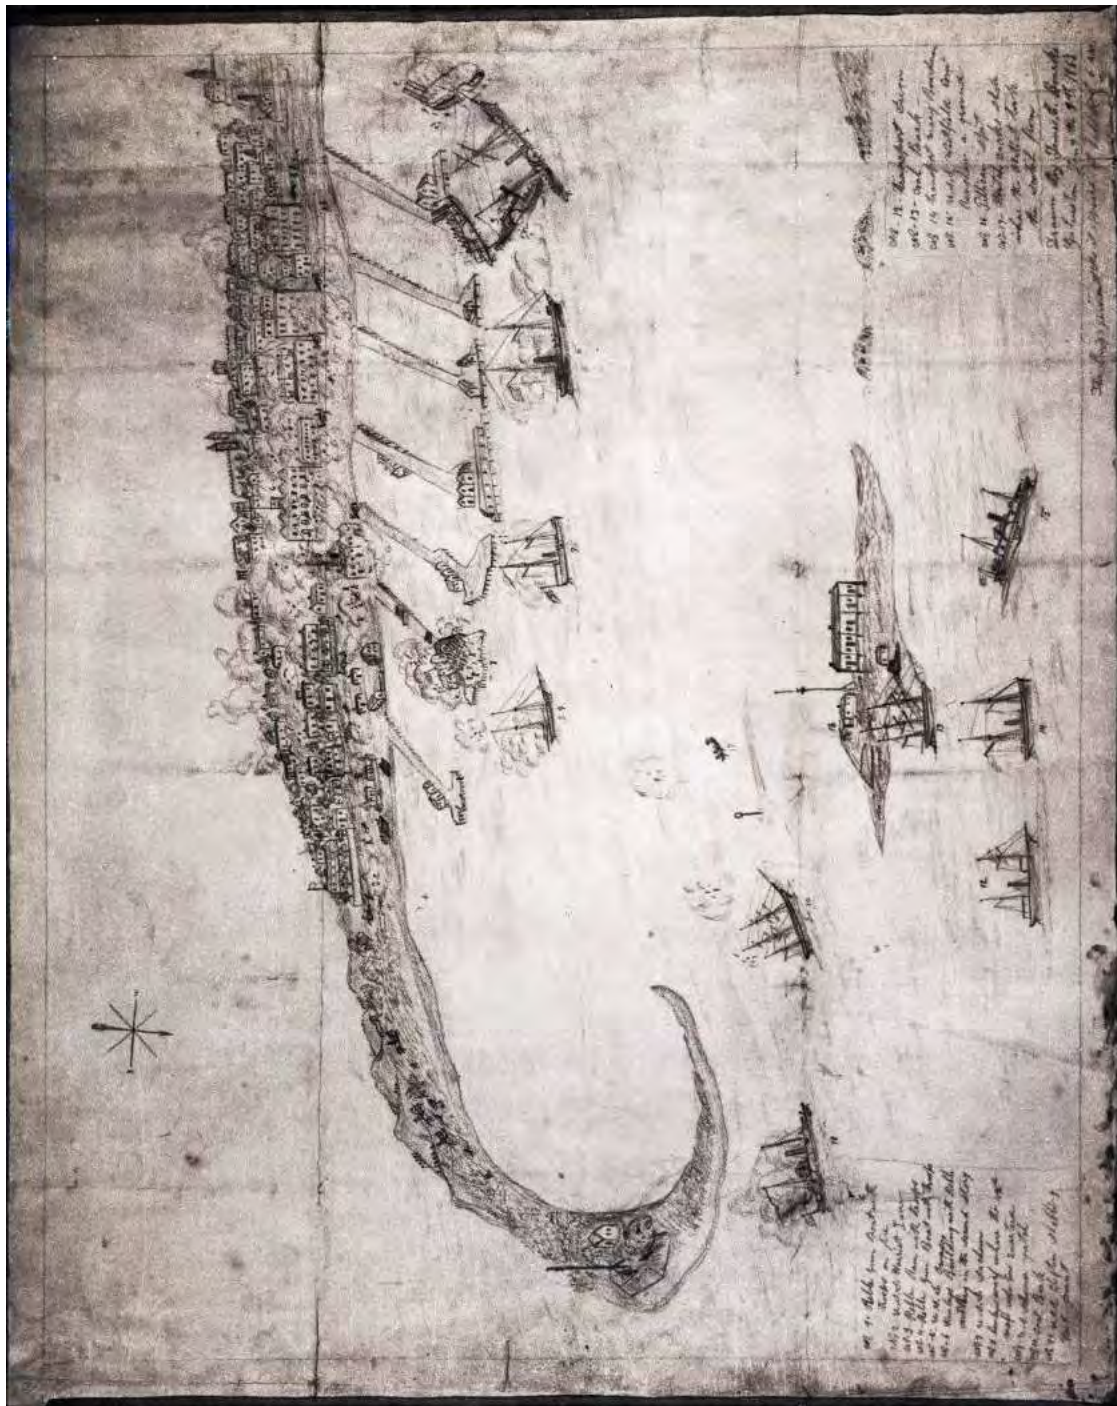
The scene of the battle as it appeared at 6:30 a.m. was sketched by James Bourke (reproduced as Figure 13). Bourke's drawing shows *Harriet Lane* rammed by a cotton clad and under attack. *Owasco* is seen defending *Harriet Lane* before retreating. The 42nd Massachusetts Volunteers, barricaded at the end of Kuhn's Wharf (called Henleys Wharf by the Bourke), are under attack from Confederate artillery placements in the second story of the Henley Building. *Clifton* is shelling Fort Point. *Saxon*, *Mary Boardman* and a coal bark are standing by near Pelican Spit. And *Westfield* is seen aground on a sand bar, although its orientation is incorrectly portrayed with the bow directed westward.

FIGURE 13. BATTLE OF GALVESTON EYEWITNESS SKETCH (IMAGE PROVIDED COURTESY OF THE ROSENBERG LIBRARY, GALVESTON).

DRAWING LEGEND: "No. 1 - Reble [sic.] Gun Boat [*Neptune?*] with troops on fire; No. 2 - U.S.S. *Harriett Lane*; No. 3 - Reble Ram with troops [*Bayou City?*]; No. 4 - Reble Gun Boat with troops; No. 5 - U.S.S. *Owasco*; No. 6 - Henleys Building with Reble Artillery in the second story; No. 7 - U.S.S. *Sachem*; No. 8 - Henleys [Kuhn's] wharf where the 42nd Mass. volunteers quartered; No. 9 - U.S. Schooner yacht [sic.]; No. 10 - coal Bark; No. 11 - U.S.S. *Clifton* shelling Fort Point; No. 12 - transport *Saxon*; No. 13 - coal Bark; No. 14 - transport *Mary Boardman*; No. 15 - U.S.S. *Westfield* Com. Renshaw a ground; No. 16 - Pellican [sic.] Spit; No. 17 - Hitchcocks shole [sic.] where the artist took the scetch from; Drawn By James E. Bourke, Galveston, Jan'ry the 1st, 1863. The Engagement as it appeared at half past 6 A.M."

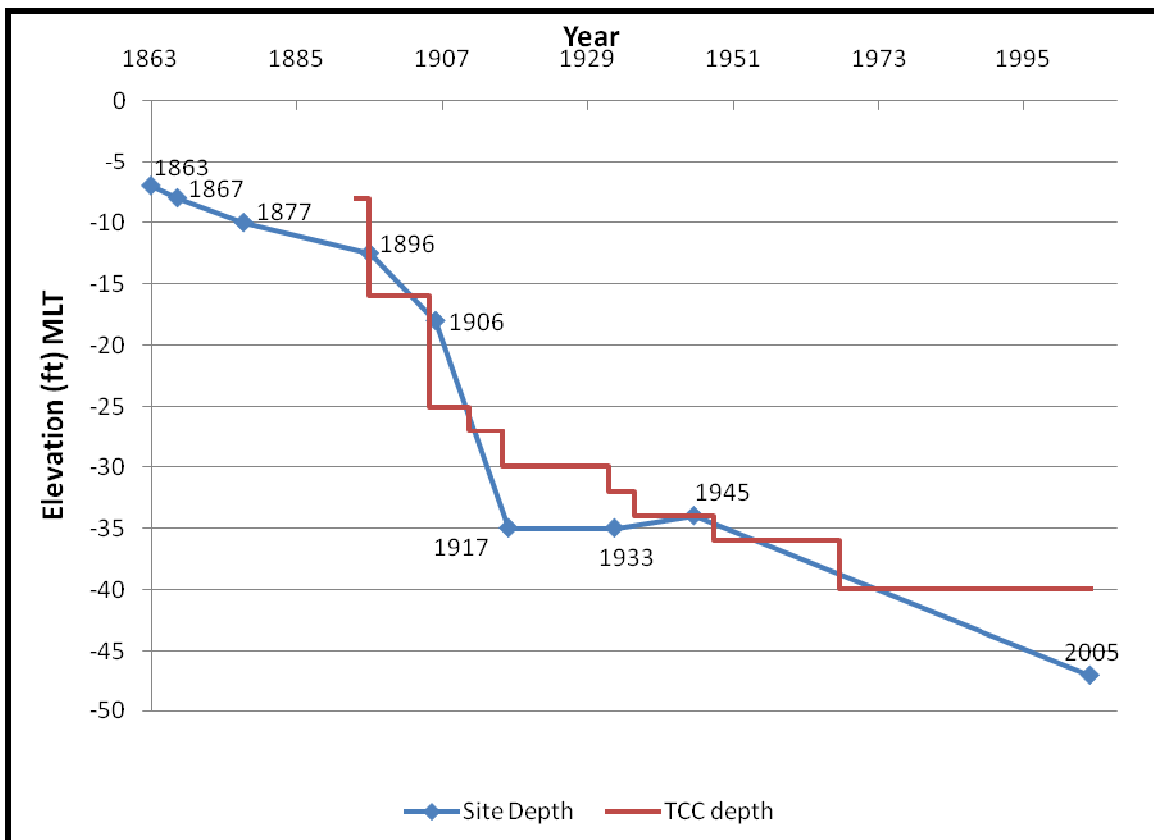
FIGURE 20. HISTORY OF SITE EROSION AND TCC DREDGING.

The erosion history of the site is illustrated on Figure 20. The rate of erosion appears to have been relatively constant for much of the site's history except for roughly 20 years of rapid erosion from 1896 to 1917. Early erosion of the site might be attributable to scour induced by the wreck itself. Prior to 1876 the tidal regime was unaltered from its natural state, and left alone the flood tidal delta might have remained relatively stable. The very presence of the wreck, combined with the introduction of various improvements to Galveston Bay navigation, which altered the natural current regime, likely affected erosion and deposition rates at the site in complex ways.

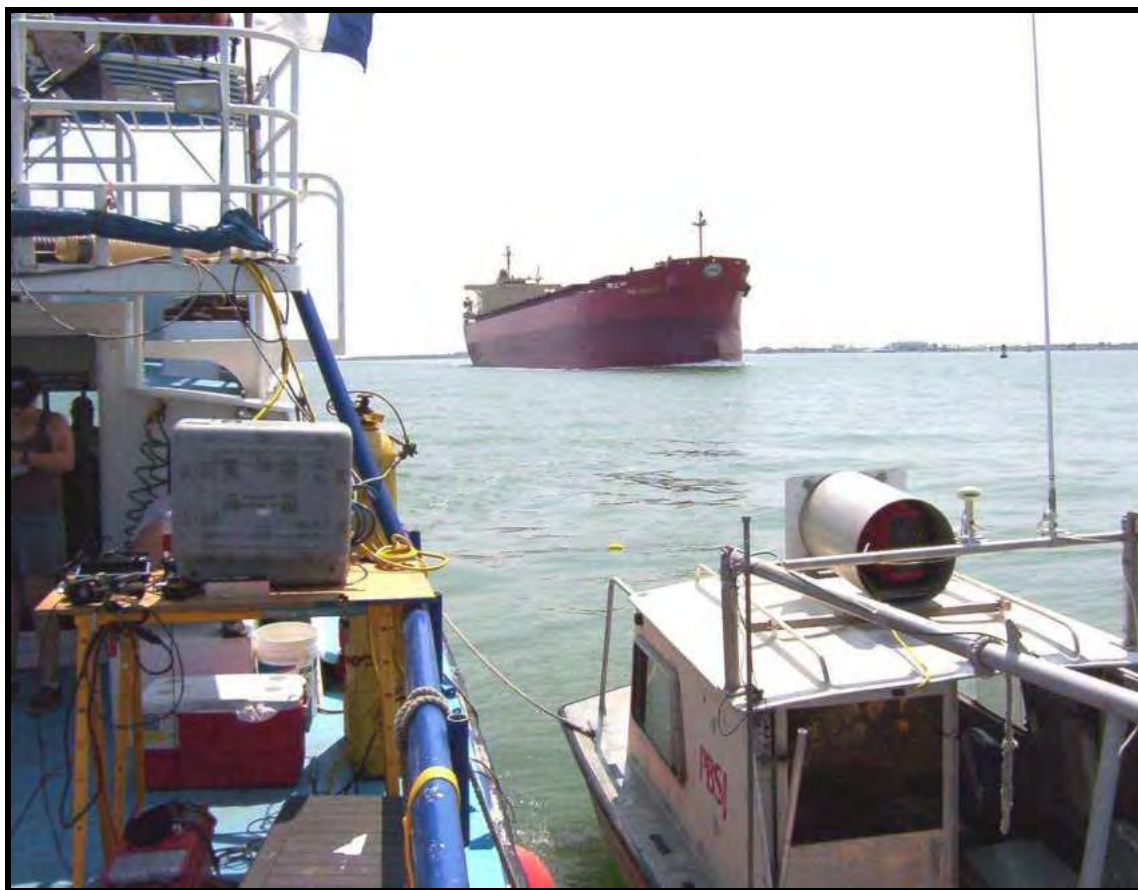
FIGURE 25. PROXIMITY OF DIVE ANCHORAGE TO SHIP TRAFFIC

The proximity of Anomaly GV0032 and *Westfield* to the TCC (Figure 25) necessitated bringing divers to the surface when ships passed. The large displacement of water by ships creates a hazardous current as they pass and can potentially impact the anchorage of the dive vessel. The diver ascent began at least 10 minutes prior to the arrival of each ship in order to allow a margin of safety. Passage of ships on the HGNC did not create a noticeable current; however, the diver was recalled from the water whenever the captain of an approaching vessel on the HGNC made this request.

Daily anchoring of the dive boat was a time-consuming task complicated by proximity of the dive locations to the TCC combined with changes in wind and current directions. A three-point anchorage system was necessary to hold the stern of the dive boat close enough to the desired dive target so that the diver's umbilical would reach. Unfortunately it was not always possible to place anchors at optimal positions to allow for shifts in wind and current directions. The dive boat could not be anchored within the TCC nor could anchors be placed within the channel. This limited the spread of the three-point anchor array to 180 degrees of a circle located northeast of the TCC and made holding a position close to the channel problematic when faced with a southerly wind, especially if the tide was slack.

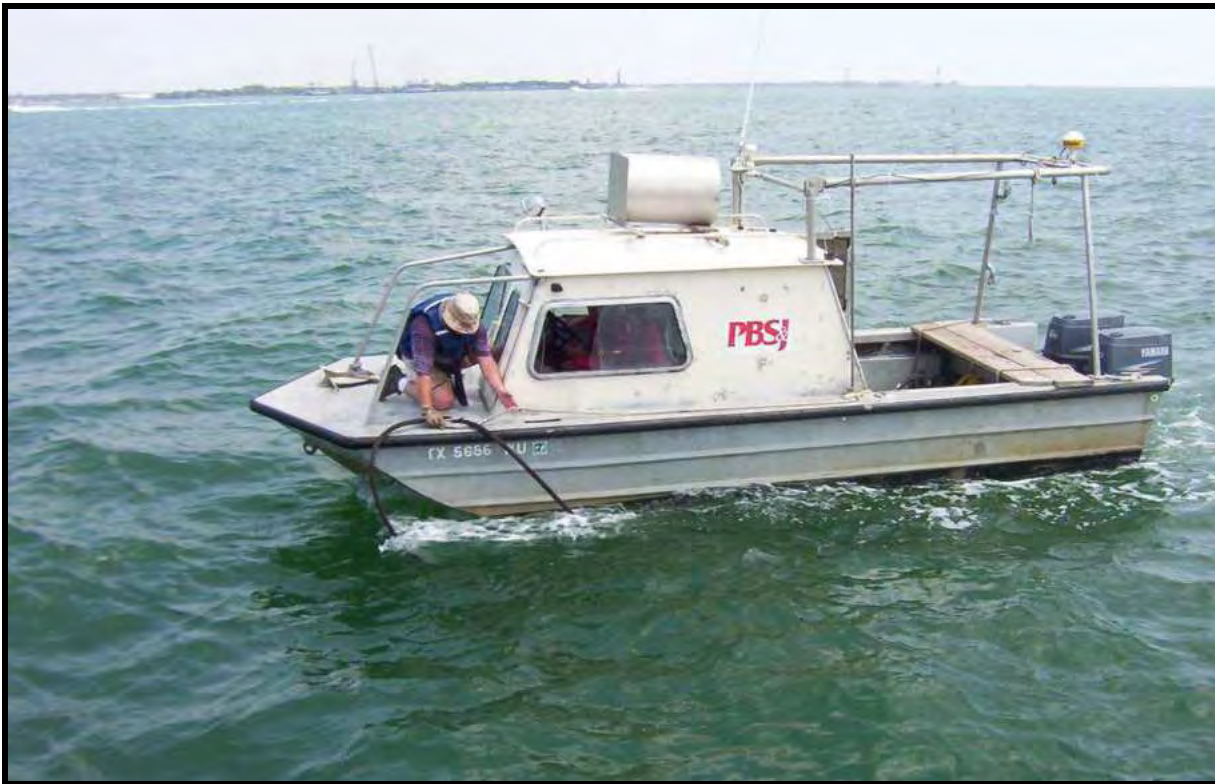
FIGURE 26. DRAGGING CABLE ANOMALY SOURCE AWAY FROM GV0032

and returned to the site. Subsurface probing at the location of these objects returned negative results. At the conclusion of the day's diving operations, a length of 1-1½-inch braided steel cable was snagged by the starboard stern anchor. Its weight prohibited lifting it on board, so it was dragged away from the dive vessel (Figure 26) and disposed of outside of navigation channels. Examination of the boat location at the time of the dives and during the anchoring process suggested that the cable might be the source of Anomaly GV0032. A subsequent magnetometer survey was conducted over the area, which returned negative results (Figure 27) and proved that this length of modern cable was the source of Anomaly GV0032. The miscellaneous ferrous concretions were not substantial enough to create a magnetic anomaly.

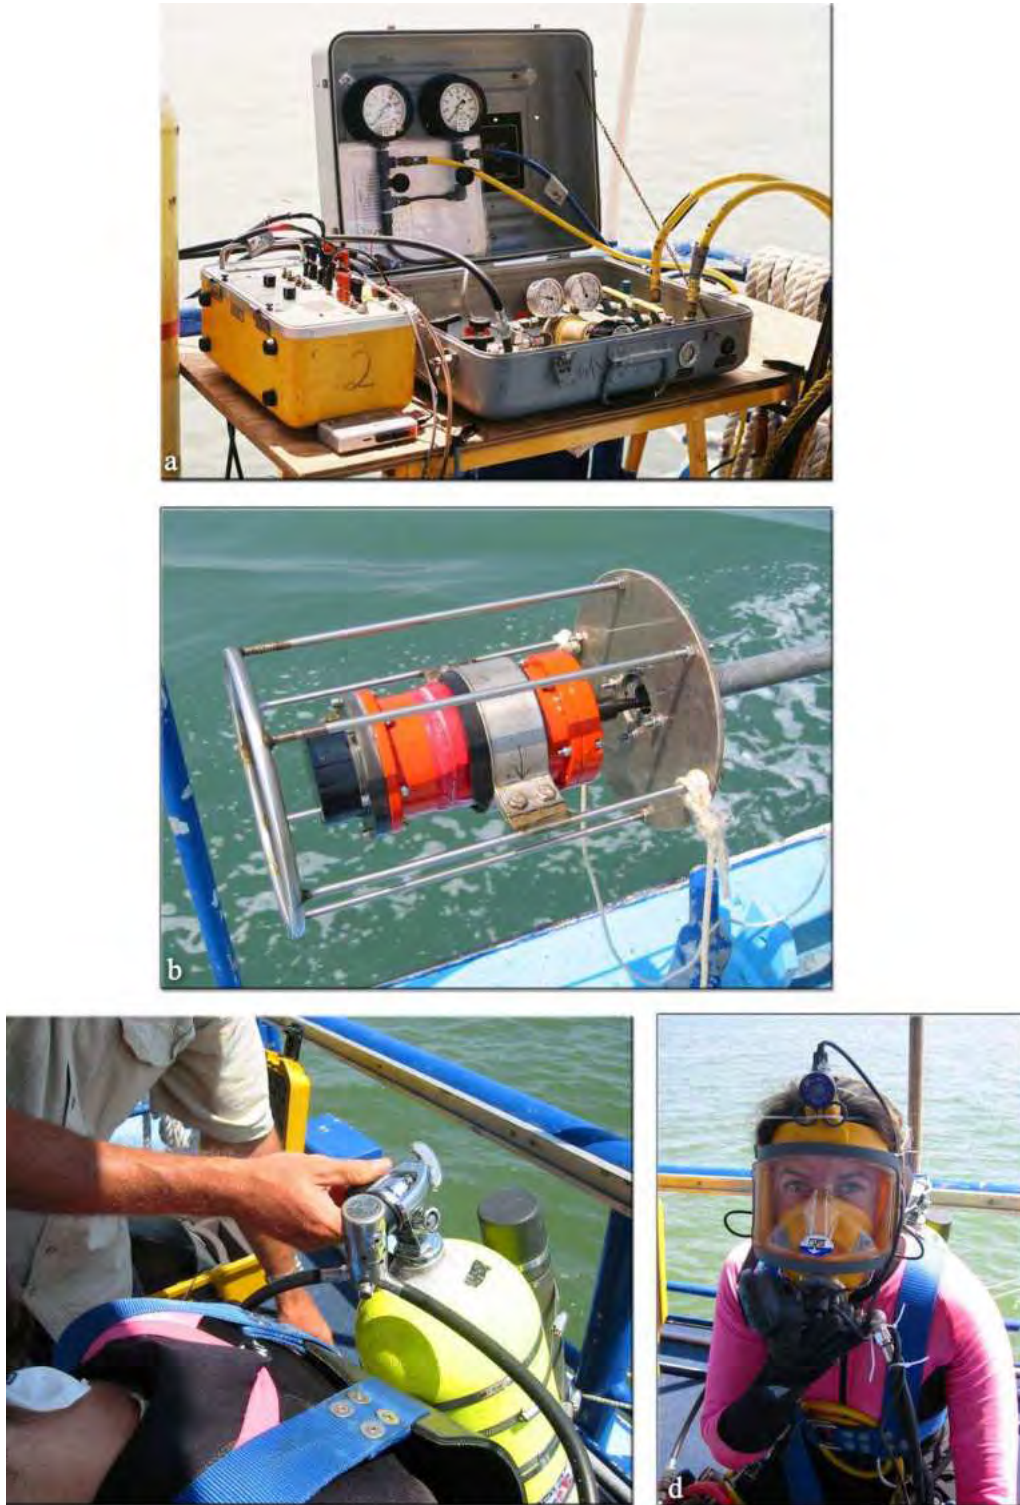
FIGURE 29. DIVE AND POSITIONING OF EQUIPMENT USED FOR D.O. 0005

Another significant improvement over the 2005 field session was the addition of audio and video recording capabilities. Beginning with Dive 7 (of 26), diver video and audio were recorded. A low-light camera was fastened to the top of the primary dive mask (Figure 29d). The video feed was displayed on a deck monitor while it was recorded, so persons keeping dive notes on the boat could

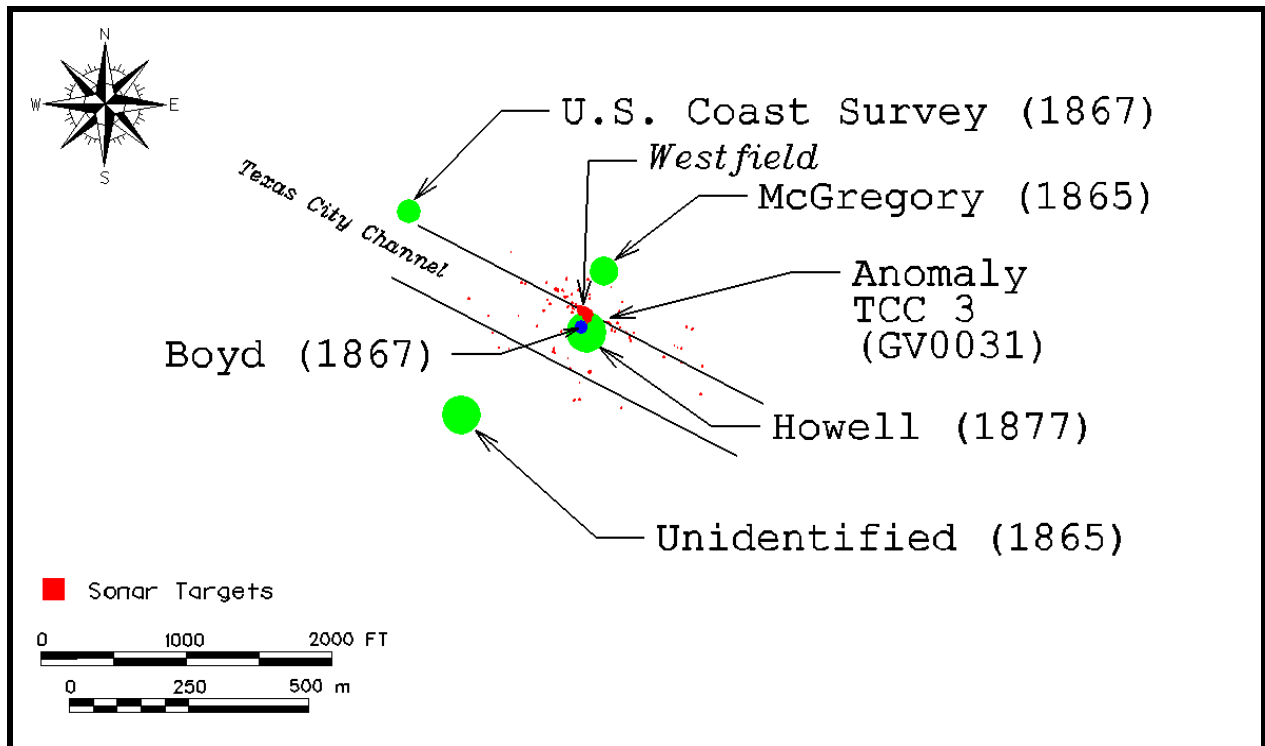
FIGURE 30. COMBINED POSITION ESTIMATES FOR USS *WESTFIELD*

Six historic charts were digitally geo-referenced by Atkins in 2004 when the location of *Westfield* was still unknown. No sonar target had been discovered at that time, and the site was only known as a magnetic anomaly with the designation GV0031. The geo-referencing methodology is documented in Gearhart et al. (2005). One of these charts (Stanton 1868) was discounted because of obvious inaccuracies. The geo-referenced positions for the five remaining charted positions of *Westfield* relative to the TCC are summarized on Figure 30. Five of the six position estimates resulting from Gearhart et al. (2005), again excluding Stanton (1868), cluster within 449 m of one another. Three positions cluster within 133 m of one another. The average of the three most closely grouped positions falls directly on top of *Westfield*. The average of all five positions falls 130 m west of the three-position average.

The cartographic results provide a strong argument to support the identification of 41GV151 as *Westfield*. They also indicate a clear consensus among map makers that *Westfield* grounded on the north side of a shoal. Historic accounts of the battle indicate it must have been steaming in a westerly direction at the time, since it was trying to intercept Confederate steamers approaching Galveston from farther up the bay. These results also demonstrate this methodology's potential for a remarkable level of geographic accuracy, especially when multiple source maps are available to allow removal of random errors through averaging of positions.

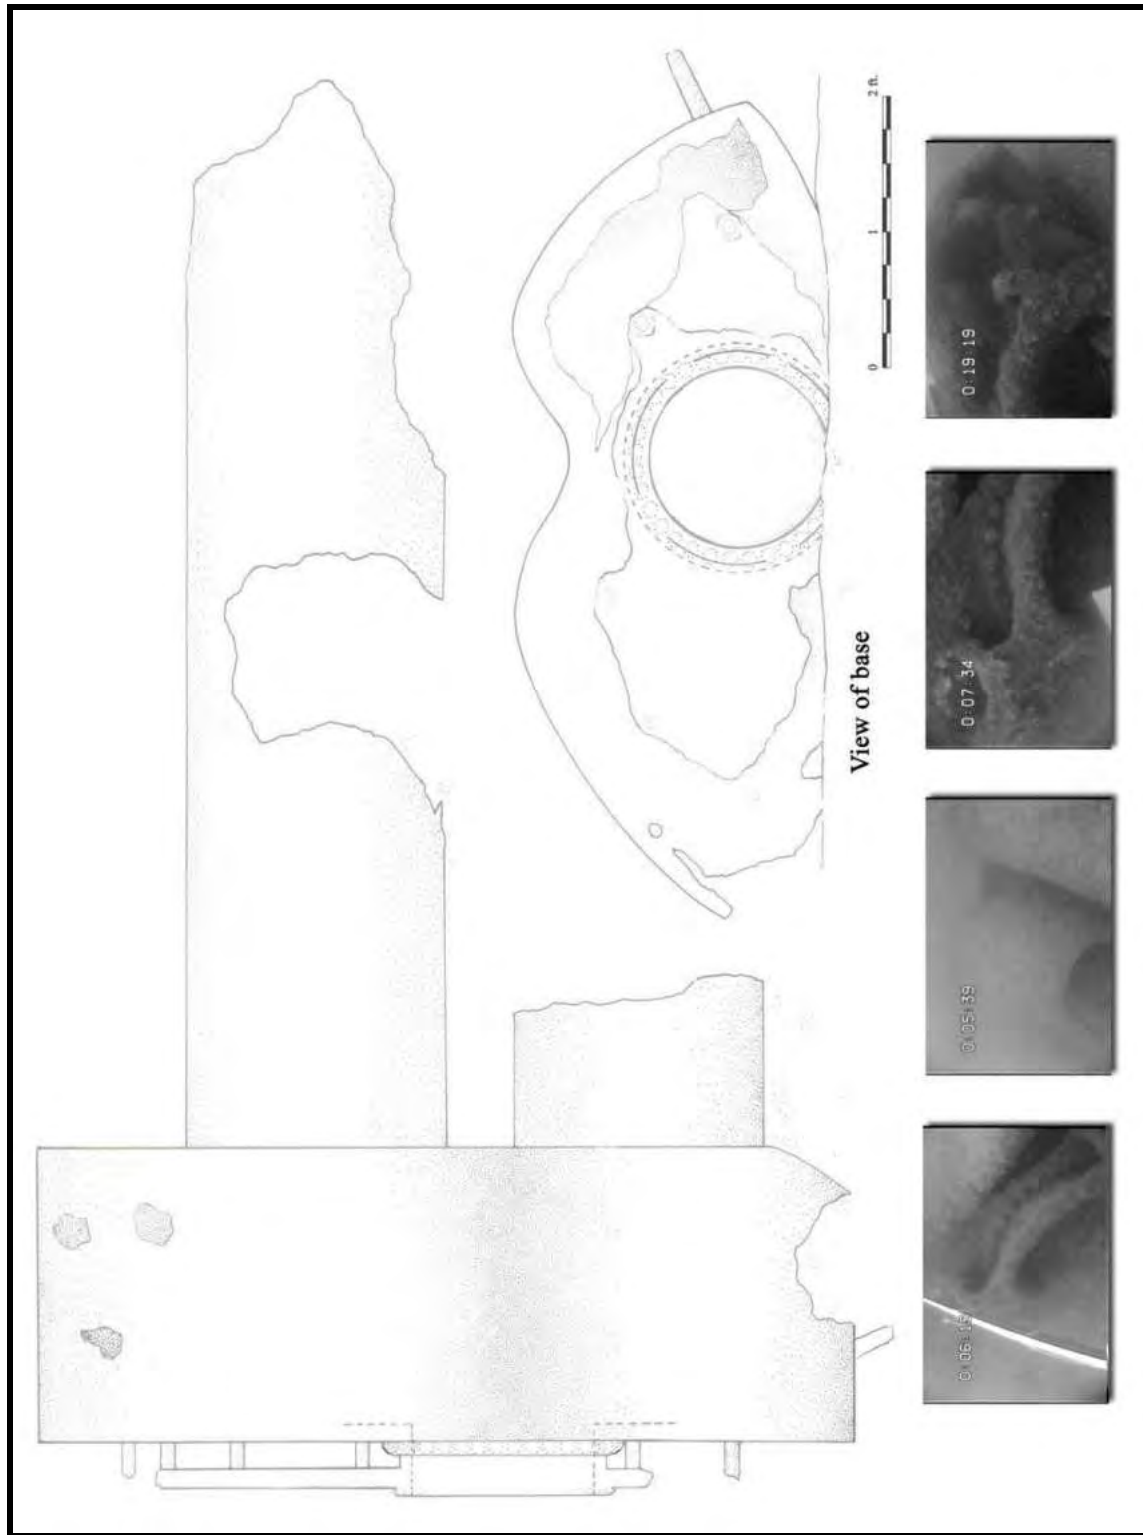
FIGURE 33: BOILER FLUES, ARTIFACT 122-001 (DRAWING BY AMY BORGES)

Two large artifacts are believed to be part of tubular return flue boilers. The most complete example of boiler flues from the site consists of two large-diameter pipes connected to the base of a combustion chamber (Figure 33). The artifact was broken at one end and was somewhat centrally located within the debris field. It is the most easily recognizable object in the sonar image (see Figure 28). The overall dimensions of the artifact recorded in 2006 are 10 ft 3 inches long by 6 ft wide. A second large object, measuring approximately 9 by 6.5 inches, is the firebox from one of the boilers. The object consists of two rectangular chambers that contain parallel iron firegrates (one section is disarticulated).

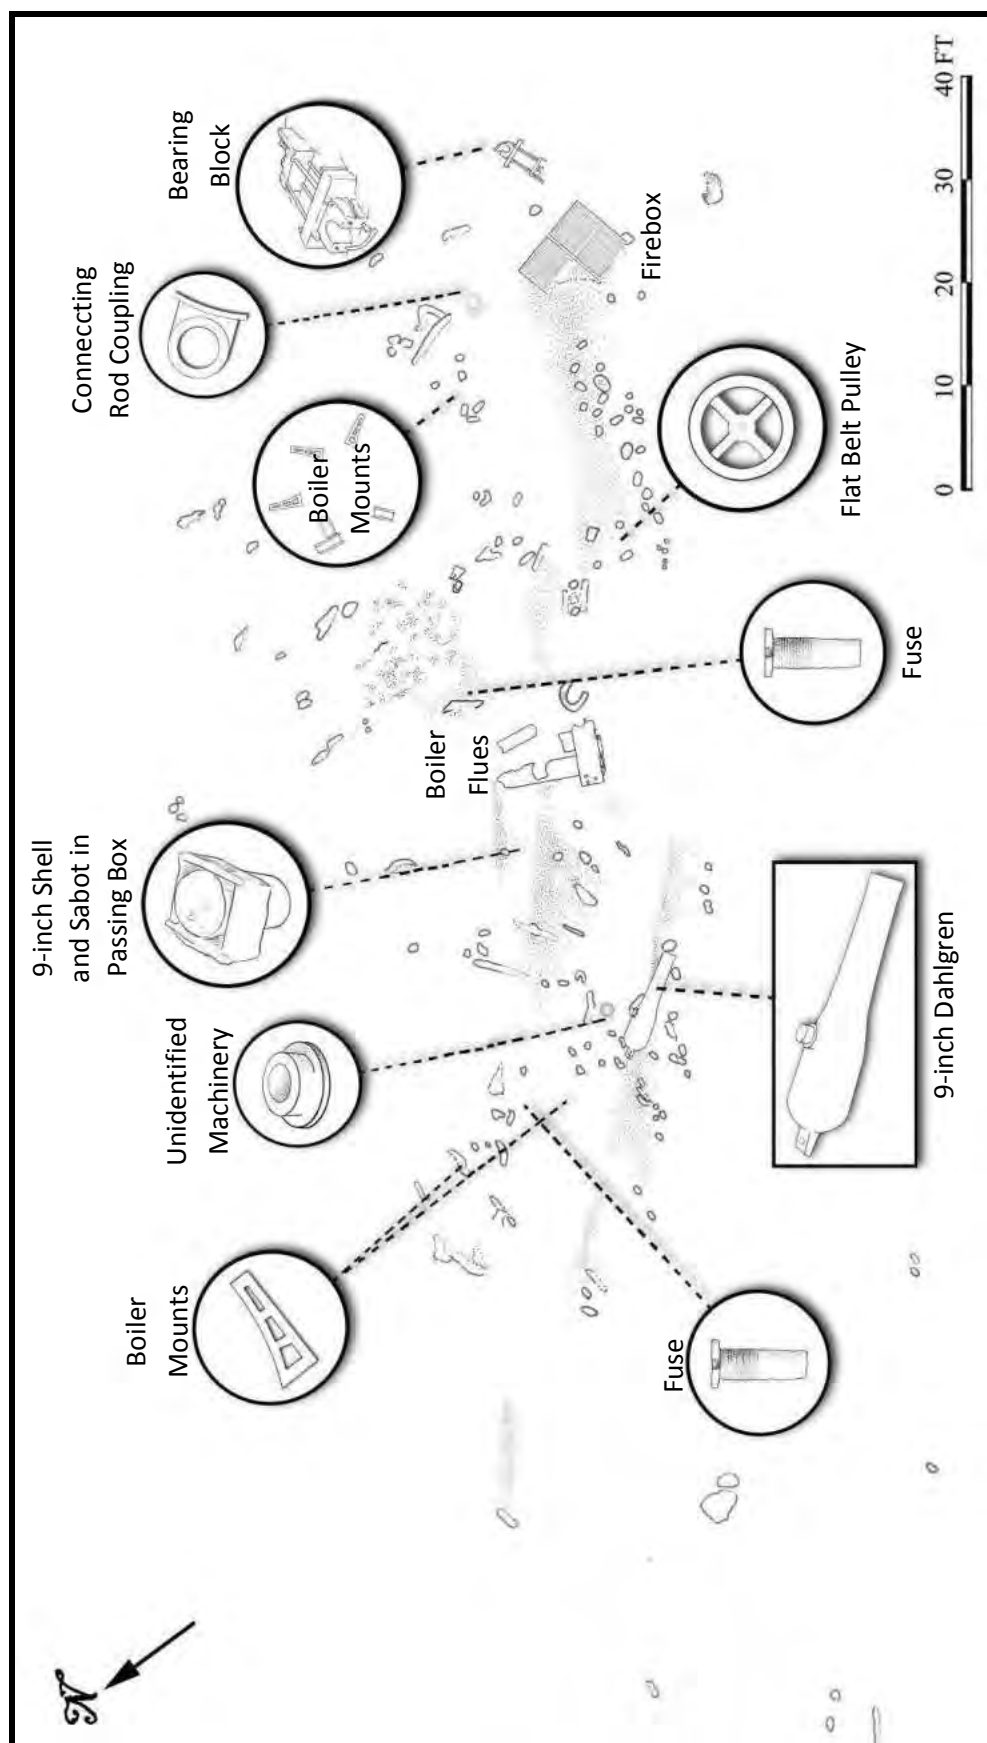
Figure 36. Site Plan (drawn by Amy Borgens)

Dive operations to map the horizontal extent of the wreck were completed through a total of 26 dives. The total bottom coverage of dives, excluding Dive 1 for which the USBL system was not yet active, is illustrated in Appendix D, Figure D-5. Diver positions for each 2-second period of 25 dives are represented by individual dots on the figure. In heavily trafficked areas these dots merge into a cloud. All of the larger concentrations of visible artifacts were visited by divers. The positions for individual objects were recorded as Target numbers (see Appendix D, Figure D-6). Objects having the potential to yield diagnostic information were documented by measurements, sketches, and video photography. The distribution of select artifacts is depicted on Figure 36.

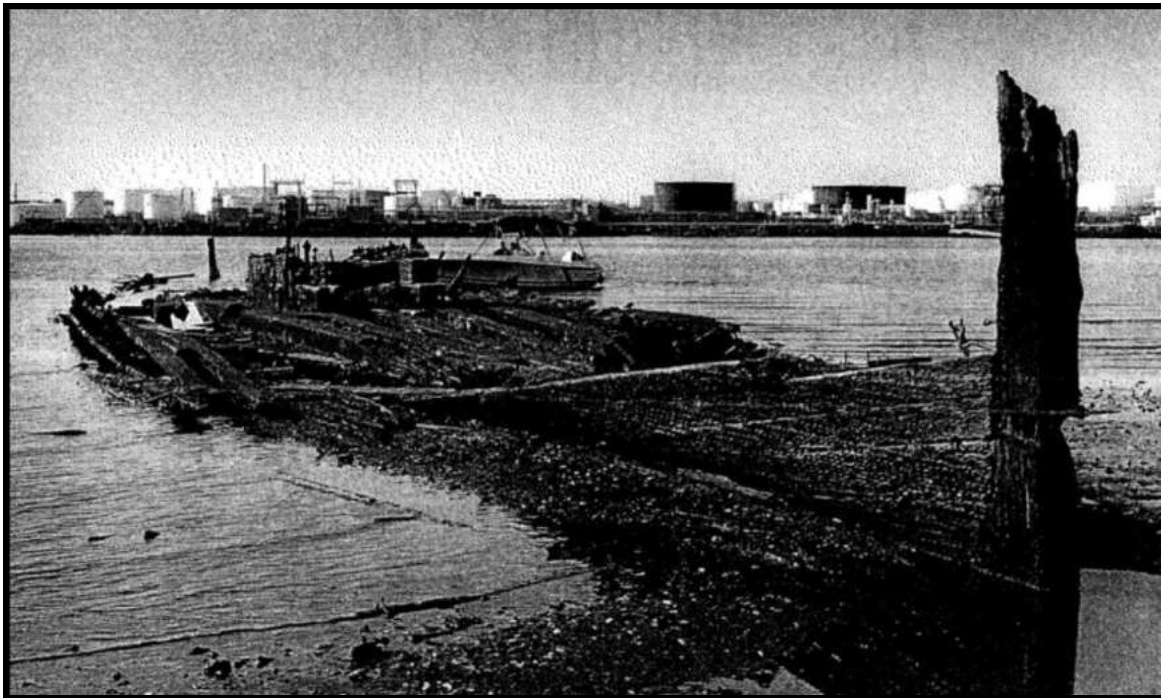
FIGURE 45. *WESTFIELD II* (JAMES ET AL. 1999)

The Simonson-built Staten Island ferry *Westfield II* (Figure 2b) was still in service into the early 1900s, even after the explosion of its boiler in 1871. That event is still considered the worst disaster in the history of the ferry service, and yet in spite of the catastrophe, at the time of its retirement in 1905 it held the record for the longest tenure of service in the fleet at 44 years (Scull 1982:10). The remnants of two wrecked ferryboats near that of *Astoria* in New York Harbor are believed to be *Westfield II* and *Middleton*. The wreck of *Westfield II* (Figure 45), known as vessel no. 58, was

examined by Panamerican Consultants in the late 1990s. The lower hull of the ferry, consisting of frame pairs, sister keelsons, engine bed timbers, veiling, and hull planking, was in excellent

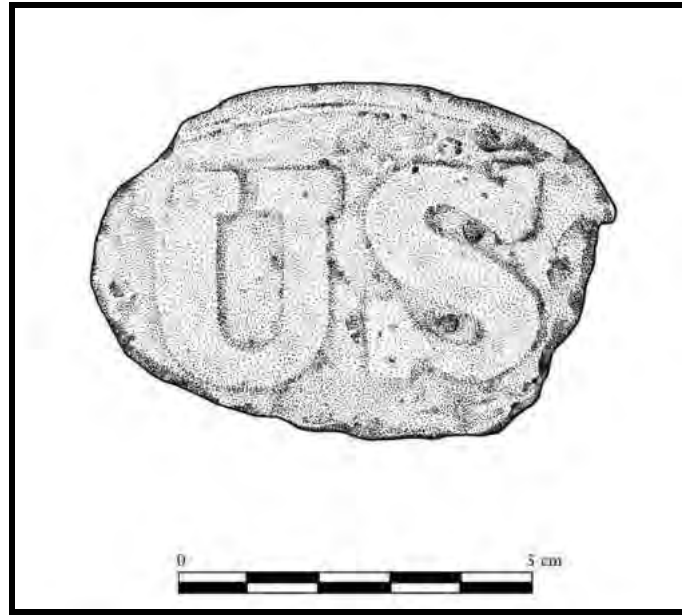
Figure 46. Union Belt Buckle
(Illustration by A. Borgens 2009)

Preliminary archeological dives in 2005, 2006 and 2009 discovered a relatively small number of artifacts of a more personal nature than the larger fragments of mostly iron that dominated the visible debris field. A historic ginger bottle and sherds of glass were observed in 2006. A complete, intrusive historic Billy Baxter ginger ale bottle (circa 1920) also was discovered, suggesting other fragile, light-weight artifacts may have survived. A Union belt buckle was recovered during fieldwork in May 2009 (Figure 46).

A 4-x-5-ft area of unit 15 was cleared of loose shell hash that was roughly 6 inches deep. The diver conducting the dredging was unsure whether sterile clay was reached during the course of work due to the dense nature of the sediment underlying the shell hash. One large immovable artifact was encountered buried in the excavation unit. A total of three small artifacts were collected from the top 6 inches of shell hash; two fastenerlike concretions were on top of the sediment. The most diagnostic artifact recovered during the May 2009 field session was collected during the final dive at unit 15, while retrieving a sample of shell hash. This was a lead Union belt buckle stamped “US” (Artifact 6; see Figure 46). The outer brass plating had long since deteriorated.

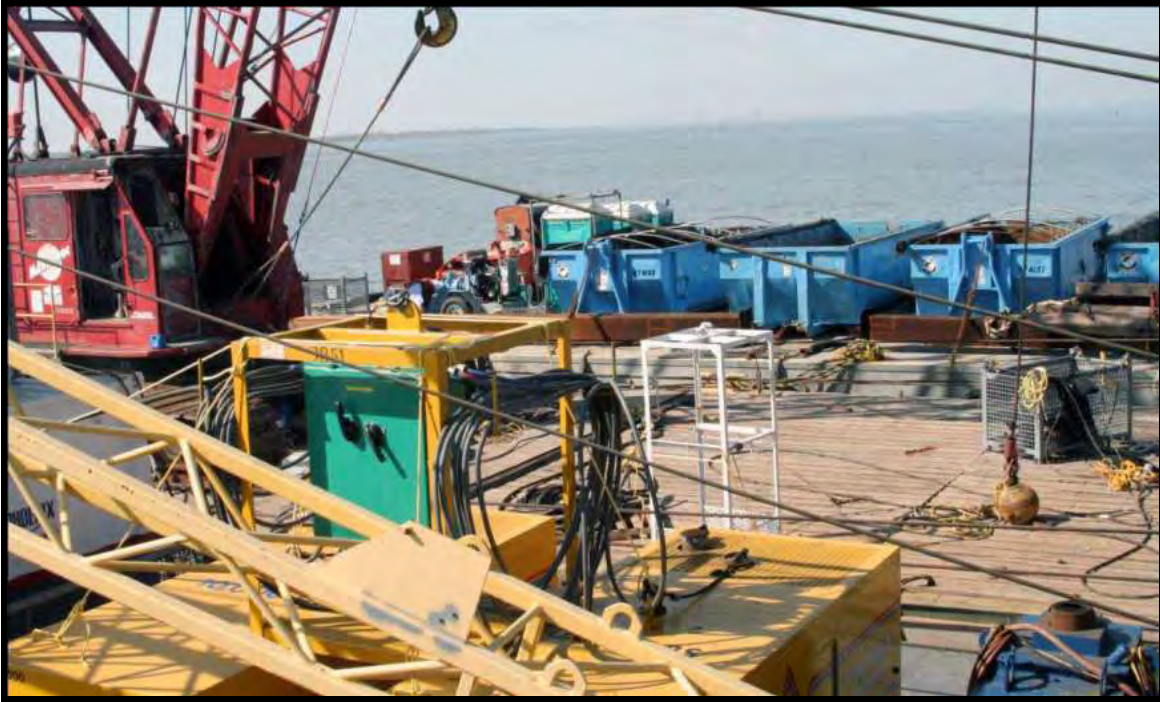
FIGURE 53. DETAIL OF BARGES DURING MOBILIZATION (PHOTOGRAPH BY AMY BORGENS)

Mobilization of the on-site Galveston fieldwork took four days, November 14–17, after which the first phase was commenced. Work vessels included a 120-x-40-ft barge equipped with a large (138-ton) crane. The barge included a “laydown” and sorting area for large artifacts, and the vessel positioning and navigation operations (“survey shack”); a 100-ft-long barge, equipped with a small (16-ton) crane, housed the diver operations including the communications shack, air compressor stations, recompression chamber, generators, and water pumps; and a 100-x-40-ft materials barge, carried up to nine roll-off/filter boxes used for artifact wet storage, sediment storage, and large artifact screening. The USACE contracted SUPSALV and their subcontractor DonJon Marine Co., Inc. for set-up and management of the Galveston-based barge operations. The barges and cranes were owned and operated by J&S Contractors of Freeport, Texas. Diving and survey/navigation personnel and equipment were provided by Phoenix International (under contract with SUPSALV). Atkins archeologists coordinated and supervised collection protocols to ensure adherence to the research design.

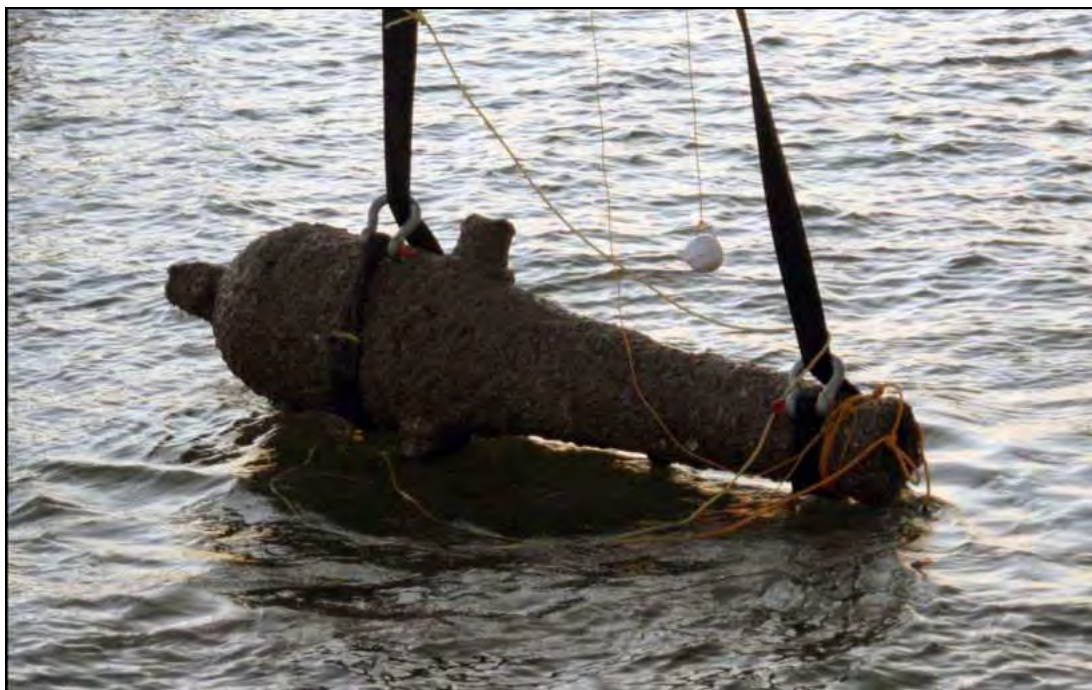
FIGURE 55. RECOVERY OF DAHLGREN CANNON (PHOTOGRAPH BY AMY BORGENS)

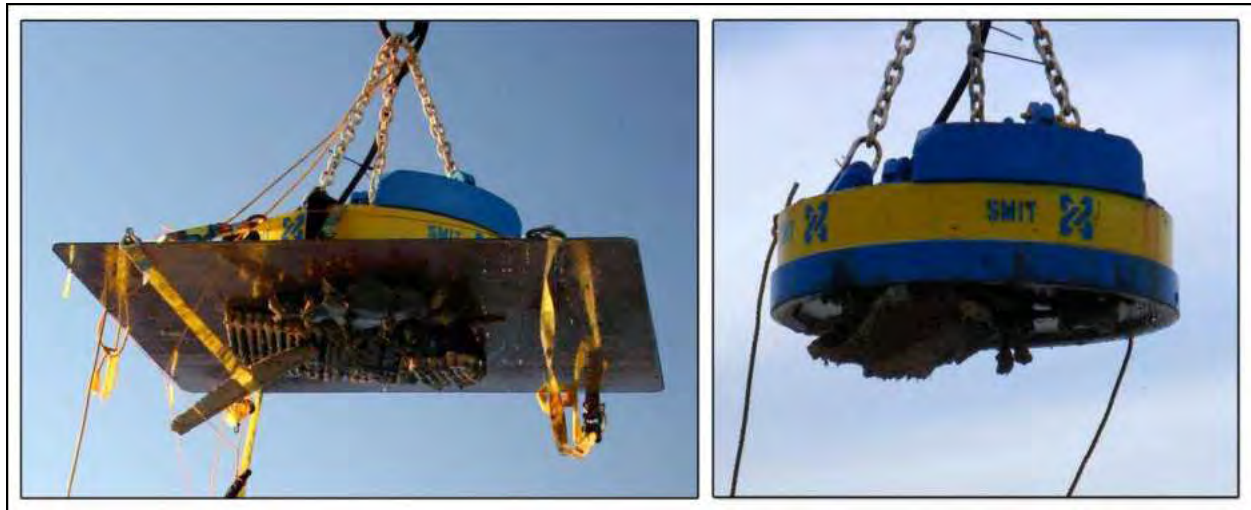
FIGURE 56. DETAIL OF ELECTROMAGNET (WITH AND WITHOUT ATTACHED PLATE)

The second phase of operations, conducted November 25–27, involved using an electromagnet to systematically remove ferrous artifacts from the seafloor. The magnet, owned and operated by SMIT Americas, Inc., measured 5.5 ft in diameter with a lift capacity of 33 tons and was deployed using the large crane (Figure 56). The purpose of the magnet was to remove known artifacts that were too large for recovery using the clamshell yet too numerous to recover by diving as originally intended. Weather delays necessitated that this method be considered in order to put the project back on schedule. All agency archeologists were consulted regarding this decision and agreed to test this methodology. The general effectiveness and safety (to personnel and artifacts) of the magnet was successfully demonstrated to the satisfaction of archeologists on the barge deck using modern objects prior to its use on the wreck site. An attempt was made to increase the effective surface area of the magnet by attaching a 10-x-8-ft steel plate (see Figure 56); however, this method proved unsatisfactory, as the magnetic charge dissipated substantially outside of the central 5.5-ft-

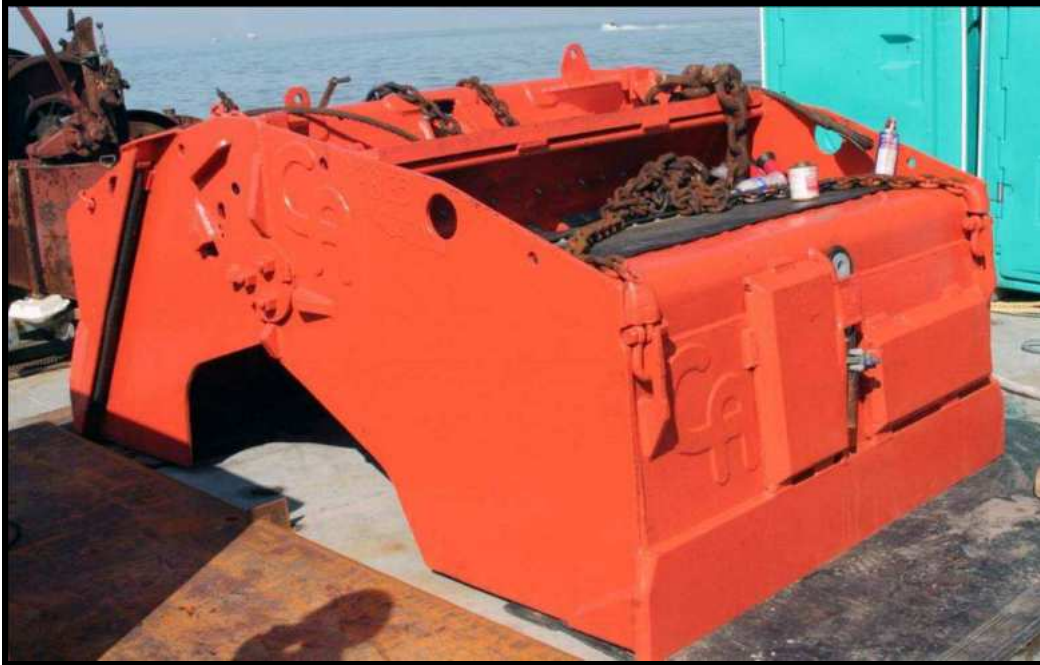
FIGURE 57. ENVIRONMENTAL CLAMSHELL DREDGE

The final phase of the Galveston fieldwork consisted of systematic clamshell dredge recovery of sediment from the site. The clamshell was a 3-cubic-yard smooth environmental bucket. The smooth environmental bucket does not have teeth and is less inclined to dig into the underlying clay bed. The clamshell measured 6 x 9 ft when open (Figure 57) and weighed 5,100 pounds empty. Environmental clamshell buckets are generally used to remove contaminated materials and, as such are designed to minimize resuspension of sediments and to protect water quality. They are manufactured to ensure minimal loss of materials during extraction.

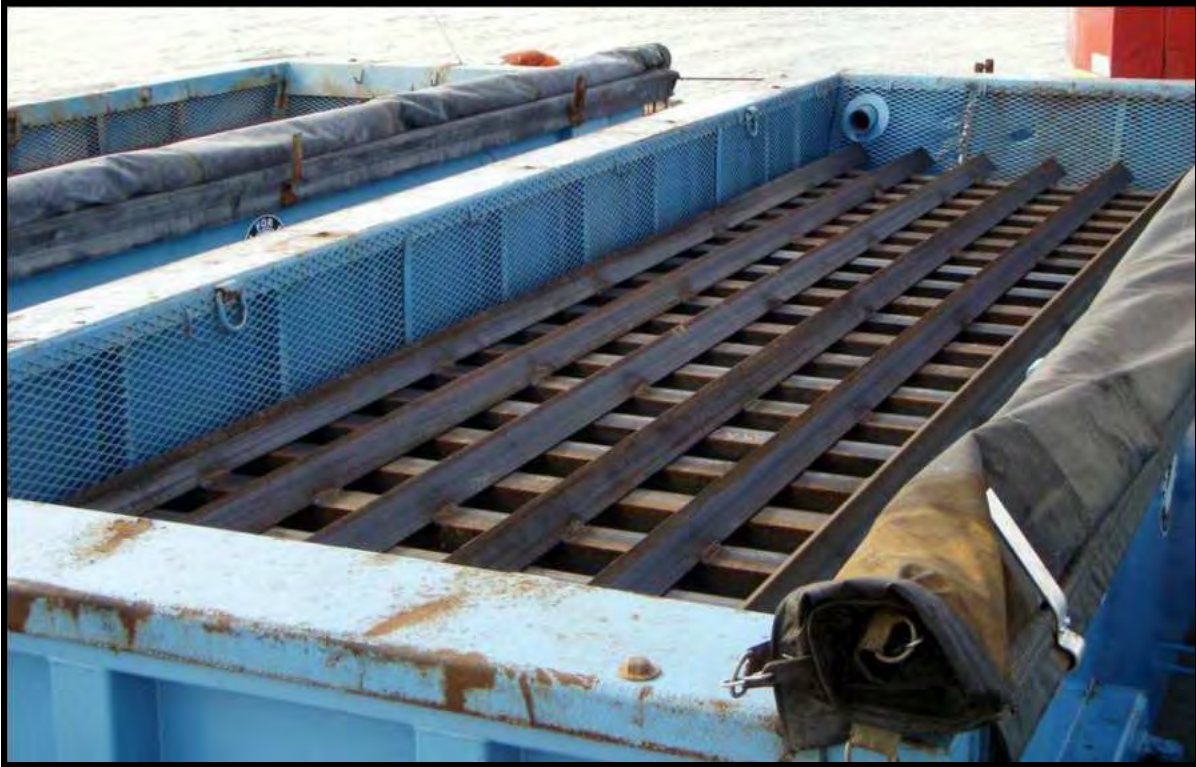
Each clamshell load was placed into a specialized 23-ft-long x 8-ft-wide x 5-ft-deep, watertight roll-off box containing an interior lining of steel screens of $\frac{1}{4}$ inch on the bottom and 1-inch screens on the side (termed a “filter box”). Atkins archeologists were present on the spud barge and materials barge to maintain a record of provenience for each clamshell load and filter box. Each filter box contained a removable inset 6-inch steel screen so that any MEC within the sediment could be identified and removed during this phase of the operation (Figure 59). The loaded clamshell was placed on top of the 6-inch screen and opened. Donjon personnel used water hoses to rinse sediment and clay from the matrix while Atkins archeologists supervised the recovery of artifacts from the screen. Any artifacts larger than 6 inches (or otherwise visible in the sediment/shell hash matrix) were removed and placed in wet storage containers, labeled with the corresponding clamshell and grid number for provenience. The remaining materials were rinsed through the 6-inch screen to be collected on the underlying $\frac{1}{4}$ -inch screen.

FIGURE 59. FILTER BOX WITH INSET 6-INCH MEC SCREEN INSERTED (PHOTOGRAPH BY SARA LAURENCE)

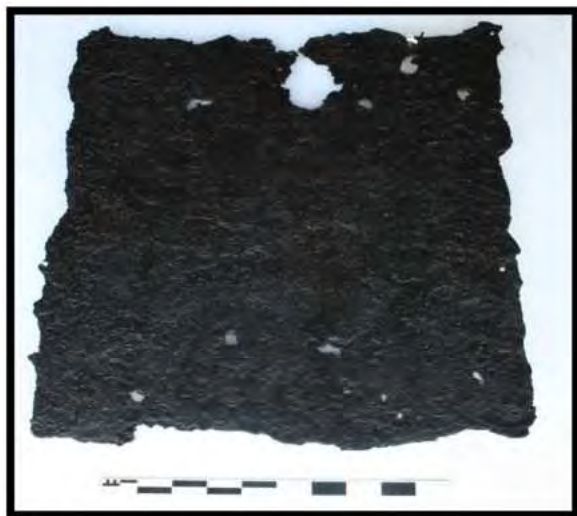
Six boilerplates used as armor were recovered relatively intact (Artifacts 102-006, 108-001, 111-001, 111-002, 111-003, and 122-045). Their sizes varied by a few inches due to corrosion along the plates' edges; however, the most intact plate (Artifact 108-001), measured 5.0 x 5.0 ft, allowing the original size to be determined (Figure 64). This size is consistent with the size of plates covering the cabin in the Memphis drawing of *Westfield* (Figure 3). Conservators determined that the plates were originally 5/16-inch thick, sufficient only to protect the gun crews from small arms fire.

FIGURE 64. SQUARE ARMORED PLATE
(ARTIFACT 108-001; SCALE CM/DM)

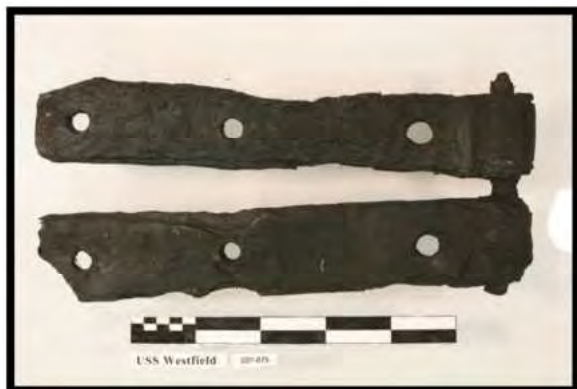
FIGURE 66. ARMOR HINGE
(ARTIFACT 107-075; SCALE CM)

The Memphis drawing (Figure 3) depicts that the gun decks at the bow and stern, were protected by smaller hinged metal plates. In the drawing these are clearly shown as less than half the width of the 5-ft plates protecting the cabin. These smaller plates could be raised or lowered as required when using the pivot guns. Artifact 123-037 and 125-001 are the best preserved examples out of five that were identified conclusively as the smaller size of hinged armor plates (Artifacts 103-076, 110-002, 110-003, 123-037, and 125-001). These plates measure approximately 3.0 x 2.5 ft. Their height indicates that when folded down, 2 ft of the armored bulwarks remained standing as shown in Figure 3 for both the broadside gun ports and the pivot gun positions. Hinges were preserved on several of these plates. Hinge measurements are consistent with those used on the broadside gun port plate (Figure 65). Numerous hinges also were found separated from the armor plates, often with their upper and lower components. Figure 66 displays some of these examples with their original pivot bolts still intact (Artifacts 103-075, 104-015, and 107-075).
