Investigation and Recovery of USS Westfield (Site 41GV151) Galveston Bay, Galveston County, Texas

Document No. 100102a
Atkins Job No. 044118606

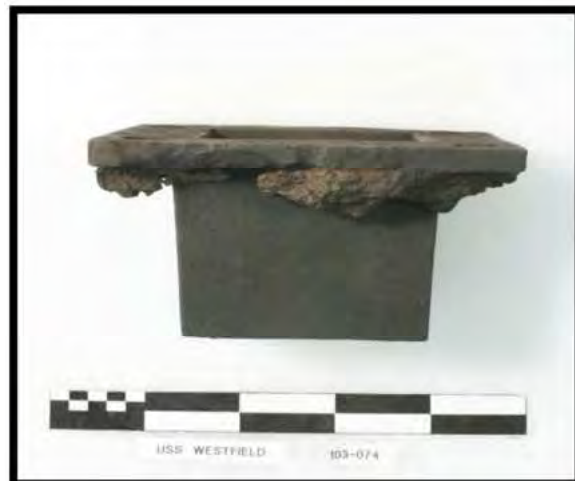
FIGURE 67. STANCHION SOCKET
(ARTIFACT 103-074; SCALE CM)

Behind the bulwarks *Westfield* was equipped with defensive netting to repel enemy boarding parties. The Memphis drawing (Figure 3) shows netting supported by stanchions on both the bow and stern decks. These stanchions were supported by sockets imbedded in the deck. One of these sockets survived intact (Artifact 103-074). The artifact is cast iron and still contains some of the wood from the original deck (Figure 67). Based on the socket size, the stanchion measured 2-1/2 x 3-3/4 inches thick at the bottom of the socket. A similar stanchion (Figure 68) was recovered from the Civil War steamer, USS *Otsego*, the difference being that the latter object was made of brass and contained smaller measurements (Diveley 2008:223). *Westfield* required numerous posts and sockets in order to support nets around each gun deck. A general idea of the socket arrangement can be inferred from Figure 69, in which an unknown converted ferry gunboat has all of the stanchions erected in their respective sockets.

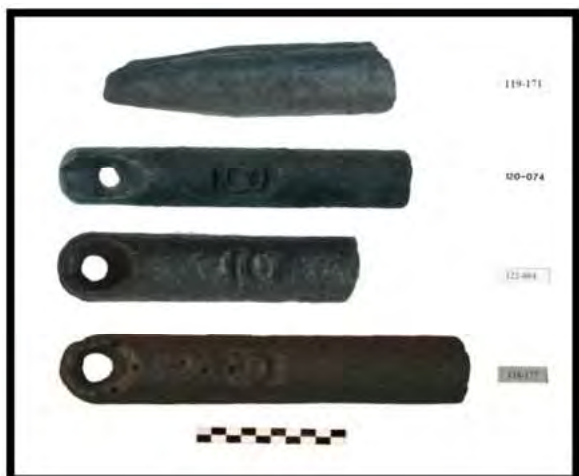
During this period, sash weights were commonly used to counter balance the weight of large windows. This helped keep them open and prevented the windows from slamming down when being closed. Archeologists recovered numerous sash weights from *Westfield* (Figure 70). These weights may have been left over from when the vessel served as a ferryboat. During the rushed conversion of *Westfield*, and the removal of the large windows, many of the sash weights may have

FIGURE 70. SASH WEIGHTS

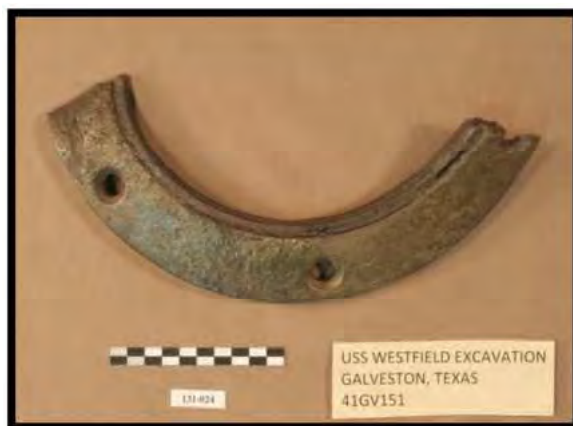
FIGURE 72. BRASS PORT HOLE FRAGMENT
(ARTIFACT 131-024)

Artifact 131-024 is also believed to have come from a porthole but having a smaller diameter than Artifact 124-034. The object consists of a bent brass rim fragment with recessed fastening holes and a series of parallel ribs on the inside circumference (Figure 72). The outer diameter is about 13 inches. The backside of the rim is hollowed out indicating that the artifact was part of a frame. The ribs lining the margin of the interior curve might have functioned to hold a gasket in place. This object resembles the outer supporting rim of a porthole frame that was mounted to a wall surface. The complete porthole likely included a second inner frame holding the glass that could be closed and tightened into the gasket to create a watertight seal (Figure 73).

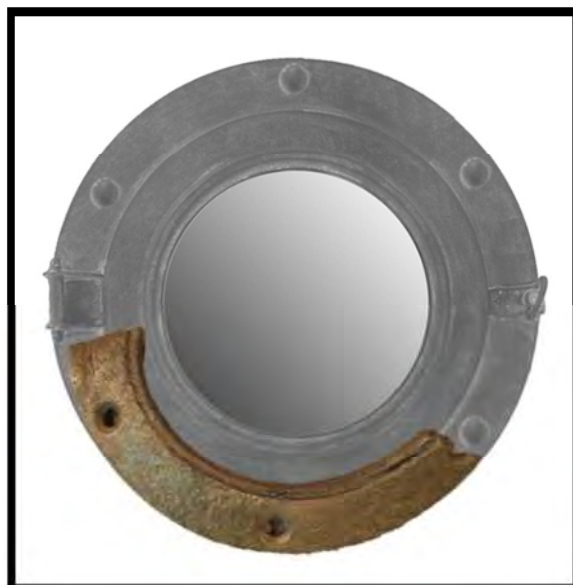
FIGURE 73. THEORETICAL RECONSTRUCTION
OF PORT HOLE

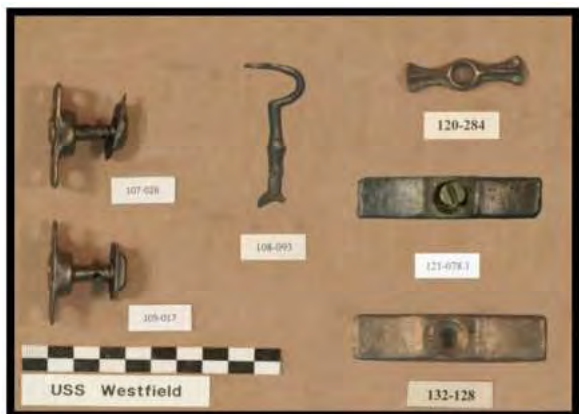
FIGURE 75. BRASS ARTIFACTS FROM CUPBOARDS

Numerous recovered artifacts can be associated with these refurbished cabins. Most of these artifacts appear to have come from a variety of cupboards that likely facilitated personal storage. These objects include small turning knobs (Artifacts 105-017 and 107-026), a latching hook (Artifact 108-093), and two types of cupboard turning buttons (Artifacts 120-284, 121-078.1, and 132-128). It is very unlikely that these cupboard objects were retained from *Westfield's* time as a ferry (Figure 75). Any cupboard storage would have been located in the saloon deck, which was removed during *Westfield's* conversion. Based on surviving photography of *Westfield's* sister ships, the lower main passenger cabins only contained enough room for seating and did not have space for any type of cupboard storage. Two hooks were also recovered (Figure 76). One can be easily identified as a common coat hook fragment (Artifact 121-145), while the other is larger and contains a pinhole that pierces through the end of the object (Artifact 119-216). The exact use of the latter object and its pinhole is not clear, but the object appears to be from a fixture designed to hold personal effects.

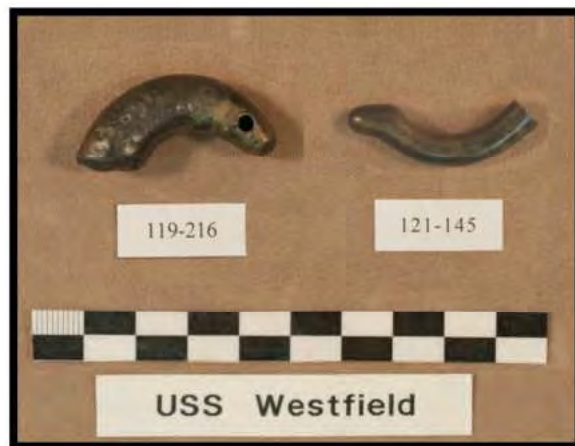
FIGURE 76. BRASS CABIN HOOKS
(ARTIFACT 119-216 & 121-145; SCALE MM/CM)

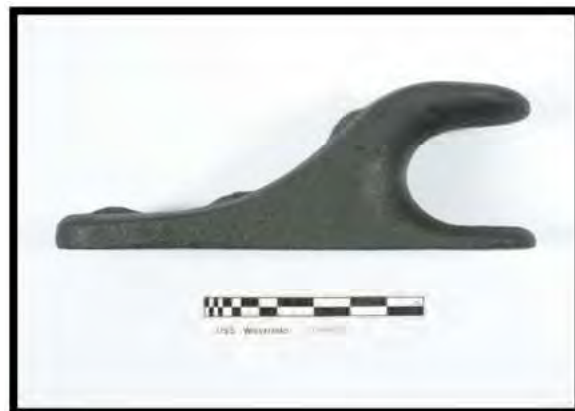
FIGURE 80. CAST IRON ROLLING CHOCK
(ARTIFACT 125-068; SCALE INCHES)

A single cast iron rolling chock (Artifact 125-068) was found near the stern area (Figure 80). This artifact was originally secured to the vessel with three fastening bolts. Like ships today, this object would have been used to guide securing lines when *Westfield* tied alongside another vessel or docked near land. Since the armored plates would have interfered with lines coming onto or leaving the vessel, the rolling chock may have been mounted on the outer guard. On the lowest part of the bulwarks, the water way timber allowed for deck drainage through scupper holes, and ropes or chains that passed through hawser pipes. An example of such a hawser pipe was recovered. Artifact 107-069 is made of lead and therefore likely received rope, since chains would have been too harsh on such a soft metal (Figure 81). The pipe measures 14.5 to 15 inches along the center excluding the flanges, consistent with the original bulwark thickness through which the pipe passed. On each end, the metal has been hammered down to create a rim or flange. Along the flanges, small holes indicate that the pipe was secured to the bulwarks with nails.

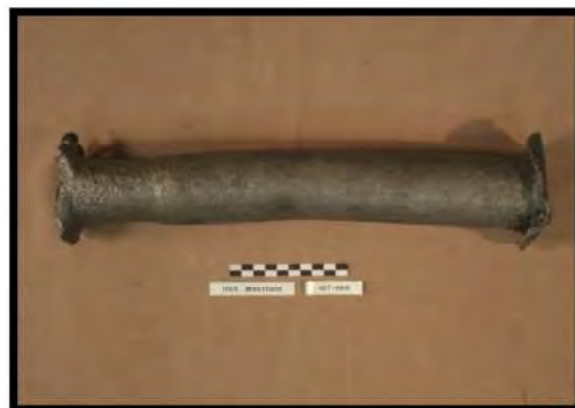
FIGURE 81. LEAD HAWSER PIPE
(ARTIFACT 107-069)

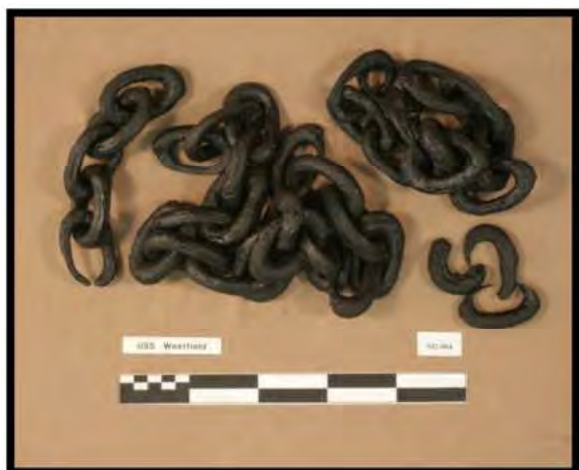
Excavations recovered nine chain segments from *Westfield*. The segments vary in length and preservation, but all were determined to have come from the same size/type of chain (Figure 82). Five of the segments were found across three sequential grids (102, 103, and 104), starting in what archeologists believe was *Westfield's* stern area, and moving east towards the former main cabin. The chain is too small for securing cannon tackle or to be used for hauling the anchors. Based on the recovered locations, these chains may have been used to steer *Westfield's* stern rudder. The chains would have connected beneath the deck on both sides of the rudder, and then would have run under the main cabin, before being redirected on chain rollers, up into the rear pilot house. For comparison, similar sized rudder chains can be seen on the steamboat *Ticonderoga* (Figure 83).

FIGURE 82. WROUGHT IRON CHAIN
(ARTIFACT 102-004; SCALE CM)

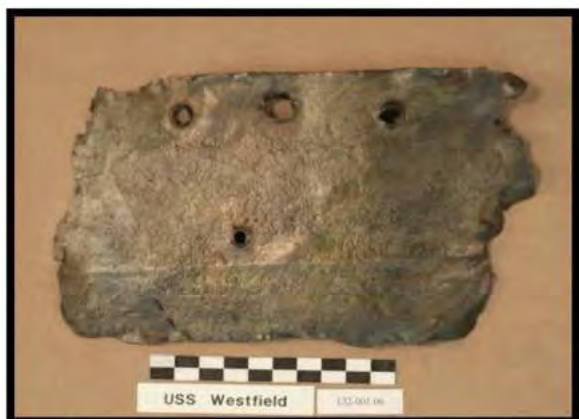
Westfield's hull is known from Confederate salvage accounts to have been sheathed with copper below the waterline. The use of copper sheathing was a time-honored method to protect the wood hull from *teredo* consumption and also to reduce fouling. Copper does not form concretion (unless in contact with or in close proximity to iron) and would have been easy to identify, yet very little copper sheathing was recovered from the site. It is likely that Confederate salvers removed any sheathing accessible from the sides of *Westfield's* hull. Substantial portions of sheathing should have remained, following their salvage efforts; however, by 1906, when additional materials were removed from the site, very little hull remained. Once wooden portions of the ship had deteriorated, storm currents might easily have carried the remaining sheathing away. Only two small fragments of sheathing were recovered (Artifact 132-1.6 and Artifact 133-114). Artifact 132-1.6 (Figure 84) was screened from sediment that was inside the firebox. Along the upper edge of the fragment are attachment holes for the sheathing tacks; these are spaced between 1.5 and 1.8 inches apart and are inset about 0.5 inches.

FIGURE 84. COPPER HULL SHEATHING
(ARTIFACT 132-001.06)

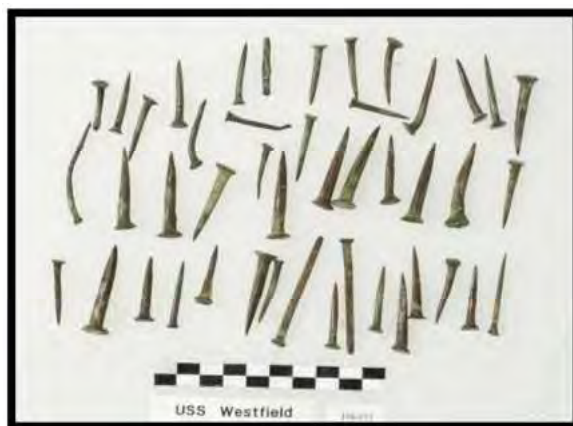
FIGURE 85. COPPER SHEATHING TACKS
(ARTIFACT 108-071)

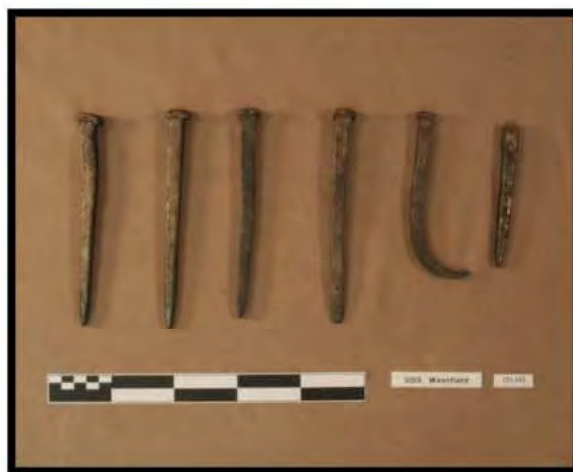
FIGURE 86. BRASS SPIKES
(ARTIFACT 121-154; SCALE CM)

different fastener types, certain examples were purpose-made for more-specialized uses. This pertains primarily to small cupreous tacks for attaching sheathing to the hull; the cupreous spikes that were used to nail planks to the frames and deck planks to the deck beams; and the cupreous bolts that were used along the keel and sister keelsons. These fasteners were manufactured from copper/tin alloys like brass or bronze because they were used in a salty, marine environment and in many cases came in direct contact with water. Fasteners used below the waterline and that were in contact with copper sheathing could only be manufactured of a similar alloy metal, as the interaction between iron fasteners and copper sheathing would degrade the iron through galvanic corrosion. Sheathing tacks are essentially small cupreous nails with a large diameter round head (Figure 85). The sheathing tacks from *Westfield* are typically about 1.1 to 1.5 inches long with heads of about 1/3-inch diameter, though larger and smaller head diameters are common. The cupreous spikes had three primary uses, as “single deck nails,” “double deck nails,” and “boat nails.” Single deck and double deck nails fastened the deck planks to the deck beams, and boat nails attached planks to frames. Boat nails were of varying lengths, were square at the point and generally rose-headed (McCarthy 2005:175). The deck nails from the *Westfield* site are typically 6.0 to 7.0 inches long with a 0.65- to 0.75-inch square head (Figure 86). There are several cupreous through-bolts that are likely from the keel or keelson of *Westfield* (Figure 87). The larger bolts range from 10 to 19 inches in length (some are broken) and have a shaft diameter of approximately 0.75 inches. Some examples, like Artifacts 107-035, 108-006, and 120-077, are through-bolts that still retain their clinch ring. The clinch ring is a round washer that was placed at either or both ends of a bolt. The act of hammering the bolt (clinching) caused the bolt head to flatten against the clinch ring and helped secure it in place. The clinch rings have a diameter of approximately 1.25 inches (McCarthy 2005:181).

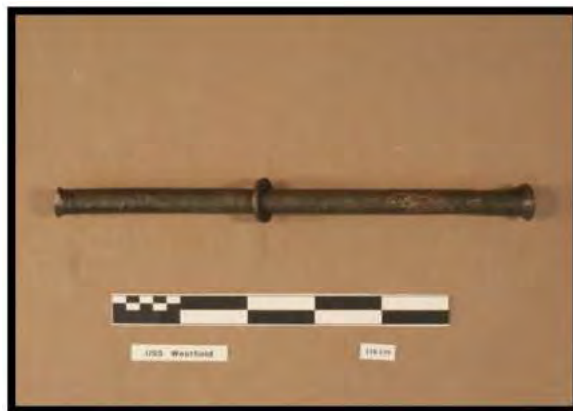
FIGURE 87. BRASS THROUGH BOLT
(ARTIFACT 118-159; SCALE CM)

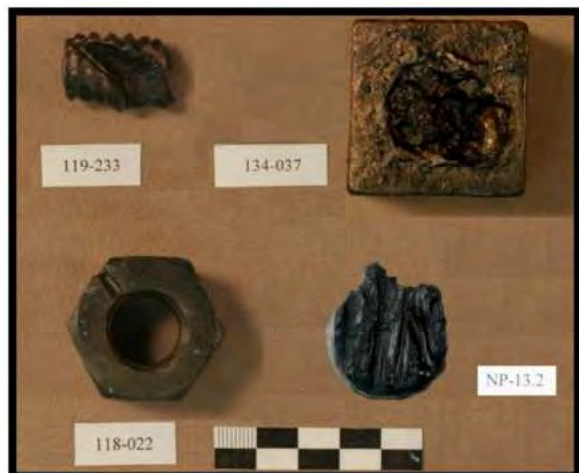
A few of these artifacts (118-022, 119-233, 134-037, and NP-13.2) display saw and hack marks that indicate the objects were removed intentionally by force (Figure 88). One of the most obvious artifacts to display these marks (Artifact 138-051.1) appears to be fastener related, but also contains decorative circles molded into the metal. This artifact was sawn off at an angle, leaving distinct teeth marks in the metal before the saw broke through and ripped off part of the edge (Figure 89).

FIGURE 88. ARTIFACTS WITH HACK AND SAW MARKS (ARTIFACT 118-022, 119-233, 134-037, & NP-13.2; SCALE MM/CM)

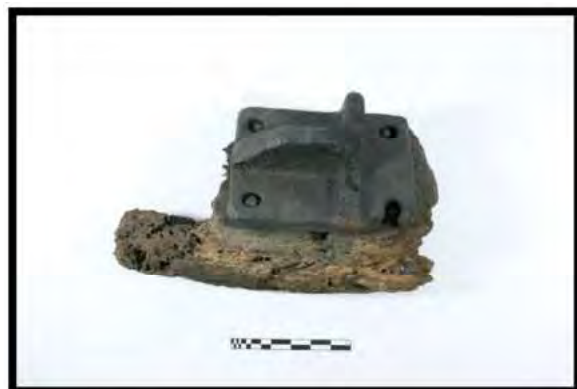
FIGURE 89. SAWN ROUNDED ARTIFACT (ARTIFACT 138-051.1; SCALE MM/CM)

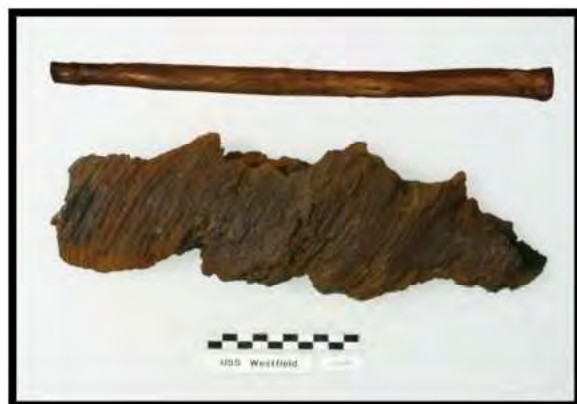
FIGURE 90. LARGE WOOD FRAGMENT WITH IRON FIXTURE (ARTIFACT 108-130; SCALE INCHES)

The largest surviving wood fragment (Artifact 108-130) measures approximately 16 inches long x 8 inches thick (including the bracket) x 7.5 inches wide. This artifact survived because of a large cast iron fixture that is attached to the wood's top surface. The fixture has heavy raised projections or ridges presumably designed to support another structure. An illegible three-digit number (possibly 082, 532 or 522) is embossed on the surface of one projection. Four bolts that did not survive once attached the object to the wood. On the underside of the fixture, an additional ridge was received by a channel cut into the wood. This mortise and tenon-like feature would have helped prevent the fixture from sliding and placing too much lateral strain on the bolts. Although the purpose of this fixture is not known, the object was reinforced to support a heavy load (Figure 90).

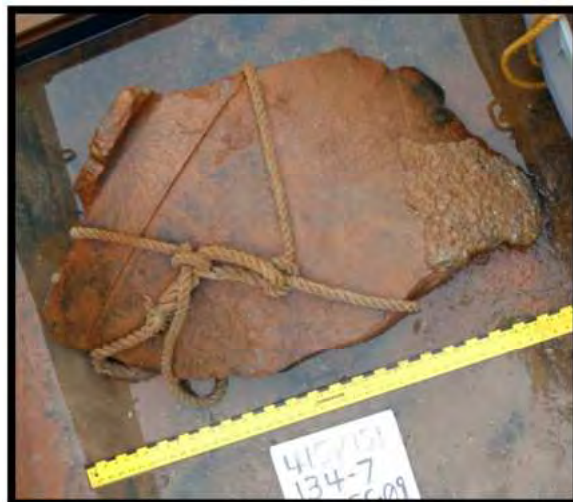
FIGURE 96. LARGE CYLINDER FRAGMENT (ARTIFACT 134-007; SCALE INCHES)

Several fragments of *Westfield's* cylinder and condenser assembly have been identified, of which four are of considerable size (Figure 96). All of these fragments have a curvature consistent with a diameter of 50 inches, matching the historical record. Most engine cylinders had a wall thickness of 1 to 1.5 inches but also incorporated stiffening rings spaced evenly along the cylinder assembly as a method of reinforcement (Whittier 1983:15). *Westfield's* cylinder and condenser artifacts are 1 inch thick and many exhibit stiffening rings measuring 5 inches high and 0.5 inches thick (in addition to the wall thickness). All four of the larger curved fragments can be identified as coming from the lower condenser. Although heavily weathered, Artifact 132-016 still contains a broken remnant of the dividing plate that separated the condenser from the upper cylinder (Figure 97). Two of the artifacts (132-006 and 138-001), are still bolted to the base plate that formed the condenser's foundation (figures 98 and 99). In order to secure the engine cylinder and condenser together to the lower base plate, the ends of each cylindrical component contain a 1-inch-thick lip, 4 inches wide. On this lip, fastening bolts are spaced 6.5 inches apart. In total, four base plate fragments were recovered (132-001.91, 132-006, 138-001, and 140-004). These plates are 1.75 inches thick. During initial de-concretion efforts, conservators noticed that all of these plates retained wooden splinters on their undersides from the massive bed frame timbers that formed the foundation of the entire engine. Amazingly, Artifacts 132-006 and 138-001, along with Artifact 134-007 (no base plate) still fit together and can be rejoined along their fracture points (Figure 100). Based on the rejoining of these artifacts and the known orientation of *Westfield's* engine (condenser/engine cylinder aft, air pump/hot well forward), conservators were able to determine that these three artifact came from the starboard side of the vessel. Following the bolt pattern on these joined artifacts, base plate Artifact 132-001.91, which could not be rejoined, came from *Westfield's* port side (Figure 101).

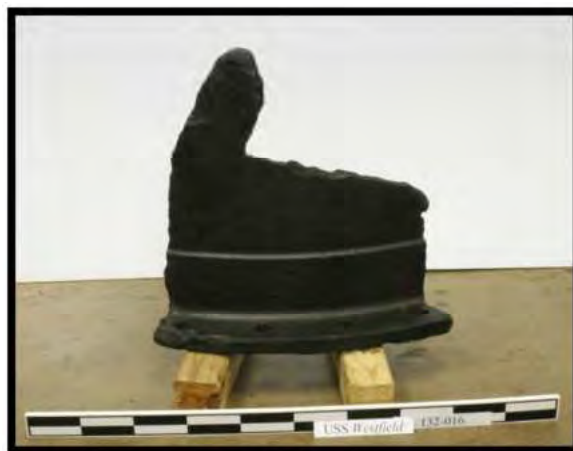
FIGURE 97. FRAGMENT FROM TOP OF CONDENSER (ARTIFACT 132-016; SCALE DM)

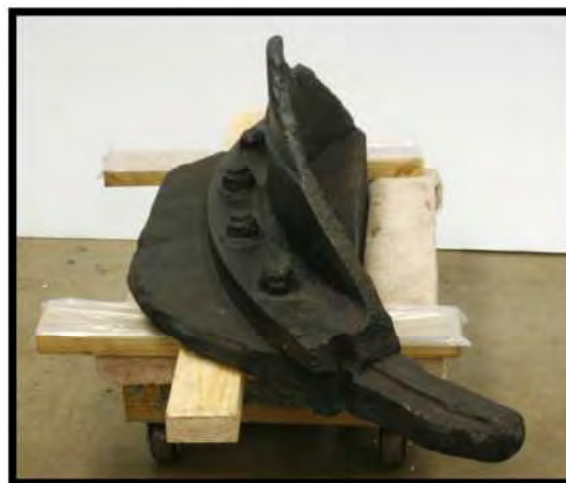
FIGURE 98. FRAGMENT OF CYLINDER ON BASEPLATE (ARTIFACT 138-001)

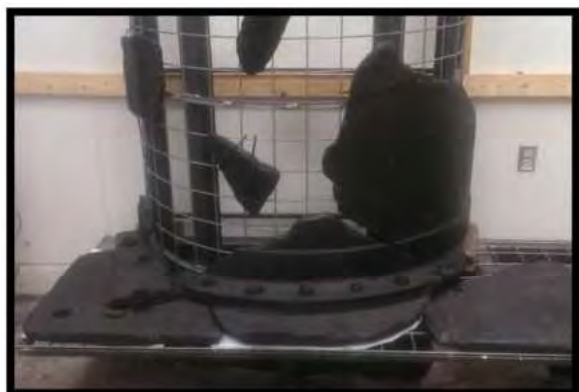
FIGURE 100. REJOINED CYLINDER FRAGMENTS
(ARTIFACTS 132-006, 138,001, & 134-007)

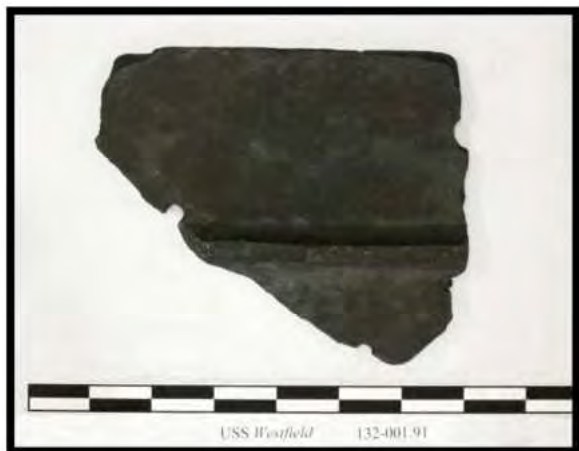
FIGURE 101. FRAGMENT OF BASEPLATE (ARTIFACT
132-001.91; SCALE DM)

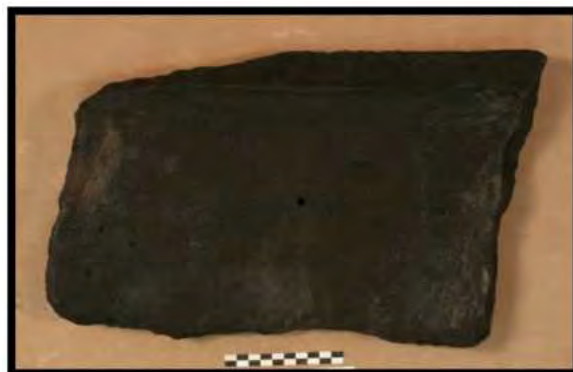
FIGURE 103. ROUNDED FRAGMENT FROM REAR
CHANNEL WAY WALL (ARTIFACT 133-004)

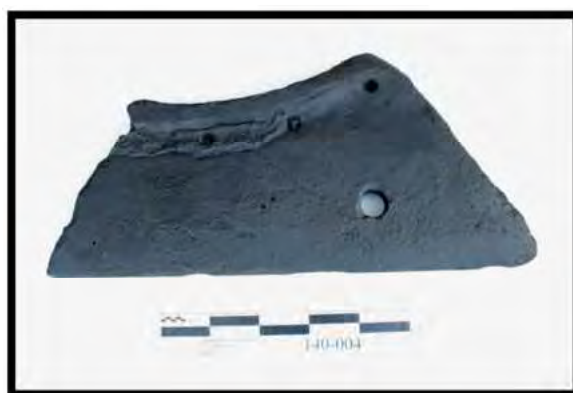
FIGURE 104. UNDERSIDE OF AIR PUMP BASE PLATE
WITH NARROWING CHANNEL WAY WALL (ARTIFACT
140-004; SCALE CM)

Beneath the base plate fragments, portions of the "channel way" leading to the air pump survived. The largest channel fragment, found on Artifact 138-001 (Figure 102), although incomplete, indicates that the port and starboard sides of the channel way were relatively flat and the chamber had a depth of at least 1 ft. Numerous fragments from the channel way walls survived independently. These fragments, combined with the portions that remained attached to the base plates, allowed conservators to determine that the original shape of the channel way was designed to facilitate the forward movement of water. One smaller fragment came from the aft portion of the channel way (Artifact 133-004). This fragment shows that the shape of the condenser continued down into the channel way creating a rounded aft wall (Figure 103). The largest recovered base plate fragment (Artifact 140-004) supported the air pump/hot well cylinder assembly. A surviving section of the inner ring on the base plate has a diameter of 42 inches. Remnants of the channel way show that its walls slightly narrow in the forward direction to accommodate the smaller diameter of the air pump cylinder (Figure 104). Artifact 140-004 is from the starboard side of the channel way.

through rounded holes in the base plate as seen in figures 99 and 104. Each hole had a diameter of 2 to 2.25 inches. Cast iron washers lay between the square nut and the plate surface (Figure 109). The washers acted as a sacrificial surface that could rotate if needed and spread the load placed on the bolt heads (Jim Jobling, personal communication 2014). A variant of this bolt type was also recovered (Artifact 132-001.92). Rather than containing a smaller square nut and an underlying washer, this bolt instead utilized a single larger wrought iron nut that accomplished both tasks (Figure 110).

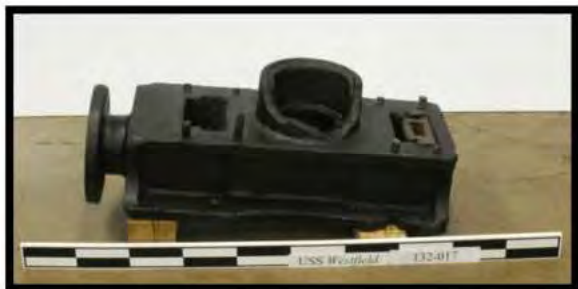
FIGURE 105. VALVE ASSEMBLY FROM AIR PUMP/HOT WELL RESERVOIR (ARTIFACT 132-017; SCALE DM)

No historical information has been found regarding the construction of *Westfield's* air pump and hot well. Fortunately, in addition to the lower base plate fragment (Artifact 140-004), a large artifact from the air pump was recovered remarkably intact (Artifact 132-017). This artifact is one of two valve assemblies that received water from the upper hot well reservoir as a means to refuel the boilers' water level (Figure 105). Like the base plate fragment, the recovered valve assembly came from the starboard side of the engine assembly. This placement is evident due to the forward flowing direction of the interior valves. The artifact measures 2 ft long, 10 inches wide, and 6 inches tall. The pipe that led to the forward boilers has a diameter of 4 inches and an attachment flange with a diameter of 9 inches. The feed pipe that led down from the hot well reservoir is broken but can be reconstructed with a diameter of 7.75 inches. After removing protective cover plates and broken pipe flanges, conservators recovered all of the original sealing gaskets (Figure 106). Inside the artifact, two brass valves are held in place by brass wedges, all of which are seated in lead (Figure 107).

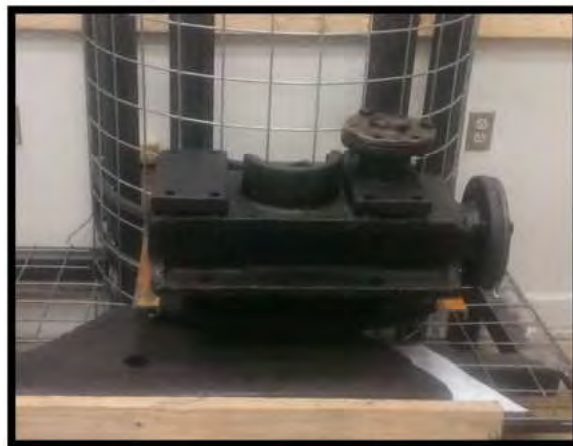
FIGURE 108. RECONSTRUCTED VALVE ASSEMBLY AND LOWER BASE PLATE FRAGMENT (ARTIFACTS 132-017 AND 140-004)

Originally, this artifact was mounted outside the air pump cylinder on a shelf, directly beneath the hot well reservoir (Figure 108). Both the shelf and a large fragment of the air pump cylinder survived with the valve assembly. The shelf measured 1 ft 4 inches wide and 6 inches tall from the base plate. The air pump cylinder fragment indicates an internal diameter of 40 inches that fit into the curved portion of the base plate (Artifact 140-004), and like the condenser/engine cylinder, was mounted with a reinforced supporting flange that bolted down over the plate. Unfortunately, the exact heights of the air pump and the hot well can only be speculated. On most walking beam engines, this dual assembly generally reached just slightly taller than both the condenser and the engine cylinder's lower piston stop. Applying this generality to *Westfield*, the height would have measured approximately 6 feet tall. Based on other walking beam engines, the air pump cylinder, if completed, once contained a rounded flange at the top with a rim that stood just inside the edge. This flange was utilized as a lower base plate for the hot well reservoir cover. During construction, the cover would have been lowered down and seated onto this plate. The rim on the plate sat inside the cover, preventing the cover from sliding off. One fragment from this plate and rim survived (Artifact 132-001.57). The rim on this fragment sits 1.5 inches inward from the ledge, indicating that the cover contained a general thickness of 1 inch, plus a 0.5 inch stiffening ring at the bottom. Based on the curvature, the rim on the plate had an inside diameter of 5 ft 2 inches. Adding the thickness of the missing cover (not accounting for the stiffening rim), the hot well reservoir had an inside diameter of 5 ft 4 inches.

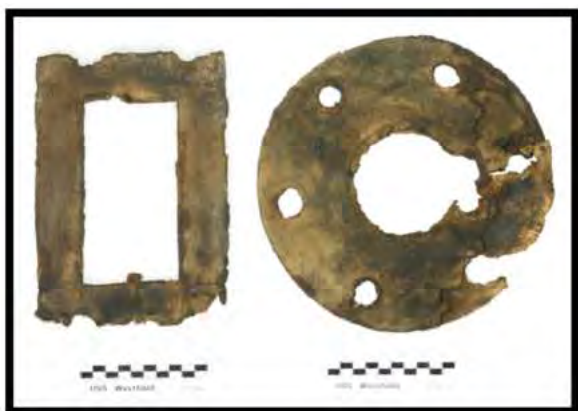
FIGURE 106. EXAMPLES OF INTACT GASKETS FROM VALVE ASSEMBLY (ARTIFACT 132-017.6 AND 132-017.8)

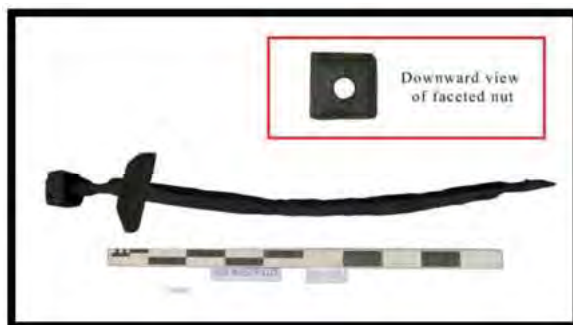
FIGURE 109. TYPE 1 MASSIVE BOLT AND WASHER FASTENER FOR CYLINDER BASE/BED FRAME TIMBERS (ARTIFACT 138-003; SCALE CM/DM)

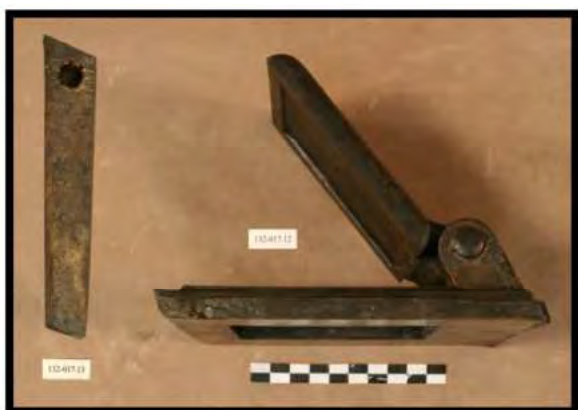
FIGURE 107. BRASS VALVE AND WEDGE FROM VALVE ASSEMBLY (ARTIFACTS 132-017.12 AND 132-017.13)

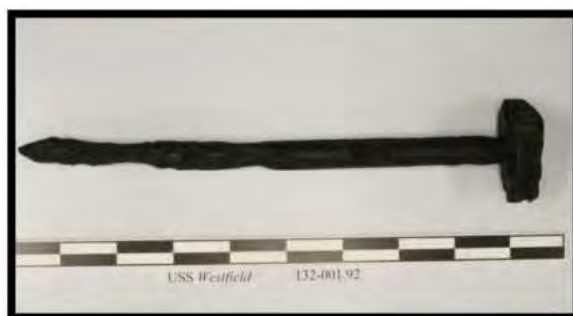
FIGURE 110. TYPE 2 MASSIVE BOLT FASTENER FOR CYLINDER BASE/BED FRAME TIMBERS (ARTIFACT 132-001.92; SCALE DM)

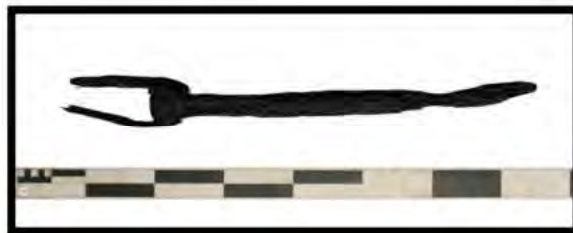
FIGURE 113. SMALLER TURNBUCKLE FROM SMOKE STACK (ARTIFACT 133-034; SCALE CM/DM)

Excavations recovered two wrought iron turn buckles of which one was smaller and the other heavily constructed. The smaller of these turn buckles measures about 3 inches wide across the buckle (Artifact 133-034). Due to the smaller size, this artifact may have supported *Westfield's* smoke stack rather than the engine (Figure 113). The A-frame required substantial reinforced rods and turnbuckles to counteract the forces of the constantly moving engine. The larger turn buckle (Artifact 117-002) measured 1 ft 8 inches long, 6 inches wide, and 2 inches thick. Attached to each end of the buckle, several feet of the securing rod survived (Figure 114). Like the stub on the bearing block shackle, the rod has a diameter of 1 inch. Numerous other wrought iron rod fragments were recovered. All of these artifacts contained hexagonal nuts that were threaded onto the rods. Interestingly, some of the threads on these wrought iron rods are brass. Artifact 133-053 contains a heavily eroded nut that allows parts of the brass threading to be inspected (Figure 115). This brass bushing prevented the nut and bolt from rusting together, therefore allowing tightening or loosening as needed.

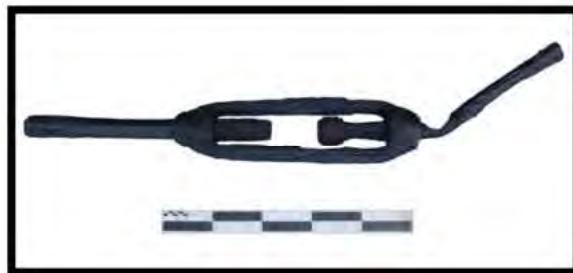
FIGURE 114. LARGE TURN BUCKLE FROM A-FRAME (ARTIFACT 117-002; SCALE CM/DM)

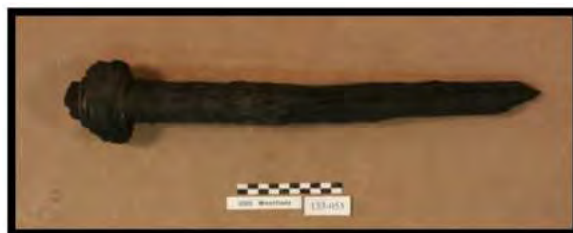
FIGURE 115. ROD ARTIFACT WITH THREADED BRASS BUSHING (ARTIFACT 133-053)

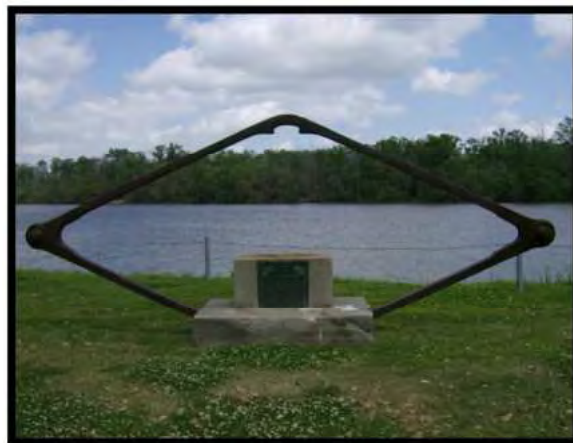
FIGURE 116. WALKING BEAM FROM *USS CLIFTON* AT RIVERFRONT PARK, BEAUMONT, TEXAS (UNKNOWN PHOTOGRAPHER)

Like *Westfield*, *Clifton* sank in Texas during the Civil War. Salvage operations recovered *Clifton*'s walking beam during the early 20th century (Figure 116). In 2012, this artifact underwent conservation at the CRL. During conservation, measurements recorded from *Clifton*'s walking beam were smaller than those indicated by the Memphis drawing, at 20 ft wide by 9 ft tall. This difference in size may be an issue of artistic interpretation or engine manufacturers. Since the vessels were built at the same time and designed for the same engine, a difference in walking beam size is unlikely. Evidence from an artifact is more reliable than a drawing; therefore, *Westfield*'s reconstruction follows the dimensions of *Clifton*'s walking beam.

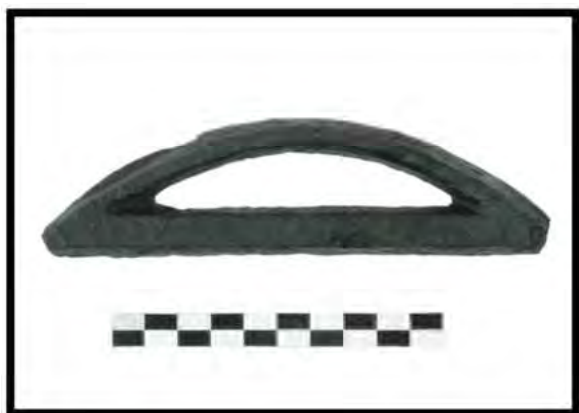
FIGURE 117. UNIDENTIFIED MOON-SHAPED MACHINERY COMPONENT (ARTIFACT 40)

Just south of the firebox on what would have been *Westfield's* starboard side, recovery efforts found a unique object (Artifact 40) shaped like a quarter moon with a larger flat edge (Figure 117). The poor state of the metal was beyond saving, yet conservators successfully made a mold and resin copy of the original to allow for study. This artifact was made of cast iron and contained a unique curve along the length. The curve prevented the object from lying flat. On the rounded edge, an indentation was molded at the time the artifact was manufactured. This indentation may have allowed the artifact to be easily removed from another object. How this artifact was used remains unclear.

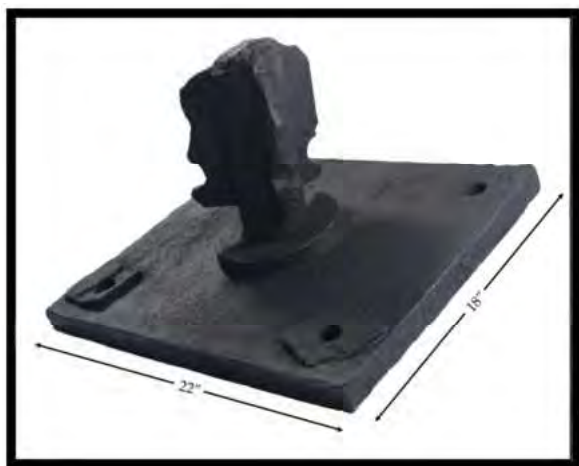
FIGURE 118. UNIDENTIFIED MACHINERY - POSSIBLY STEAM DRIVEN WINCH OR CAPSTAN COMPONENT (ARTIFACT 106-004; SCALE INCHES)

On the port side of the vessel, outside the area believed to have been the main cabin, a large cast iron artifact was recovered (Artifact 106-004). This artifact is one of the largest pieces of machinery recovered from *Westfield* (Figure 118). Comprised of two components, the artifact was designed to accommodate a heavy load. A flat base measuring 22 x 18 x 1 inch contains a central hole with a reinforced upper ring. The central hole supports a cylindrical shaft that once rotated. The top of the shaft contains three fins, each with a small one inch semi-circular hole at the bottom. Below the base, the shaft changes shape and becomes square. This square portion may have been a key that engaged into another part of a larger machinery assembly. Although the exact purpose of this machinery is not clear, the evidence suggests a rotating winch of some sort. If the artifact's recovered location remains close to where it was originally used, the provenience suggests that the object may have once been part of steam driven capstan utilized for the rear anchor chains.

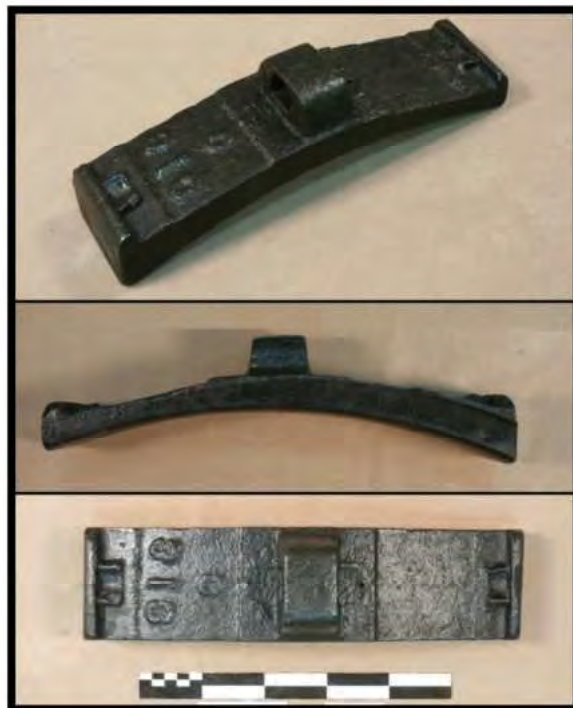
FIGURE 119. UNIDENTIFIED MACHINERY COMPONENT WITH EMBOSSED "313" (ARTIFACT 129-002)

Artifact 129-002 is an unidentified cast iron machinery piece that has many diagnostic features (Figure 119). In general appearance, the artifact looks like a rounded pad that fit over another curved object. The other missing object clearly rotated and over time wore down the artifact's lower surface and one of the sides. All of the wear marks are radial and very smooth. However, the wear pattern is uneven, suggesting that the artifact may have been out of calibration with the other piece of machinery. Looking at the artifact from either side, the artifact originally appeared to have identical ends. Now one end is quite thinner than the other. The top of the artifact contains the embossed numbers "313" and "0". There are also several curved mounting points on the top ends, as well as a raised opening at the top center. These features imply that another object slid through the opening and lay down into the mounting points. Despite that numerous components on walking beam engines rotated, there does not seem to be any equivalent to this artifact on existing plans. How this artifact was used, and to what piece of machinery it belonged, remains unclear.

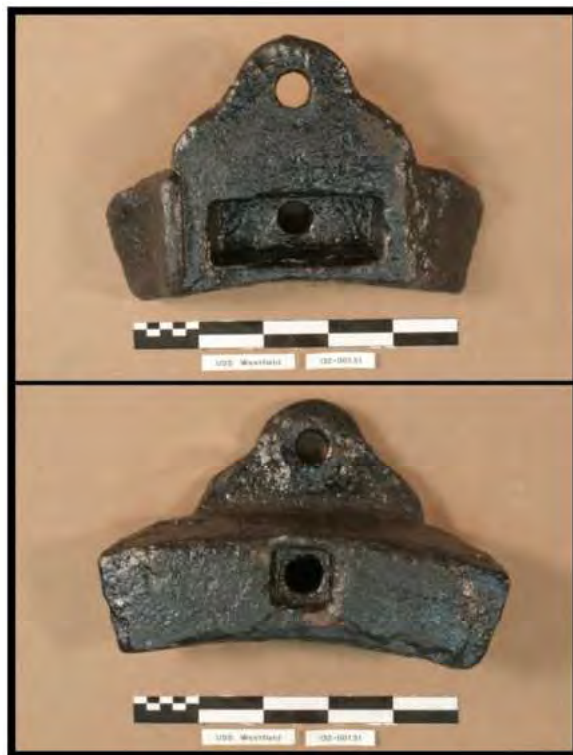
FIGURE 120. UNIDENTIFIED CAST IRON PEDESTAL-LIKE OBJECT (ARTIFACT 132-001.51)

One of the first artifacts conserved by CRL was a pedestal-like artifact made of cast iron (Artifact 132-001-51). The main body of the artifact is heavily constructed, rounded on two sides, and contains a central mounting hole for a recessed square headed bolt (Figure 120). On the bottom side of the object, two projecting ridges indicate that the artifact sat on another object that likely contained dual recesses to receive the artifact. The ridges on the artifact likely sat within those recesses to prevent sliding, and the upper recessed bolt secured both objects together. Based on tiny fragments of wood recovered from the recessed bolt hole, conservators believe the other object was made of wood. Branching off from the wider rounded side of the artifact, a unique rim shape contains a reinforced mounting hole for another unknown object. How this object was used is unclear, but the heavy construction and reinforced features indicate it may have been a part utilized in machinery.

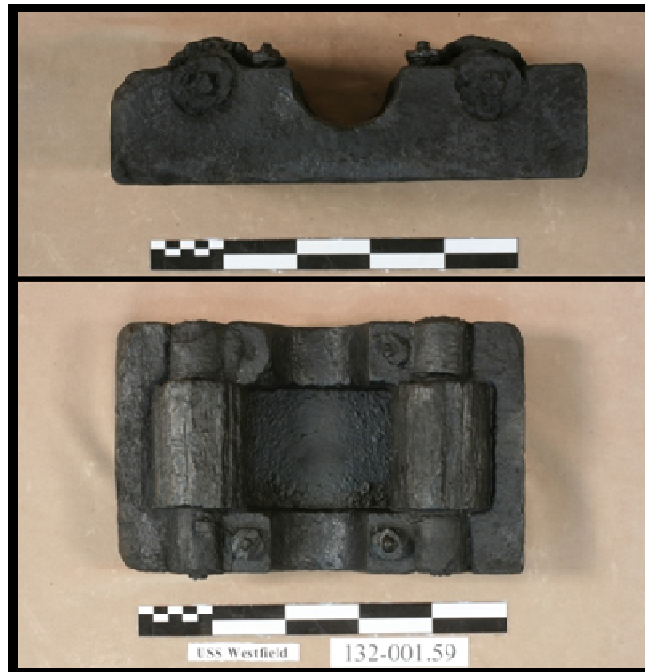
FIGURE 121. UNIDENTIFIED SMALL BEARING BLOCK
(ARTIFACT 132-001.59)

Artifact 132-001.59 contains many features to suggest the object may have been a three part bearing block for a larger piece of machinery (Figure 121). The artifact appears to be the lower base for an object consisting of two components. Four hexagonal bolts near the center likely joined the artifact to the now missing top portion. The interior is hollowed out in a rectangle that follows the shape of the exterior. Across the hollowed out center, there are three semi-circles on each outside

wall. If this object was a bearing block, then the missing upper section likely also contained these semi-circles to secure the objects that the artifact intended to bear. The outer semi-circles are smaller and both still retain axel-like objects and rollers that are now fused to the main artifact. Both of these axels and their associated rollers are wrought iron. The center larger semi-circles are open, indicating that the object they supported is now lost. The surviving axels and rollers may have assisted in rotating a belt of some sort through the machinery. Without more of the original machinery to which this artifact belonged, the exact function remains speculative.

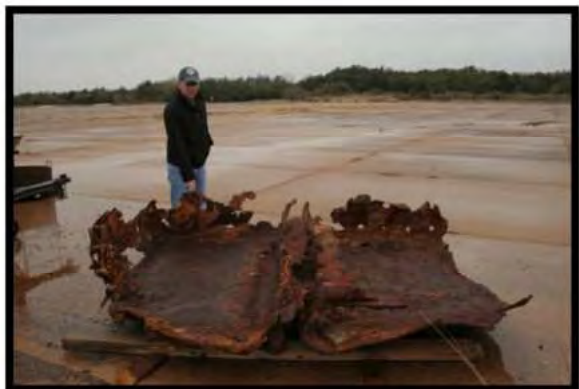
FIGURE 123. REMAINS OF LOWER FIREBOX
(ARTIFACT 132-001)

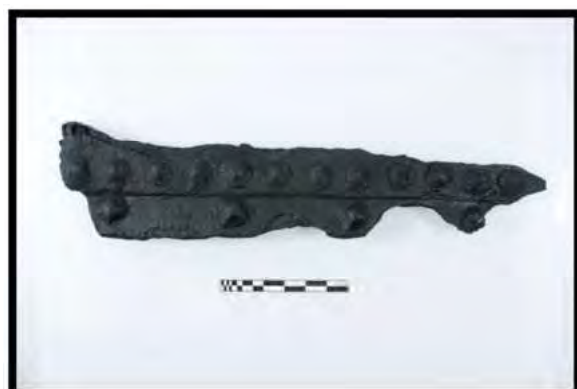
FIGURE 126. RIVETED PLATE FROM STEAM DRUM
(ARTIFACT NP-50; SCALE INCHES)

The section of riveted plating clarifies how the two boilers were originally joined together. Unlike other recovered boilerplates, this small fragment (Artifact NP-50) contained not only a folded riveted seam, but a reinforced underlying plate secured by square-headed bolts (Figure 126). An example of this plate can be found on an image of *Clifton*'s upper steam drum, photographed over 70 years after the vessel's sinking (highlighted in Figure 127). This image offers considerable information about how the boilers were constructed. Following manufacture, the boilers would have required individual lowering and placement into *Clifton*'s hull. Based on this image, each boiler contained half of a shared upper chimney flue. The flue fed up and out of the vessel's central machinery compartment, before connecting to the smoke stack. The two portions of the flue were joined together along a central seam, reinforced on both sides by square-headed bolts.

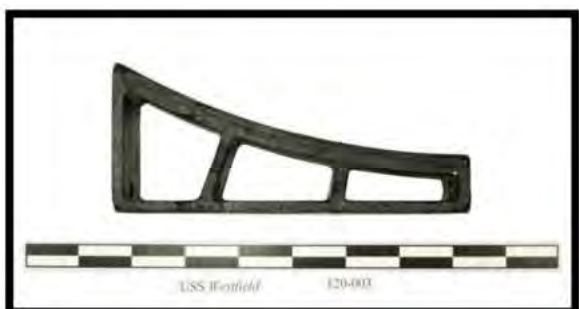
FIGURE 124. BOILER MOUNT (ARTIFACT 120-003;
SCALE DM)

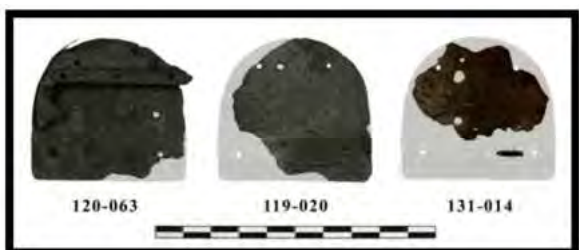
FIGURE 125. FIRE DOORS (ARTIFACTS 119-020,
120-063, AND 131-014; SCALE DM)

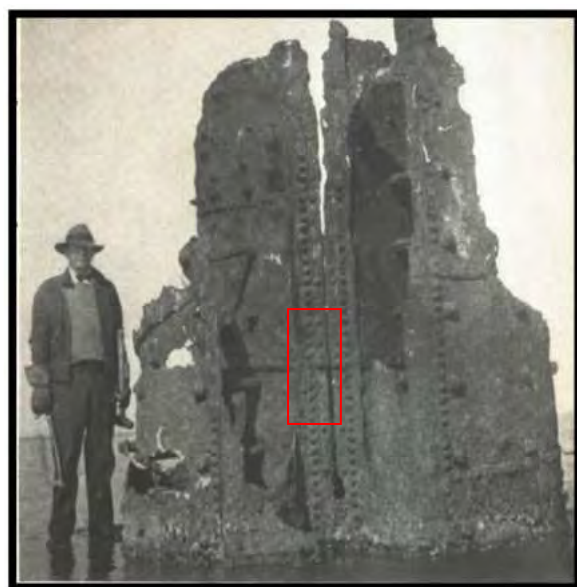
FIGURE 127. REMAINS OF USS *CLIFTON*'S STEAM
DRUM (WILTON AND DIXON 1935:63)

Numerous large staybolts from *Westfield's* wreck site indicate that the vessel utilized this type of steam drum (Figure 128). On the *Clifton* image, rather than completely encircling the flue, the plates of the steam drum abruptly curve inward, and are securely riveted down before reaching the reinforced central seam. This indicates that each boiler utilized a separate steam drum compartment. While the other side of the drum cannot be seen within the image, the arrangement was likely identical to the one found on the front. This would have created two distinct semi-circular steam compartments.

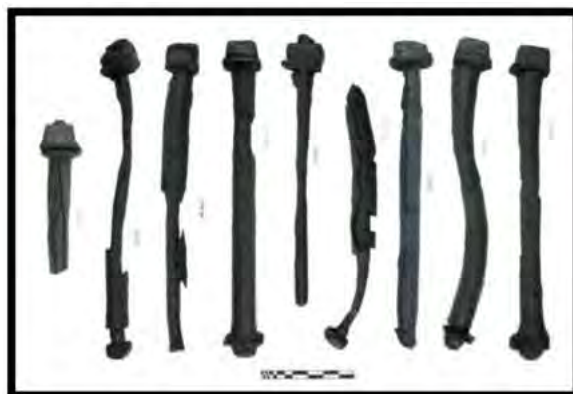
FIGURE 128. MASSIVE STAYBOLTS FROM UPPER
STEAM DRUM (SCALE INCHES)

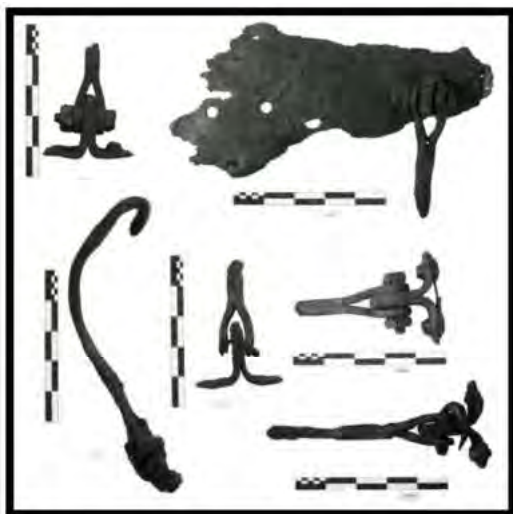
FIGURE 131. CROW'S FOOT STAVING DEVICES

The crow's feet came in several variations. The majority are of the single type. These were made out of two pieces of rectangular boiler iron that were bent into a "T" shape. The object was riveted to a surface and then a staying rod with end loops was placed over the device. To secure the rod, a bolt was passed through the loops and the shaft of the "T" (Figure 131). Another type incorporates two longer boiler straps that were folded down on all four ends, creating a double crow's foot in the shape of a handle (Figure 132; Peabody and Miller 1894:92). Several larger plates believed to have come from the lower portion of the chimney flue, utilized a large number of these double crow's feet (Figure 133). These handle-like staying devices received vertical support rods attached to the crowns of the furnaces and the longitudinal supports that ran the length of the boiler. Another example consisted of a double crow's foot, that was shaped like the cross section of an "I" beam. A large number of these supported heavier objects in the boiler.

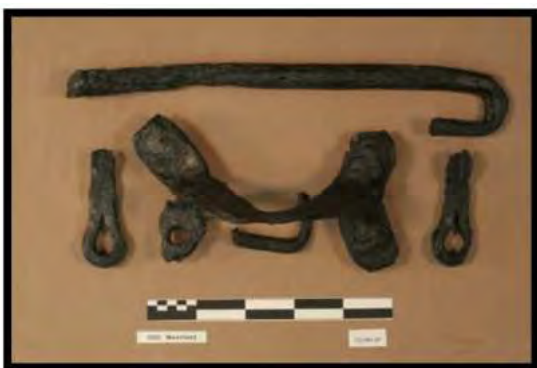
FIGURE 132. DOUBLE CROW'S FOOT, HANDLE-SHAPED WITH HOOKED RECEIVING ROD (ARTIFACT 132-001.49)

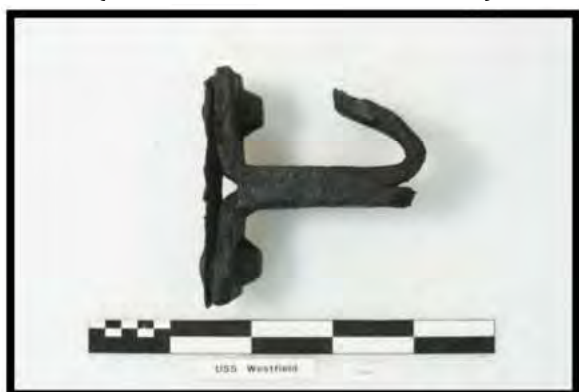
FIGURE 137. DOUBLE-ENDED CROW'S FOOT
FASTENER (ARTIFACT 132-431; SCALE CM)

two on top and two on bottom, to join the outer water jacket to the bottom of the furnaces (Figure 137). The transition to these fasteners was likely necessary to prevent the furnaces from shifting under the weight of the fire grates, which may have happened if the furnaces stood on top of cylindrical staybolts, rather than flat-surfaced brackets.

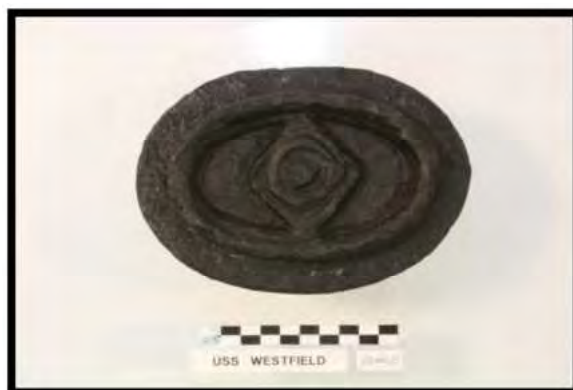
FIGURE 139. SMALLER SIZED HAND HOLE CLEANING
COVER (ARTIFACT 132-001.55)

To access different parts of the water jacket surrounding the firebox, numerous "hand holes" were placed, that permitted occasional cleaning. Exactly where these hand holes were placed is speculative. Yet as mentioned earlier, convenient placements would have positioned many on the corner edges of the firebox, in between the water legs, and in the spandrels above the furnaces (Figure 138). The plate on the hand hole could be removed when the boiler was not pressurized. This was done by unthreading a nut and removing the securing handle. Three different sizes of hand hole cover were recovered. The smallest measured 6-3/8th inches by 4-3/8th inches. While the cast iron was in relatively good condition, the wrought iron handle did not survive (Figure 139). The middle size measured 7-5/8th inches by 5-5/8th inches. This type used a double-arched handle, which when facing looks like an "X" (Figure 140). The larger size measured 10-1/8th inches by 7-5/8th inches. The handle on this version was singular, consisting of only one arch (Figure 141).

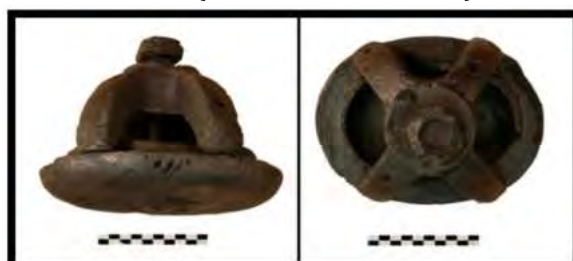
FIGURE 140. MEDIUM SIZED HAND HOLE CLEANING
COVER (ARTIFACT 118-178)

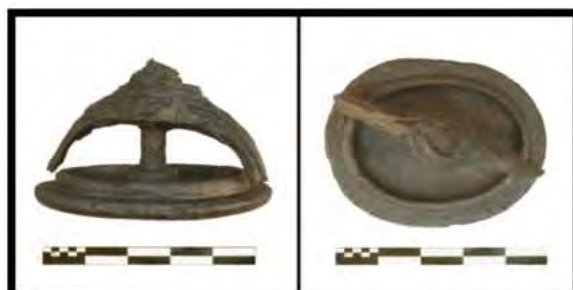
FIGURE 141. LARGER SIZED HAND HOLE CLEANING
COVER (ARTIFACT 120-053; SCALE CM)

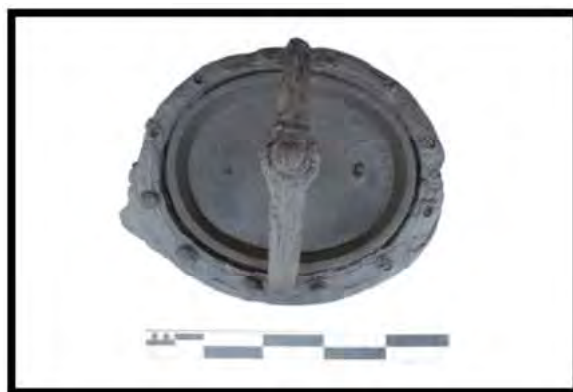
FIGURE 142. MAN HOLE ACCESS HATCH INTO
BOILER (ARTIFACT 122-042; SCALE CM/DM)

A similar, yet much larger version of these artifacts was known as a "man hole." This artifact type permitted physical human access into the boiler's interior. Two of these large artifacts were recovered (Artifacts 119-019 and 122-042). In general appearance, man holes resembled hand holes, but were considerably more reinforced (Figure 142). The back plates measured 14.5 inches by 12 inches. Both of the recovered man hole covers contained a single arched handle. Rather than just relying on the handle to secure the covers in place, the entire back plate was secured against a thick wrought iron lip that was rivet down on the boilerplate. One of these man hole covers (Artifact 119-019) is believed to have come from the rear of the boiler barrel (Figure 143). The artifact still retains a large piece of boiler plating complete with a rounded strap of rivets (Figure 144). A third man hole was indirectly identified. Knowledge of the object's former presence can be found in too cast iron fragments (Artifacts 131-019 and 132-001.56) that once formed the man hole's frame (Figure 145). This missing man hole is also believed to have come from the boiler barrel, specifically on the top. Examining the artifacts, the original shape can be determined as oval. Yet, while the tops of these artifacts remain flat, their bases are arched, indicating that they were mounted to a cylindrical surface. An identical example of this frame can be seen on the boiler plan for the USS *Commodore Barney* (Figure 146).
