Investigation and Recovery of USS Westfield (Site 41GV151) Galveston Bay, Galveston County, Texas

Document No. 100102a
Atkins Job No. 044118606

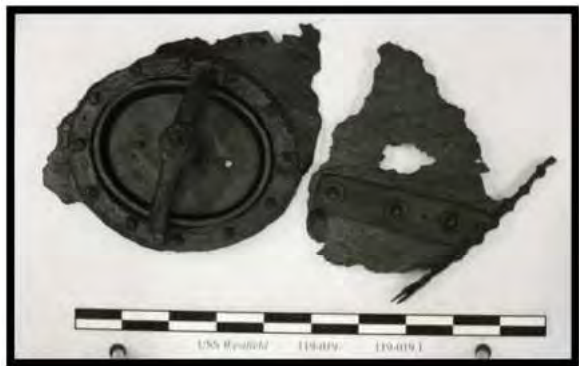
FIGURE 143. MAN HOLE ACCESS HATCH FROM REAR BOILER BARREL (ARTIFACT 119-019; SCALE DM)

A similar, yet much larger version of these artifacts was known as a "man hole." This artifact type permitted physical human access into the boiler's interior. Two of these large artifacts were recovered (Artifacts 119-019 and 122-042). In general appearance, man holes resembled hand holes, but were considerably more reinforced (Figure 142). The back plates measured 14.5 inches by 12 inches. Both of the recovered man hole covers contained a single arched handle. Rather than just relying on the handle to secure the covers in place, the entire back plate was secured against a thick wrought iron lip that was rivet down on the boilerplate. One of these man hole covers (Artifact 119-019) is believed to have come from the rear of the boiler barrel (Figure 143). The artifact still retains a large piece of boiler plating complete with a rounded strap of rivets (Figure 144). A third man hole was indirectly identified. Knowledge of the object's former presence can be found in too cast iron fragments (Artifacts 131-019 and 132-001.56) that once formed the man hole's frame (Figure 145). This missing man hole is also believed to have come from the boiler barrel, specifically on the top. Examining the artifacts, the original shape can be determined as oval. Yet, while the tops of these artifacts remain flat, their bases are arched, indicating that they were mounted to a cylindrical surface. An identical example of this frame can be seen on the boiler plan for the USS *Commodore Barney* (Figure 146).

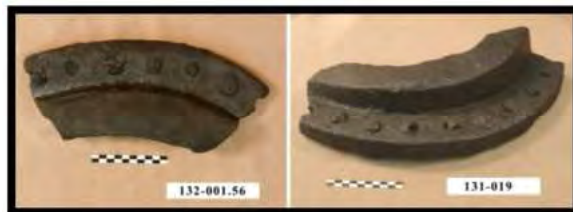
FIGURE 145. FRAGMENTS OF MAN HOLE FRAME FROM TOP OF BOILER BARREL (ARTIFACTS 131-019 AND 132-001.56)

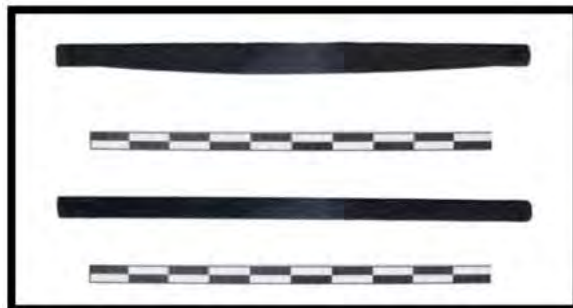
FIGURE 149. EXAMPLE OF CENTER OR REAR
BEARING BAR (SCALE DM)

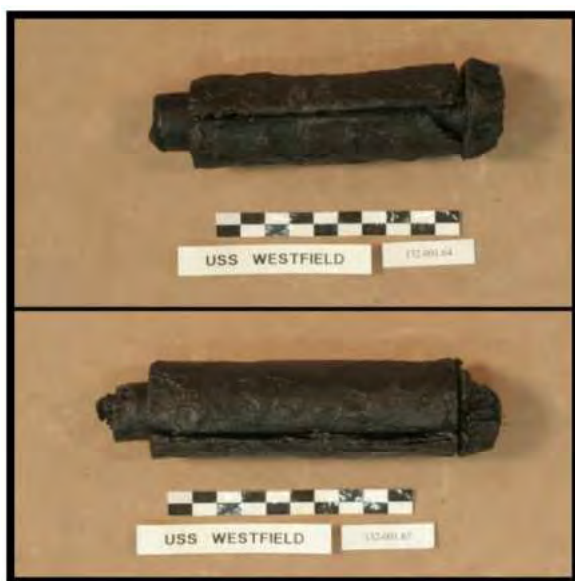
FIGURE 147. EXAMPLES OF FIRE BOX STAYBOLTS
(ARTIFACTS 132-001.64 AND 132-001.67)

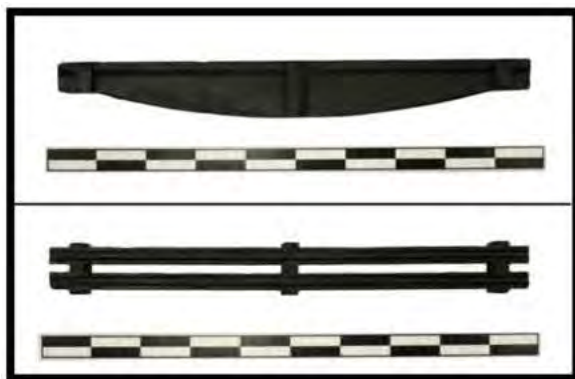
FIGURE 148. EXAMPLE OF FIRE GRATE (SCALE DM)

Inside the firebox, each furnace contained two rows of fire grates, with 12 grates in each row (Figure 135). The grates measure 3 ft long x 4 inches wide and are 5 inches thick at the midsection, tapering to 2.5 inches at each end (Figure 148). From underneath the two rows of grates, several of the bearing bars were successfully recovered. These bars are shaped similarly to a fire grate, with the exception of being longer and solid to support a greater weight (Figure 149). Each bar, rested on tabs that were riveted on the furnace walls. The best preserved example of one of these tabs can be found on the earlier mentioned water leg (Figure 150). The lower portion of the tab is secured to the water leg with two square-headed bolts. Although broken, the tab appears to have once bent outward into the furnace to support the end of a bearing bar. How the bar stayed on the tab without sliding forward or aft is not clear.

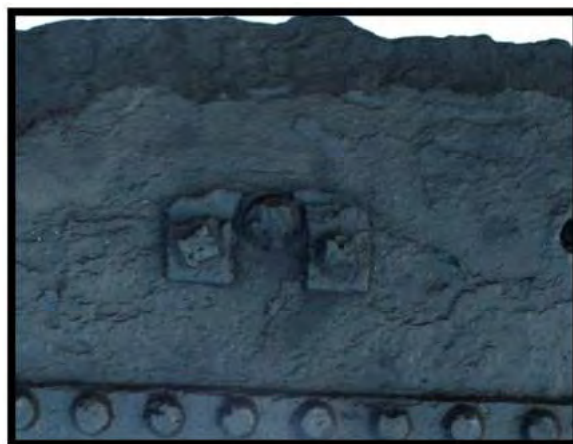
FIGURE 150. BROKEN TAB FOR SUPPORTING
BEARING BARS (CLOSE UP SHOT FROM WATER LEG;
ARTIFACT 132-001.79; ALSO SEEN IN FIGURE 136)

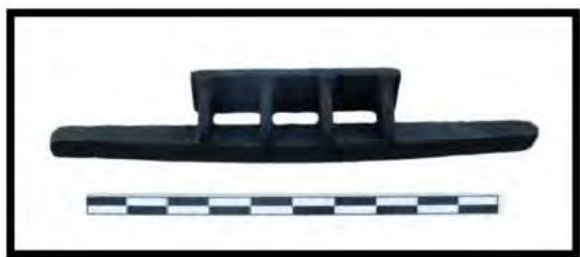
FIGURE 152. FORWARD BEARING BAR WITH "DEAD PLATE" (SCALE DM)

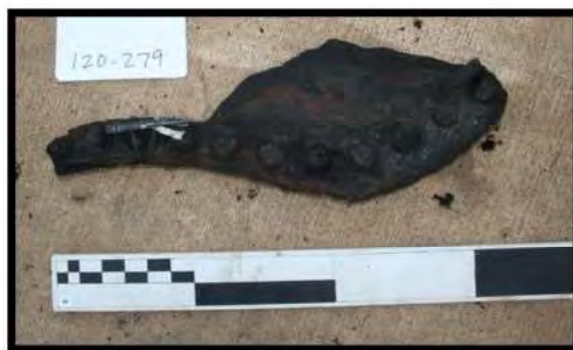
FIGURE 153. TRANSITION PLATES BETWEEN LOWER ASH-PIT AND UPPER FIRE DOOR FRAMES (ARTIFACT NO 120-279; SCALE CM/DM)

If the lower ash-pits were individual openings, the openings would normally adopt a flat-sided oval shape or a rectangular frame. When the lower ash-pit and upper fire door frame joined as one, the shape of the opening required a frame that merged between the two shapes. Artifact 120-279 contains a unique shape unlike any other found within the boiler artifacts (Figure 153). The top plate contains a line of rivets that are purposely placed to help fold an underlying plate into a distinct shape. The curvature of the underlying plate indicates that the artifact came from part of the outer water jacket. Based on the curvature of the riveting pattern, this artifact served a very specific purpose. The shape served as the transition point between a lower ash pit and an upper fire door frame (Figure 154). Two portions of fire door frames were recovered (Artifacts 120-002 and

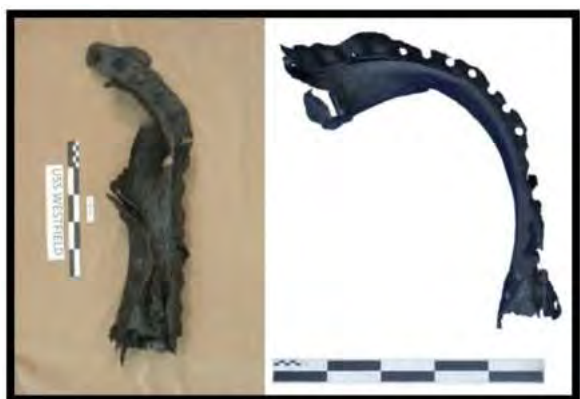
FIGURE 155. TWISTED FRAMES FROM UPPER FIRE DOORS (ARTIFACTS 120-002 AND 120-023; SCALE CM/DM)

120-023). These artifacts follow the curvature of the fire doors, although both are twisted outwards, away from their original mounting points due to an interior explosion (Figure 155).

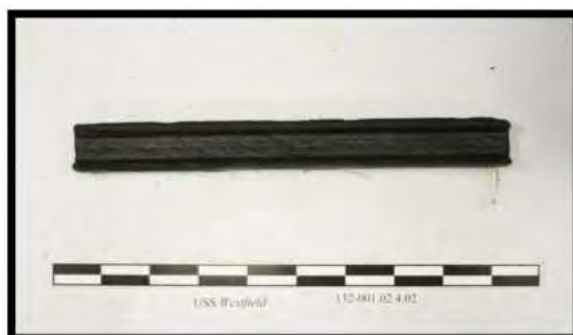
FIGURE 156. RAIL ROAD IRON POSSIBLY UTILIZED AS REPLACEMENT FIRE GRATE (SCALE DM)

When the artifacts first arrived at Texas A&M University, CRL's manager, Jim Jobling (personal communication 2010) speculated that twelve recovered pieces of railroad iron may have been stored on the ship as replacement fire grates. Following conservation, three of these railroad irons revealed that they were physically cut down to 3 feet, the same length as the fire grates (Figure 156). When these vessels were in enemy waters, the crews were required to make use of the materials they immediately possessed or those that could be acquired. A single recovered railroad spike (Artifact 132-101) suggests that railroad irons were not just excess pieces, but sections that may have been removed from existing tracks (Figure 157). Scavenging while in Confederate territory was not uncommon. The journal of Henry Gusley, a marine aboard *Westfield* mentioned raiding Confederate towns for food and supplies (Cotham 2006:114). Other artifacts may have been repurposed as well.

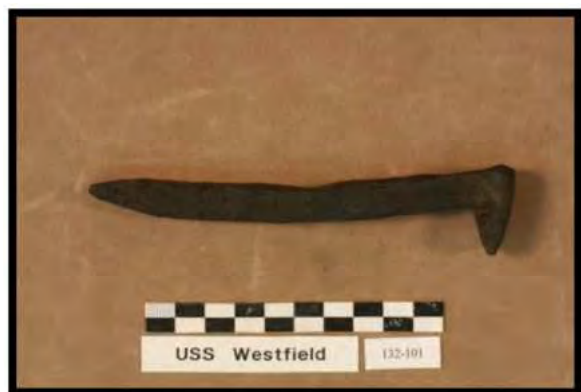
FIGURE 157. SINGLE RAIL ROAD SPIKE
(ARTIFACT 132-101)

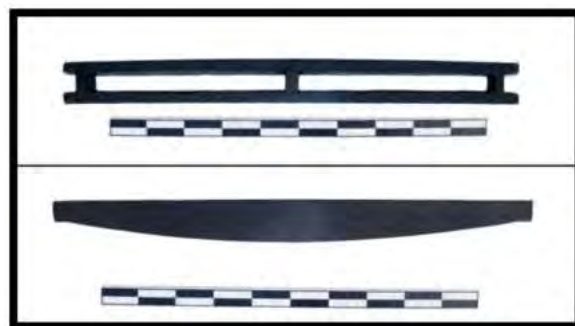
FIGURE 158. LARGER FIRE GRATE POSSIBLY
REUTILIZED AS LOWER BEARING BAR (SCALE DM)

Two larger fire grates were found within the vicinity of the firebox, but no definitive explanation could be determined on how these grates were utilized (Figure 158). Both of these grates measure 46.5 inches x 4 inches and are 3 inches thick at the midsection, tapering to 1.5 inches. These grates led to much speculation by conservators that part of the recovered firebox was missing. Yet, this could not be the case, since all of the retaining firebox walls remained relatively intact. While many other boilers incorporated rows of fire grates containing different lengths (Main 1865:52), the recovered firebox from *Westfield* suggested that all grates were the same size. Interestingly, these two mysterious grates are the same length as the normally solid bearing bars beneath the fire grates. Having no other explanation, the author speculates that these fire grates were obtained from a larger boiler and brought aboard *Westfield* to be utilized as replacement bearing bars due to their equivalent size.

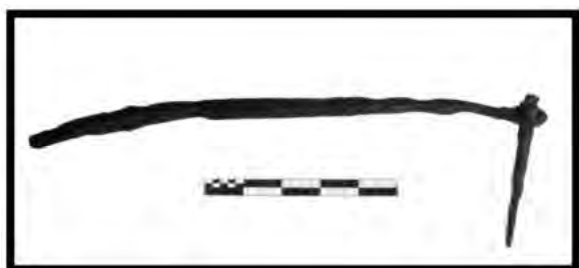
FIGURE 161. FIRE DOOR LEVER AND PIN
(ARTIFACT 125-006; SCALE CM)

When a crew member desired to open the door, he lifted the lever up from a securing cradle fastened to the boiler wall, and then pulled the lever and door open. One of these fire door levers was recovered (Artifact 125-006). The lever consists of an elongated bar with a lifting handle on one end and a pivot ring and inner pin on the other (Figure 161).

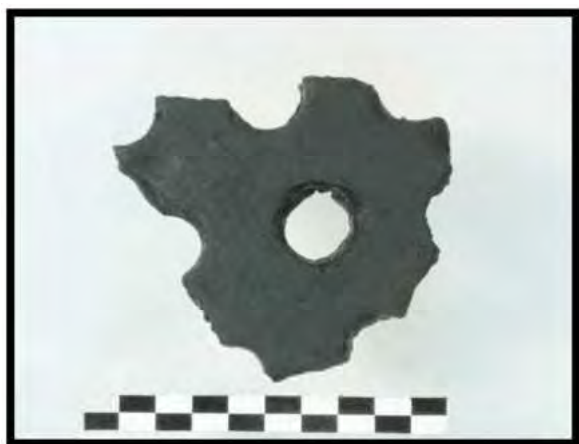
FIGURE 162. CAST IRON FRAGMENT OF BAFFLE
PLATE (ARTIFACT 119-197)

One fragment of a baffle plate was recovered (Artifact 119-197). This small fragment is made of cast iron, and is pierced by numerous holes that facilitated draft (Figure 162). Each of these holes measures $\frac{3}{4}$ inches in diameter. If completed, the baffle plate would have followed the shape of the fire door, but would have been of reduced height and width (Figure 163). This allowed the door to be closed flush against the door frame, while permitting the baffle plate to rest just above the dead plate. A similar example of a baffle plate can be seen on the steamboat *Moyie* (Figure 164). The spacing of the holes and the thickness of the cast iron is almost identical to the fragment recovered from *Westfield*.

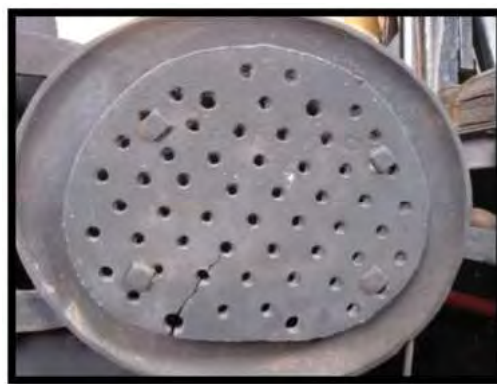
FIGURE 164. BAFFLE PLATE FROM STEAMBOAT
MOYIE (IMAGE COURTESY OF SS *MOYIE*
NATIONAL HISTORIC SITE OF CANADA)

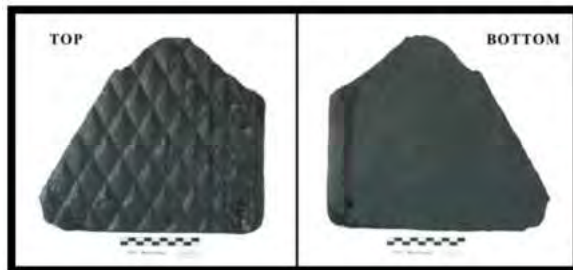
FIGURE 166. DIAMOND PATTERNED SCUFF PLATE
WITH JOINING SEAM (ARTIFACT 132-001.73)

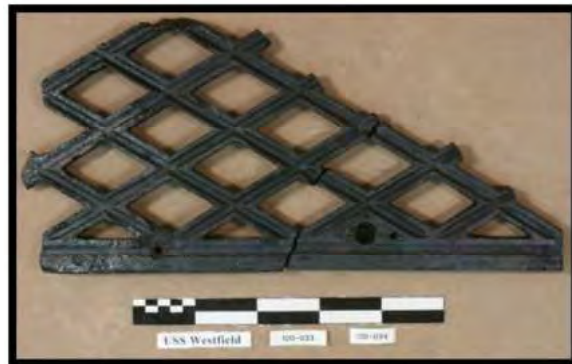
FIGURE 167. OPEN DIAMOND PATTERNED
SCUFF PLATE FROM MAIN DECK
(ARTIFACTS 120-033 AND 120-034)

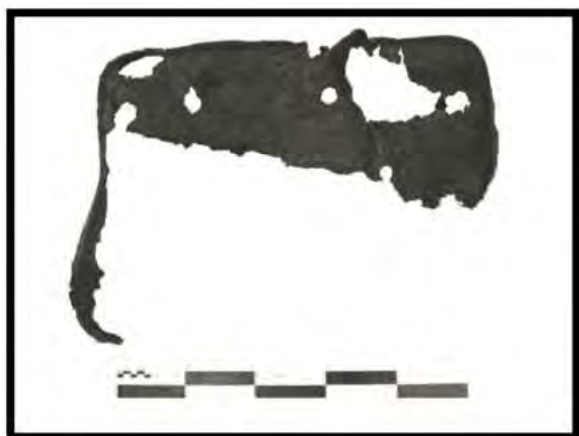
FIGURE 169. FLUE DOOR FROM *WESTFIELD* BOILER
(SCALE CM/DM)

The chimney flue was situated above the fire doors and the inner furnaces. This location marked the termination point for the fire tubes. While no remnants of the fire tubes were found, a single access door for maintaining and cleaning the tubes was recovered (Artifact 109-127). Known as a flue door, this artifact was considerably damaged and twisted (Figure 169). The artifact originally measured approximately 22 inches wide by 16 inches tall. Based on a series of fastener holes, conservators believe this artifact had a similar construction as the fire doors. The surviving portion

of the door represents the outer cover plate. The rear plate and staybolts are missing. Other holes on the plate may indicate where hinges were once placed. Unfortunately, not enough of the plate survives to make any definitive conclusions.

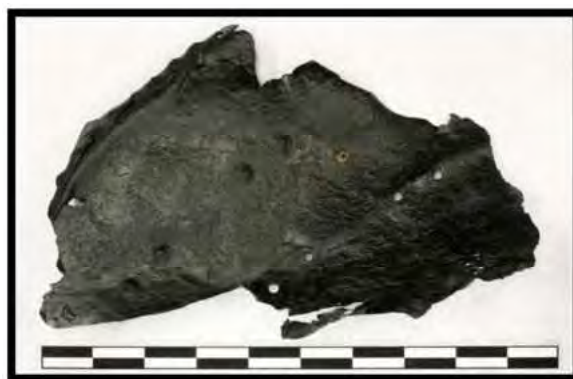
FIGURE 170. PLATE FROM UPPER FIRE BOX COVER
(ARTIFACT 124-032; SCALE DM)

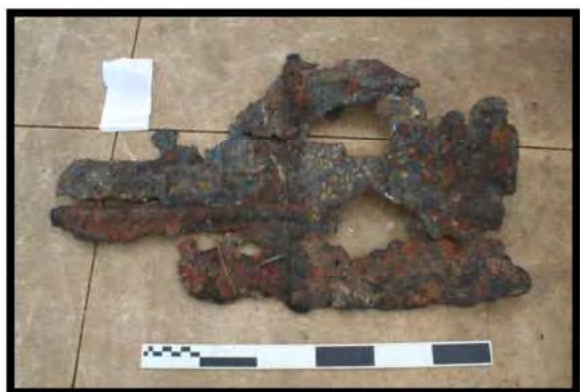
FIGURE 172. LARGE SECTION OF PLATING
FROM OUTER BOILER BARREL
(ARTIFACT 110-005; SCALE CM/DM)

Large flues carried the heated gases, ash, and smoke from the firebox into the boiler barrel. Unlike the firebox, the barrel no longer exists. Yet numerous fragments survived that help explain the original design. Most of the riveted plate recovered from the wreck site is believed to have originated from the boiler barrel, because while most of the plates are deformed they still retain curvature. Two of the best examples can be found in Artifacts 110-005 and 119-001 (figures 172 and 173). One of the most notable features of these artifacts is the absence of internal staying devices. This is not to say that these devices did not exist in the barrel, but only that they were not as necessary and therefore more sparingly used. Unlike the firebox which required heavy staying on the numerous flat surfaces, the round shape of the barrel expanded and contracted with more ease.

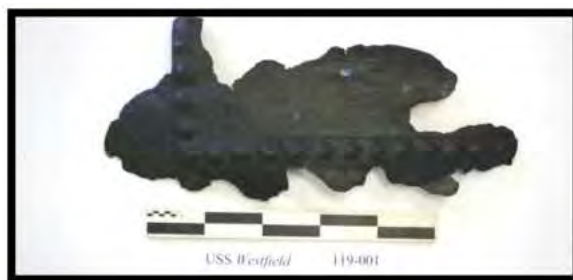
FIGURE 173. SMALL SECTION OF PLATING FROM
OUTER BOILER BARREL
(ARTIFACT 119-001; SCALE CM/DM)

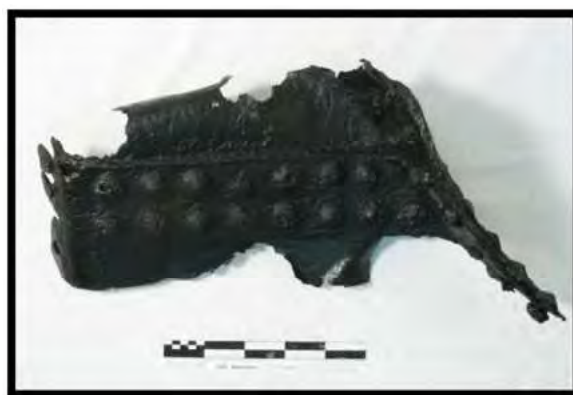
FIGURE 180. LOWER BOILER BARREL CONNECTION PLATES (ARTIFACT 133-011; SCALE CM/DM)

Like the previous artifacts, Artifact 133-011 served as a connection point between the boiler barrel and firebox; however, this object originated from the bottom of the boiler (Figure 180). For this reason, the artifact does not display the eccentric circles. Instead the artifact contains a well preserved, albeit slightly crushed portion of the barrel curve, and a section from the rectangular base of the firebox. The artifact also demonstrates that, in its original context, an additional double-riveted strap branched off from the barrel, before running down the back of firebox and folding underneath.

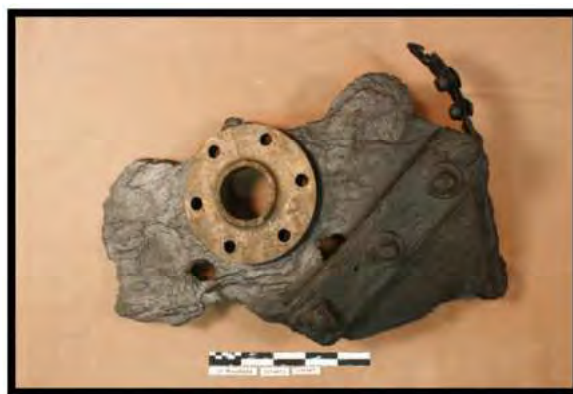
FIGURE 181. REAR FIREBOX FEED WATER PIPE (ARTIFACT 133-007; SCALE CM/DM)

A second artifact came from the same vicinity. Artifact 133-007 was placed slightly higher up on the side of the firebox, yet still below the boiler barrel. The most unique feature consisted of an attached brass pipe flange (Figure 181). Feed pipes leading into the boiler would have been used to refuel the water level. This pipe likely led back to the valve system located beneath the hot well reservoir on the walking beam engine. During conservation, the question arose as to whether this artifact could have come from the front or sides of the boiler, or possibly higher up on the back of the firebox. Several staybolt holes in the metal eliminated any chance that the artifact came from the boiler's front. Staybolts on the front of the boiler would have been on either side of the fire doors. Based on the width of each furnace, this artifact would not have been able to fit without interfering with fire doors. The second evidence comes from the joining of the outer plate with the line of rivets that run up the artifact's side. Based on other recovered artifacts, plates from the front

Close examination reveals that the seam of Artifact 133-007 contains original curvature. This curvature marks the transition point where one of the water legs begins to curve under the boiler. Figure 182, displays Artifacts 133-011 and 133-007 in their original context. A final comment on Artifact 133-007 relates to a bar-like strap that is mounted near the flange with three bolts and underlying washers. One of the recovered man holes, still retained a portion of boiler plating (Artifact 119-019). Mounted to that plate, was a similar bar-like strap (Figure 143). A considerable amount of this strap material was recovered from the wreck site. These straps were intended to hold the boiler in place. They would have secured both boilers together and to the inner hull of the ship. An identical example can be seen on the steamboat *Ticonderoga* (Figure 183). The only difference is that on *Ticonderoga*, the strap material joined to the boilers horizontally. Based on Artifact 133-007, *Westfield* used this strap in a diagonal fashion. The straps would have crossed between the two boilers, likely at several locations, creating an "X". Artifact 118-002 may be an example of these crossed securing straps from between the boilers (Figure 184). The artifact is constructed of the same thickness and width. Several broken bolts through the metal show how the artifact was once secured.

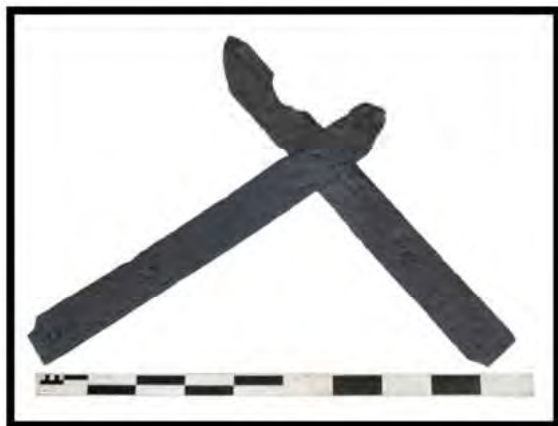
FIGURE 184. WROUGHT IRON BOILER SECURING STRAPS FROM *WESTFIELD* (ARTIFACT 118-002; SCALE CM/DM)

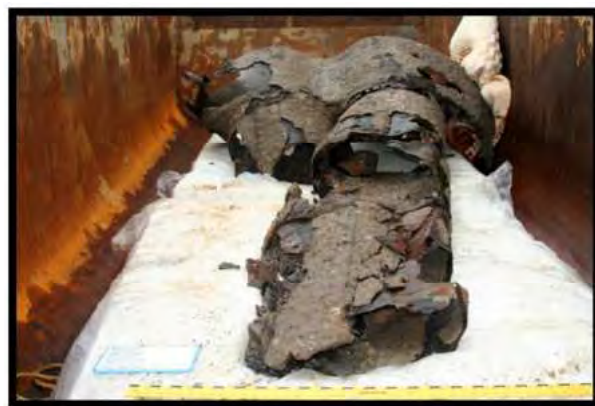
FIGURE 185. *WESTFIELD*'S BOILER FLUES (ARTIFACT 122-001; SCALE INCHES)

A massive section of the lower flues survived from inside the boiler barrel. Artifact 122-001 consists of two flues and the lower base section of the rear combustion chamber (Figure 185). Combined, the artifact measures 10.1 x 6.0 x 3.0 ft. The flues were built of wrought iron sheets, folded over, and riveted into tubular sections. Each section was then riveted to the next, to create the overall flue. Inside, each flue has a diameter of 1¾ ft. Both flues join onto a plate that has been carefully formed outwards and then tucked inside the base of the combustion chamber. The unique folds on this plate make the transition of the metal appear almost organic. This same fluid design stands out on Artifact 133-014, although on a much smaller scale (Figure 186). This artifact appears to have served the same function and likely came from slightly higher up on the combustion chamber (Figure 187). While considerably distorted, enough of the original curve remains to determine that the artifact once held a flue with an internal diameter somewhere between 10-14 inches.

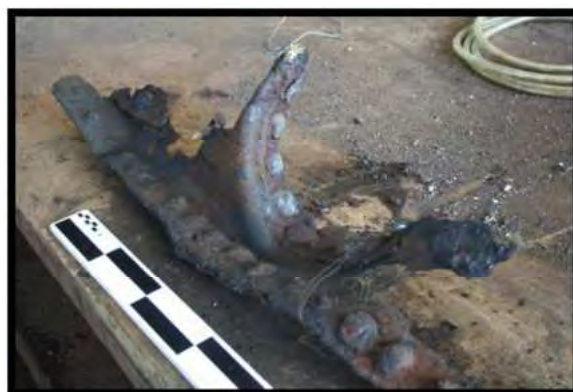
FIGURE 186. PLATING DESIGNED TO HOLD SMALLER ROUND FLUE (ARTIFACT 133-014; SCALE CM/DM)

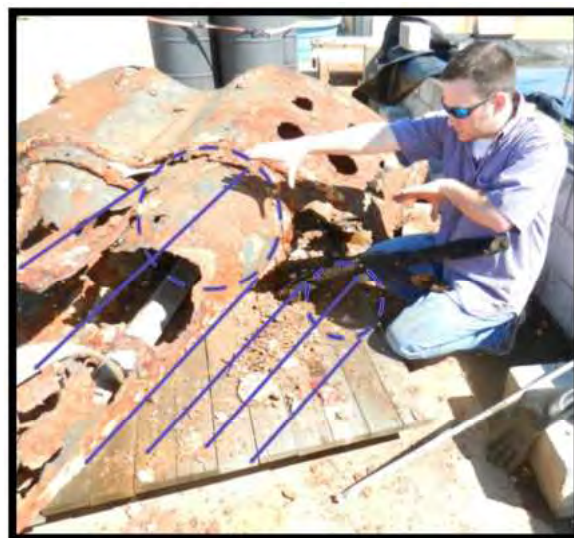
FIGURE 187. BOILER FLUES (ARTIFACT 133-014) IN CONTEXT

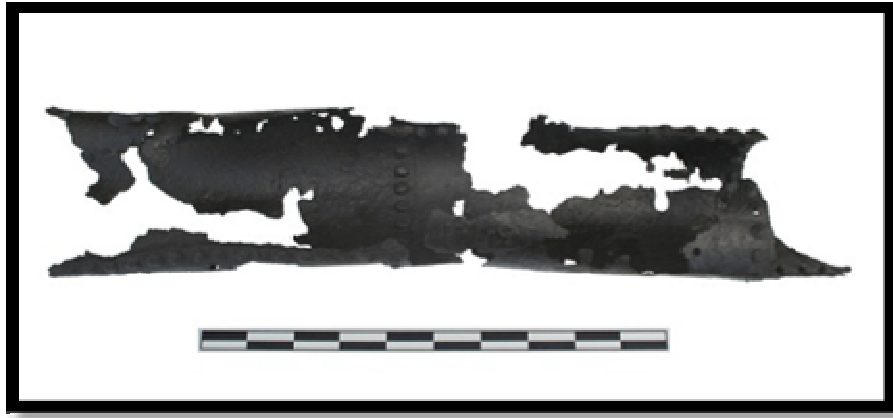
FIGURE 188. SMALLER UPPER SIDE FLUE ON *WESTFIELD* (ARTIFACT 121-010; SCALE DM)

One smaller separated flue was recovered (Figure 188). Artifact 121-010 consists of two pipe segments with an internal diameter of approximately 1 ft. Although smaller, the construction is identical to the larger flues. These artifacts suggest that in addition to the two main flues that left the firebox and joined the combustion chamber, additional smaller flues followed that same path.

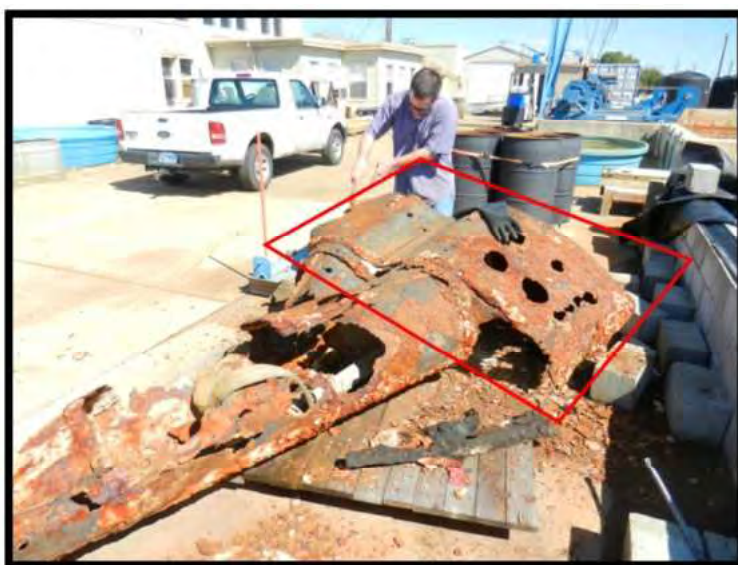
FIGURE 190. REMAINS OF LOWER COMBUSTION CHAMBER (ARTIFACT IS UPSIDE DOWN)

The surviving portion of *Westfield's* combustion chamber measured 2.2-x-6.0-x-3.0-ft (Figure 190). The base of the chamber was secured to the outer boiler barrel with several types of fasteners. Most of the underside, but not the direct bottom, used threaded staybolts. Many of the bolts were also found on the back wall. All of these bolts are heavily corroded, with only a few of them displaying their original threads. The more preserved examples show that after placement, the bolts were hammered over on both sides into conical rivets. The spacing appears similar to staybolts on the firebox, but this cannot be confirmed. The plating where most staybolts were positioned has corroded away. Of the staybolts that remain, they are too far from each other to determine a definitive spacing pattern. Several examples of these bolts were found separately from the combustion chamber and are in considerably better condition. These bolts were conserved as representative examples (Figure 191). At the very bottom of the chamber, the remnants of two double-ended crow's feet indicate, that like the firebox, the iron workers did not trust placing a heavy load onto staybolts. Staybolts were utilized inside compartments, but whenever a direct load required support, double-ended crow's feet were the fastener of choice.

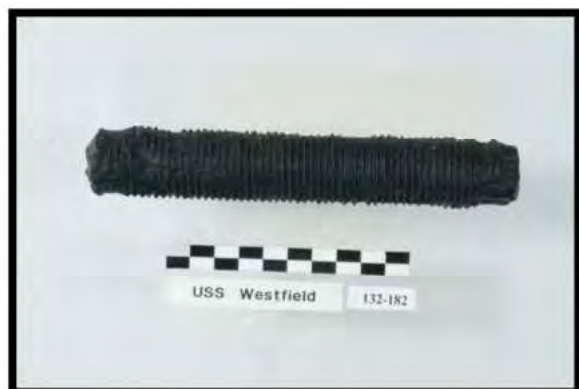
FIGURE 191. THREADED STAYBOLT WITH HAMMERED ENDS (ARTIFACT 132-182)

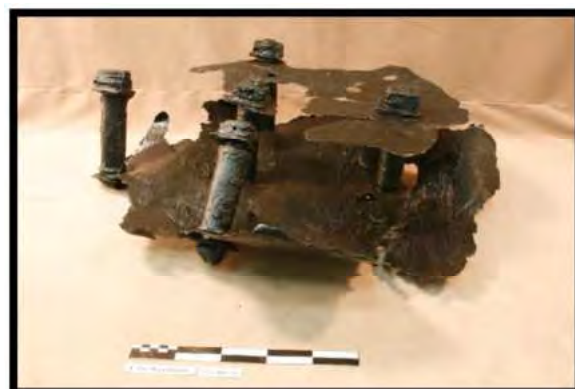
FIGURE 192. UPPER FRAGMENT OF COMBUSTION CHAMBER (ARTIFACT 132-001.76; SCALE CM)

One section from higher up on the combustion chamber was recovered separately (Figure 192). Artifact 132-001.76 consists of plate fragments from both the outer water jacket and the inner combustion chamber. Heavy staybolts secured these plates together. These staybolts are considerably larger and more robust than those found on the firebox. After the bolt passed through the plates and the central sleeve, a large threaded square nut was screwed down over a washer. This was common design found on other boilers (Figure 193). Although unclear, the heavy-duty

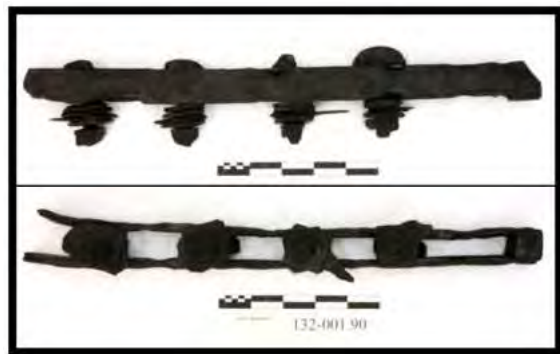
FIGURE 195. GIRDER STAY FROM TOP OF COMBUSTION CHAMBER (ARTIFACT 132-001.90; SCALE CM)

The top of the combustion chamber would have been flat as on most boilers. To ensure that the top of the chamber did not warp, heavy staying devices were required. These devices were known as girder stays. They were typically used when it was "not convenient to stay a flat surface to the opposite shell of the boiler" (Peabody and Miller 1894:108). These devices were commonly used on return flue scotch boilers to support the roof of combustion chambers (International Correspondence Schools 1897:330). One such device was recovered from *Westfield* (Artifact 132-001.90). The artifact appears very similar to the girder stays found in scotch boilers, although somewhat more primitive and possibly an earlier version (Figure 195). One end of the girder stay contains a slightly angled clamp that fit over another object. The other end has broken off, but still retains portions of the clamp, showing that not much of original size has been compromised. Passing through the girder are four threaded bolts containing hooks. The hooks lay over the girder, and the bolts passed through the center, and then into the combustion chamber. Fragments from the top plate of the combustion chamber are still threaded onto the bolt. Underneath, on the end of each bolt, square nuts and washers held the entire assembly together. The surviving base of the combustion chamber measures 2.2 inches wide. Not accounting for the end clamps, the central portion of the girder stay measures approximately 29 inches. The closeness of these two measurements suggests the girder stay came from this location of the boiler.

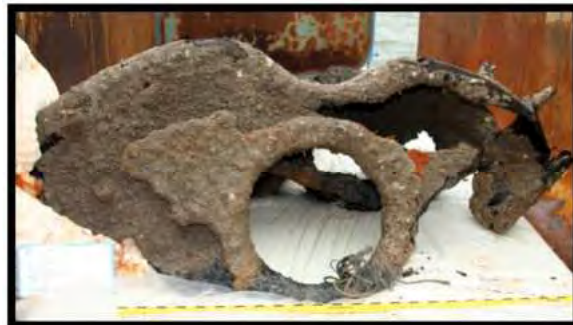
FIGURE 196. REAR ACCESS HATCH TO COMBUSTION CHAMBER (SCALE INCHES)

In order to clean the interior of the combustion chamber, a large access port was situated on the lower rear wall (Figure 196). This circular opening survived intact, and the diameter measures 16.0 inches. A single circular door (Artifact 120-009) was recovered and is believed to have originated from this location (Figure 197). The door has a diameter of 22 inches. The construction of the door matches that found on the fire doors. A front and rear plate are joined together with four small staybolts to maintain an even space between them. A single hinge runs across the door's outside plate diameter, before breaking off just past the edge. Like the fire doors, this round door closed against the outside of the boiler, rather than being seated in an internal frame. A similar example of this door can be seen in a historic photo of the steamer *Mary Powell* (Figure 198).

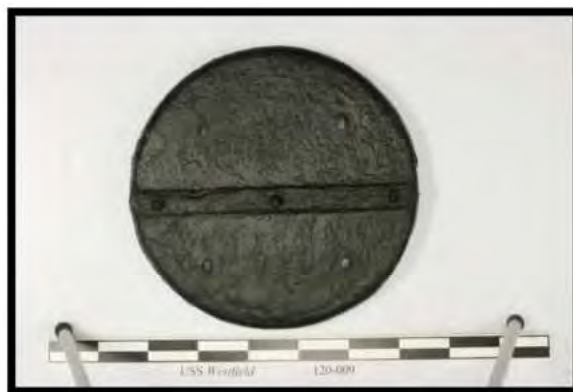
FIGURE 197. DOOR FROM HATCH ON REAR COMBUSTION CHAMBER (ARTIFACT 120-009; SCALE DM)

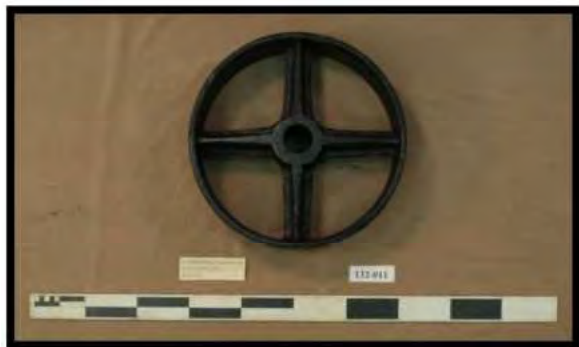
FIGURE 199. CAST IRON WHEEL FROM DONKEY ENGINE (ARTIFACT 132-011; SCALE CM/DM)

Four remaining artifacts fall into a miscellaneous category; however, all are believed to have been associated with the boiler room. Artifact 132-011 consists of a single cast iron wheel (Figure 199). The wheel contains four reinforced spokes that radiate out from a central shaft. Two small holes are placed within this shaft, along the interior walls. These holes were likely used for a key that held an axle in place. This wheel is believed to have come from a small engine. *Westfield's* boiler system

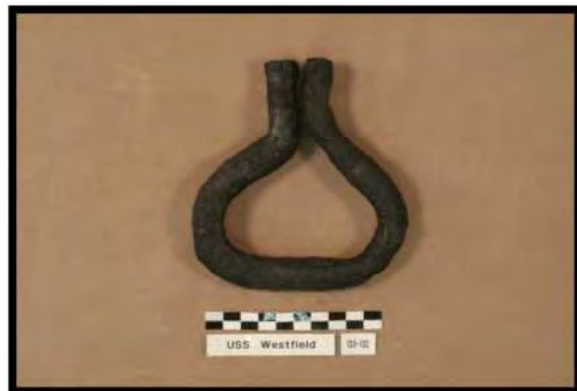
FIGURE 201. COAL STOKER HANDLE (ARTIFACT 133-132)

A second artifact (133-132) was likely a stoker handle used to tend the fires within the furnaces (Figure 201). Commonly, four types of stoker tools were used (Figure 202). The "slice" bar broke up the fire's thick surface crust when using bituminous coal. Anthracite coal burned considerably more efficiently, and did not tend to clump together. Generally, only the cinders needed occasional breaking. The similar "T" bar tool achieved this. A "hoe" bar was used to level the fire and clean out the lower ash pits. Finally, the "poker" bar reached in between the gratings and allowed the fireman to clean any ash or broken bit of coal out from within the slots.

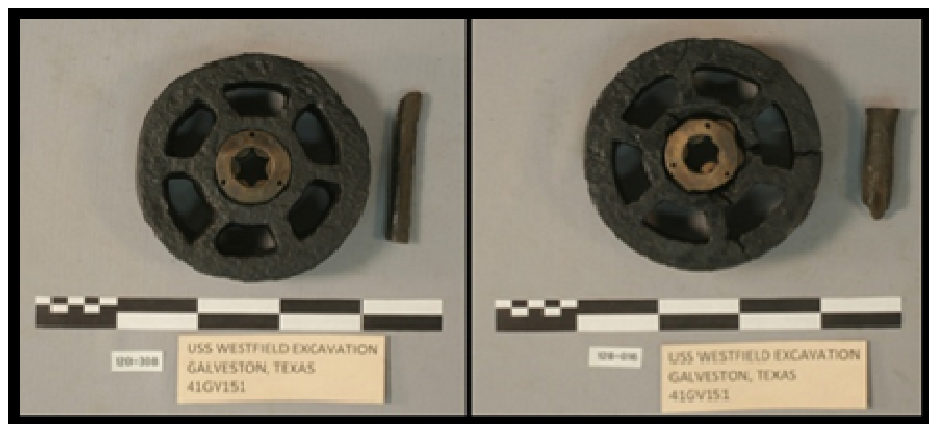
FIGURE 203. CAST IRON SHEAVES WITH BRASS BEARINGS (ARTIFACTS 120-308 AND 128-016)

The two final artifacts (120-308 and 128-016) are both relatively identical, consisting of a sheave and pin (Figure 203). Individually, each sheave is made up of a cast iron wheel that utilizes internal brass bearings. Within the bearings both artifacts had a remnant of a wrought iron pin. The edges of the wheel are recessed to carry a cable or chain. Normally, a block or sheave during this period was made of wood. These artifacts seem like they were intended to carry an extremely heavy load. Although the use of these artifacts has not been conclusively identified, there is a possibility that they were used to haul heavy loads of coal. One theory suggests that they may have been positioned on each side of the boiler to allow for the quick transport and refilling of the coal bunkers.

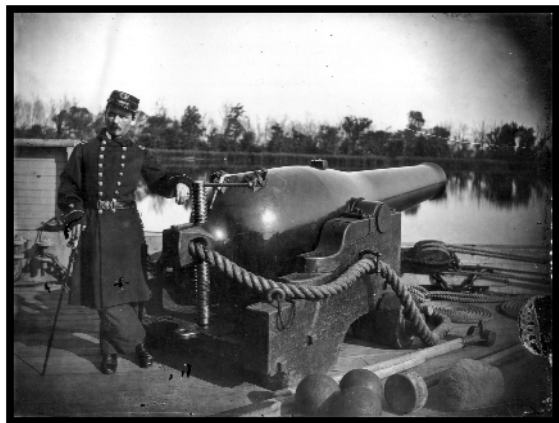
FIGURE 204: HISTORIC IMAGE OF A DAHLGREN 9-INCH CANNON. COURTESY OF THE NATIONAL ARCHIVES, FROM THE MATHEW BRADY CIVIL WAR PHOTOS COLLECTION.

Several artifacts recovered from the site in the vicinity of the cannon have been identified as parts of a gun carriage or associated tackle. Details from the Brady Collection photograph shown in Figure 204 are enlarged in Figure 212 to illustrate the function of various artifacts recovered from the site including: a rear gun sight (figures 213 and 214; compare Figure 212-A); a firing hammer and hammer cord (figures 215, 216 and 217; compare Figure 212-B); a fragment of an elevation screw (Figure 218; compare Figure 212-C); and a cascabel block, attached when recovered, used to secure the breach rope (figures 219 and 220; compare Figure 212-D).

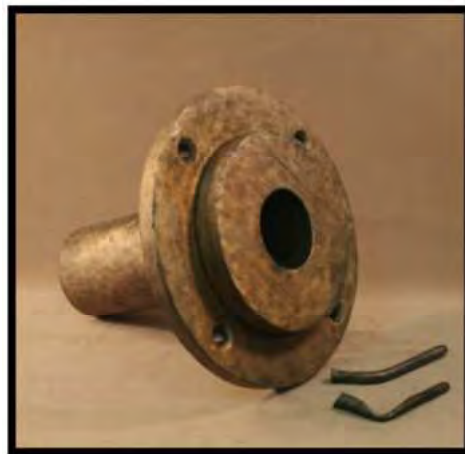
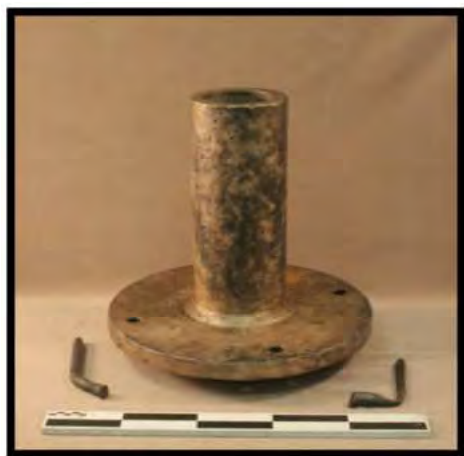
FIGURE 207. *WESTFIELD* DECK SOCKET FOR PIVOT CARRIAGE (ARTIFACT 122-046)

FIGURE 206. *WESTFIELD* DECK SOCKET FOR PIVOT CARRIAGE (ARTIFACT 122-046; SCALE CM/DM)

1863 (*Houston Tri-Weekly Telegraph* 1863a). A heavy brass deck socket for a pivot carriage (Artifact 122-046; figures 206 and 207) was recovered near the rear cabin bulkhead. This was presumably associated with the pivot Dahlgren mounted at the stern. An example of how the pivot socket would have been incorporated into the main deck is shown in the right foreground of Figure 208. It is unclear how such a heavy artifact, its shaft originally embedded in the main deck, moved forwards the length of the aft deck before sinking to the seafloor. One possible scenario is that a section of deck containing the socket detached under its weight as the vessel burned but retained sufficient buoyancy to float forward until coming to rest near the cabin bulkhead.

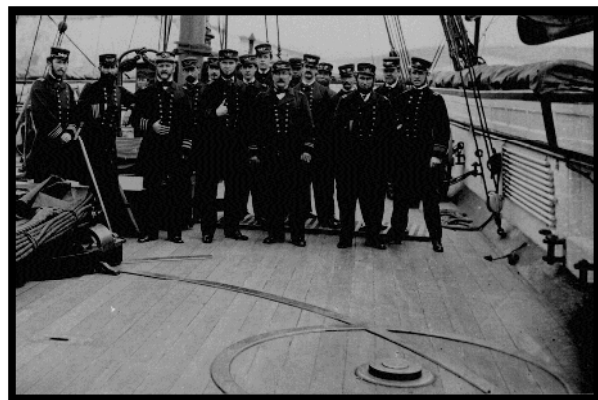
FIGURE 208. SOCKET FOR PIVOT CARRIAGE IN DECK OF UNIDENTIFIED GUNBOAT.

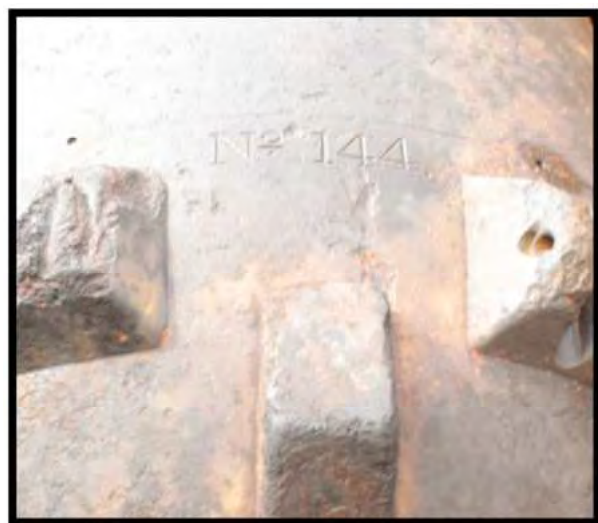
FIGURE 209. *WESTFIELD* DAHLGREN SERIAL NUMBER (ARTIFACT 123-001)

The *Westfield* Dahlgren's government serial number, No. 144, is stamped on top of the gun just forward of the gun sight position (Figure 209). The gun was cast at the Cyrus Alger and Company foundry in south Boston in 1857 (Olmstead, et al. 1997:243). The serial number might ultimately be used to establish the origin of the recovered Dahlgren, as originally belonging either to *Westfield* or borrowed from *Clifton*. The authors suspect, based on its location within the debris field, that the recovered Dahlgren was positioned in the broadside gun port immediately aft of the cabin on the starboard side when the ship was destroyed. Since *Westfield*'s original Dahlgren was pivot-mounted at the stern, this position implies that the recovered gun was mounted on a Marsilly carriage and was the gun borrowed from USS *Clifton*, although that determination has yet to be confirmed by research. The conserved Dahlgren is illustrated in Figure 210 as it now appears on a reconstructed Marsilly carriage.

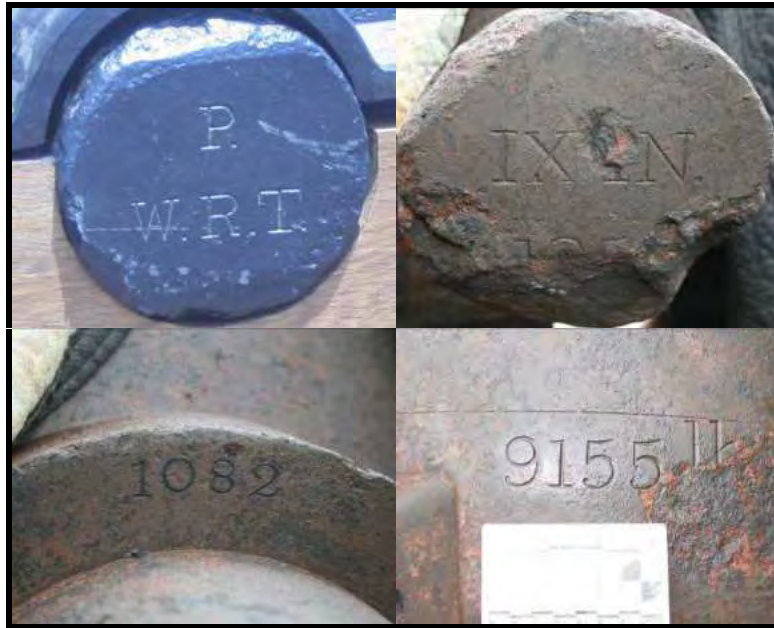
FIGURE 211. IDENTIFYING STAMPS ON *WESTFIELD'S* 9-INCH DAHLGREN

The left trunnion is stamped “P” for proof and “WRT” (Figure 211), indicating that the gun was inspected at the foundry by William R. Taylor in his first year working at the Alger foundry (Olmstead, et al. 1997: 170). The right trunnion is marked “IX IN” for 9-inch Dahlgren. The Alger foundry casting number “1082” is stamped on the rimbase of the right trunnion (Figure 211) and on the top of the cascabel as stipulated by The Bureau of Ordnance (Unidentified 1881:331). Just forward and to the side of the left firing mechanism is stamped the cannon’s weight, “9155” pounds. The foundry’s initials, located on the base line just to the side of the right ignition base, have eroded away.

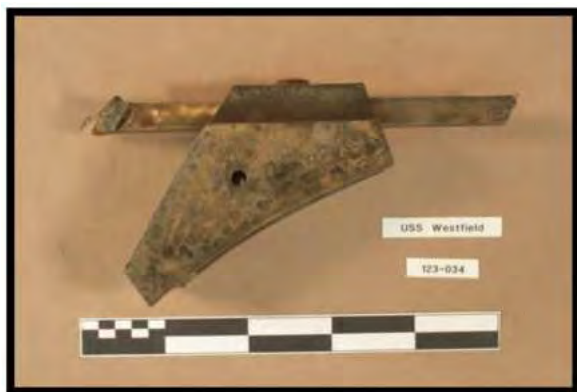
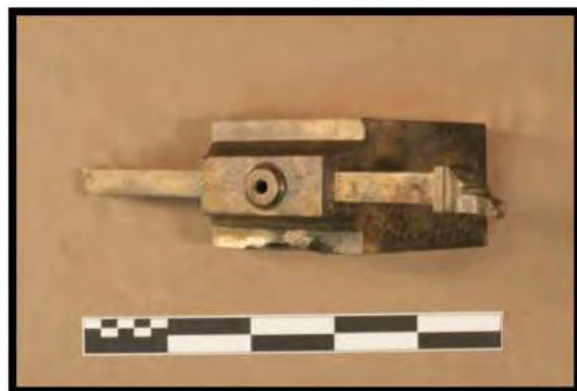
The Dahlgren's rear gun sight (figures 213 and 214) was recovered from sediment directly beneath the cannon. Both pieces are stamped with the Dahlgren's government serial number, 144. The bent firing hammer (figures 215 and 216) was attached to the Dahlgren when it was recovered and, likewise, is stamped with serial number 144. A coil of well-preserved cord, believed to be the Dahlgren's hammer cord (Figure 217), was recovered from inside the cannon's muzzle. A more

FIGURE 213: DAHLGREN REAR GUN SIGHT (SIDE)
(ARTIFACT 123-34; SCALE CM)

FIGURE 214: DAHLGREN REAR GUN SIGHT (TOP)
(ARTIFACT 123-34; SCALE CM)

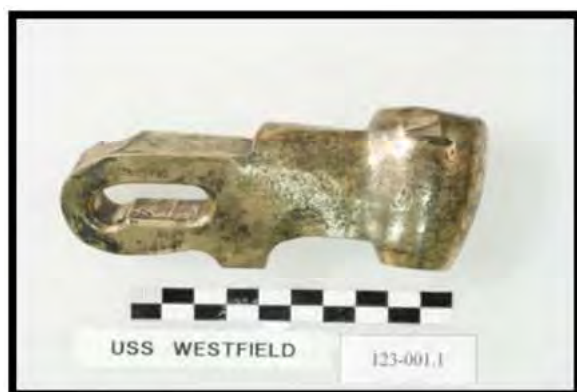
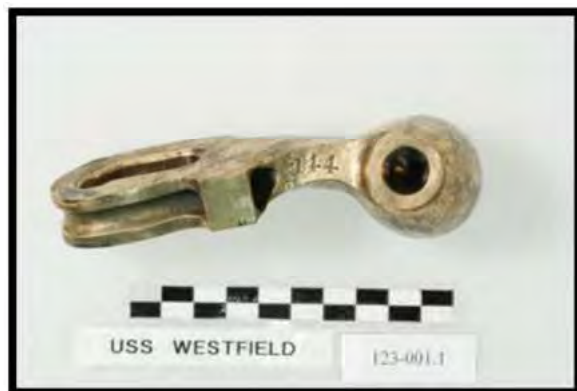
FIGURE 215: DAHLGREN FIRING HAMMER (SIDE)
(ARTIFACT 123-001.1)

FIGURE 216: DAHLGREN HAMMER (BOTTOM)
(ARTIFACT 123-001.1)

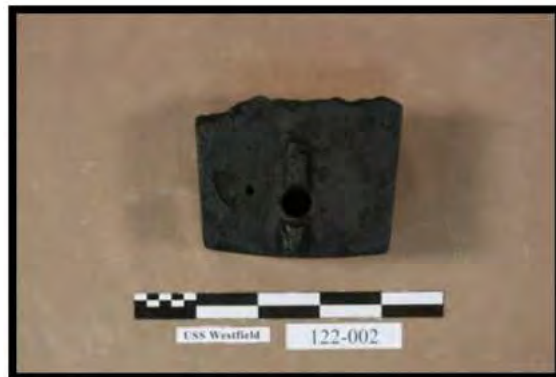
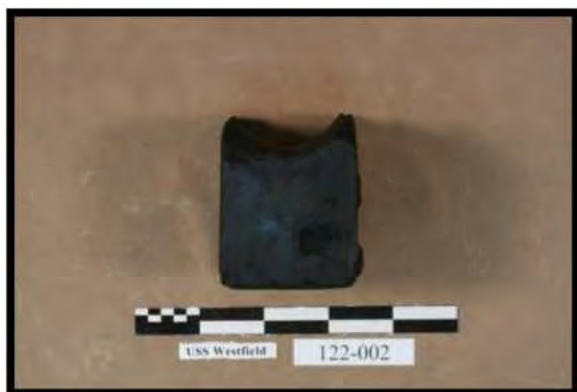
FIGURE 220: DAHLGREN CASCABEL BLOCK (TOP)
(ARTIFACT 122-002; SCALE CM)

FIGURE 219: DAHLGREN CASCABEL BLOCK (SIDE)
(ARTIFACT 122-002; SCALE CM)

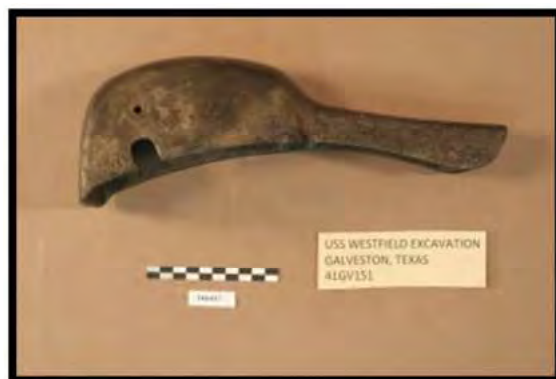
FIGURE 221. REAR GUN SIGHT COVER
(ARTIFACT 104-17)

A rear gun sight cover (Figure 221) was recovered about 30 ft aft of the Dahlgren. It is 12 x 2 $\frac{5}{8}$ x 3 inches and marked "PF 8 OF 56." Its style matches site covers used on Dahlgren cannons (Figure 222, for example); however, it does not quite fit over the recovered gun sight. This artifact might be associated with the other Dahlgren, which was recovered by Confederate salvers in 1863.

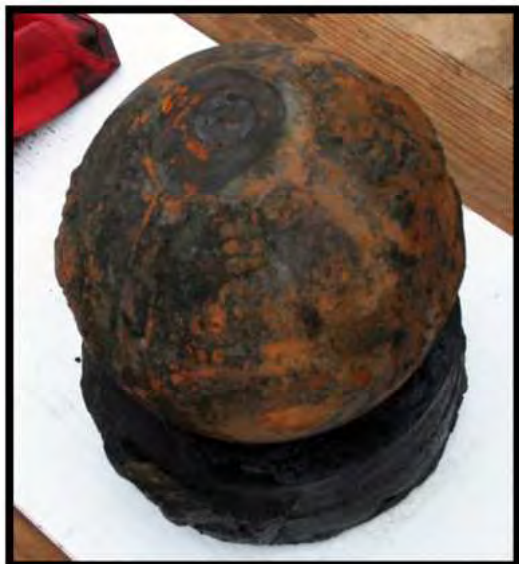
FIGURE 229. 9-INCH SHELL ON SABOT
(PHOTOGRAPH BY AMY BORGENS)

Four of the 9-inch shells were concreted to their respective sabots (e.g., Figure 229), including one recovered from the base of the cannon's bore. Wooden sabots were affixed with tin straps to the base of each shell, opposite the fuse. Remnants of tin straps and a tin band around the fuse can be seen in Figure 229 as a slight stain on the shell. Tack holes where tin straps were fastened to the edge of a sabot can be seen in the side view of Figure 230. The alignment maintained by the sabot and straps kept the fuse pointed away from the firing charge, hopefully assuring the shell did not ignite while in the muzzle. Iron concretions protected the surviving sabots from *teredo* consumption, including a fused 9-inch shell on a sabot inside a wooden passing box (Figure 231), one of the best examples of wood preservation in the artifact assemblage. Another 9-inch shell (Artifact 121-002) was discovered concreted to a sabot, with a wooden plug in its fuse hole, and stored inside of a passing box. Passing boxes were used to temporarily store shells while passing them up to the gun deck. The fact that the latter shell had not been fused suggests it was stored in the aft magazine when the ship was destroyed.

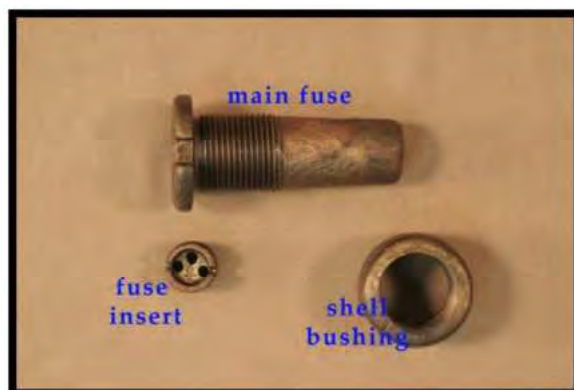
FIGURE 232. WATERCAP FUSE
(ARTIFACT 109-80)

Seventy-one brass fuses have been identified within the artifact collection. All the fuses are the standard U.S. Navy watercap type issued for naval shells (Figure 232, for example). The watercap fuses were an improved version of the naval fuse designed by Cyrus Alger and used during the Mexican-American War. The timing mechanism, or wick, inside each brass fuse consisted of a tightly wound plug of paper infused with gunpowder (Figure 233). The burn time of each fuse was controlled by the length of the paper wick.

Clearly the cap had been removed prior to loading the cannon. The fuse in Figure 232 is shown disassembled to illustrate the bushing, normally residing in a shell's fuse hole until it was time to arm the shell, and the threaded brass insert with three holes exposing the wick to muzzle flash. The fuses from *Westfield* typically have 14 threads, measure 2.4 inches long, and have a maximum diameter of 1.25 inches at the head of the fuse. The shaft measurement varies with each individual fuse and can range from 0.63 to 0.80 inch in diameter. Each fuse is typically stamped ORD with a manufacturing date and an anchor to denote naval use. Many of the fuses from *Westfield* retain these marks and are stamped 1861 or 1862.

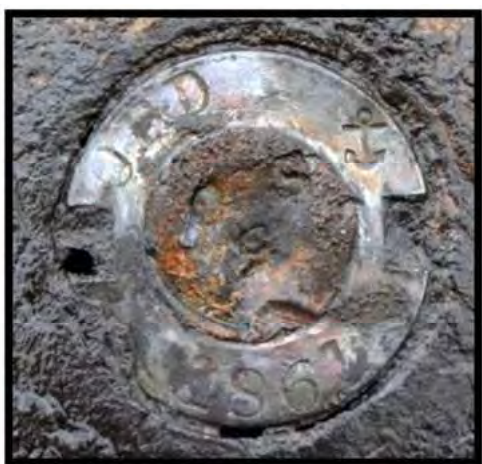
FIGURE 234. LEAD SAFETY PATCH
ON 5-SECOND FUSE
(PHOTOGRAPH BY AMY BORGES)

A watercap that prevented moisture from entering the fuse was sealed by a lead safety patch stamped with the burning time in seconds (Figure 234). Twenty-one fuses retained their lead safety patch with burning times of 5 and 15 seconds clearly legible. Slightly more than half of the lead fuse caps recovered from the site came from fused shells, which appeared to offer a more protective environment due to their relatively stable positions. The lead would have been removed from a fuse shortly before firing a shell, as the fuse was ignited by the muzzle flash. For example, the fused shell in the Dahlgren bore did not have a lead cap in place, despite the protection afforded by its location.

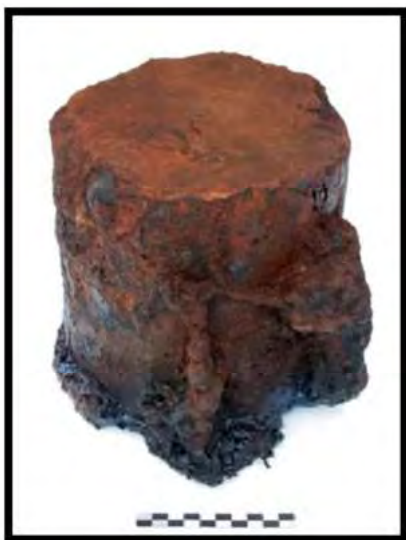
FIGURE 235. CANISTER SHOT
(ARTIFACT 121-048; PHOTOGRAPH BY
CHRIS CARTELLONE AND KIRSTEN ATWOOD)

Ten complete or partial canister shot have been identified. Diameters of shot represented include 1.3 and 1.5 inches. Several of these were recovered with portions of their outer tin casing intact. One of the best-preserved examples of a complete canister shot (Artifact 121-48) is shown prior to conservation in Figure 235. It measures 7.3 inches long and has a diameter of 7.9 inches. The tin casing does not generally survive conservation. Figure 236 shows the same artifact disassembled after conservation. Only a small fragment of tin survived. This canister contained 86 solid iron shot. Two other conserved examples (Figure 237) illustrate how solid shot was packed in sawdust within the canisters.

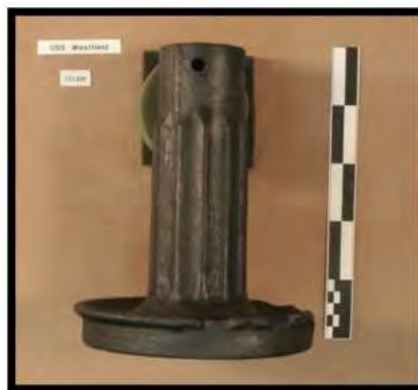
FIGURE 238. GRAPE SHOT STAND
(ARTIFACT 121-049; SCALE CM)

Grape shot was much less common than canister shot in the artifact assemblage. Only five examples of iron shot were large enough that conservators classified them as grape shot. An empty iron stand, designed to hold grape shot for a 9-in Dahlgren, also was recovered from *Westfield* (Figure 238). It was found concreted to a 2.5-in solid shot and fragments of rope and canvas. The maximum diameter of its base, if not damaged, would have been 8.56 inches. Grapeshot for the naval 9-inch Dahlgren was held in place by a "quilted" sailcloth enclosure and measured 10.75 inches in length with a diameter of 8.65 inches. The standard diameter grape shot for the 9-inch quilted round is 2.80 inches (Bell 2003:99, 109).
