Investigation and Recovery of USS Westfield (Site 41GV151) Galveston Bay, Galveston County, Texas

Document No. 100102a
Atkins Job No. 044118606

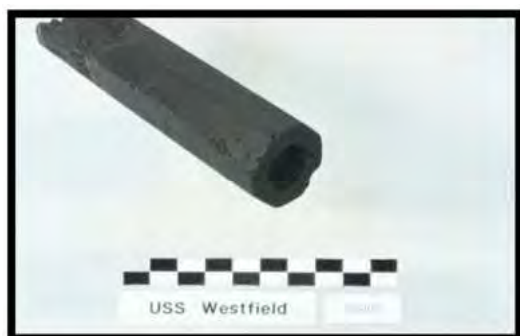
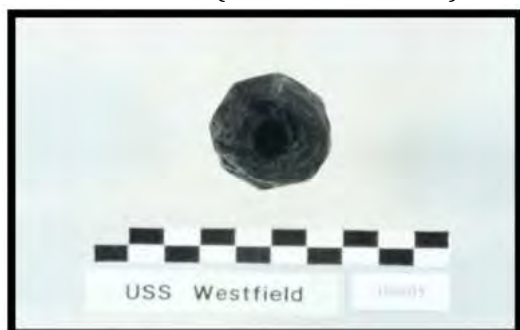
FIGURE 240. BREECH END OF FIREARM BARREL
FRAGMENT (ARTIFACT 110-015)

FIGURE 241. BROKEN END OF FIREARM BARREL
(ARTIFACT 110-015)

A second firearm fragment (Artifact 110-015; figures 240 and 241) is only the rear portion of the barrel at the breech where it fastened to the breech plug. The breech plug is not preserved but remnants of it were attached to the barrel and observed by conservators. The octagon-shaped barrel fragment has a length of 5.13 inches and has a maximum width of 1.00 inch. The rear of the barrel was threaded for its attachment to the breech plug and has an interior diameter of approximately 0.63 inches at this juncture. A lead shot recovered from inside the barrel with a fragment of wadding (Figure 242) has a diameter of 0.37 to 0.41 inches. The wadding consists of a plain fine weave. The fibers are heavily impregnated with iron and dirt. Cleaning this material would have damaged the fibers and separated the weave, so it was preserved with silicone oil without further treatment. The fibers are short and appear to be cotton or linen, most likely cotton.

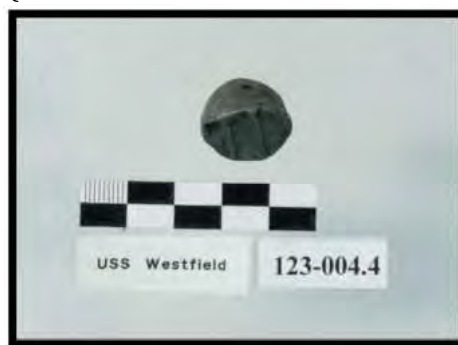
FIGURE 243. LEAD MUSKET SHOT
(ARTIFACT 123-004.4)

A second damaged lead shot (Figure 243), of which just more than half remains, was recovered from grid 123. Artifact 123-004.4 was cut in half, which has had the effect of creating an irregular diameter varying from 0.63 to 0.75 inches. This size of projectile, though damaged, is consistent with musket caliber shot of the period.

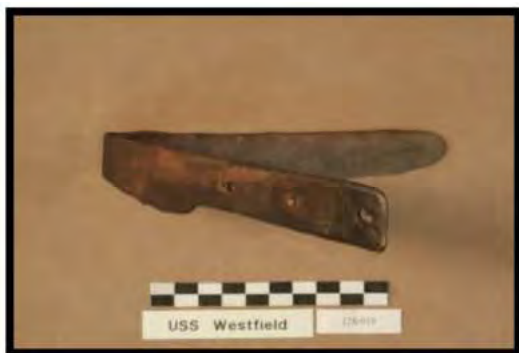
FIGURE 244. COPPER POWDER KNIFE
(ARTIFACT 128-019)

A copper knife was recovered from Unit 128 (Figure 244). This is a rather unique artifact, as most knives of the time would have been made of much harder steel. Copper knives were part of the standard tool kit supplied to each powder magazine. The Ordnance Instructions for the United States Navy, Tables of Allowances of Ordnance Equipments and Stores lists an allowance of one copper knife for each magazine (U.S. Navy Department, Bureau of Ordnance 1864: cii). Given that the forward magazine exploded, this knife must have come from the aft magazine. The fact that it survived in good condition, minus its wooden handle, suggests that no explosion occurred in the aft magazine.

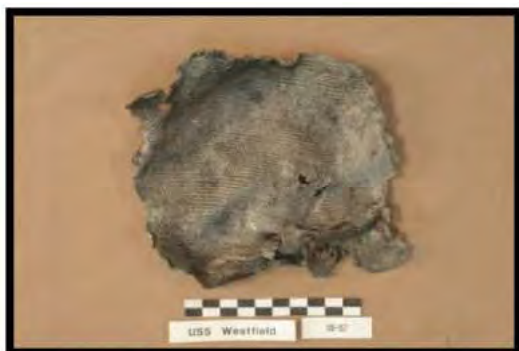
FIGURE 245. LEAD SHEET WITH FABRIC
IMPRESSION (ARTIFACT 118-157)

Over one-hundred miscellaneous fragments of lead were recovered from *Westfield*. While many were intrusive fishing weights, the purposes of others could not be determined. Most of the recovered lead appeared as non-diagnostic scraps of metal. Of the few that did contain diagnostic features, only one can be potentially recognized as having a specific function. The lead sheet shown in Figure 245 contains a unique impression resembling a fabric weave, providing a clue as to its function. The Union Navy lined powder magazines aboard naval vessels with lead to prevent accidental sparking (U.S. Navy Department, Bureau of Ordnance 1864: III-48). Coarse woolen baize cloth was hung as a screen over entrances to prevent sparks from entering the magazine. The imprint might have been caused by stacking powder barrels on a woolen baize cloth laid down on the magazine floor or by stacking woolen powder cartridge bags directly on the lead sheeted floor.

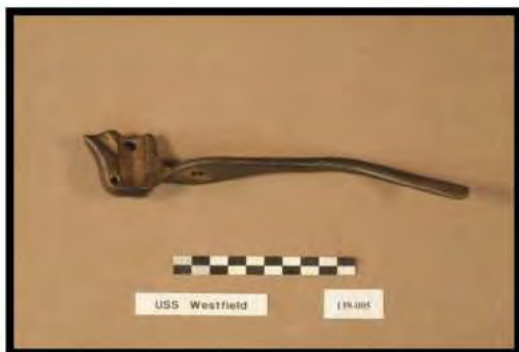
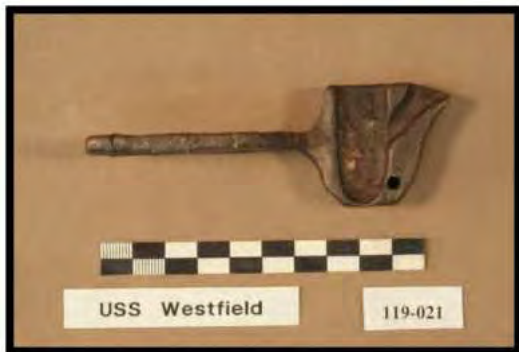
FIGURE 246. BULLET MOLD
(ARTIFACTS 139-005 AND 119-021)

A hand-held brass bullet mold was recovered in two pieces from grids 119 and 139 (Figure 246). The right half of the mold is complete though the handle is bent (Artifact 139-5). The handle is broken on the left half of the mold (Artifact 119-21). The length of the complete half is 7.5 inches. The handles likely had wooden grips and may have been similar to a locally produced mid-nineteenth-century example from the Gillespie County Historical Society on display at the Bob Bullock Texas State History Museum in Austin, Texas. The mold would have created a conical-shaped lead projectile approximately 1.35 inches long with a diameter of 0.60 inch.

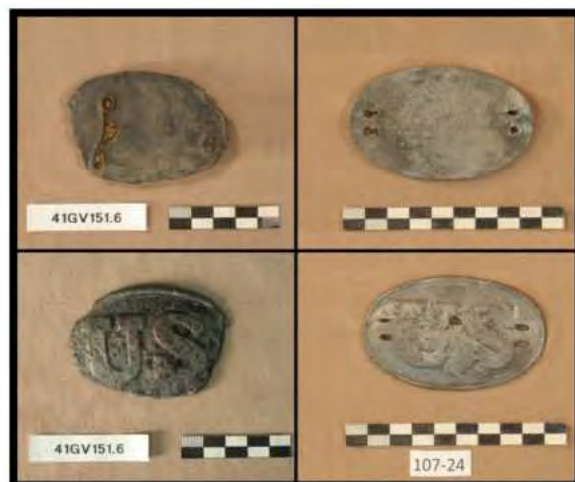
FIGURE 247. EXAMPLES OF UNION BELT AND
CARTRIDGE BOX PLATES
(ARTIFACTS 6 AND 107-024)

Eleven plates were dispersed in the northern portion of the wreck site. Six plates were used on cartridge boxes and 5 plates are the standard U.S. military buckles (typically the Model 1856) issued for belts. Figure 247 displays examples of “U.S.” marked belt and cartridge box plates, differentiated by the different types of clasps either on the back or sides of the plate. Those marked with the “U.S.” symbol appear to be lead but once had a shell of brass overlaid above the lead. Traces of this cupreous material can still be seen on closer examination. The buckles from the cartridge boxes are all complete. All but one of the belt buckles is heavily eroded and damaged.

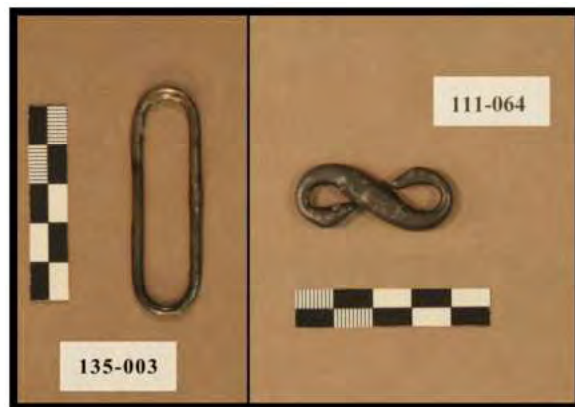
FIGURE 249. TWO ARTIFACTS ASSOCIATED
WITH SNAKE BUCKLES (ARTIFACTS 111-064
AND 135-003; SCALE MM/CM)

The British blockade runners supplied the Confederate troops with snake or “S” shaped buckles, which were attached to two oval links on either side of the “S” (Figure 248). Two heavily eroded pieces (Artifacts 111-064 and 135-003) of this buckle type were found on the *Westfield* site and may have been taken off a British blockade runner, as the Union personnel were not above using British plates also (Figure 249). Since these artifacts were not found together, archeologists cannot confirm if the pieces represent two separate buckles or one buckle that became dispersed following *Westfield's* explosion. The midpoint of one long side on the belt plate loop shows a weld point, and the metal is thicker at that point. In addition, a break point is seen next to the weld point. This is most likely the original attachment to a small circular loop where the snake buckle would have attached. Another identical loop on the other side of the snake belt plate would have completed the attachment to the belt.

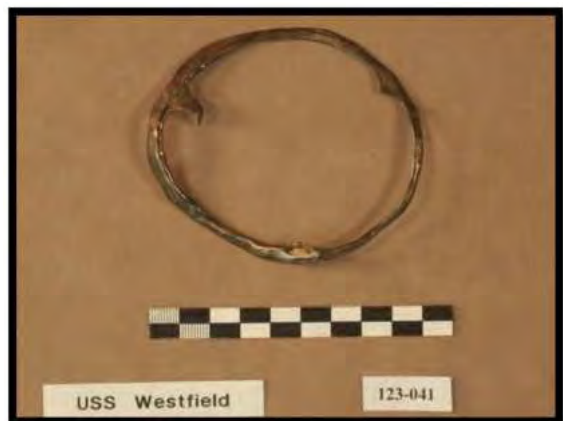
FIGURE 250. BRASS BUCKLE FRAME
(ARTIFACT 123-041)

One other artifact resembles a buckle (Artifact 123-041). Unfortunately the piece is poorly preserved and only survives as an outer frame. The frame may have held a decorative item as indicated by three triangular tabs that line the interior, similar to the image in Figure 250.

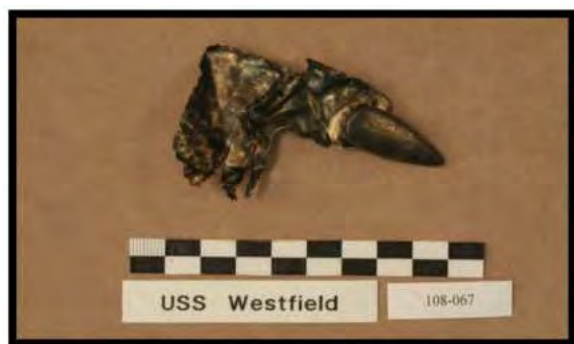
FIGURE 251. BRASS HOOK FOR BAYONET FROG
(ARTIFACT 108-067)

Only a few other clothing artifacts were recovered from *Westfield*. Most of these came from military equipment. Artifact 108-067 consists of a small brass hook and plating that once wrapped around a bayonet scabbard (Figure 251). As seen in Figure 252, the hook was used to attach the bayonet scabbard to a leather belt accessory known as a frog.

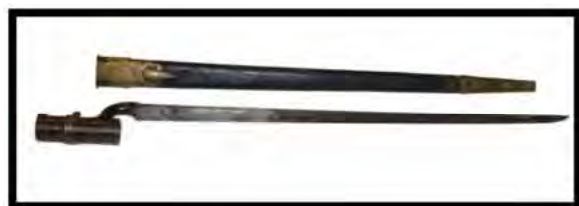
FIGURE 252. COMPARATIVE EXAMPLE OF AN INTACT
BAYONET SHEATH WITH BRASS FROG ACCESSORY
(IMAGE COURTESY OF "THE HORSE SOLDIER")

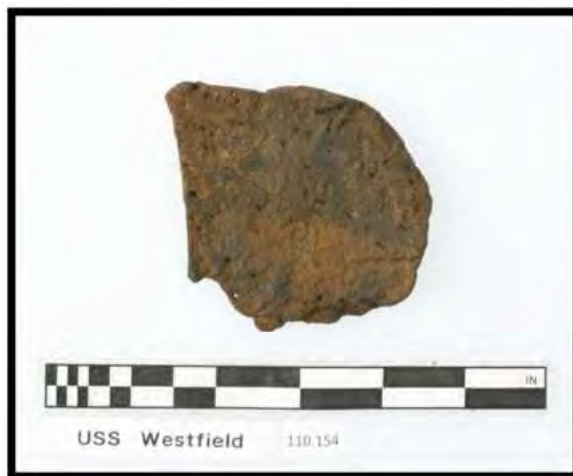
FIGURE 255. LEATHER HEEL FROM LEFT SIDED
BOOT (ARTIFACT 110-154; SCALE INCHES)

At first, Artifact 110-154 appeared as a scrap of non-diagnostic leather. Only after conservation did stitching holes and cut edges become apparent. This artifact proved to be a left heel from a leather boot (Figure 255). During the Civil War, most soldiers' footwear did not contain a proper left or right, which allowed a shoe to be worn on either foot. The indication that this artifact belonged to a left sided sole, may mean that the boot once came from an officer.

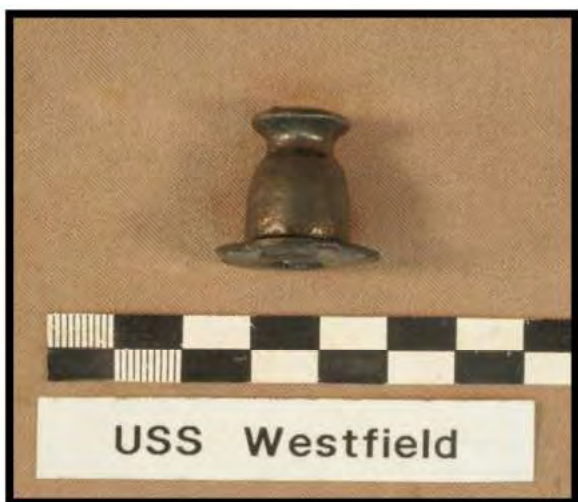
FIGURE 258. BRASS TOP AND CAP FROM
ENFIELD OIL CAN (ARTIFACT 132-001.02)

Marines aboard *Westfield* were issued standard oil bottles to maintain and lubricate their Enfield muskets. Although heavily eroded, a brass top and cap (Artifact 132-001.02) from one of these bottles survived (Figure 258). In original form, the oil bottle contained a rolled sheet of zinc for the bottle and a threaded brass top and cap. The cap contained vertical grooves along the rim to allow for easy fingertip removal. Attached to the inner cap, a steel applicator allowed oil to be removed and applied to the musket (Figure 259).

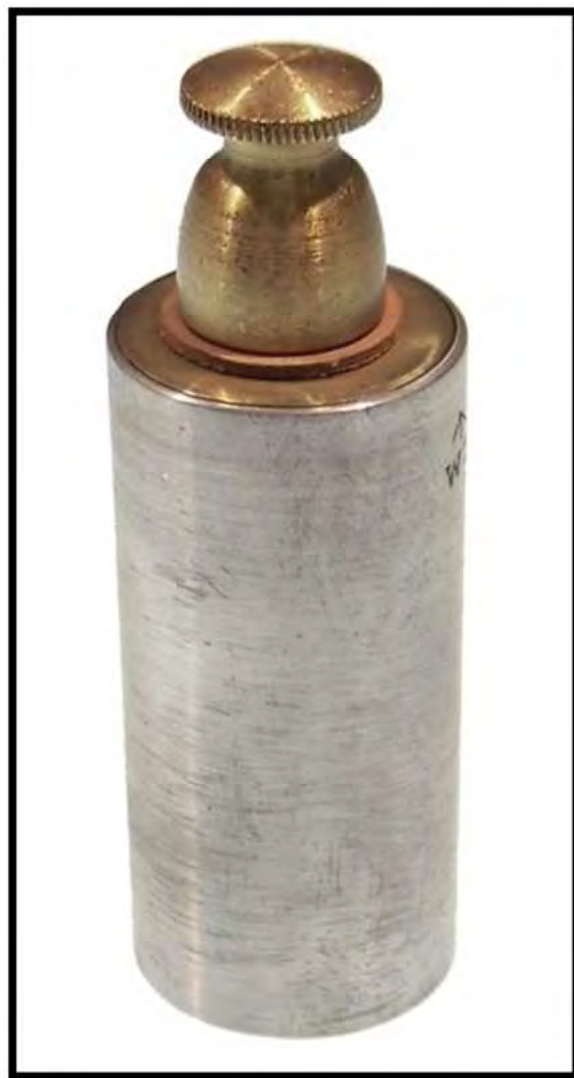
FIGURE 259. REPRODUCTION ENFIELD OIL CAN
(IMAGE COURTESY OF S & S FIREARMS)

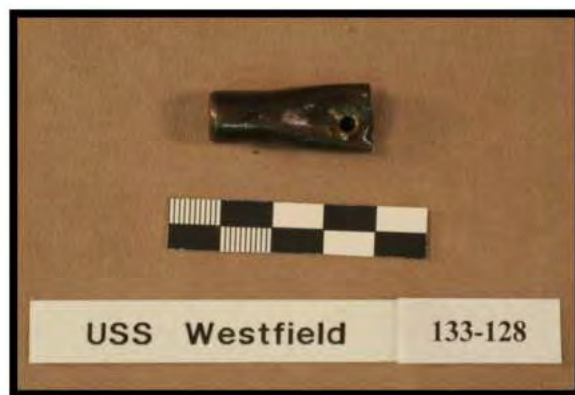
FIGURE 260. BRASS CYLINDER FROM ENFIELD
MUSKET ROD (ARTIFACT 133-128)

Part of maintaining an Enfield musket, included running a ramrod down the barrel with a cleaning jag to swab out debris. A fitting from one of these rods was recovered from *Westfield* (Artifact 133-128). This fitting consists of a small brass cylinder with internal threading on one end and two small pin holes on the other. These pin holes pierce through the cylinder's diameter. The side with the holes is crushed, but the rest of the artifact is relatively well preserved. The artifact was designed to secure a brush or cleaning jag to the rod. The internal threading allowed the cleaning jag to be screwed onto the rod's tip. To secure the cylindrical fitting to the rod, a small iron pin was pushed through the holes in both the fitting and the rod (Figure 260).

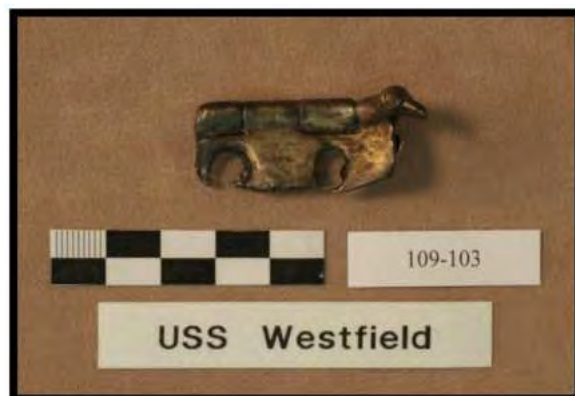
FIGURE 264. INTACT BRASS HINGE
(ARTIFACT 109-103)

An assortment of other artifacts may have come from seaman's storage chests, foot lockers, or other types of boxes. All of these artifacts are cupreous and were found scattered across the site. As with other artifacts, this disarticulation does not allow archeologists to determine with certainty how many original objects are represented in the collection. Despite this, four hinge fragments (Artifacts 102-062, 105-023, 106-031, and 107-028.1) are of the same size, and design, and if joined represent two complete hinges with an upper and lower portion (Figure 263). These fragments appear to have come from the same original object. One other hinge (Artifact 109-103) of a different type came from a different object (Figure 264).

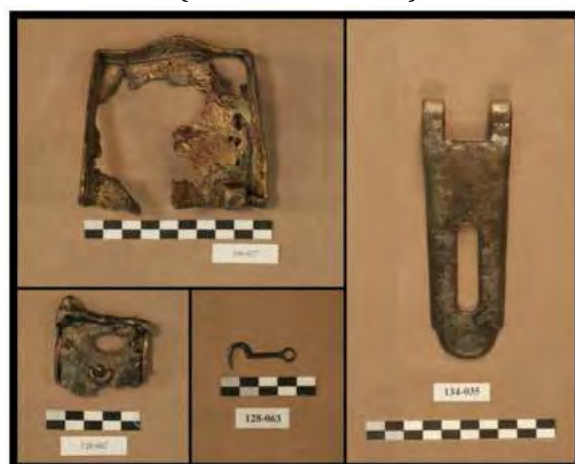
FIGURE 265. ASSORTMENT OF BRASS LOCKING
DEVICES (ARTIFACTS 106-027, 128-062,
128-063, AND 134-035)

Four locking devices were also found (Figure 265). A cupreous hasp (Artifact 134-035) for a padlock clasp contains two holes on one end. One of these holes is filled with brass, suggesting that the other portion of the hasp was also made of brass. The other end has decorative beveling, flat on one side and concave on the other, and a long ellipse opening to allow a loop to enter and a lock to be attached. Another lock type consisted of a small hook with a flat backside and a decorative embossed front (Artifact 128-063). The hook was once fixed to a box and rotated counterclockwise, so that the embossed side faced outward.

The other locking devices consisted of fragments from two different sized rectangular lock plates. The larger lock plate (Artifact 106-027) contains mounting points suggesting that the artifact came from the back portion of a lock assembly. The smaller lock plate (Artifact 128-062) contains an oval or key entry that indicates that the object is from the front of a lock assembly. Falling into the same category as locks, a small cupreous key (Artifact 120-295) was recovered but cannot be confirmed

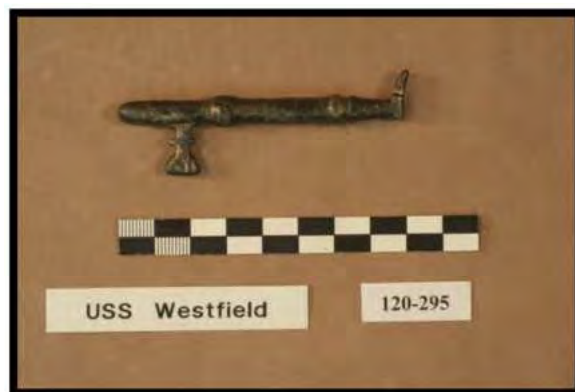
FIGURE 266. BRASS SKELETON KEY
(ARTIFACT 120-295)

as belonging to one of these boxes or from one of the ship's doors (Figure 266). The key contains three decorative bands around the shaft and is mostly complete, with the exception of a missing portion of the ring.

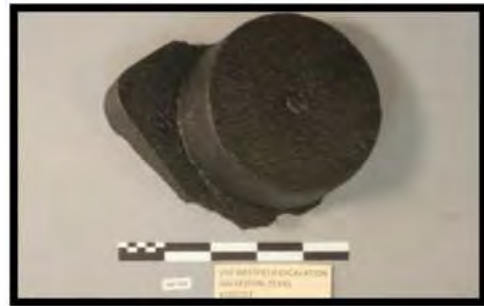
FIGURE 271. LARGER CYLINDRICAL NAVAL STOVE COVER (ARTIFACT 110-150; SCALE CM)

To feed *Westfield's* large crew, the vessel required a shipboard kitchen or galley. Two small cast iron artifacts were recovered from what is believed to have been the starboard central side of the ship. Conservators believe that both of these objects served as cover plates from a large marine stove located near this vicinity of the wreck site. The larger artifact (110-150) contains a square base that is largely damaged, but rounded corners and a central raised circular portion indicate that the object was designed to fit over something without moving (Figure 271). Similar examples from 1835 can be found in French naval stoves for shipboard use (see Figure 272). These stoves contained built-in cylindrical recesses into which pots were placed. When not in use, square and round cover plates covered these recesses. The smaller artifact (119-126) was once part of a round cover plate that if complete, contained an internal diameter of approximately twelve inches (Figure 273). If these artifacts are close to their original position, *Westfield's* kitchen may have been situated on the starboard side of the vessel.

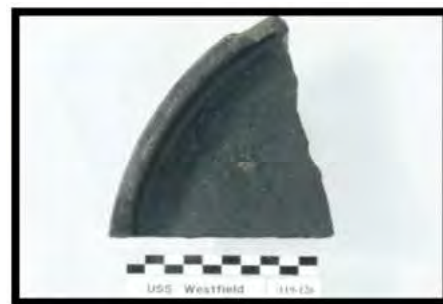
FIGURE 273. SMALLER NAVAL STOVE COVER (ARTIFACT 119-126)

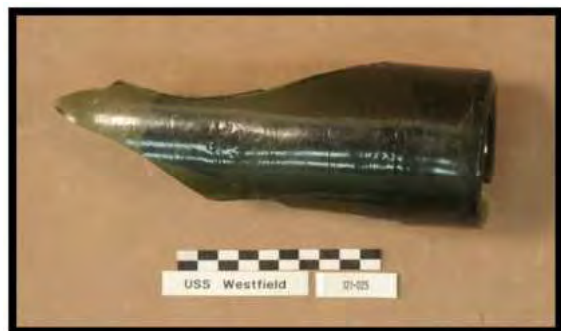
FIGURE 275. DARK GREEN WINE BOTTLE (ARTIFACT 121-025)

Several fragments of light green glass were recovered from *Westfield*. The largest piece (Artifact 121-025), represents a one-third surviving section of a wine bottle (Figure 275). The glass is thick and heavy, and is missing the neck, rim, and most of the body. Significant portions of the base and kick-up are still intact. The breaks in the bottle show that unlike modern bottles, these 19th-century bottles have many imperfections, such as uneven wall thicknesses and bubbles contained within the glass. Several fragments were also found of darker green glass. The largest piece consisted on only the lower base (Artifact 132-396). This bottle contains very thick heavy glass that is opaque (Figure 276). Only the base, kick-up, and a small portion of walls are preserved. The kick-up has low sloping walls that are almost at 45 degrees from the walls of the bottle. A small, shallow pontil scar is visible on the outside showing from where the bottle was blown.

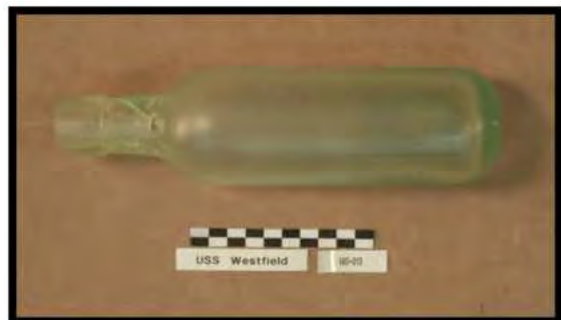
FIGURE 277. SODA OR MINERAL WATER BOTTLE (ARTIFACT 140-013)

Conservators believe one of the more intact bottles (Artifact 140-013) recovered from *Westfield* is intrusive, but nonetheless historic. The bottle's color is a light bluish-green. The neck and rim are broken in multiple places and missing a few fragments, but the bottle is otherwise complete (Figure

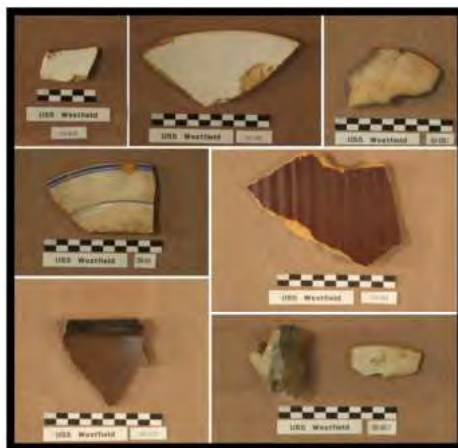
FIGURE 278. MISCELLANEOUS CERAMIC SHERDS (ARTIFACTS 134-046, 120-280, 103-039, 139-011, 124-033, 109-123, AND 132-001.7)

The following fragments represent the most diagnostic or largest examples of different ceramics types recovered from *Westfield* (Figure 278). Artifact 134-046 consists of a small porcelain rim sherd. This fragment has a bend on the opposite end of the rim, where the original object may have sloped downwards to create the concave lower portion of a plate or bowl. Artifact 120-280 is one of the largest surviving ceramics in the collection. This sherd came from an ironware plate or platter that contained an original diameter of approximately 12.59 inches. The side opposite of the rim bends to slope down into concave lower portion of the plate. Perhaps the most diagnostic fragment, is Artifact 103-039. This small surviving fragment of whiteware was found by conservators with a fabric impression preserved in the concretion. The impression indicates that original fabric pieces were folded over, and possibly wrapped around the ceramic piece. This suggested to conservators that the plate was protected with a layer of linen while in cupboard storage. Unfortunately, the impression of the cloth did not survive conservation attempts. A second larger whiteware sherd, Artifact 139-011, contained an original plate diameter of approximately 9.84 inches. This plate is decorated with three blue annular lines; two around the edge, one thick and one thin, and one thin line where the sherd bends down into the lower portion of the plate. Artifact 124-033 is the largest ceramic piece recovered from *Westfield*. The stoneware sherd contains an exterior color of tan with a mottled glaze, and on the inner side, a dusky red or maroon glaze with horizontal striations or grooves from the manufacturing turning process. The last two ceramic examples are both sherds of salt-glazed stoneware. Based on their design, these artifacts may have been associated with each other or with other examples of the same purpose. Artifact 109-123 was from the lower body and base of a large rounded pot container. The outer surface is colored light olive gray. The inner surface has streaks of orange and dark brown indicating that the color was unevenly applied with brushstrokes prior to firing. Towards the base, the painted streaks changed from angled to parallel with the base. The second salt-glazed fragment, Artifact 132-001.7, is a small rim sherd from a lid and contains the same colors as the previously mentioned artifact. Although small, the sherd is

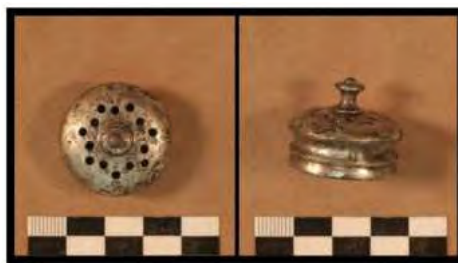
FIGURE 279. ELECTROPLATED SILVER CONDIMENT SHAKER CAP (ARTIFACT 109-010)

Only one example of metal tableware (Artifact 109-010), an electroplated silver condiment shaker cap, possibly for dispensing salt or pepper, was preserved from *Westfield* (Figure 279). Silver was one of the first metals to be electroplated commercially, primarily for tableware. Electroplated silver objects were highly decorative and resistant to attack from fruit acids and other foodstuffs (Canning 1960:383). Few small personal artifacts belonging to *Westfield* are as diagnostic or important as the condiment shaker cap. Such a decorative item may have come from the Commodore's or officers' table. The discovery of the shaker cap was momentous and is a very good example of why x-raying is so important in archeological marine conservation. Weeks of x-raying *Westfield* concretions had yielded little more than a series of bolts, bleeds, and boiler bits. A large bolt, which appeared to have a small radio dense button towards the end, was visible on the x-ray. Further x-rays revealed the shaker cap, which confirmed suspicions that this was something significant.

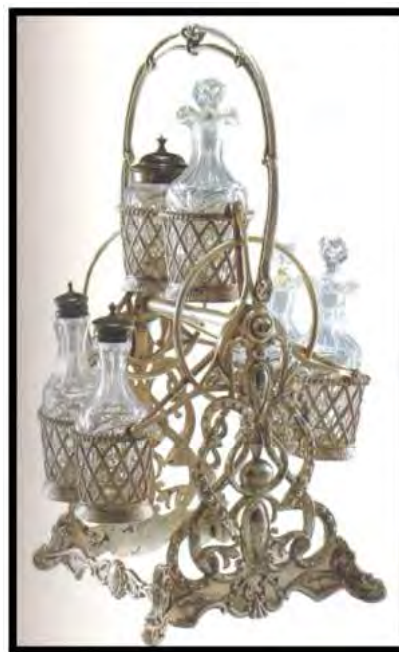
FIGURE 280. EXAMPLE OF A VICTORIAN ELECTROPLATED CRUET MADE IN 1861 (IMAGE COURTESY OF CHANTICLEER PRESS, INC.)

In Donald Fennimore's *American Silver and Pewter* (2000:68), the author lists a Victorian electroplated cruet made in 1861 by the Meriden Britannia Company from Meriden, Connecticut. This example shown in Figure 280 has three free-swinging baskets which rotate a center axel, allowing the items in each basket to be easily reached. While the set from which the *Westfield* shaker cap came from may not have been as fanciful as this, the cap does match others in this set almost identically. The cap most likely came from a glass bottle similar to those shown on the bottom left of Figure 280.

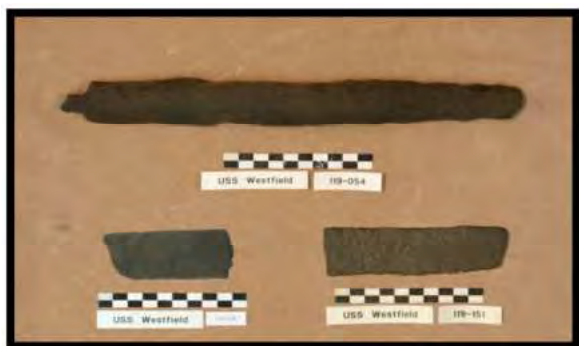
FIGURE 281. CONSERVED FILE TOOLS (ARTIFACT NO. 119-054, 119-151, AND 119-138)

All three of the files were recovered in very poor condition, and required molding and casting to preserve their shape and information (Figure 281). The original artifacts did not survive this process. Following conservation, one of the file casts was mostly complete (Artifact 119-054), and the results preserved a half-round epoxy file from the point to the upper portion of the tang or spike). The majority of the handle did not survive. Teeth were spaced 0.05 inches apart on the front and back face, and along the edges. The flat face contained angled, double-cut teeth, while the rounded face contained angled, single-cut teeth. The other two file casts (Artifacts 119-151 and 119-138) survived only as short fragments, both from the point end of the file, opposite of the tang or spike. These files contained angled, double-cut teeth, spaced 0.04 inches apart on both faces and along their edges.

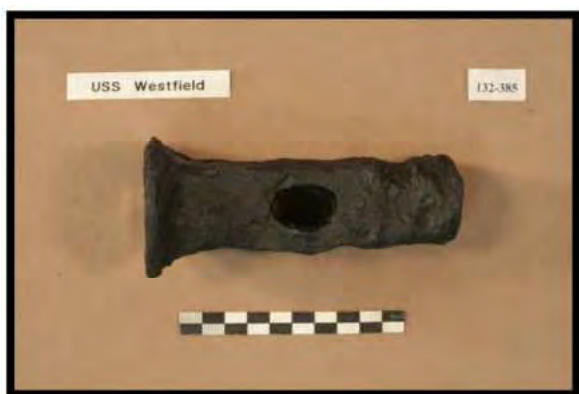
FIGURE 282. WROUGHT IRON HAMMER HEAD TOOL (ARTIFACT NO. 132-385)

The remaining tools from *Westfield* fall into a category of miscellaneous types and uses. A hammer head (Artifact 132-385) was recovered near *Westfield*'s firebox (Figure 282). This places the hammer just south of the grid square in which the files were found, again offering the possibility that many of these tools originally came from the same area of the ship. The hammer contains a square shape that expanded into a rounded striking end. At the center, an elliptical hole once supported a wooden handle, of which two fragments survived. The U.S. Navy issued a variety of hammers to navy ships, including chipping hammers, hand hammers, riveting hammers, and assorted copper hammers (United States Navy Department 1865:26). The type of this particular example is difficult to identify due to the hammer's poor preservation.

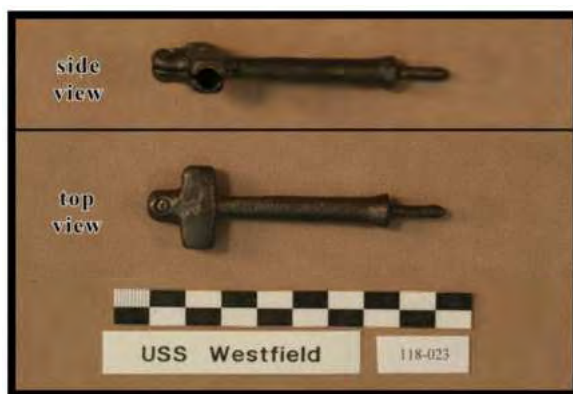
FIGURE 286. BRASS SOCKET TRAMMEL FROM NAVIGATIONAL BEAM COMPASS (ARTIFACT 118-023)

A single brass socket or trammel (Artifact 118-023) survived from a navigational beam compass (Figure 286). Originally, there would have been two of these trammels that slid along a rod in order to widen or shorten the distance between them, when used on a navigational chart. To support the rod, two arms or extensions are hollowed out in the shape of a cylinder on either side of the object, creating a head. Based on this hollowed head, the original rod was also cylindrical and contained a diameter of approximately 0.21 inches. A small slit extends .89 inches from the top of the tool dividing the head into two sections. Piercing through this divided head, a small broken screw was once used to tighten, or secure the trammel at the desired location on the rod. The bottom of the artifact contains a tab that appears to have inserted into another object. Following the example of modern trammels, the broken screw likely ended in a small wheel or thumb screw that could be turned with two fingers, and the tab on the bottom accommodated different end caps that could contain ink, pencil graphite, or needle tips for numerous navigational needs (Figure 287).

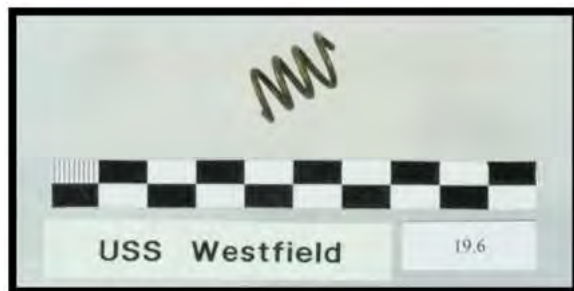
FIGURE 291. SMALL BRASS SPRING (ARTIFACT NO. 19.6)

Excavations recovered five small cupreous springs of equal coil size diameter (Figure 291). The lengths of these artifacts varied between one to two centimeters. The springs all appear to have been clipped to their respective lengths rather than undergoing breakage during site formation processes. How these artifacts were used on *Westfield* is not clear. Conservators found two of the springs within the same concretion, while the remaining three contained proveniences of no apparent pattern. All of the artifacts were found within concretions that contained an assortment of miscellaneous bolts, fasteners and metal fragments. These accompanying artifacts do not appear to have shared any correlation to the springs' original use.

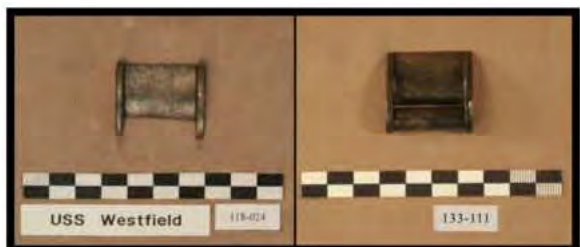
FIGURE 288. BRASS TOURNIQUET BUCKLES (ARTIFACT NO. 118-024 AND 133-111)

Two brass tourniquet buckles (Artifacts 118-024 and 133-111) recovered from the wreck site serve as large reminders that *Westfield* and her crew faced constant danger (Figure 288). Like today, tourniquets were used in the Civil War to stem blood flow in limbs when personnel were injured or about to undergo an amputation. Only certain brass portions of *Westfield's* tourniquets survived. There are several mounting holes on both buckles where pieces have broken away. Originally, the tourniquets contained a rolling arm with prongs that bit into a cloth strap to apply pressure on a limb (Figure 289). Small rust deposits on the mounting holes suggest that the original securing pins were iron and did not survive. Without the pins, the rolling arms became detached on both artifacts, as did one of the cylindrical cloth guides on Artifact 118-024.

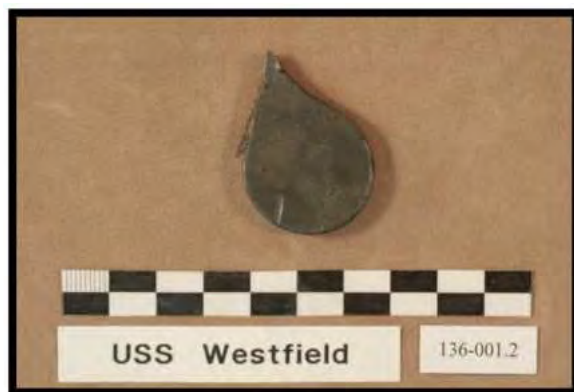
FIGURE 292. SMALL BRASS TAB (ARTIFACT NO. 136-001.6)

A small brass tab (Artifact 136-001.2) was found concreted to a fist-sized chunk of coal (Figure 292). The artifact resembles a finger lever that snapped off from a larger mechanical device. Since coal was found concreted to most artifacts due to *Westfield's* explosion, the artifact cannot be readily associated with something mechanical in the boiler or engine room. How the object was used or from what type of device it came is unclear. The item may have been personal or from a larger piece of shipboard equipment.

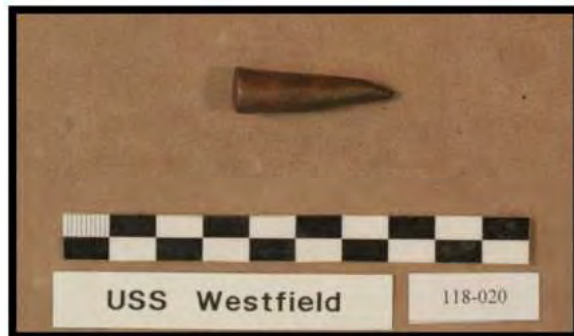
FIGURE 293. SMALL COPPER PUNCH TOOL (ARTIFACT NO. 118-020)

Over 1500 copper tack fasteners were recovered from *Westfield*. These fasteners vary in size since they were all handmade. One supposed tack however (Artifact 118-020), is considerably larger than the rest and does not appear to have contained a head (Figure 293). In general shape, the object is conical. The head may have broken off and the object became weathered and slightly rounded, erasing any evidence. Conservators disagree on whether or not this object was something else, such as a copper punch tool. Rather than weathering and erosion, the rounded head may have been caused by another object striking the head. Additionally, a slight bend at the narrowest point suggests that the object is slightly distorted. This distortion could have been caused due to the soft nature of the metal being used over a longer period of time.

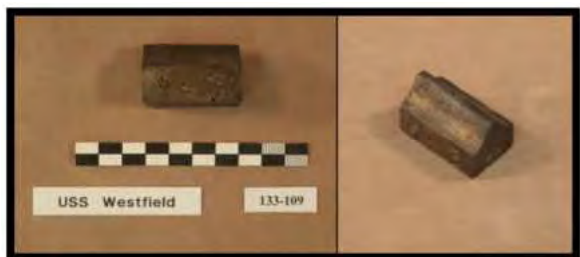
FIGURE 290. UNIDENTIFIED BRASS ARTIFACT - POSSIBLY A GUN SIGHT (ARTIFACT 133-109)

A larger brass artifact is believed by conservators to be a gun sight from a large piece of ordnance (Artifact 133-109). The object has a rectangular lower body, which on top of the longest sides, slopes gracefully upwards into a sight-like ridge (Figure 290). The artifact contains four broken mounting points that appear to contain screws that snapped off inside the object. Without understanding to what the artifact mounted, the use of the object is still considered unidentified.

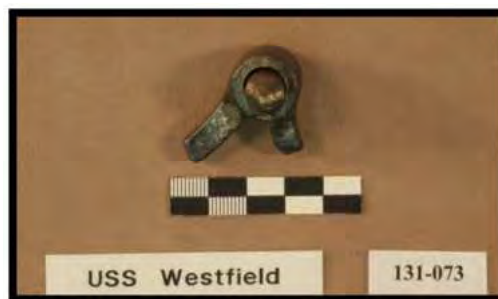
FIGURE 294. POSSIBLE FRAGMENT FROM NAVIGATIONAL SEXTANT (ARTIFACT NO. 131-073)

A rather unique shaped artifact led to much speculation among conservators (Artifact 131-073). The artifact contains two dual arms that radiate out from a reinforced open center (Figure 294). Inside the opening, a heavy pin was hammered on one side to prevent slipping, but is now broken. The reinforced center and the large size of the pin suggest the artifact originally came from a much larger object. Based on the curved shape of the arms, conservators believe the artifact came from a navigational sextant, and that the heavy pin once supported a pivoting telescope. Unfortunately, without more of the object, this theory cannot be confirmed.

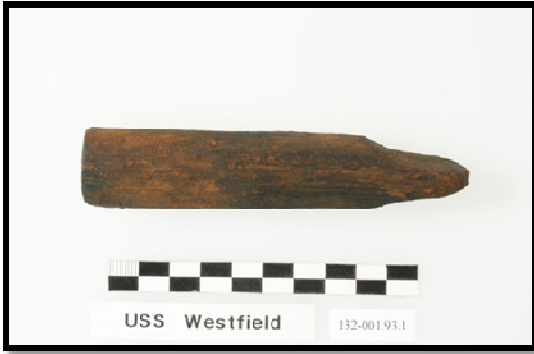
FIGURE 295. SMALL WOODEN DOWEL POSSIBLY USED AS PESTLE TOOL

During the conservation of one of *Westfield's* fire grates, a small wooden dowel-like object was recovered from within the concretion (Artifact 132-001.93.1). The original use of the object is not clear. One of the ends contains two carved out sections that resemble holding points as though for an index finger and thumb (Figure 295). Conservators have theorized that the artifact could have been used as a kitchen stirring tool or a pestle from a grinding bowl.

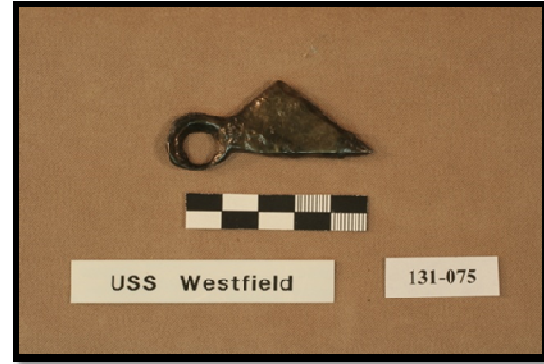
FIGURE 296. SMALL BRASS TRIANGULAR TAG (ARTIFACT NO. 131-075)

One small brass artifact (131-075) resembles a tag that might have hung or possibly rotated as a fitting on a larger device. With the exception of a heavily weathered ring at one corner, this artifact is triangular with angles measuring 45, 45, and 90 degrees (Figure 296). Opposite of the ring, between the upper 90 degree and lower 45 degree angles, the in-between edge has been intentionally sharpened for an unknown purpose. All other edges are rounded.

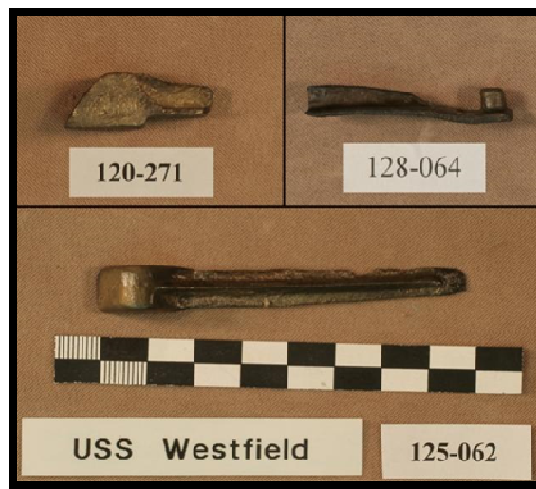
FIGURE 297. UNIDENTIFIED BRASS TABS (ARTIFACT NO. 120-271, 125-062, AND 128-064)

Three artifacts (120-271, 125-062, and 128-064), which all are related in design, still have not been identified (Figure 297). The artifacts are made of brass and reinforced with ridges to prevent bending. Only Artifact 125-062 appears to be complete. The other two artifacts have snapped approximately midway through their original length. Artifact 128-064 contains a button at the end that once clipped onto an unknown object. These objects may have been used in a larger common device.

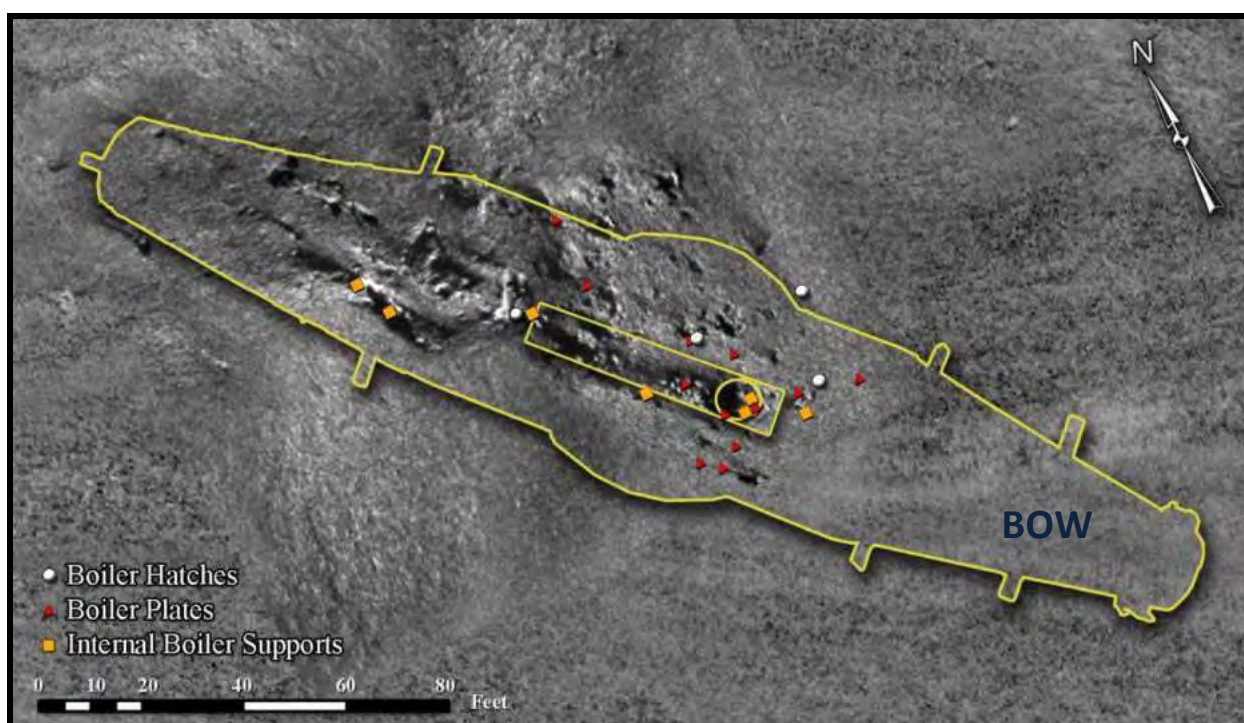
FIGURE 299. DISTRIBUTION OF BOILER HATCHES, BOILERPLATE, AND INTERNAL SUPPORTS
(FIGURE BY SARA LAURENCE AND AMY BORGES)

Figures 299–301 illustrate the locations of artifacts that are related to the machine area of the ship, including boiler hatches and plates, internal boiler supports (excluding staybolts), railroad iron used as substitute fire grates, coal, cast iron floor plates, and brick. For most of these groups, the artifacts are generally concentrated in the area of the boilers (near the smokestack in the figures) at the southeast end of the visible artifact debris field. One exception is the brick, which is fragmented

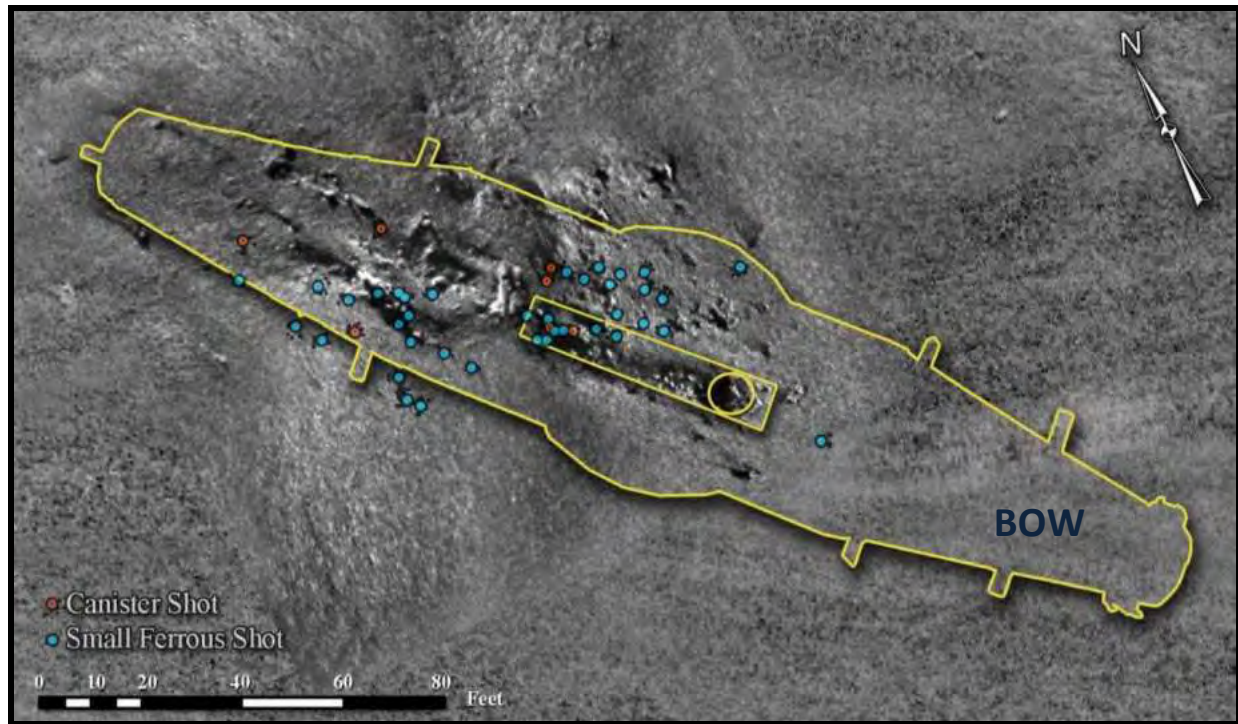
FIGURE 303. DISTRIBUTION OF CANISTER SHOT AND SMALL SOLID SHOT (IMAGE BY SARA LAURENCE AND AMY BORGENS)
