CENTER FOR MARITIME ARCHAEOLOGY & CONSERVATION • NAUTICAL ARCHAEOLOGY PROGRAM

# AC News & Reports

Volume 3, Number 1

Spring 2011

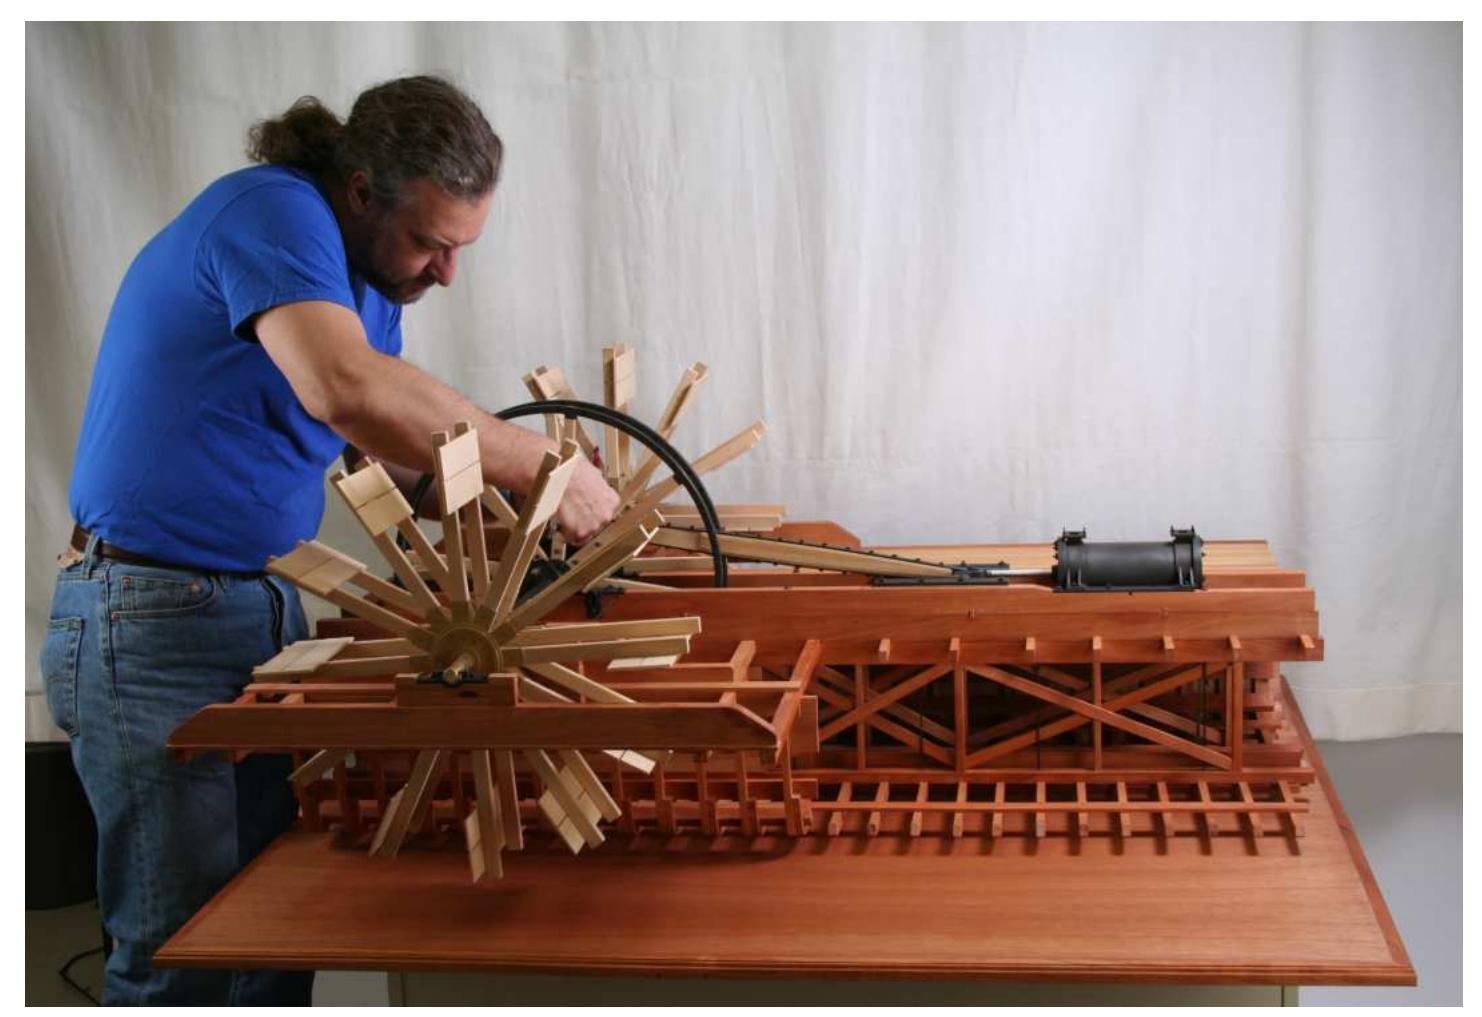
Figure 2: Glenn Grieco with model of Heroine's steam engine. Photo: C. Wayne Smith.

The study of *Heroine*'s machinery has been spearheaded by CMAC research associate and model maker Glenn Grieco (with some contributory work by the author). Grieco began his work in 2004 by personally recording flywheel and paddle wheel assemblies on the wreck, and later supplementing his notes with additional data recorded in the field and -- once all the machinery elements were recovered -- in the laboratory. After reconstructing the machinery with the aid of a CAD program, he scratch-built a model of *Heroine*'s hull showing the 'as-built' arrangement of engine support timbers, the boat's single centerline-mounted piston, the crank or 'pitman', and the twin flywheels and side wheels (fig. 2). This model is now part of an exhibit on *Heroine* at the Oklahoma History

Center. Work on the propulsion system continues with Grieco's recent CAD reassembly of the boilers, an arrangement based on recovered elements such as cast iron mountings, fire grates, bricks, sheet metal casing, and a feed-water pipe fitted with a one-way valve. Our knowledge of the fabrication and day-today operation of 1830s steam technology has vastly increased as a result of *Heroine*'s bounty of information and Grieco's detailed analyses.

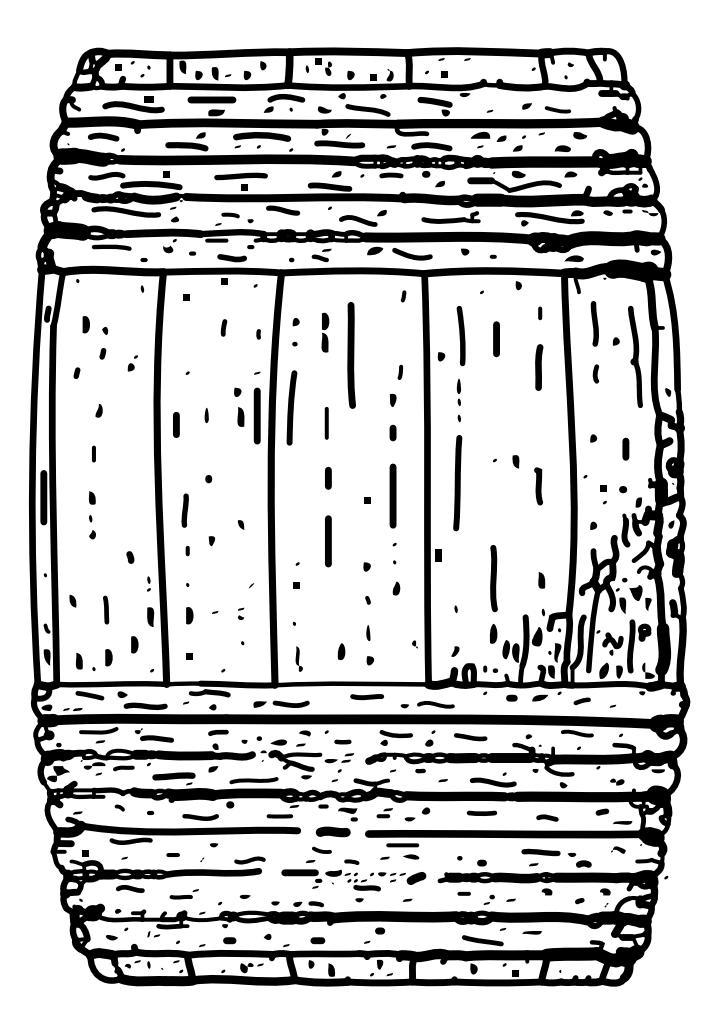
Figure 1: Reconstruction of a wooden-hooped barrel. Technically, a "barrel" is a cask of a certain size. However, as American usage designates most casks as barrels, this study uses the term "barrel" throughout. Conveniently for this study, all the "casks" in the assemblage are in fact barrel-size, so "barrel" is correct either way. After Danielle Jones.

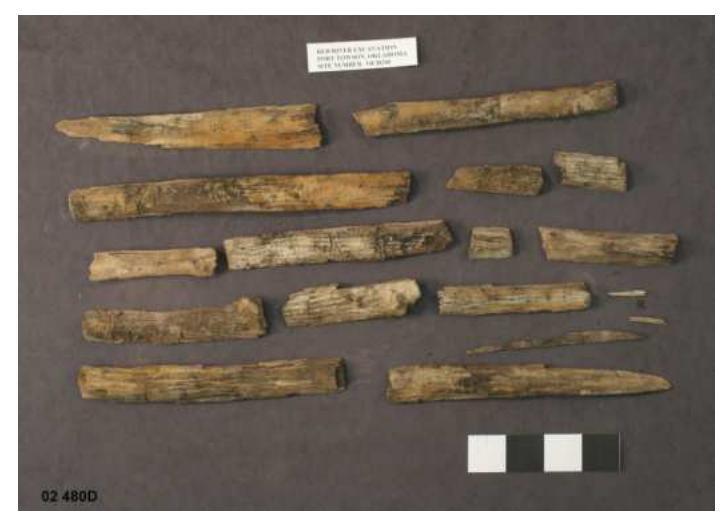
Figure 2: Where their ends overlapped, wooden hoops were tapered and notched, and secured to the barrel with small nails. Bark was generally not removed. Hoops often broke during handling, and barrel maintenance frequently included replacing broken ones.

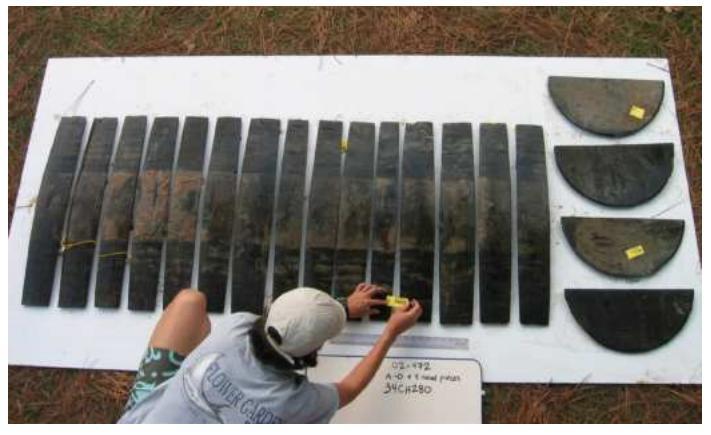
Figure 3: Barrel Feature 02-04 (02-472) was one of three pork barrels raised with contents intact. Note the dark ends of the staves showing impressions of a solid covering of wooden hoops, leaving only the bilge in the center uncovered.

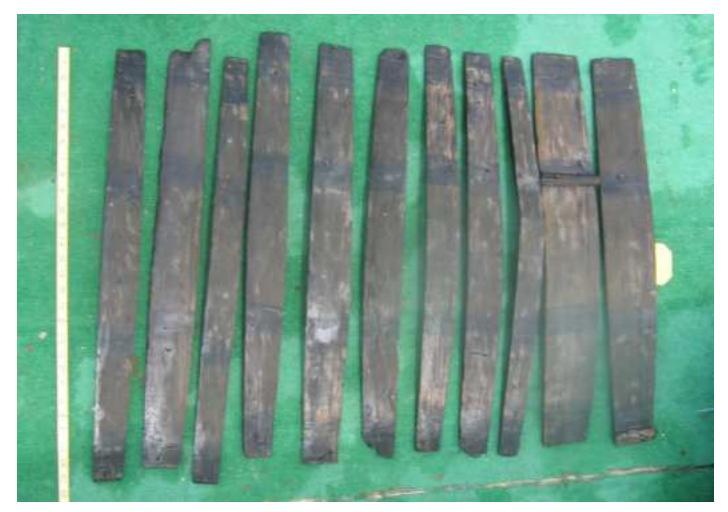
Figure 4: This barrel (02-1035) probably held flour. Hoop impressions show only ten hoops in four widely spaced groups. Note the two staves on the right with remnants of hoops still attached.

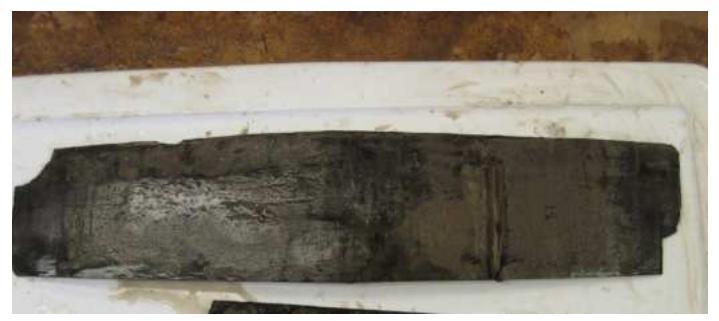
Figure 5: This stave (02-700) is typical of the "bean barrels." It is broad, thin and lightly hooped.

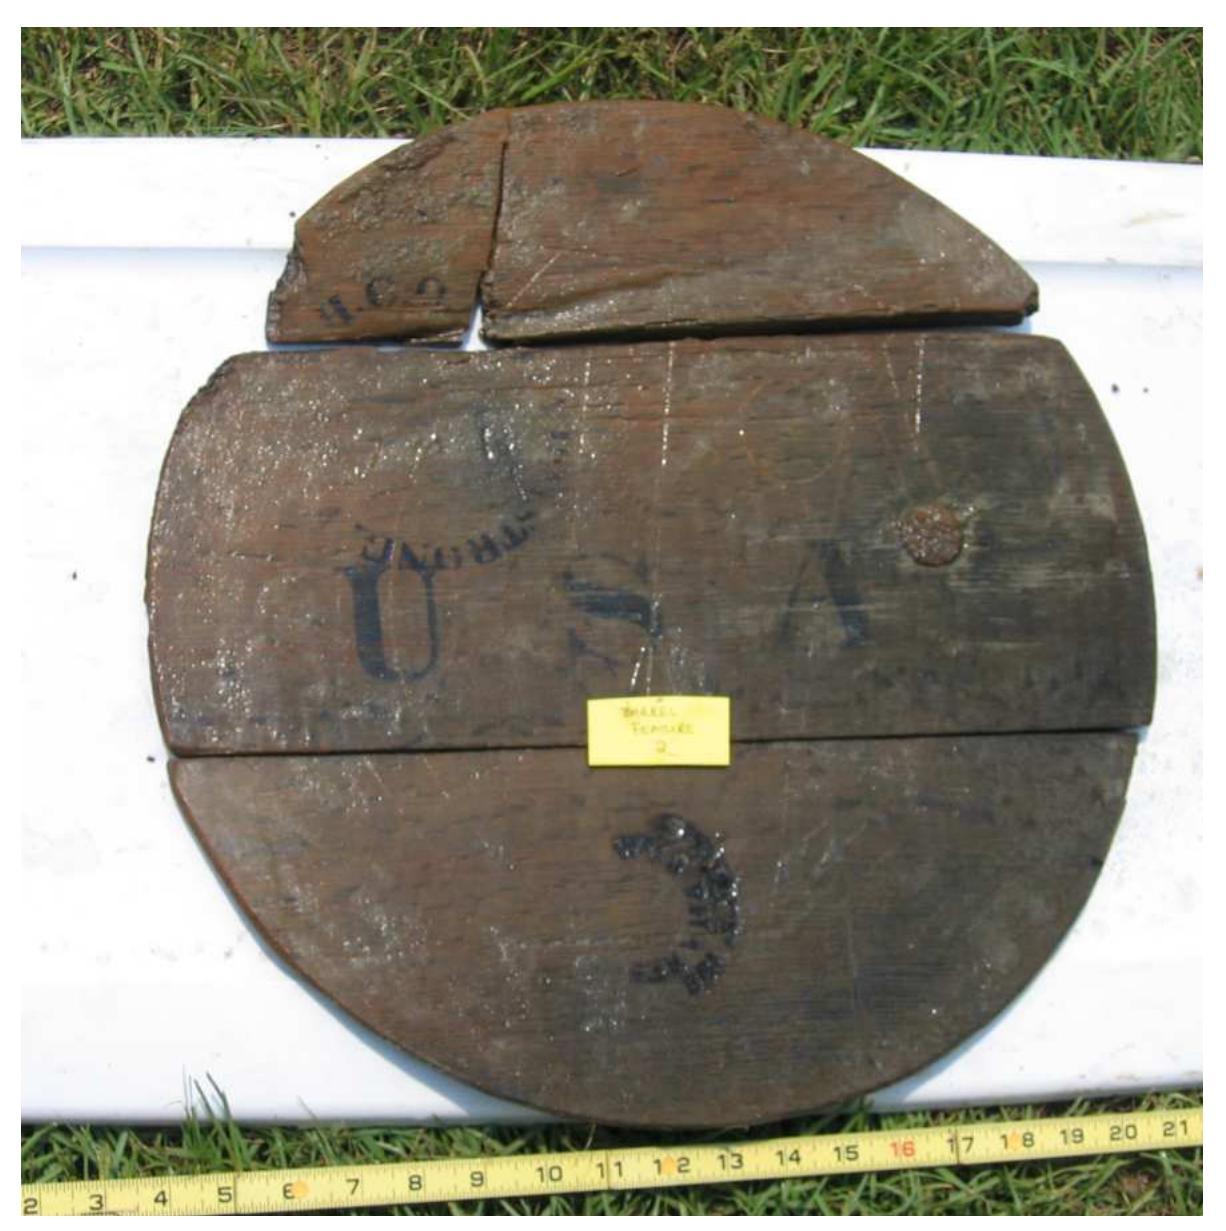
Figure 6: This three-piece flour barrel head (02-684) is marked with the brands of the flour supplier W&R Phares, Cincinnati flour inspector Armstrong, and the United States Army (USA). It has a 1-inch bunghole. Incised straight lines, curved lines and circles are coopers' marks.

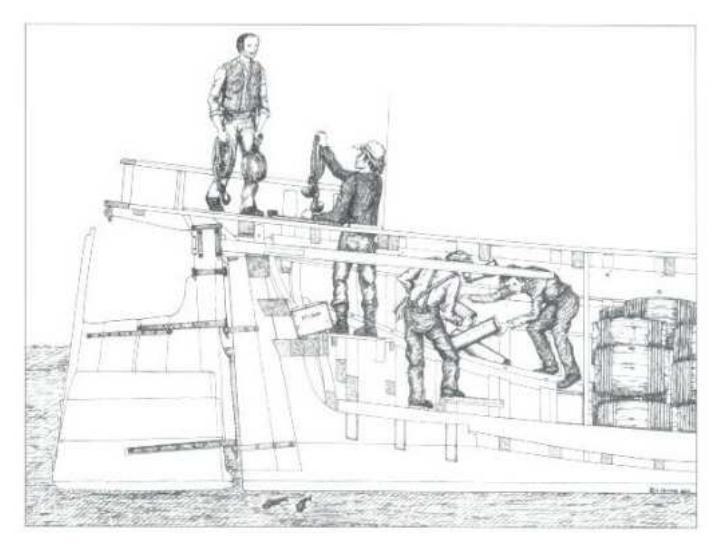
Figure 2: The stern compartment known as the "run" as it may have appeared on *Heroine*. An area primarily used by the crew for storage and one of the more secure areas of the wreck. Drawing: Dr. Kevin Crisman, 2005.

understanding of which artifacts best represent life on board *Heroine*. Damage caused by the river is most prevalent in the forward and after holds. The stern and bow compartments, on the other hand, were relatively secure against the current and do not appear to have trapped intrusive materials due to their quick burial in sediment. There is a possibility, however, that they were affected by between 1838 and 1843 salvage attempts. Artifacts recovered from these two compartments are likely to be original Heroine artifacts, unlike some artifacts excavated from the main hold (fig. 2). Precise identification of artifacts through comparative research is another step to ruling out invasive material. It is only through understanding the history of *Heroine*, the forces acting on the site, and the artifacts themselves that the most accurate conclusions can be reached with regard to what life might have been like on board this 19th century steamboat.

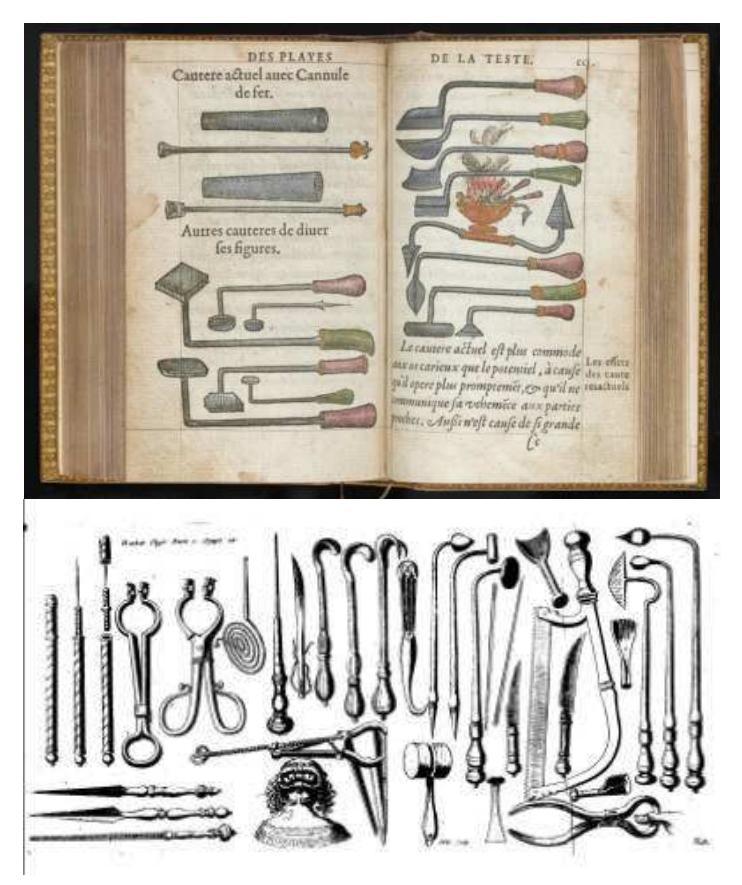
Figure 2: Surgical instruments illustrated in Ambroise Paré's The Method of Treating Wounds... (1651) Wellcome Library, London (top). Surgical instruments illustrated in Paul Barbette's Thesaurus Chirurgiae (1687) (bottom).

The purely surgical duties of a shipboard surgeon included dressing minor injuries, contusions, fractures and broken bones, the removal of gunshot and in rarer cases trepanation and amputation. The instruments used in these procedures such as pincers, trocars, scalpels, bistouries, forceps, directors, trephines, cautery irons and needles for suturing wounds were all composed either completely of metal or of a metal tool portion and wooden handle. In the 17th century, such tools were often made of iron or crude forms of steel: both of which do not survive well in the marine environment. Therefore, much of the research at the Shipwreck Galleries revolved around examining the morphology of unidentified wooden handles whose provenience and associated finds suggested they might be part of the surgeon's equipment. Illustrations from contemporary medical treatises served as a basis for comparison of handle forms and the instruments to which they originally belonged. A number of more delicate and ornately turned wooden handles recovered from Batavia have morphological parallels in the works of famous surgeons such as Ambrose Paré and Paul Barbette (fig. 2).

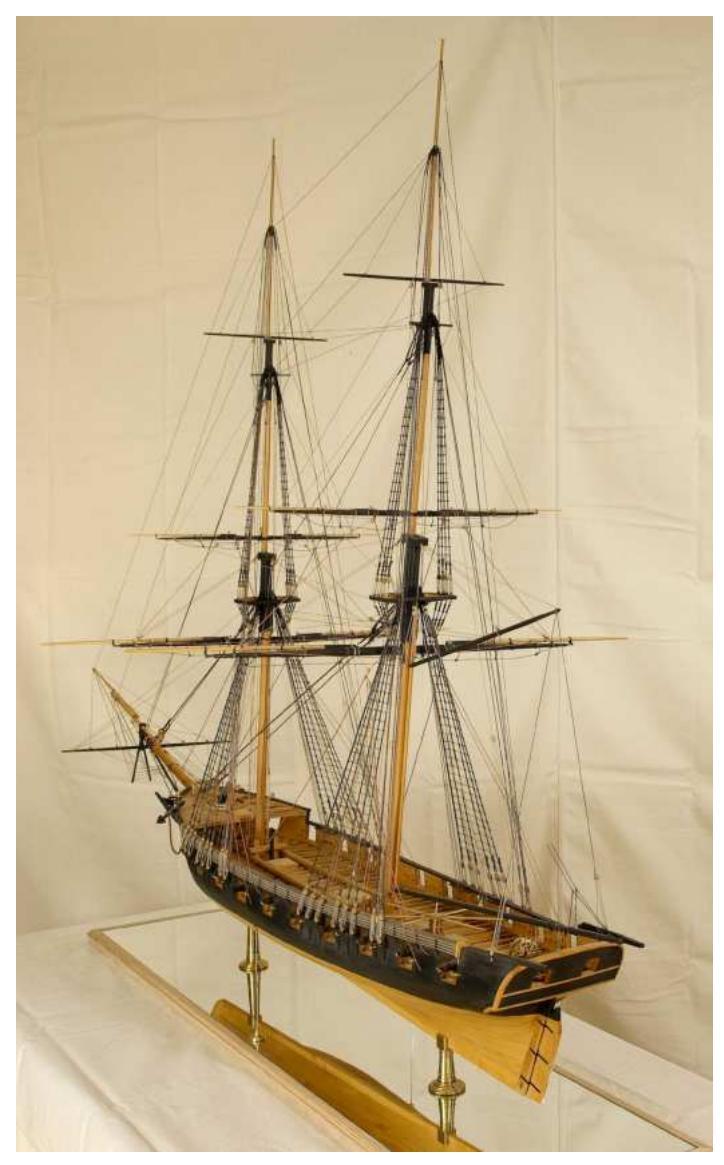
Figure 1: Port stern quarter view of *Jefferson* showing shallow hull and comparatively tall rig. Photo: C. Wayne Smith.

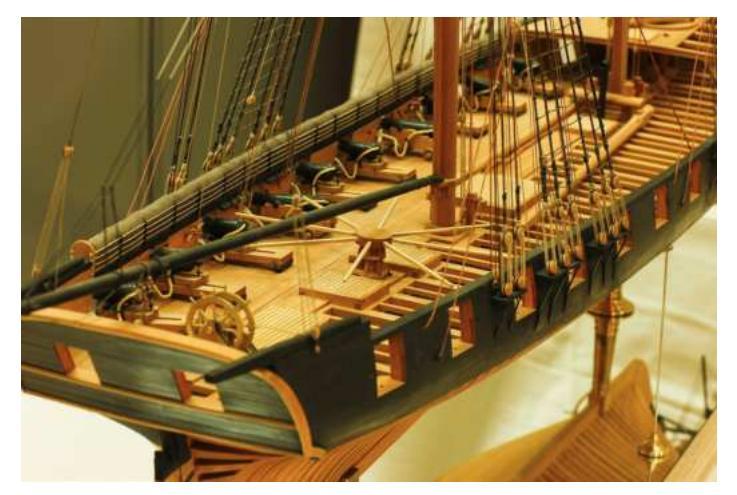
Figure 2: Stern of model showing exposed frames and deck beams on the starboard side of the vessel and completed bulwarks with guns on the port side. Photo: C. Wayne Smith.

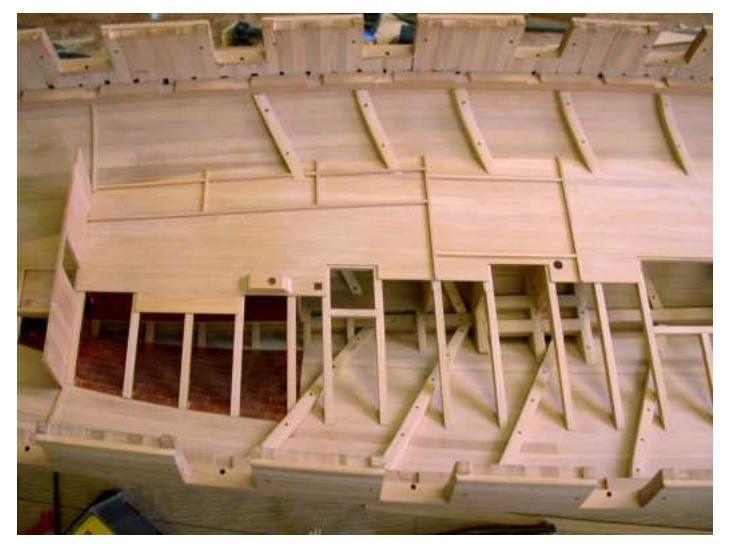
Figure 3: Construction of *Jefferson's* lower decks. Note the diagonal riders, elongated mast step and coppered magazine. Photo: C. Wayne Smith.

Early in the life of the vessel, her main mast was moved aft to improve her sailing qualities. The original mast step was extended aft to accommodate the new placement of the mast. This explains the unusual double mast step that can be seen in the model constructed exactly as the original. Other structures of interest visible in the model are the copper-lined magazine just forward of the captain's quarters, officers' quarters and staterooms. The port side of the vessel has been planked and fitted out to represent what the vessel probably looked like at launch (fig. 3).

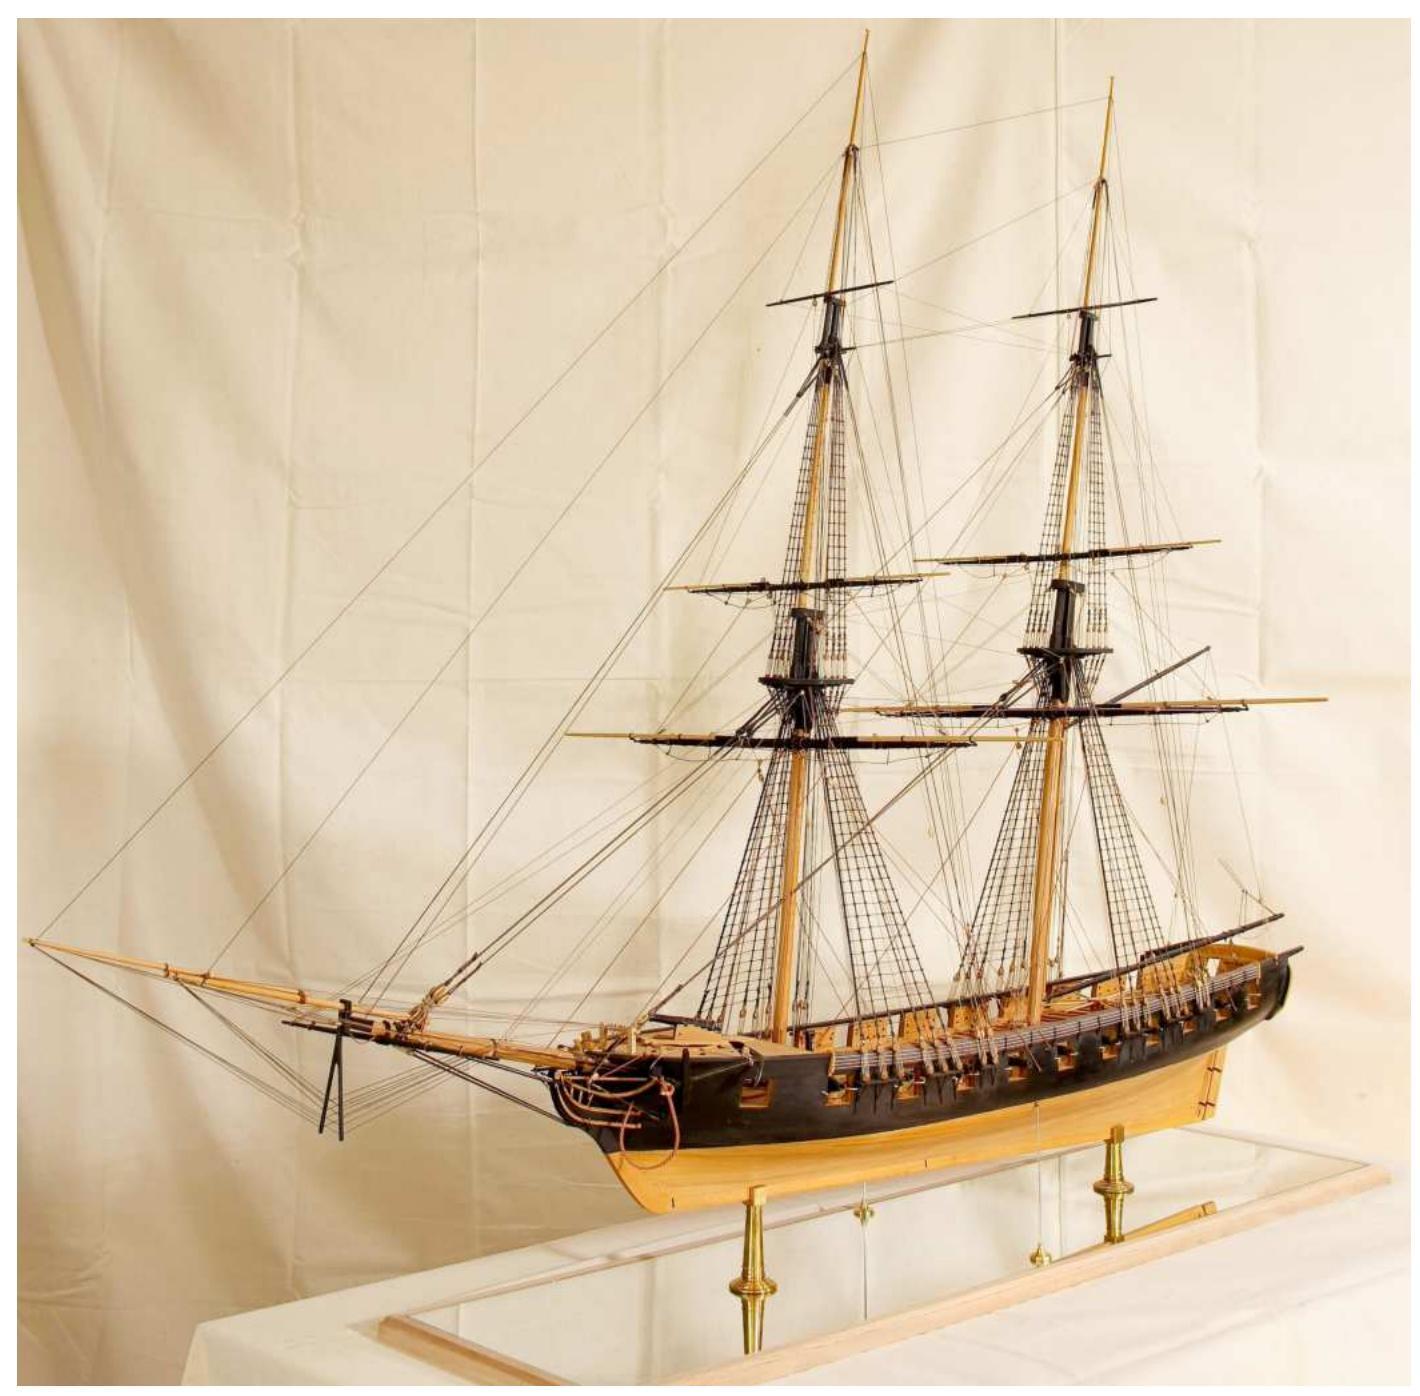
Figure 4: Port side of completed Jefferson Model. Photo: C. Wayne Smith.

Unfortuntely, nothing remains of *Jefferson*'s deck, deck furniture, and fittings in the archaeological remains. The deck structure and hatches, capstan, wheel, and other details were constructed according to Crisman's reconstruction. There are also no remains of the hammock rails and netting along the top of the caprail, although these structures almost certainly would have been used. The starboard side of the model shows the bulwarks as excavated and the port side shows the bulwarks with hammock netting as reconstructed (fig. 4).

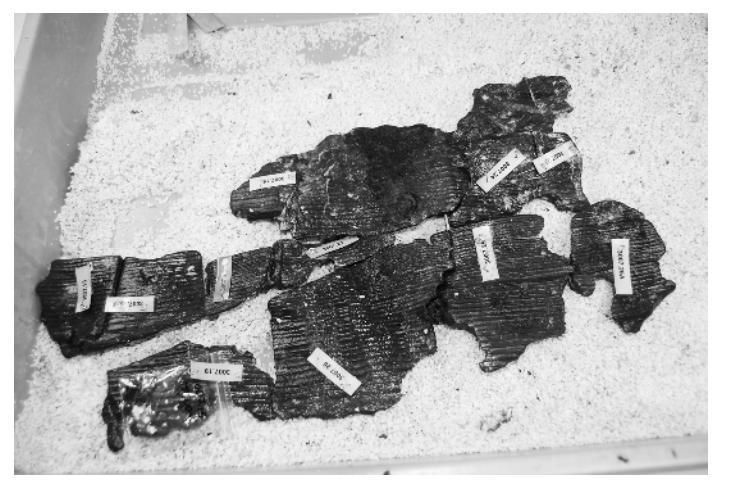
Figure 1: Timber fragments supported by marble chips. Photo: John D. Littlefield.

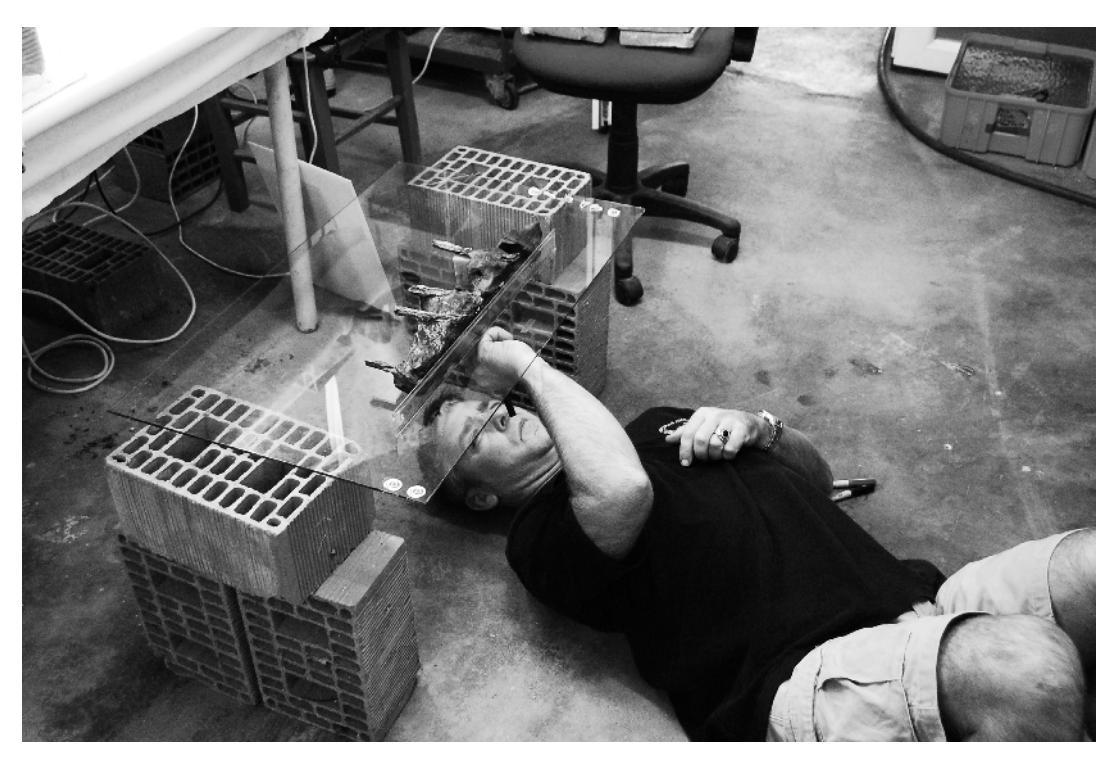
Figure 2: Recording an unstable timber section. Photo: Kimberly Rash.

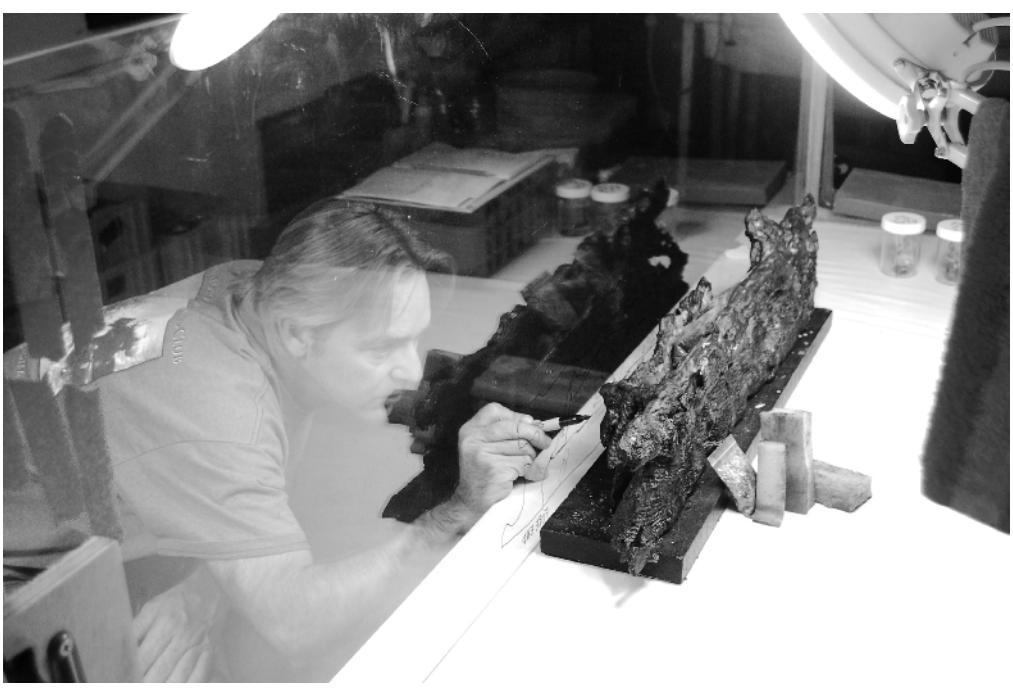
Figure 3: Recording the keel's molded face. Photo: Kimberly Rash.

In the case of recording the vessel's keel, even with this adaptive measure employed, results were less than satisfactory. Several attempts were made, but after recording one face and moving to another, timber fragments were not stable and resulted in non-matching drawings. The keel did, however, have a relatively well-preserved, flat inner face. Consequently, recording set-up methods were creatively adapted once more by placing the timber's inner face down on the glass to give the best alignment of the fragments in all three dimensions. This

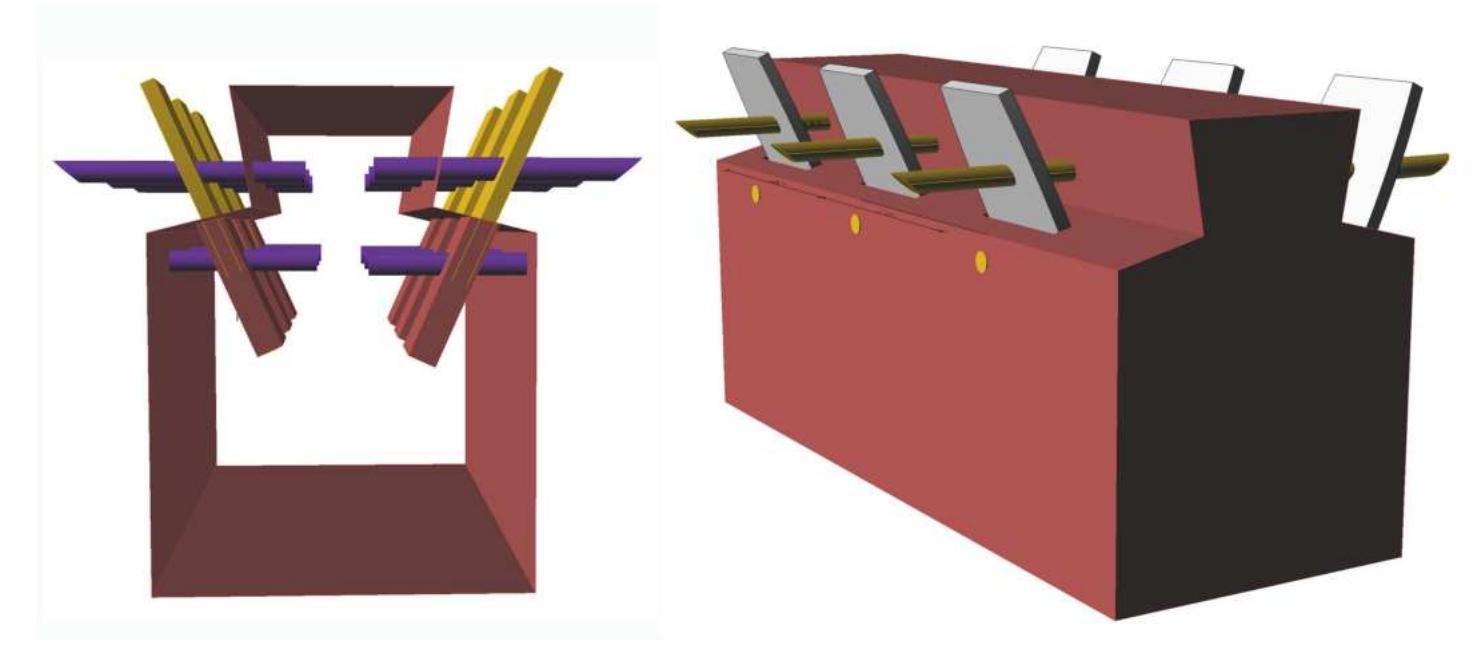
Figure 4: Three-dimensional reconstruction of the keel's profile. Image: Sheila Matthews and John D. Littlefield.
