CRL Report 12: A chest from the *Brother Jonathan* shipwreck

California State Lands Commission / Institute for Western Maritime Archaeology

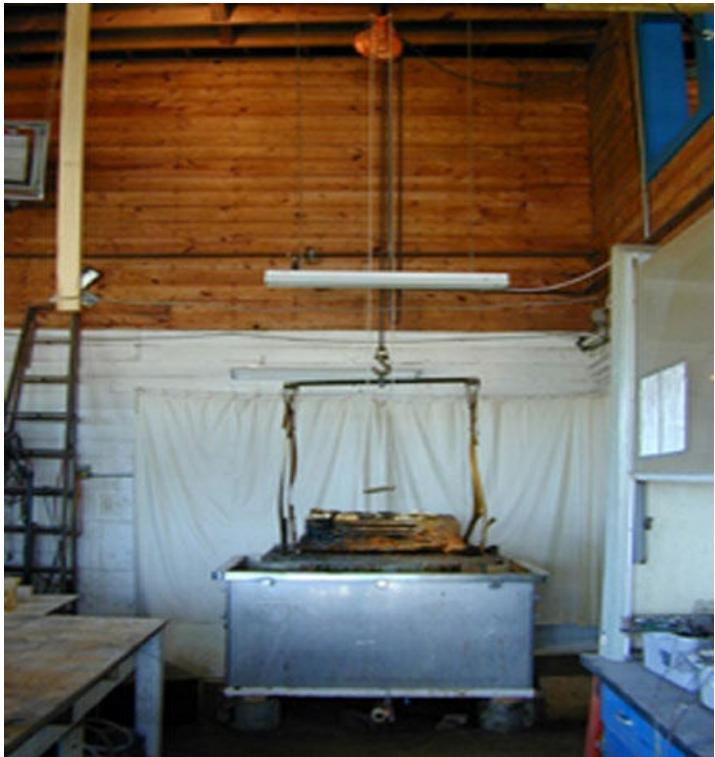
The stainless steel vat, the crate on the fiberglass grate, and the electric chain hoist installed over the vat.

As is the case with all encrusted metal and organic material from underwater sites, it is necessary to keep the material wet at all times. When not being worked on, the crate is stored in a solution of 5% sodium sesquicarbonate mixed with tap water. When the conservator is working on the crate, it is kept wet using a stream of water pumped from the vat. To facilitate the documentation and the conservation work, a large stainless steel vat was placed in a corner of the conservation labortory. A web cam was installed over the vat to document the work, a white vinyl curtain was installed behind the vat and daylight balance fluorescent lights for daylight are installed over the vat. The crate was placed on a fiberglass grate and an electric chain hoist was installed over the vat. This enables the worker to raise and lower the crate unassisted and with ease. Since the webcam is continuously broadcasting and saving images of the ongoing work, the work surfaces of the crate are labeled in plan view from the perspective of the web camera -- top, north, south, east, west. The south side is exposed to the camera, and in typical plan view, north is up.

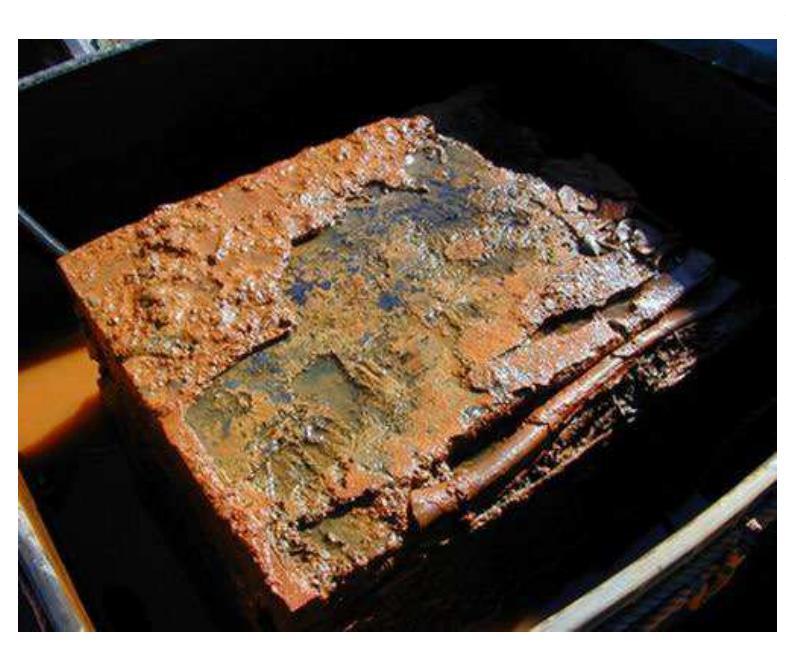
View of the "top" of the crate as it was received for conservation

The interior of the box was lined with tin sheeting which was soldered with lead at the junctures. The tin sheeting has for the most part deteriorated; however, the soldered seams are in good condition. The box was carefully and tightly packed with an array of material. Most of the objects were grouped into like items and carefully packaged and wrapped in paper, some of which still have the faint remains of a label.

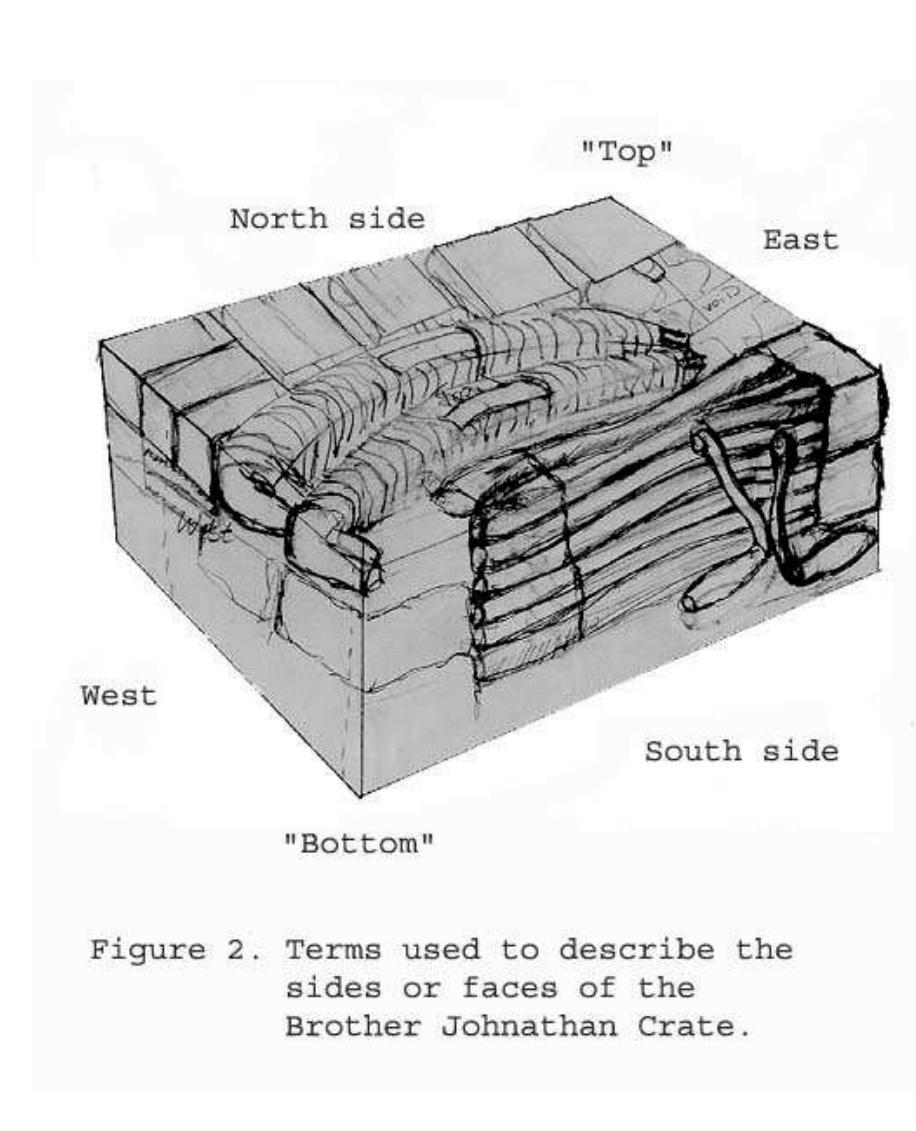
"Top" designates the top of the working area, the area that is uppermost on the crate. "South" and "North" designate parallel sides that are the longer length of the crate. "East" and "West" designate the sides that are the shorter sides of the crate. In the photograph above and the plan drawing to the right, the south side is at the lower right, while the north side is at the upper left. The east side is to the right and the west is to the left. .

To facilitate the following description the work surfaces of the crate have been designated as described above and as indicated in the plan to the left.

In the photograph above, the hafted axes are located at the top of the crate and down the south side.

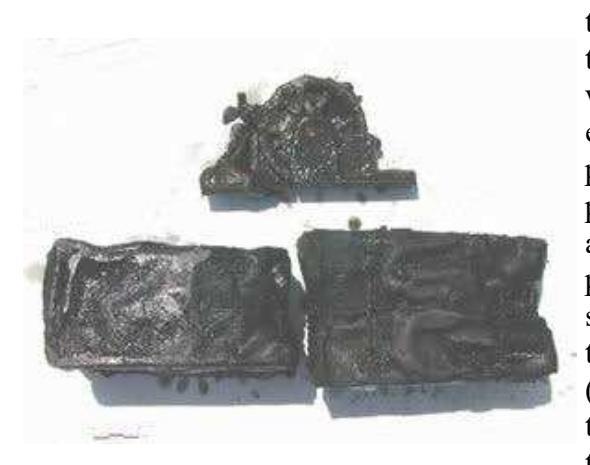
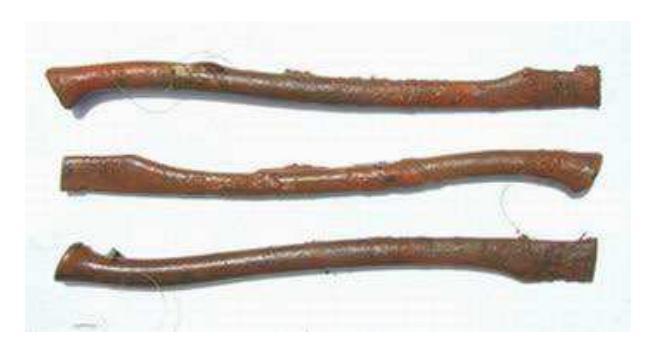
Three packages of cast iron pulleys (possibly sash window weight pulleys) were placed just north of the the axe heads. Two of the packages are shown to the left. Each package contains four pulleys, one of which is shown above the two packages. It is exciting to find the wrapping paper so well preserved. It is hoped that as the conservation of the paper is completed the stains can be removed and any identifying labels will be legible. Each paper package containing the pulleys is tied securely with string. Three additional packages of pulleys (for a total of 24 pulleys) were found in the opposite (north-west) corner of the crate. The conservation of the paper and the pulleys has not begun; however the paper will be folded back so the pulleys can be extracted. they will then be conserved individually by different processes.

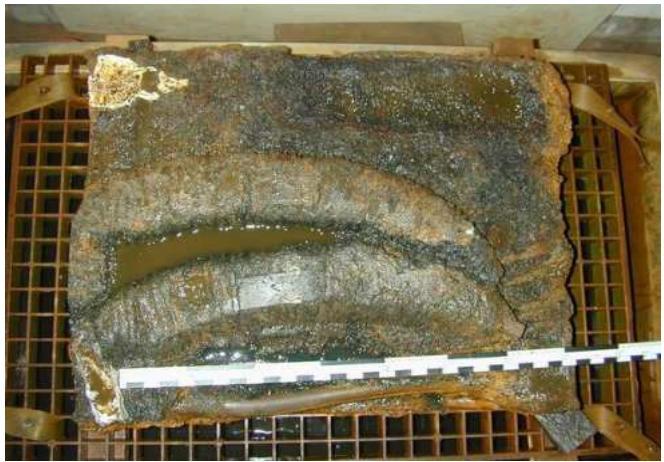
In the center of the top surface there were two rope wrapped bundles that, based on the x-rays, we believe to be iron scythes, They are wrapped in rope to protect the blades. The white epoxy at the lower left of the photograph is a cast of the corroded handle on one of the scythes. The x-rays indicate that there are six scythes in each rope-wrapped bundle. At the center of both bundles the faint outline of a rectangular paper label can be seen. These may be a manufacturers' label that identifies the contents. Hopefully, during the conservation, some of the paper will be preserved and the writing will be legible. If so, then additional information can be gained about these tools.

The hafted axes can be seen along the south side of the crate. In the upper left (NW corner) and continuing down the west side is a small hafted hatchet (this was under the second group of pulley packages). The impression of the corroded scythe hafting tang on one of the scythes has been cast with white epoxy.

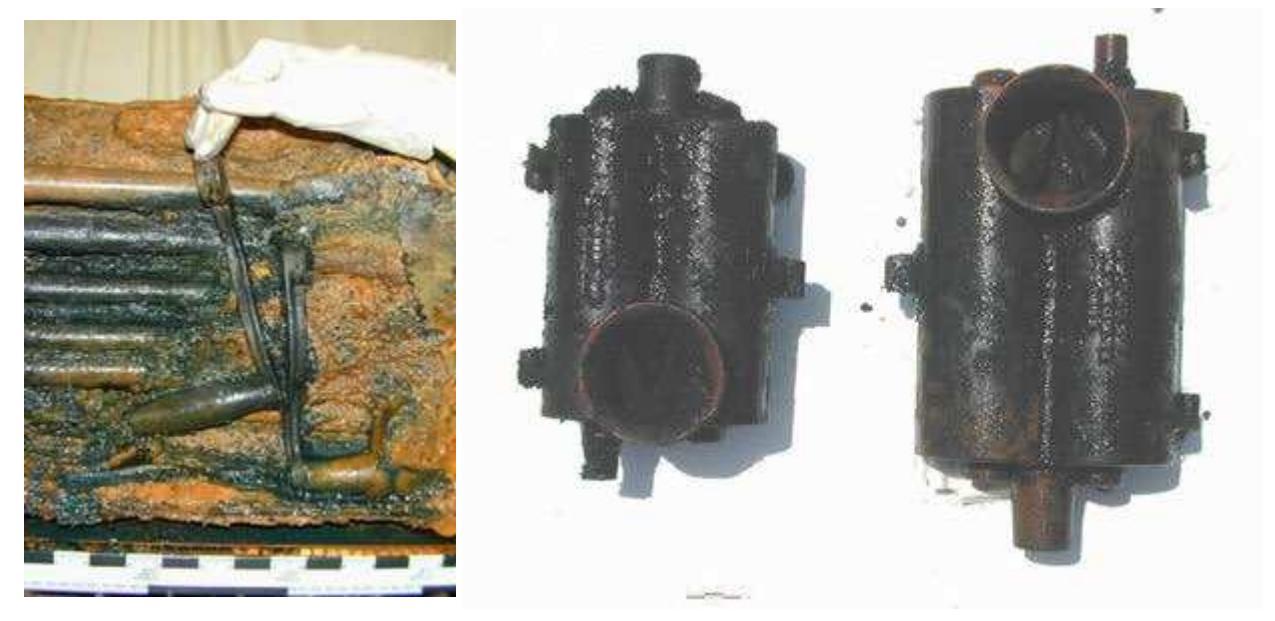
Along the south side, overlapping the axe handles are two cast iron handles for the meat grinders. Each has a wood hand grip, easily seen in the photograph below. The cast iron is very graphitized with little remaining iron. When the handles were removed, the fragile iron broke into several pieces, but they can be easily reassembled. Four meat grinders were found in the crate -- two small ones and two large ones. On the right, below, are examples of the two different sizes of meat grinders. Cast into the top of both sizes were the markings, "PATENTED / MARCH 1(?) / 1859". By searching in the U.S. Patent Office archives we found a patent issued to Albert W. Hale on March 15, 1859. The plans for the patented meat grinders are slightly different from those recovered here, but it is obvious that they are the same patented design. To date, only two handles have been found, so another two must be in the crate somewhere.

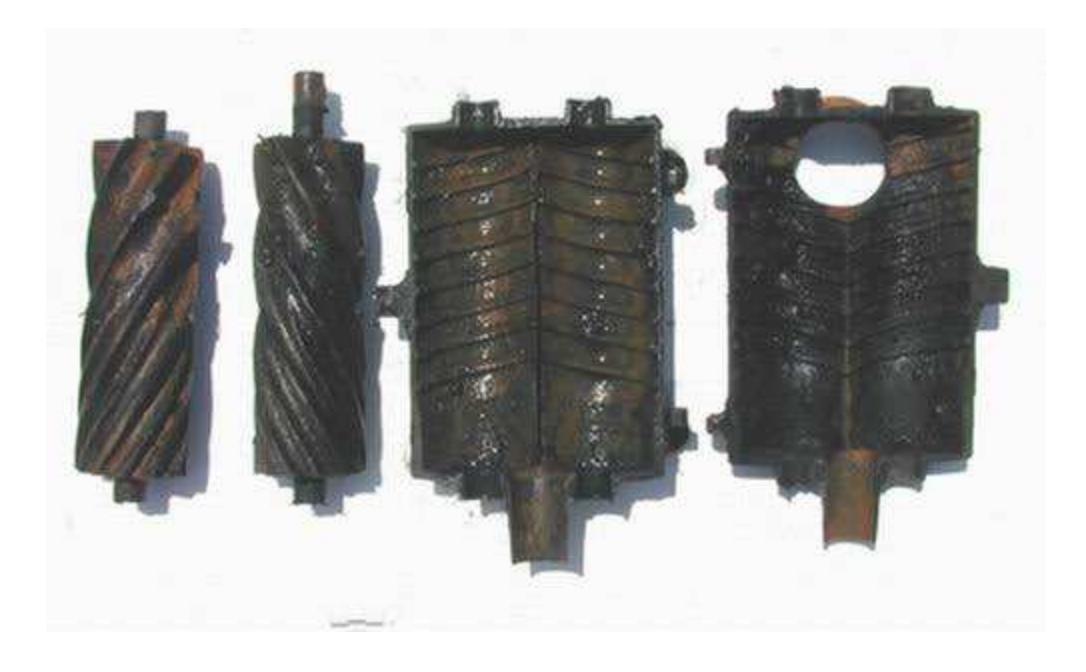
Below is a picture of the inside of one of the large meat grinders. The cast iron is badly graphitized and little iron remains. They have a very weak magnetic attraction. Still the overall preservation is good. In fact, the ease with which they came apart is amazing!

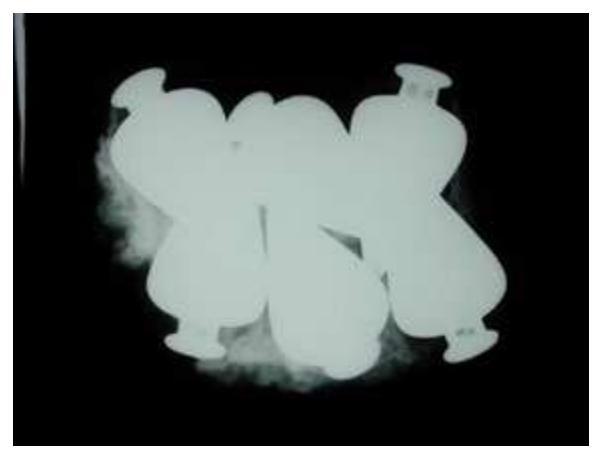
To the right is an X-ray of a small, paper-wrapped package containing six brass plumb bobs.

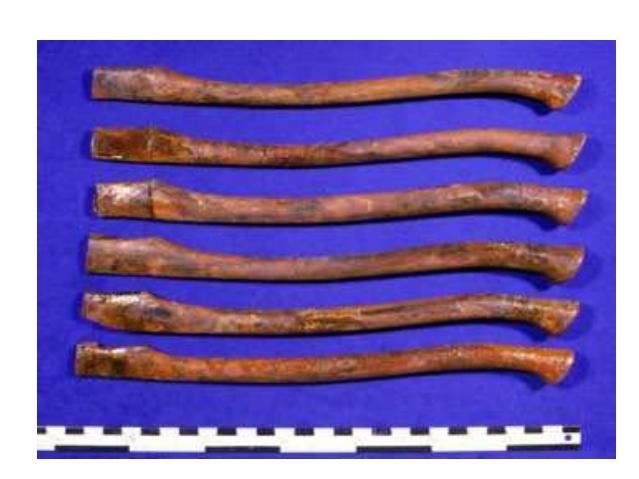
The first set of axe handles (BJ-17-5) after cleaning.

The six axe handles removed in spring 2001 (BJ-17-5) were stored in water over the summer. Encrustation and graphite from the axe heads were cleaned from the handles. Desalination required two baths of rainwater and three baths of deionized water. Dehydration of the first set of handles will be completed by the end of summer 2002 and conservation will begin in fall 2002. Due to the excellent state of preservation, the acetone-rosin method will be used to conserve wooden artifacts removed from the crate. The wood cells are impregnated with pine rosin, imparting a golden color to the wood and yielding a strong, stable artifact.

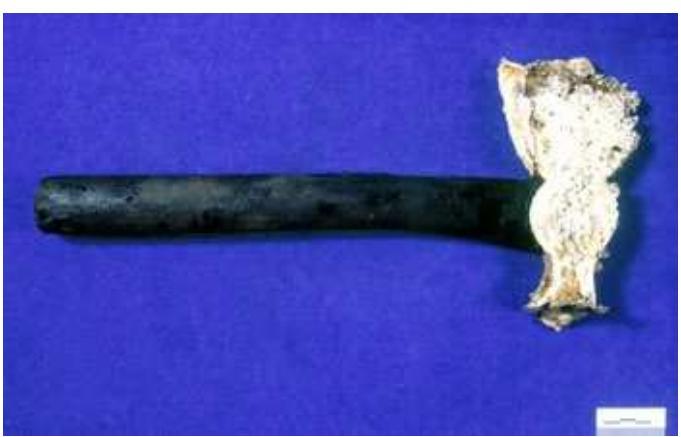
Wooden hatchet handle with silicone rubber cast of iron head.

Two packages, each containing six hatchets, were found stacked on top of each other. Due its inherent fragility, the paper used to wrap the heads has disintegrated. Within the wrapping paper, partial molds of each hatchet head were present; these were cast using RTV-112, a silicone rubber molding compound, before the handles were removed.

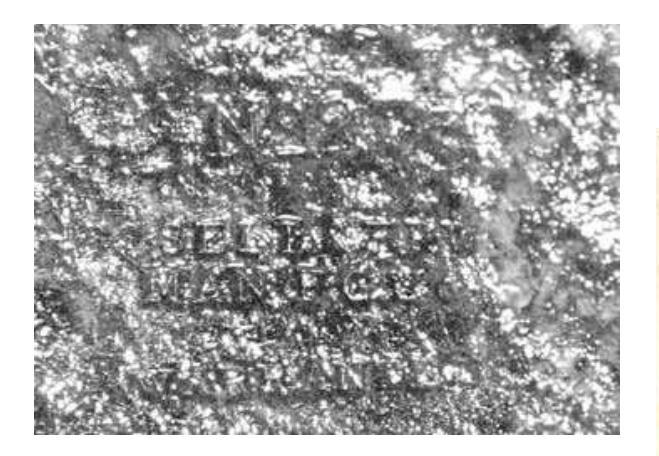
Stamped inscription preserved on iron hatchet blade. The mark reads "No. 2/ USSELL & ERW / MANF'G Co. / WARRANTEED".

By chance, the stamped impression of a maker's mark was preserved in one of the natural molds of the hatchet heads. The inscription appears to read "No. 2/ USSELL & ERW / MANF'G Co. / WARRANTEED".

Through an educated guess, this mark was identified as the stamp of the Russell and Erwin Manufacturing Company, which manufactured goods in Connecticut and had a warehouse in San Francisco. A reprint of the company's 1865 catalogue was obtained from the Texas A&M University library. All of the artifacts discovered to date in the crate are listed in this catalogue. As a result of this discovery, the Brother Jonathan crate is currently believed to represent a shipment from the warehouse in San Francisco to a general store in Portland or Victoria.

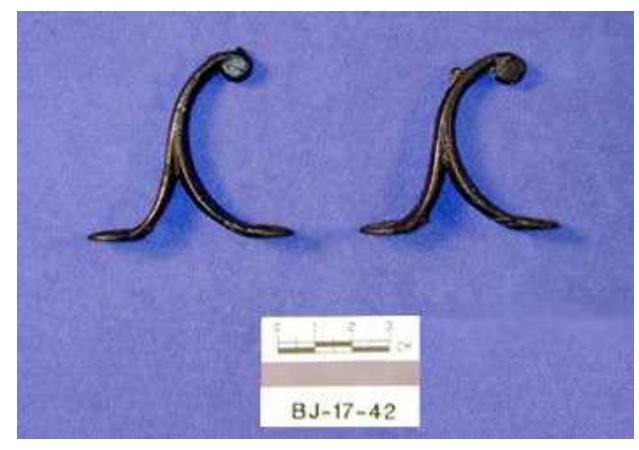
A pair of cast iron hooks recovered from the crate.

To date, eight packages of single cast-iron wall hooks have been removed from the crate. The packages are wrapped in paper and tied with string, and it appears that each has a small rectangle of paper, possibly a product label, at one end. One badly damaged intact package of hooks (BJ-17-42) was X-rayed and carefully unpacked. It contained 72 hooks. Due to the similar sizes of the other packages, it is assumed that they contain the same number of hooks. The Russell and Erwin catalogue lists these hooks for sale by the gross (18 pieces),

The hooks were put into a sodium sulfite solution, sealed, and placed in a warming oven at 60°C. Hamilton (1996: 80) describes the effects of this treatment as follows: "When a marine iron object is immersed in this hot reducing solution, the iron corrosion compounds are converted to magnetite, and the chlorides are transferred to the solution and discarded with each bath change." Following two treatments of sodium sulfite, the hooks were thoroughly rinsed, then boiled in deionized water until all chlorides were removed. The next step was to coat the hooks with three layers of tannic acid and coat them in microcrystalline wax.

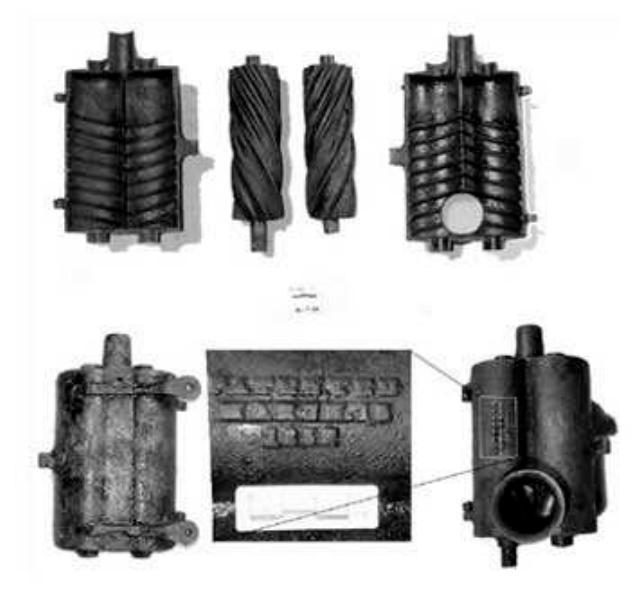
Interior and exterior of meat grinder from the Brother Jonathan crate.

Four cast-iron meat grinders were excavated in spring 2001. During fall 2001, surface debris and concretion were removed and all components were disassembled, permitting examination of the interior of the grinders. Most of the metallic iron in the grinders has corroded, leaving only a graphite skeleton of the artifact. Unfortunately, during cleaning, a small piece of the grinder disinteg1rated. Research shows that the missing piece was a blade that ran down the center of the mincer between the rollers.

The exterior casings of the meat grinders have little remaining iron, while the interior cylinders are better preserved. It should be possible to conserve the rollers using sodium sulfite. As long as the mostly graphitized casing retains some level of magnetism, indicating the presence of metallic iron, the same treatment can be used on these components.

Conservation of two grinders, one large and one small (BJ-17-25 and BJ-17-27), began in February 2002. After three months in three warm baths of sodium sulfite, the pieces were rinsed and placed in deionized water. Upon completion in May, the results were found to be excellent. The treatment removed remaining concretion and only the casing stuffer of the small grinder exhibits a slight degree of degradation. After several boiling baths to remove remaining chlorides, the pieces were painted with three coats of tannic acid. The final step of this process was to coat the pieces in microcrystalline wax. Conservation of the two remaining grinders will begin in fall 2002.

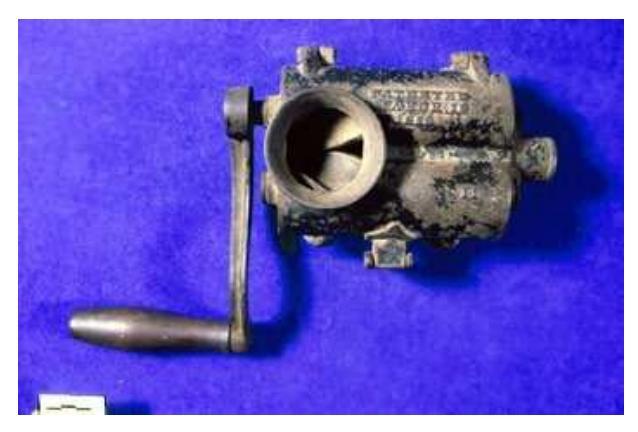
Meat grinder purchased through online auction for comparative research.

Through an online auction, Dr. Hamilton purchased a working example of a small grinder similar to those recovered from the crate. This antique will be used for comparative purposes. This grinder has one essential feature that was lost on the *Brother Jonathan* grinders: it contains the blade in the center of the mincer. By molding this blade, a replica cast will be made for the *Brother Jonathan* grinders.

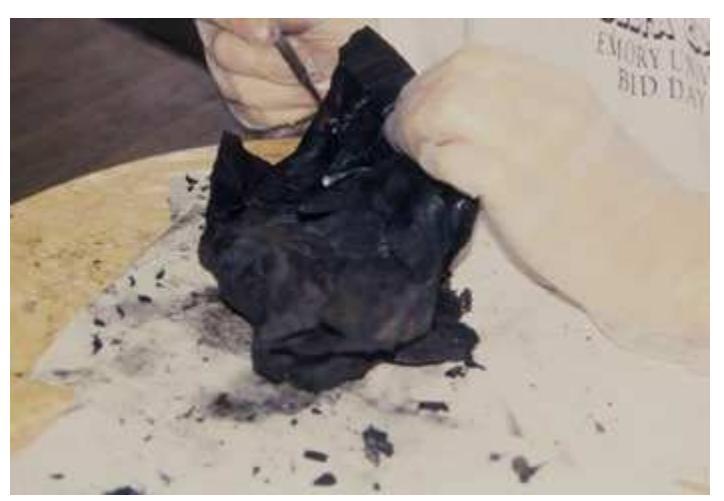
Unwrapping and cleaning a paper-wrapped package of plumb bobs.

The intact package was put through a standard series of dehydrations baths used at the Conservation Research Laboratory. The treatment solution consists of silicone oil (SFD1) with 35% methyl trimethoxysilane (MTMS) by volume added as a crosslinker. The package was immersed in the silicone oil solution and placed under a vacuum.

After cleaning and documentation of the entire package, it was slowly and carefully unwrapped. After unwrapping, the brass plumb bobs were removed. The silicone was polymerized in the paper with the addition of a catalyst. The reconstruction of the package is ongoing. Torn pieces will be glued together using butcher paper as a backing instrument. During this process, the shape of the package has been maintained by carved foam replicas of the plumb bobs.

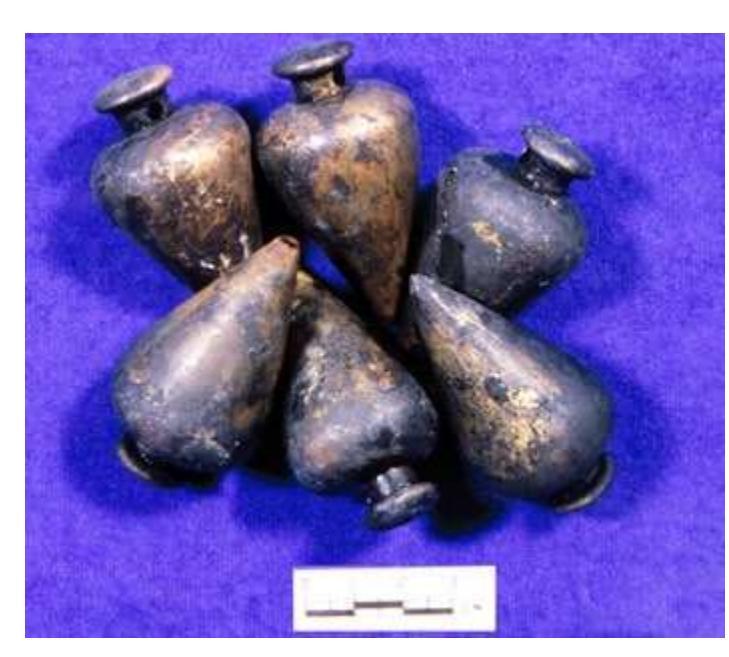
Examples of brass plumb bobs from the crate.

The plumb bobs are brass with steel tips. Due to galvanic action in the saltwater environment, the tips of the plumb bobs were lost. Reproductions of the steel tips will be cast in epoxy resin. The brass component of the plumb bobs are currently undergoing electrolytic reduction. Careful monitoring during summer 2002 will insure that treatment can be completed during fall 2002.

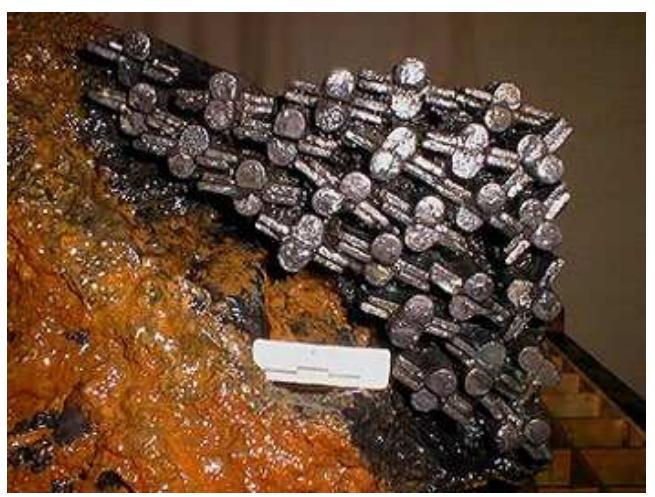
Arrangement of door rails within the crate.

The total artifact count for this lot is 50, comprising 25 pairs of rails. Each pair was wrapped at an angle with a single sheet of lightweight paper. The placement of the rails in the crate provides further evidence that the crate is being excavated upside down. During removal, the uppermost pair was always wedged under the next pair. If the crate were to be turned "right side up", the top pair would be free and not wedged under another.

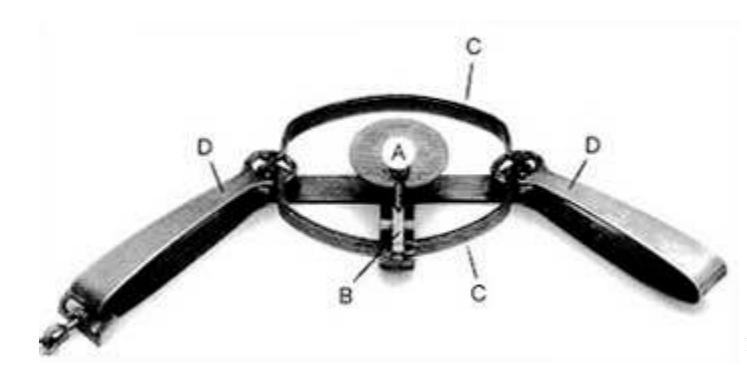
Parts of a long spring trap.

The second layer of the east half of the crate contained many voids left by corroded iron artifacts. Epoxy was used to cast all voids. Lot BJ-17-18 consisted of two obvious shapes: a horizontal, hollow, flat, rectangular piece with holes and a thin V-shaped piece containing some intact metal. Following casting, cleaning, and research, it is believed that these pieces belong to a set of long spring traps. The V-shaped portion (D) of the trap is the spring; each trap has two.

While no intact metal remained in the bases, some metallic iron was preserved in the springs. Because the springs needed to be flexible, they were forged using higher-quality iron than was used for the base pieces. Curved cavities with a central ridge were uncovered along the east edge; these have also been cast in epoxy. These are the jaws of the trap (C). There are no teeth on the jaws, suggesting that the traps were intended for hunting small animals.

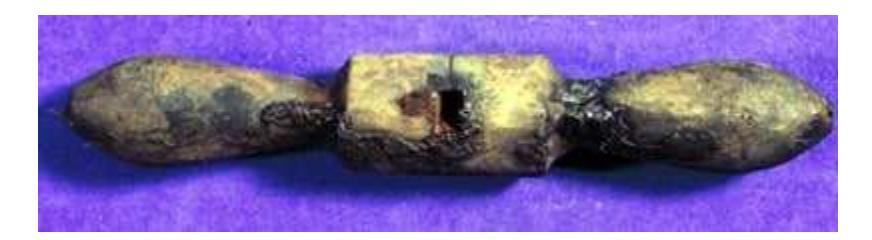
Wooden tool handle (BJ-17-43), possibly for an auger.

One wooden tool handle (BJ-17-43) shaped like a small rolling pin was discovered in late spring 2001. Removal of the cast iron rails (BJ-17-41) exposed other similar pieces. The metal portion of the tool was cast in epoxy. Instead of the expected spiral auger shape, the tool cavity had a square cross-section with a 30° twist 2 cm below the handle. Four other auger handles were removed, and four more remain in the crate. At least three different sizes of handles can be distinguished. Some of the tools may be bunghole borers, used by coopers in manufacturing casks and barrels.
